# NATIONAL TRANSPORTATION SAFETY BOARD

## AIRCRAFT ACCIDENT REPORT

EXPLOSIVE DECOMPRESSION--  
LOSS OF CARGO DOOR IN FLIGHT  
UNITED AIRLINES FLIGHT 811  
BOEING 747-122, N4713U  
HONOLULU, HAWAII  
FEBRUARY 24, 1989

**Adopted: March 18, 1992  
Notation 5059C**

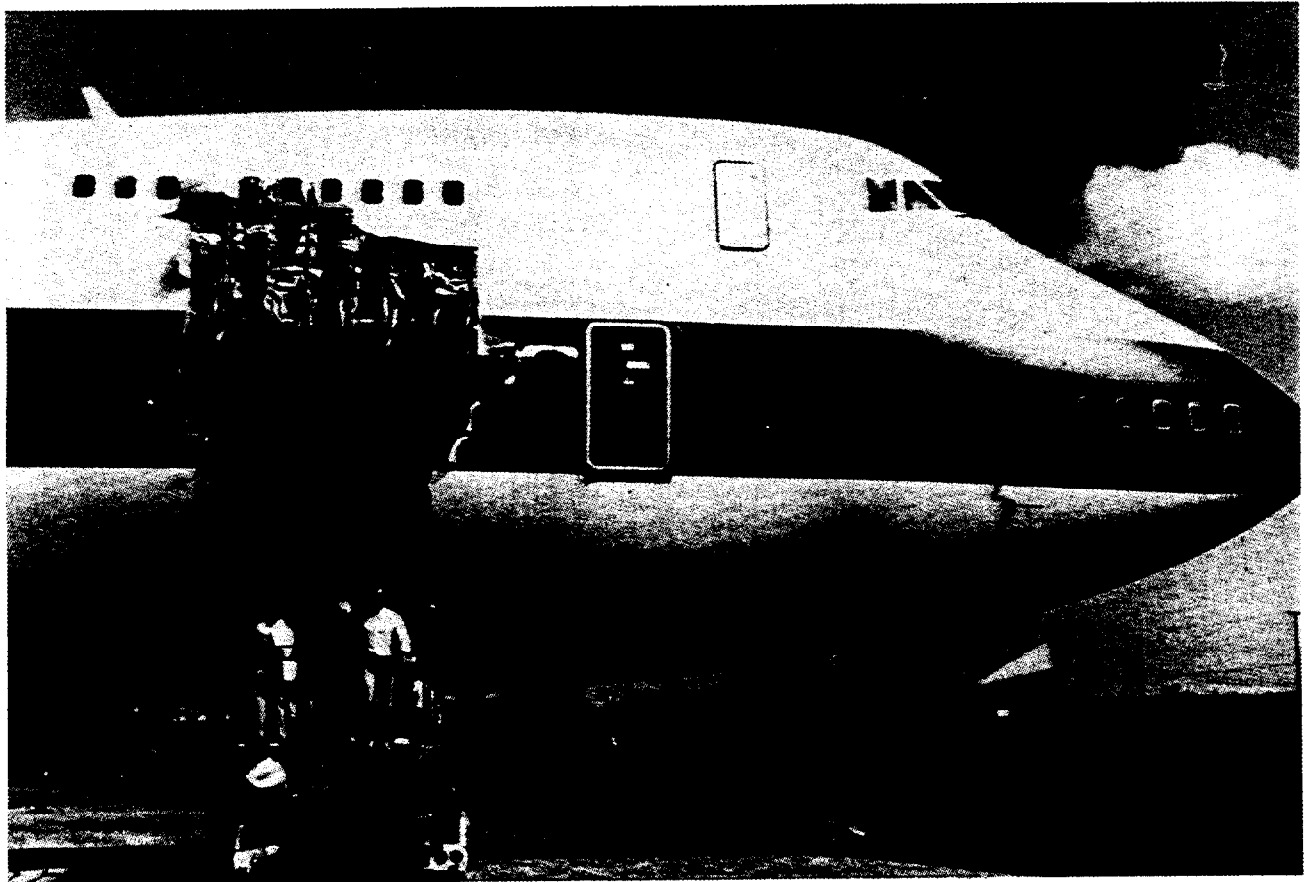
The primary damage to the airplane consisted of a hole on the right side in the area of the forward lower lobe cargo door, approximately 10 by 15 feet large. The cargo door fuselage cutout lower sill and side frames were intact but the door was missing (see figures 1 and 2). An area of fuselage skin measuring about 13 feet lengthwise by 15 feet vertically, and extending from the upper sill of the forward cargo door to the upper deck window belt, had separated from the airplane at a location above the cargo door extending to the upper deck windows. The floor beams adjacent to and inboard of the cargo door area had been fractured and buckled downward.

Figure 1 .--Overall view of forward cargo door area  
on the right side of the aircraft.

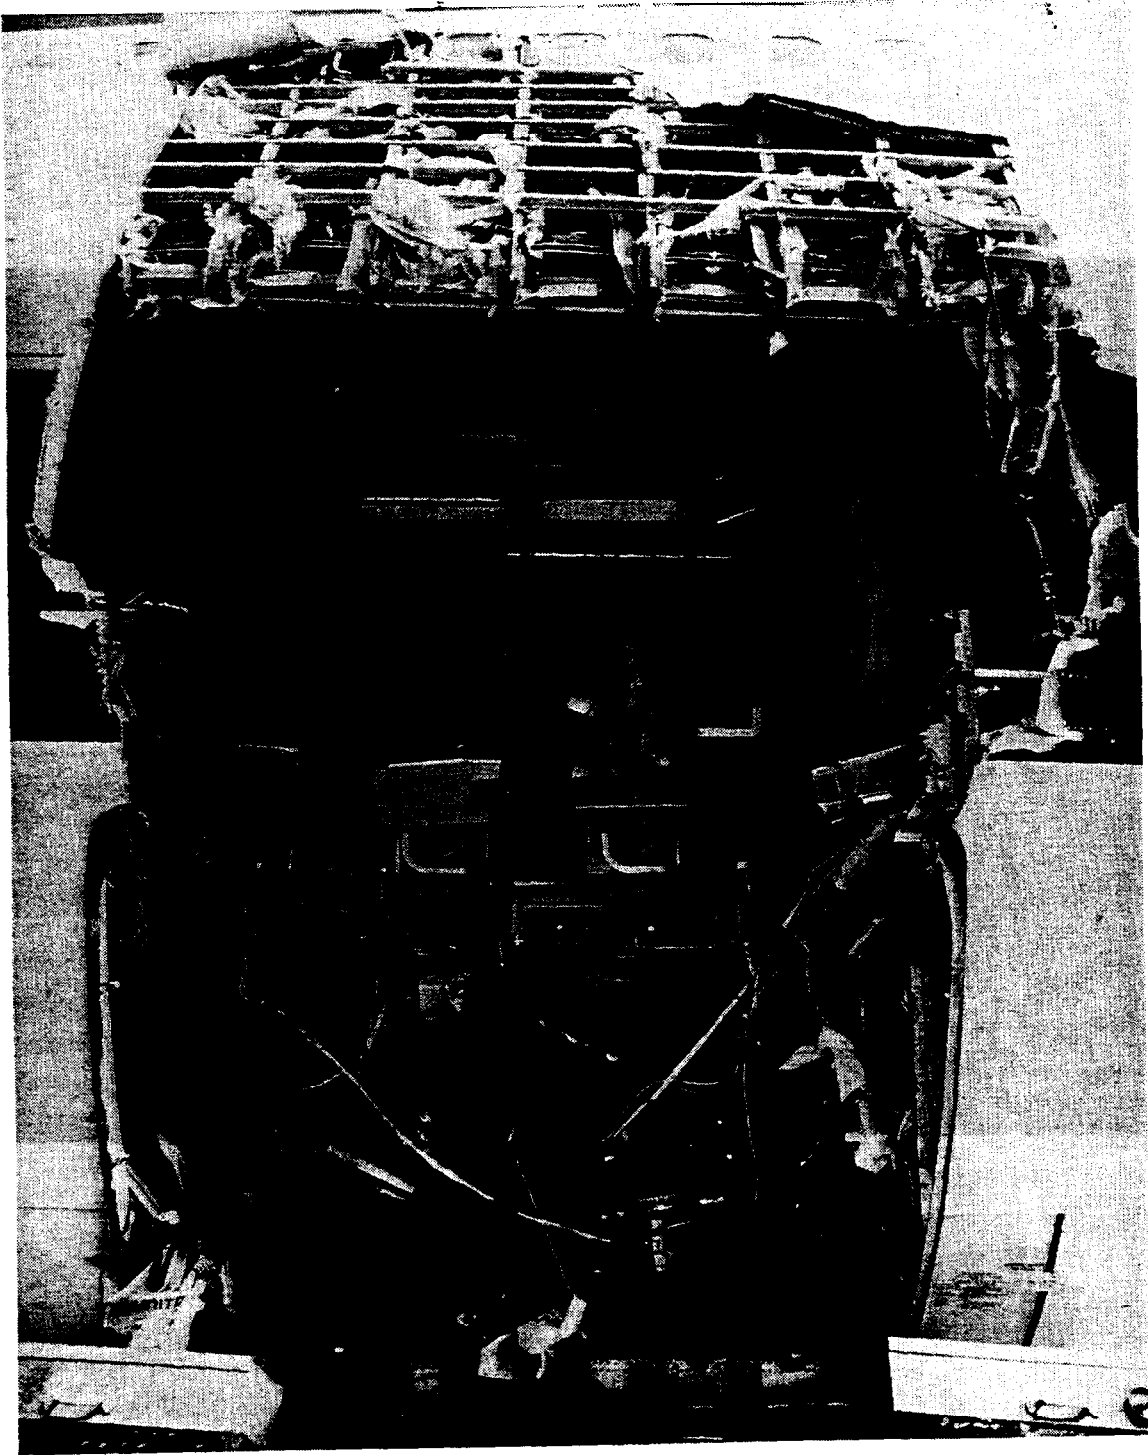
Examination of all structure around the area of primary damage disclosed no evidence of preexisting cracks or corrosion. All fractures were typical of fresh overstress breaks.

Figure 2.--**Close-up** view of hole and surrounding structure damage.

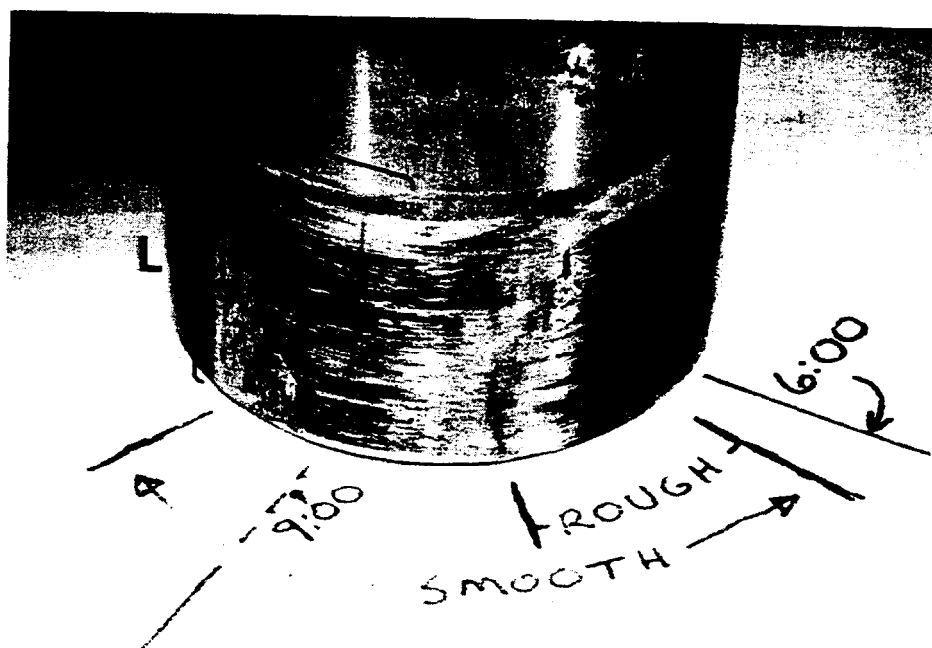
Based on the orientation of the latching mechanisms, the fully unlatched latching cams would first contact the latch pins from about the 1:15 o'clock position to the 7:15 position as the door was closed. As the cams are being latched around the pins, they would rotate approximately **80°**, making contact with the pins from about the **4:15** position to the **10:15** position (See figure 7).

Figure 7.--Latch pin number 6. Note the rough and smooth areas and the steps indicating the contact area with the latch cam.

Detailed examination of the exposed surface of the pins (the portion of the pins extending from the housings) revealed various types of wear and damage. In general, all of the forward door cargo latch pins had smooth wear over the entire portion of the pin area contacted by the cams during normal closing and opening of the door. The pins also had distinct roughened (smeared) areas between the 6:15 and the 7:30 positions (See figure-8). The roughened areas had evidence of “heat tinting” and transfer of cam material to the surface of the pins. On pins 1 and 8 the roughened areas extended past the pin bottom to the 5:00 position. The 7:30 position approximately corresponds to the area on the pin where the lower surface of the cam would be relative to the pin when the latch cams are in the unlatched or nearly unlatched position.

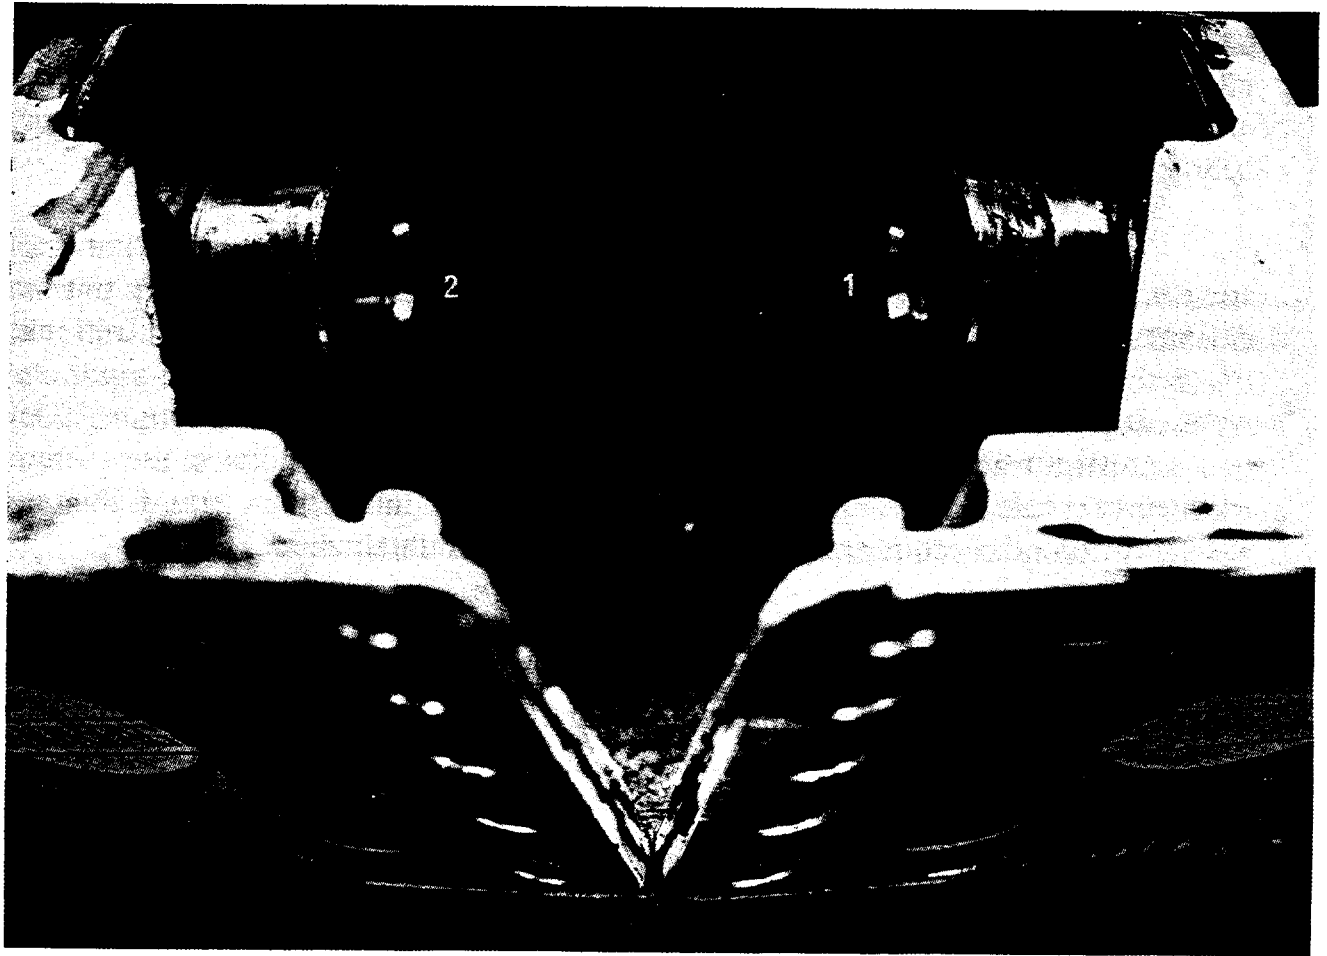
Figure 8.--**Lower** latch pin and housing assemblies  
Nos. 1 and 2 looking up and slightly outboard.

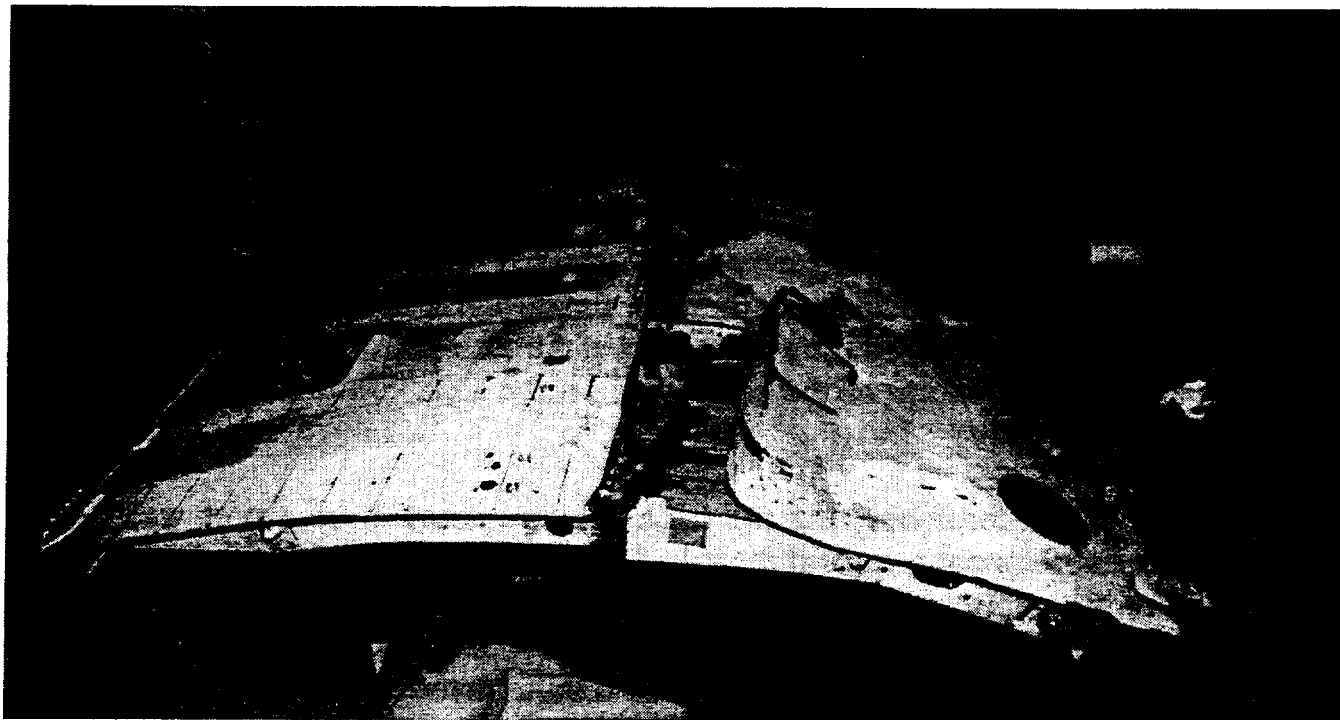
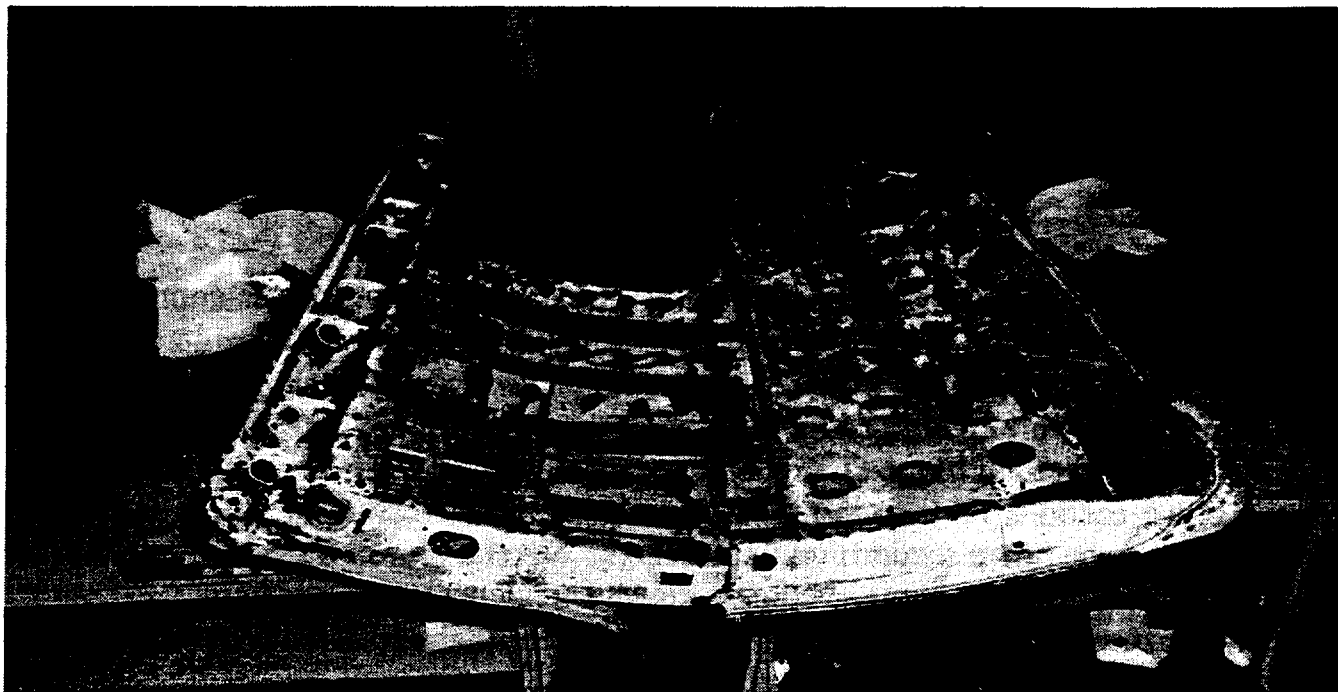
The cargo door had fractured longitudinally near the mid-span lap joint near stringer 34R, just beneath the mid-span torque tubes. Except for an area of missing skin between frames 2 and 3 and a portion of frame webs where the upper latch lock torque tube had torn out, the frames and skin of the upper door

piece mated to the lower door piece.<sup>2</sup> Several areas of the upper door skin along the longitudinal fracture were bent back. In addition, a large area of lower door skin between frame 6 and the aft door edge had peeled downward from the fracture line. The two door pieces are shown together in Figures 9 and 10. Examinations of the fracture surfaces of the skin and frames revealed no evidence of **pre-existing** cracks. All fractures were typical of overstress separation.

Figures 9 and 10.--Exterior [top photo] and interior bottom photo] views of cargo doors after removal of pull-in hooks, latch cams, lock sectors, and actuators.

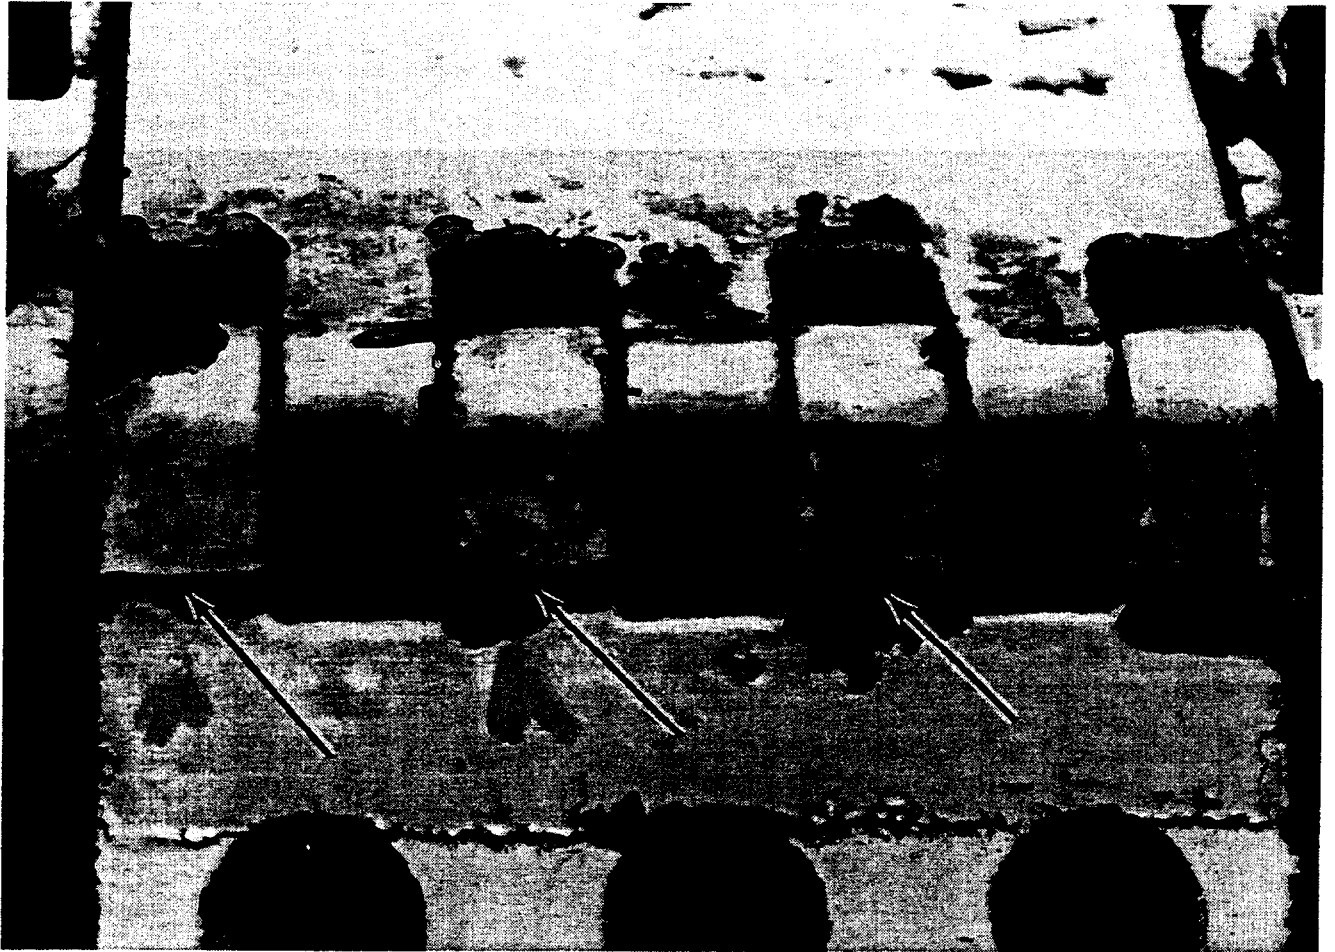
Figure 14.--Close-up view of cargo door hinge section.  
**Arrows** show impressions caused by contact with opposite hinge section.

were slightly bent. The upper flange of the door, to which the door hinges are attached, was not deformed. The forward cargo door can rotate open 143 degrees before the hinge would deform, permitting the door to contact the fuselage above.

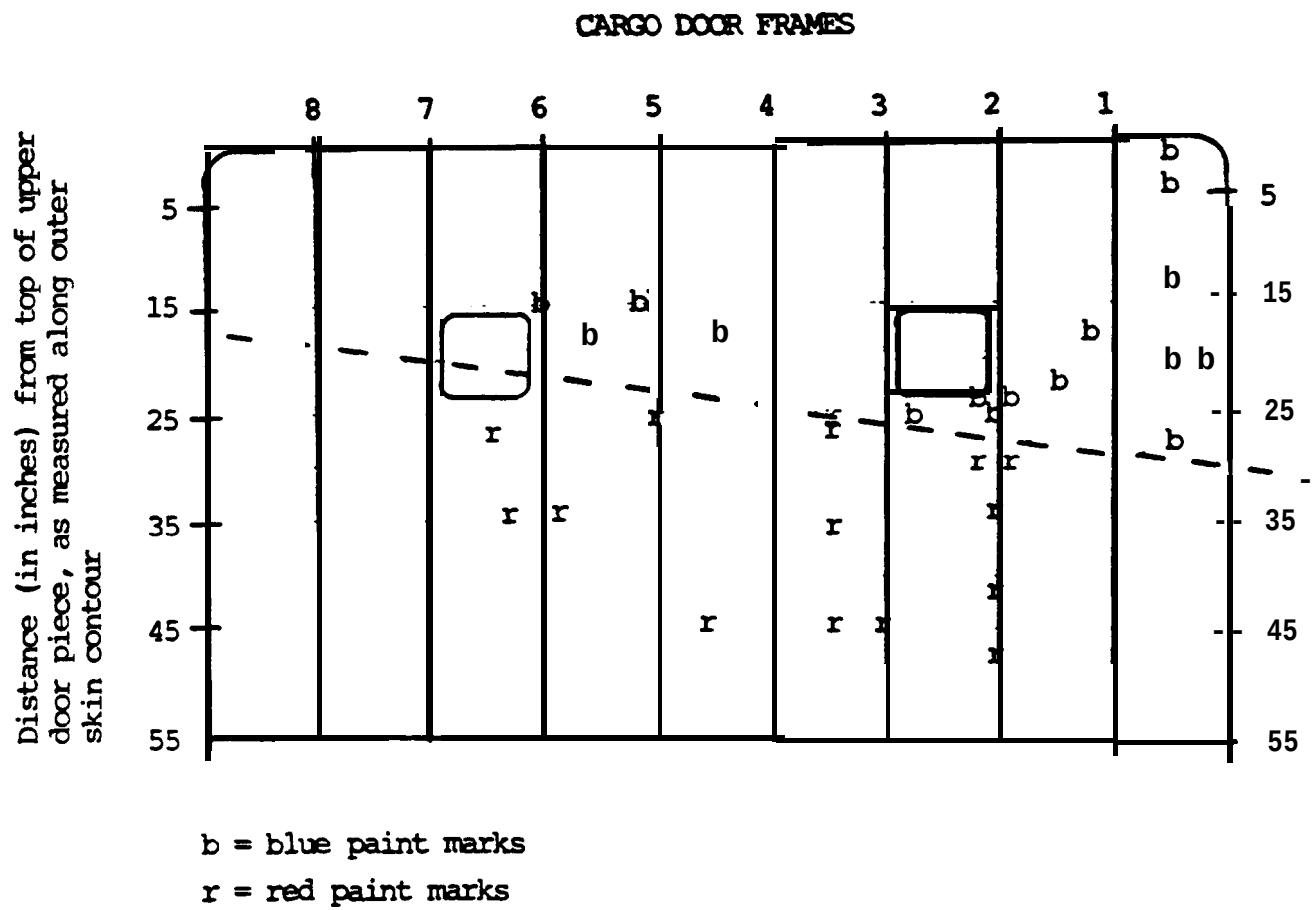
Figure 15.--Documented paint marks on outer skin of upper door piece.  
Dashed line is approximately 8 degrees from horizontal.
