AIRCRAFT ACCIDENT REPORT 4/90

Air Accidents Investigation Branch

**Report on the accident to
Boeing 737-400 G-OBME
near Kegworth, Leicestershire
on 8 January 1989**

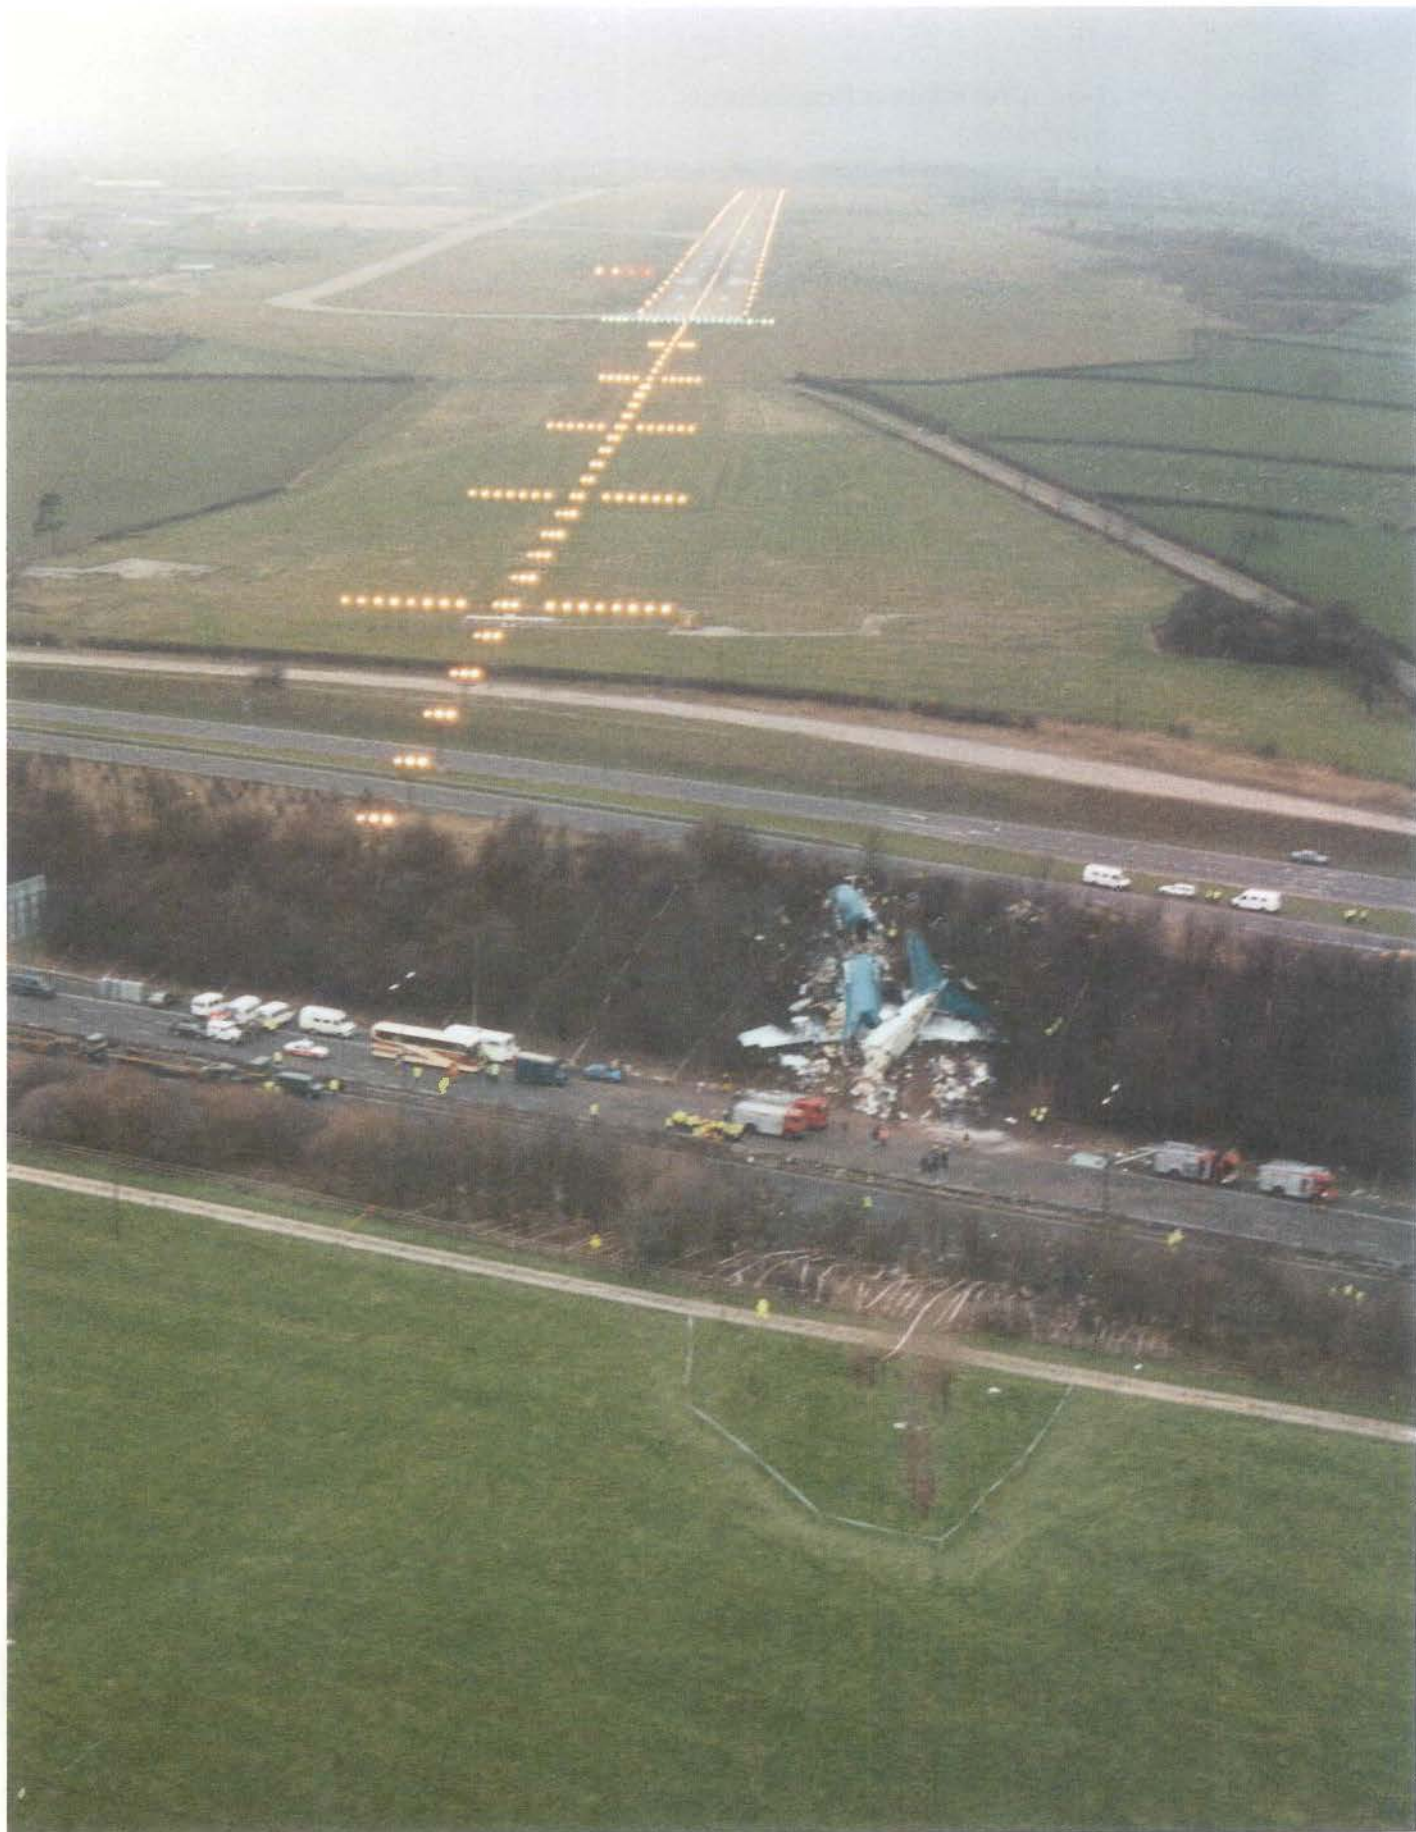
FIG 1: SHOWING CRASH-SITE OF G-OBME

G-OBME suffered severe impact damage and the fuselage broke into 3 main sections (Fig 1). The nose section travelled the greatest distance up the western embankment of the M1, the centre-section remained upright with the wings attached and the tail-section buckled over, and to the right of, that section of fuselage just aft of the wing.
