# AIRCRAFT ACCIDENT REPORT

**NORTHWEST AIRLINES, INC.**

**Boeing 720B, N724US**

**February 12, 1963**

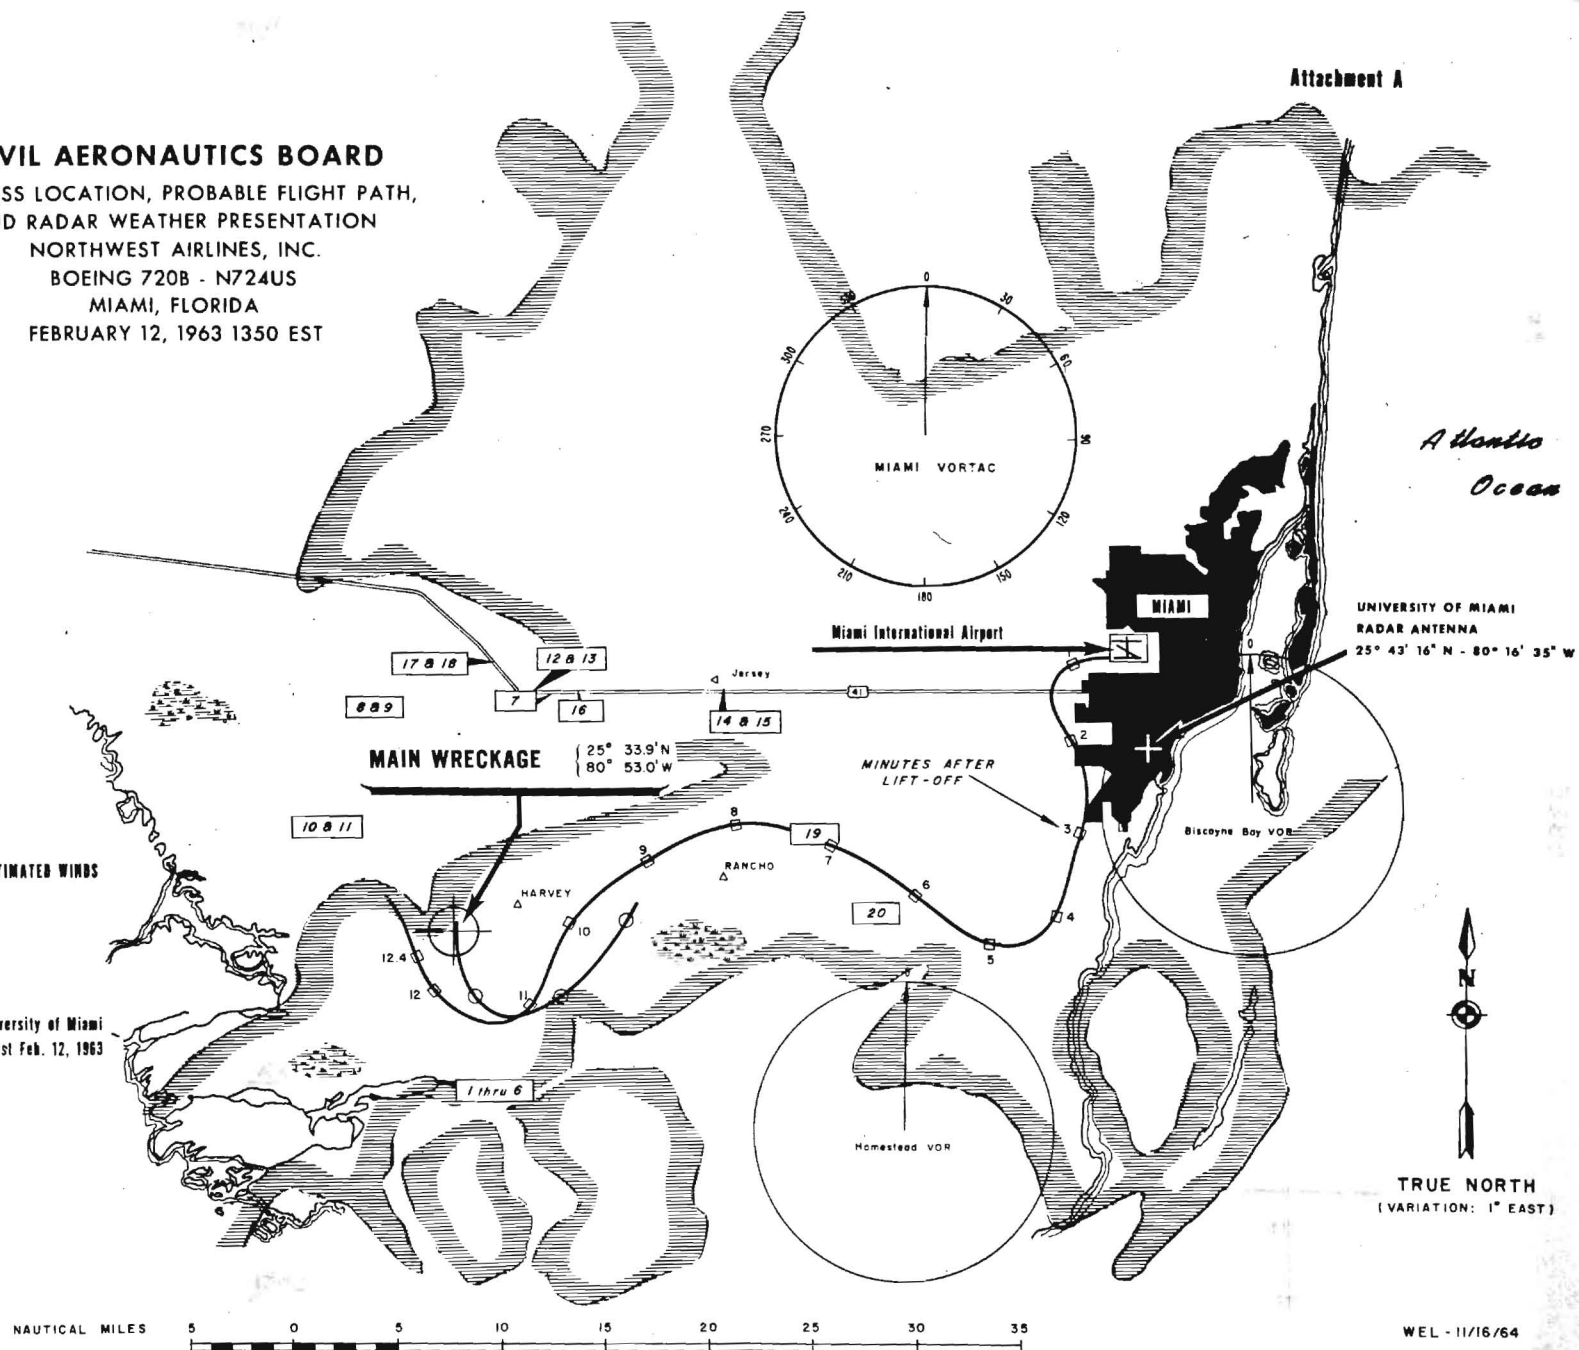
- MIAMI CENTER RADAR PLOT
- FLIGHT TRACK BASED ON ESTIMATED WINDS
- 889 WITNESS LOCATIONS
- WEATHER RADAR PLOT

NOTE: Weather based on photograph of University of Miami radar scope with +0.2° tilt at 1348 est Feb. 12, 1963

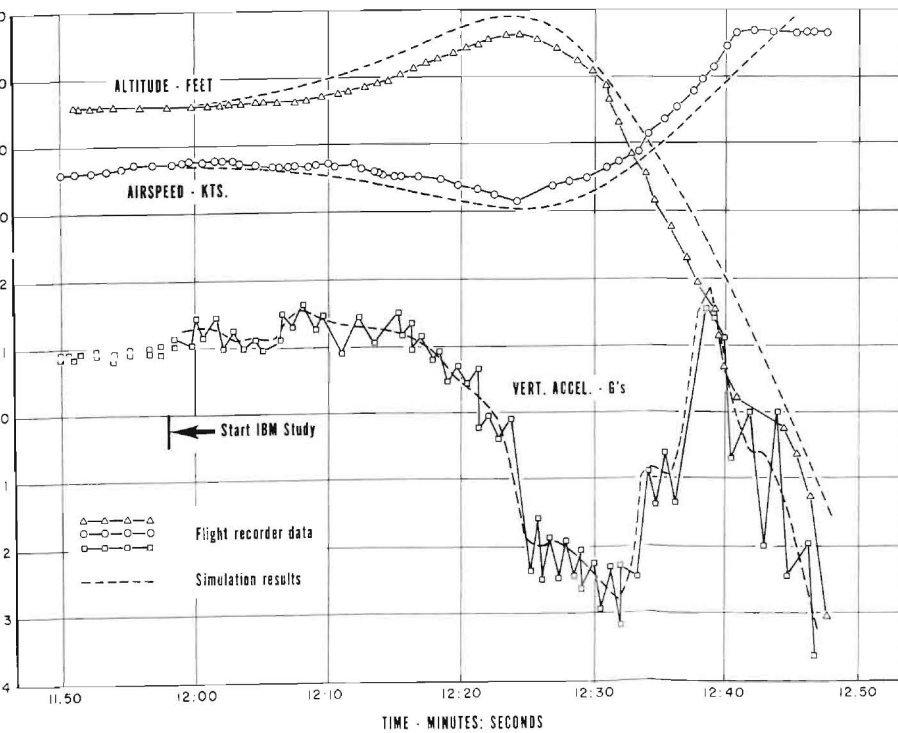
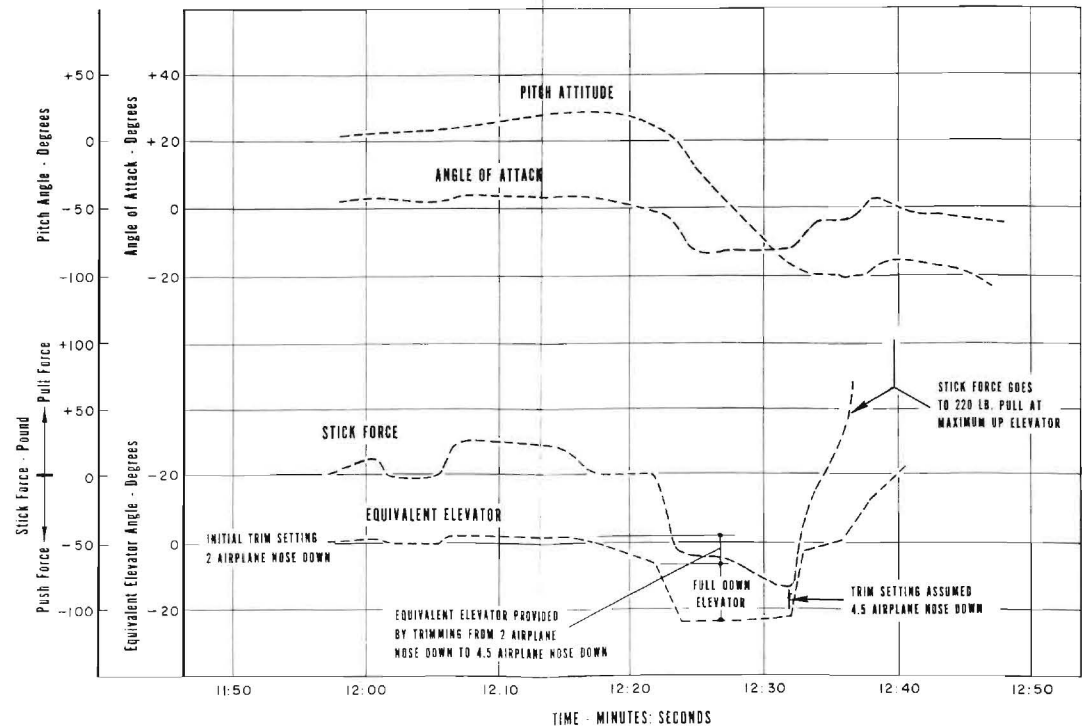
Attachment D  
 REFERENCE: Boeing Document D6-6135

COMPARISON OF TRACES FROM FLIGHT RECORDER AND FLIGHT PATH ANALYSIS

DATA FROM FLIGHT PATH ANALYSIS

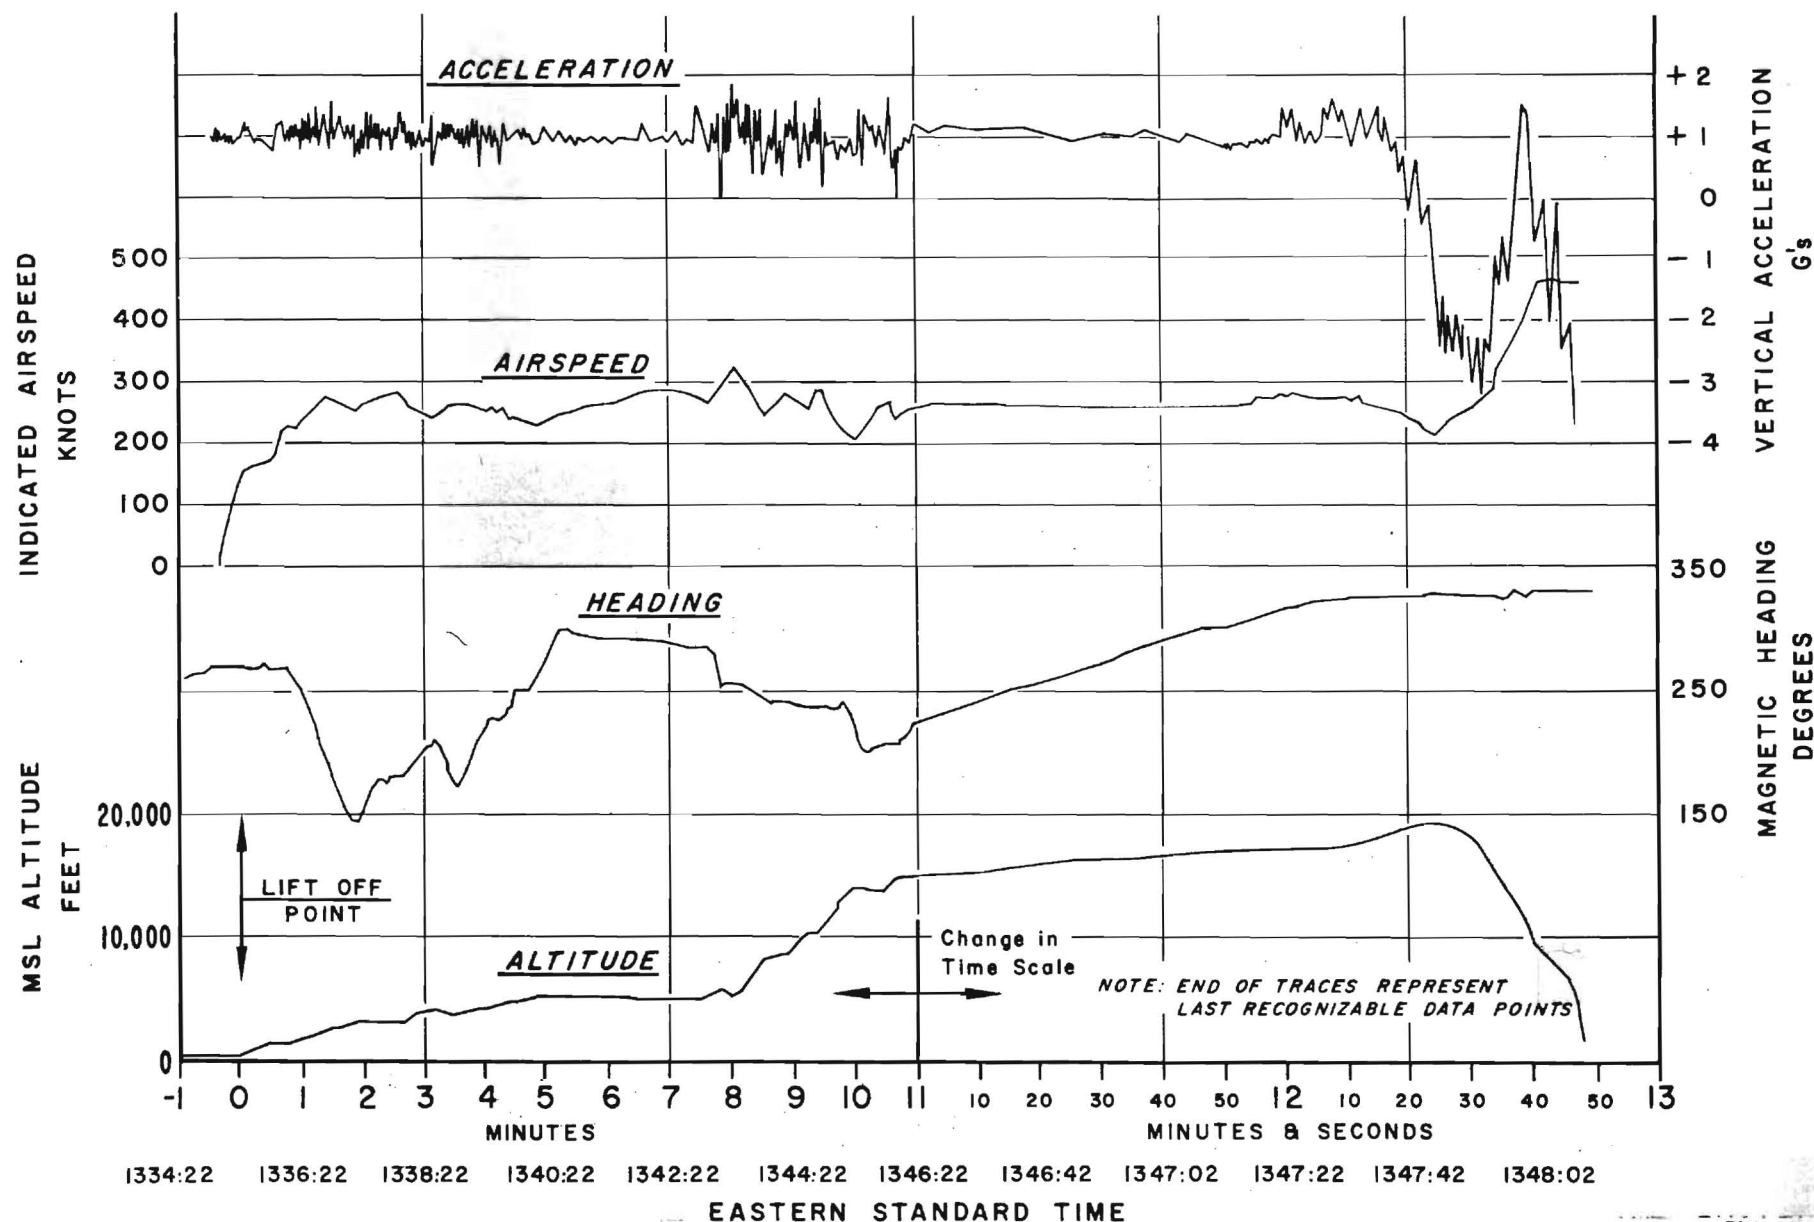
# CIVIL AERONAUTICS BOARD FLIGHT RECORDER DATA

The aircraft was equipped with a Fairchild flight recorder which scribes oscillographic traces of in-flight pressure altitude, indicated airspeed, magnetic heading, and vertical acceleration as a function of time. The read-out of the flight recorder tape from Flight 705 (See Attachment B) indicates that following lift-off at 1335:22, a series of turns to headings of south, southwest, west, and northwest were accomplished while climbing to 5,000 feet in light turbulence. At 1342:46, as a climb was begun, heavier turbulence was encountered for approximately three minutes, until a left turn to 200 degrees was accomplished just prior to the cessation of the large acceleration excursions. The indicated airspeed fluctuated from 320 knots to 210 knots, and the altitude increased from 5,000 feet to 15,000 feet. The aircraft continued climbing from 15,000 feet to 17,250 feet in a right turn which continued through 320 degrees while the climb ceased and altitude remained constant for about 12 seconds. At 1347:25 the altitude began increasing again and the rate of climb gradually increased to approximately 9,000 feet per minute at 1347:38. Following this the rate of climb decreased through zero at 1347:47 when the altitude peaked momentarily at 19,285 feet. During this climb the airspeed decreased from 270 to 215 knots and as the peak altitude was approached the vertical accelerations changed rapidly from 1G to about -2G. In the next seven seconds the negative acceleration continued to increase at a slower rate, with rapid fluctuations, to a mean value of about -2.8G, while altitude was lost at an increasing rate. As the descent continued with rapidly increasing airspeed, the acceleration trace went from the high negative peak to 1.5G, where it reversed again. In the last

nine seconds of the readout the altitude trace continued to decrease, the air-speed trace increased until the stylus hit the mechanical stop, the acceleration trace increased in a negative direction, and the heading remained fairly constant at 330 degrees. The final maneuver from the onset of the climb at 1347:25 lasted approximately 45 seconds.

FAIRCHILD FLIGHT RECORDER, SERIAL NUMBER 1071

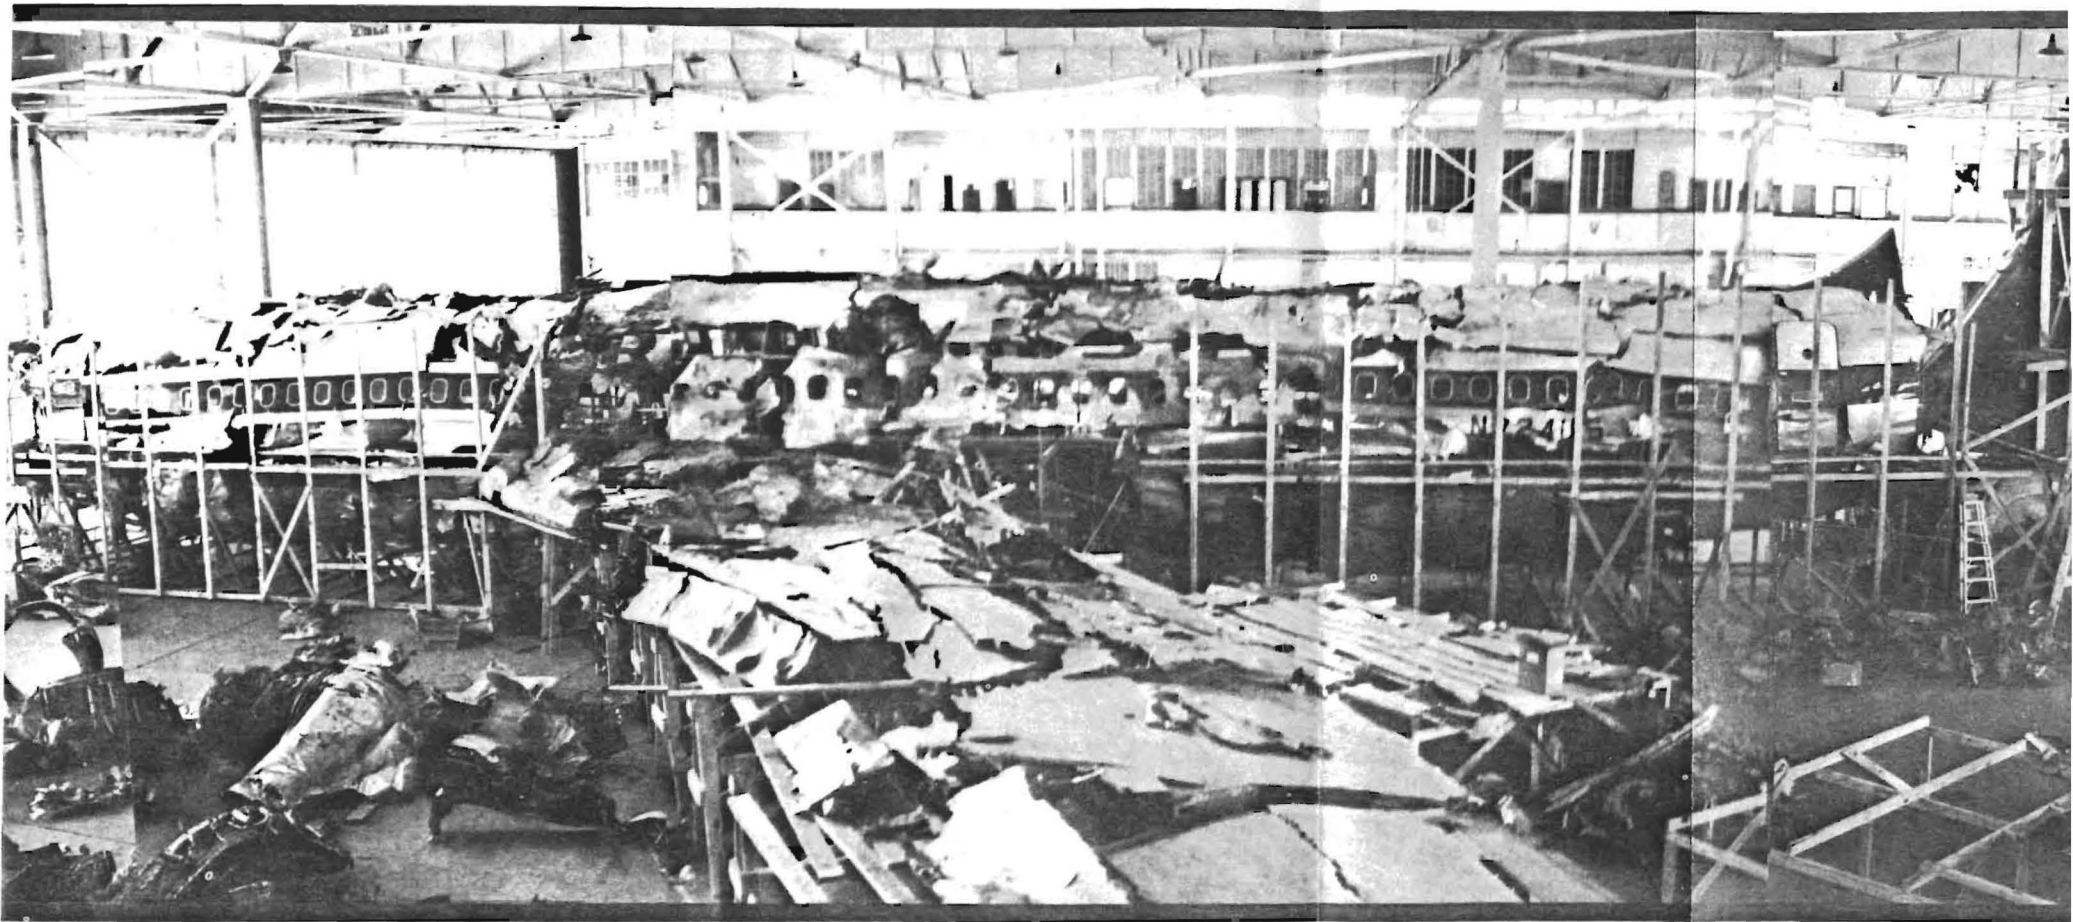
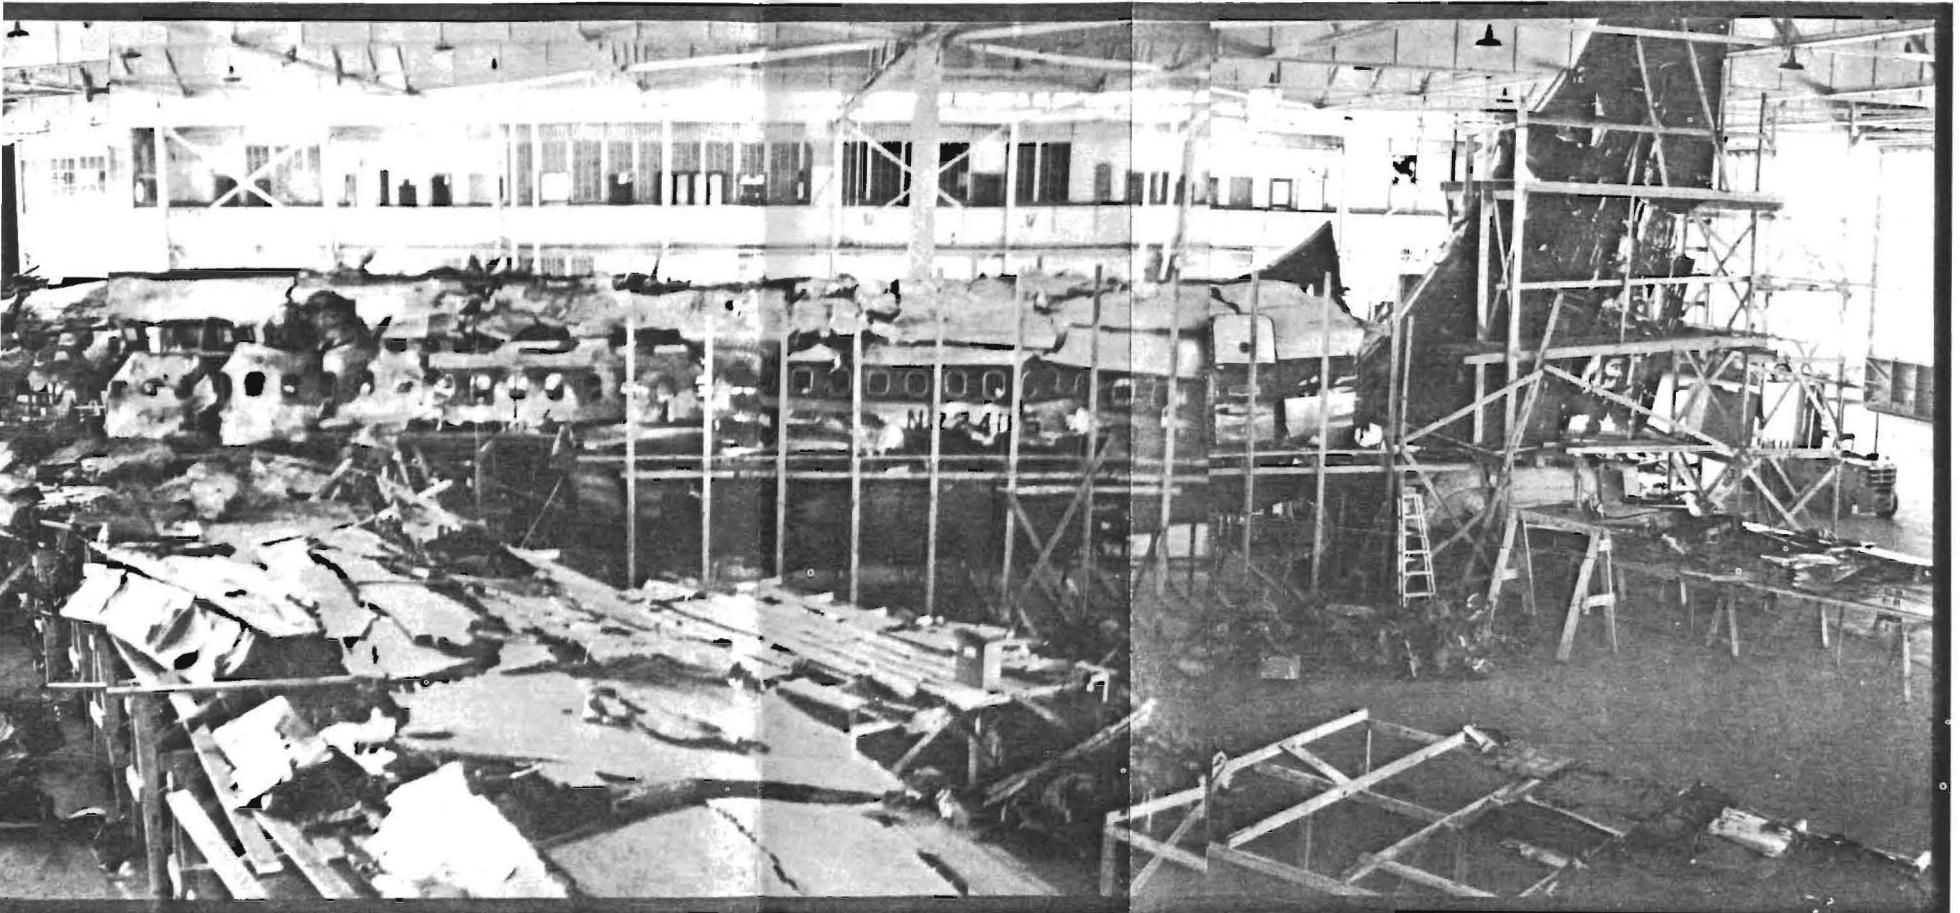
WRECKAGE MOCKUP

A mockup (see attachment C) of the aircraft was completed on April 1, 1963, and the detailed study, was resumed. The main failures in both wings and horizontal stabilizers were in a downward direction, and virtually symmetrical. The forward fuselage broke upward and the vertical stabilizer failed to the left. All four engines generally separated upward and outboard; however, certain peculiarities in the No. 3 engine separation generated considerable interest during the investigation. The reverser on this engine landed approximately 1,300 feet from the main engine section. The No. 3 engine also varied in that its final position was 150 feet on an azimuth of 015 degrees relative to its initial impact point. The other engines bounced approximately 40-45 feet on azimuths of 055, 080, and 060 degrees from their respective craters. Approximately four feet of the right wing, from the leading edge aft to the front spar, and inboard of the No. 3 nacelle, was broken away. Collision of the reverser with this leading edge section was indicated in the pattern of scratches found within the creases which resulted at ground impact. The main engine mount fractures were examined for fatigue, which might have resulted from damage sustained at the Fort Lauderdale accident,<sup>6/</sup> but none was found.
