# AIRCRAFT ACCIDENT REPORT

EASTERN AIR LINES, INC  
DOUGLAS DC-8, N8607  
NEW ORLEANS, LOUISIANA  
FEBRUARY 25, 1964

## SYNOPSIS

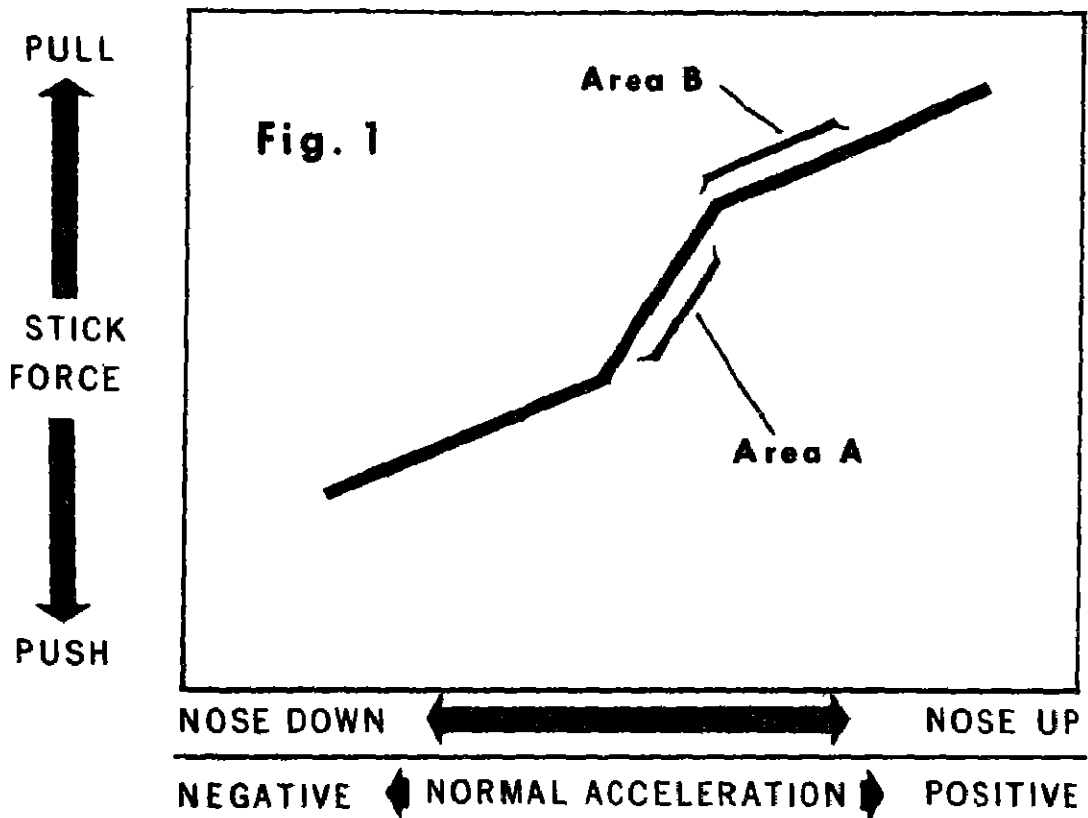
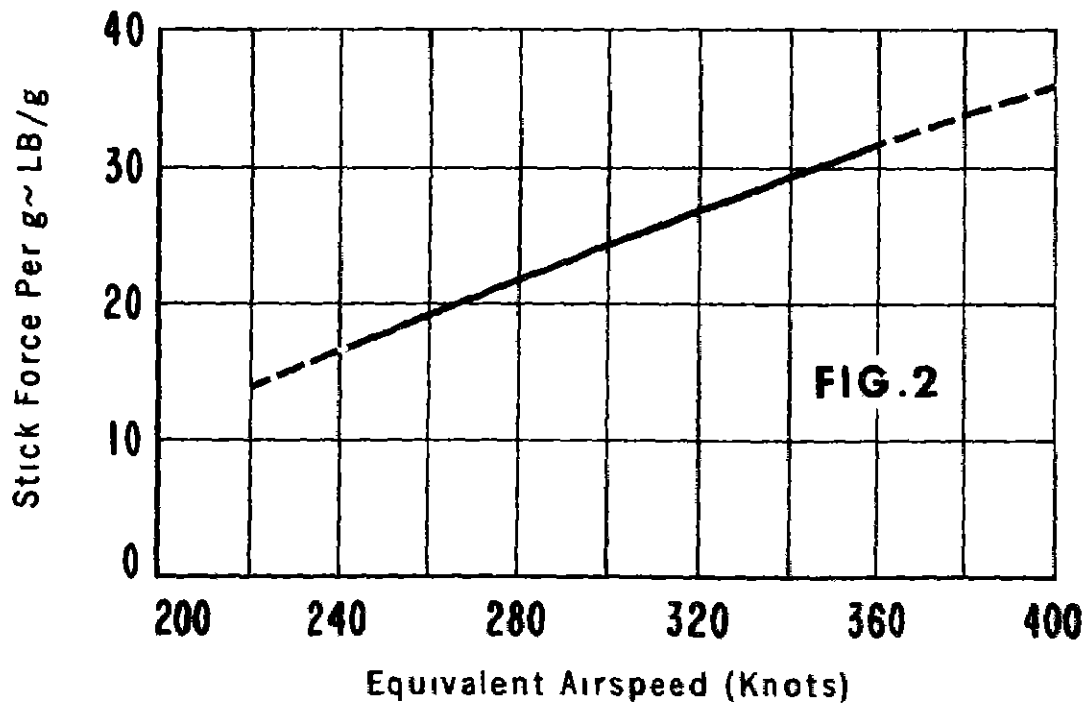
## ATTACHMENT C

The variation of stick force per g versus speed for the 2-degree AND case, shown in Figure 2 of Attachment C, is also significant. It should be noted that while the stick force per g is light but at a reasonable level at 310 knots, it degenerates to about 13 pounds at 220 knots. This level of force gradient is extremely light<sup>10/</sup> and is, to a large extent masked by the friction forces of the system which are about - 5 to 6 pounds. Thus, at 220 knots a pilot could maintain a 1.5-g maneuver without feeling any resistive force, or he could hold limit load (2.5-g) by feeling out only about 14 pounds, considerably less than required for a similar maneuver in a military fighter aircraft.
