NATIONAL  
TRANSPORTATION  
SAFETY  
BOARD

# AIRCRAFT ACCIDENT REPORT

EASTERN AIR LINES, INC.

L-1011, N310EA

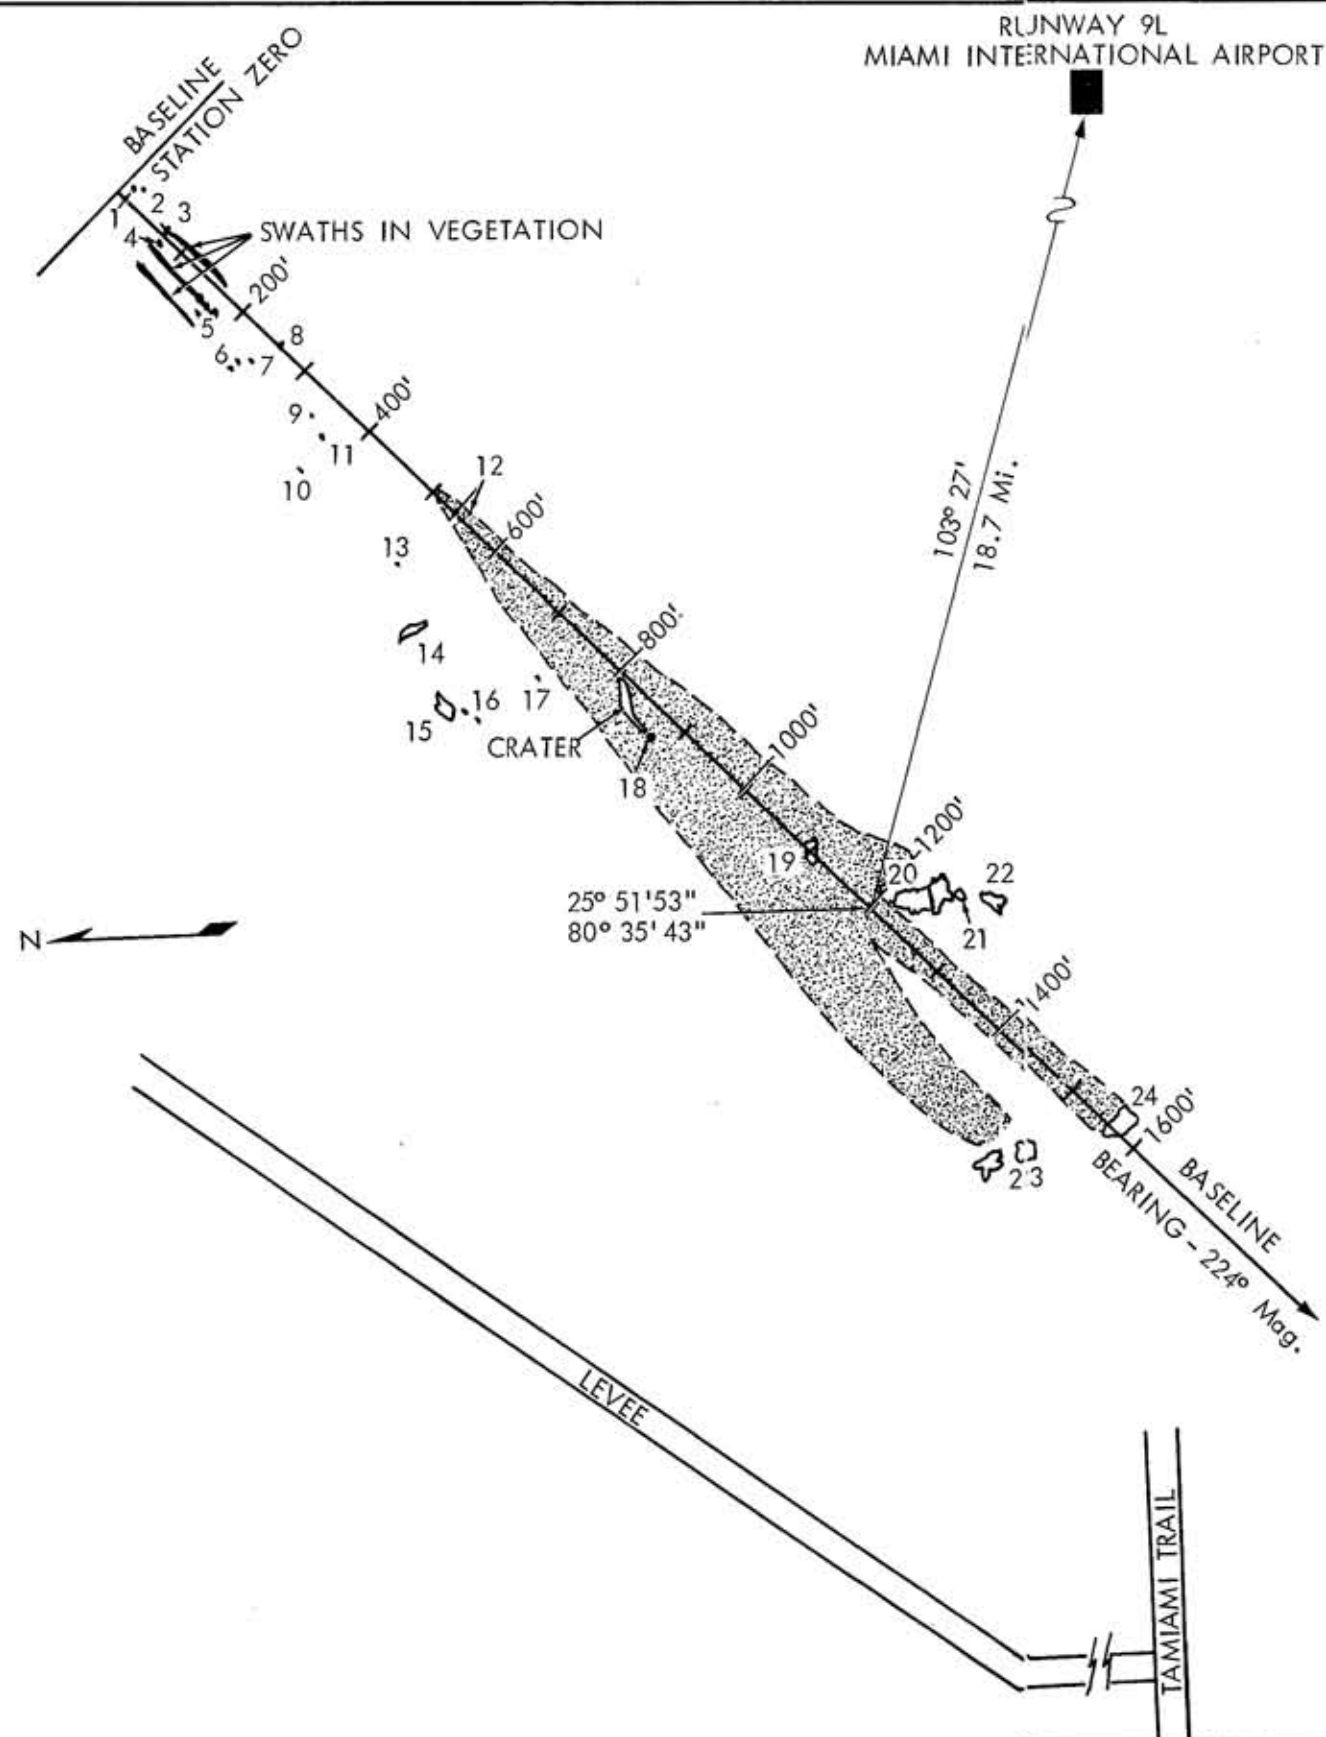
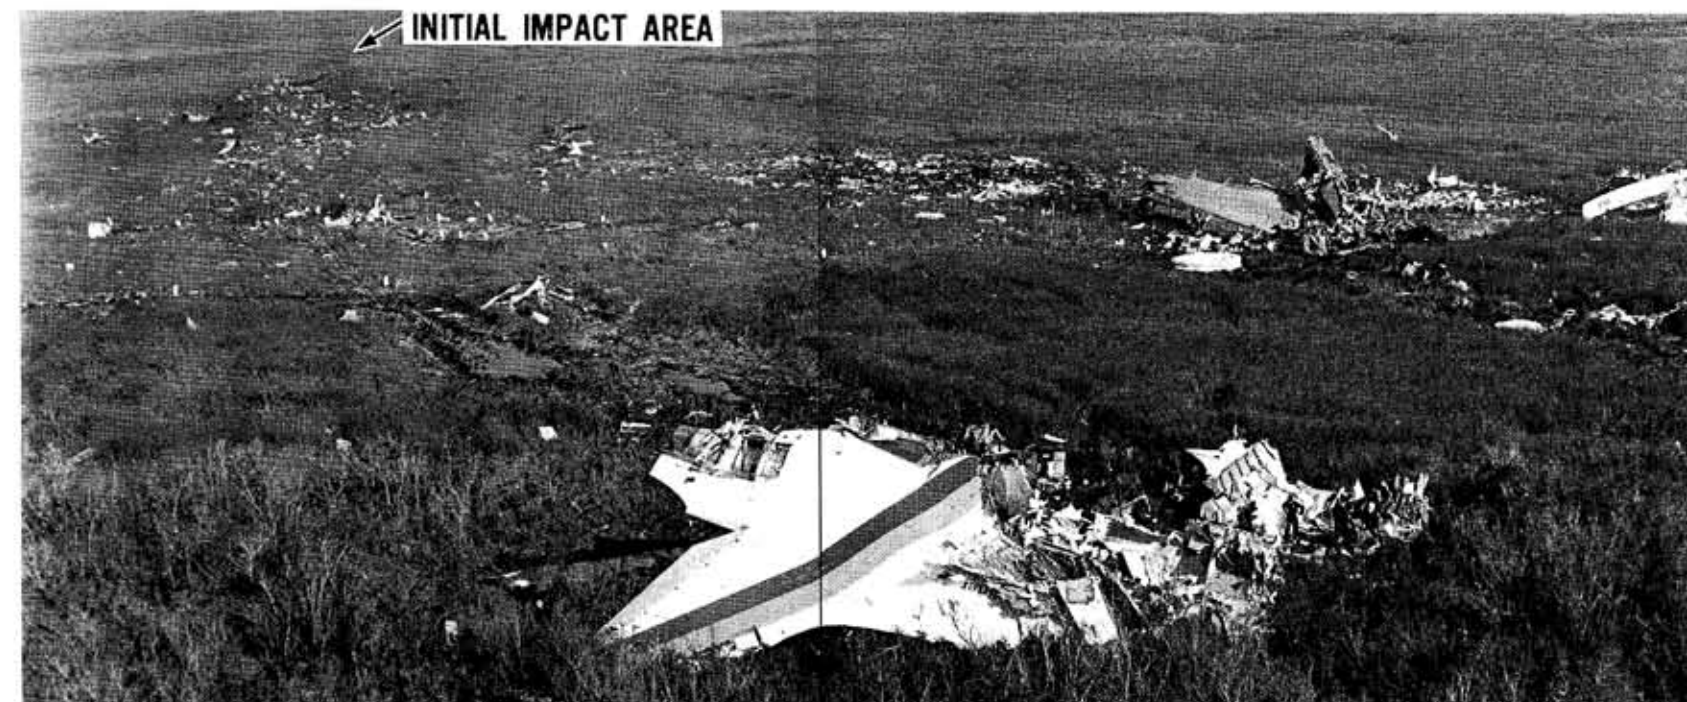
**WRECKAGE DISTRIBUTION CHART**  
**EASTERN AIRLINES, INC. L-1011, N 310EA**  
**NEAR MIAMI, FLORIDA**  
**December 29, 1972**

The left outer wing structure impacted the ground first; the No. 1 engine, and then the left main landing gear, followed immediately. The aircraft disintegrated, scattering wreckage over an area approximately 1,600 feet long and 300 feet wide. No complete circumferential cross-section remained of the passenger compartment of the fuselage, which was broken into four main sections and numerous small pieces. The entire left wing and left stabilizer were demolished. No evidence of in-flight structural failure, fire, or explosion was found.

- 1-4. Small pieces of left-hand Wing, outer structure.
5. Small Engine parts-2 fan blades, Oil cooler.
6. Engine mount frame, part of No. 1 fan case, oil scavenge filter.
