**AIRCRAFT ACCIDENT REPORT
92-11**

EL AL FLIGHT 1862

**BOEING 747-258F 4X-AXG
BIJLMERMEER, AMSTERDAM
OCTOBER 4, 1992**

on the accident with EI AI 1862
on October 4, 1992
at Amsterdam – Bijlmermeer

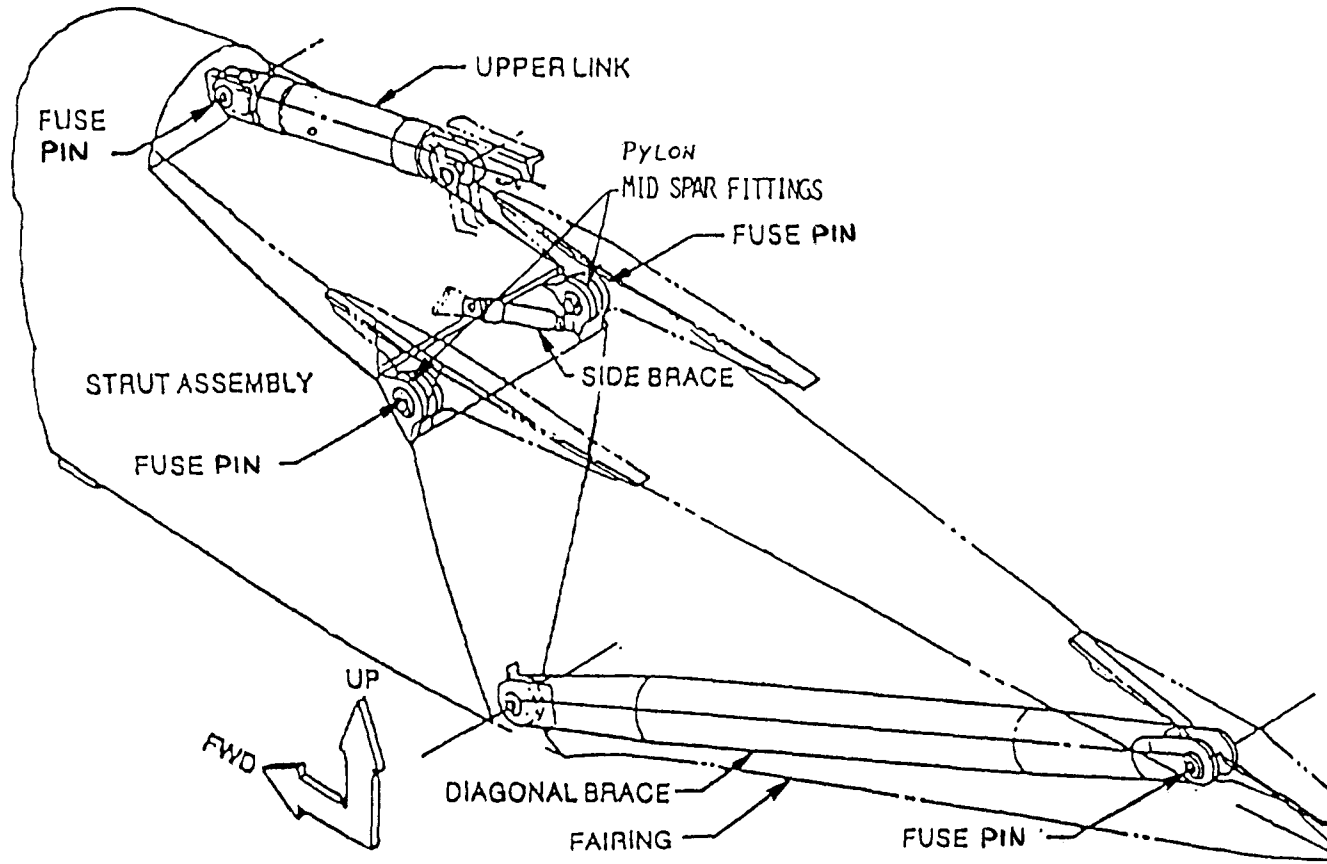
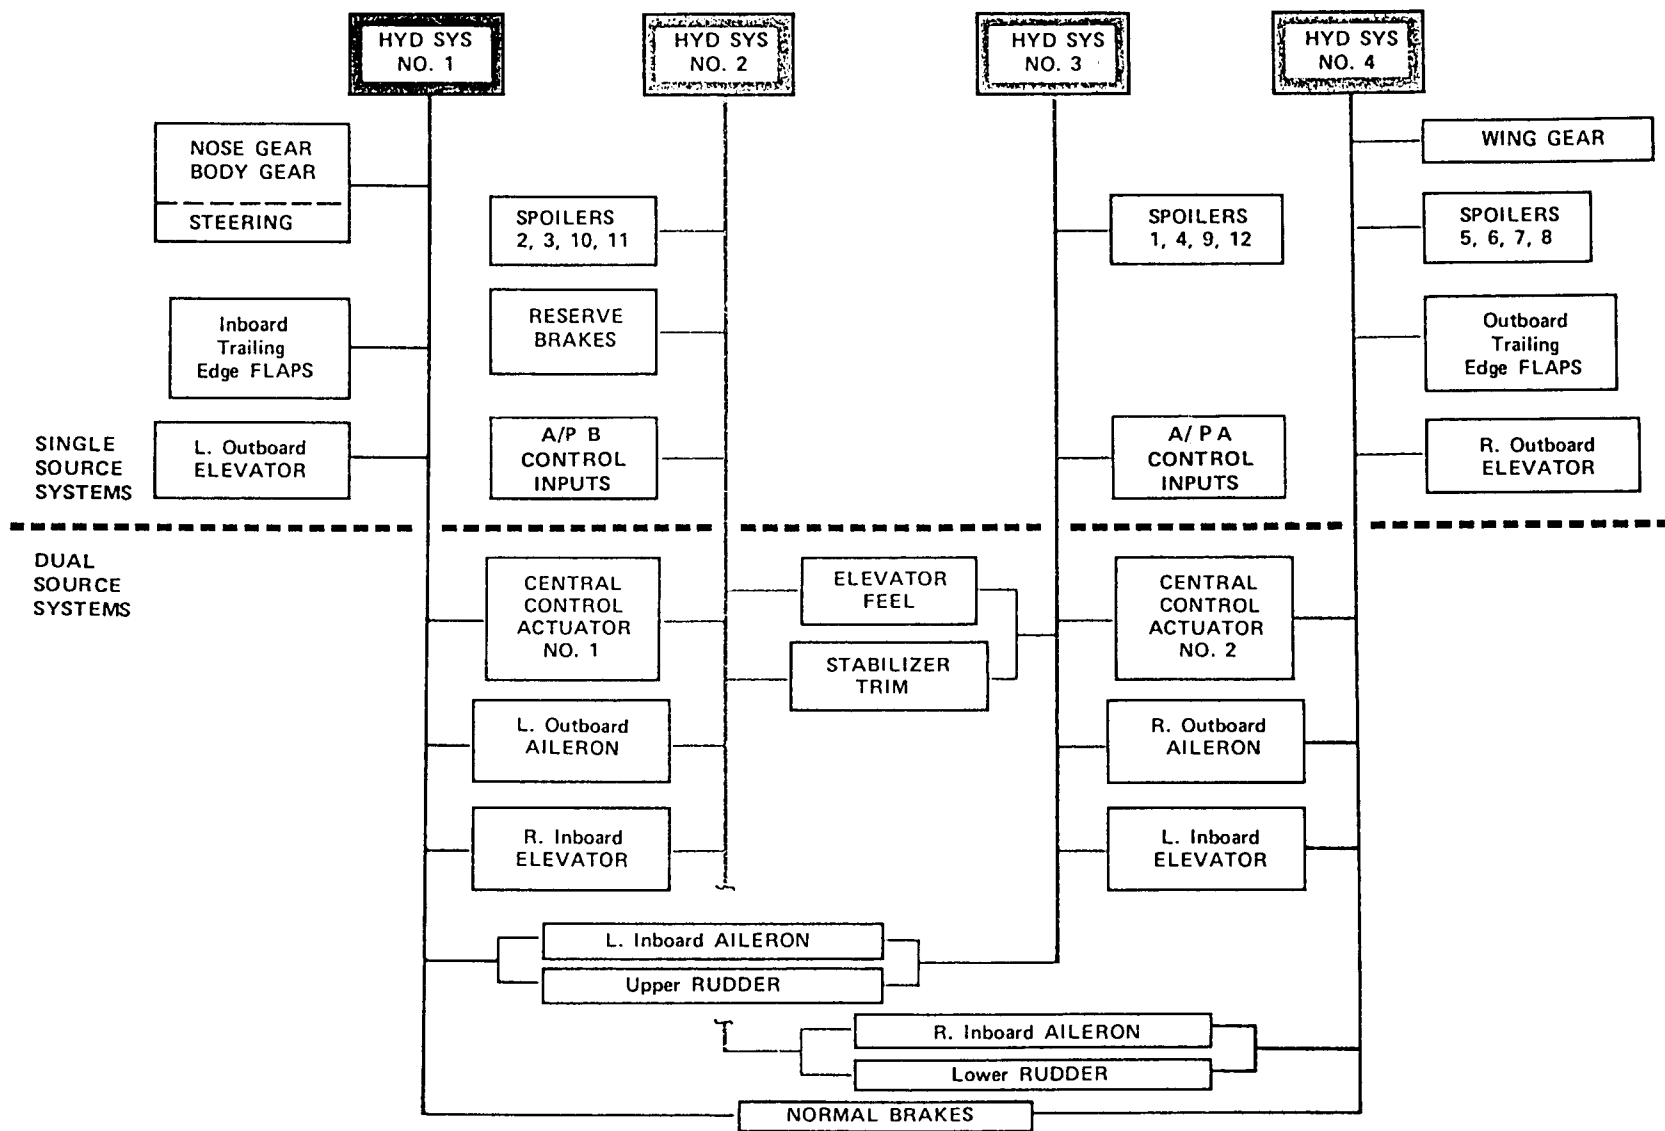
Figure 1. PYLON TO WING ATTACHMENTS RH WING

The design of the engine nacelle and pylon incorporates provisions that preclude a wing fuel cell rupture in case of engine separation, by means of structural fuses. A clean breakaway of the nacelle and/or pylon from the wing is ensured when the shearloading of the fuse pins exceeds the design load conditions.

The structural fuse concept utilizes hollow shear pins at the four wing attachment fittings between pylon and wing. The wing support structure and fittings have been designed sufficiently stronger than the fuse pins thus safeguarding the wing from structural damage in case of an overload condition.

The fuse pin at the forward end of the upper link, the aft end of the diagonal brace and at both midspar fittings are the primary fuse pins. The fuse pins at the forward end of the upper link and the aft end of the diagonal brace are designed to fail at a slightly lower load than the fuse pins at the other ends in order to assure a controlled separation of the pylon from the wing.

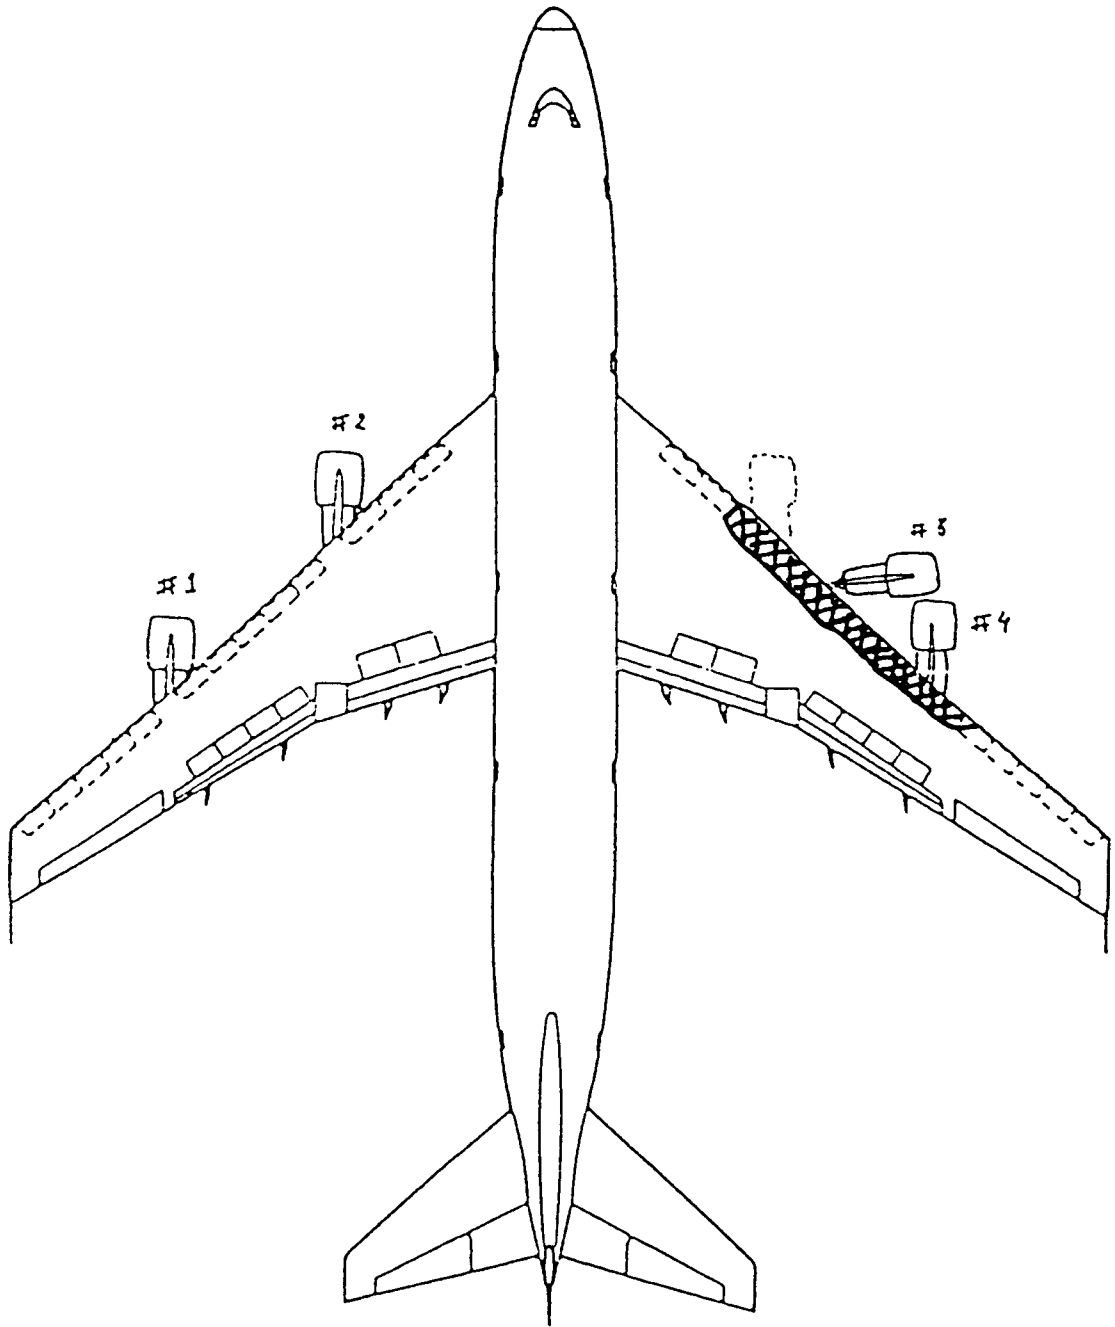
Figure 4. ESTIMATED DAMAGE TO RH WING LEADING EDGE

On land, in the area to the West and Southwest of the location where engines no. 3 and 4 were recovered, several parts of the leading edge flaps and RH wing leading edge structure were recovered. The largest parts comprised a slightly damaged and partly opened LE flap and drive (no. 18), the top skin panel above pylon no. 3 and the adjacent inboard top skin panel located above the most outboard Krügerflap.

The top skin panel above pylon no. 3 showed extensive chafing from the pylon structure. Smaller parts of LE flaps and wing LE structure were found in this same area.

Engine and pylon no. 3 separated from the wing and collided with engine no. 4, in an outward and rearward direction. In view of the amount of LE flaps and LE structure found, the right wing leading edge must have been damaged up to the front spar of the right hand wing over an area approximately 1 meter left of pylon no. 3 to approx 1 meter right of no. 4. It is assumed that due to the speed of the aircraft, the aerodynamic distortion and turbulence, some parts were blown off the leading edge of the right hand wing up to the front spar.

Figure 4 illustrates the estimated damage to the right hand wing.

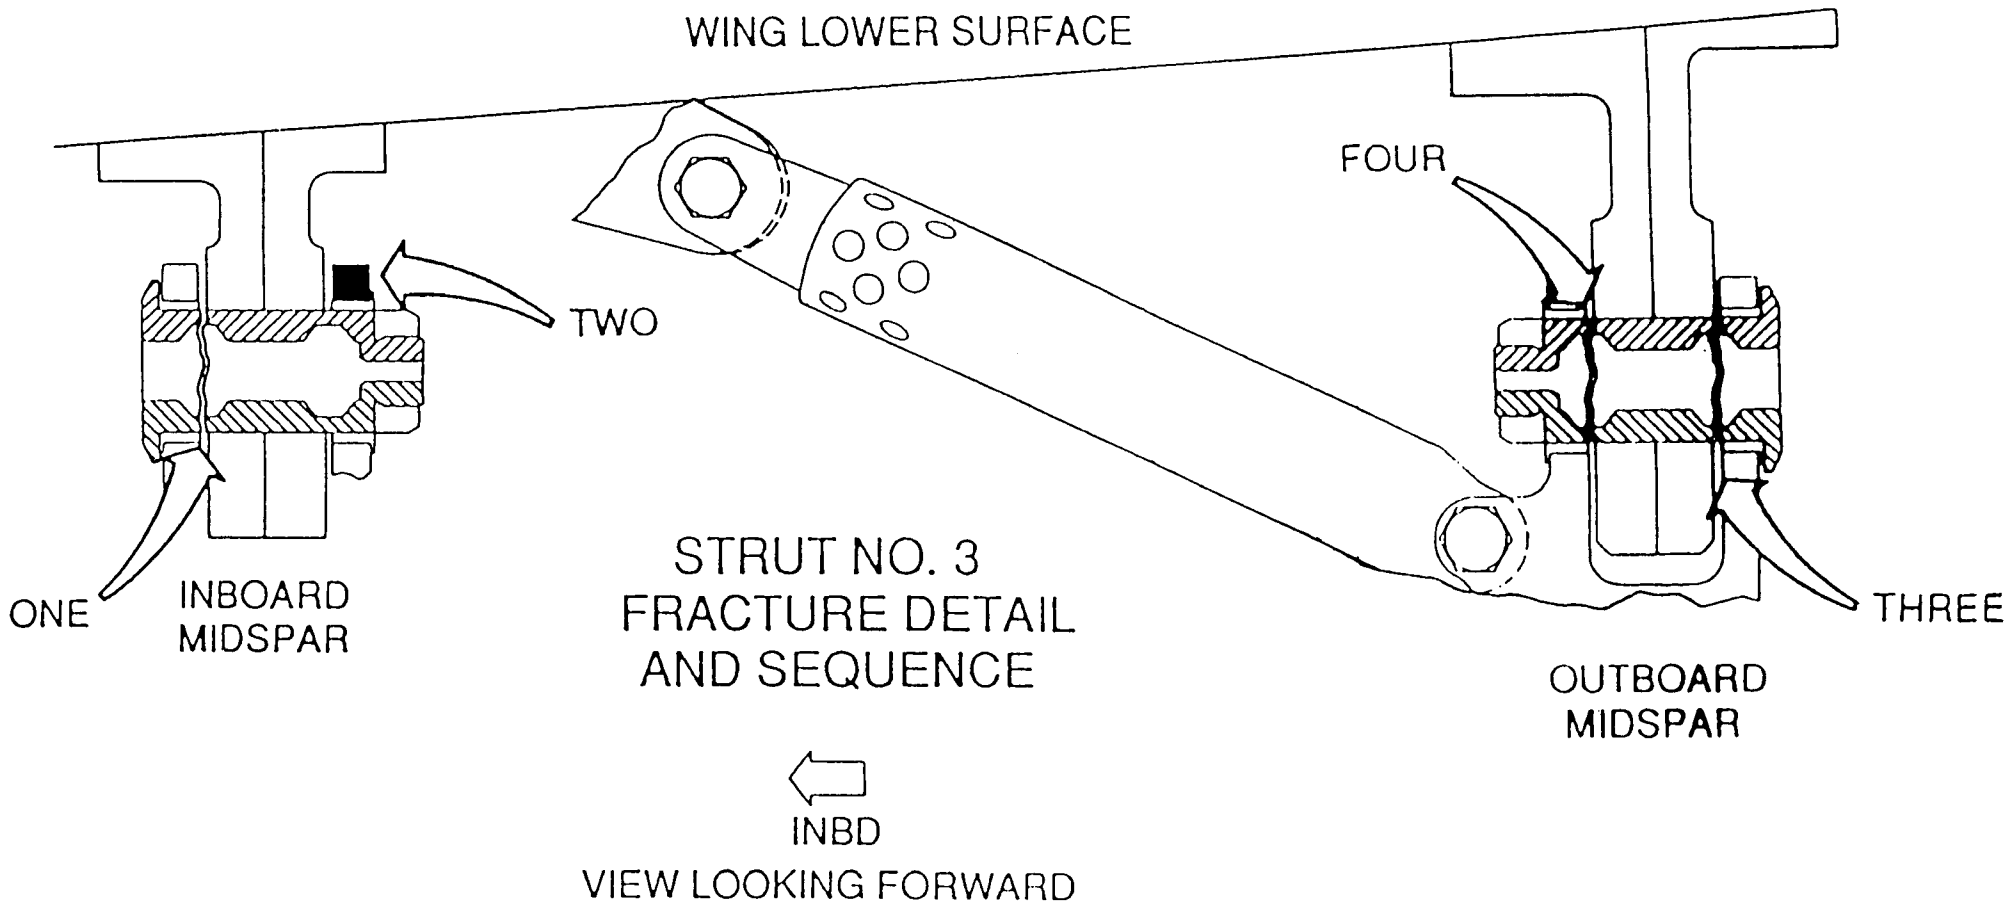
Figure 6. PROBABLE SEPARATION SEQUENCE

The inboard midspar fitting was recovered. The outboard lug of the fitting had fractured with a 150 degrees segment of the lug missing. The lug fracture was determined to be ductile (i.e. no fatigue) and appeared to have resulted primarily from tension and to a lesser extent from lateral bending. The ductile failure can only be explained if it was eccentrically loaded. For this to occur the inboard shear face of the fuse pin must have sheared first in order to subject the lug to an eccentric load.

As there is no in service evidence that the EI Al airplane experienced a static overload preceding the accident it is assumed that the inboard shear face of the fuse pin was initially fatigued and then failed under normal flight conditions.
