**AIRCRAFT ACCIDENT REPORT
92-11**

EL AL FLIGHT 1862

**BOEING 747-258F 4X-AXG
BIJLMERMEER, AMSTERDAM
OCTOBER 4, 1992**

FINAL RAPPORT

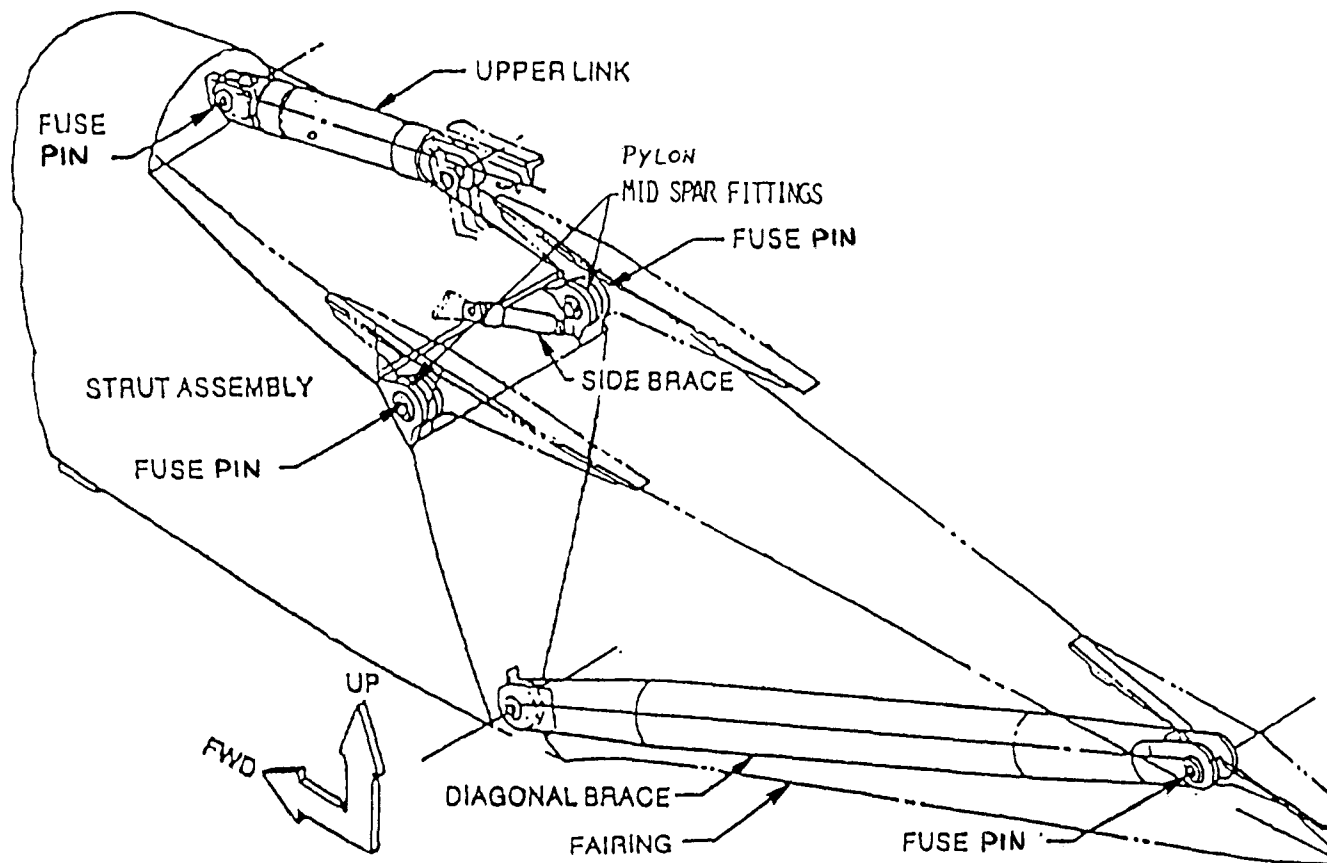
Figure 1. PYLON TO WING ATTACHMENTS RH WING

The design of the engine nacelle and pylon incorporates provisions that preclude a wing fuel cell rupture in case of engine separation, by means of structural fuses. A clean breakaway of the nacelle and/or pylon from the wing is ensured when the shearloading of the fuse pins exceeds the design load conditions.

The structural fuse concept utilizes hollow shear pins at the four wing attachment fittings between pylon and wing. The wing support structure and fittings have been designed sufficiently stronger than the fuse pins thus safeguarding the wing from structural damage in case of an overload condition.

The fuse pin at the forward end of the upper link, the aft end of the diagonal brace and at both midspar fittings are the primary fuse pins. The fuse pins at the forward end of the upper link and the aft end of the diagonal brace are designed to fail at a slightly lower load than the fuse pins at the other ends in order to assure a controlled separation of the pylon from the wing.

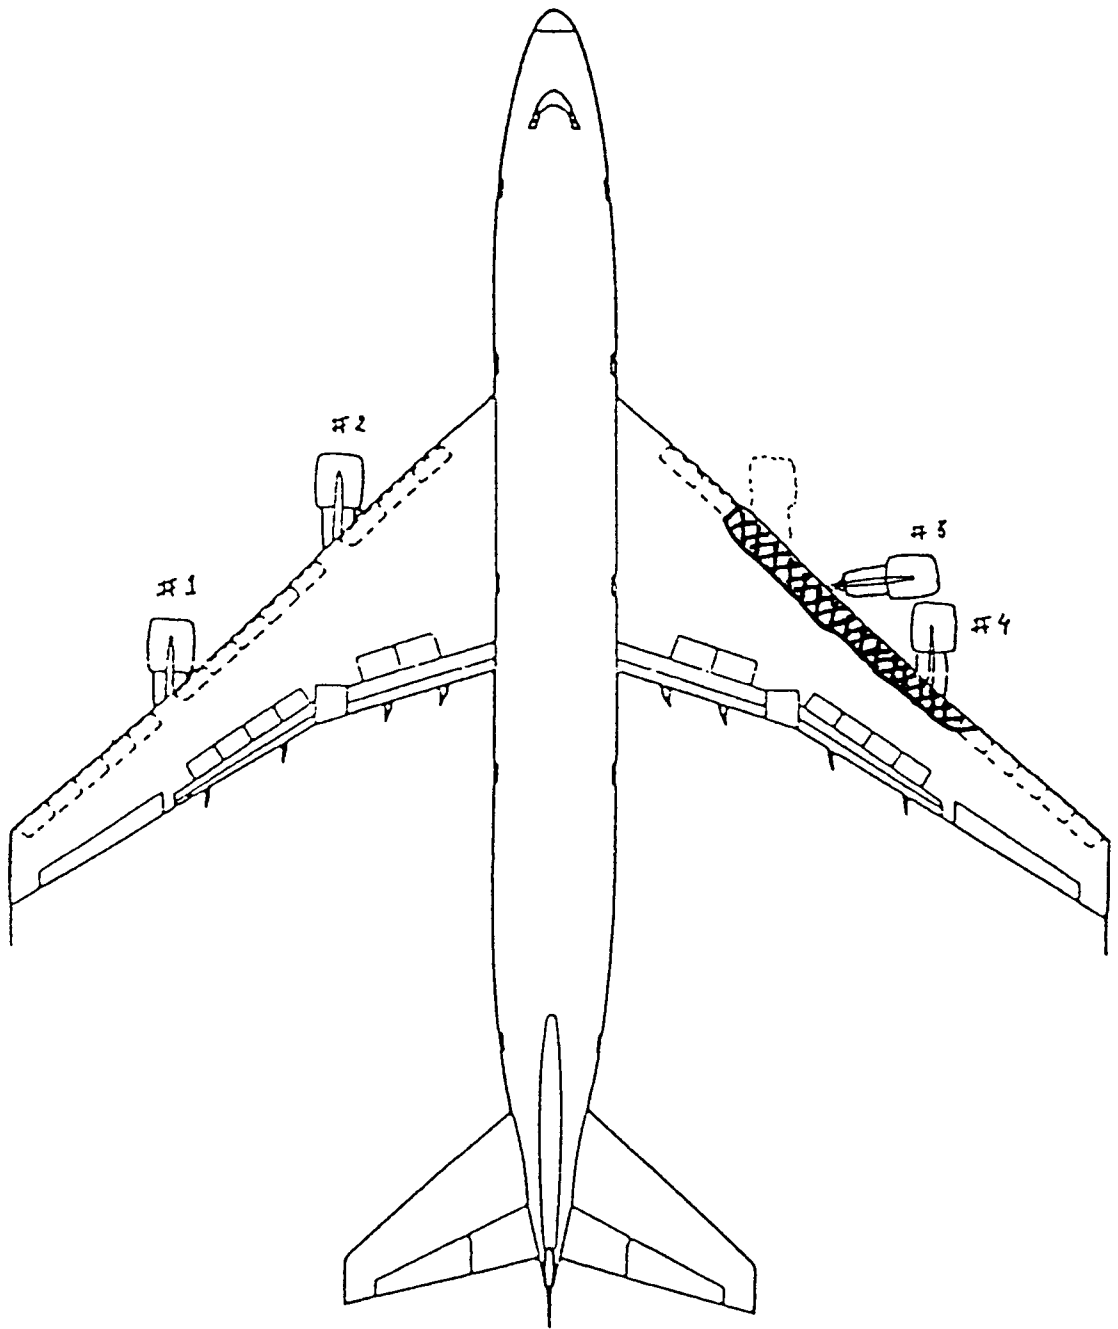
Figure 4. ESTIMATED DAMAGE TO RH WING LEADING EDGE

Engine and pylon no. 3 separated from the wing and collided with engine no. 4, in an outward and rearward direction. In view of the amount of LE flaps and LE structure found, the right wing leading edge must have been damaged up to the front spar of the right hand wing over an area approximately 1 meter left of pylon no. 3 to approx 1 meter right of no. 4. It is assumed that due to the speed of the aircraft, the aerodynamic distortion and turbulence, some parts were blown off the leading edge of the right hand wing up to the front spar.

Figure 4 illustrates the estimated damage to the right hand wing.

Note: The amount of damage on the left wing leading edge after separation of pylon no. 2, from a B747 accident at Anchorage on March 31, 1993, is indicative for the amount of damage probably inflicted on the EI AI 1862 right wing leading edge.

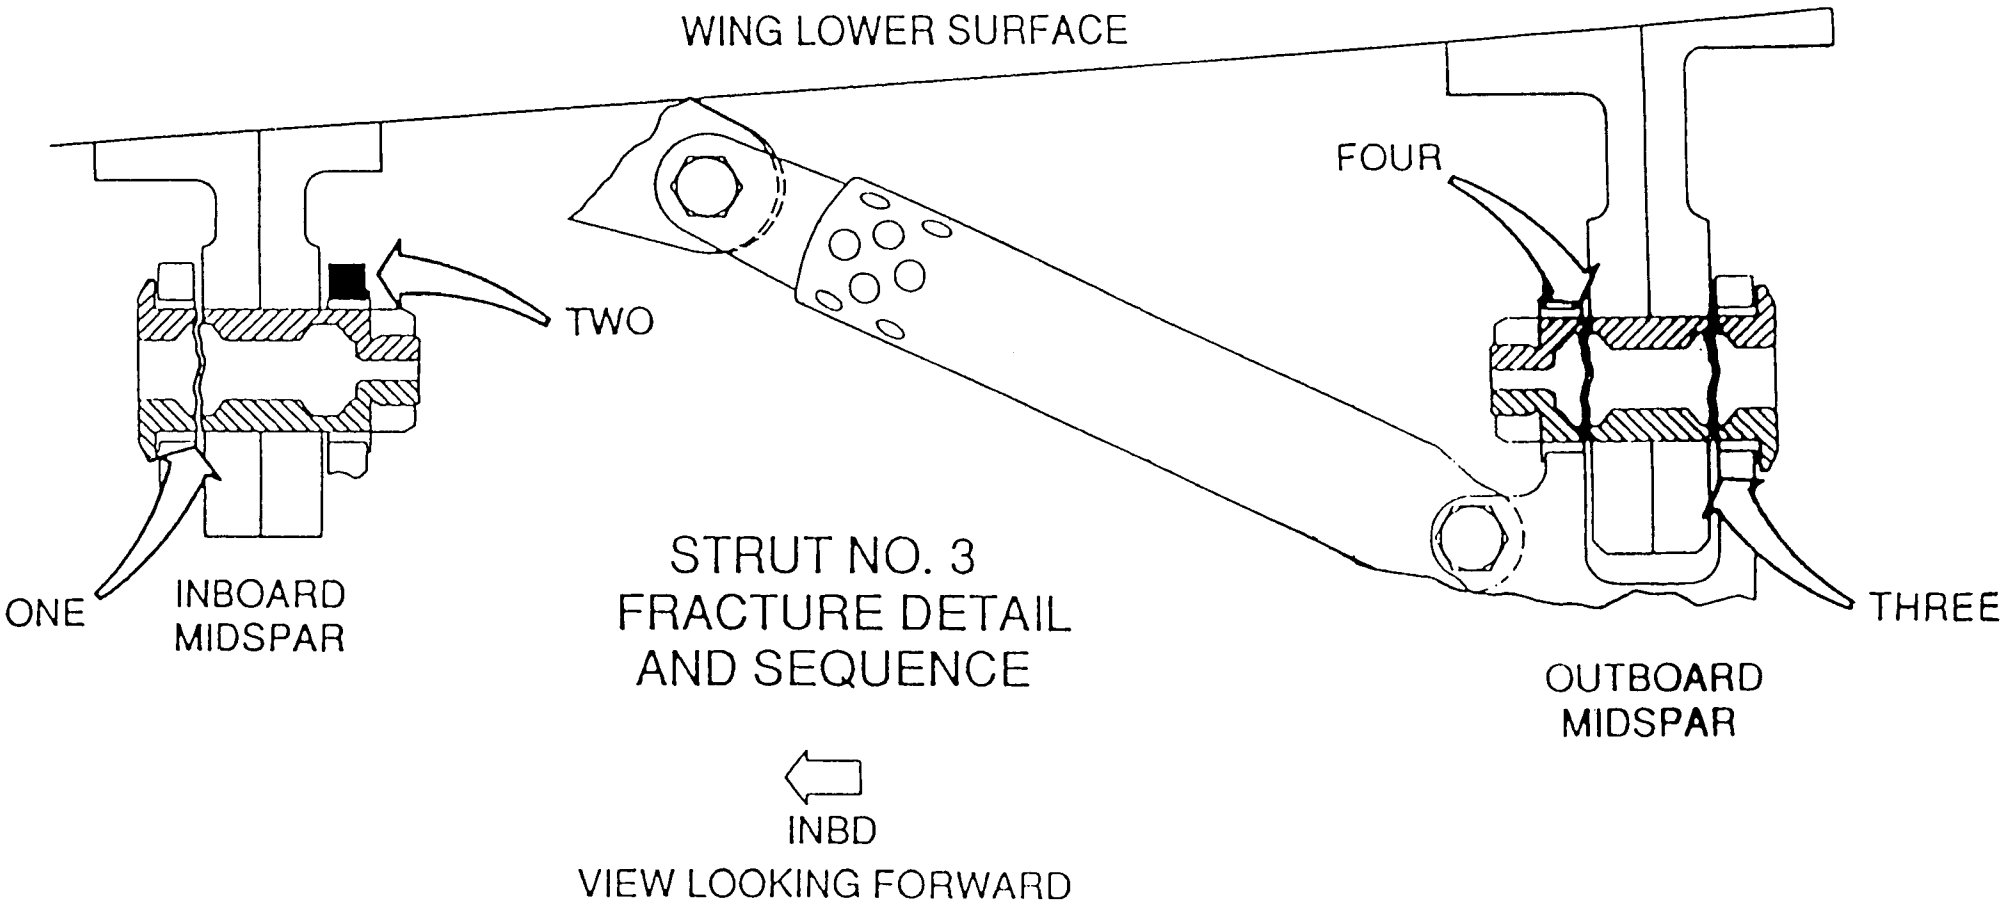
PROBABLE SEPARATION SEQUENCE

The inboard midspar fitting was recovered. The outboard lug of the fitting had fractured with a 150 degrees segment of the lug missing. The lug fracture was determined to be ductile (i.e. no fatigue) and appeared to have resulted primarily from tension and to a lesser extent from lateral bending. The ductile failure can only be explained if it was eccentrically loaded. For this to occur the inboard shear face of the fuse pin must have sheared first in order to subject the lug to an eccentric load.

As there is no in service evidence that the EI Al airplane experienced a static overload preceding the accident it is assumed that the inboard shear face of the fuse pin was initially fatigued and then failed under normal flight conditions.

Based on this assumption separation scenario 2 was further developed with regard to the question whether the failure did occur before the fatal flight or during this flight.

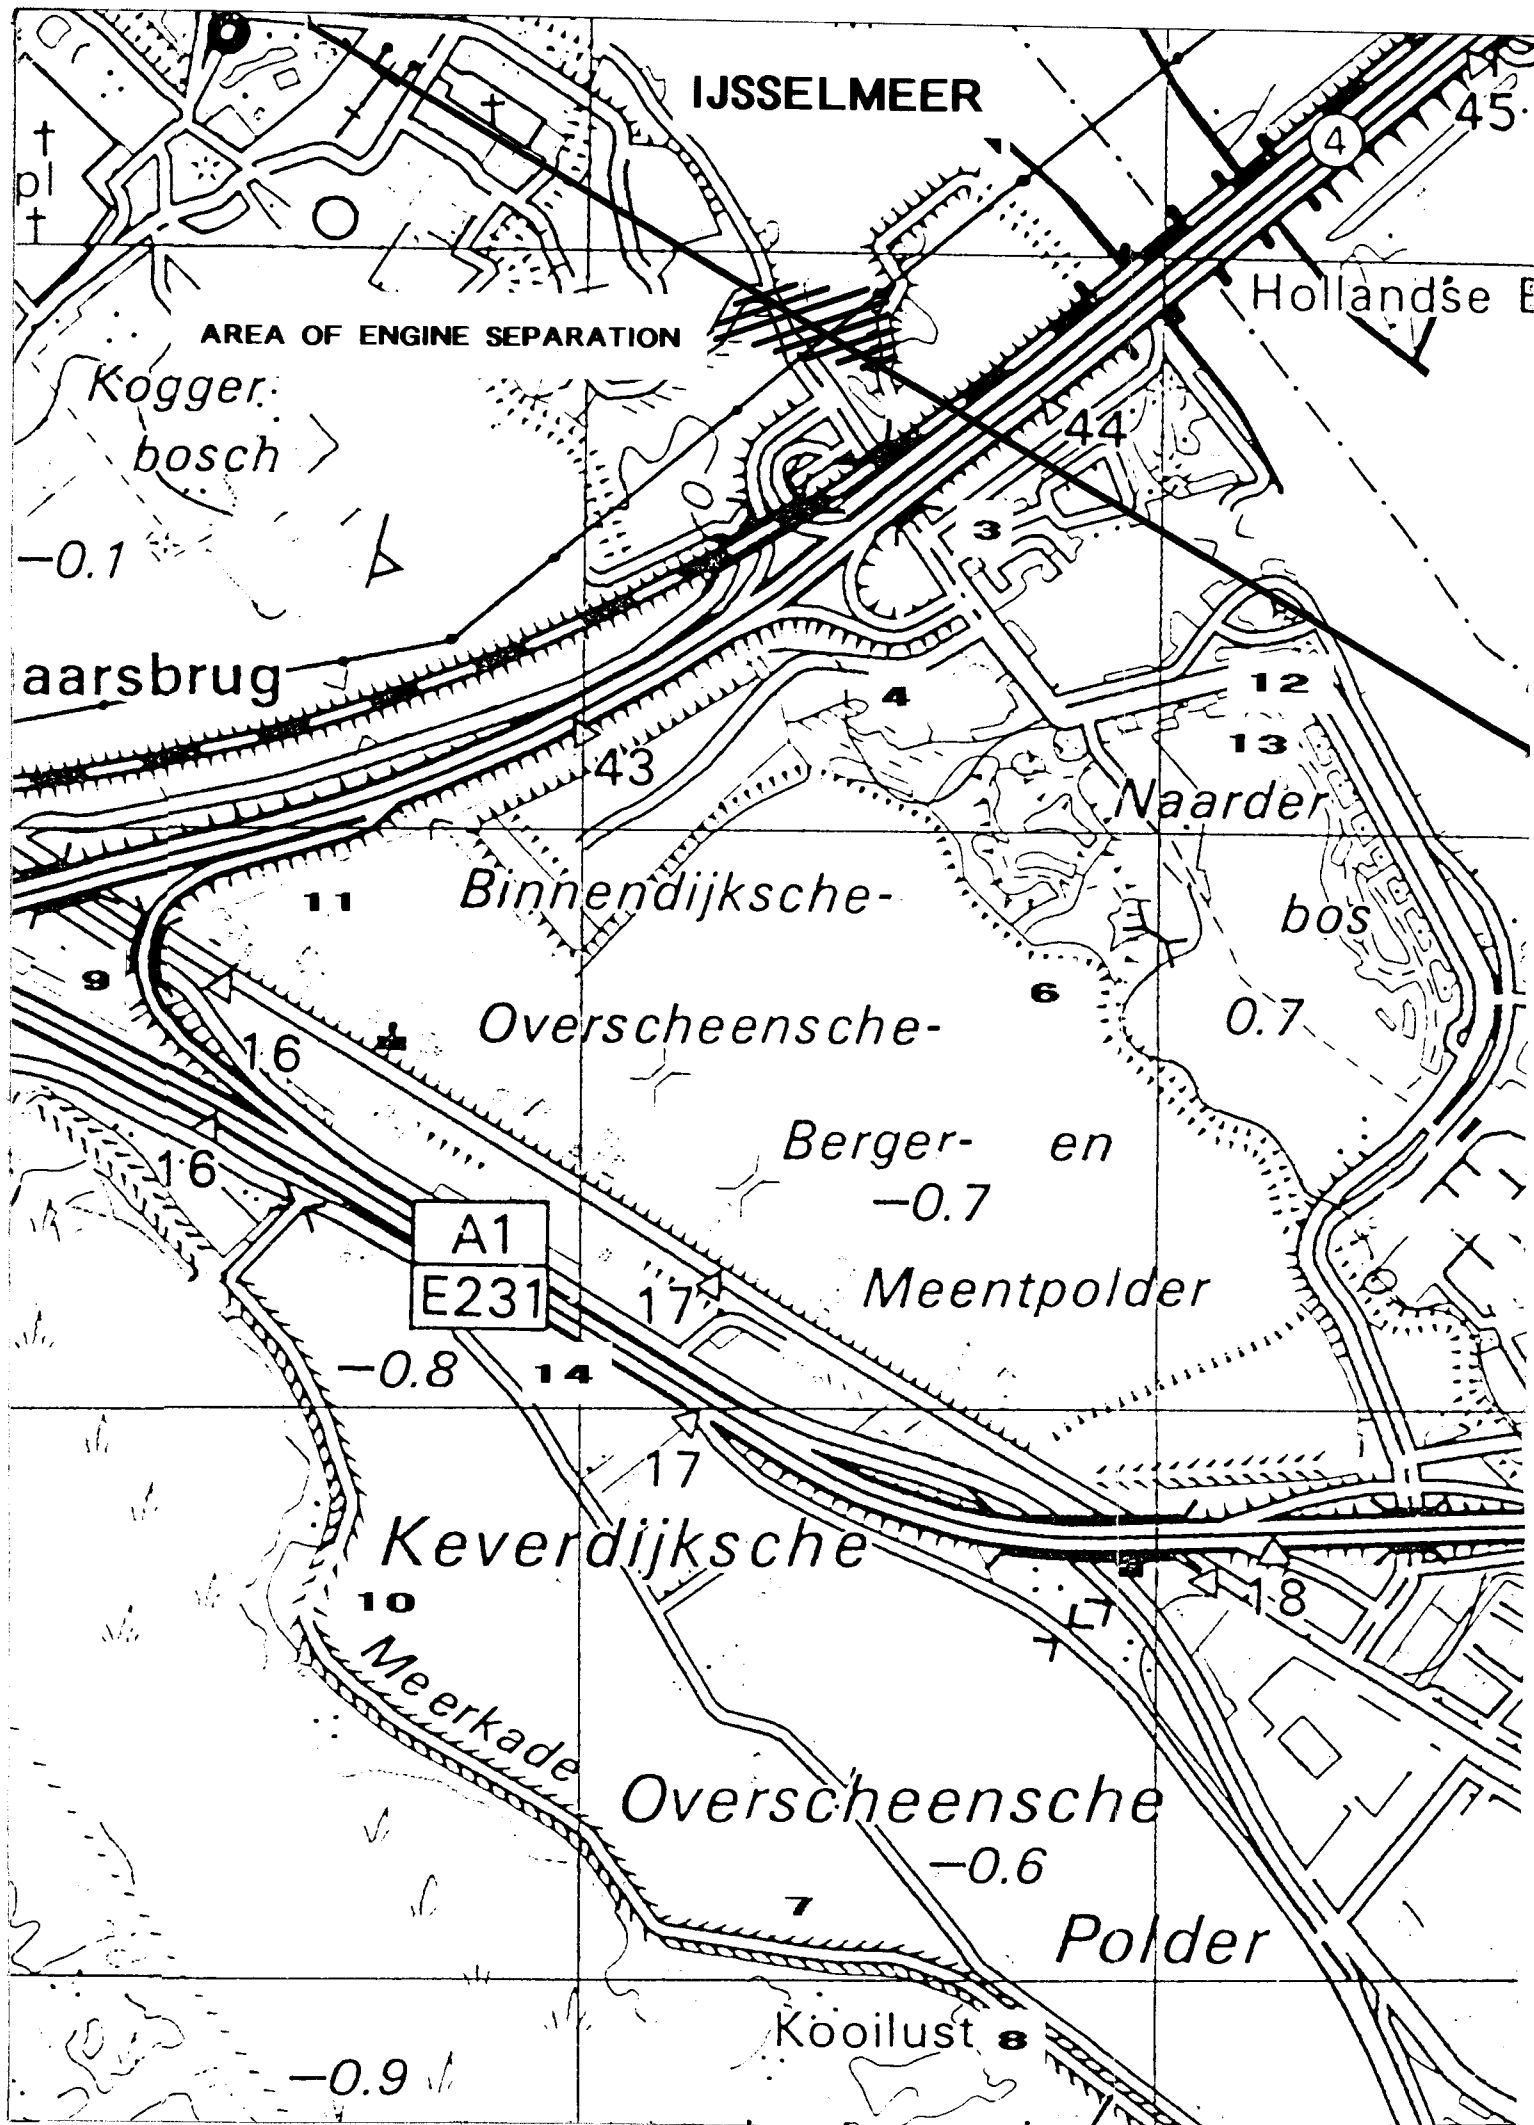
WRECKAGE DISTRIBUTION CHART

1. Engine no. 4, with pylon and cowling parts of no. 4
2. Engine no. 3, with pylon and cowling parts of no. 3 and 4, parts of fanblades of no. 4
3. Diagonal brace no. 3
4. Diagonal brace no. 4
5. Spinner no. 4
6. Part of tailcone no. 3
7. Tip of tailcone no. 3
8. Reverser screen parts
9. Cowling parts no. 3
10. Cowling parts
11. Part wing leading edge
12. Leading edge flap no. 18 (RH wing) and flapdrive
13. Air driven pump no. 3 and 4
14. Rear part of pylon no. 4
15. Pneumatic system bleed air pipe (near Muiden, not on the map)

Scattered over the area: small parts of honeycomb material of cowling no. 4 and parts of leading edge panels and structure of the RH wing
