CRA Activities in Fukuoka FIR

IPACG FIT/35
September 2023

Outline of FANS Problem Reports

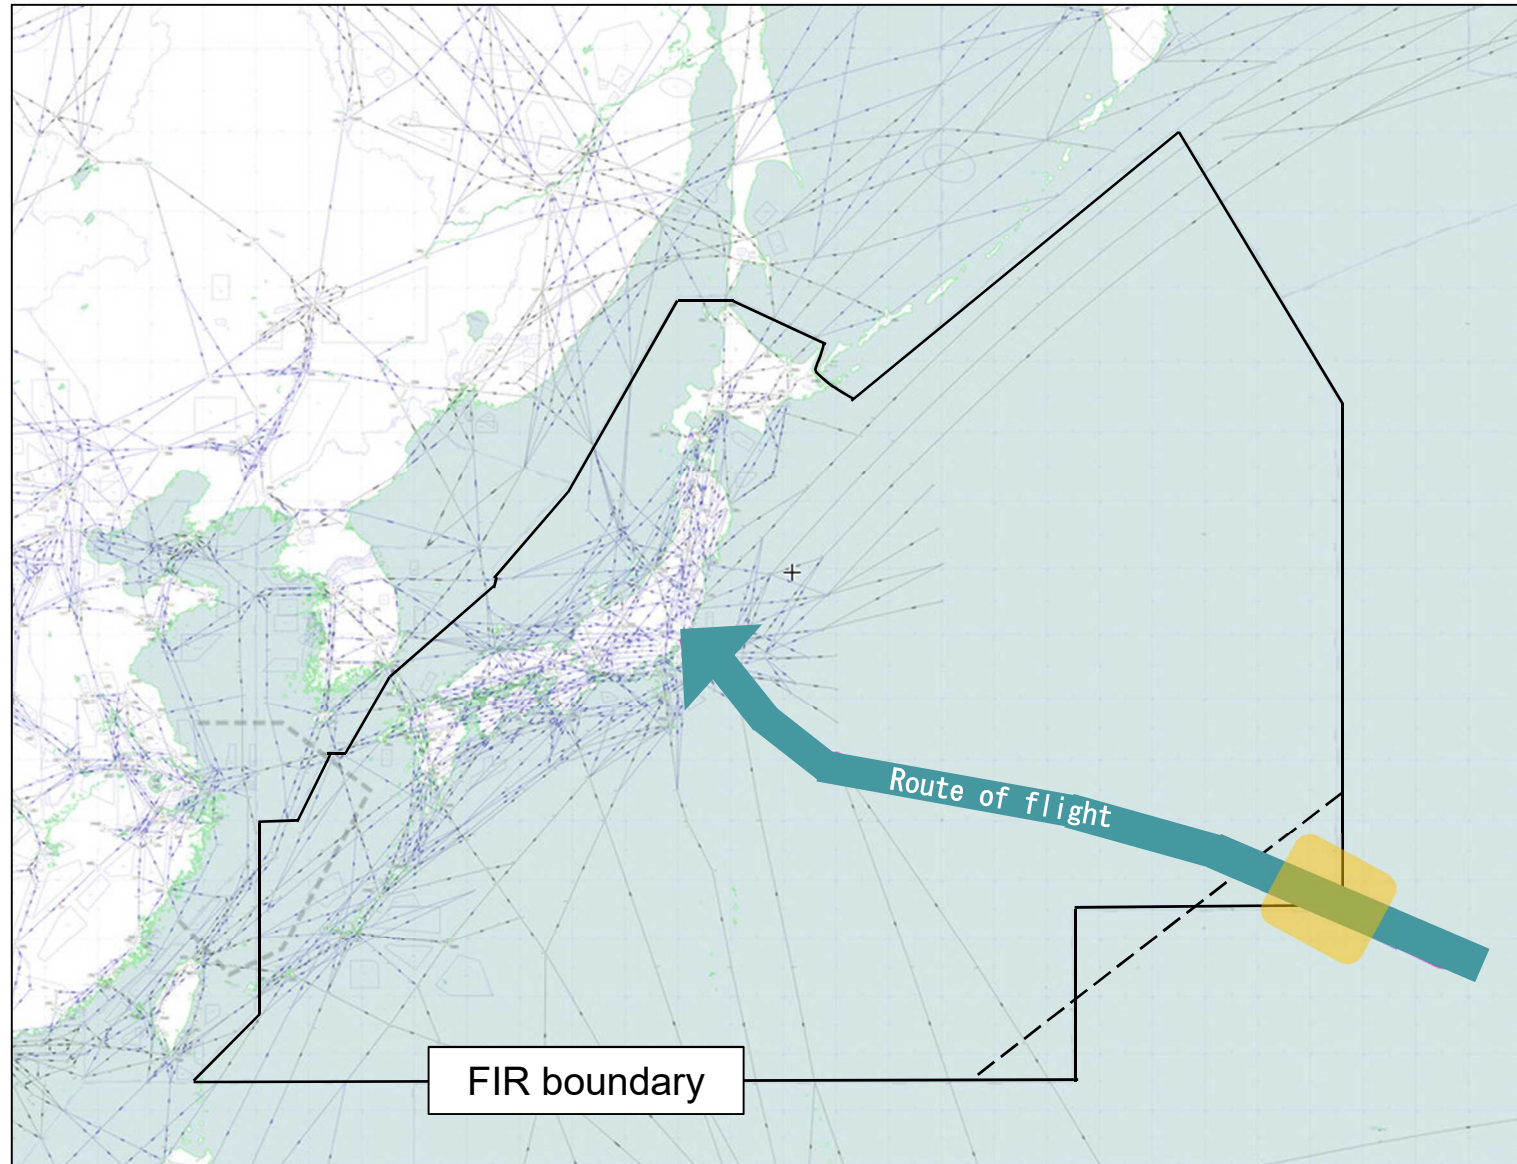
Route

Auto-transfer was not implemented when entering Fukuoka FIR from Oakland FIR. After initiated manual log off and log on to RJJJ again, the aircraft was able to successfully send “Position Report” and “Altitude Change Request”.

- The aircraft did manually log off just after passing FIR boundary, but it was before the data link transfer to RJJJ was implemented.
- No reports of communication problems on that day.

:
The point of Auto
transfer failure

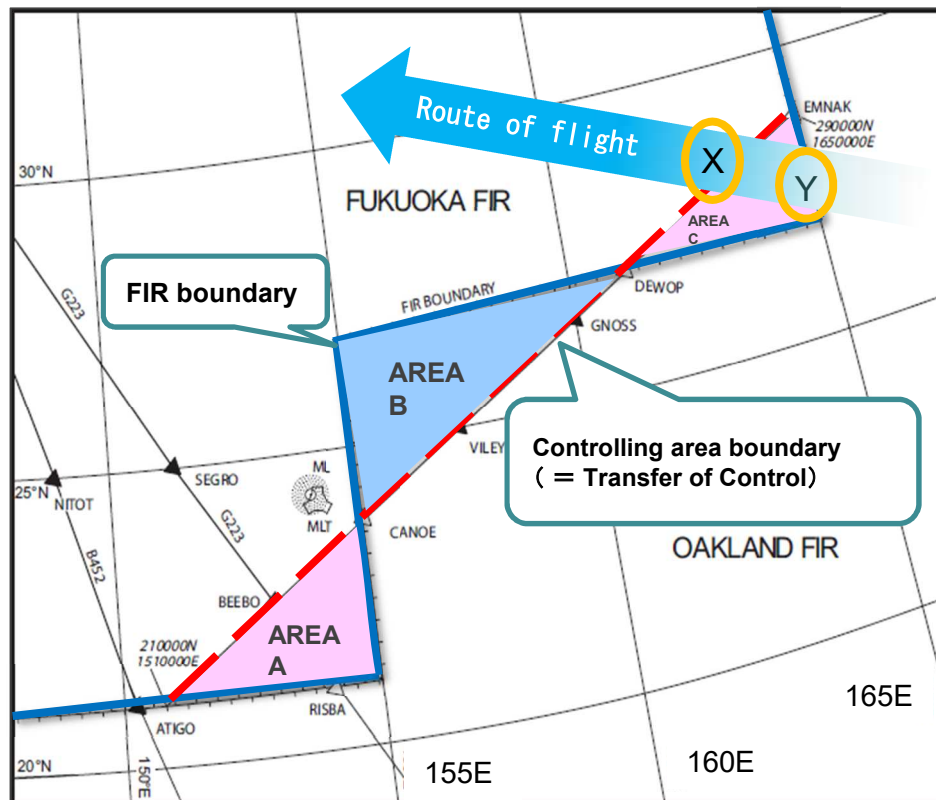
“FIR boundary” and “Controlling area boundary” are different

: Transfer of voice communication and current data authority is initiated at the controlling area boundary.

X : 2757N16253E
(=END SERVICE is uplinked immediately before this point)

Y : FIR boundary, but Oakland ARTCC is still in control.
(=Before Transfer of control)

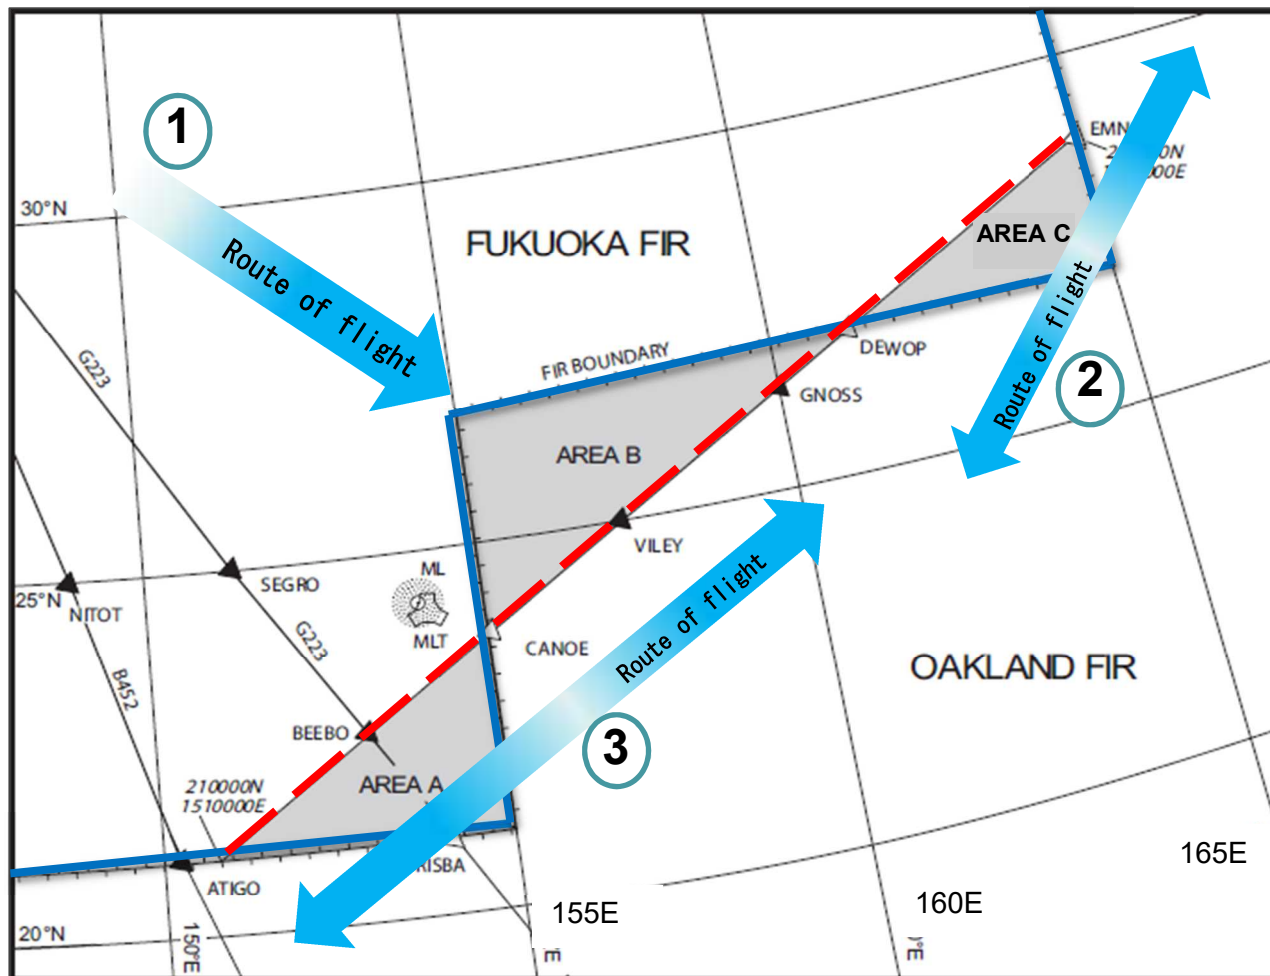
This is the only point in the oceanic data link airspace where FIR boundary differs from the controlling area boundary.

AREA B is still controlling area of Fukuoka ATMC.
Transfer of control is initiated at the controlling area boundary.

AREA A/C is controlling area of Oakland ARTCC.
Transfer of voice communication and current data authority is not required.

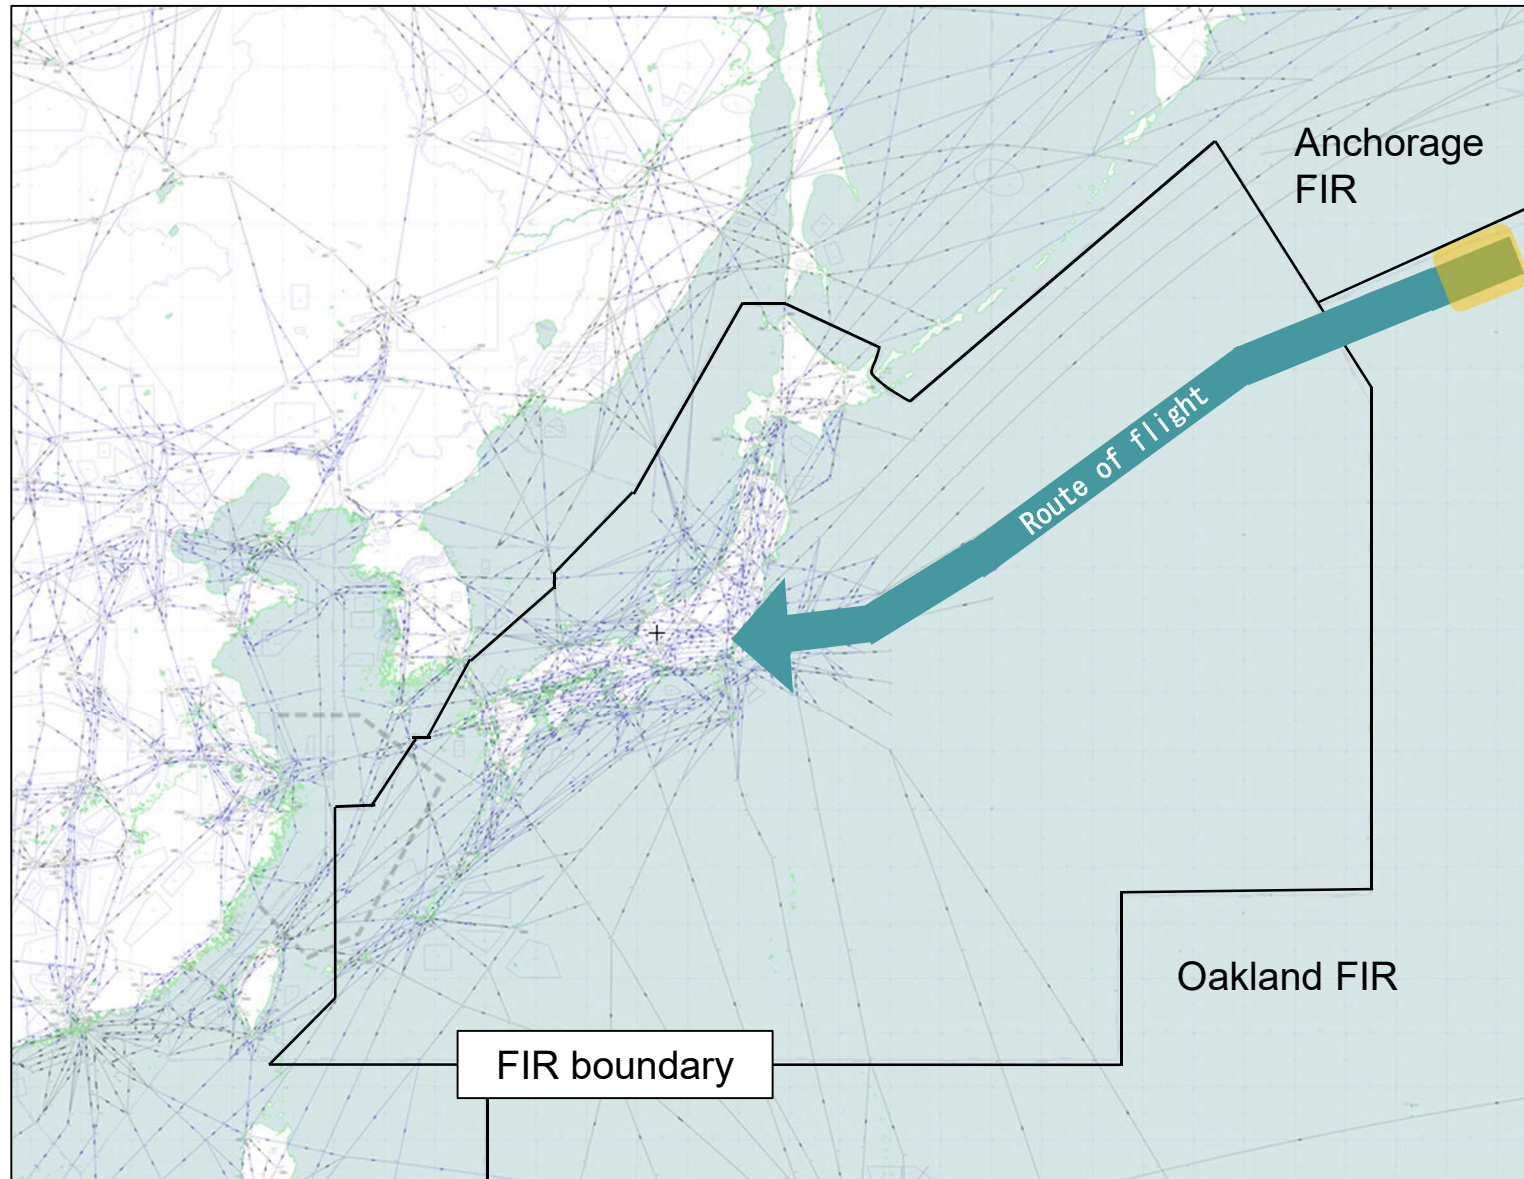
Route of Flight

The current data authority of aircraft flying from Oakland ARTCC to Fukuoka FIR was transferred at 4700N17000E prior to FIR boundary 4508N16321E.

The aircraft couldn't receive a response from KZAK via HF voice communication, nor did it receive a response from RJJJ via CPDLC. After logging on to KZAK again, HF communication and CPDLC were established, and auto-transfer was implemented when entering Fukuoka FIR from Oakland FIR.

- FIR boundary ETA 0546z, transfer of CDA at 4700N17000E 0503z
- No equipment malfunction of the aircraft
- No reports of communication problems on that day.

:
The point of Auto
transfer failure

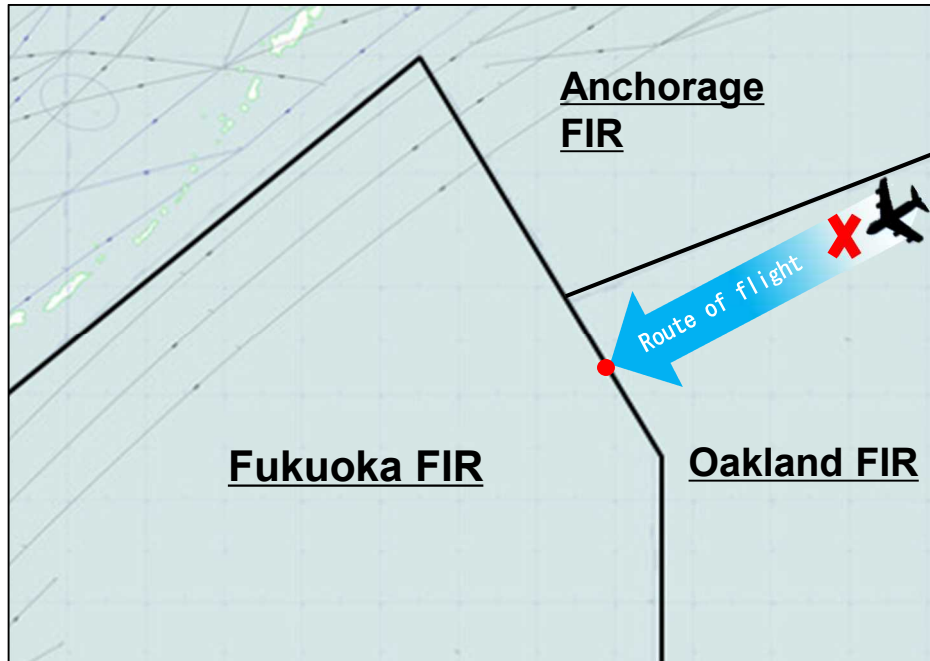
Cause of early transfer of CPDLC authority

The cause was incorrect aircraft selection by ATCs.

: The controller intended to terminate the CPDLC connection with a different aircraft but instead the controller inadvertently terminated the CPDLC connection with this aircraft.

X : Position of transfer of CPDLC authority
4700N17000E

● : FIR boundary
4508N16321E

- Aircraft ➤
 - AFN log on again in the flying airspace and establish CPDLC connection.
 - Confirm if the communication should be transferred to next ATC facility after sending Position report and reconfirming present position.
- ATMC ➤ Similar events can occur within Fukuoka ATMC. For preventive measures, the details of the event are shared with ATCs.

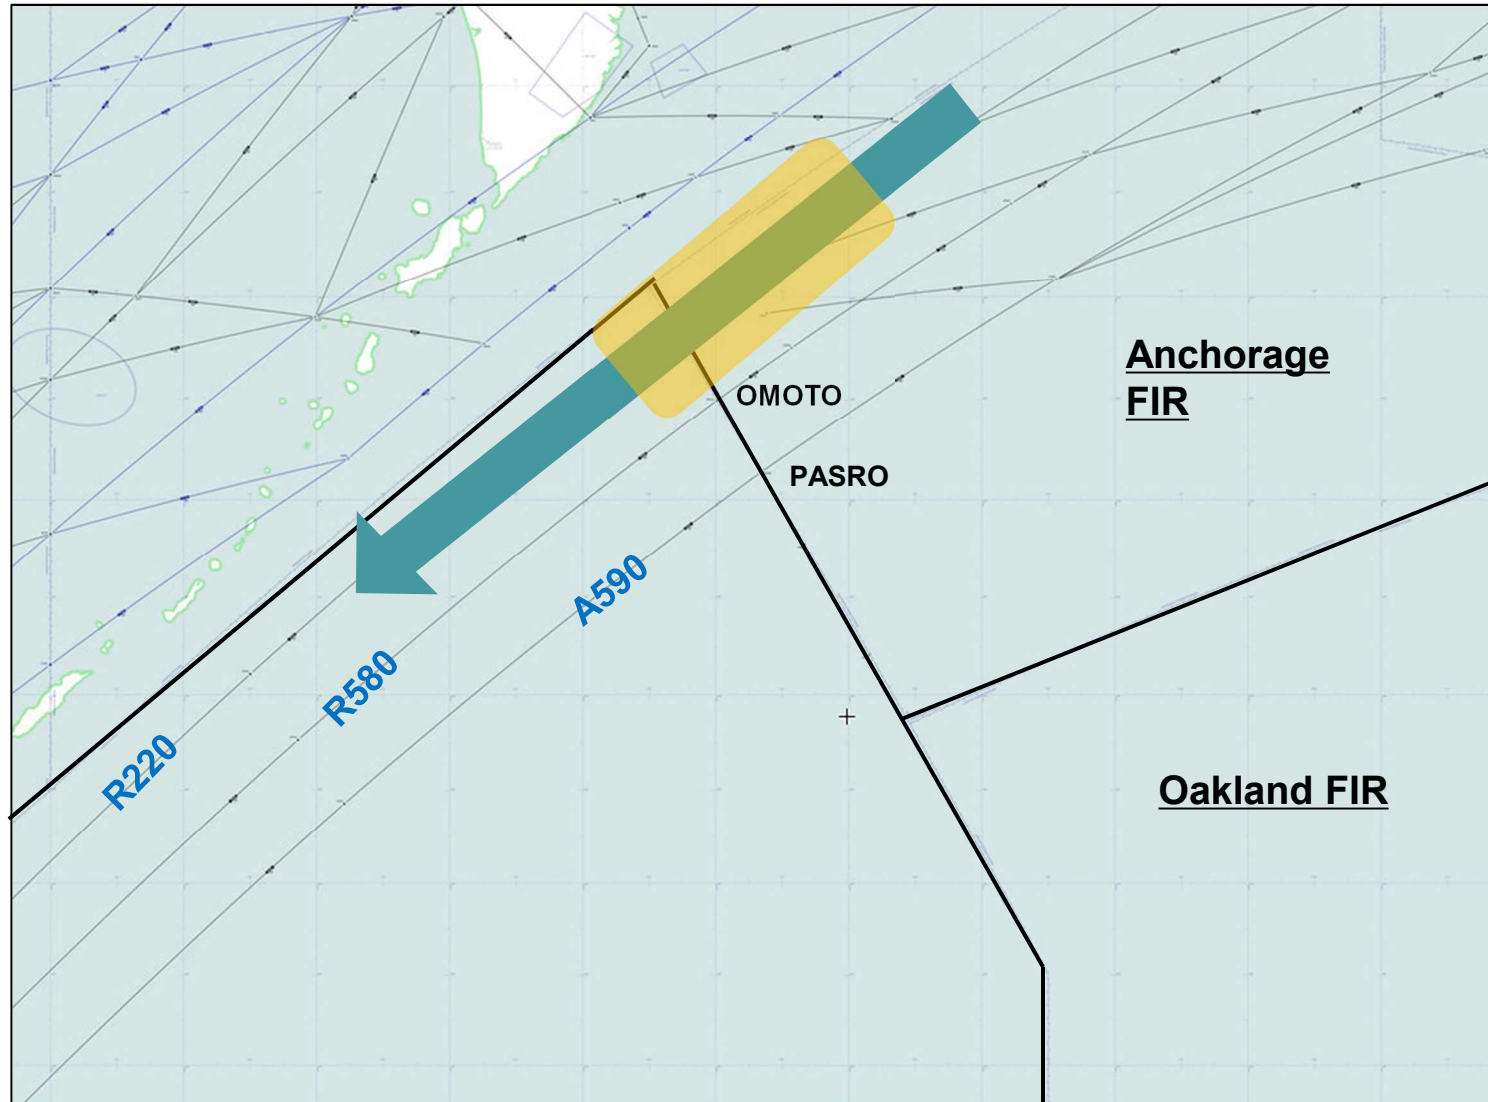
Route of Flight

Auto-transfer about aircraft flying on R220 from Anchorage ARTCC to Fukuoka FIR was not implemented, and AFN logon could not be established even after manually logging on. After several more manual AFN logon, a pilot spent 20 minutes to successfully complete AFN logon.

- FIR boundary NIPPI ETA 0221z, but the time of successful AFN logon was 0242z.
- No equipment malfunction of the aircraft, and the aircraft had no communication problems the following day or later.
- No reports of satellite communication problems on that day.
- There was a failure report regarding DLCS, Data Link Center System, on that day.

:
The point of
Auto transfer failure
&
Log on failure

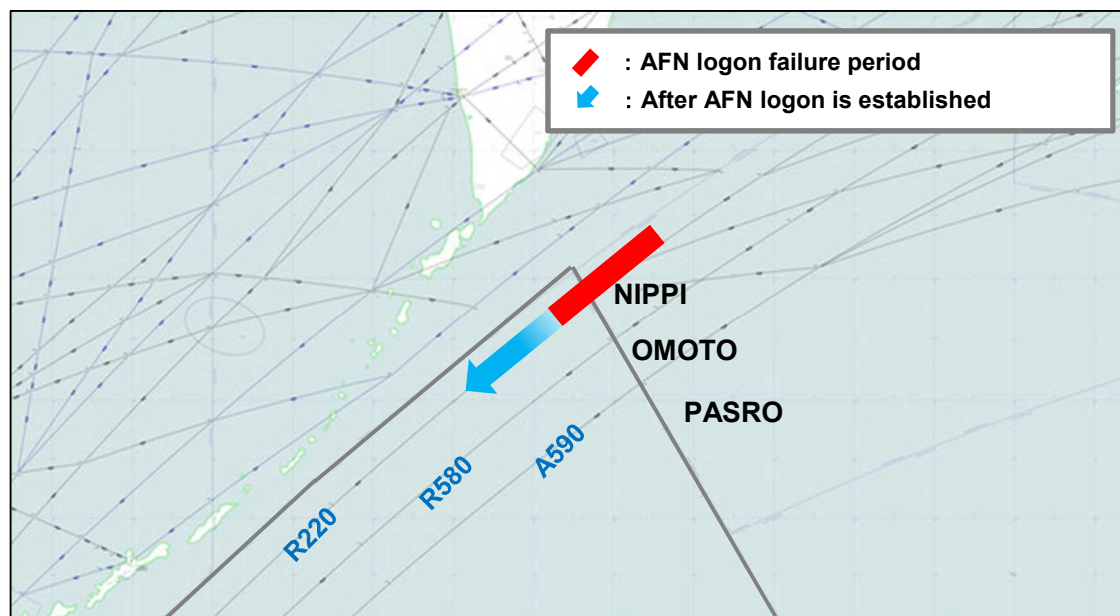
The cause of AFN LOG ON Failure

The timing of AFN logon was during DLCS failure

- DLCS failure time : 0053 ~ 0342z.
- The time the aircraft successfully logged on was also 0342z.
