Official Accident Report Index Page

Report Number	NTSS-AAR-78-12
Report Title	Investigation Report--Wing Failure of Boeing 747-131, Near Madrid, Spain, May 9, 1976
Report Date	October 6, 1978
Organization Name	National Transportation Safety Board Bureau of Technology Washington, D. C. 20594
WUN	2479
Sponsor Name	NATIONAL TRANSPORTATION SAFETY BOARD Washington, D. C. 20594
Report Type	Special Investigation Report May 9, 1976
Distribution Status	This document is available to the public through the National Technical Information Service, Springfield, Virginia 22151
Report Class	UNCLASSIFIED
Pg Class	UNCLASSIFIED
Pages	43
Price	H03.A01
Keywords	Aircraft accident; lightning strike; explosion; fuel flameability; wing failure; gust overload; fuel ignition.
Abstract	On May 9, 1976, an Imperial Iranian Air Force Boeing 747-131 crashed as it approached Madrid, Spain. Witnesses observed lightning strike the aircraft followed by fire, explosion, and separation of the left wing. The report includes fire pattern studies, structural failure descriptions, trajectory analysis, fuel flammability calculations, gust loading analysis, and an analytical treatment of several hypotheses.

Flight number	U

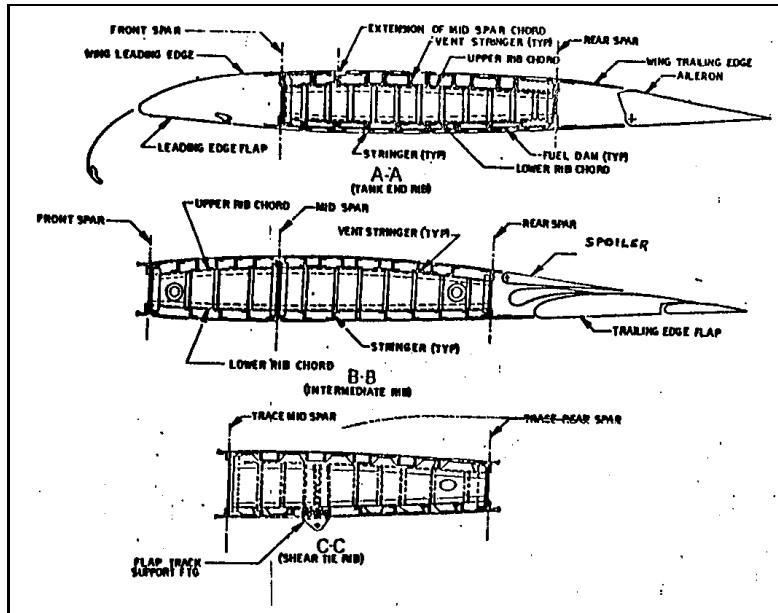
MAJOR WING STRUCTURE

Pitting and localized burn areas typical of lightning attachment damage were found on the left wingtip and on the vertical fin at the VOR antenna. The left wing had separated into 15 major pieces before ground impact and parts of it were found at each location of wreckage. (See drawing on page 31.)

The left wing outboard of the No. 1 engine position separated in three major pieces and along three lines of fracture. The left wingtip, a piece about 20 ft long, separated on a line parallel to the fuselage centerline and roughly halfway between the end of the wing and the No. 1 engine. A second line of separation was just outboard of the No. 1 engine and ran parallel to the rib centerlines. The third line of separation spanned between the first two and ran along the front spar. The wingtip, consisting of the high frequency antenna and coupler, also separated from the wing.
