AIRCRAFT ACCIDENT INVESTIGATION REPORT

Japan Air Lines Co., Ltd.
Boeing 747 SR-100, JA8119
Gunma Prefecture, Japan
August 12, 1985

Aircraft Accident Investigation Commission
Ministry of Transport

June 19, 1987

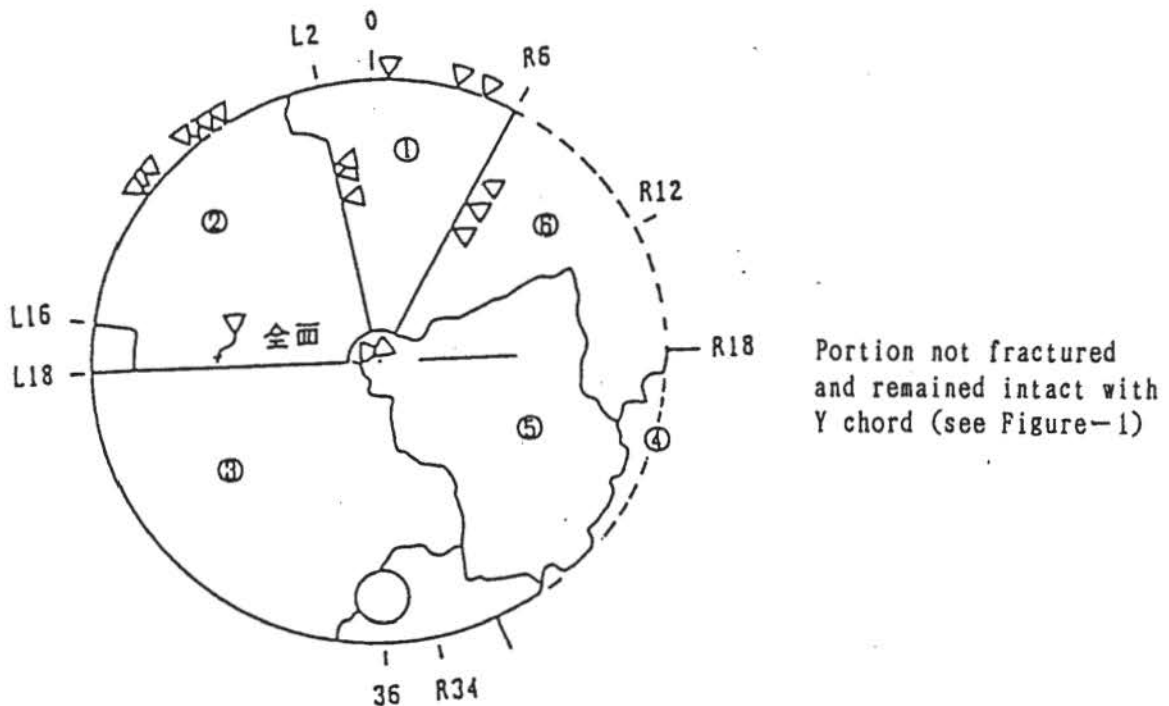
Figure-6 Major Fracture Lines

Major fracture lines, indicate points observed by electron microscope, as viewed from aft of the pressure bulkhead.

(a) Fracture of webs along L18 stiffener

Fracture of the aft pressure bulkhead along L18 stiffener is as shown in Attached Figure-37.

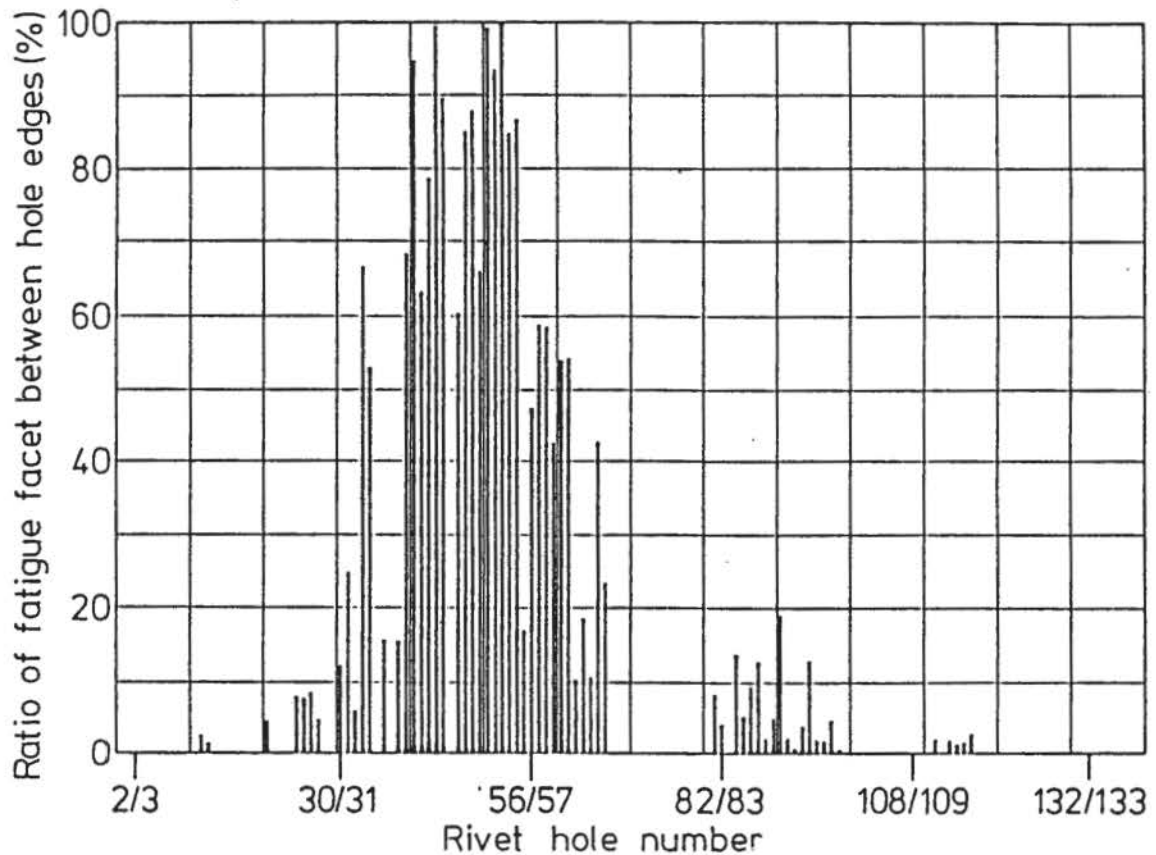
Figure-7 Distribution of Fatigue Failure Ratios between Hole Edges

Ratios of fatigue failure between the hole edges, when shown in a bar chart, are varying along stiffener L18 as in Figure-7 below.

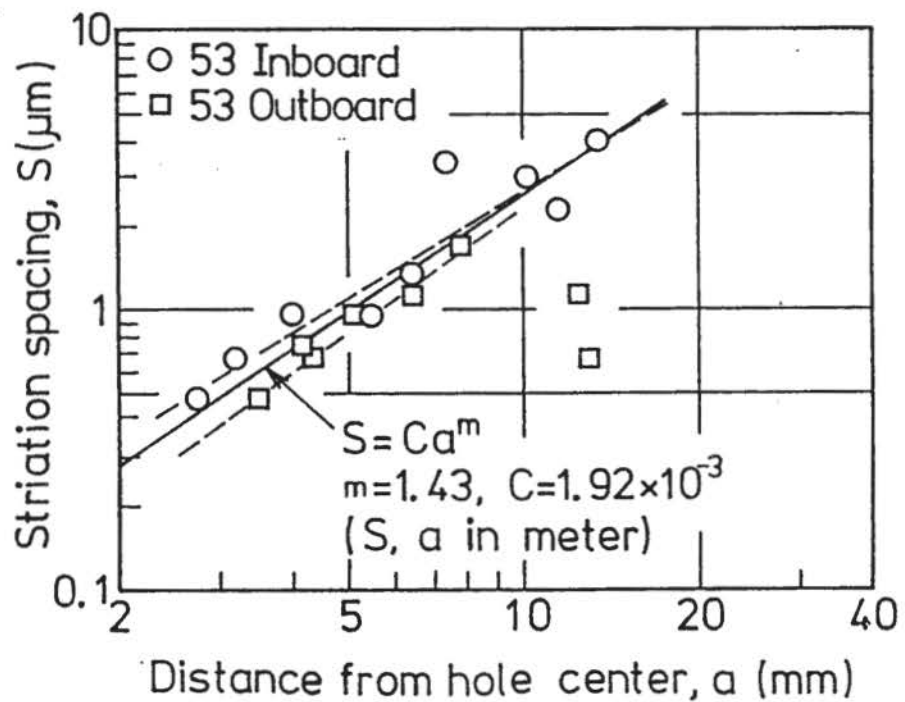
Figure-8 Variation in Striation Intervals
(53rd rivet)

Relationship between the distance from the hole center (a) and the striation spacing (s) is shown in Figure-8, taking as an example rivet hole 53 where striation was clearly observed from a scanning electron microscopic observation on the fatigue fracture surface.

In Table-5 are shown the striation spacing(s) at the distance (a) of 2.5 mm from the hole center, the exponent (m) indicative of relation between (s) and (a), the correlation coefficient (r) indicating the degree to which data are arranged linearly when plotted on the graph as in Figure-8, and the number of striation (N) calculated thereon.

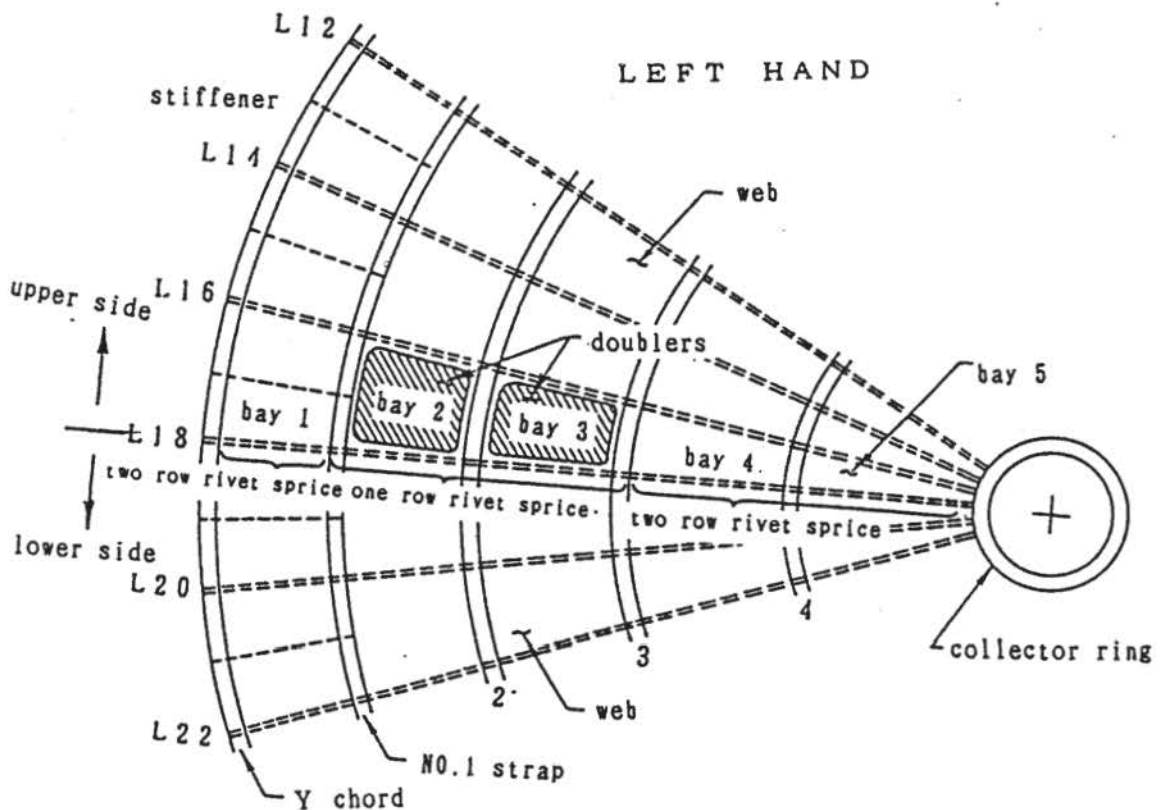
Figure-12 Vicinity of L18 Splice of the Aft Pressure Bulkhead

When L18 splice is broken into two portions, upper and lower, the stress of bay 5 connected with a collector ring increase. This indicates a possibility that the connection of the web and the ring is then ruptured towards a series of succeeding ruptures.

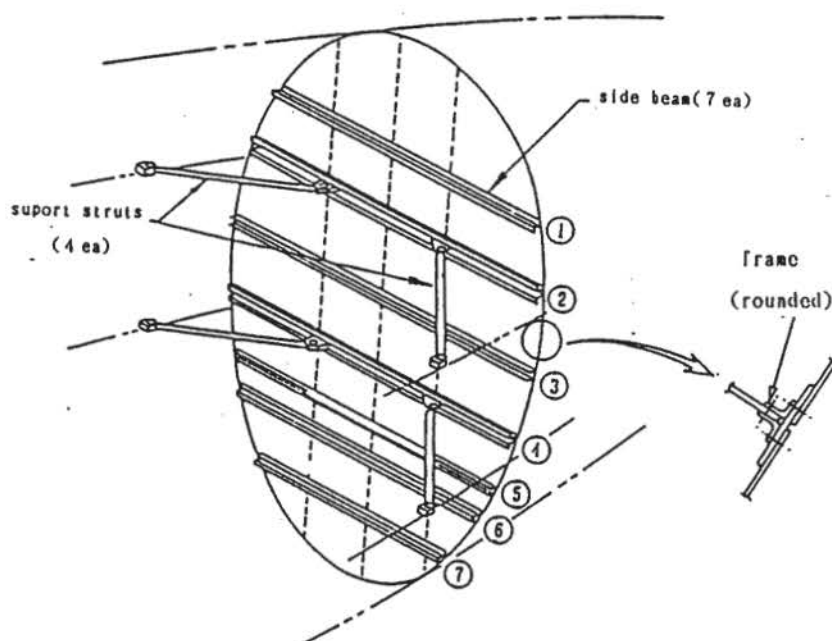
Figure-14 Outline of APU Firewall Structure

In order to study how structures in the vicinity of the APU firewall may be damaged in case the air in the cabin flows out by rupture of the aft pressure bulkhead (BS2360) and effects as a pressure on the APU firewall, analysis and calculation were made on the strength of each structure in the vicinity.

(5) The time required for the pressure to the APU firewall to reach about 4 psi is estimated to be extremely short, and therefore the rupture would have been momentary and impulsive. However, the actual process of destruction would have been more complicated than that estimated in the above calculation which based on static analysis.

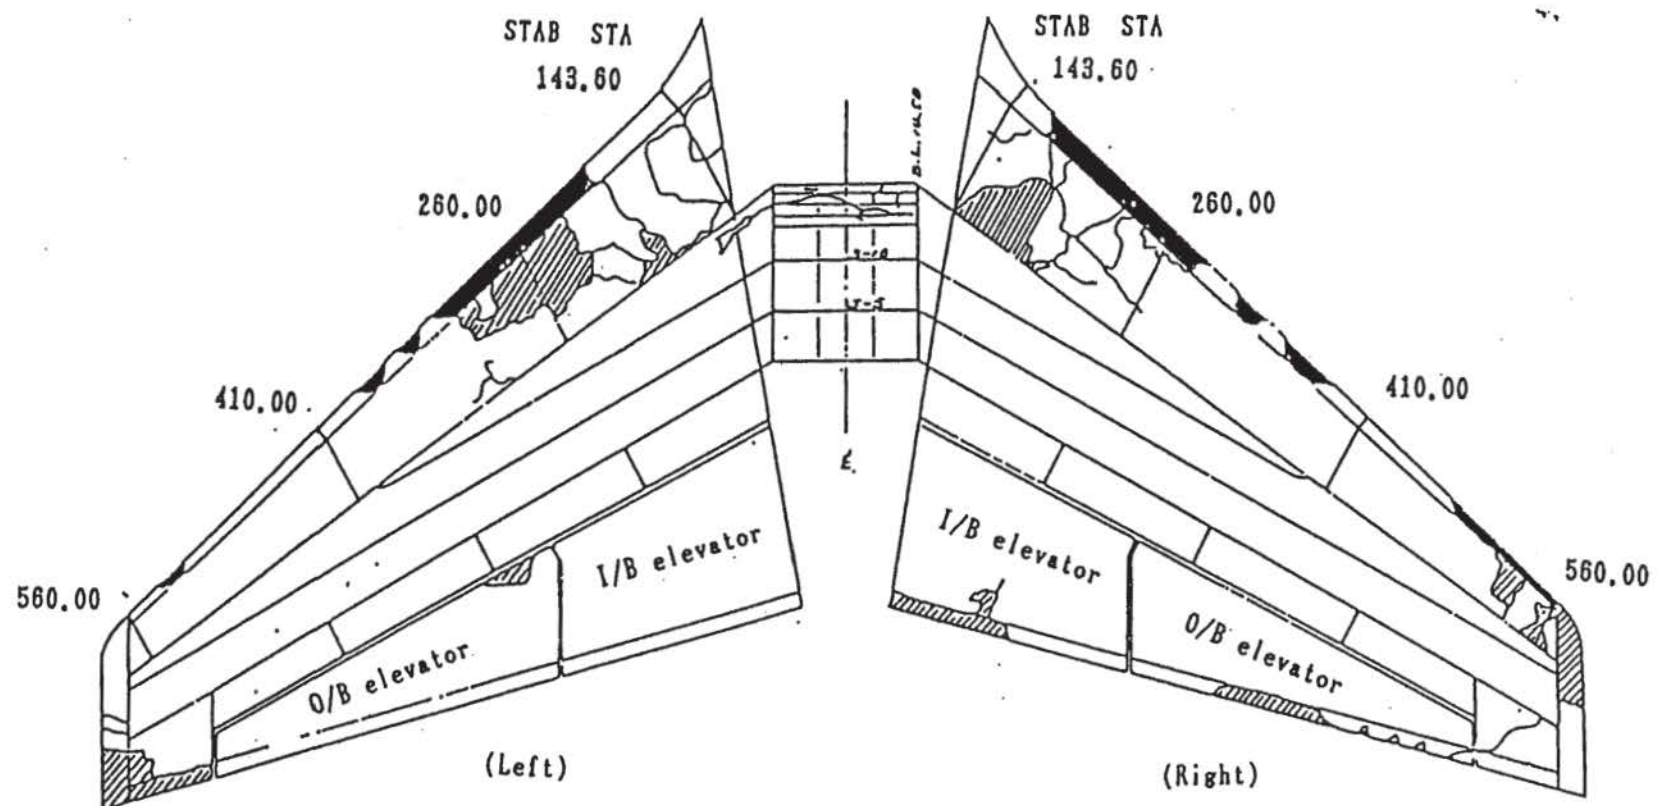
30 Damage to horizontal stabilizer (upper surface)

- (4) The horizontal plane was separated from the fuselage, and the left outside elevator was torn off from the stabilizer. A portion of the leading edge of the root of the stabilizer was fractured and separated.
The left leading edge of the horizontal stabilizer's center section and up to the vicinity of SS165.73 was damaged (see Photo-6).

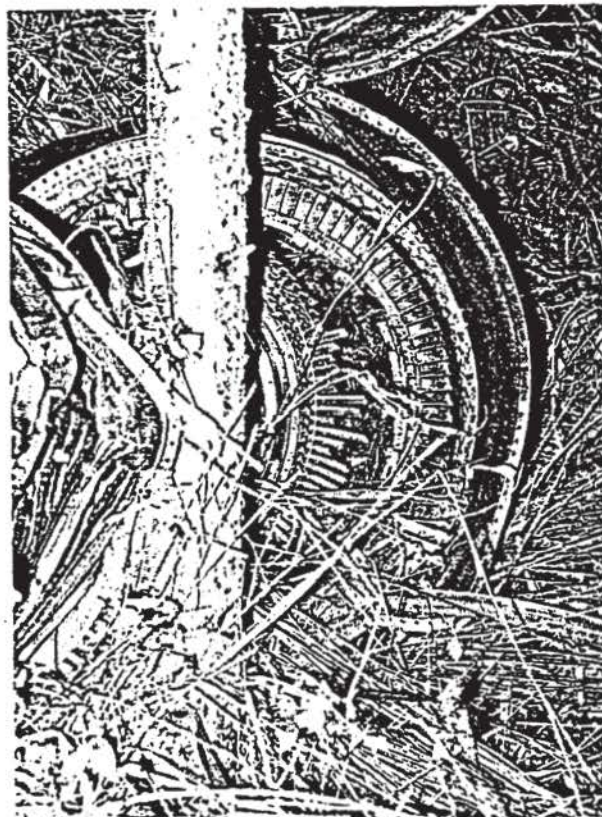
10 Part of No.4 engine

(4) The fan section and core of No.4 engine were destroyed, the fan and the high pressure compressor shaft being severed, and broken into two in the vicinity of stage 9 of the high pressure compressor. The spinner, fan blades, fan case, thrust reverser, engine mounts, gear boxes, combustion chamber, high and low pressure turbine blades, turbine sleeve and plug were torn off and separated (see Photo-10).

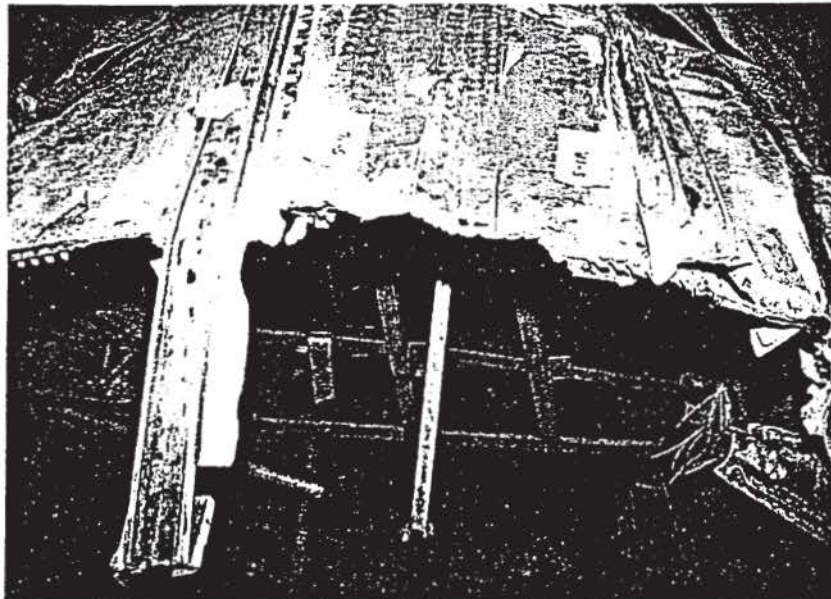
(a) Between fuselage stringer 1L (hereinafter stringers are represented by abbreviation only, where L indicates left side, and R right side) and 1R, the forward angle, doubler, and forward fuselage skin were all fractured on fastener row ① (see Photo-33).

33 Rupture of BS2658 APU firewall
installation parts between SIL and S1R

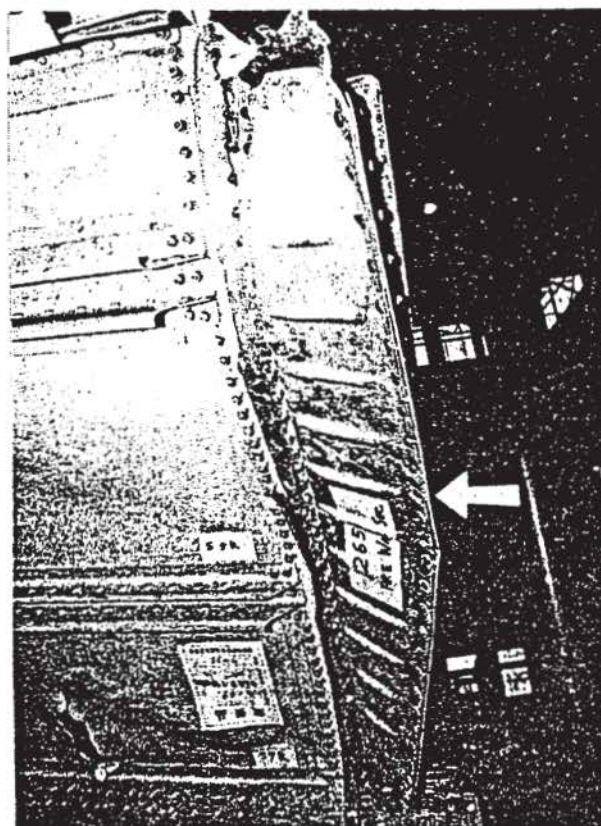
(b) Between 2R and 7R, both angles were partially fractured at the L section's corner (hereinafter referred to as "corner"), but the hinge support channel of the APU air intake duct remained attached.

34 Hinge support channel of APU air intake duct

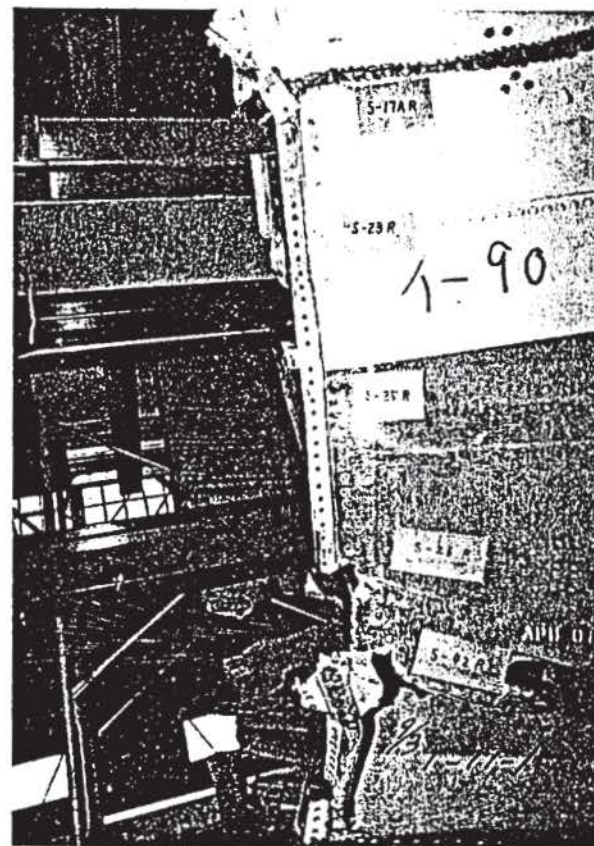
36 Damage of APU firewall installation section at
BS2658 near S23R

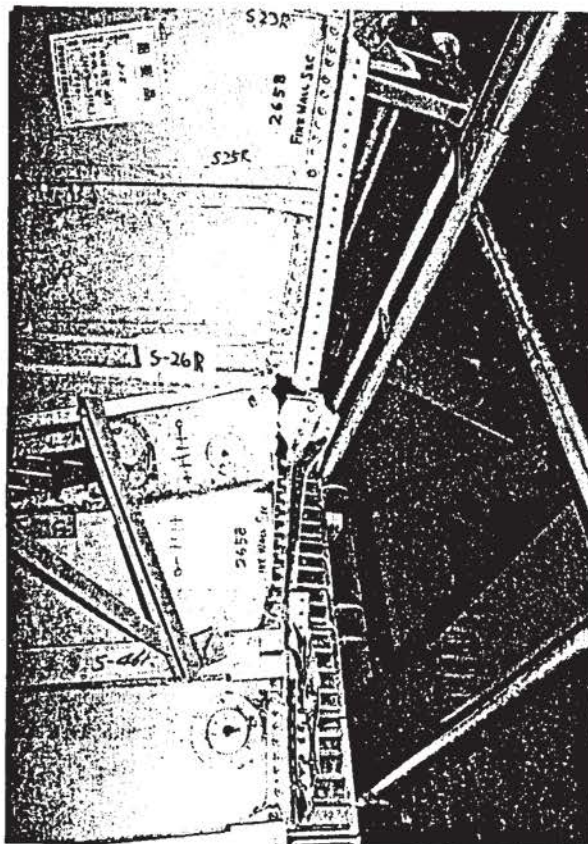
- 37 Damage of APU firewall installation section at BS2658 near S25R

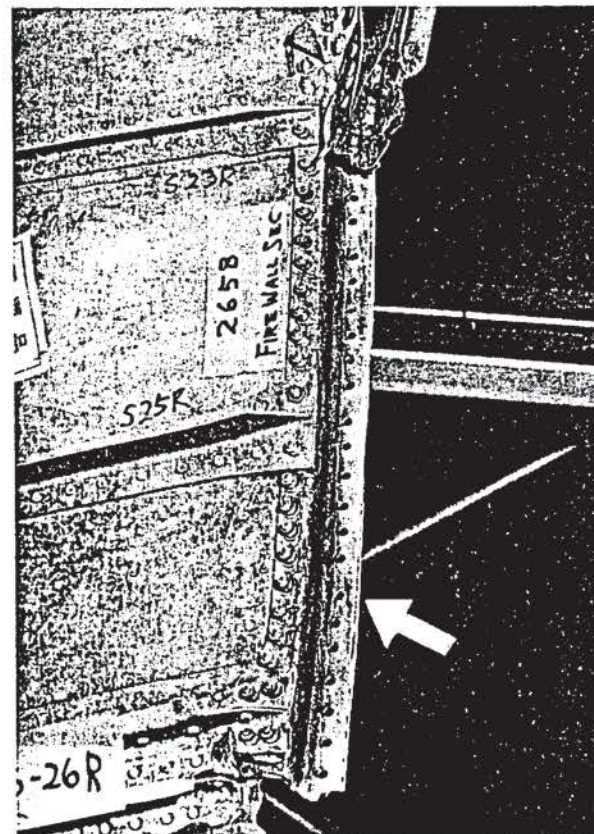
- 38 Warped doubler in APU firewall installation section at BS2658 near S25R

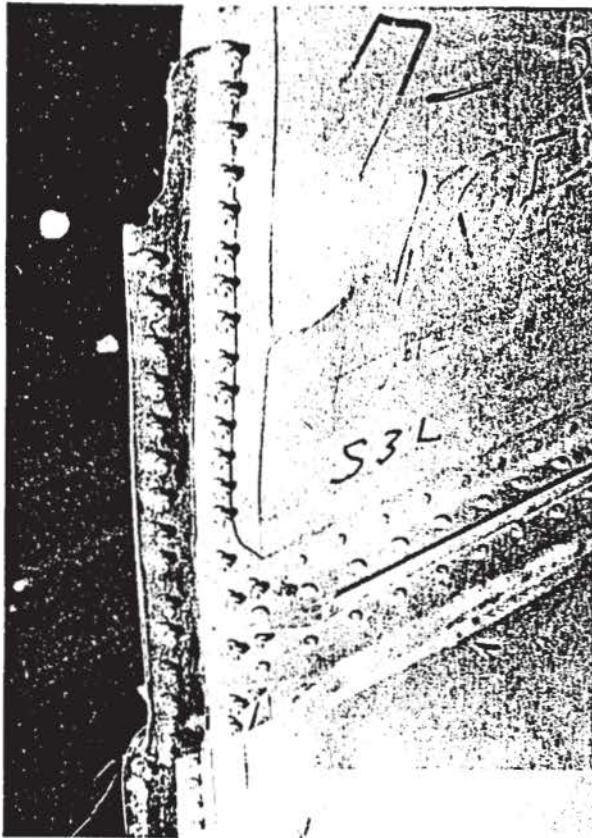
39 Damage of APU firewall installation section at
BS2658 near S3L

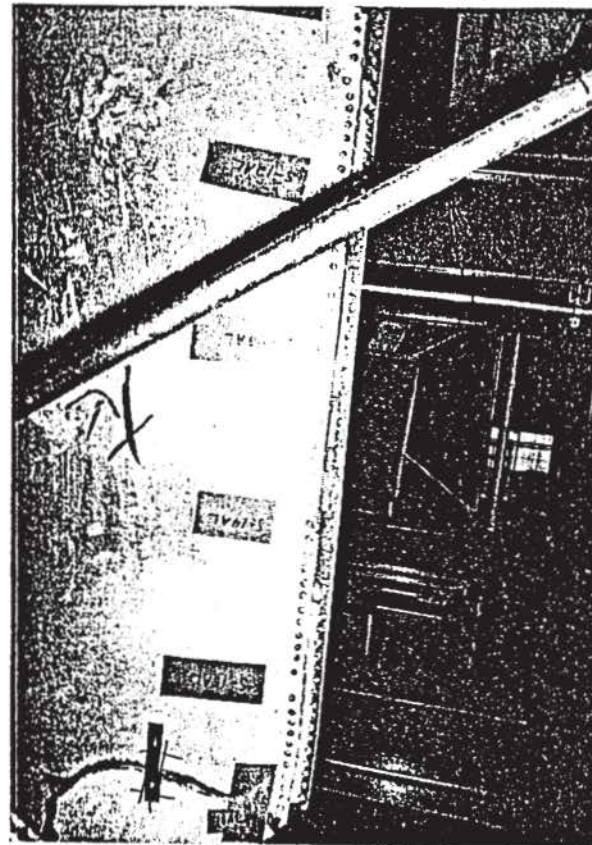
40 Damage of APU firewall installation section at
BS2658 near S14AL

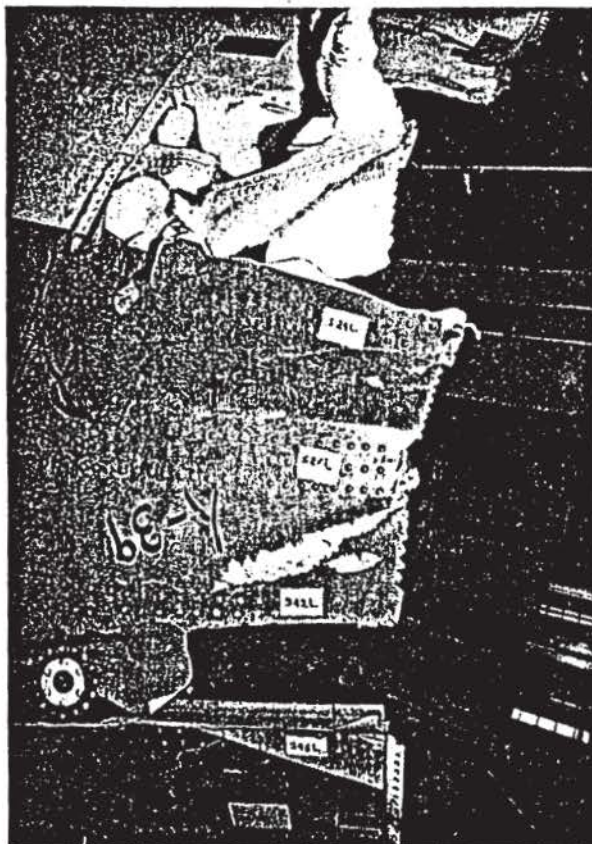
41 Damage of APU firewall installation section at
BS2658 near S26L

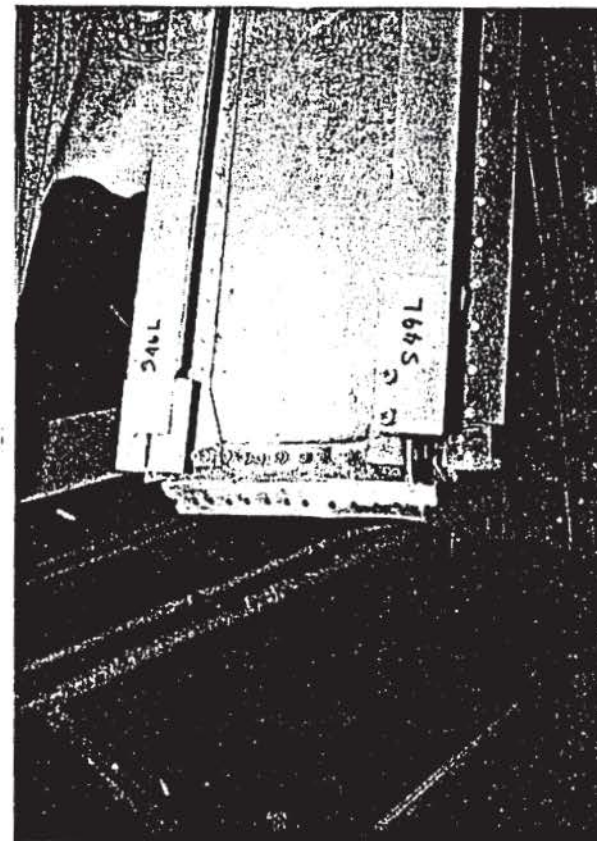
42 Damage of APU firewall installation section at
BS2658 between S46L and S49L

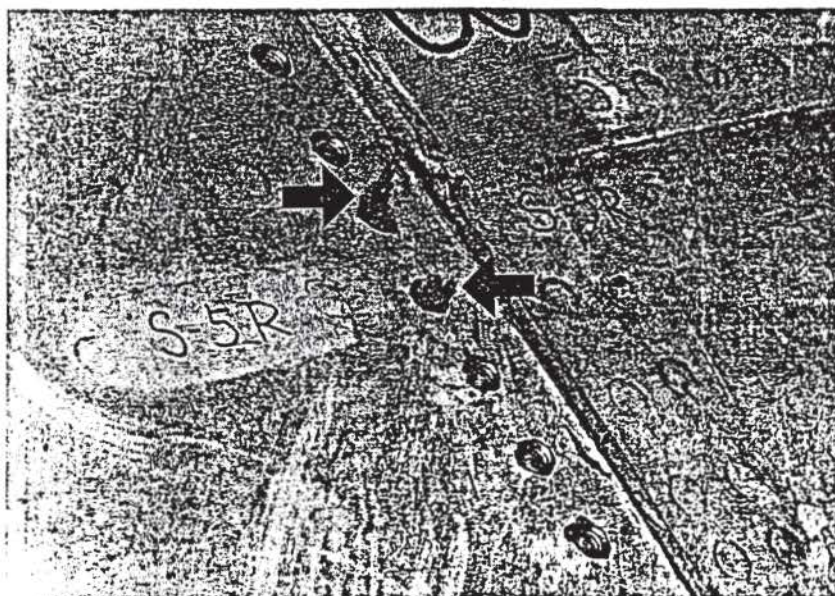
- 43 Insulation materials that appear to have blown through fastener holes in fuselage skin at BS2638

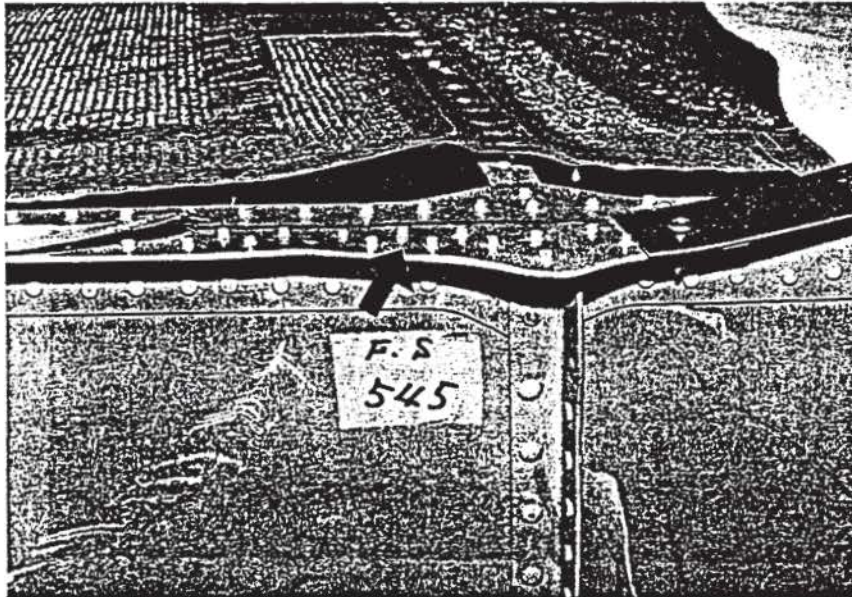
45 Fractured rivets at vertical stabilizer
forward torque box front spar left chord

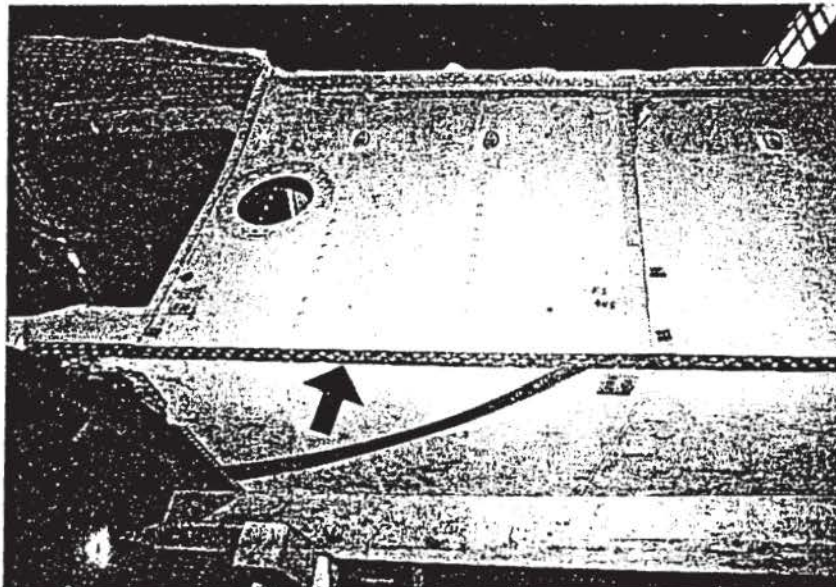
46 Fractured skin at vertical stabilizer forward
torque box front spar right chord

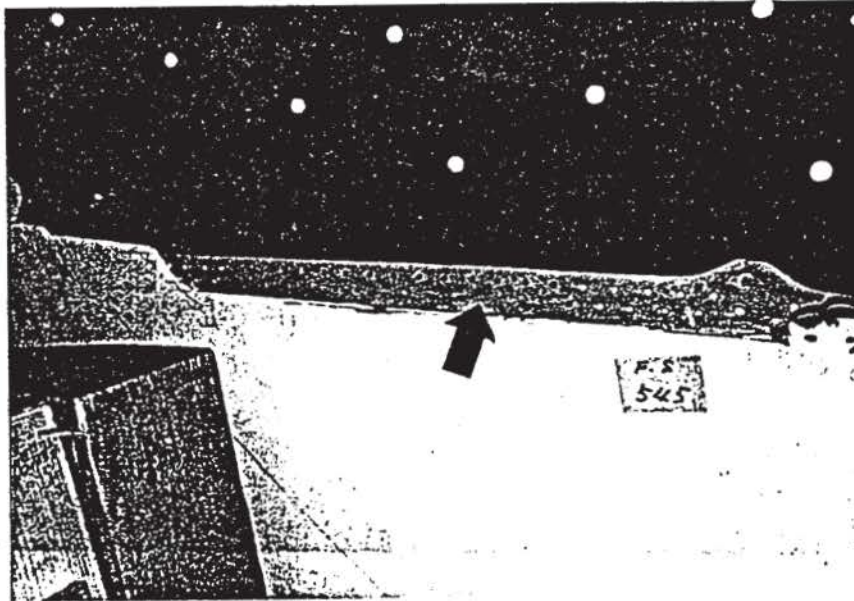
- 47 Fractured rivets at vertical stabilizer forward torque box spar right chord near FS545

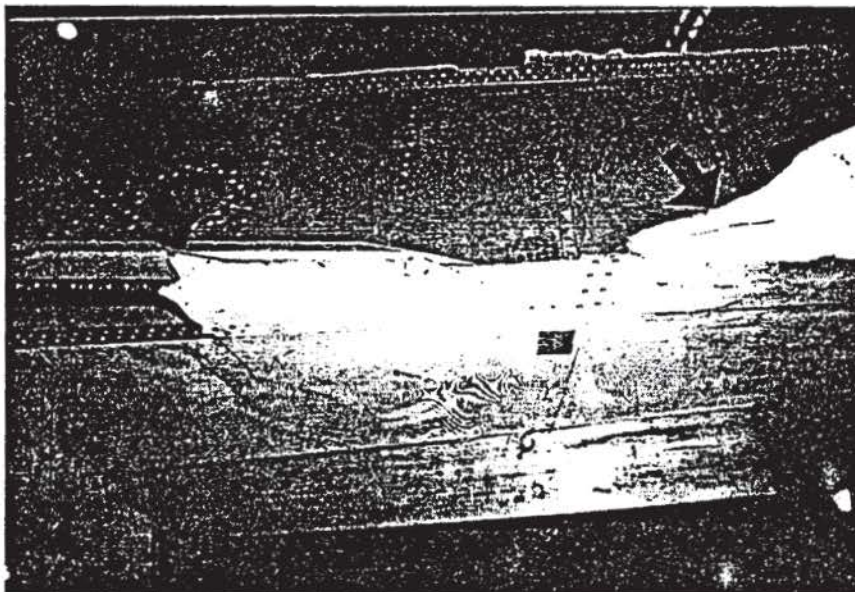
- 48 Fractured skin at vertical stabilizer forward torque box front spar right chord near FS495

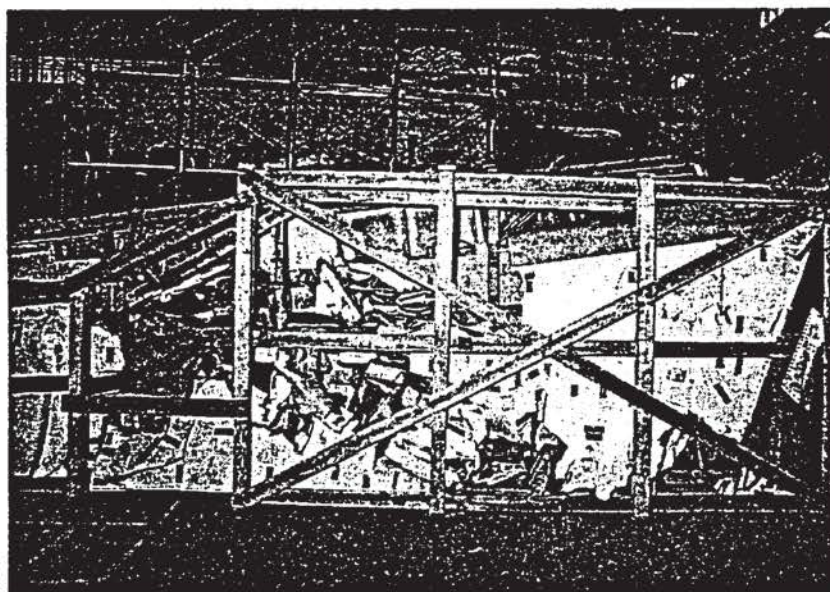
60 Fractured left horizontal stabilizer leading edge

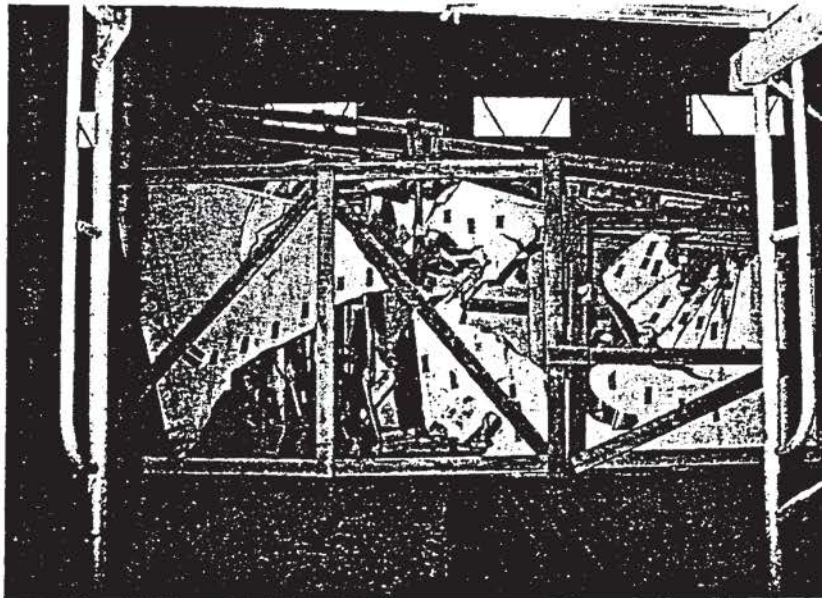
61 Fractured right horizontal stabilizer leading edge

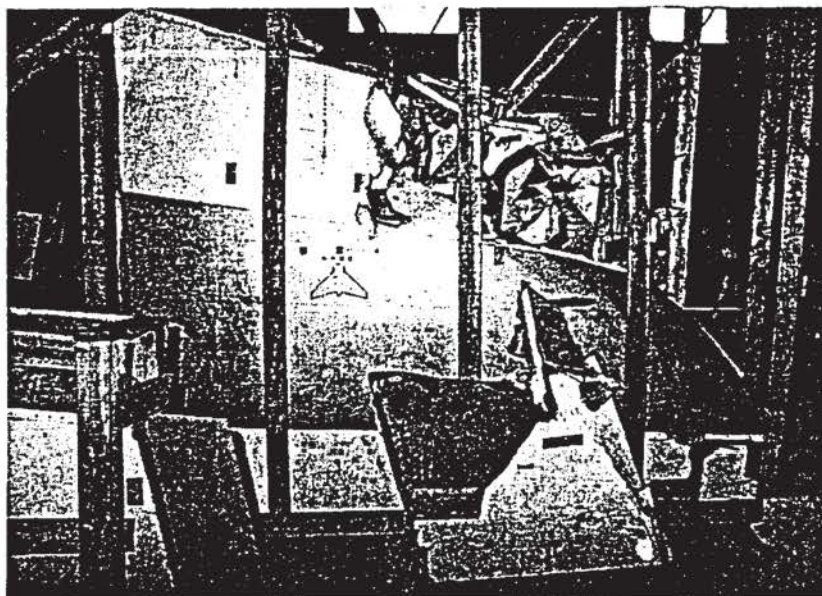
62 Fractured right horizontal stabilizer tip

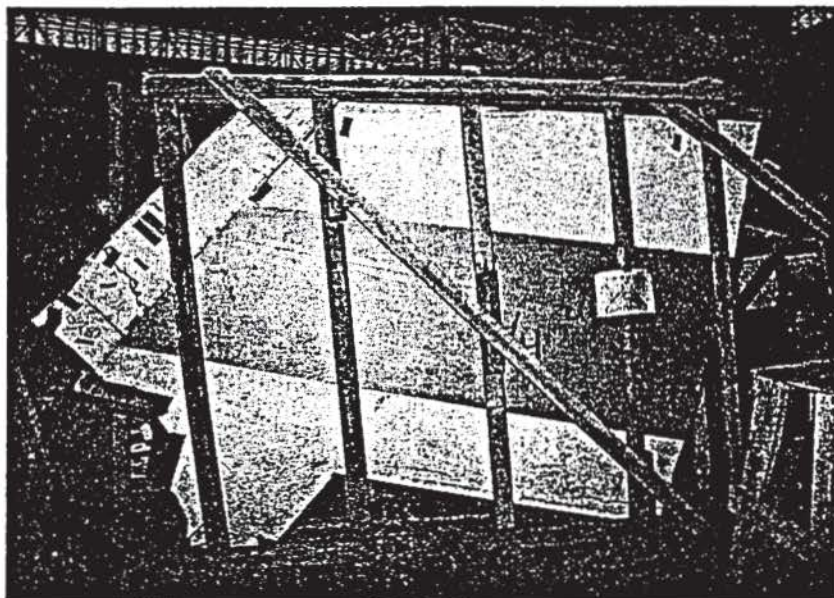
63 Fractured left horizontal stabilizer tip

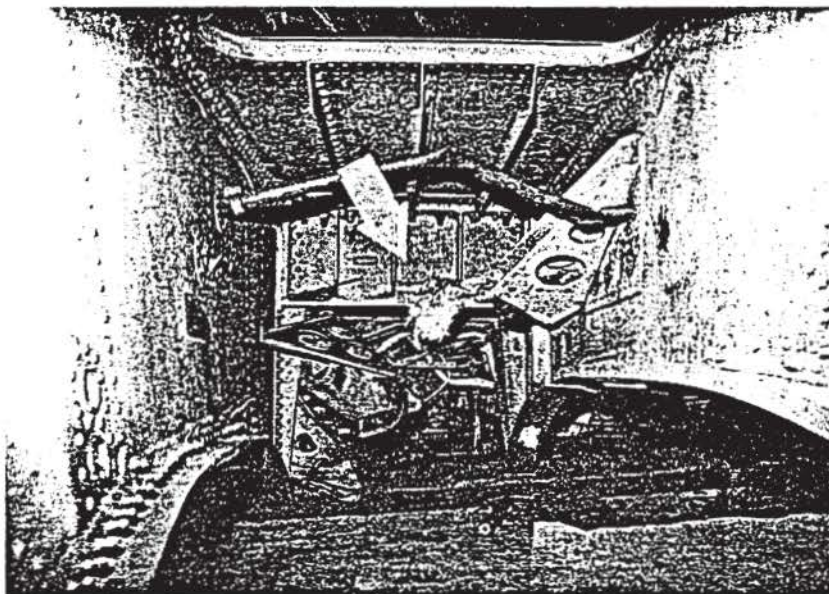
- 94 Fuselage frame at fuselage to vertical fin joint
(BS2436-2460)

Clump of head insulation materials found
reinforcement beam in fuselage frame.

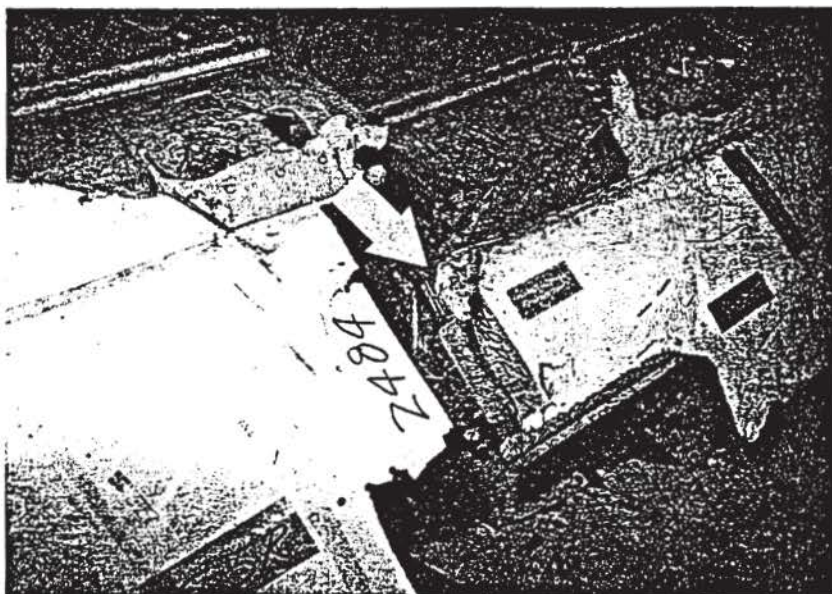
- 95 Fuselage rupture at fuselage to vertical fin joint
(BS2484)

Heat insulation materials found in right skin corner at base of aft torque box.

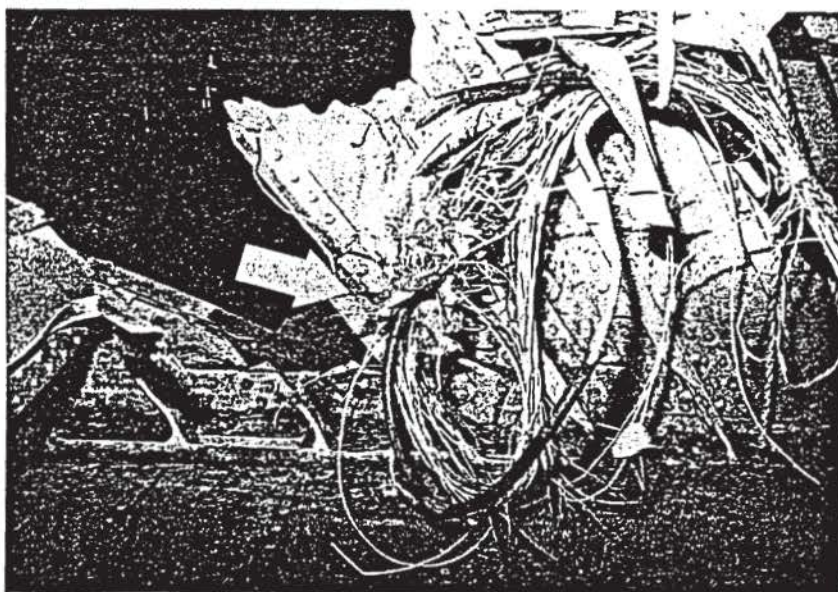
- 96 Vertical stabilizer aft torque box-root of skin on
left side

Film covering heat insulation materials found
tangled in antenna cable, etc.

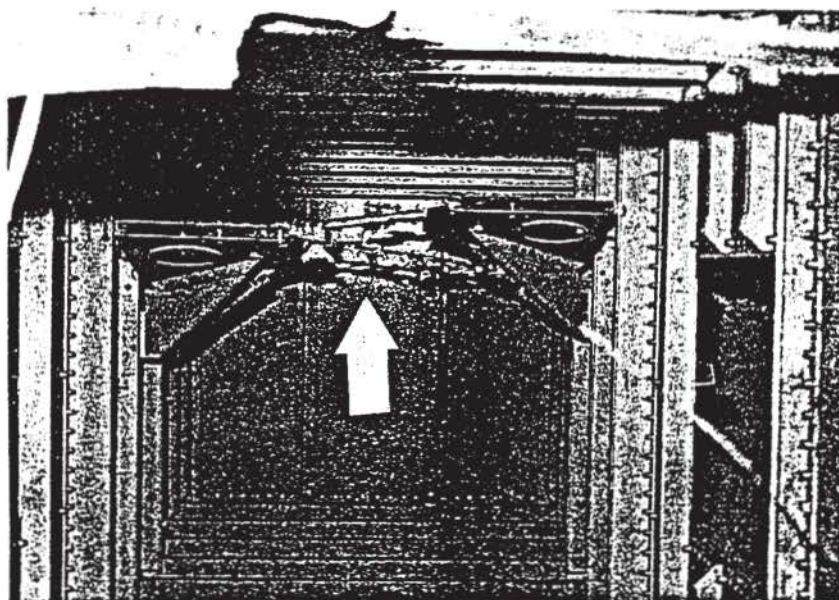
97 Central part of horizontal stabilizer center section

Heat insulation found adhering to control cable inside.

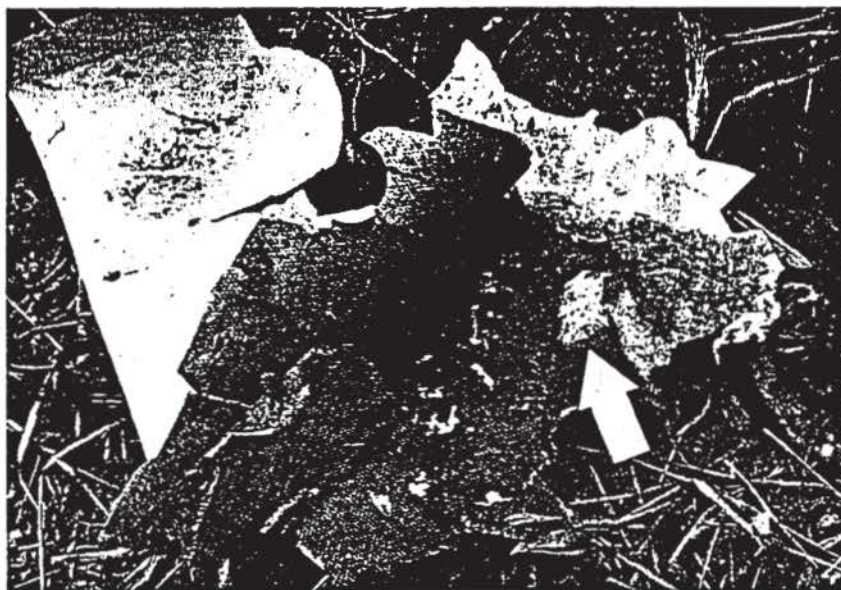
98 Insulation materials adhering to fragments of ceiling of rearmost cabin lavatory (lavatory R)

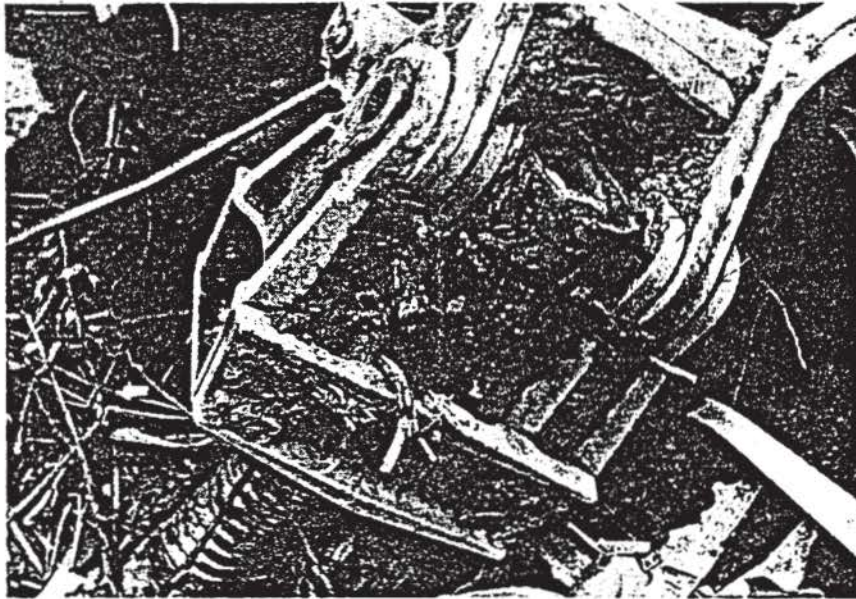
99 Fracture of horizontal stabilizer jack screw (crash site)

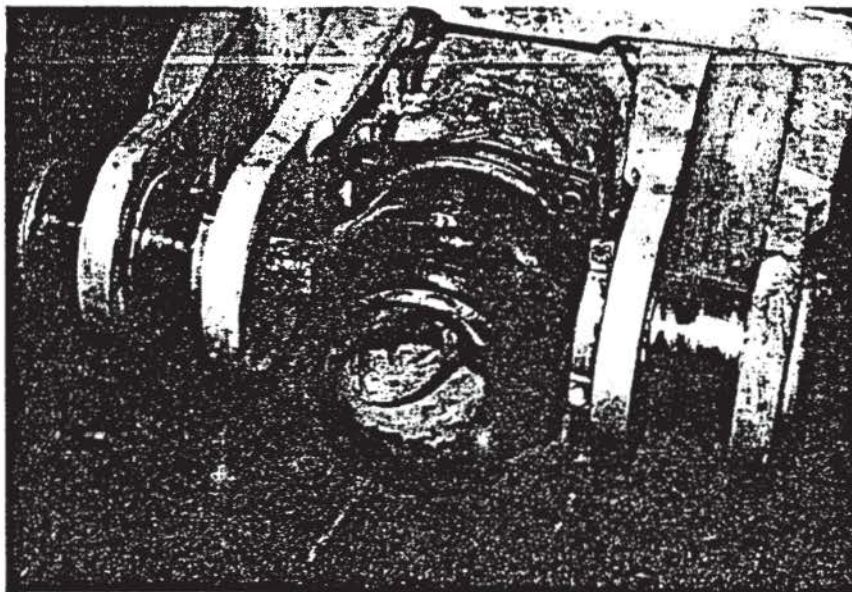
100 Fracture of horizontal stabilizer jack screw
(condition before teardown).

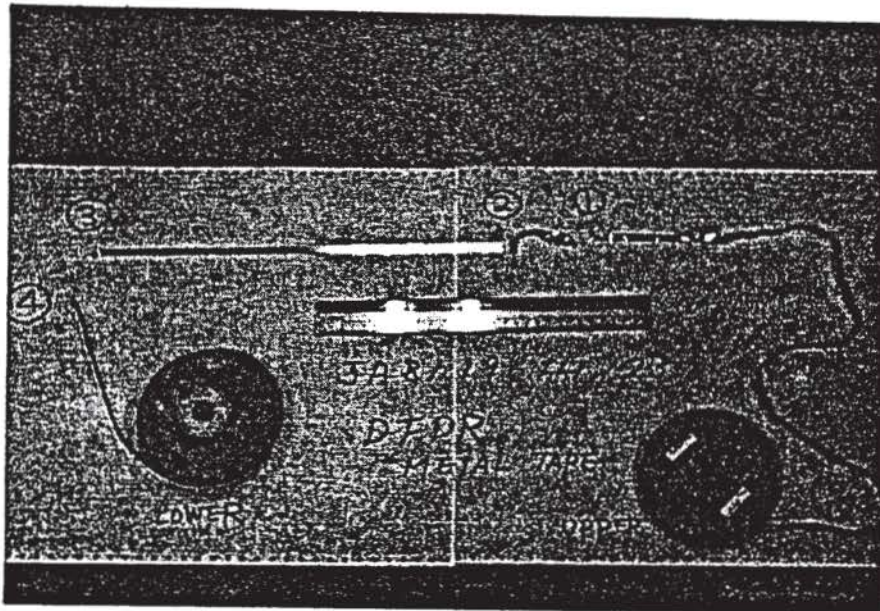
101 Damage to magnetic tape

写真の中の③④は当該飛行以外の記録部分の損傷であり、
また、テープが白くなっている箇所はフラッシュ・ライト
のためである。

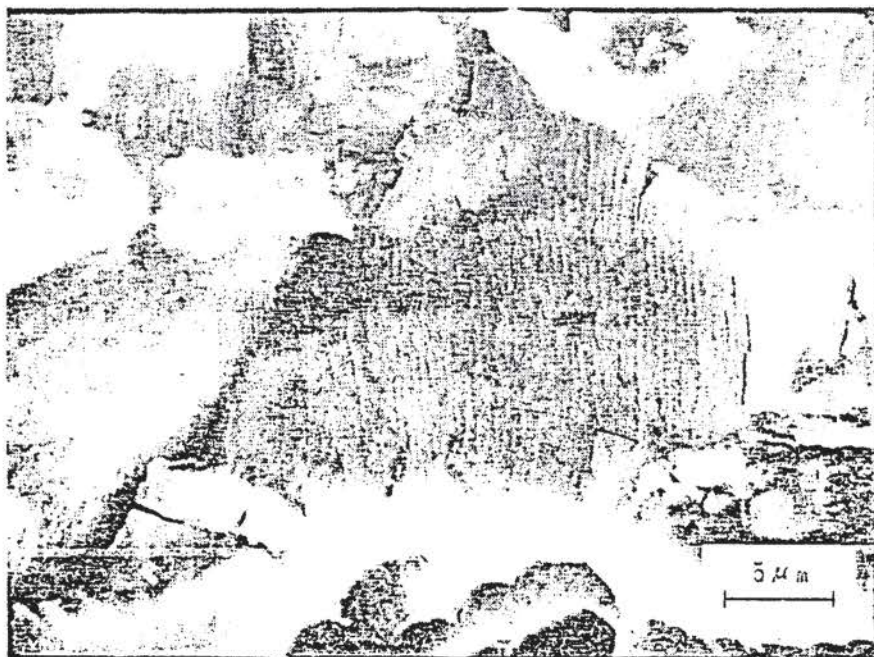
Photo-109 Fracture surface of rivet hole No.34 inboard. Typical fatigue fracture facet. Fine striation patterns show stable crack propagation due to cyclic loading. The spacing of the striation gives the rate of propagation being $0.23\mu\text{m}$ per cycle at this point, 0.28mm from hole edge. Crack grew from left to right on the photo.

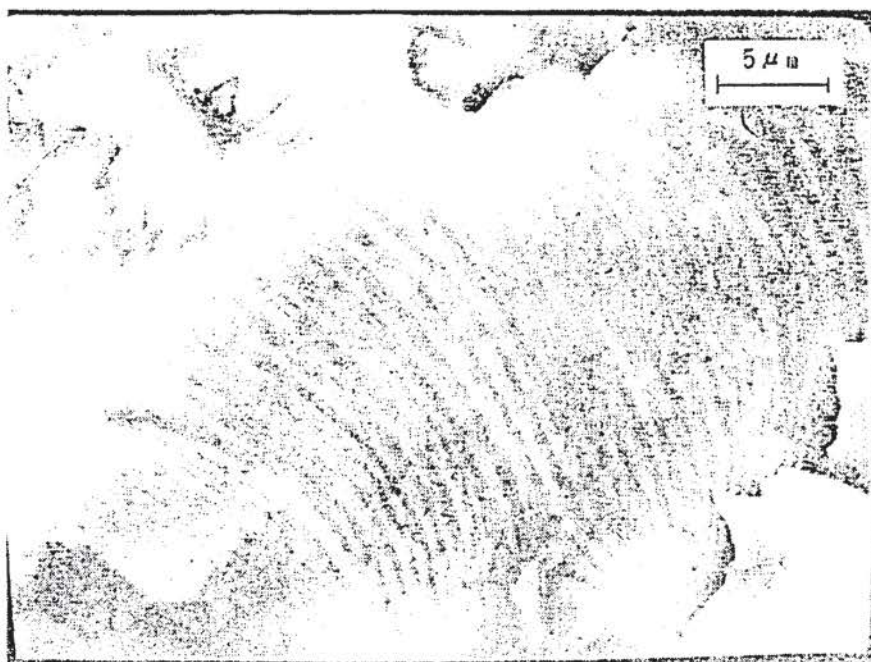
Photo-110 Fracture surface of rivet hole No.34 inboard. Striation spacing increases as crack growth rate increases, at 3.05mm from hole edge near the transition point shown photo-107.

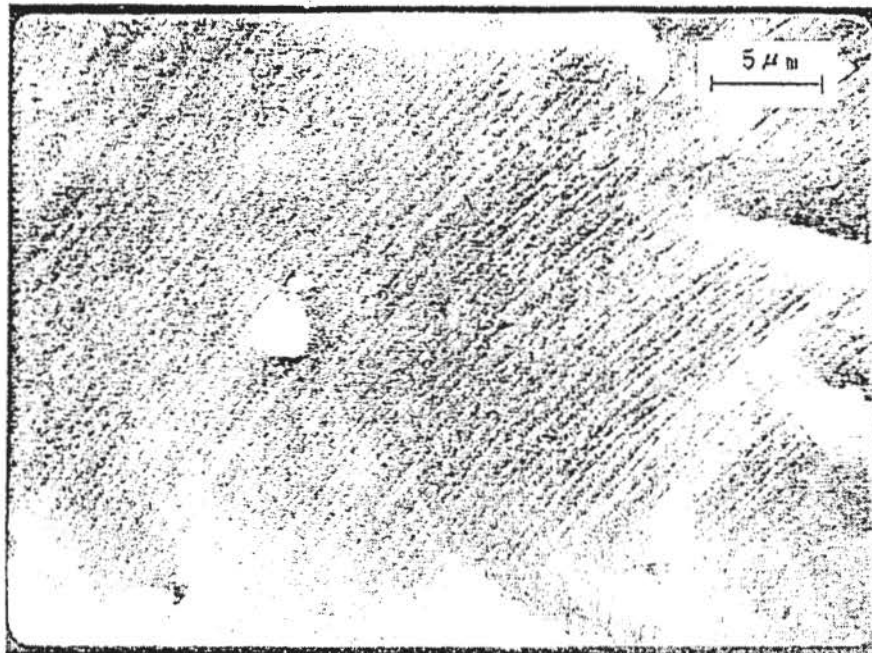
Photo-112 Fracture surface of rivet hole No.53 outboard. Clear striations observed at 1.00mm from egde of rivet hole No.53 outboard. Direction of crack growth is from lower right to upper left on the photo, as a result of local bending load.

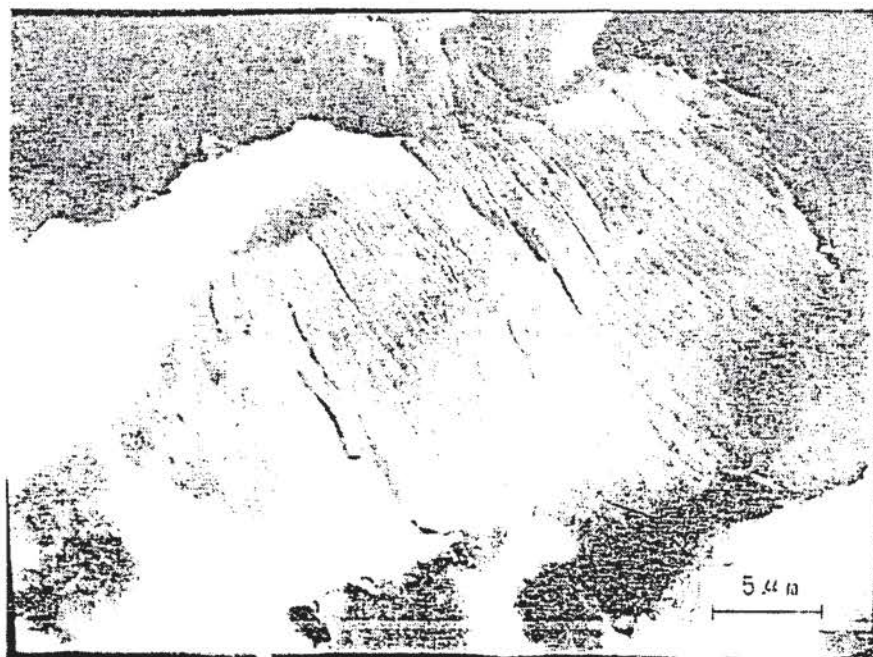
Photo-113 Fracture surface of rivet hole No.66 outboard. Direction of crack growth is from upper right to lower left on the photo at 0.80mm from egde of rivet hole No.66 outboard.
