AIRCRAFT ACCIDENT INVESTIGATION REPORT

Japan Air Lines Co., Ltd.
Boeing 747 SR-100, JA8119
Gunma Prefecture, Japan
August 12, 1985

Aircraft Accident Investigation Commission
Ministry of Transport

June 19, 1987

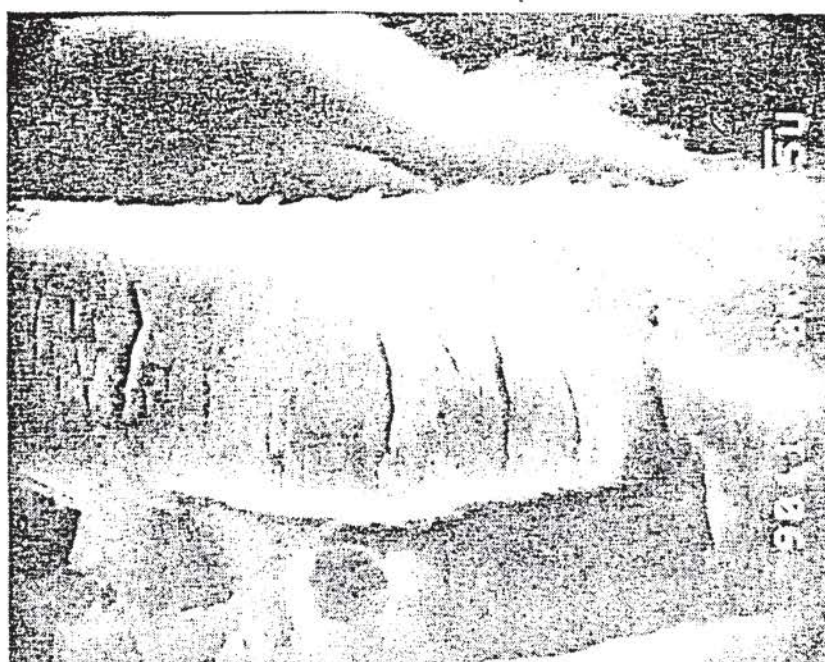
Photo-114 Fracture surface of rivet hole No.90 inboard. Direction of crack growth is from left to right on the photo at 2.60mm from egde of rivet hole No.90 inboard.

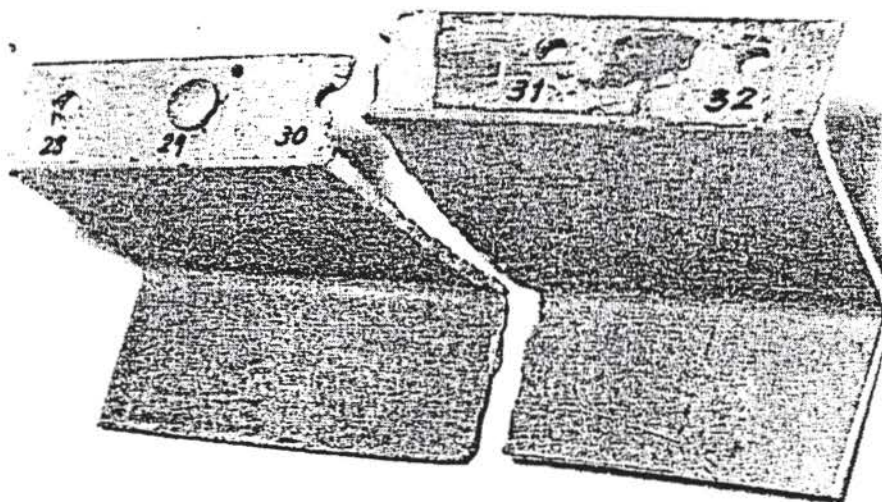
Photo-119 Fracture aspect of stiffener L18, at rivet hole No.30.

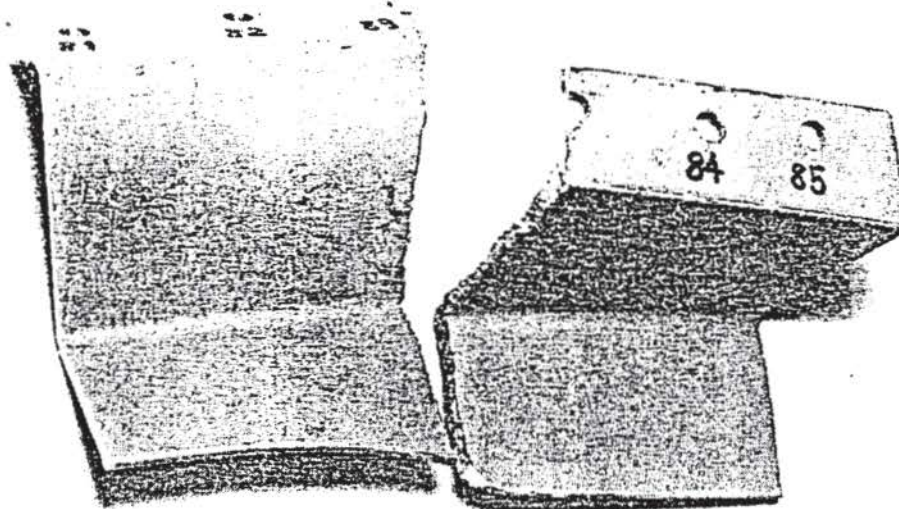
Photo-120 Fracture aspect of stiffener L18, at rivet hole No.83.

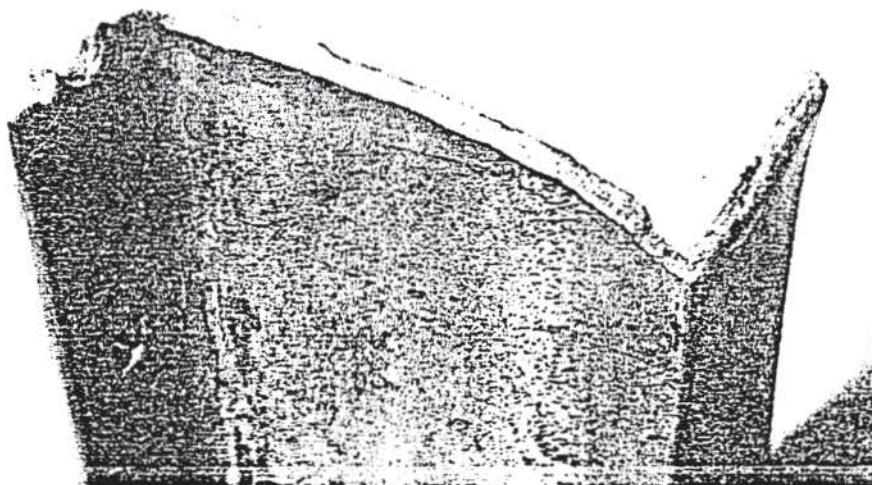
Photo-121 Close-up view of stiffener L18, revealing shear mode fracture, at rivet hole No.30 outboard.

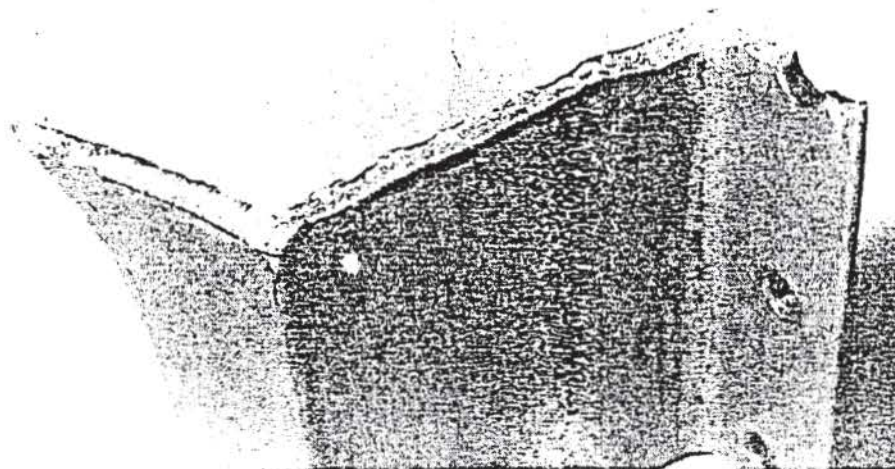
Photo-122 Close-up view of stiffener L18, revealing shear mode fracture, at rivet hole No.83 outboard.
