Ref: 20150/4342/2005

Date: 03 September 2005

## ***AIRCRAFT ACCIDENT 01/04***

# ***FINAL REPORT ON THE ACCIDENT INVOLVING KISH AIRLINES FOKKER F27 MK.050, IRANIAN REGISTERED AS EP-LCA ON APPROACH TO SHARJAH INTERNATIONAL AIRPORT UNITED ARAB EMIRATES ON 10 FEBRUARY, 2004***

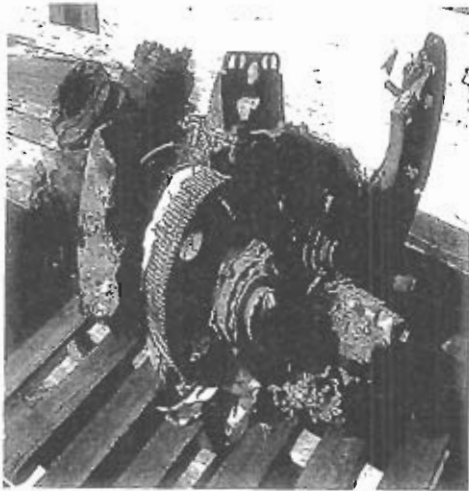
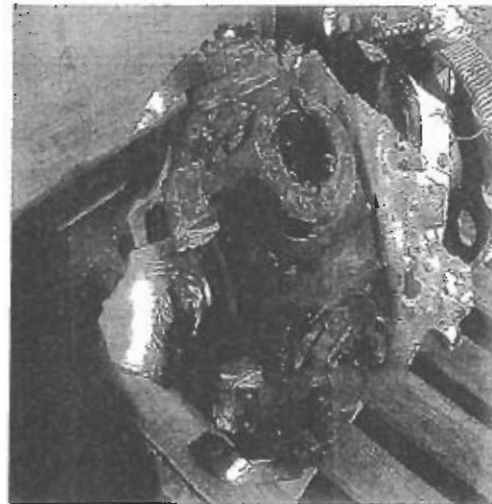
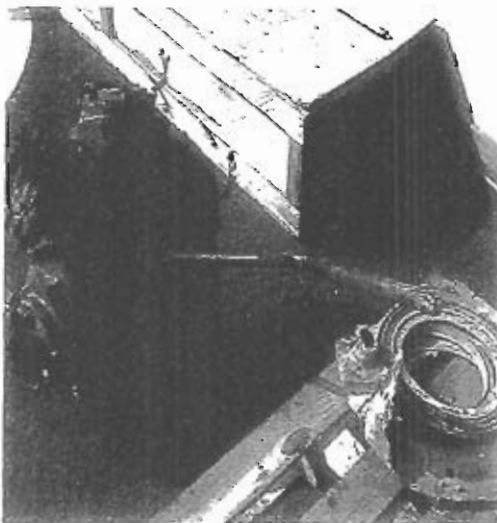
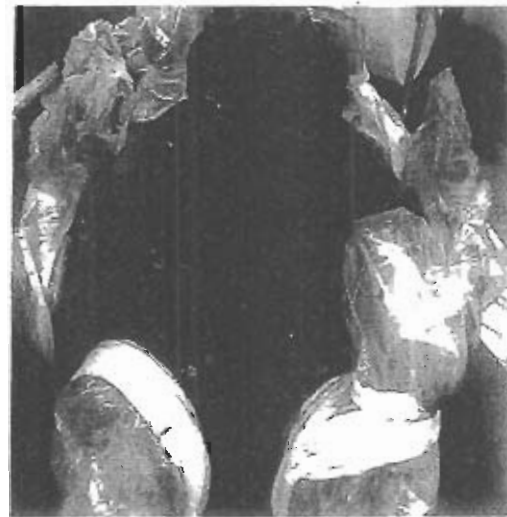
Propeller condition upon receipt & after removal from the gearbox

External examination of the counterweight position, using prepared acetates of the various counterweight centreline angles relative to the plane of propeller rotation, indicated that the left-hand propeller was approximately in a reverse position,  $-18^{\circ}$ . Using a depth micrometer to establish the as-found position of the piston indicated a blade angle of approximately  $-15^{\circ}$ . The result of the inspection reflect the as found condition for the blade angle and it should be noted take into account any post impact movement and potential movement during subsequent recovery and transportation.

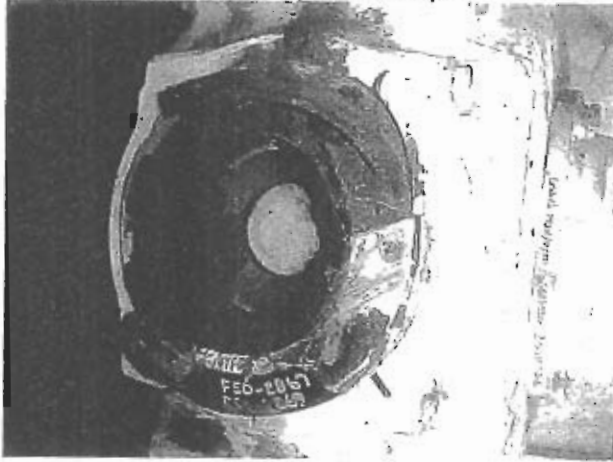
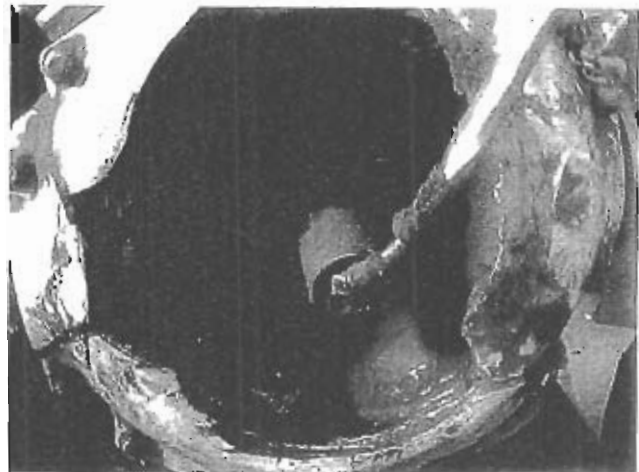
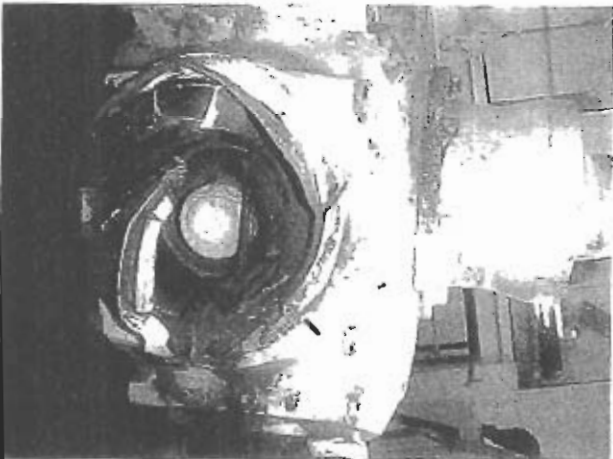
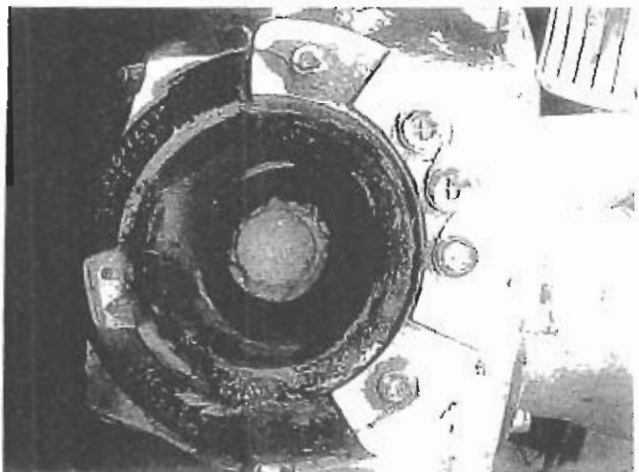
### Propeller condition upon receipt

External examination of the hub and six blade/counterweight positions showed three had become detached and the remaining blade angles ranged from  $+15^{\circ}$  to  $+27^{\circ}$ . Measurement of the as-found piston position indicated a blade angle of approximately  $+17^{\circ}$ . These examinations reflect the as found condition for the blade angle which takes into account post impact movement and potential movement during subsequent recovery and transportation.

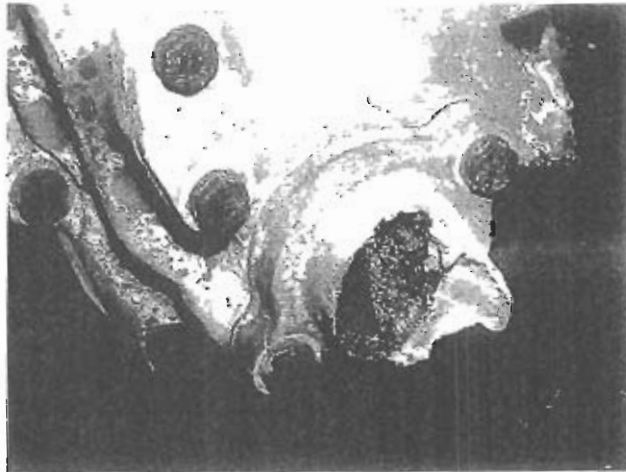
It was not possible to install a dummy beta tube on the rig to check the operation of the beta light switch due to distortion of the main body resulting from the fire. The rear cover had burnt through during fire, see figure below. It was noted that the spring used to hold the beta cam had moved from its seat although it is considered that this most likely occurred during the cleaning process prior to handling at DPRO-G, see figure below.

Burnt Rear Cover

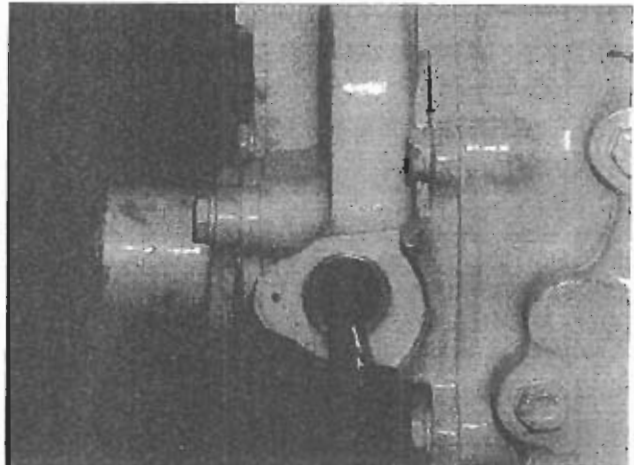
After washing down, detailed examination showed that the rear housing had fractured and one of the lugs on the end cap had fractured. It was not possible to install the rigging pin due to the movement of the end cap.

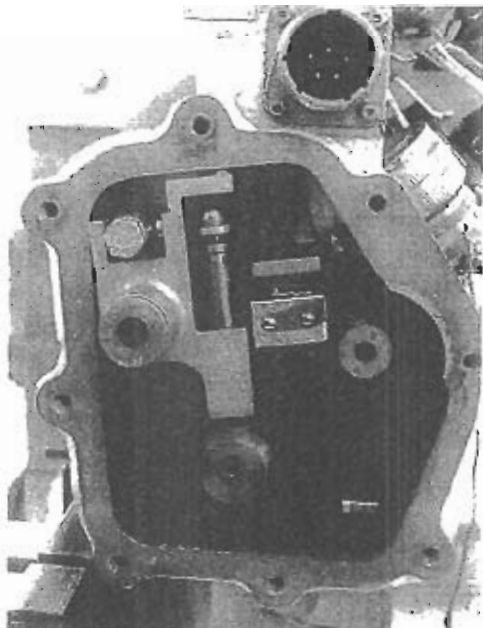
View on beta plunger

In addition the spring used to hold the beta plunger in place was missing. It was found around the side of the unit and was considered to have been displaced either during the impact or during the process of cleaning the PCU prior to handling in the workshop.

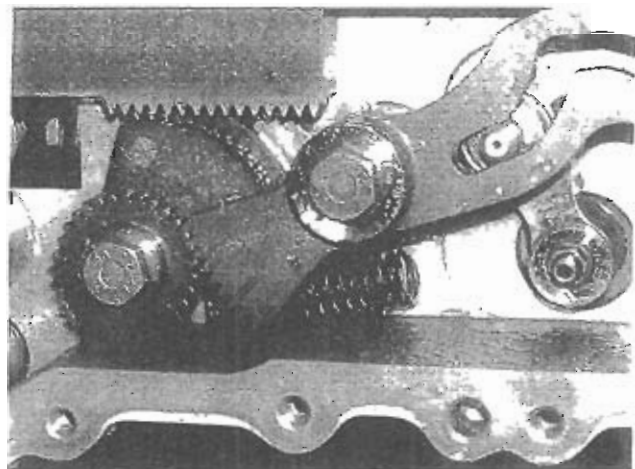
Location of displaced spring

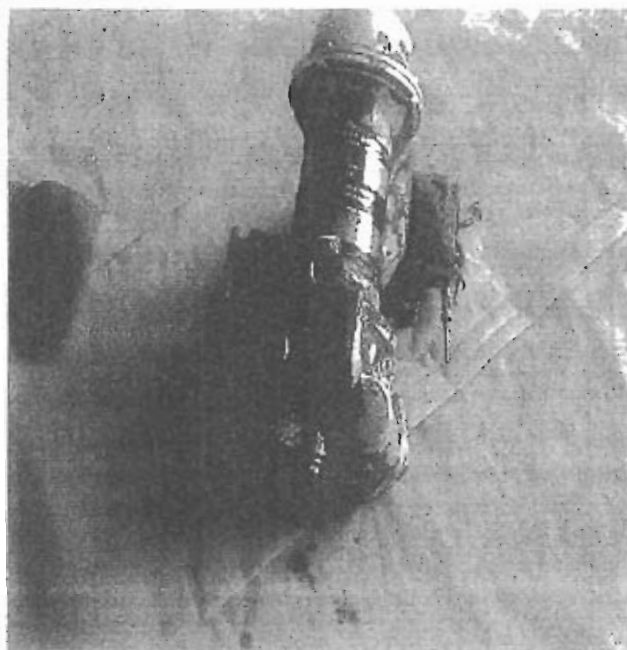
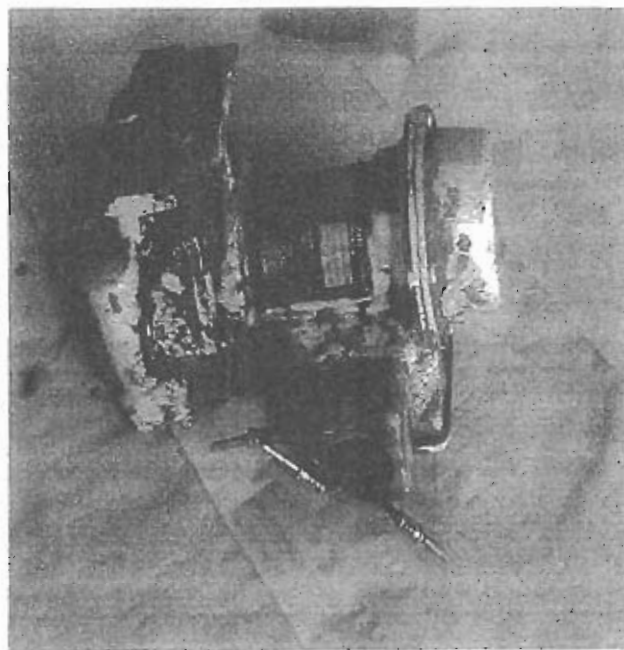
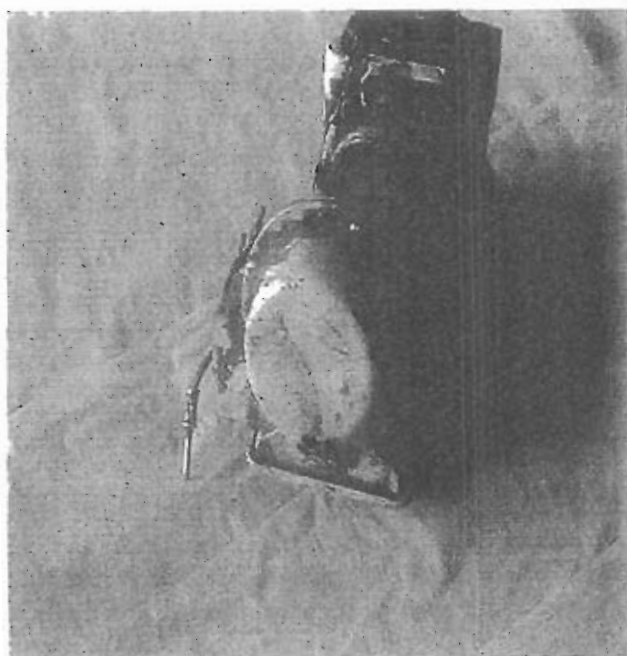
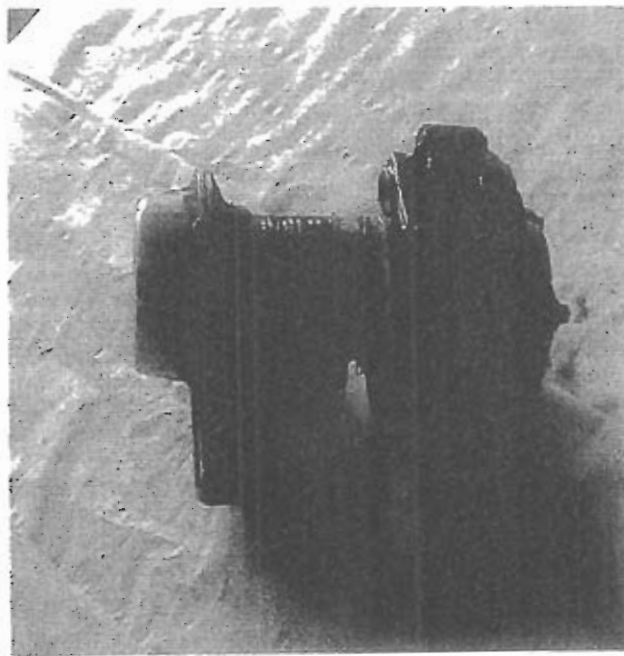
This unit was identified as type number RFP 35, and serial number DRG 63/86. The electrical connector was missing and the mounting face had fractured. As this unit had not suffered any fire damage, it is considered that this probably had been fitted to the RH powerplant. A label stating RH feather pump was found in the PCU package. No specific inspection, test or teardown was undertaken on the OSG.

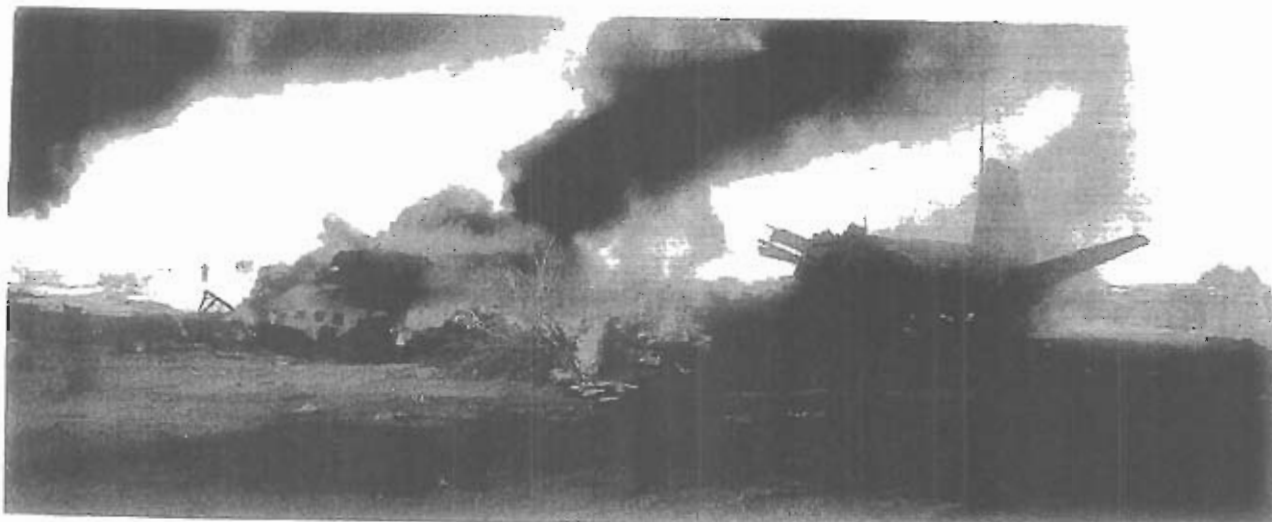
TAKEN 5 MINUTES AFTER IMPACT
