BAe 146 Magnetic Chip Detector

Majesty Airlines (MJA)
4,000 employees
Regional carrier
Operates 737 and BAe 146 aircraft

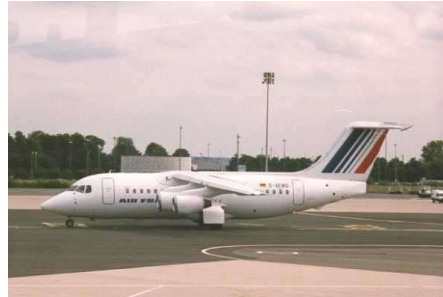
The captain watched as the crew chief checked the engines. The cowls were covered with oil and oil spilled to the ground when the cowls were opened. All four magnetic chip detector plugs were removed and found to have no seals.

Since Dennis did not read the AMM, he did not comply with these requirements. During the MEDA investigation, Dennis also admitted that he did not remember checking the plugs for seals prior to fitting them to the engines. Furthermore, he took the SOAP samples from the MCDP housings, not the engine oil tanks. However, during the MEDA investigation it was determined that not conducting ground runs was the normal practice at MJA.

1. The SOAP samples must be obtained from the engine oil tanks within 15 minutes of engine shutdown,
2. The MCDPs must be installed with a new seal, and
3. The engines then must be operated to check for oil leaks and satisfactory engine operation.
