Loss of Control  
Sundance Helicopters, Inc.  
Eurocopter AS350-B2, N37SH  
Near Las Vegas, Nevada  
December 7, 2011

NTSB/AAR-13/01  
PB2013-103890

# Aircraft Accident Report

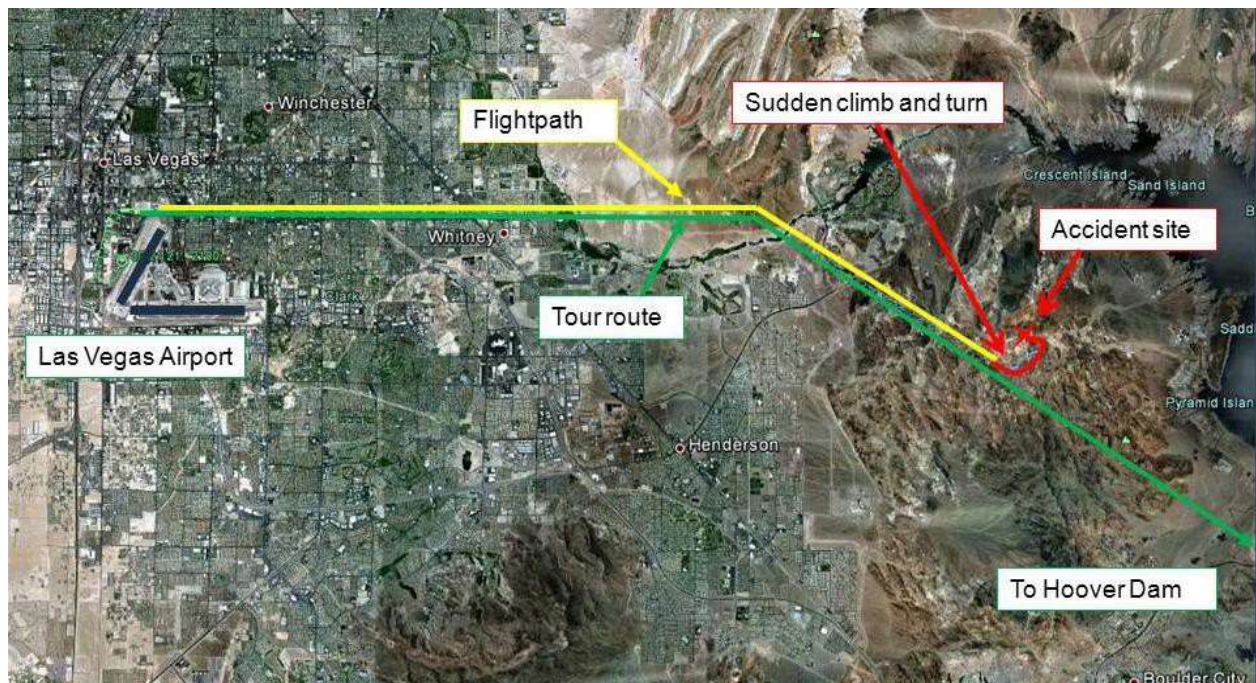
The accident occurred when the helicopter unexpectedly climbed about 600 feet, turned about 90° to the left, and then descended about 800 feet, entered a left turn, and descended at a rate of at least 2,500 feet per minute to impact. During examination of the wreckage, the main rotor fore/aft servo, one of the three hydraulic servos that provide inputs to the main rotor, was found with its flight control input rod not connected. The bolt, washer, self-locking nut, and split pin (sometimes referred to as a “cotter pin” or “cotter key”) that normally secure the input rod to the main rotor fore/aft servo were not found. The investigation revealed that the hardware was improperly secured during maintenance that had been conducted the day before the accident. The nut became loose (likely because it was degraded)<sup>1</sup> and, without the split pin, the nut separated from the bolt, the bolt disconnected, and the input rod separated from the linkage while the helicopter was in flight, at which point the helicopter became uncontrollable and crashed.

**Figure 1.** Accident flightpath (depicted in yellow) overlaid with the prescribed Twilight tour route (depicted in green).

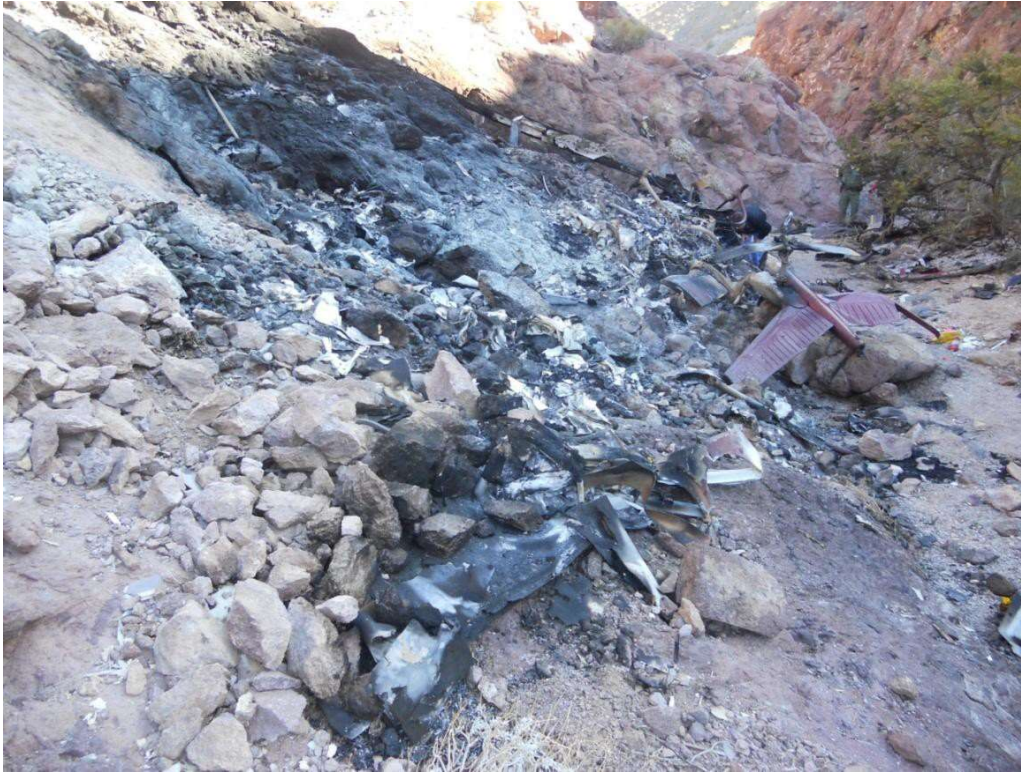
The helicopter crashed in a ravine between Henderson, Nevada, and Lake Mead.<sup>9</sup> The helicopter impacted the terrain in a nose-low attitude on an approximate north-easterly heading. The cockpit area and predominate helicopter structure were found in the immediate wreckage area. A large amount of the structure forward of the horizontal stabilizer was consumed by postimpact fire. See figure 2 for a photograph of the main helicopter wreckage.

**Figure 2.** Photograph of the main helicopter wreckage.

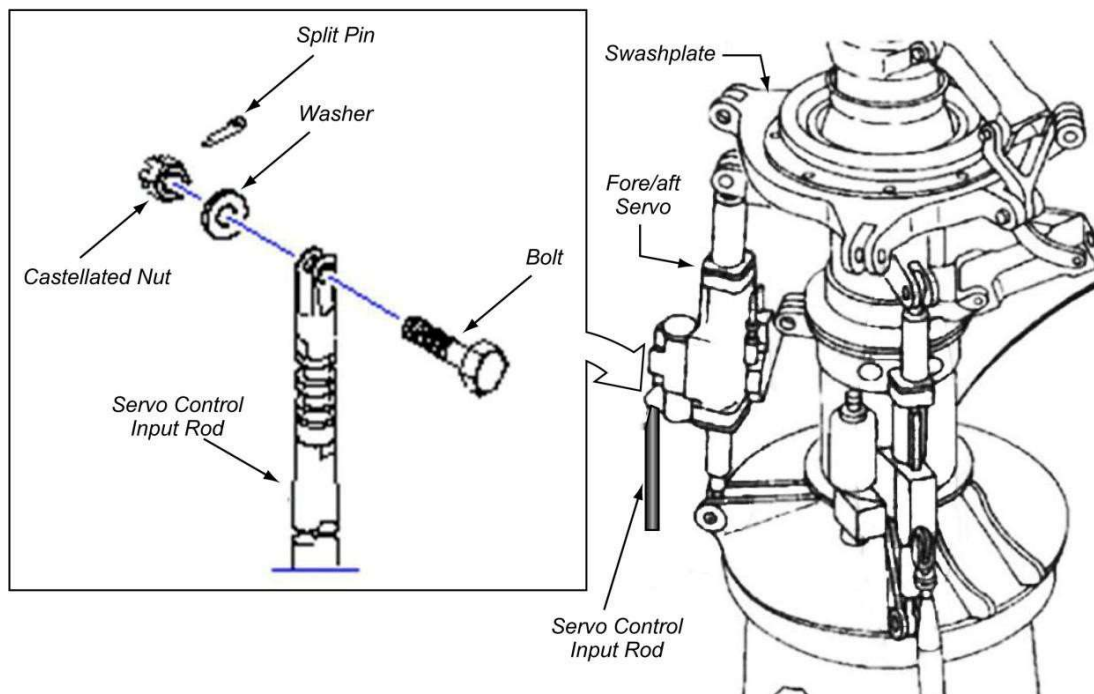
**Figure 3.** Schematic of the main rotor servo assembly and the fore/aft main rotor servo's input rod assembly.

At the accident site, the fore/aft main rotor servo’s control input rod was found disconnected from the input lever, and the connection hardware (bolt, washer, self-locking nut, and split pin) was not found. The fore/aft servo connection hardware also was not found during subsequent comprehensive and detailed examinations of the wreckage and engine.<sup>14</sup> (The NTSB notes that the main rotor transmission area of the helicopter is not sealed. Therefore, if the connection hardware separates during flight, it most likely would not be contained.) The control input rods for both of the main rotor lateral servos and the tail rotor servo were found properly connected to their respective servo input levers.

The fore/aft servo’s control input rod was found in two pieces: one piece was an approximate 14-inch section of the upper input rod end that was found disconnected from the fore/aft servo input lever, and the other piece was an approximate 3-inch section of the lower end of the input tube that was found correctly attached to its linkage. Examination of the 14-inch section of the upper input rod end revealed no visible elongation of the bolt hole. The separation points on both sections of the input rod were consistent with overload/impact damage.

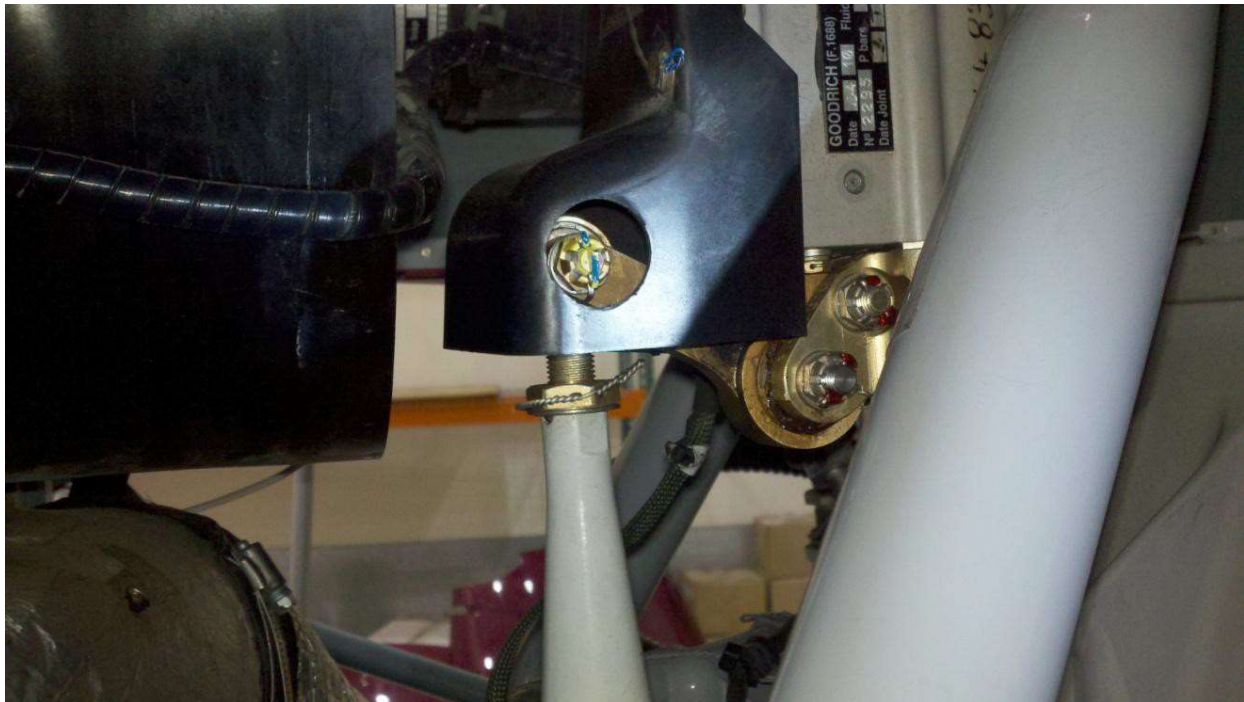
**Figure 4.** Photograph showing the nut and split pin of the fore/aft servo input rod connection hardware visible through the cutout of the ice shield (about eye level for a pilot inspecting the left MGB area).

The NTSB concludes that the mechanic, inspector, and check pilot each had at least one opportunity to observe the fore/aft servo self-locking nut and split pin; however, they did not note that the split pin was installed improperly or not present.

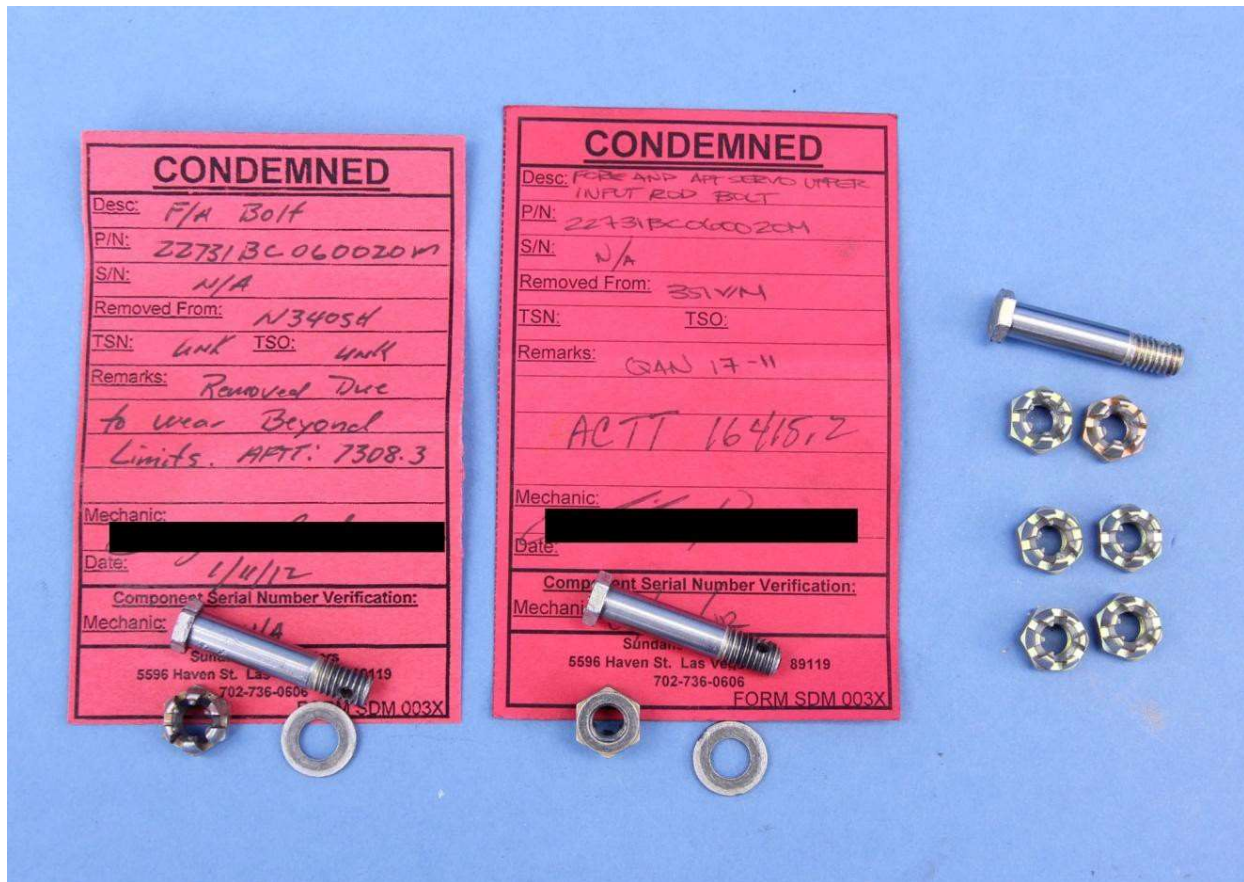
Sundance Helicopters provided the NTSB with self-locking nuts from two of the examined helicopters (N340SH and N351WM) that could be easily and fully tightened or loosened on the accompanying bolts with finger pressure. This indicates that the nuts from the two helicopters were not suitable for reuse because new nuts restrict movement by hand after two to three turns. In addition, torque measurements found that the turning resistance of the nuts on the bolts was about 1 in-lbf (inch pound force) or less in both directions. Figure 5 shows the nuts, upper input rod bolts, and washers removed from N340SH and N351WM next to a new bolt and nuts.

**Figure 5.** Photograph showing the nuts, upper input rod bolts, and washers removed from N340SH and N351WM next to a new bolt and nuts.

On the basis of this evidence, the NTSB concludes that at the time of the accident, Sundance Helicopters was not following Eurocopter and FAA self-locking nut reuse guidance, which led to the repeated improper reuse of degraded nuts on its helicopters.

helicopter with over 5,000 flight hours and that replacement of the hardware was to be accomplished at each 5,000 flight hours thereafter. Further, the alert notice stated that any time an input rod is disconnected from any of the servos, the nut must be replaced with a new nut.
