Leading Edge Protective Coating Against Fluid and Particulate Erosion for Turbofan Blades

Presented to: FAA Office of Environment and Energy

By: Delta TechOps (DTO)
MDS Coating Technologies (MCT)
America's Phenix, Inc. (AP)

Date: 11 May 2020

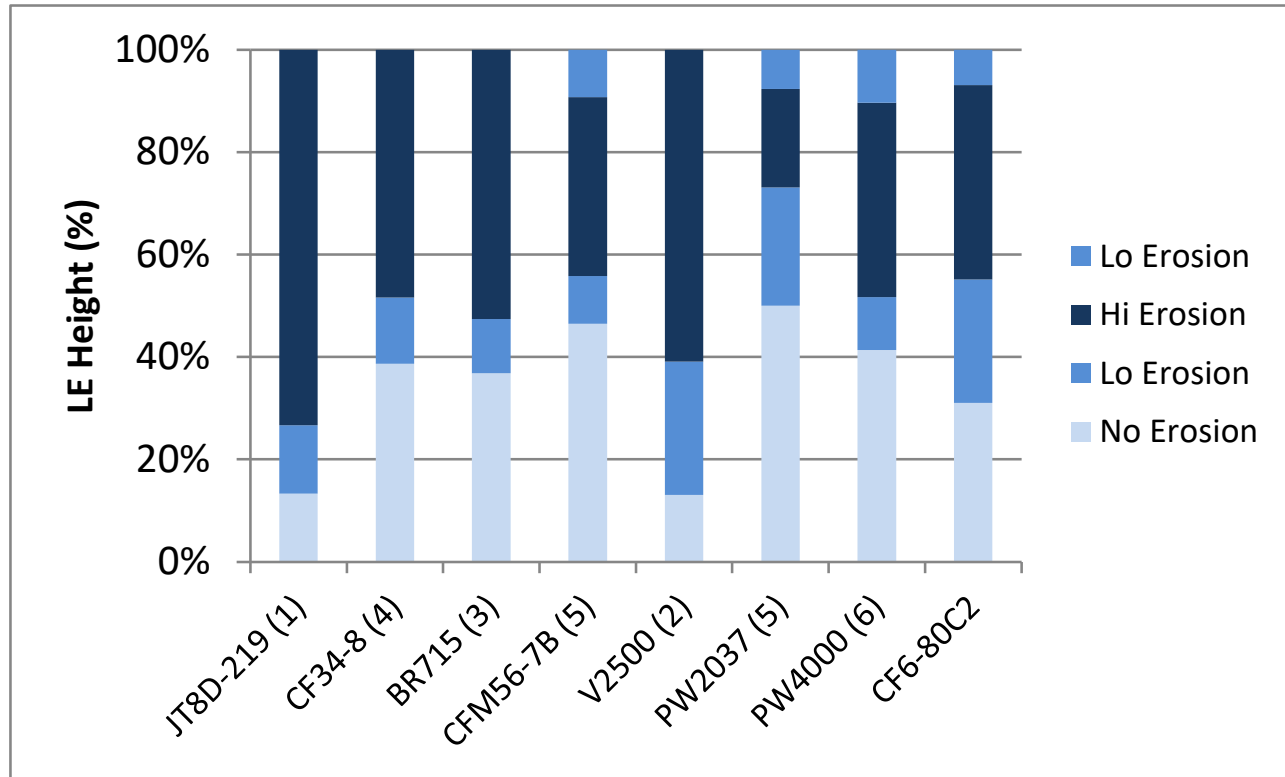
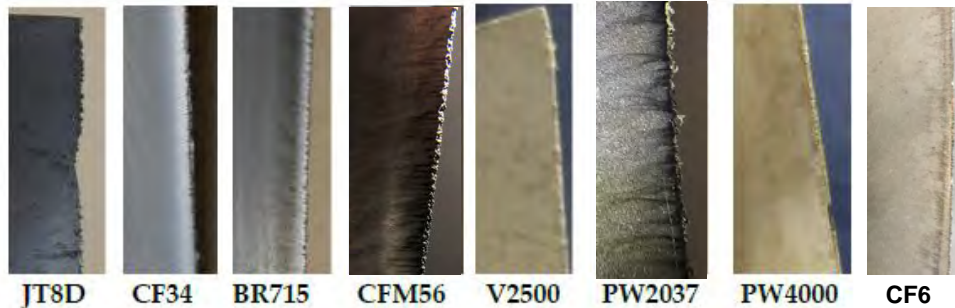
Blade Condition Analysis

- Following 1st stage fan blades inspected and analyzed:
 - JT8D
 - BR715
 - CFM56
 - PW4000
 - V2500
 - CF34
 - PW2037
 - CF6
- Engine test completed on inducted JT8D engine with:
 - existing 1st stage fan blades
 - serviceable condition 1st stage fan blades
- CFD Analysis completed on serviceable and used blades at following conditions:
 - Take-off
 - Cruise

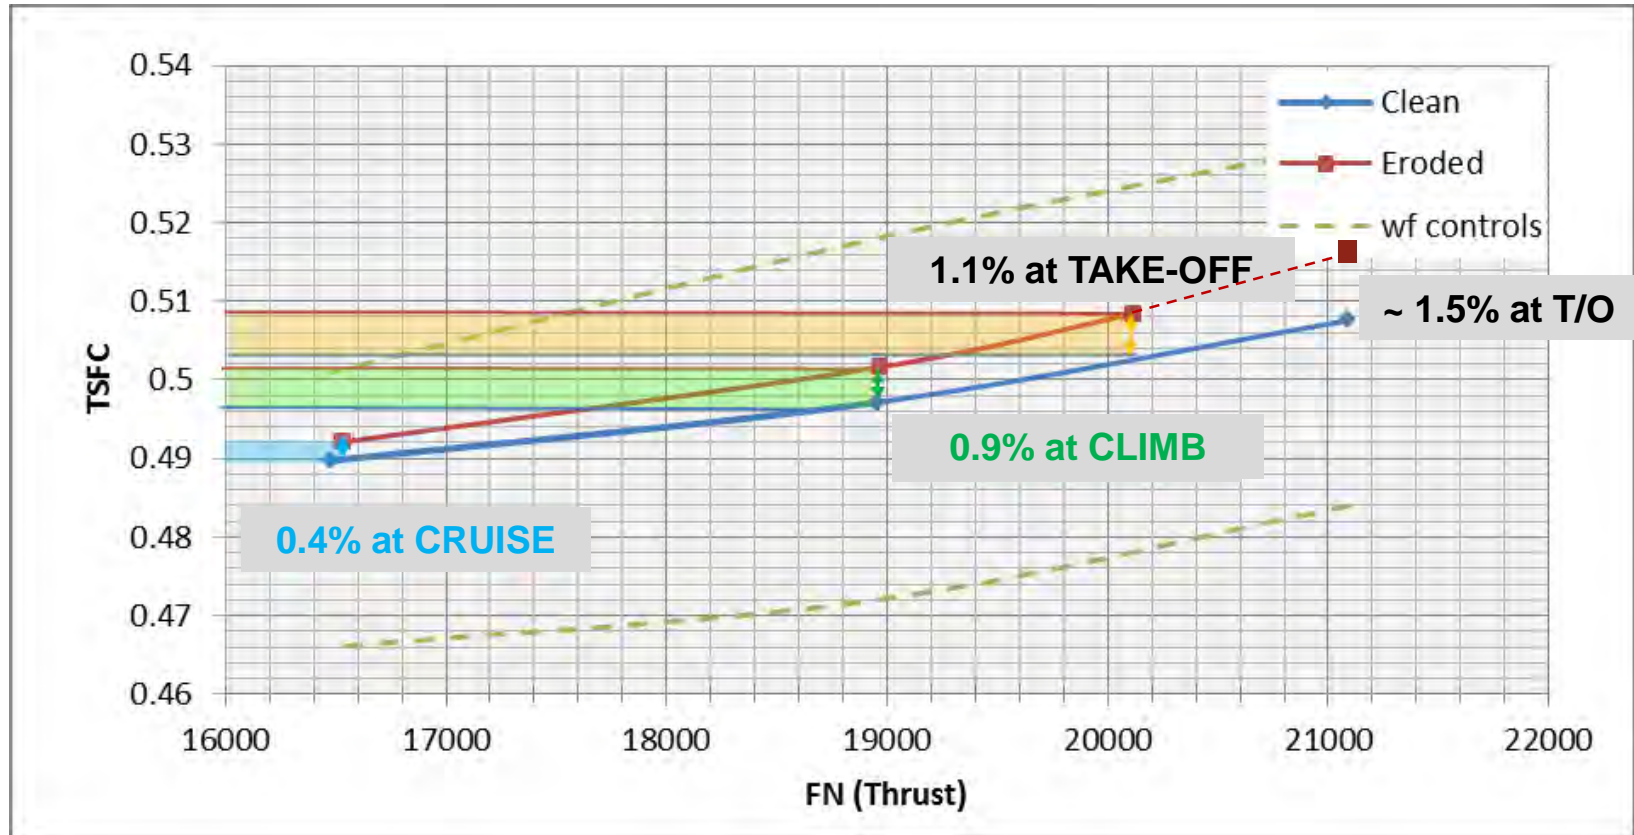
Thrust Specific Fuel Consumption (TSFC) Comparison Eroded vs. Serviceable Fan blades

— Clean = repaired, serviceable fan blades

[JT8D Engine S/N 726044](#)

Inducted May 2015

TSO = 3126 hours

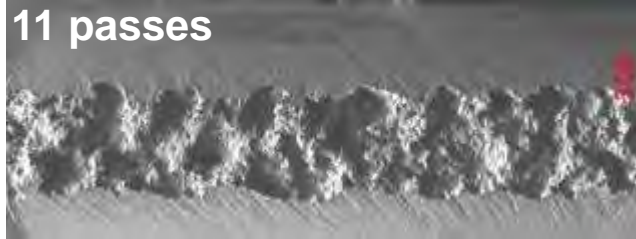
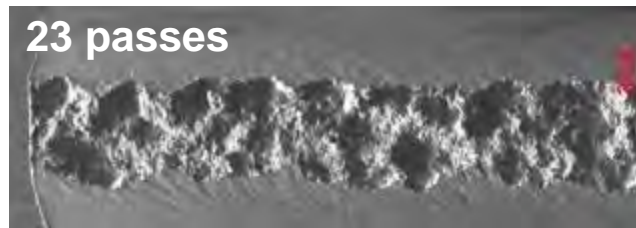
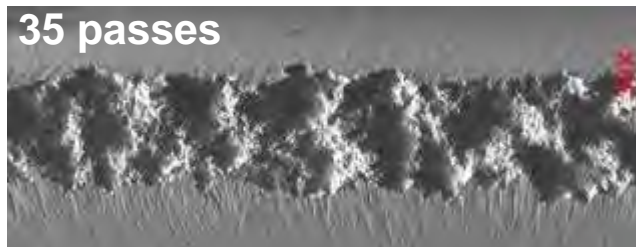
Uncoated PW2000

Breach evident @ 3 passes

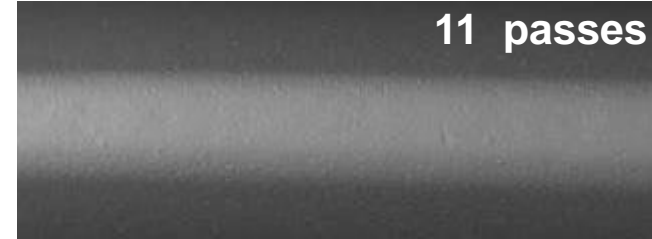
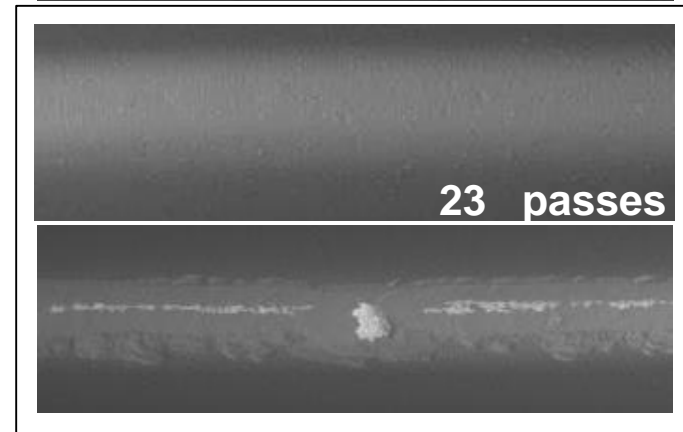
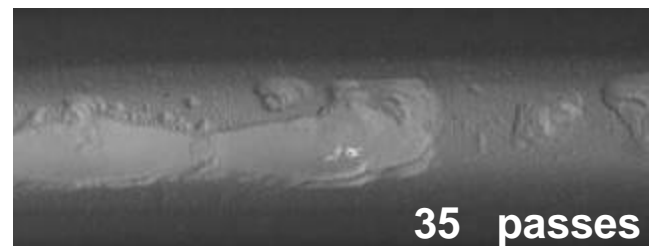
BlackGold® Coated PW2000

First substrate damage noticed after 23 passes

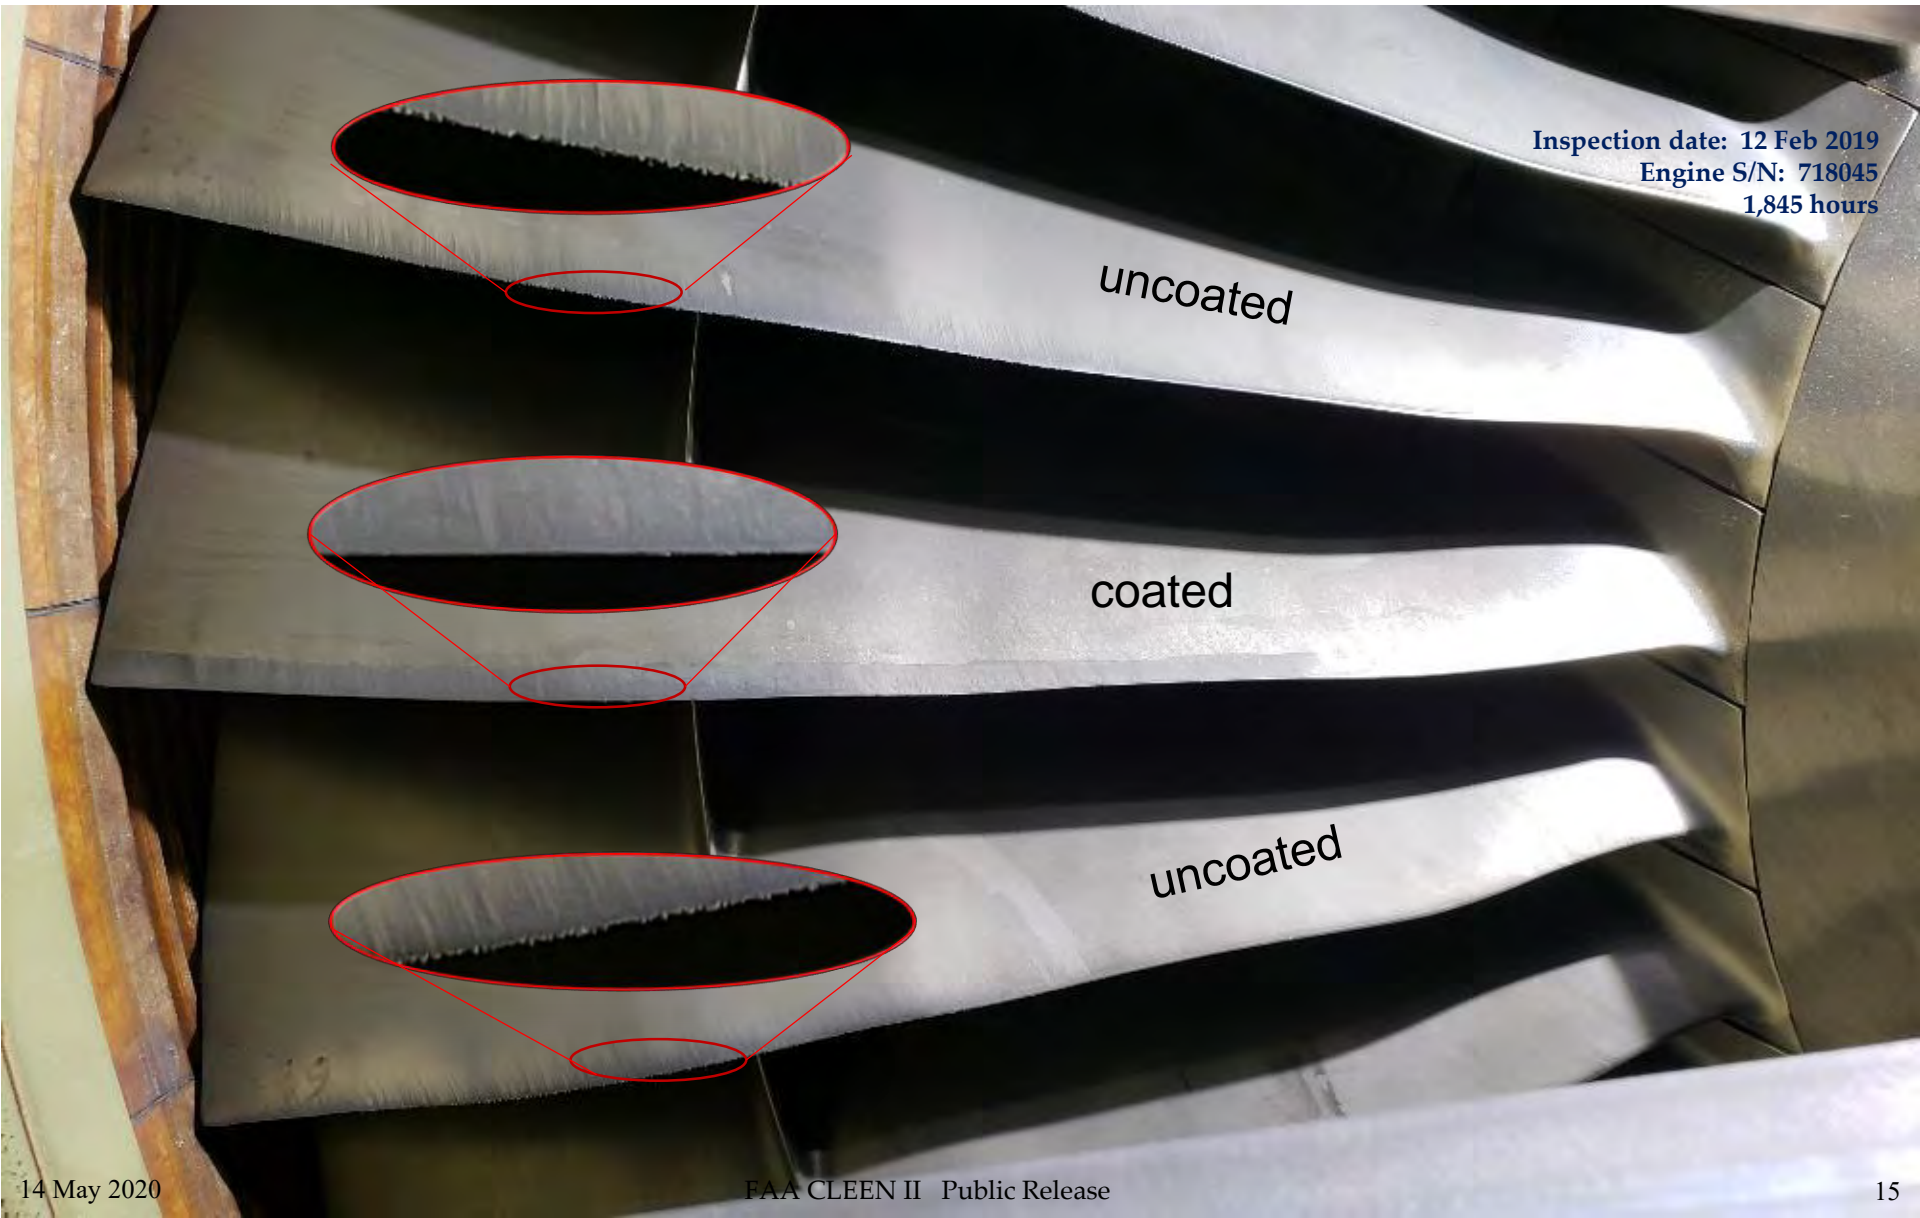
Inspection date: 12 Feb 2019
Engine S/N: 718045
1,845 hours

uncoated

coated

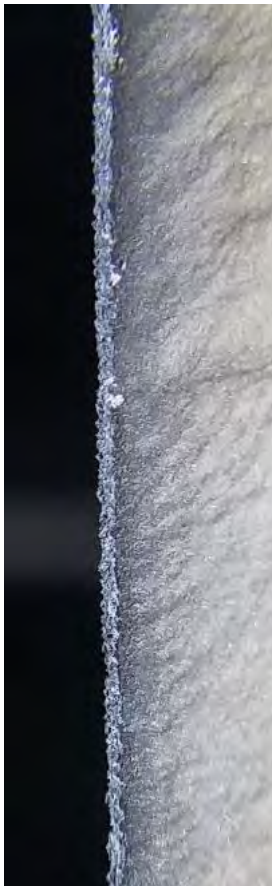
JT8D

500 hrs
≈ 2.5 months
≈ 3.5% of tour

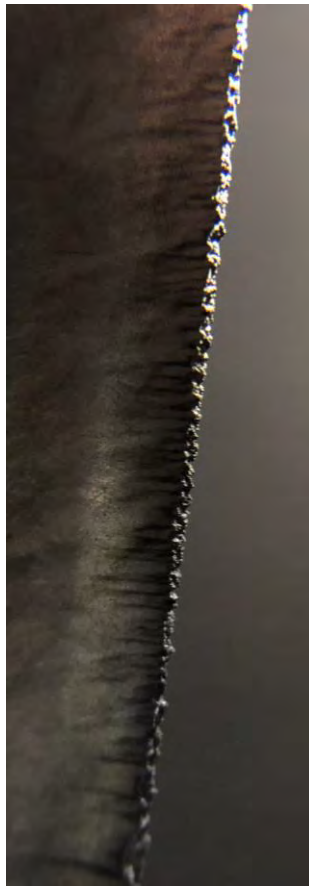
20,611 hrs
≈ 6.6 years
≈ 55% of tour

- Typical tour averages 30k to 36k operational hours
- At 20,611 hours or \approx 57% to 69% of tour => mean pit depth of 306 μm along LE erosion zone

At \approx 60 to 70% of CFM56 tour, uncoated LE pit depth \approx 75% less than uncoated JT8D at 2,081 hrs

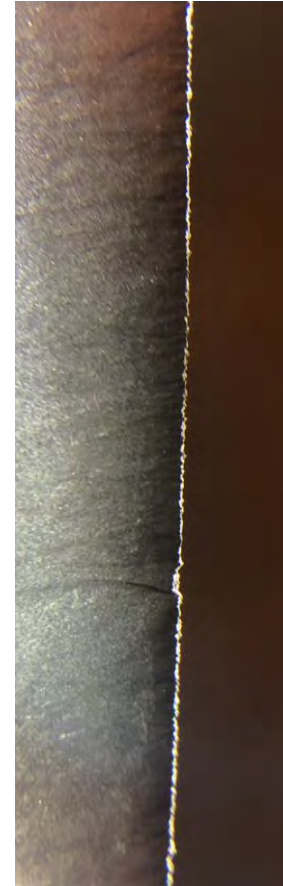
PW2037

3,094 hrs
≈ 1.25 years
≈ 20% of tour

- Typical tour averages 16,000 operational hours
- At 14,300 hours or \approx 90% of tour => mean pit depth of 168 μm along LE erosion zone

At 90% of PW2000 tour, uncoated LE pit depth \approx 50% less than uncoated JT8D at 2,081 hrs

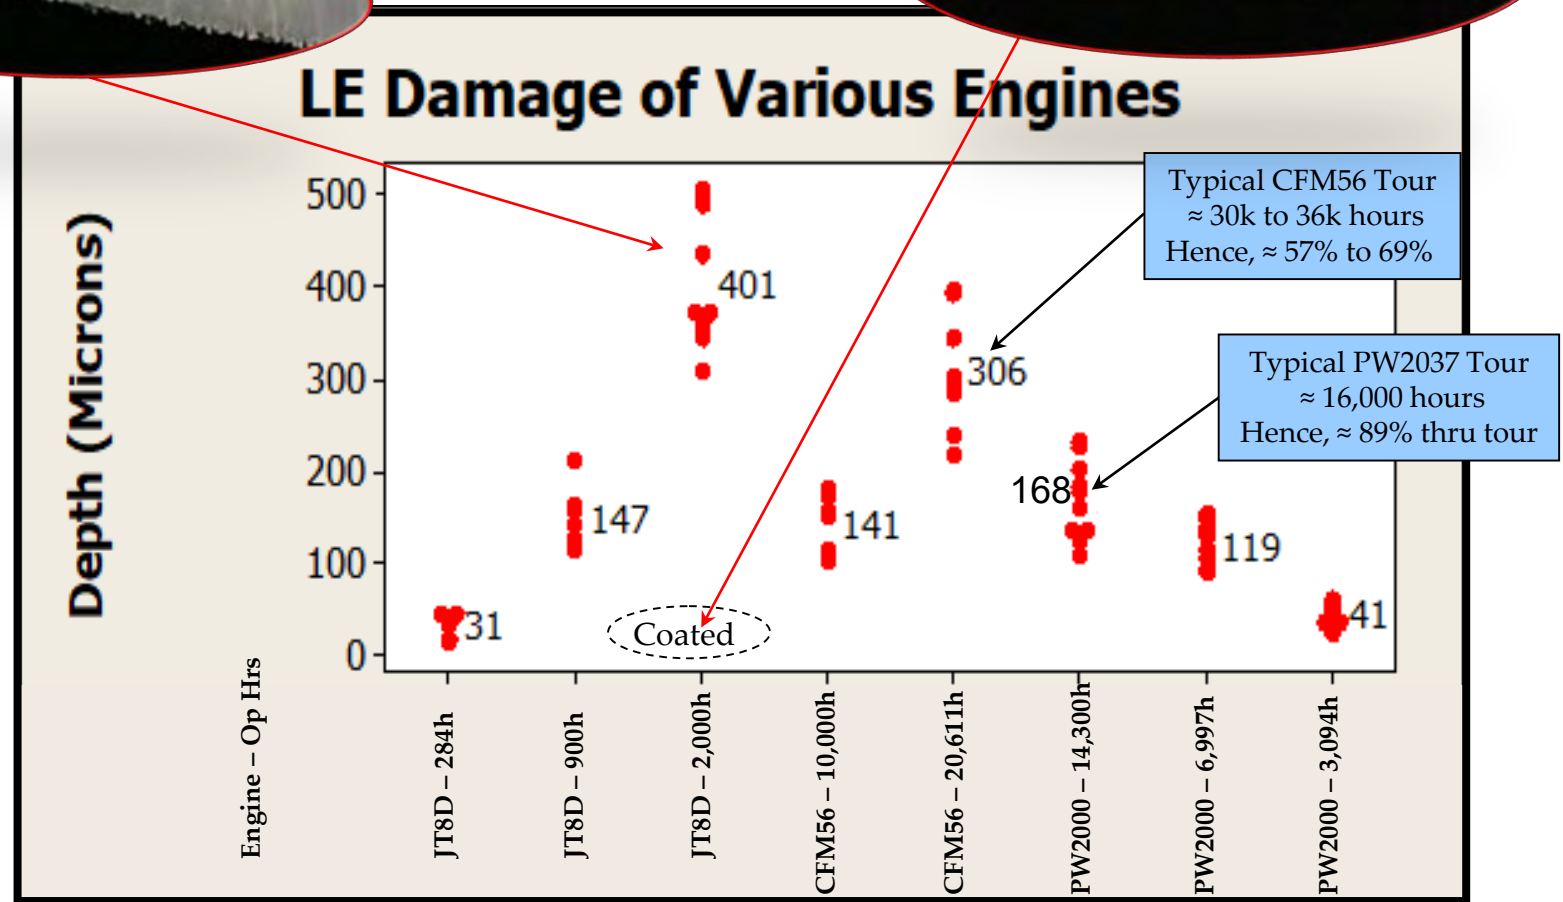
LE Depth Measurements

Uncoated @ 1845h

Coated @ 1845h

- JT8D Fan Blade LE Erosion very aggressive

- Highest rpm engine
- Fuselage mounted engine
- Uncoated Blade LE erosion => mean pit depth of 400 μm along LE erosion zone
- Coated Blade LE erosion => mean pit depth at select breach points < 100 μm
