Correcting the Effects of Magnetic Variation

Airlines should make sure they update their inertial reference systems to the latest magnetic variation (MagVar) tables in order to avoid potentially hazardous magnetic heading-related navigation errors.

By **Benjamin Weinstein**, Avionics Design Engineer

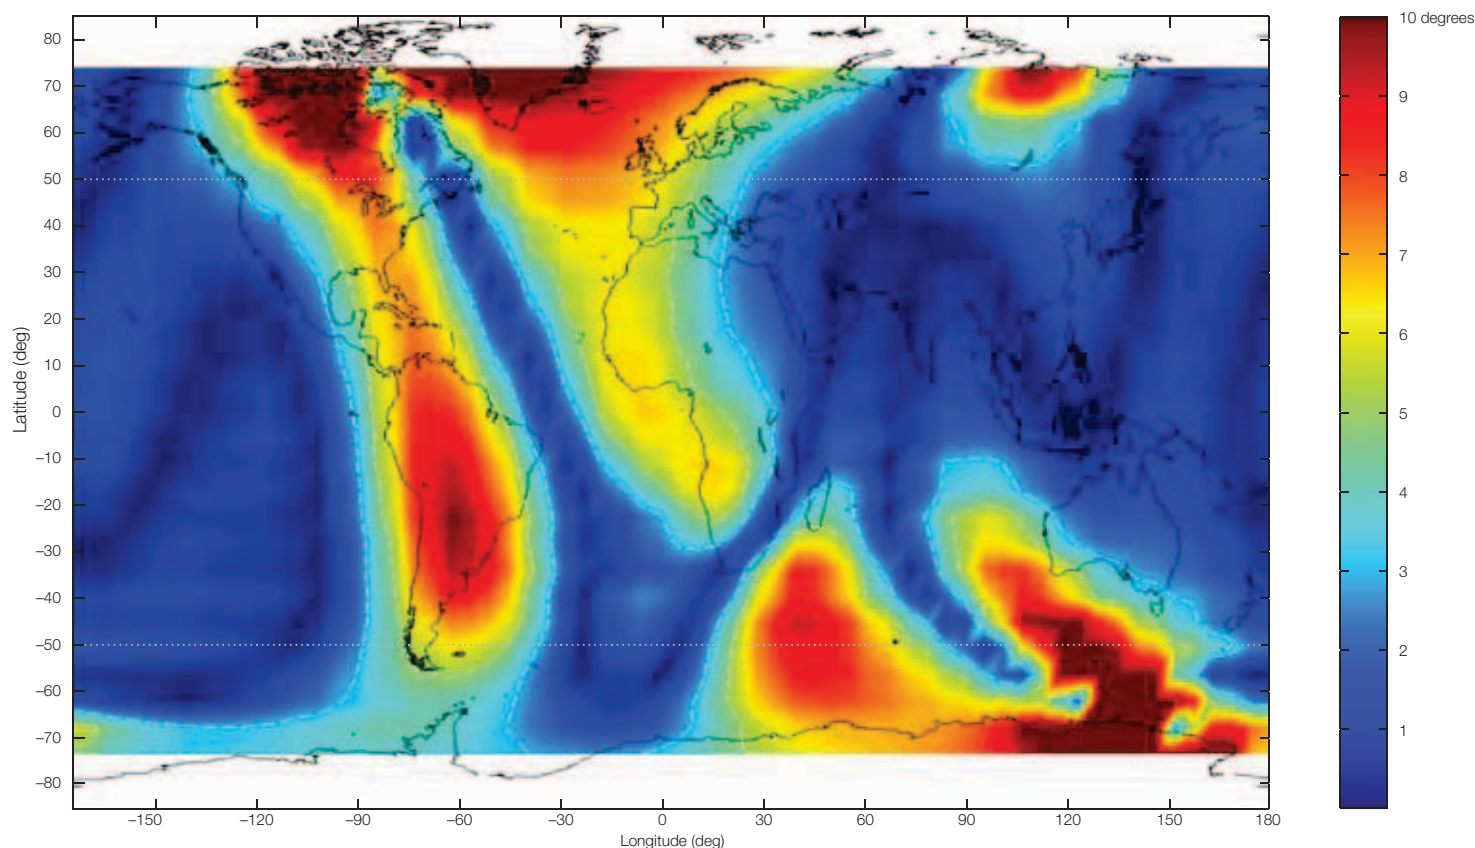
Figure 1: Deviation in degrees of magnetic variation tables, 2005 vs. 1980

Airplanes operating in certain areas of the world — primarily South America and northern parts of North America — can have heading errors exceeding 10 degrees. (Dark red indicates greater than 10 degrees of error; dark blue indicates 0 degrees of error.)

approaches in certain parts of the world can experience heading errors exceeding 10 degrees (see fig. 1).

Boeing strongly recommends that airlines flying with 1980 MagVar upgrade to the latest MagVar tables. IRU MagVar software updates are performed by Honeywell at its service centers, by approved third-party repair centers, or by airlines approved by Honeywell. Airlines should incorporate these updates into their established maintenance schedule.

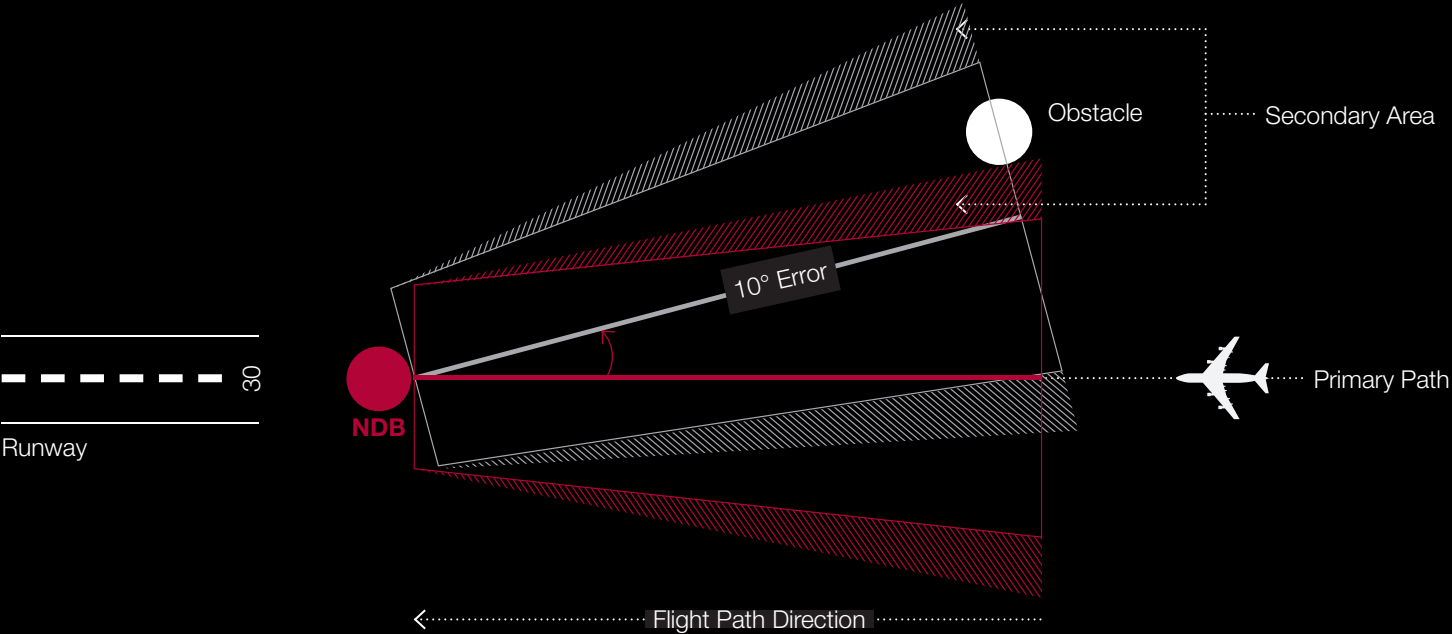
Figure 2: Effect of 10-degree MagVar error when flying toward NDB

When flying toward the NDB: Can rotate the perceived approach into the secondary area, which may allow the airplane to be outside the secondary area and increases the hazard to the airplane (see fig. 2).

Flying toward the NDB with MagVar information that is off by 10 degrees may cause a pilot to be in the path of obstacles or other dangers.

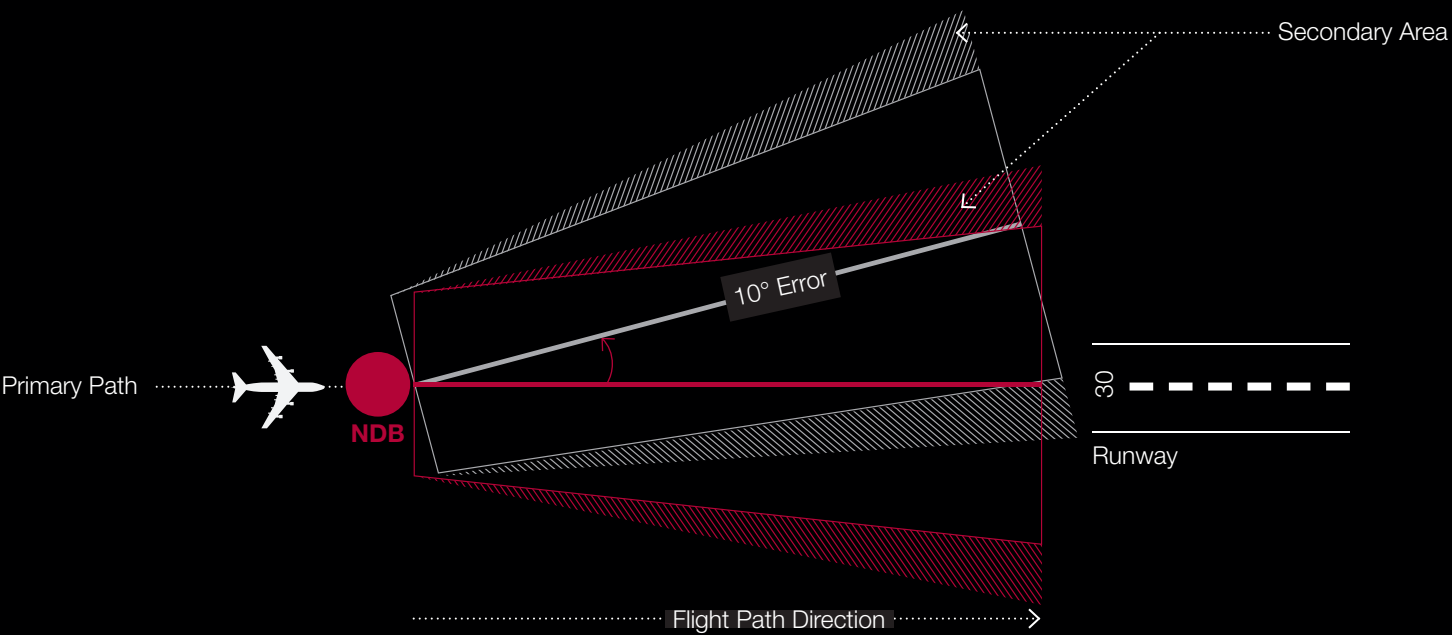
Figure 3: Effect of 10-degree MagVar error when flying away from NDB

Flying away from the NDB with MagVar information that is off by 10 degrees can cause the pilot to be off course up to 2.5 miles to the right or left of the runway on final approach.

When flying away from the NDB: Can cause the pilot to be off course up to 2.5 miles to the right or left of the runway on final approach (see fig. 3).
