# ***JCAB CRA Activities Since IPACG FIT/15***

IPACG FIT/16  
Fukuoka, Japan  
28 October, 2008

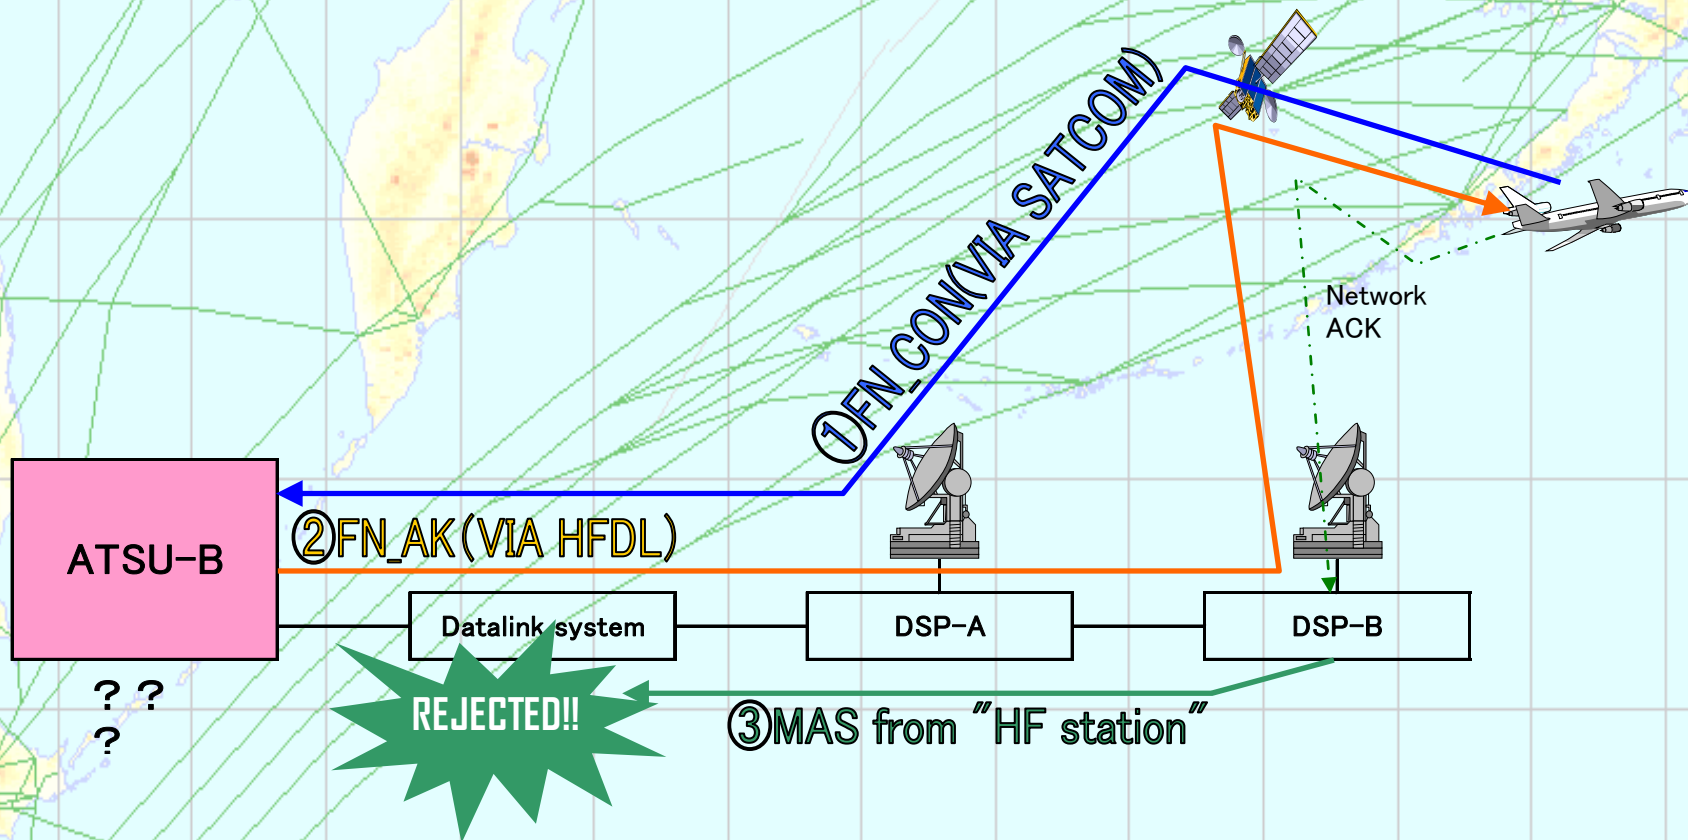
<PR10445>

- Messages downlinked via HFDDL were rejected by the data link system of the ATSU and failed to reach the ATSU end system.
- The use of HFDDL in the FIR is not approved( not available).
- 10445: Data link failure caused by the uplink via HFDDL and its MAS rejected at DLCS(Data Link Center System).
- 10457: DR downlinked via HFDDL was rejected and it failed to reach ATSU end system, resulting in the unsuccessful LOG OFF.
- 10459: CPDLC position report downlinked via HFDDL was rejected and it failed to reach the ATSU end system.
- The use of HFDDL in the FIR is not approved, which needs to be reminded among all the stakeholders concerned.
