Civilian Spatial Disorientation Mishap Experience

Stephen J.H. Véronneau, MD

Team Coordinator, Aircraft Accident Research

FAA Civil Aeromedical Institute

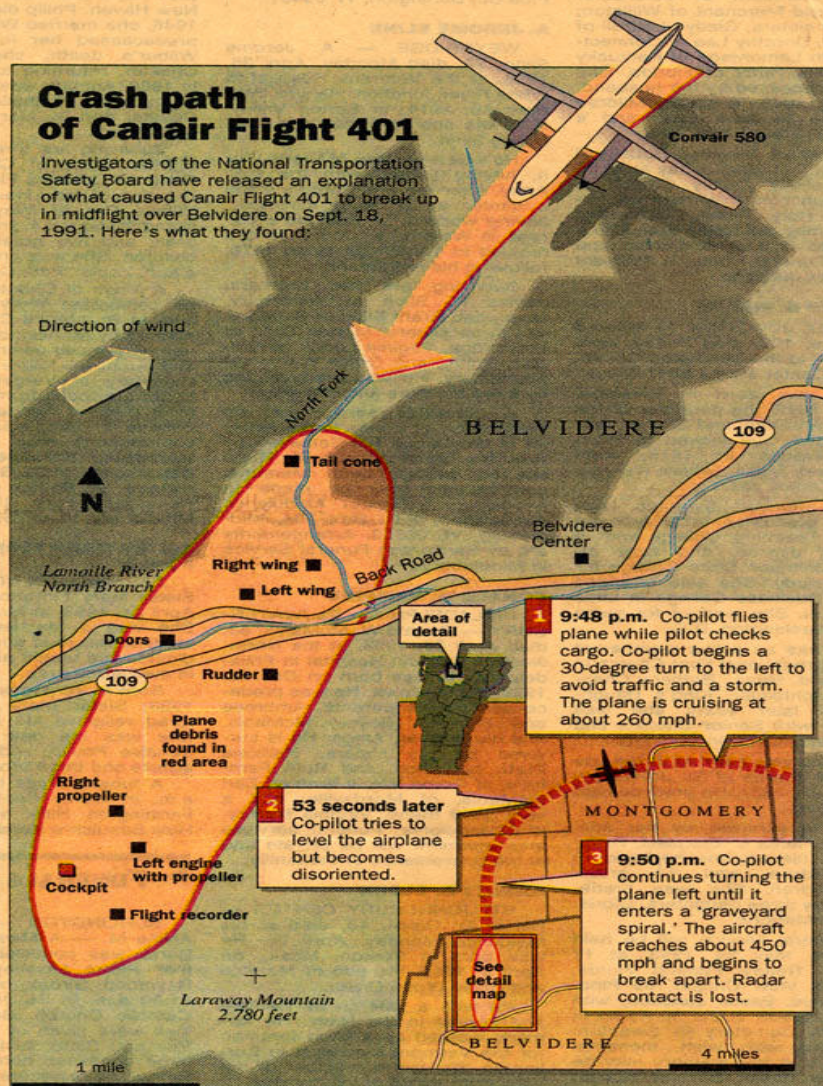
Crash path of Canair Flight 401

According to a recently released National Transportation Safety Board investigation, Zilvytis was changing the plane's direction when he became disoriented during a 30-degree left turn. Instead of straightening out the plane, Zilvytis continued turning.

Investigators think he could not see the horizon and possibly became confused about direction because of an imbalance in his inner ear fluids, caused by the turn's force. He was turning and had nothing to anchor his gaze on, they said. At the same time, he was listening to a radio transmission of weather reports, which might have distracted him.

After several repetitions of the left turn, the plane entered into a "graveyard spiral," Stephen Veronneau, one of the investigators, said in the report. McDougall was checking on the cargo at the time of the crash, the report said.

Investigators of the National Transportation Safety Board have released an explanation of what caused Canair Flight 401 to break up in midflight over Belvidere on Sept. 18, 1991. Here's what they found:

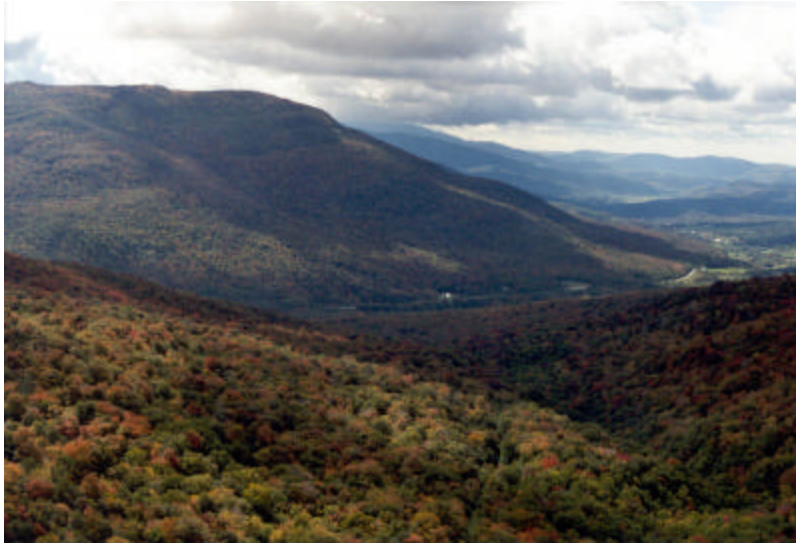
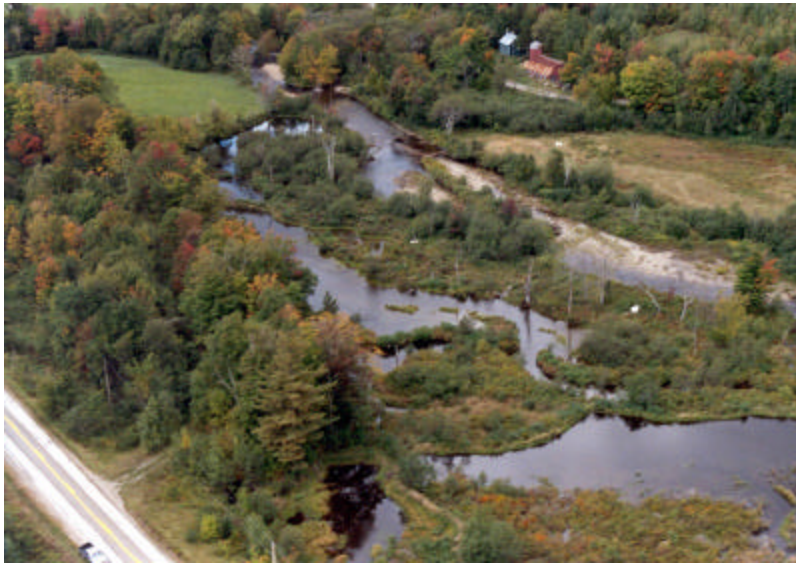
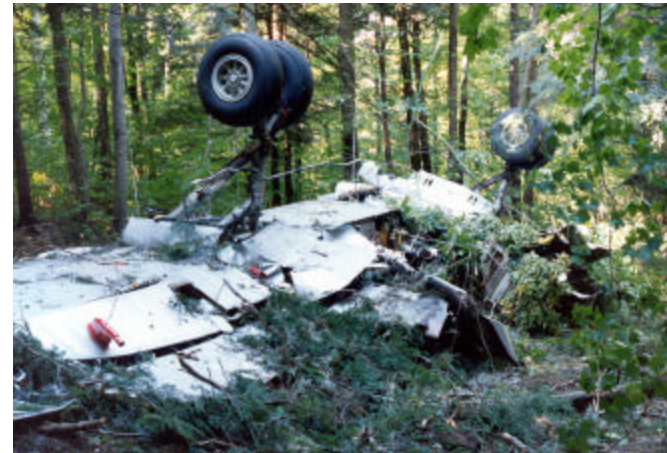
NYC91FA239 Convair 580

- 18-SEP-91 NYC91FA239
- THE AIRPLANE WAS CRUISING IN NIGHT INSTRUMENT METEOROLOGICAL CONDITIONS WHEN IT ENTERED A LEFT TURN AND EXCEEDED THE DESIGN AIRFRAME LIMITS. THE AIRPLANE BROKE UP IN THE DESCENT DUE TO AERODYNAMIC FORCES AND WAS DESTROYED. THE OUTBOARD WING PANELS HAD FAILED DOWNWARD AND CENTER WING SECTION SEPARATED FROM THE FUSELAGE. THE HORIZONTAL STABILIZER AND ELEVATORS HAD FAILED DOWN AND AFT. THE CAPTAIN WAS FOUND OUT OF THE COCKPIT WITH NO EVIDENCE OF HIM BEING IN THE SEAT AT IMPACT A HUMAN FACTORS STUDY FOUND THE AIRCRAFT'S LAST MINUTE OF FLIGHT MATCHED A PROFILE OF A PILOT EXPERIENCING SPATIAL DISORIENTATION.

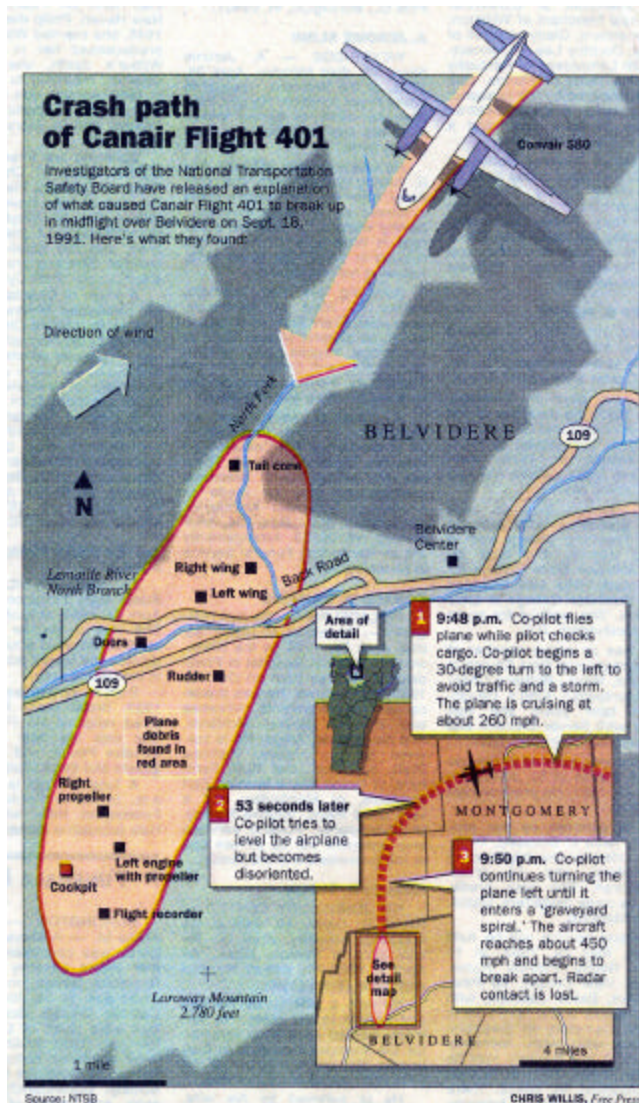
NYC91FA239 Convair 580

- 18-SEP-91 NYC91FA239
- Probable Cause
FAILURE OF THE FIRST OFFICER (CO-PILOT) TO MAINTAIN CONTROL OF THE AIRCRAFT AFTER BECOMING SPATIALLY DISORIENTED, AND HIS EXCEEDING THE DESIGN STRESS LIMITS OF THE AIRCRAFT. FACTORS RELATED TO THE ACCIDENT WERE: THE LACK OF TWO PILOTS IN THE COCKPIT, DARKNESS, AND INSTRUMENT METEOROLOGICAL CONDITIONS (IMC) AT FLIGHT ALTITUDE.

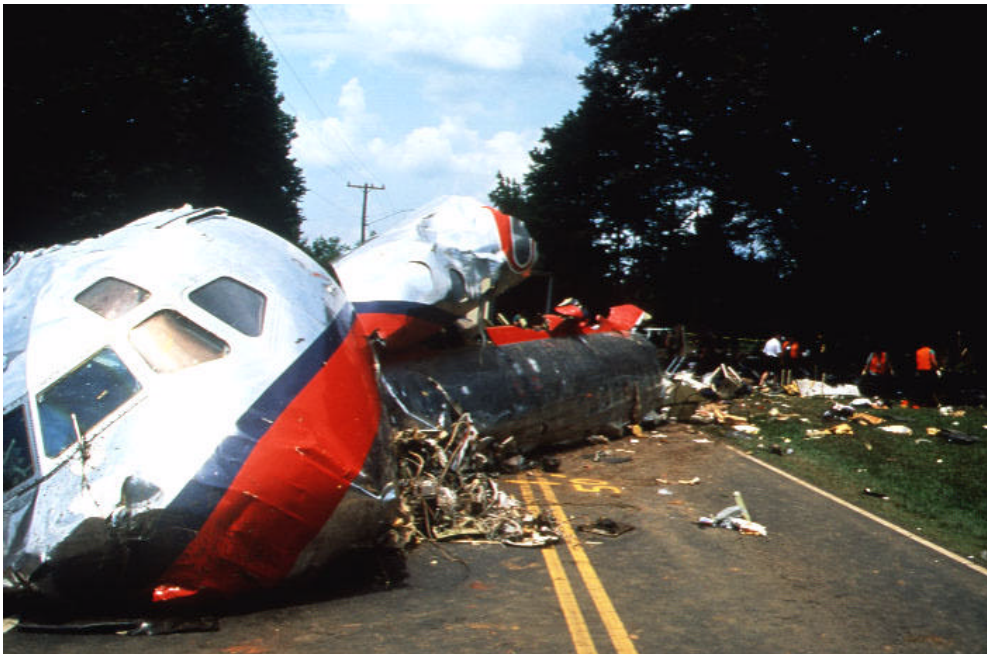
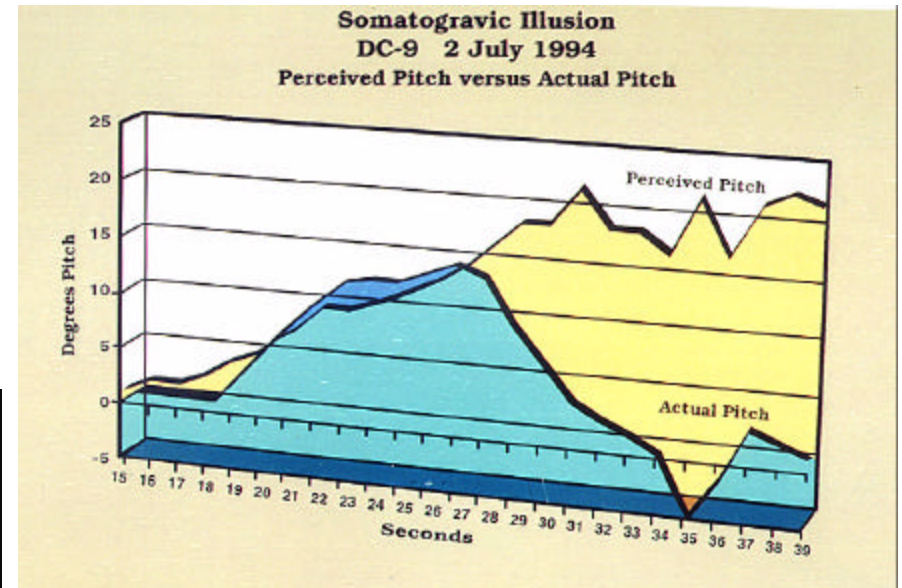
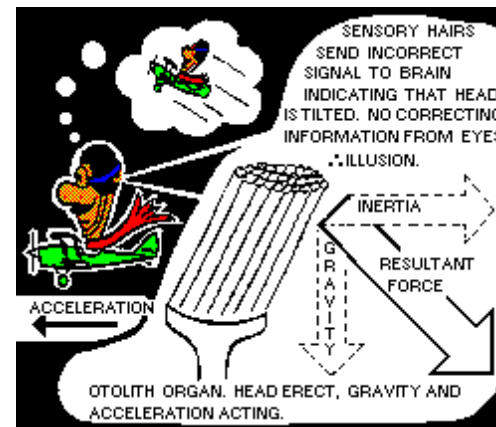
- DC-9 missed approach
- Windshear
- ATC info provided

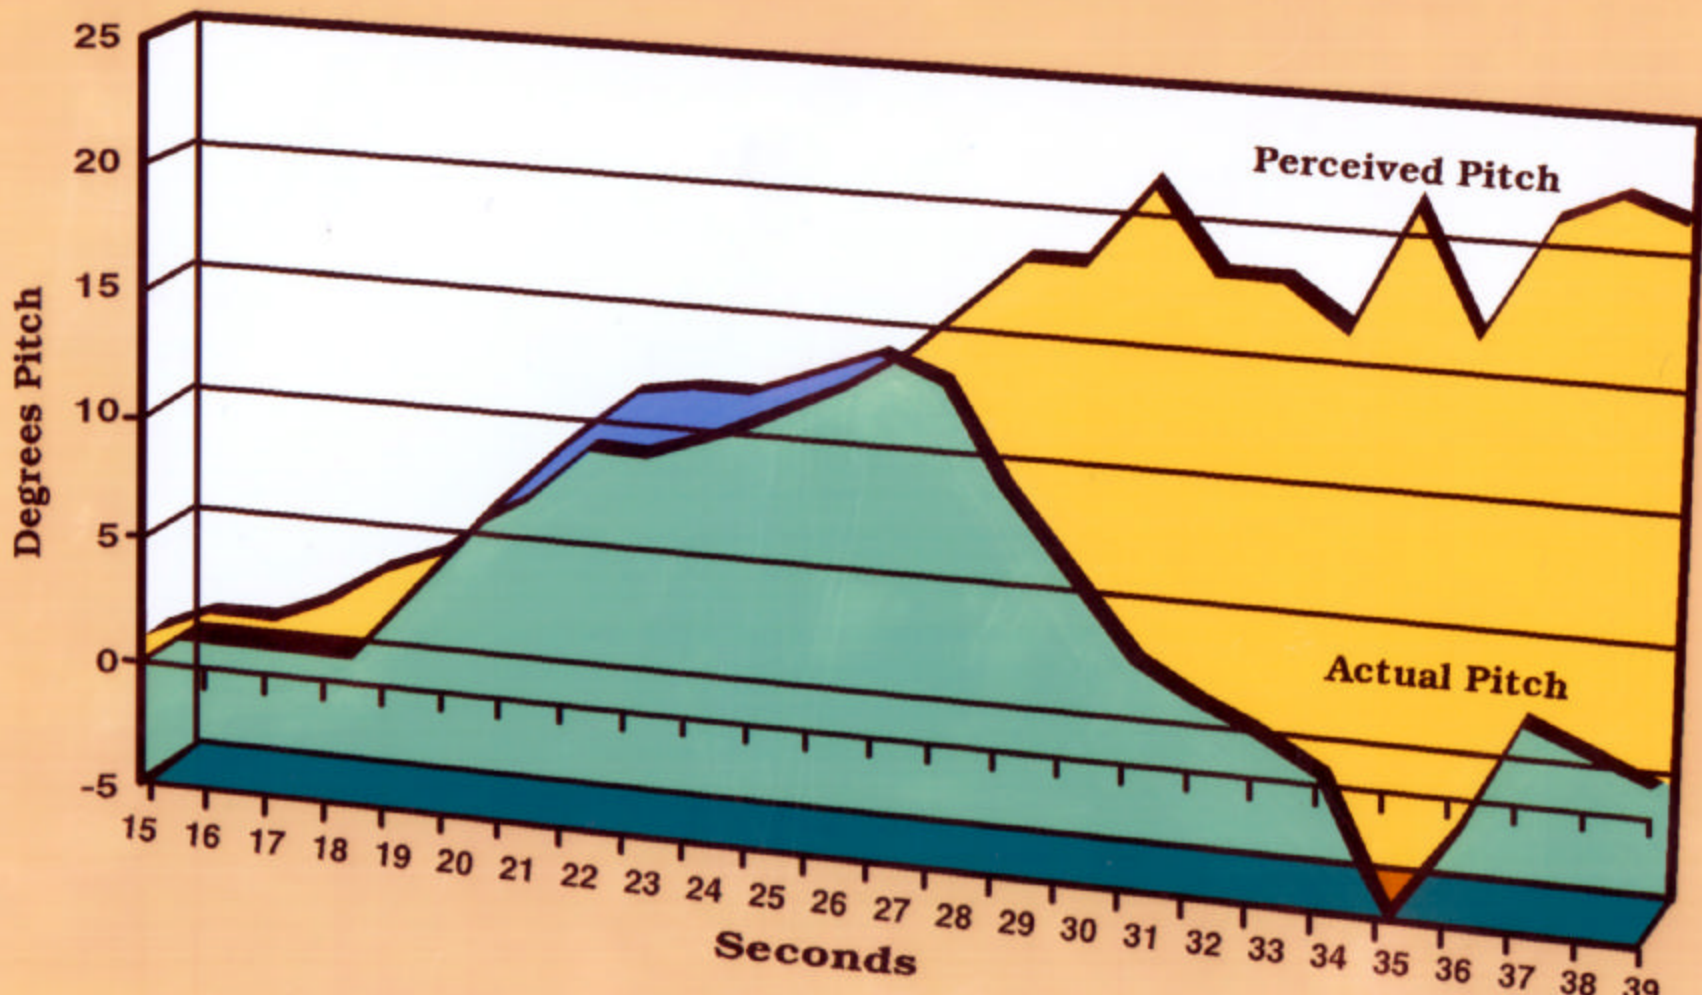
Somatogravic Illusion
DC-9 2 July 1994
Perceived Pitch versus Actual Pitch

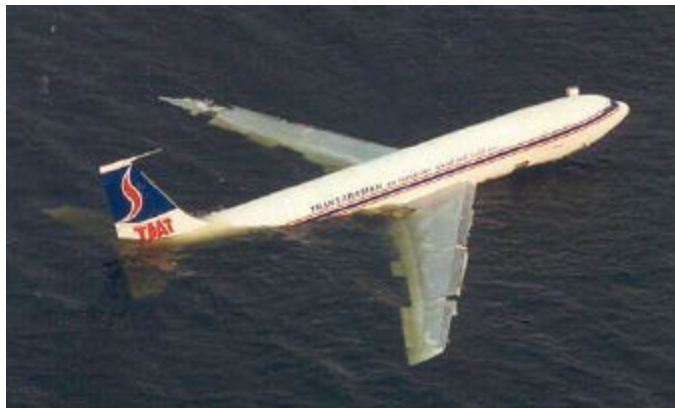
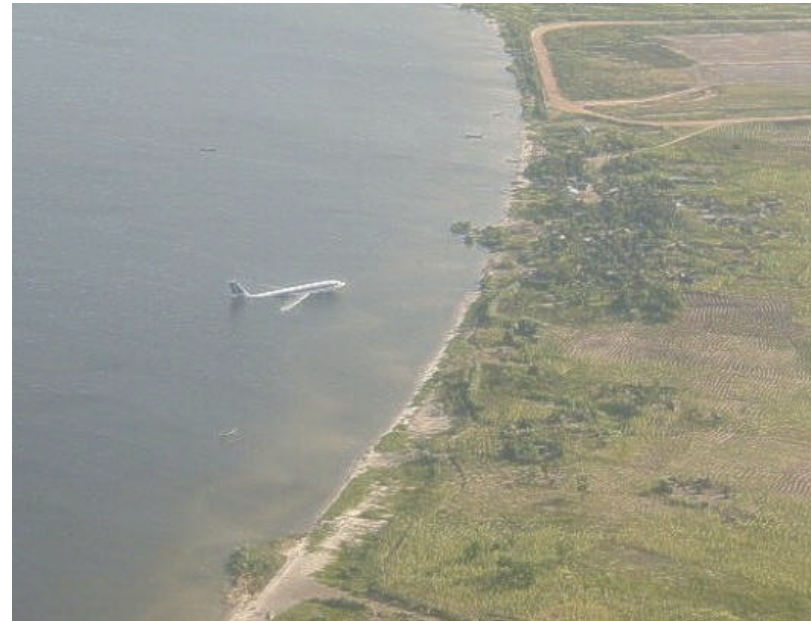
- Lake Victoria
- Black hole approach
- Narrow runway
- ATC warned
