**ROTORCRAFT OCCUPANT PROTECTION  
WORKING GROUP**

**TASKS 1 AND 2**

**COST-BENEFIT ANALYSIS REPORT TO THE  
AVIATION RULEMAKING ADVISORY COMMITTEE  
(ARAC)**

**Submitted: November 10, 2016**

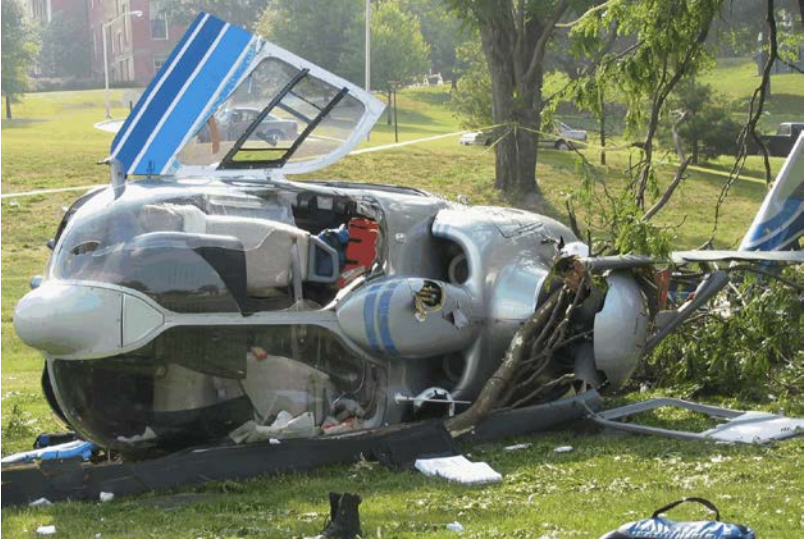
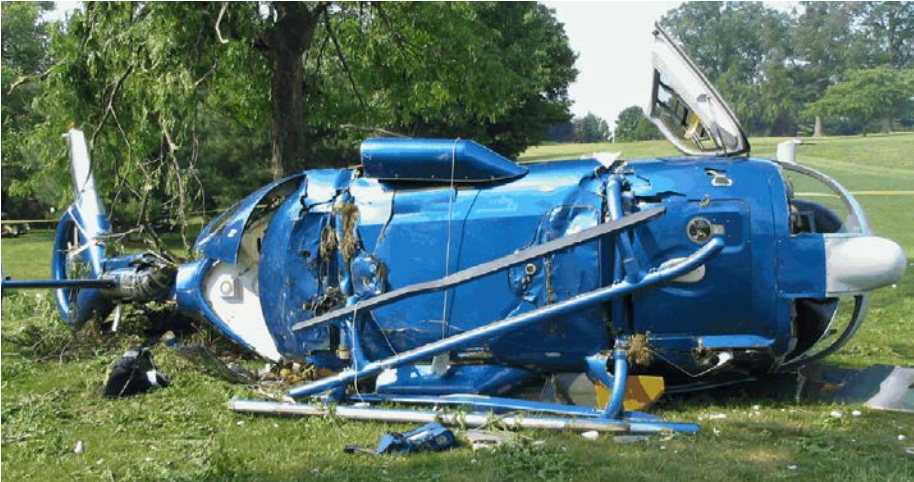
From the narrative: "Once over the golf course, the helicopter began to vibrate. The vibration increased, the nose yawed from side to side, and the helicopter "went into a spin." It descended vertically, struck a tree, then terrain, and rolled over on its side."

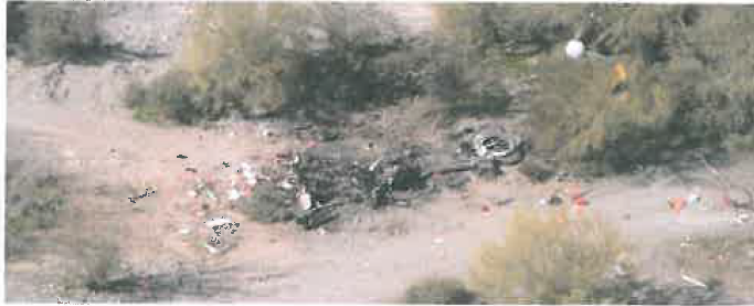
#### III. ACCIDENT SITE

- The wreckage path was approximately 1/3 mile long on a southerly heading.
- The main wreckage came to rest in relatively confined area, consistent with a vertical impact.
- Crushing and other damage observed on the aircraft structure suggests the aircraft was slightly nose low, with a slight right bank on impact.

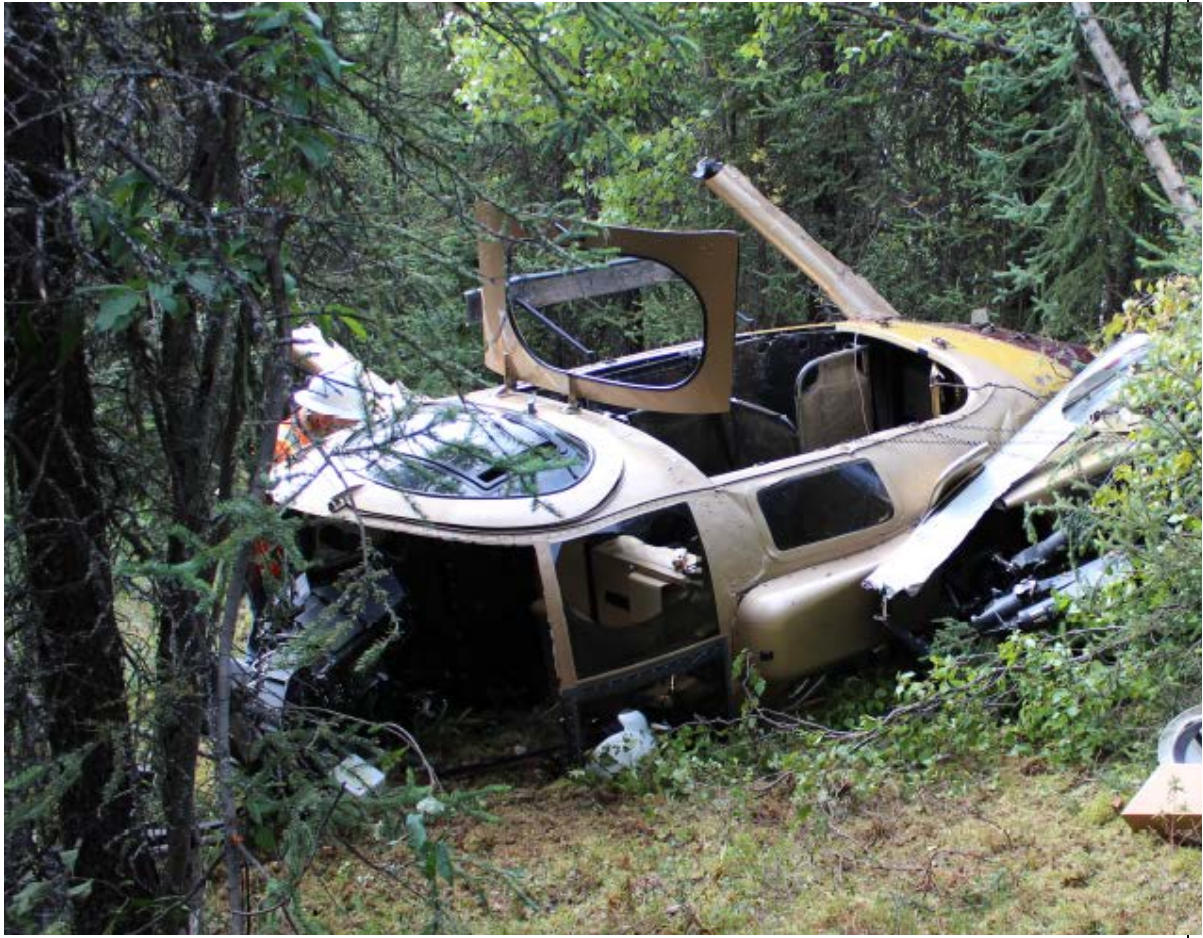
From the narrative: “The cockpit was severely damaged with extensive deformation. The canopy was segmented and separated with all canopy glass windscreens and overhead transparencies shattered or missing.”

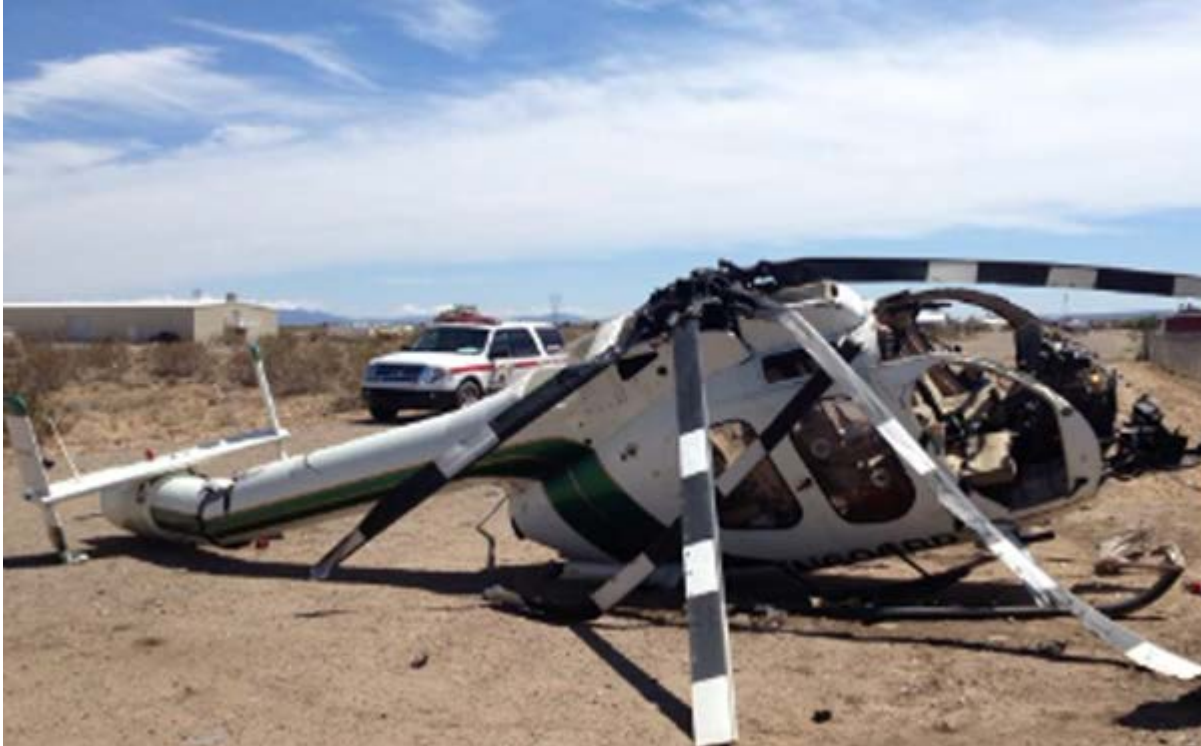
Accident photograph found online:

<b>Event ID:</b> 20140427X71558	<b>NTSB No:</b> WPR14LA173	<b>Registration:</b> N606BP	<b>Accident date:</b> 27-Apr-14
<b>Make:</b> MDHI	<b>Model:</b> MD-600N	<b>Part 27/29:</b> 27	<b>Fire:</b> None
<b>Injuries:</b> 1S, 2M	<b>Thermal Injury:</b> None	<b>Fuel Spillage:</b> None	<b>Crash Severity:</b> Moderate

**Summary:** Pilot lost control after take-off.

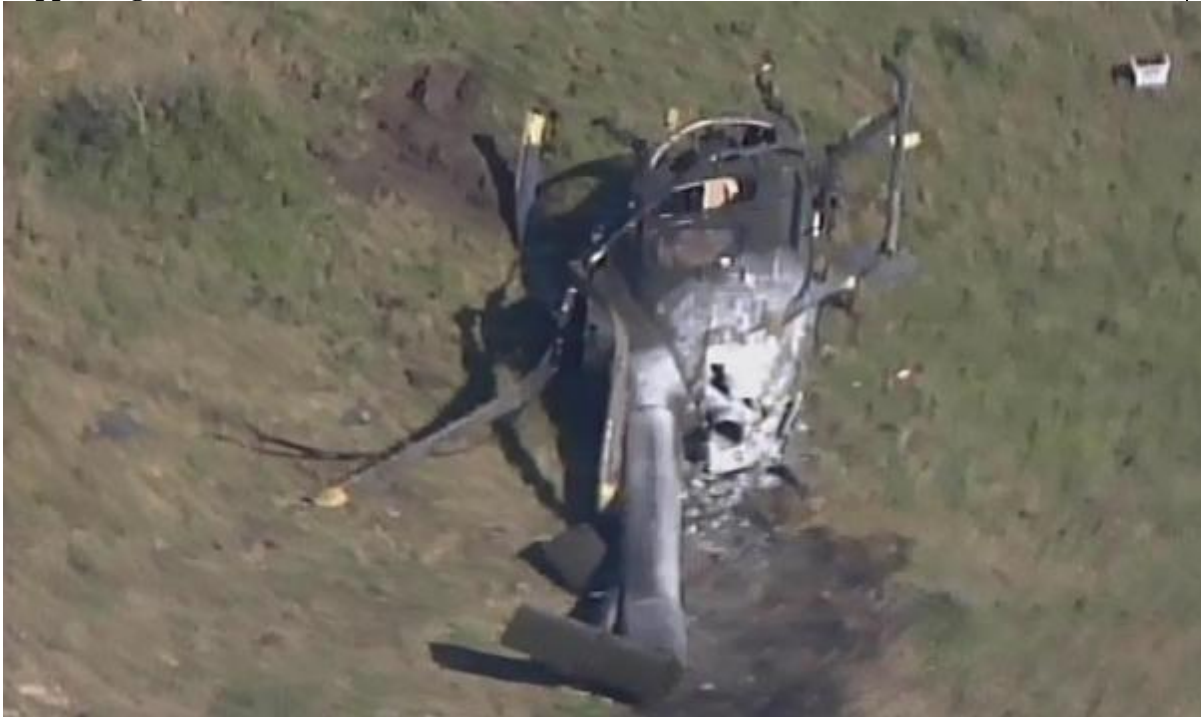
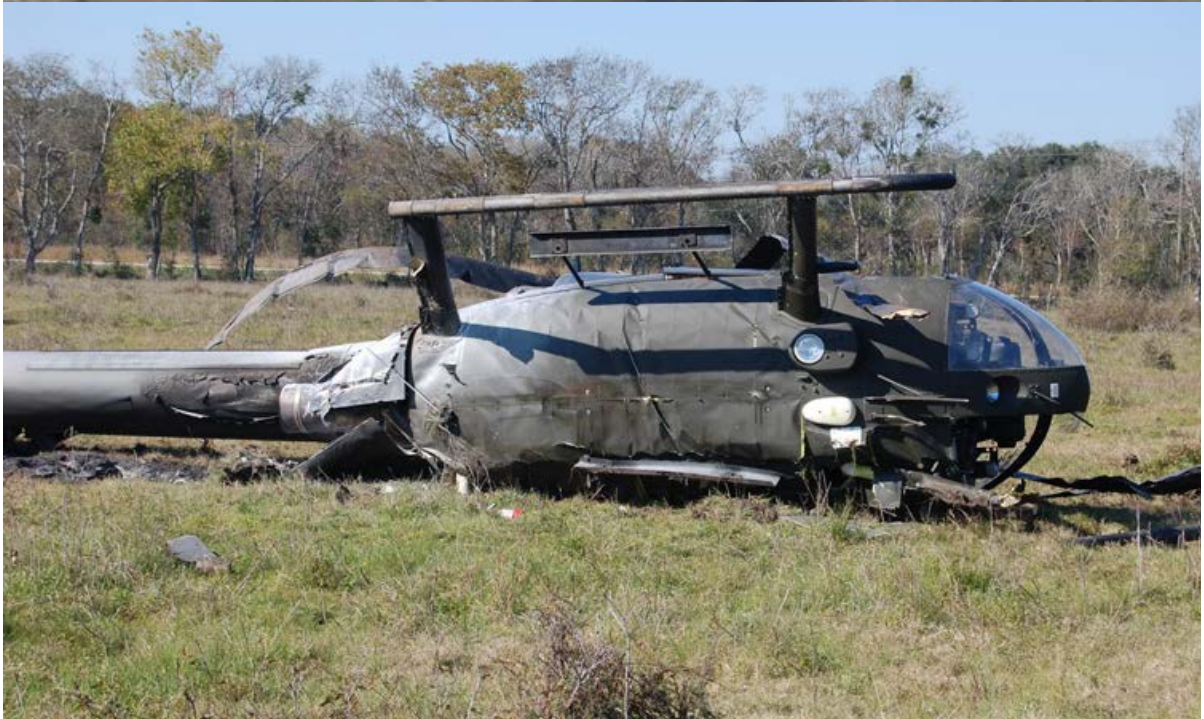
**Summary:** Minor crash during an attempted off airport landing. Following a loss of control, the rotorcraft spun and impacted terrain, and rolled onto its left side. The accident docket was not readily available (perhaps not completed yet), however accident photographs are available online. The fire appears to have been contained to the engine compartment area and to a small grassy area on the ground near the engine exhaust. It appears that the fire self-extinguished and the CRFS prevented significant fuel spillage. Had there been significant fuel spillage, it is expected the fire would have spread and consumed the airframe.

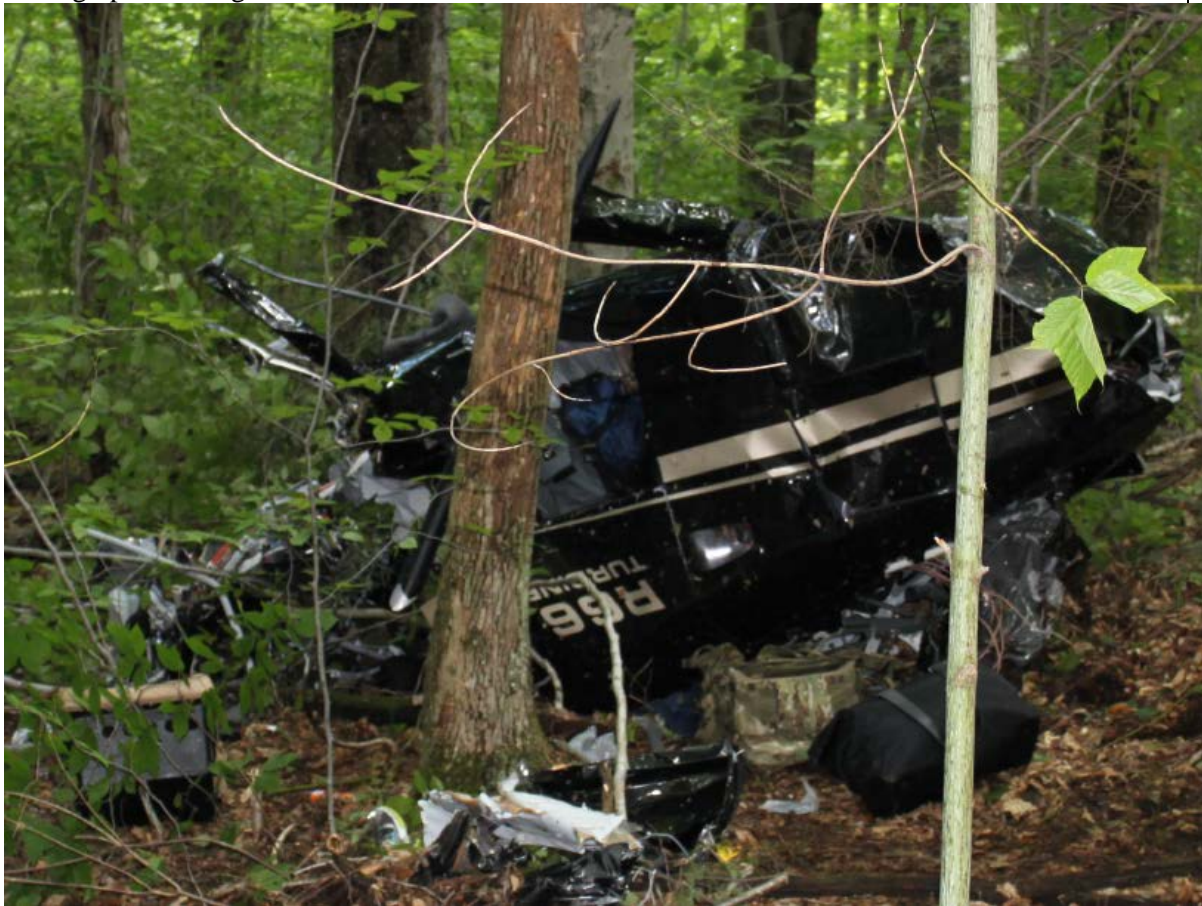
Photograph showing extensive cabin crush

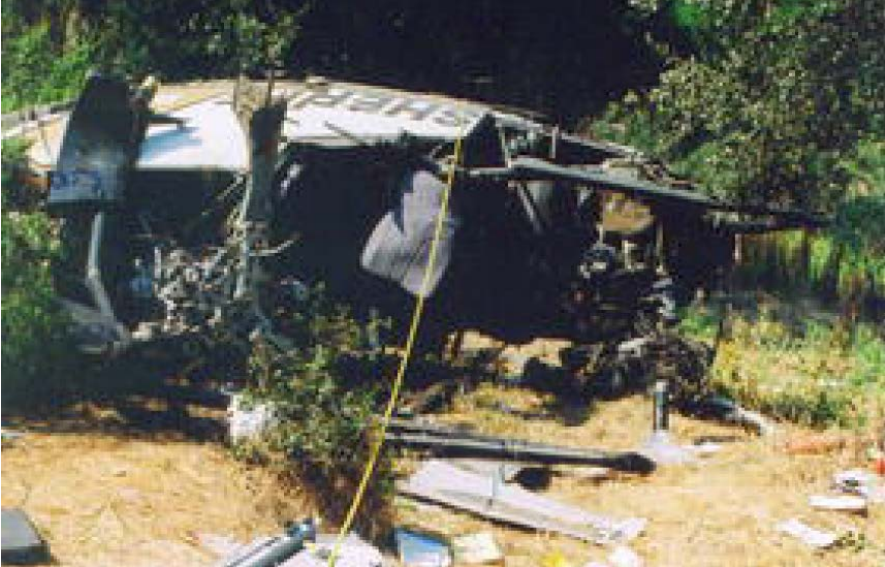
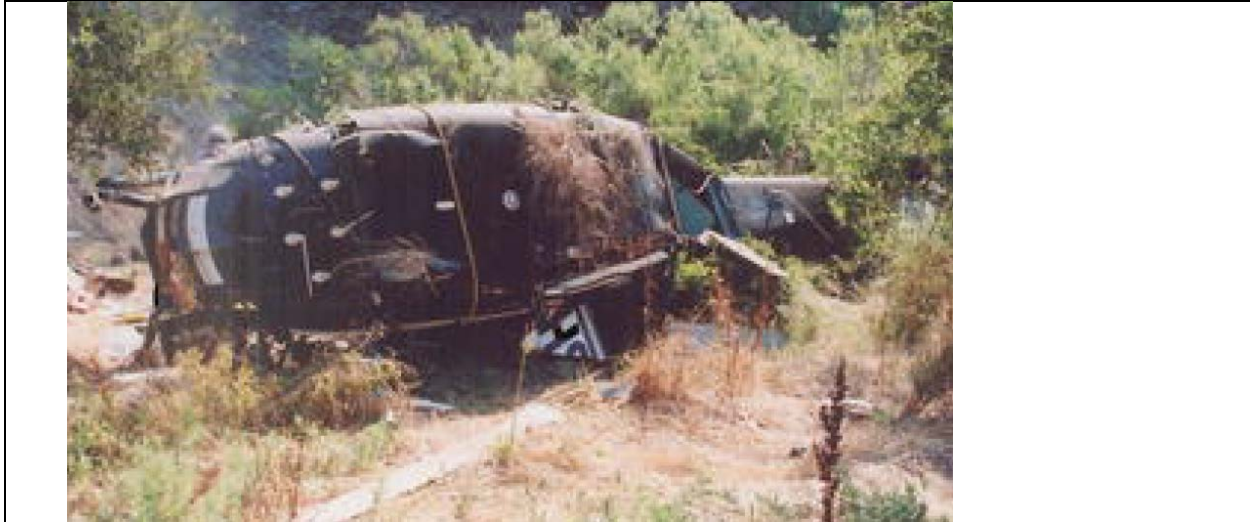
Eurocopter performed a detailed crash investigation (report in the docket). There is no mention of fuel spillage or lack of performance of the CRFS.

Photographs (note no indications of fire):

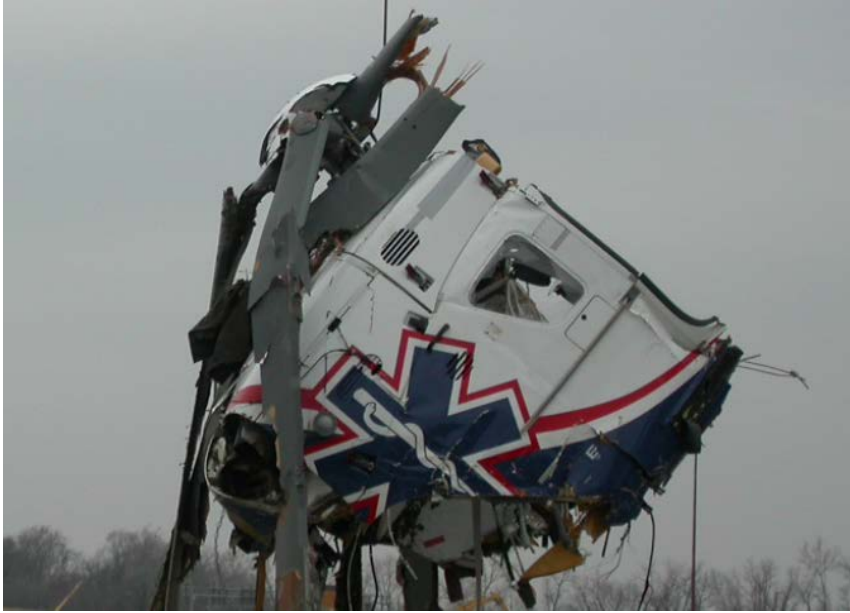
<b>Event ID:</b> 20050120X00080	<b>NTSB No:</b> NYC05MA039	<b>Registration:</b> N136LN	<b>Accident date:</b> 10-Jan-05
<b>Make:</b> Airbus	<b>Model:</b> EC 135-P2	<b>Part 27/29:</b> 27	<b>Fire:</b> None
<b>Injuries:</b> 2F, 1S	<b>Thermal Injury:</b> Yes	<b>Fuel Spillage:</b> None noted	<b>Crash Severity:</b> Severe
<b>Summary:</b> Water impact into the Potomac river. Pilot apparently misjudged his height above the water (CFIT). The crash survivor was treated for burns (as stated in the narrative), but the NTSB Factual report states there was no evidence of an inflight or post-crash fire.			
<b>Supporting Data:</b> From the narrative: "The State of Maryland, Office of the Chief Medical Examiner, performed autopsies on the pilot and the flight paramedic. The medical examiner determined that the pilot's cause of death was "multiple injuries." The flight paramedic's cause of death was listed as "drowning complicated by hypothermia"; [12] the paramedic was found still belted into the left aft cabin seat. According to the flight nurse, after the crash, he was submerged in water but was able to remove his seat restraints, exit the helicopter, and remain near the helicopter's partially submerged tail section until a rescue boat arrived. He was taken to a hospital and treated for a broken arm and burns."  From the NTSB Factual Report: "Examination of the helicopter's wreckage debris revealed no evidence of an in-flight or post-crash fire."  Photographs from the docket:

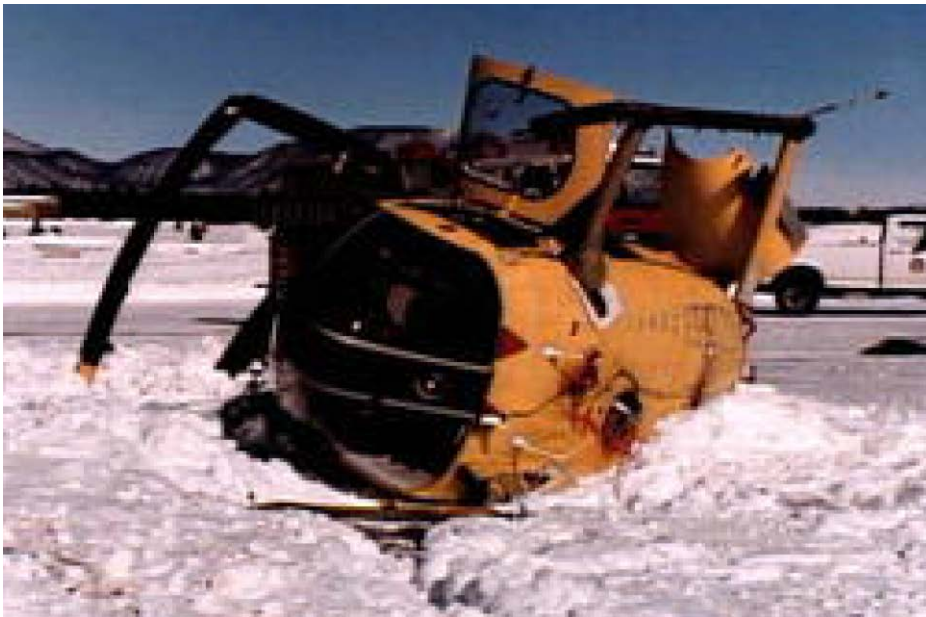
“A video recording of the accident revealed that as the aircraft touched down, the skids collapsed and the tail boom was severed by contact with the main rotor blades. The tail boom separation resulted in loss of directional control and the aircraft began yawing left during the accompanying ground run. As the ground run progressed, the aircraft veered off the left side of the runway and onto snow covered sod. The main rotor blades struck the ground as the aircraft rolled onto its right side and came to rest.”

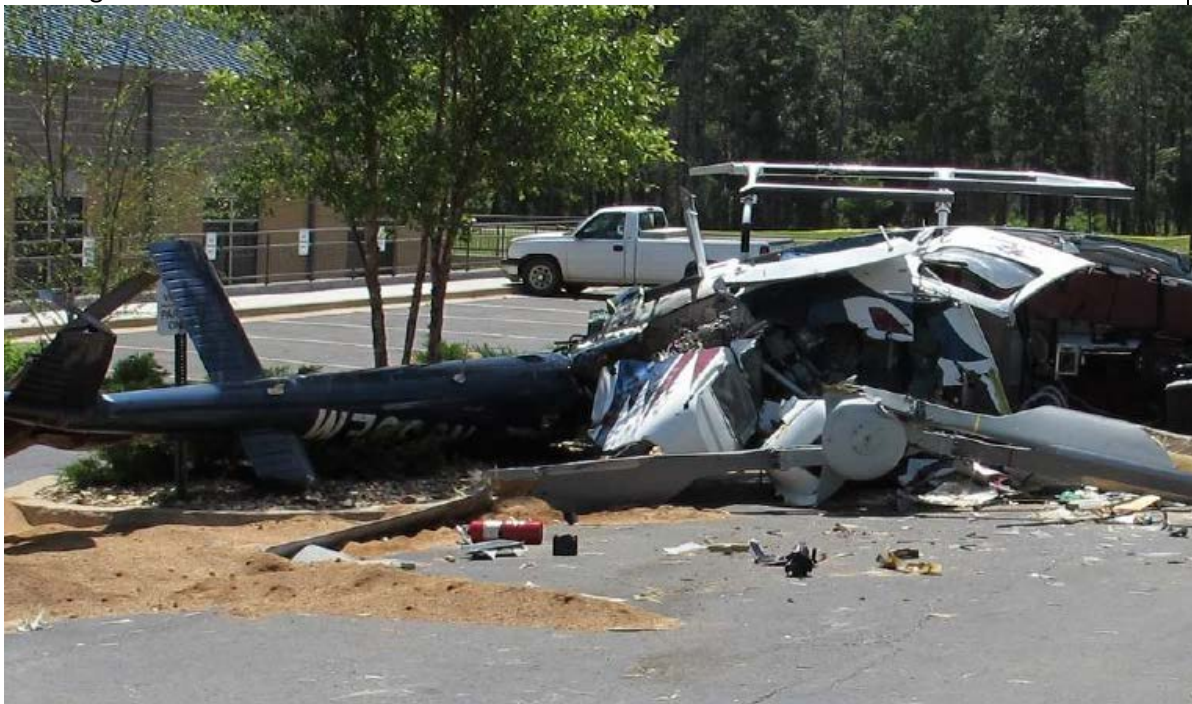
First responders report the engine was still running and fuel was leaking out of the engine area and burning. The engine was subsequently shut down and the fire put out by hand fire extinguishers. There is no report of fire entering the occupant compartment or mention of thermal injury. Photographs of the crash scene show fire damage only to the engine area of the wreckage.

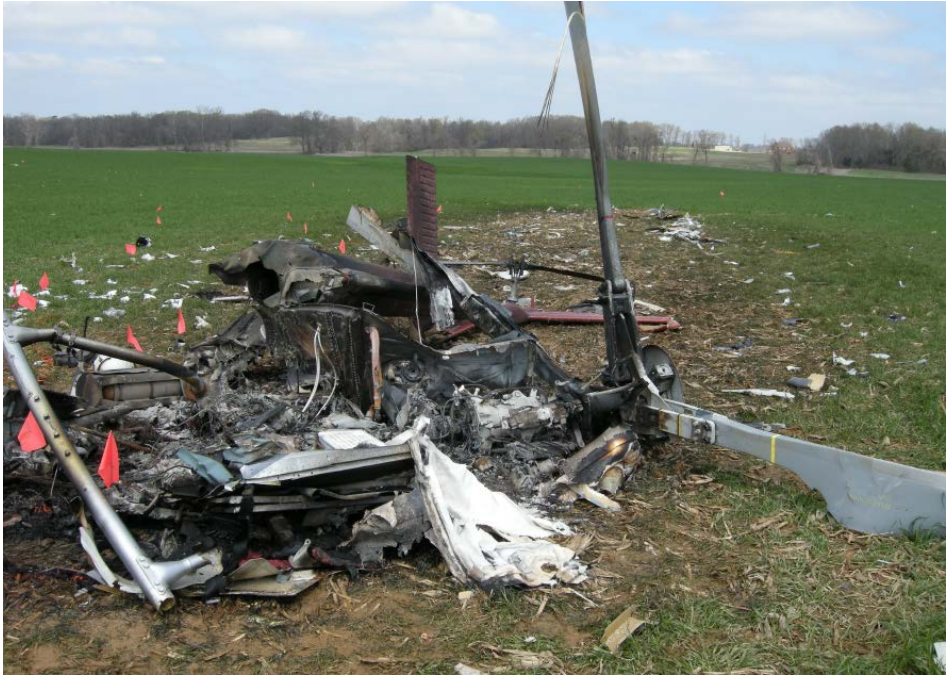
Photograph of accident:

**Summary:** FIT after entering foul weather. Extreme (non-survivable) crash.

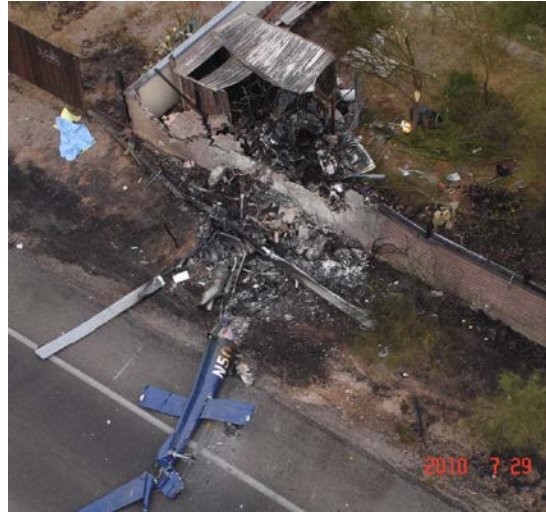
Photograph of accident:

**Summary:** Near vertical crash on top of a block wall. The fuel tank burst and a severe post-crash fire occurred. First responders (Tucson Fire dept.) could hear the pilot screaming for help, found one passenger that was conscious and able to speak but badly burned, and found one passenger dead at the scene. The thermally injured pilot and passenger died approximately 2.5 hr. after the accident. The third fatality cause was not determinable from available data.

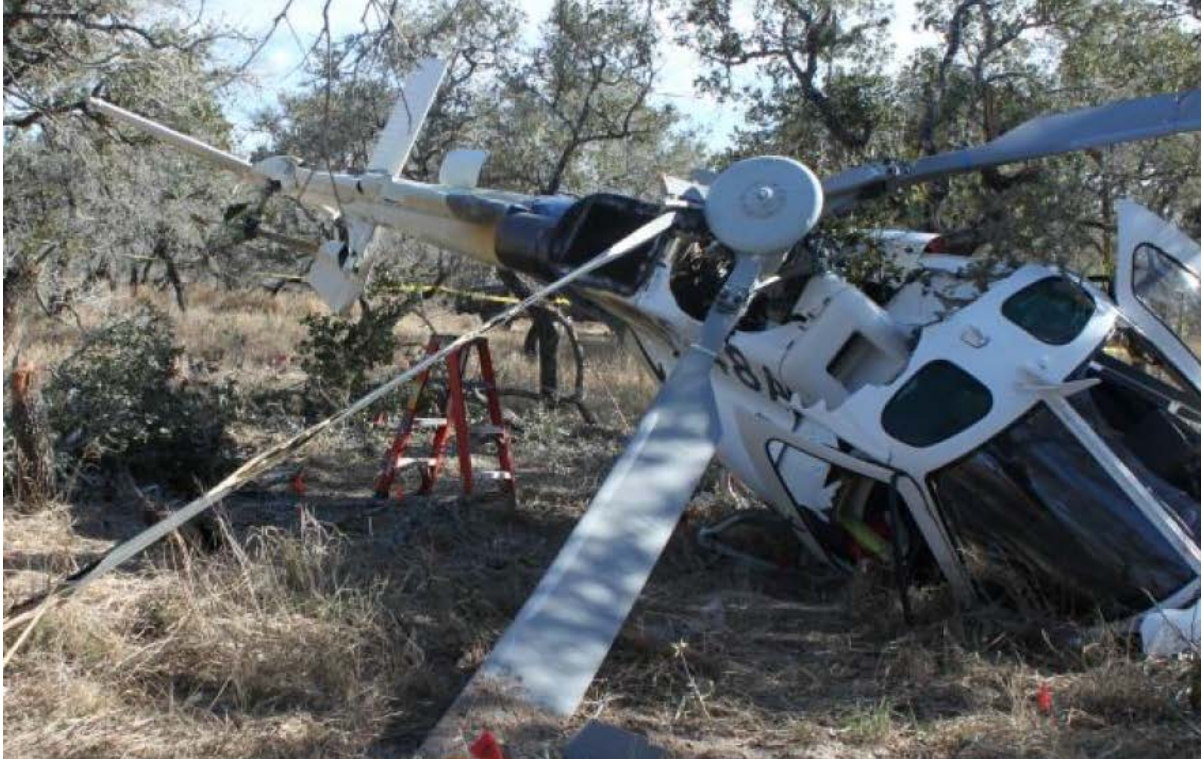
Photograph of crash scene:

From the narrative: "The fuel tank remained undamaged and secured within the fuselage; no fuel was observed leaking from the helicopter nor smelled at the accident site." "Thermal damage was evident on the left and top sides of the engine cowling and the inlet plenum. The thermal damage patterns on the structure were similar to a post-impact fire in the final resting position. The oil, fuel, and air lines remained secured; however, the external accessories of the engine were damaged from the post-impact fire."

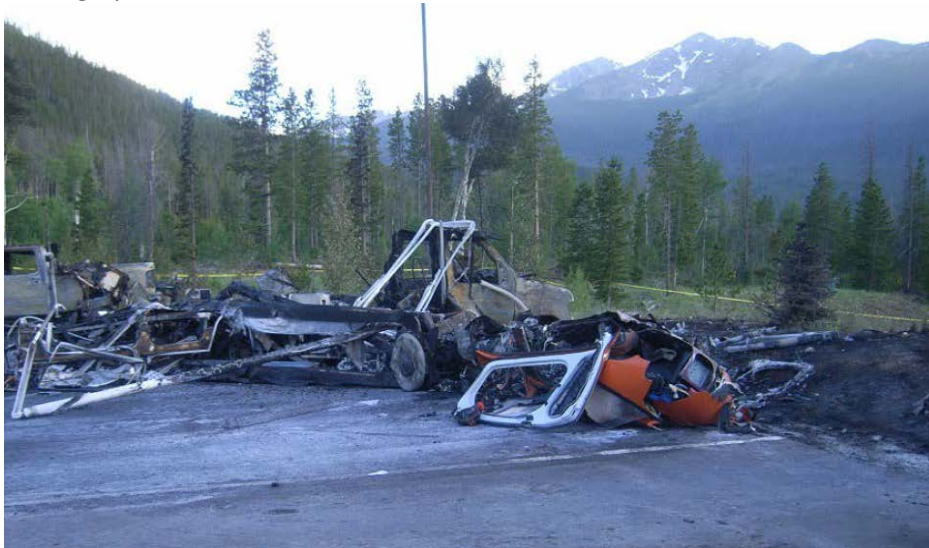
Photograph of crash scene:

**Summary:** Helicopter lost control after take-off, and impacted an RV in a parking lot. A large post-crash fire ensued when the main fuel tank ruptured. The pilot received fatal thermal injuries, one passenger received extreme thermal injuries, and another passenger received impact injuries (non-thermal).

This accident has been well publicized as video was taken at the accident scene. The pilot received critical blunt trauma injury as well as extreme (fatal) thermal injury and died shortly after the crash. One flight nurse sustained spinal fractures without thermal injury and the other flight nurse sustained burns over 90% of his body.

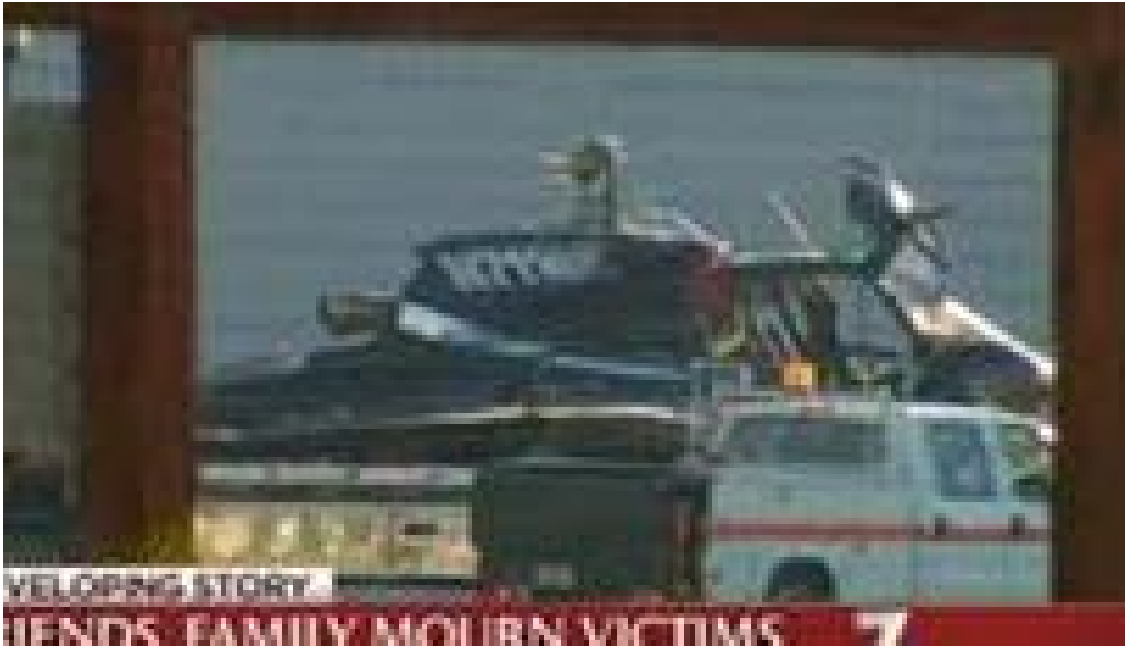
Narrative or docket not available. However, video of the incident was captured and broadcast on local TV. Below is a screen shot of the helicopter being towed from the runway.

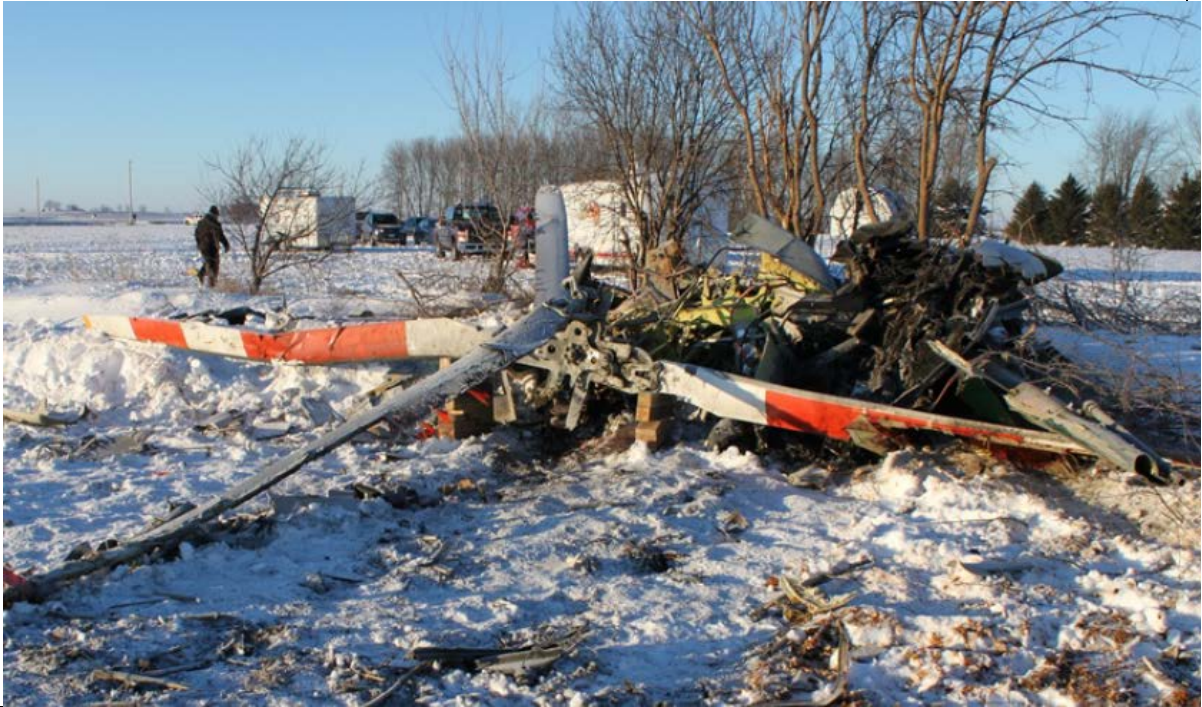
**Photograph:**

**Summary:** High speed impact after apparent engine ice build-up
