# Case Study

## Altimetry System Error Report (ASE-R) 055

**Presented to:** Altimetry System Error (ASE)  
Workshop

**Date:** September 2016

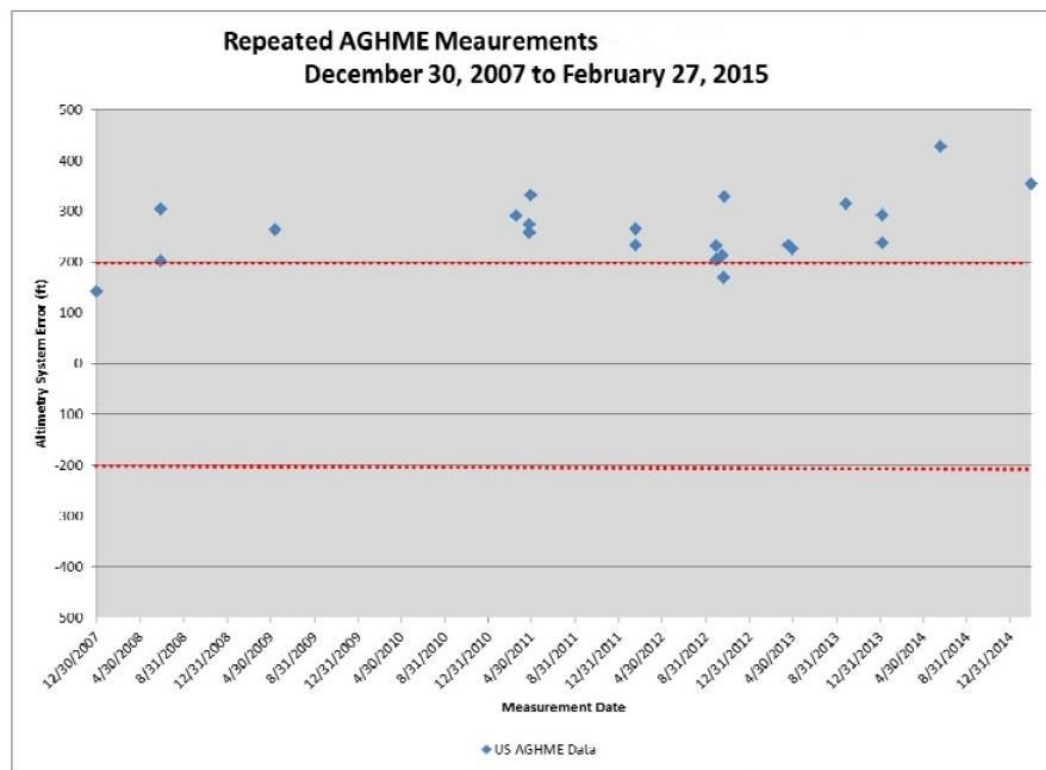
Figure 1. Aircraft Altimetry System Error History

# Identification of Unsatisfactory ASE

AGHME Identification	Date of Measurement	ASE	Flight Level
ACLE	6/27/2008	203	350
ACLE	5/13/2009	264	380
AICT	3/18/2011	291	410
ACLE	4/25/2011	258	370
ACLE	4/25/2011	274	380
ACLE	4/28/2011	331	370
AICT	2/17/2012	233	400
AICT	2/17/2012	265	400
ACLE	9/28/2012	231	330
ACLE	9/28/2012	204	350
ACLE	10/15/2012	213	300
ACLE	10/19/2012	169	370
AICT	10/22/2012	329	340
AACY	4/18/2013	233	370
AACY	4/29/2013	225	390
ACLE	9/27/2013	314	360
AICT	1/7/2014	292	410
AICT	1/7/2014	237	410
ACLE	6/19/2014	428	410
AICT	2/27/2015	354	400

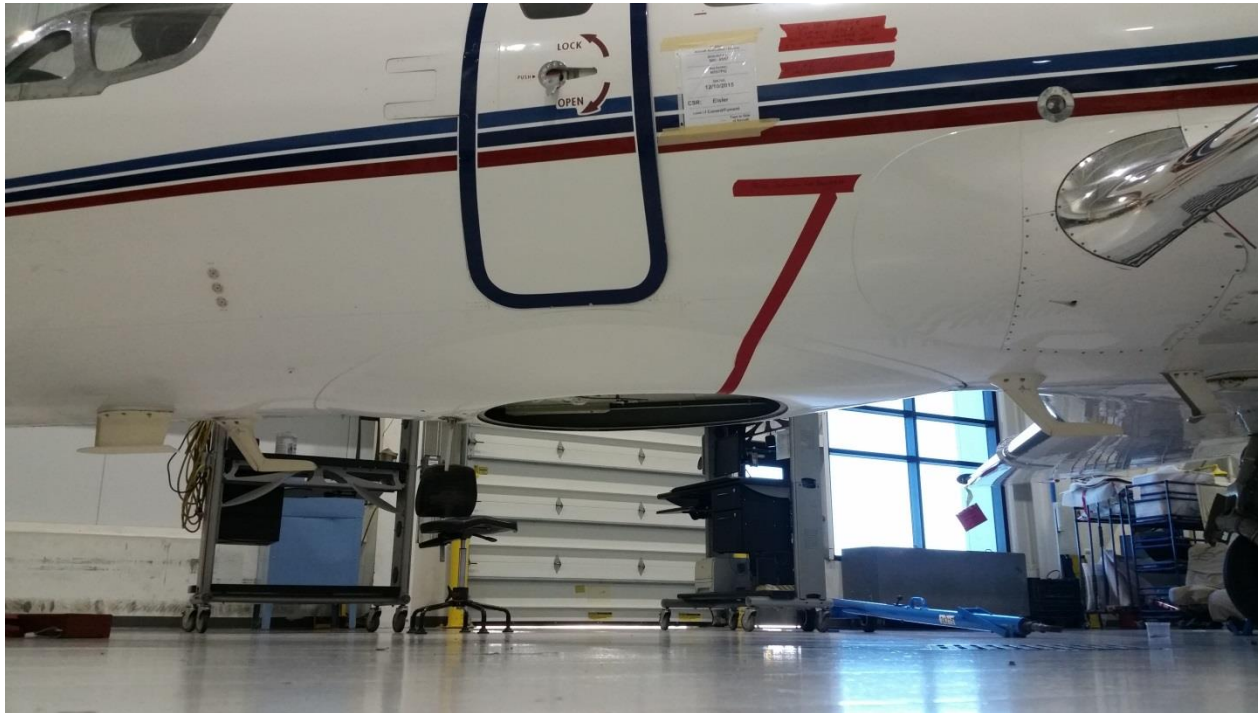
# Identification of Probable Cause

- **Contacted current design-holder (Textron)**
  - Aircraft had been customized and did not meet RVSM design requirements
  - Modification performed prior to issuance of Certificate of Airworthiness
  - Camera provisions had been added
