2nd TECHNICAL REPORT

**ON
Propulsion System and Auxiliary Power Unit
(APU)
Related Aircraft Safety Hazards**

January 31, 2005

**THE FEDERAL AVIATION ADMINISTRATION
and
THE AEROSPACE INDUSTRIES ASSOCIATION (AIA)**

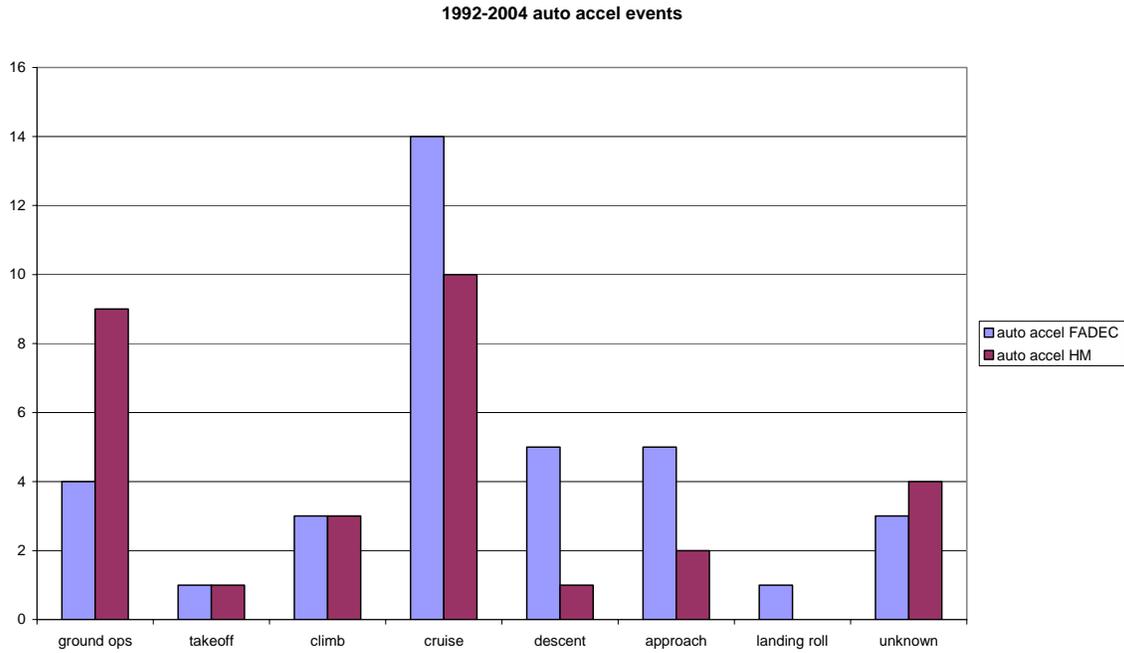
Uncommanded Thrust Increase

No level 3, 4 or 5 events were observed in the high bypass fleet as a result of an auto-accel or “thrust runaway”.

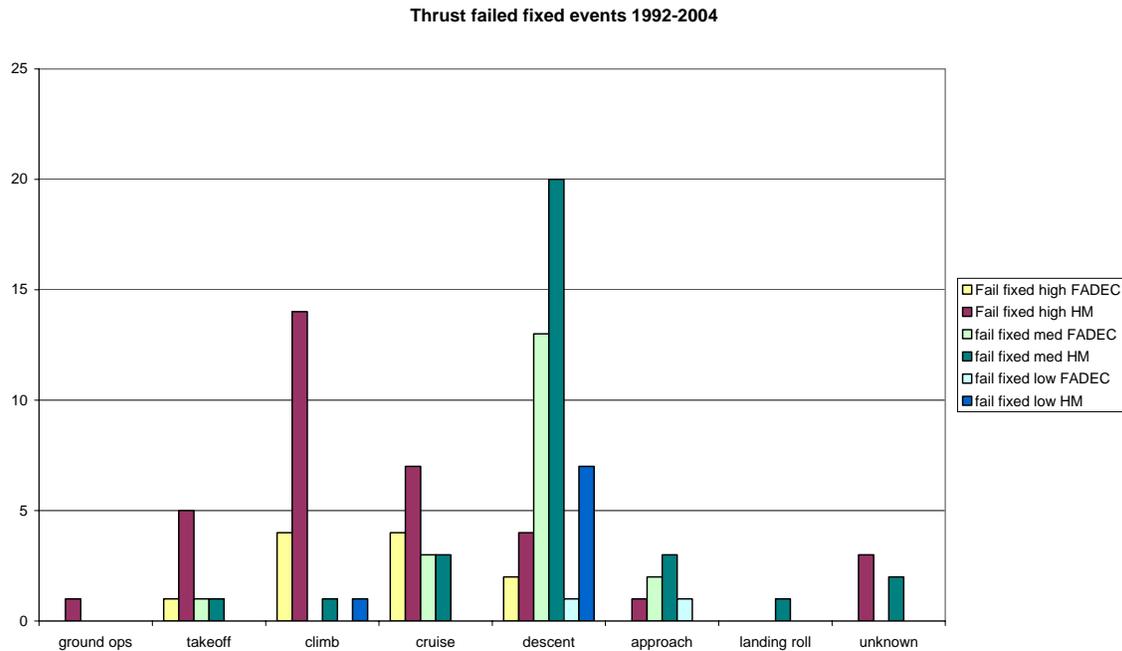
Power failed fixed

No level 3, 4 or 5 events were observed in the high bypass fleet as a result of thrust failing to a fixed setting.
