DOT/FAA/AM-06/28  
Office of Aerospace Medicine  
Washington, DC 20591

# **Aircraft Accidents and Incidents Associated With Visual Disturbances From Bright Lights During Nighttime Flight Operations**

November 2006

Final Report

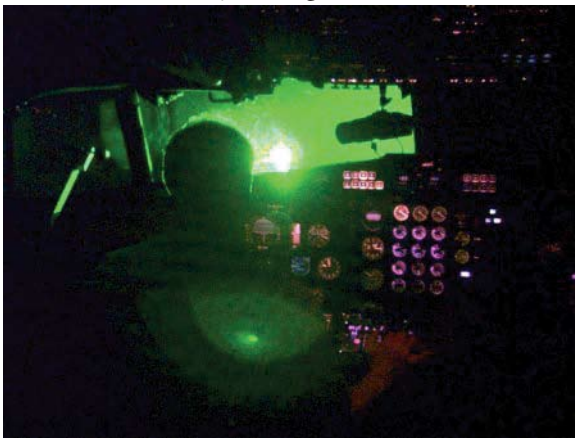
Exposure to light that is several orders of magnitude brighter than that to which the eyes are adapted can reduce or eliminate a pilot's ability to correctly perceive depth or clearly see obstacles and the terrain (Figure 2). The period of time and extent to which these effects may last varies considerably among individuals.

**Figure 2:** Cockpit glare induced by a 532 nm laser exposure ( $50 \mu\text{W}/\text{cm}^2$ ).
