EVALUATION OF HEAD AND FACE INJURY POTENTIAL OF CURRENT AIRLINE SEATS DURING CRASH DECELERATIONS

June 1966

Office of Aviation Medicine
FEDERAL AVIATION AGENCY

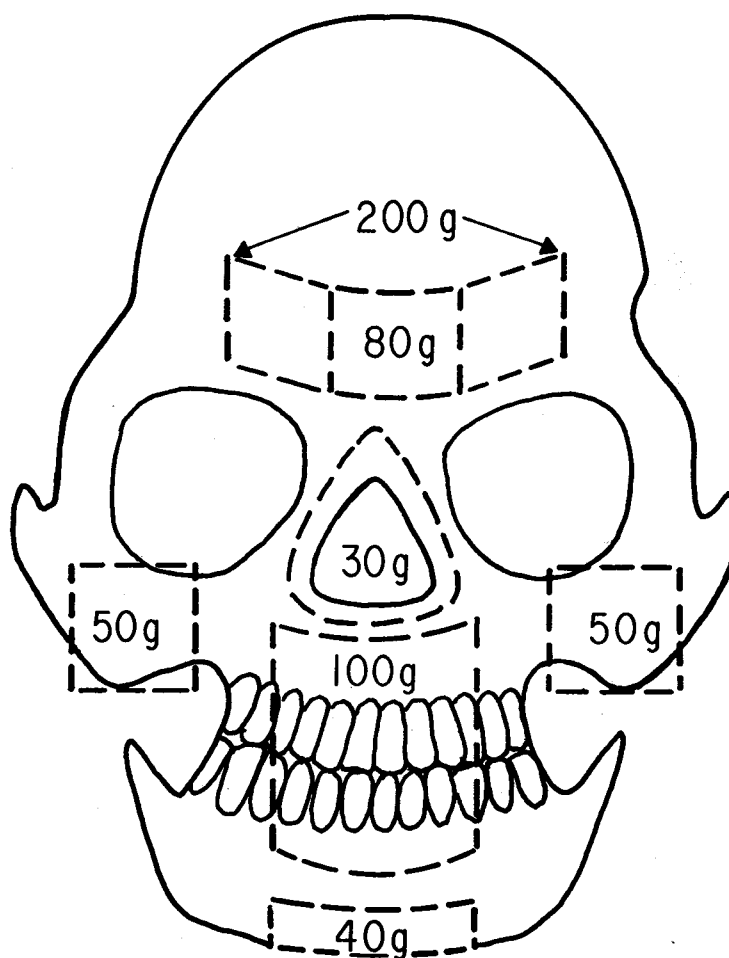
FIGURE 1. Summary of maximum tolerable impact forces on a padded deformable surface.

Figure 1 reproduces summary data² showing the tolerances of the human face and head to

resist fracture during impact against *deformable structures*.

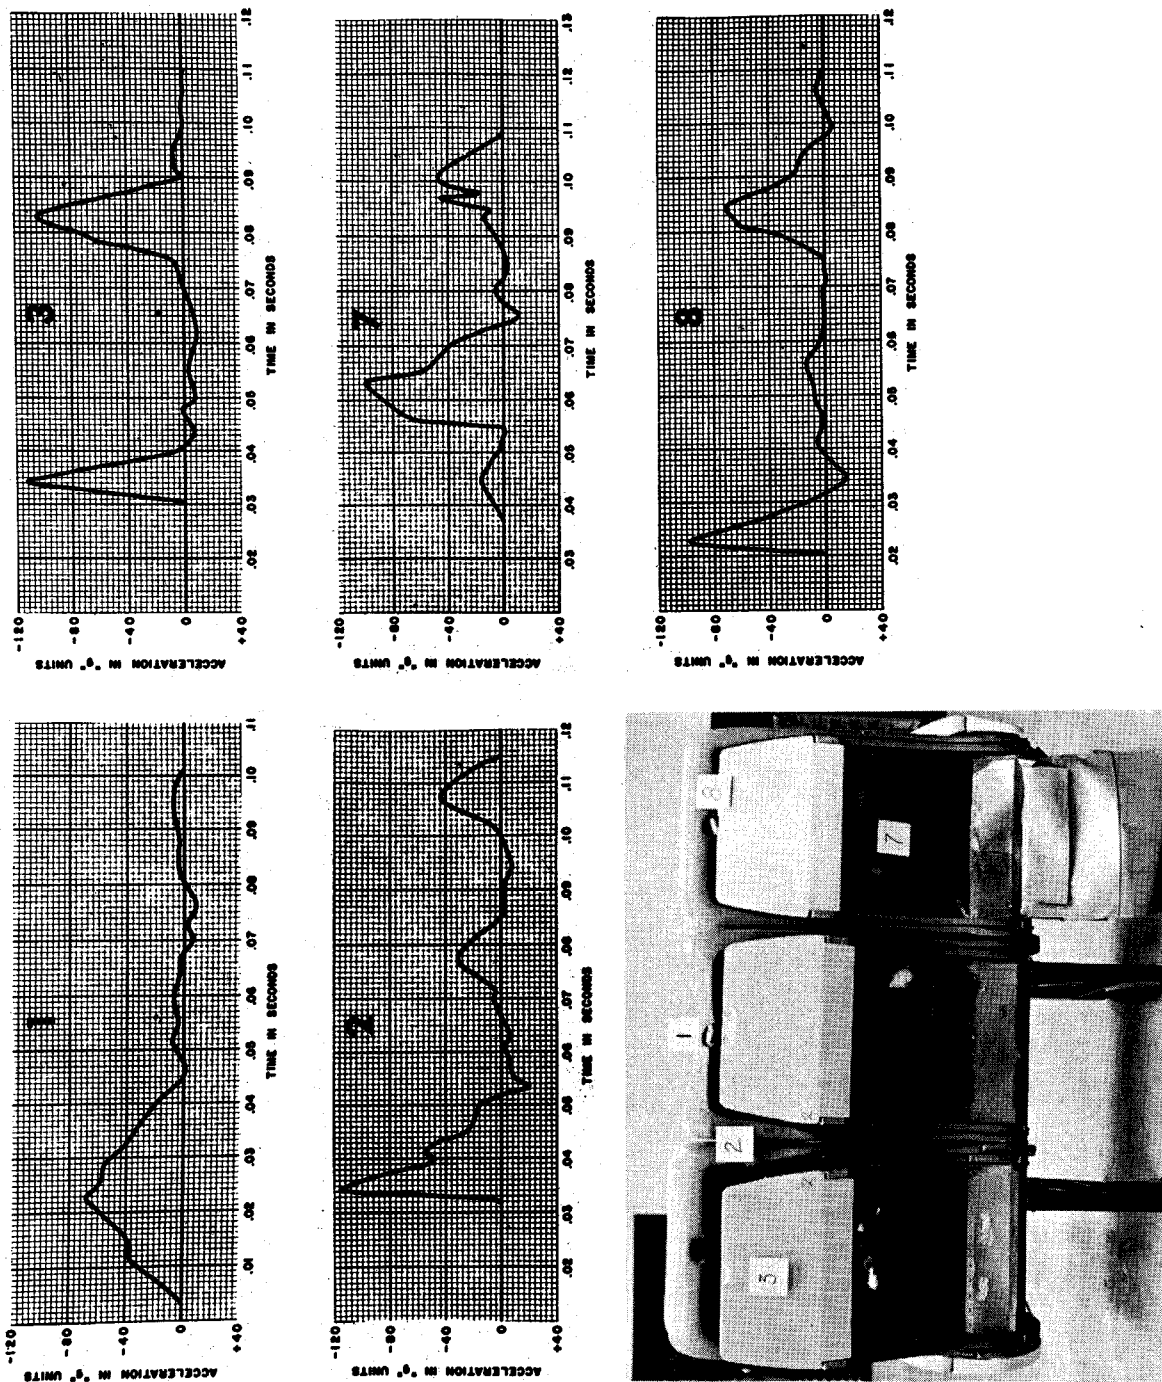
FIGURE A1. Seat A.

Five impacts of the dummy head were made against Seat A at the points shown in Figure A1

(Figures A1 through A10 are in the Appendix.) by numbers 1, 2, 3, 7, and 8. Corresponding "g" time-force curves are presented. Impact #1 (on the top of the middle seat) produced a sizeable deformation in the soft metal structure. The metal deformed readily and *contoured* to the head, distributing the force over a large area of the skull. The peak force was about 70g with a slow rise time (20 milliseconds). The deceleration extended over 40 milliseconds. Referring to Figure 1, we would expect this impact to produce no bony injury if struck by the forehead or teeth-maxilla areas, but it would be of sufficient force to fracture a single zygomatic (cheek bone), nose, or mandible (jaw bone). In all five instances, however, the passenger would be rendered unconscious.²

Impact #2 was between the left and middle seats with the seats in the upright position. Most of the force (120g peak) was used in forcing the seat backs to break forward. There was little deformation of the seat structure, causing the impact loads to be concentrated on a small area of the head. This would have produced fatal fractures. It is of interest that a steady pull of only 10 to 12 pounds is needed to force one of these seat backs forward.

Impact #3 against the center of the serving tray in the left seat back (with the seat upright) produced two peaks of over 100g: one when the seat back was forced forward and the other when the head subsequently struck the lower cross member of the seat back. There was no deformation of the serving tray. Estimates of injury potential presented in Table 1 are based on a previous report² and the area of contact of structure with the head. For injury estimates for the following figures, refer to Table 1.

Some seat-design engineers feel that under actual crash conditions the "break-away" type of seat back will fold forward from its own momentum out of the way of the head. If this is true, the head possibly will strike the lower portion of the seat back or a tubular cross member. Impact #7 simulates this condition. The right seat back was impacted in the forward position. In the graph for #7, the first small peak of about 15g was produced in bending the thin metal at the bottom of the seat before the head made contact with the heavy tubular cross member concealed beneath it. At that time a very lethal, long-duration (20 milliseconds) force of over 100g was applied to the head.

Impact #8 was against the top of the right seat back (seat upright) at the top edge of the serving tray. Note similarity of curves 3 and 8.

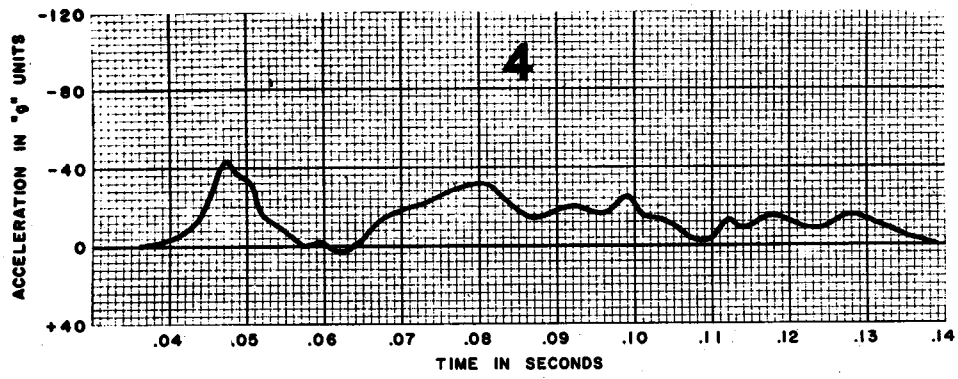
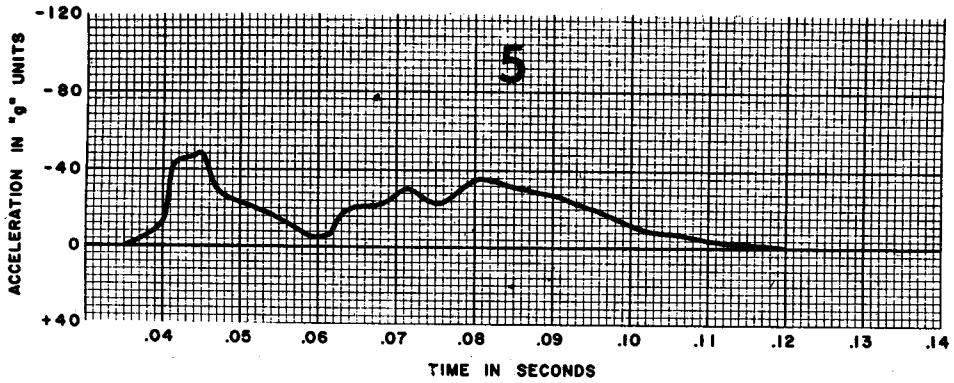
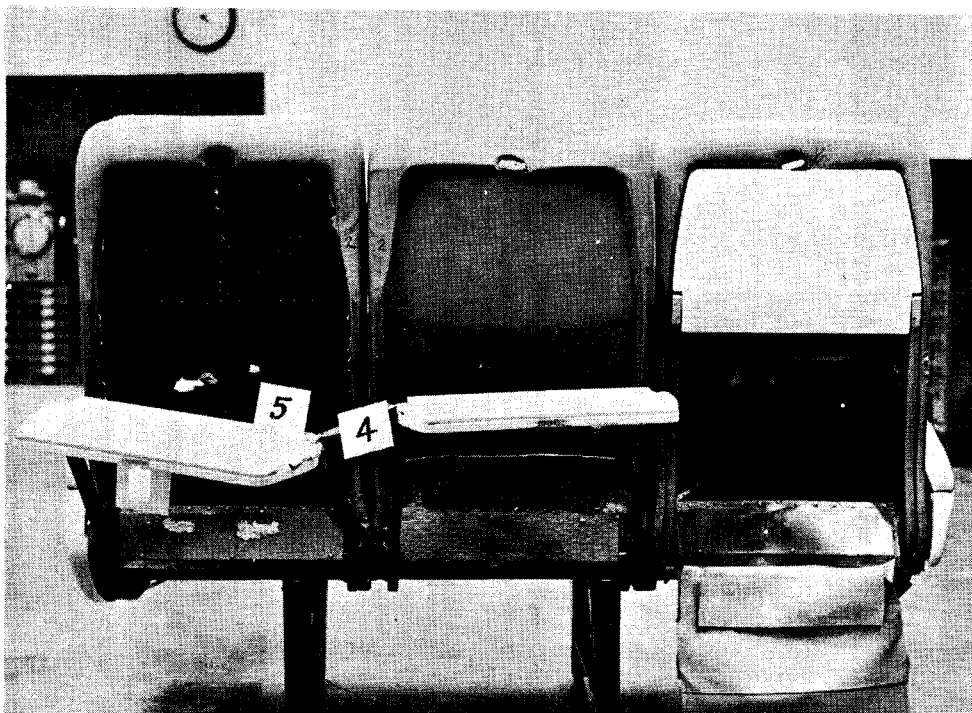
FIGURE A2. Seat A.

Since the arms supporting the folding serving trays have broken off in some airline crashes and caused serious injury, two impacts were made on the unfolded trays of Seat A (Figure A2). Impact #4 was centered in an area between the left and center trays, whereas impact #5 was against the right edge of the left seat tray. The tray support arms in both cases bent several inches but did not fracture. The impacts produced long duration forces of about 40g or less.

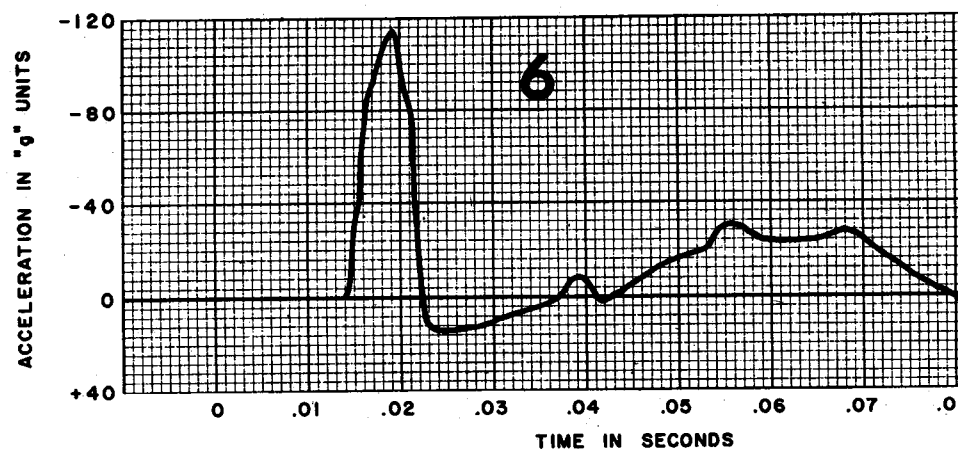
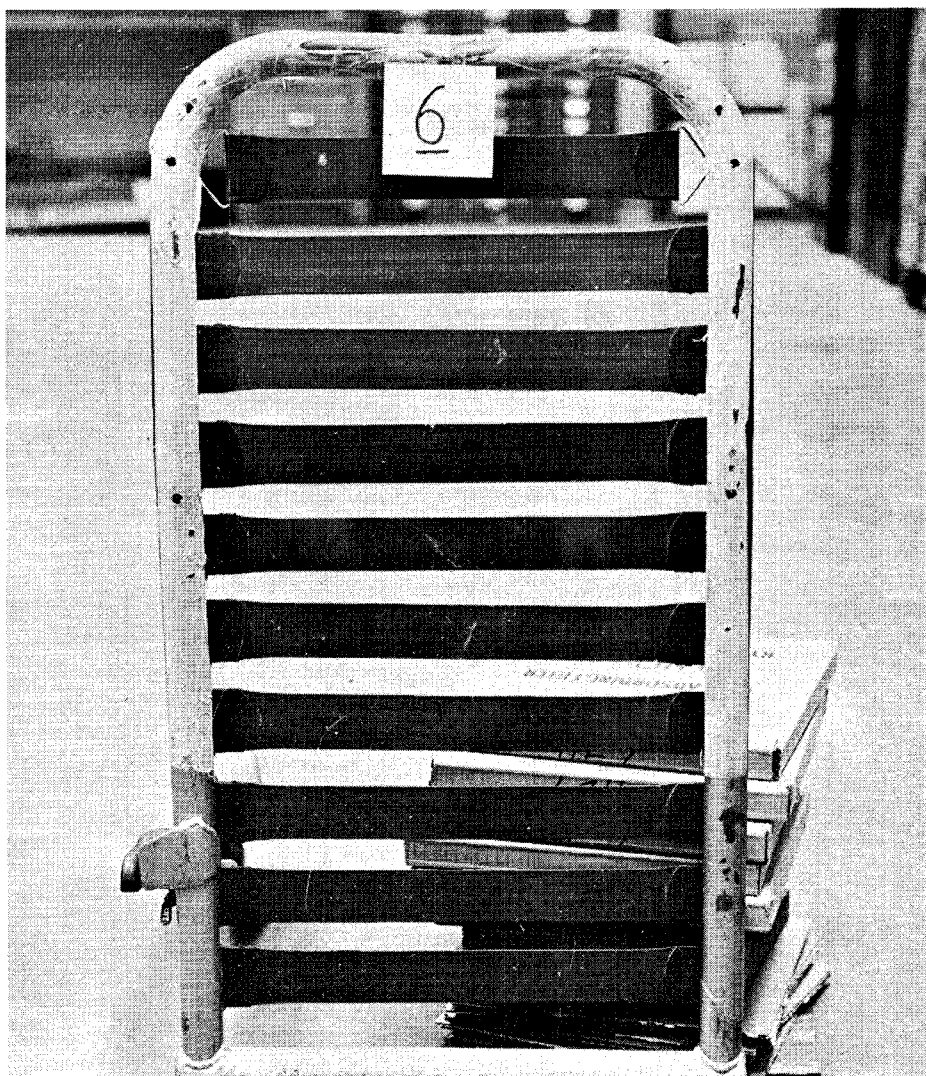
FIGURE A3. Seat B.

In Figure A3, the dent left by the head impact against the top tubular structure (Seat B) is barely visible in the photograph. The sharp

rising 120g peak force applied to an area of not more than 1 sq in. of the head would undoubtedly have caused fatal injuries.

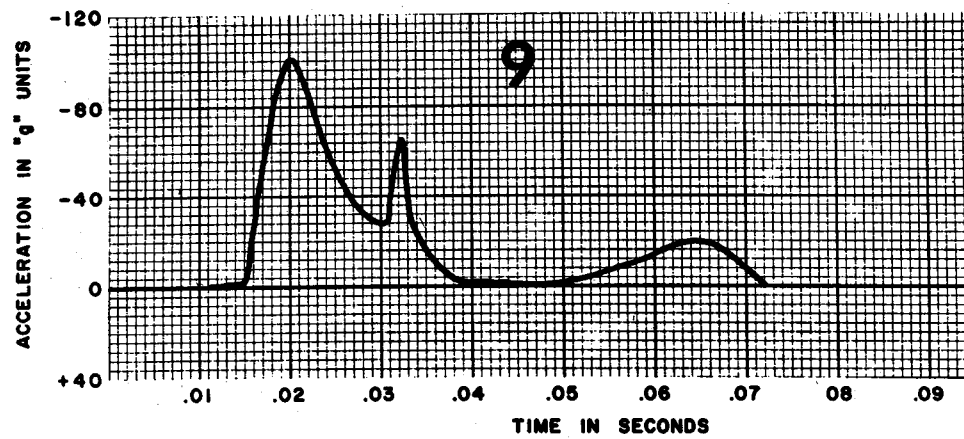
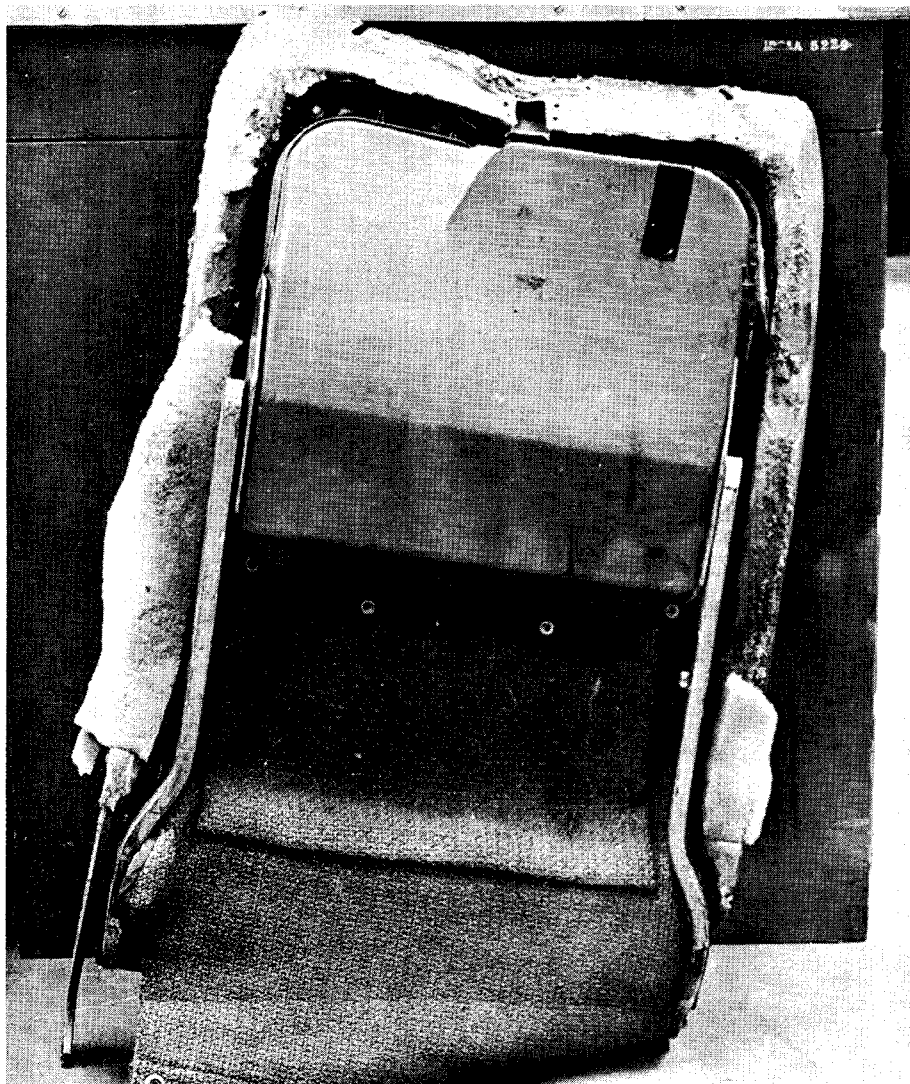
FIGURE A4. Seat C.

Impact #9 against the top edge of Seat C produced a somewhat larger dent (Figure A4). The g-force curve looks almost as severe as the one in Figure A3; however, there is one important difference. Since the metal did deform and contour to the curvatures of the head, the pressure in pounds per square inch on the head would be much less than in the previous figure and the danger of injuries reduced accordingly.

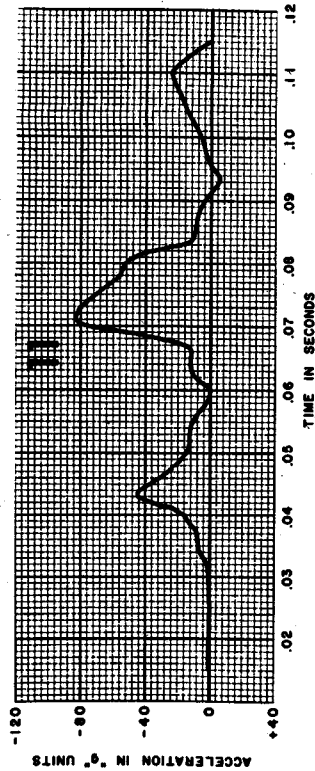
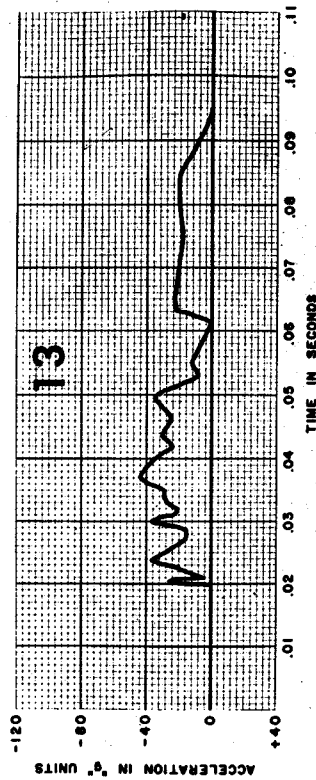
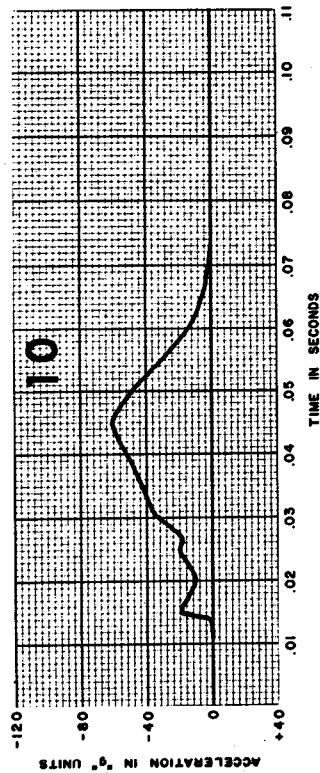
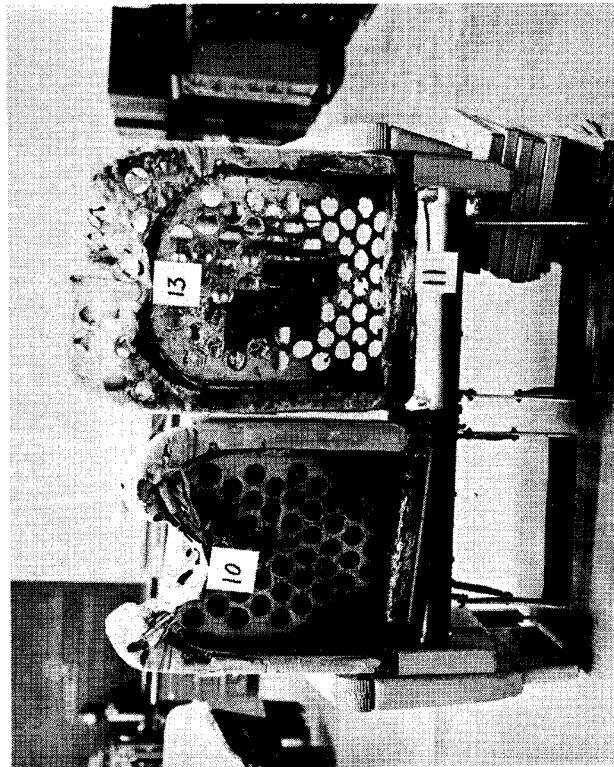
FIGURE A5. Seat D.

Three impacts against Seat D in Figure A5 show that it is a fairly safe seat for head impact. The top edge of the left seat back (test #10) deformed 11 inches and contoured perfectly to the head. Note that initial bending of the structure started at 20g and that the force is spread out with a slow rise time and a peak of not over 60g. Test #13 against the top rear surface of the right seat back shows a more desirable pattern. The head did not experience over 40g; however, test #11 against the tubular cross member at the bottom of the right seat back produced peak forces in excess of 80g. Throughout this report this type of tubular structure is shown to be very dangerous and undoubtedly causes a large number of head and leg fractures. This area of the seat requires additional safety-design consideration.

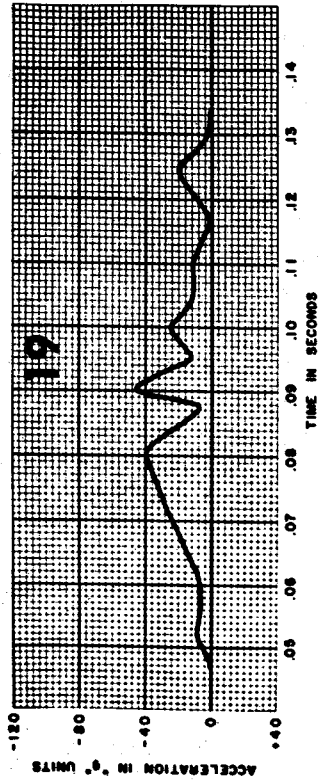
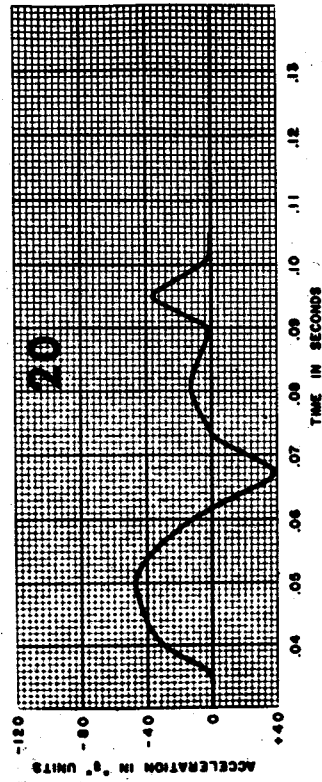
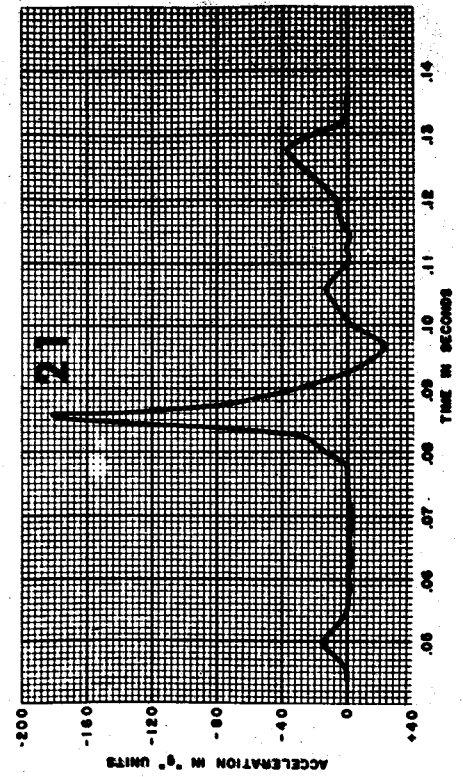
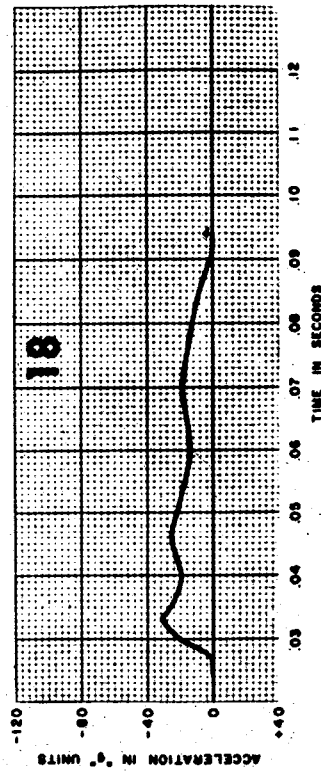
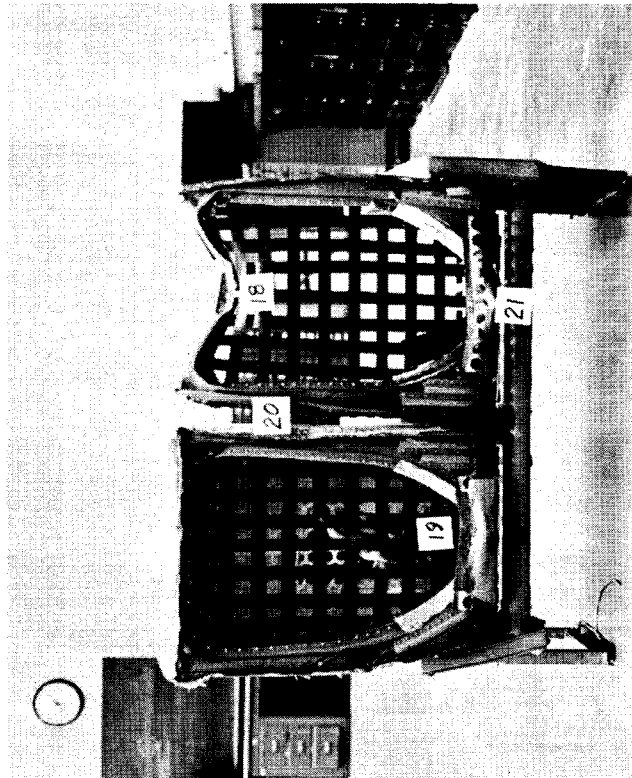
FIGURE A6. Seat E.

Seat E in Figure A6 (mostly fabricated of sheet aluminum) is shown by the force curves to have very good deforming characteristics with the exception of the lower tubular cross member, which produced fatal impact forces of 180g.

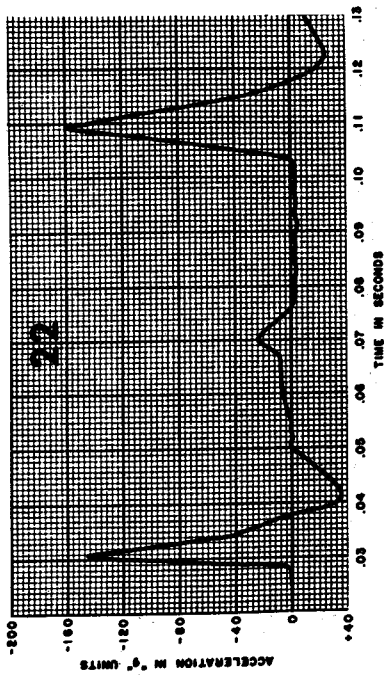
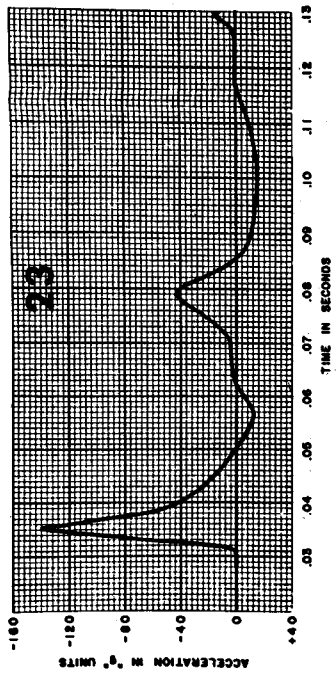
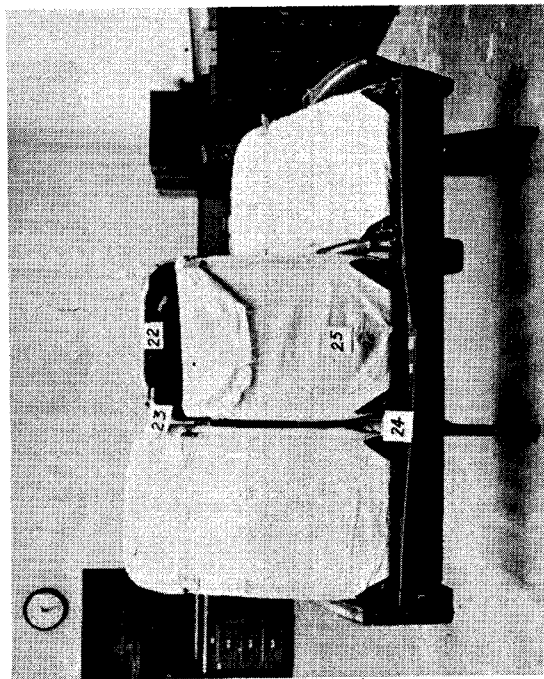
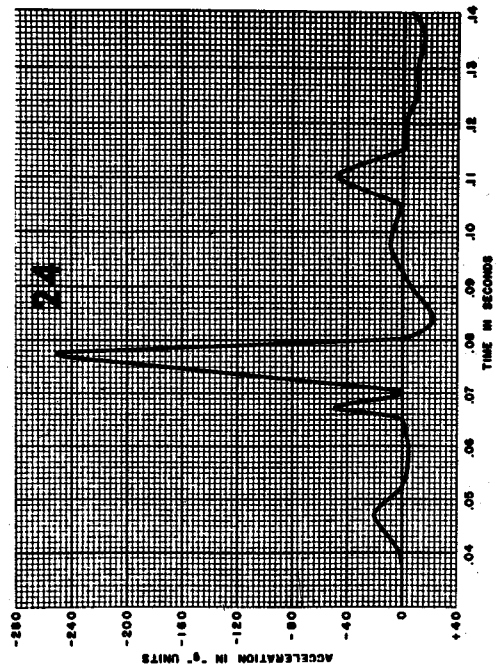
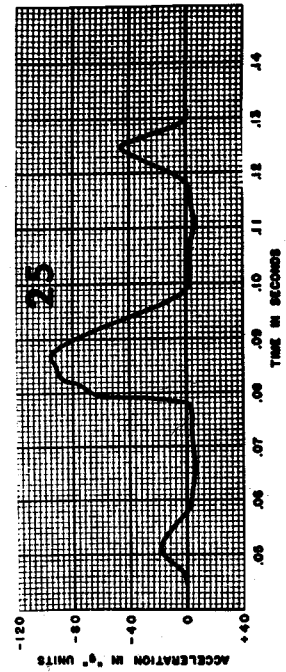
FIGURE A7. Seat F.

Seat F (Figure A7) is constructed of aluminum tubes and produced high forces during all impacts. The most dangerous part of the seat, however, is the aft end of the rigid seat arm protruding rearward between the seat backs. Test #24 against one of these arms produced a peak force of 250g.

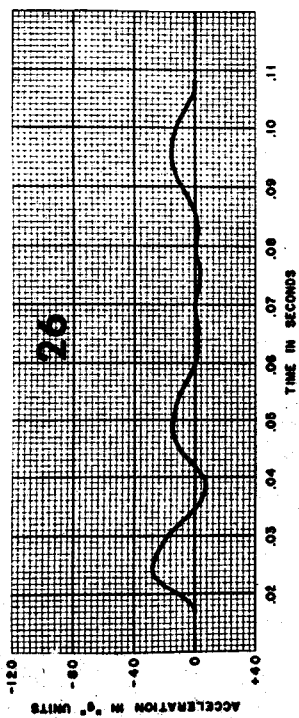
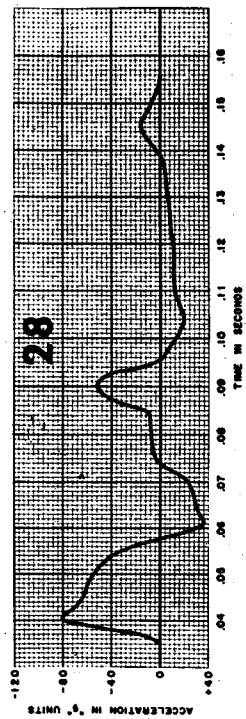
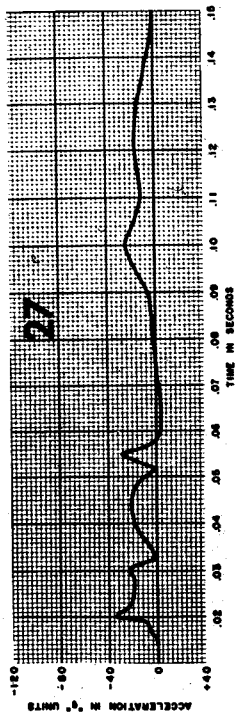
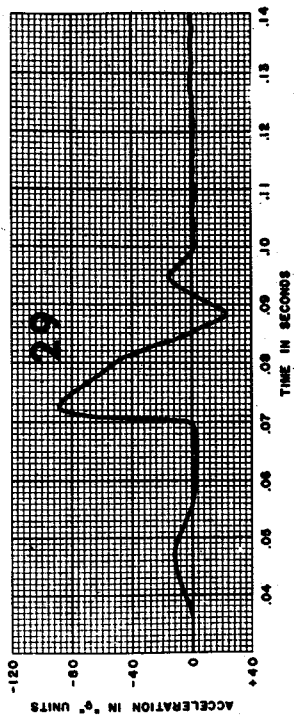
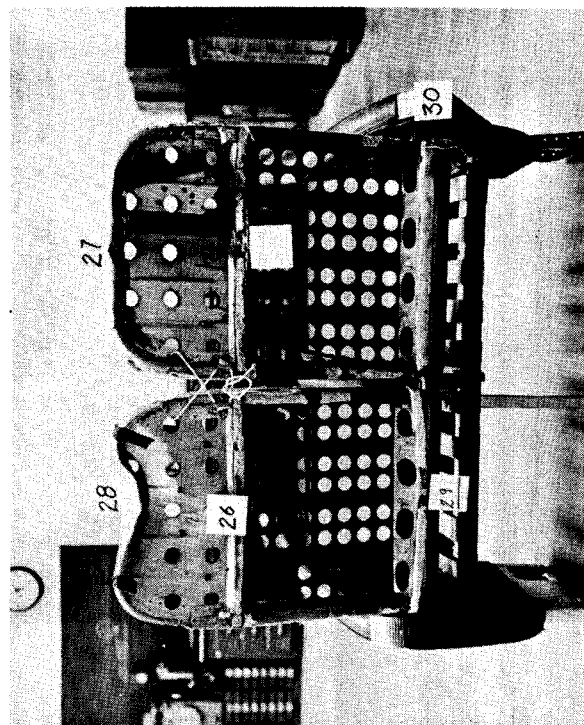
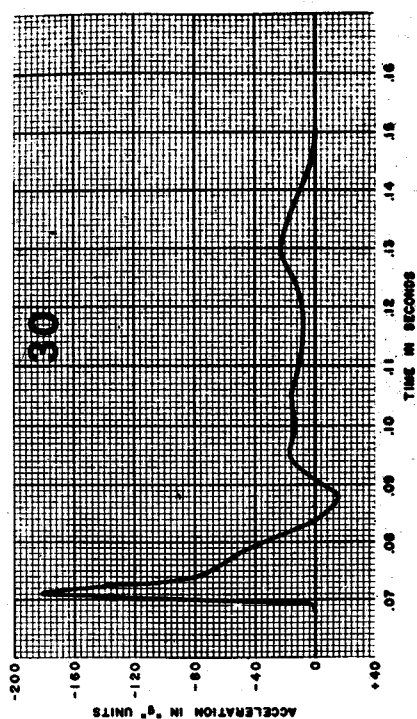
FIGURE A8. Seat G.

Seat G (Figure A8), similar in construction to that shown in Figure A4, produced low g-forces on the upper structure but again pointed out the danger of the rigid arm (test #30—180g).

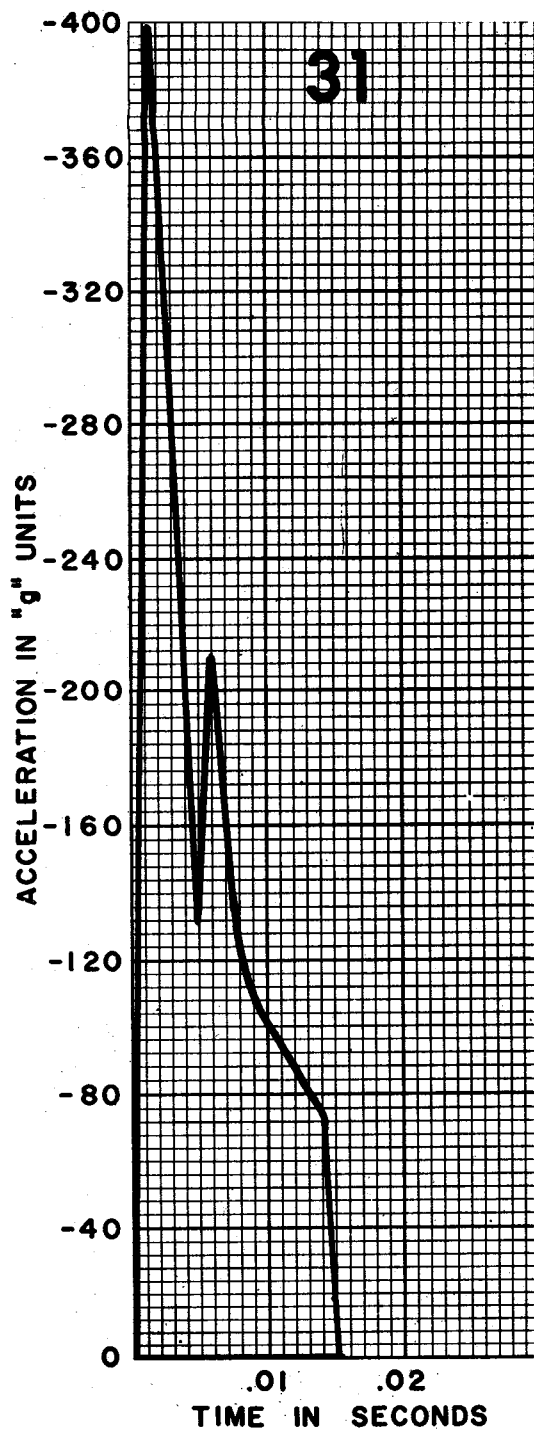
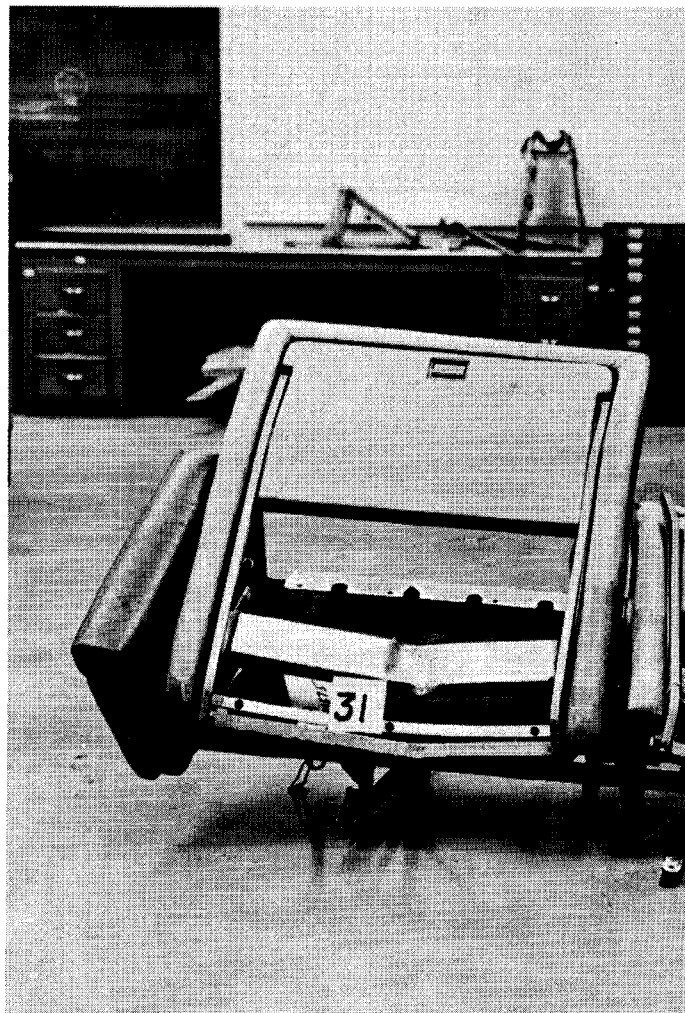
FIGURE A9. Seat H.

Seat H has two heavy, square-edged, tubular structures in the lower portion of the seat back. Tests #31 (Figure A9) and #32 (Figure A10) show unusually high g-forces when these rigid structures are impacted. The top of the seat back is also of square tubular construction and

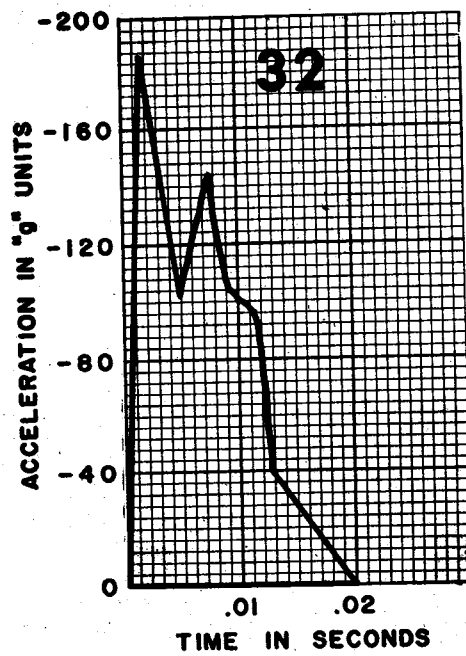
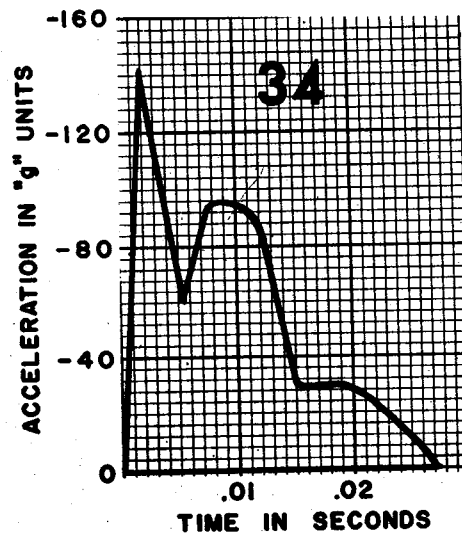
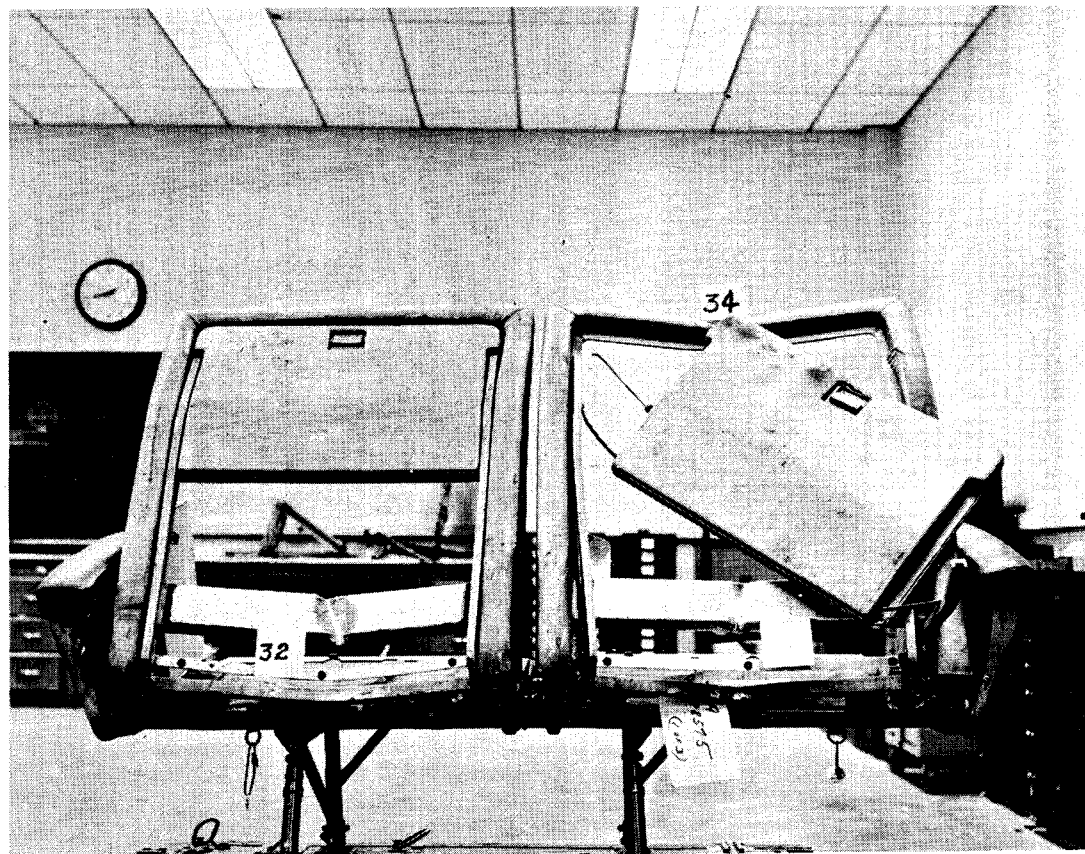
FIGURE A10. Seat H.

produced 140g when impacted (#34, Figure A10).
