## 1966 BEECH BARON

## CASE 1-1

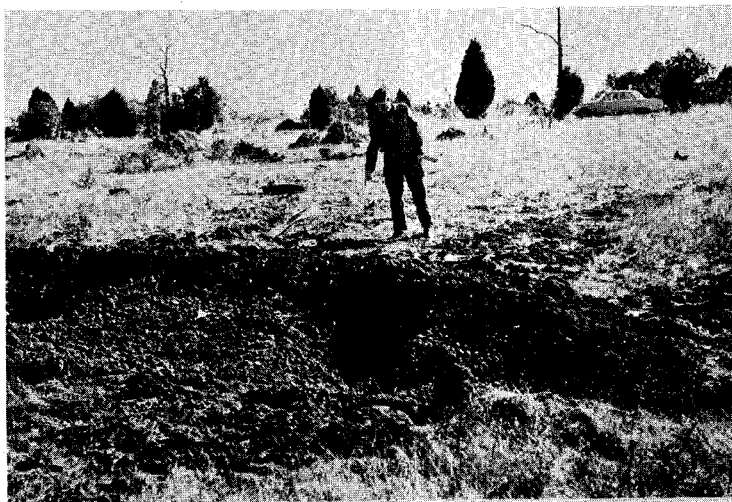
A. Crater formed by aircraft impact  
38' long, 12' wide, & 4' deep.

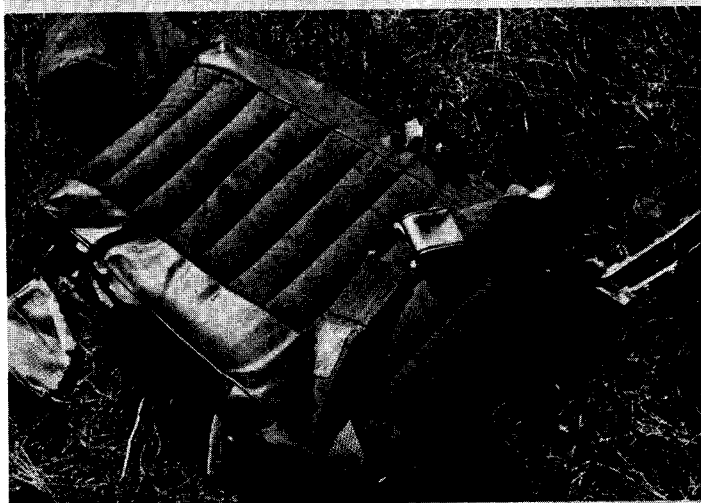
C. Part of copilot's seat showing failure  
of tongue half of seat belt buckle.

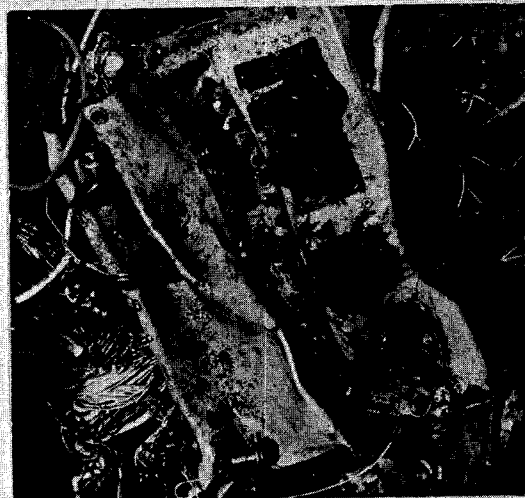
D. Portion of instrument panel,  
broken, deformed & covered  
with tissue.

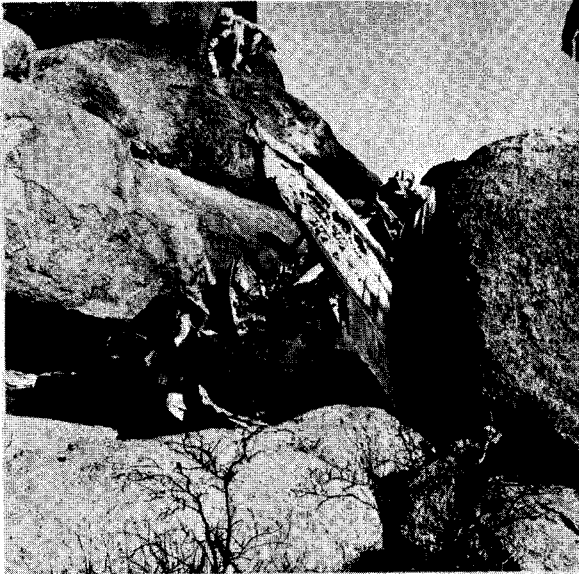
A. Remains of aircraft after impact with a stone mountain. Man indicating impact point.

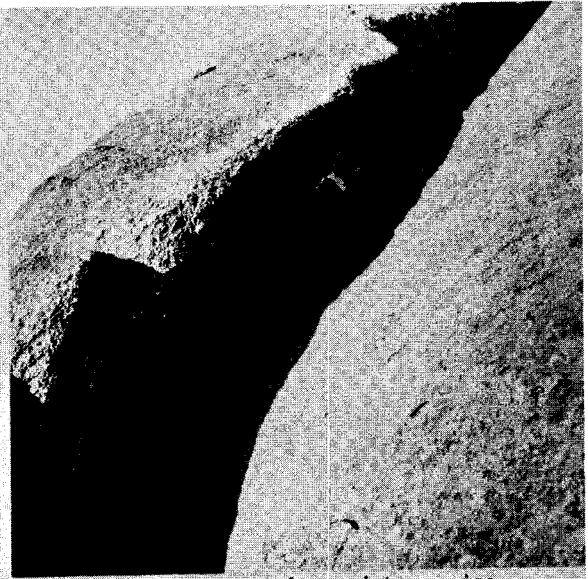
B. Bodies were thrown into crevice in the rocks.

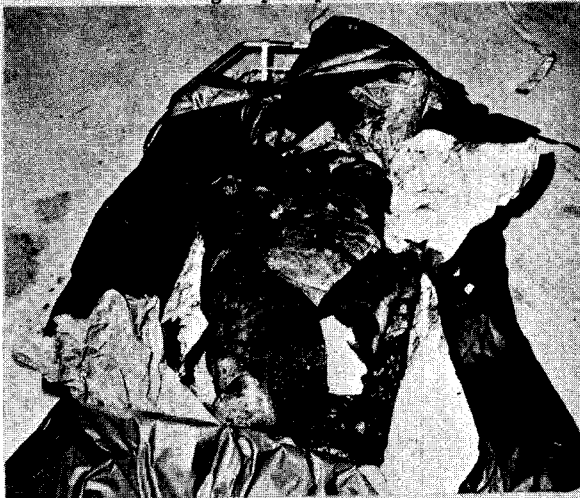
C. Remains of passenger in right front seat.

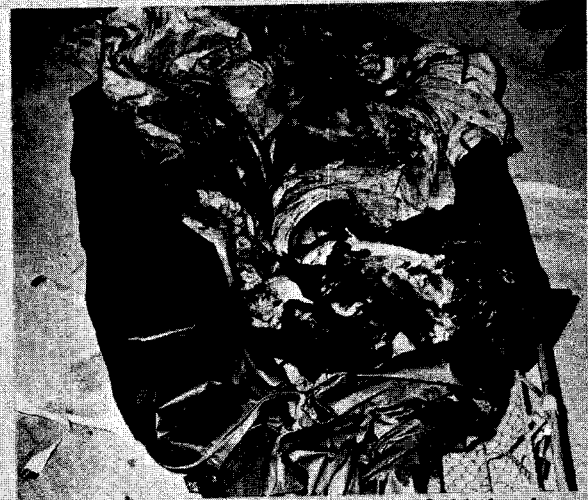
D. Remains of pilot. Note that only his hands are not injured. They probably trailed behind the body as it was ejected from the a/c.

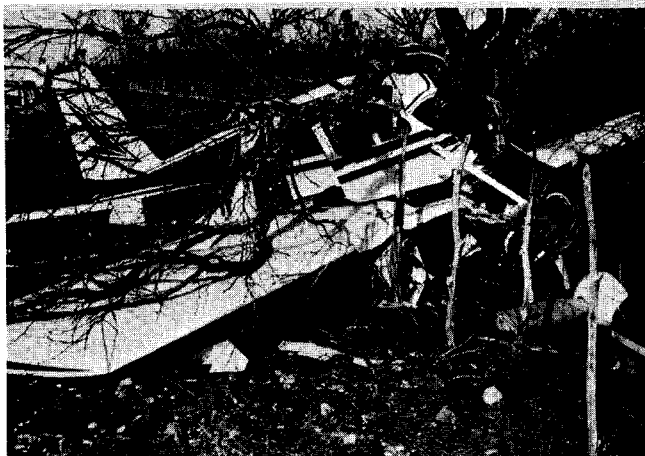
A. Overall view of aircraft impact with tree.

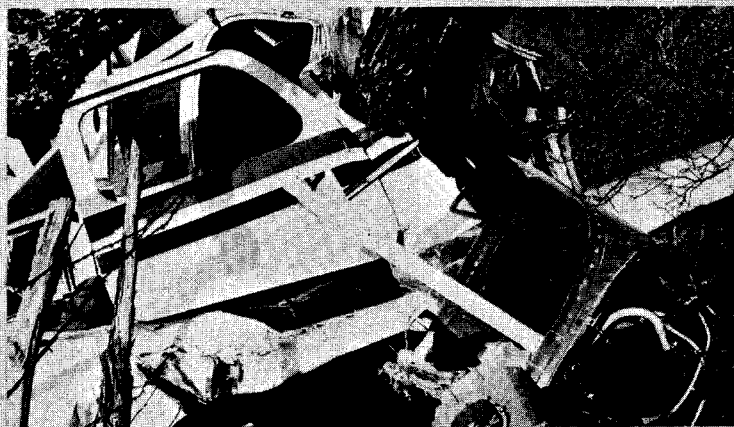
B. Close-up showing relative size of tree & depth of its penetration into the aircraft.

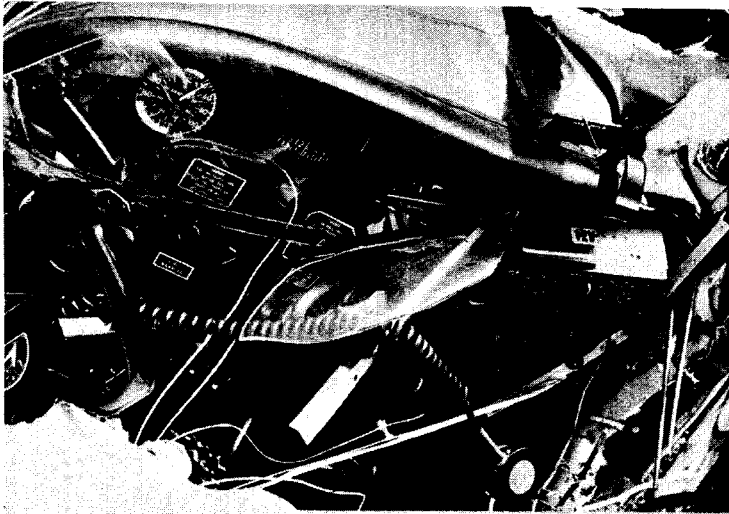
E. Right half of instrument panel sheared off by tree penetration.

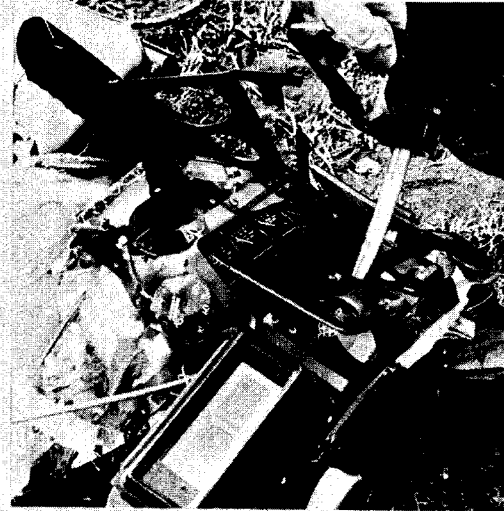
D. Left half of the instrument panel shows no signs of body impact. Note broken pieces of plastic windshield in the cockpit.

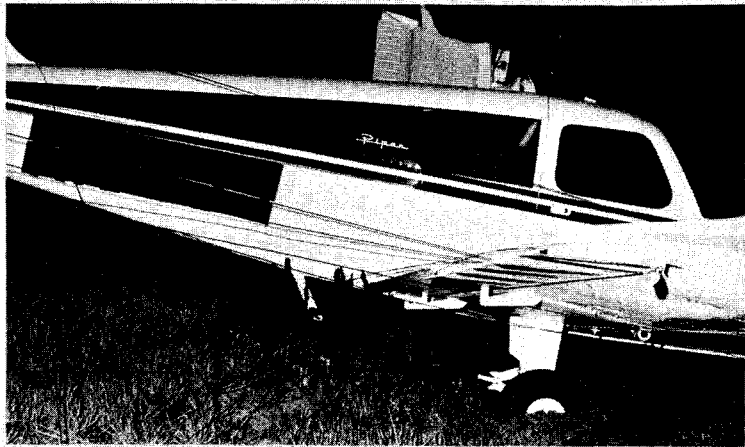
B. Five strands of steel telegraph wires stretched taut along sides of the fuselage.

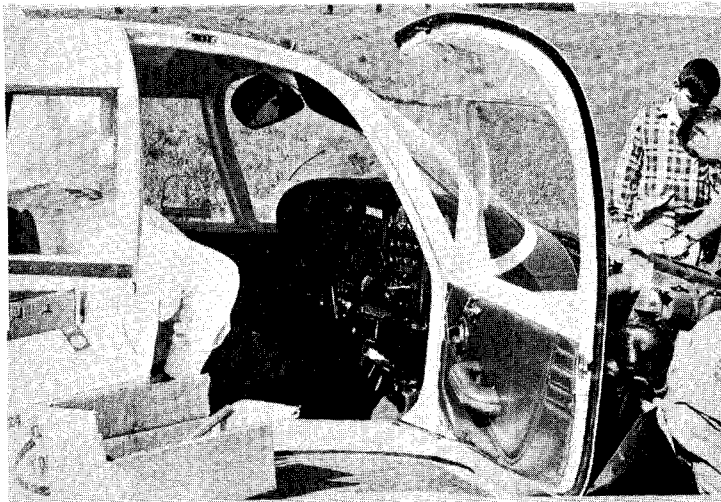
D. General view of cabin interior.

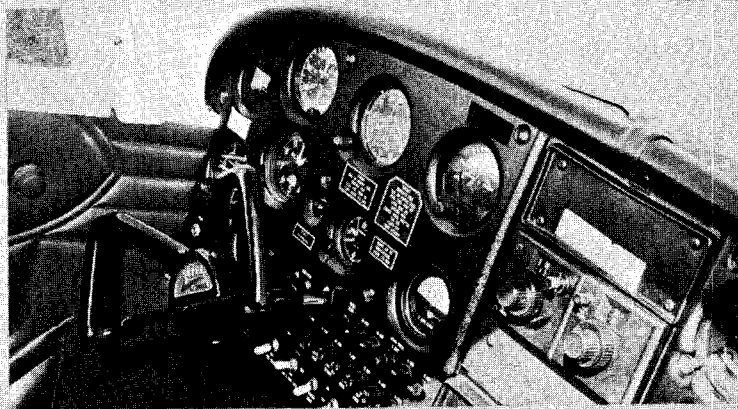
E. Upper left instrument panel. No damage from head impact.

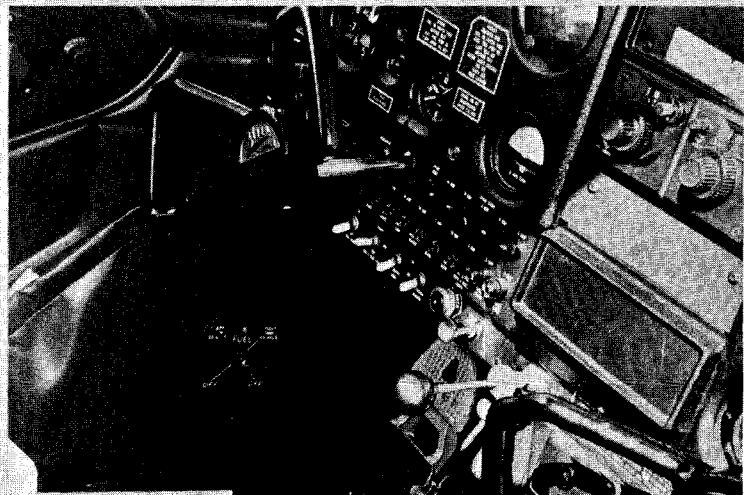
F. Lower left instrument panel. No damage from knee impact.

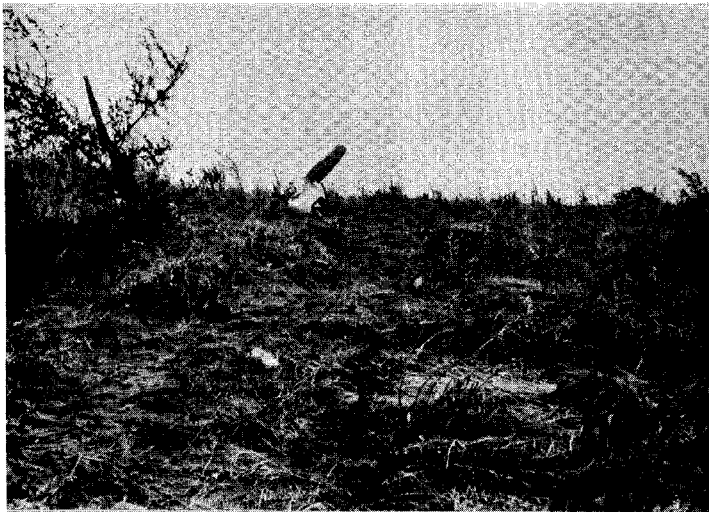
A. Path taken by aircraft during 305-foot deceleration.

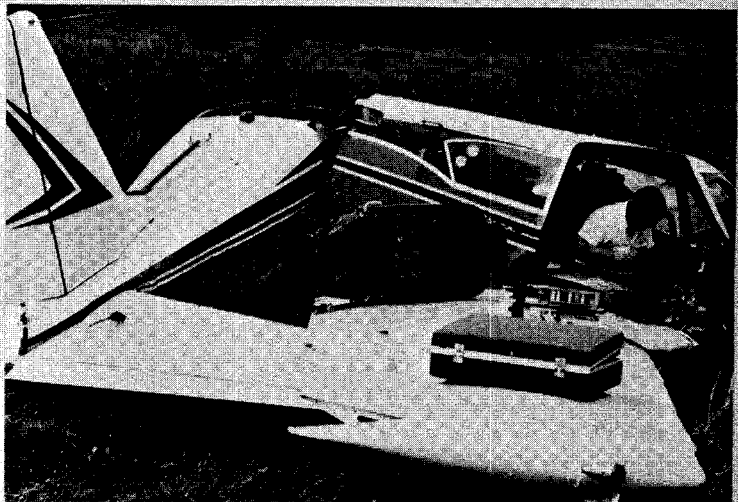
B. Final attitude of aircraft. Tail section separated at the rear of the cabin & turned 90°.

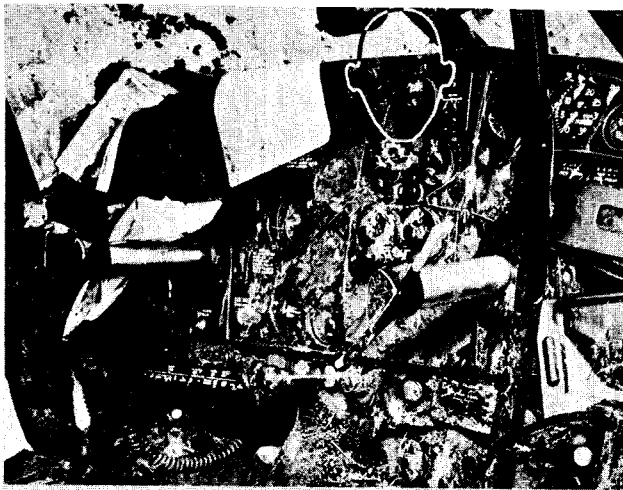
5 C), and since a significant portion of the forward force of the head and trunk was dissipated when the chest struck the control yoke fracturing several ribs as well as the horns on the yoke.

C. Left half of instrument panel showing head impact and broken control wheels.

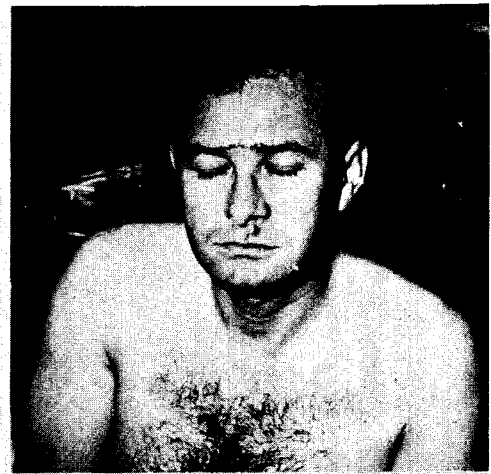
celeration of less than  $\frac{1}{2}$  "g". However, since the pilot received a 5-inch laceration across the top of both eyebrows from striking the top edge of the instrument panel, we can safely state that at one point the deceleration slightly exceeded

D. Pilot with 5-inch laceration from contact with upper instrument panel.

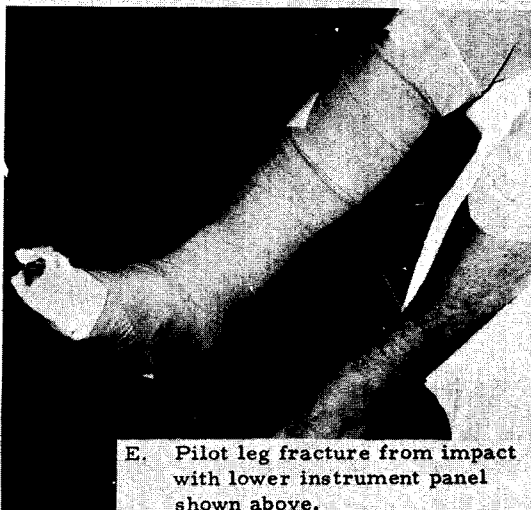
E. Pilot leg fracture from impact with lower instrument panel shown above.

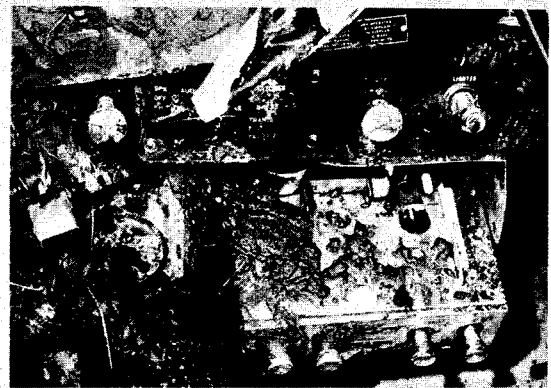
F. Lower left instrument panel. Heavy radio fractured right leg of copilot shown below.

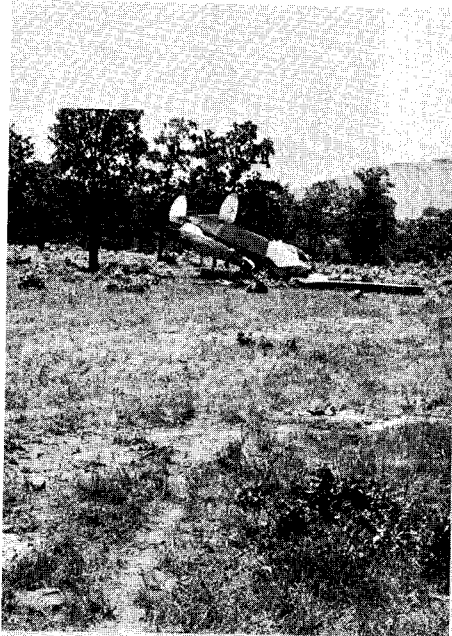
A. Distant view of resting aircraft & part of its 114-foot skid mark.

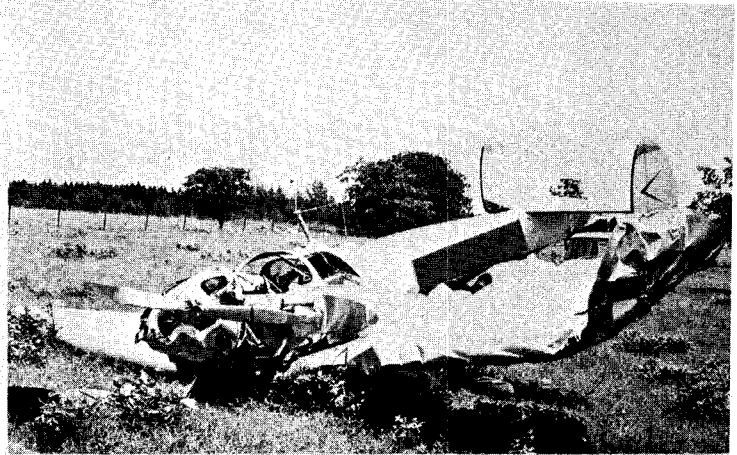
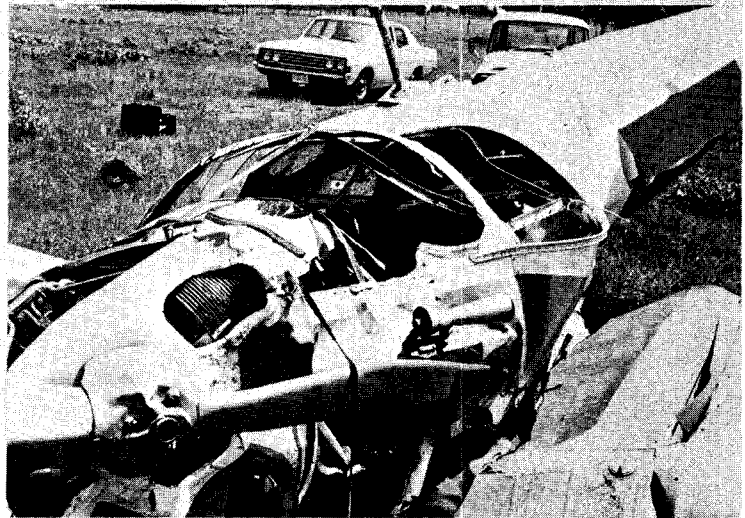
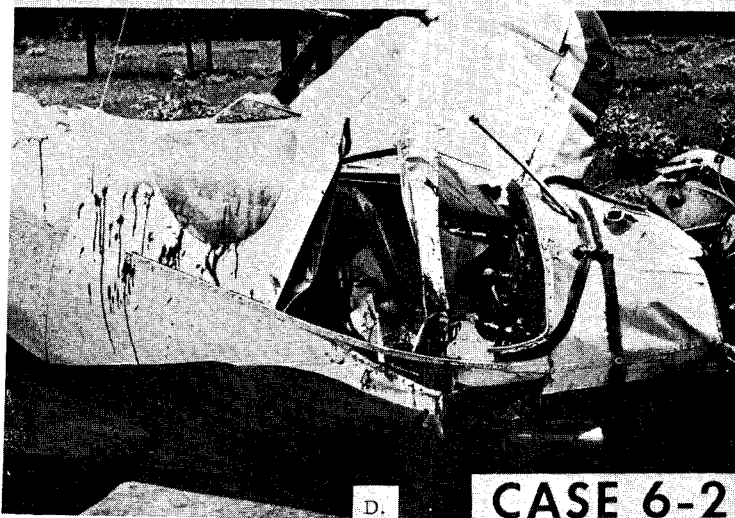
B C D  
Close-up views of the exterior of the aircraft. The cabin maintained its integrity. The plastic windshield disintegrated & some outward buckling of the sides of the cockpit may be noted.

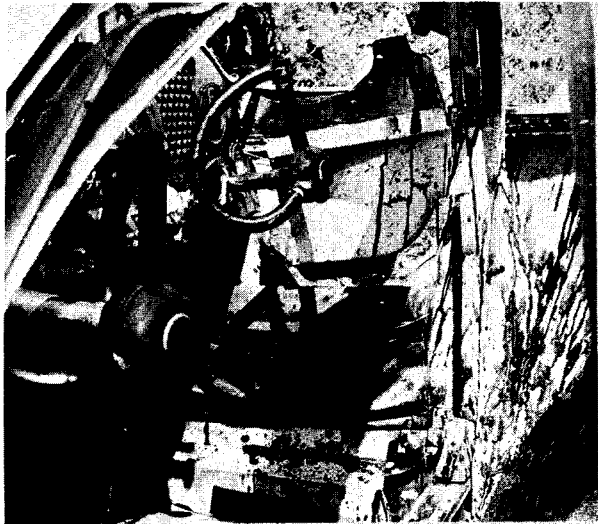
E. Internal view of cockpit. Note control wheel rims bent forward.

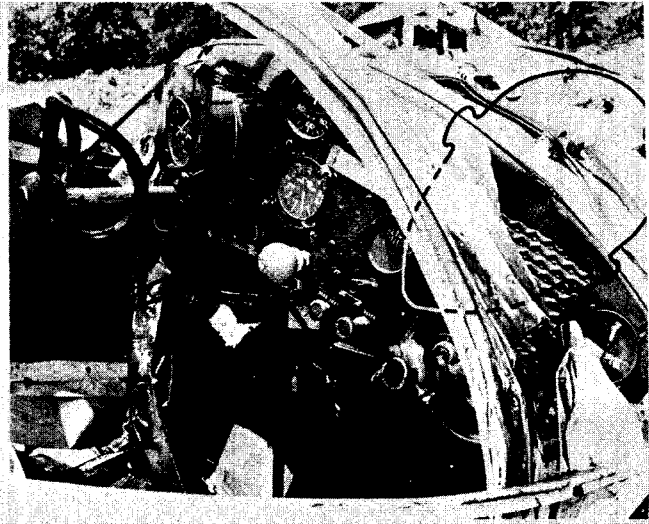
F. Head outline & dent in upper right instrument panel indicate head impact of copilot.

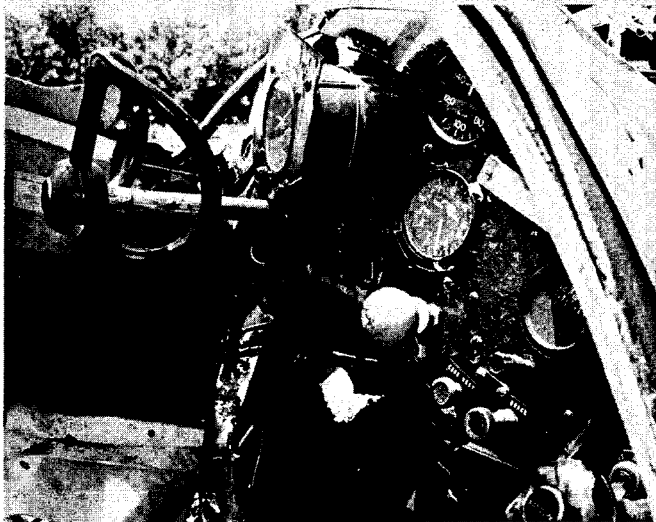
G. Area of body impact of pilot.

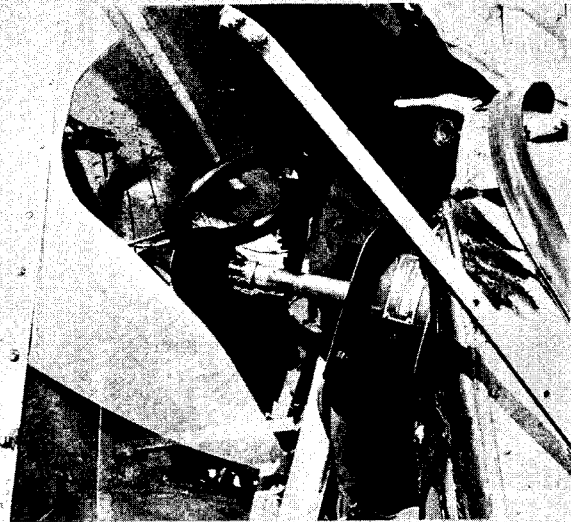
H. Note broken plexiglass windshield.

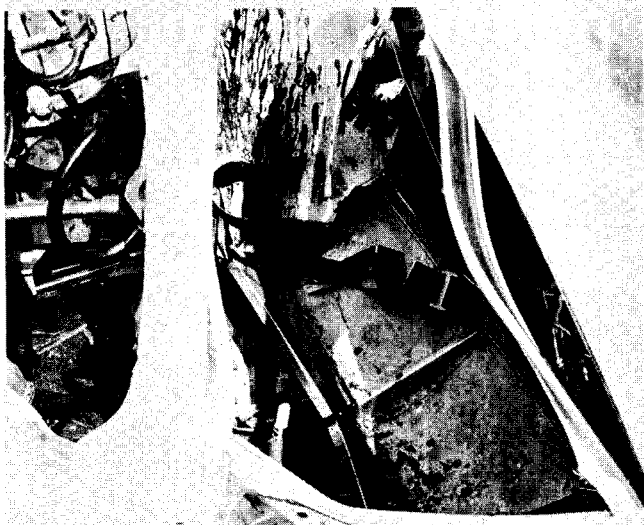
I. Seat construction consists of aluminum buckets for cushions shown in J.

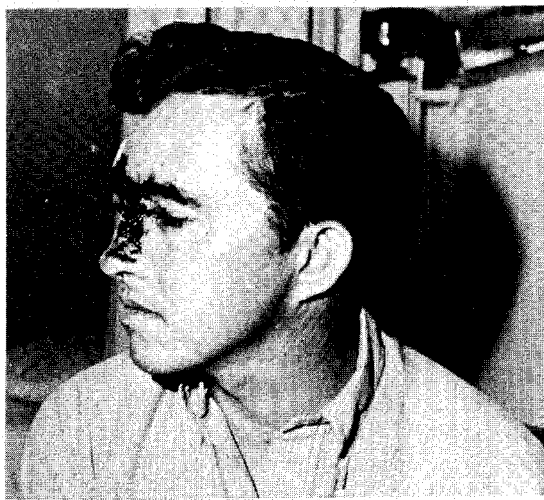
In Case Number 6, photographs are shown of the right front passenger with crushing fractures of the nose and right maxillary sinus along with severe lacerations of the nose and frontal sinus area (Case 6 K & L) received when he jackknifed over his seat belt and impacted the top edge of the instrument panel at the point indicated by the head outline (Case 6F). Since this Ercoupe 415-C (1946) skidded 114 feet before coming to rest, an average deceleration of slightly over one "g" can be calculated, assuming an impact velocity of 95 ft./sec. However, as discussed earlier, one can brace against a one "g" impact and it must be assumed that since he hit the ground at about a 30° angle, the deceleration forces were somewhat higher than one "g" during a few milliseconds time span. Again, as in Case 5, the chest contacted the control wheel and evidently the occupant was able to hang onto the rim with sufficient strength to deform the wheel toward the instrument panel (Case 6 G), probably reducing the head impact velocity to a point that barely prevented the fatal head injuries. It is impossible to calculate the exact velocity of head impact, but based upon the author's studies of tolerances of the human face to crash impact (to be discussed later), the author estimates that the head impact velocity could not have been more than 15 ft./sec. in this case. Since the stopping distance of the head was about one inch ( $\frac{1}{4}$  inch dent in panel +  $\frac{3}{4}$  inch crushing of facial bones), the deceleration of the head may be calculated to be 42 "g". The human face cannot tolerate this magnitude of deceleration force on two square inches of area (see tolerances of face discussed later). We begin to appreciate the head injuries which may occur at cabin decelerations as low as three "g" when the impact force must be absorbed on small areas of the head.

K & L Side & frontal views of facial injuries suffered by copilot when his head hit the top corner of the instrument panel (Figure F).

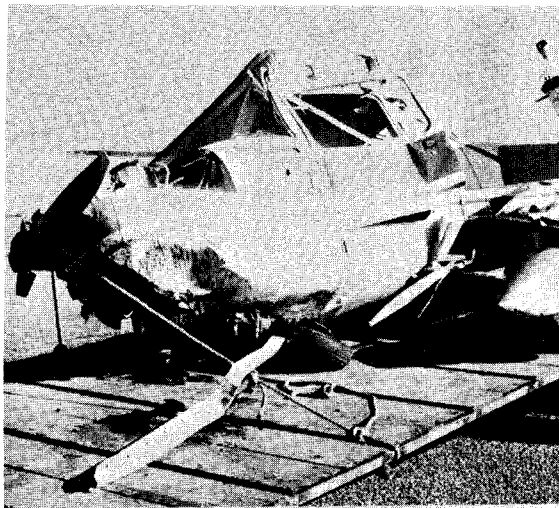
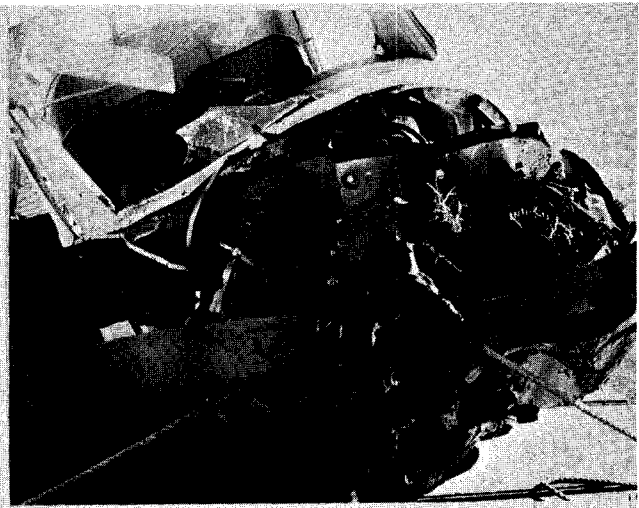
A & B Slight damage to the motor & cabin are indicative of a minor crash impact.

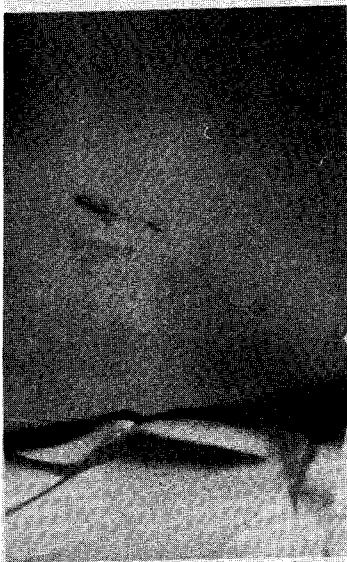
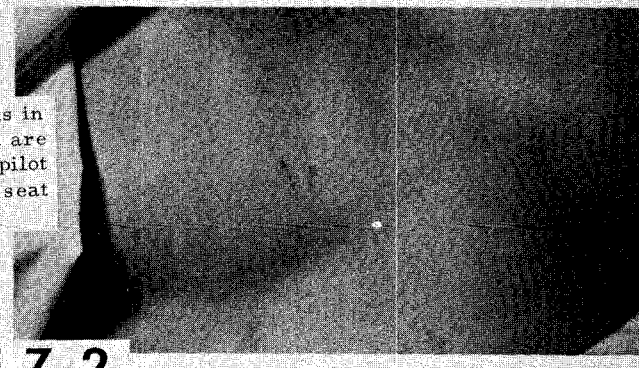
C & D Minor abrasions in the pelvic area are proof that this pilot was wearing a seat belt.

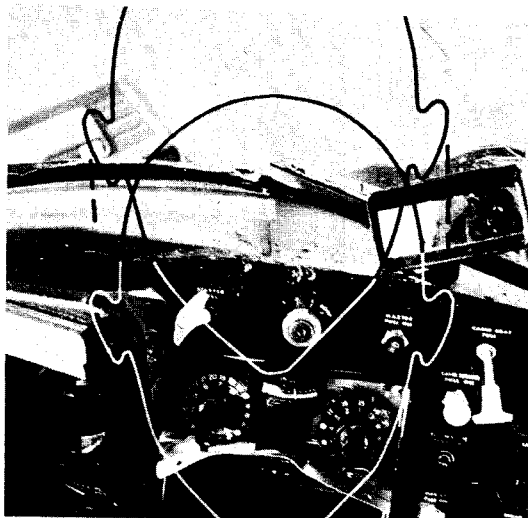
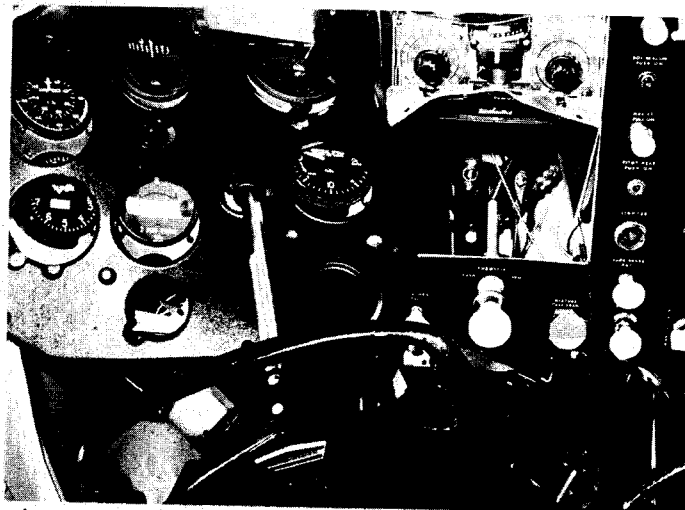
right and down with only a slight contusion of the chest and right shoulder (Case 7 F) and slowing his head velocity to a point (estimated 18 ft./sec.) that he survived with very severe facial injuries. Especially worthy of note at this point is the needless deep laceration (8 inches long) across the chin and right cheek inflicted when his face slid down and engaged the thin cover plate over the radio (Case 7 E). Teeth marks in the same figure indicate that his upper teeth and hard palate were destroyed when he impacted the top edge of the instrument panel just above the key insert.

E & F Area in center of instrument panel where pilot's head struck. Note teeth enamel above key insert and sharp edge of radio cover plate.

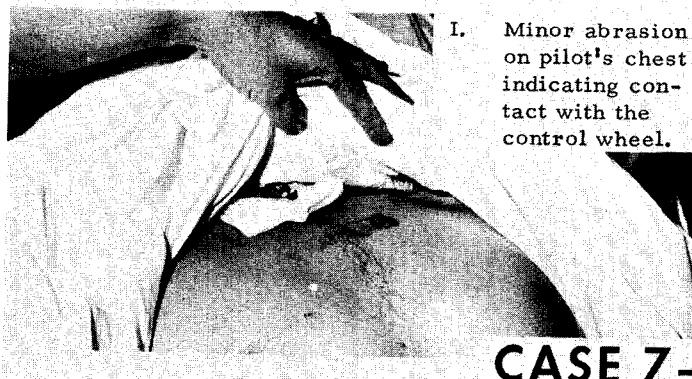
I. Minor abrasion on pilot's chest indicating contact with the control wheel.

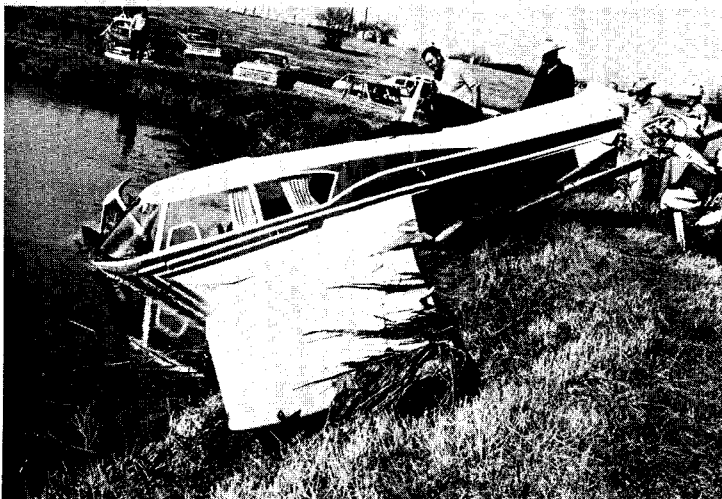
C. View of the aircraft as it was pulled out of the pond. Note cabin is entirely intact.

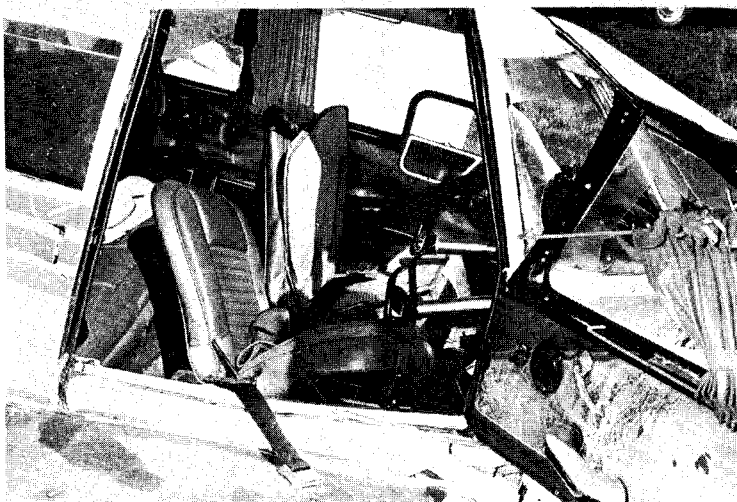
D. General appearance of cabin interior.

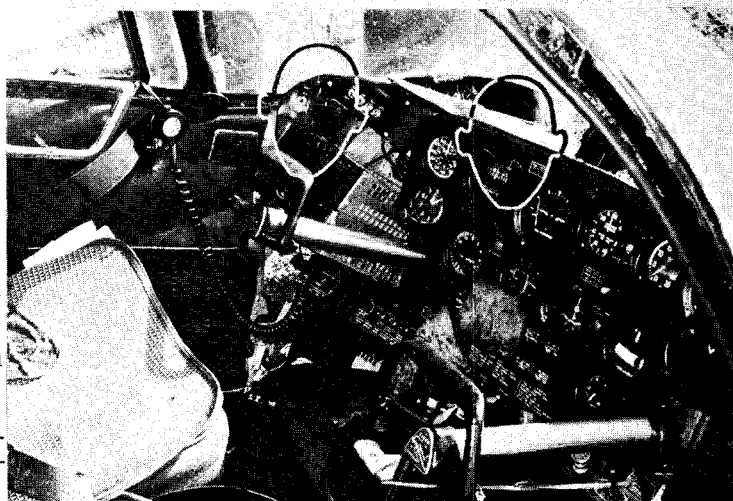
E. Head outlines indicate dented areas at top edge of the instrument panel produced by head impacts of two front seat occupants - all were knocked unconscious & drowned.

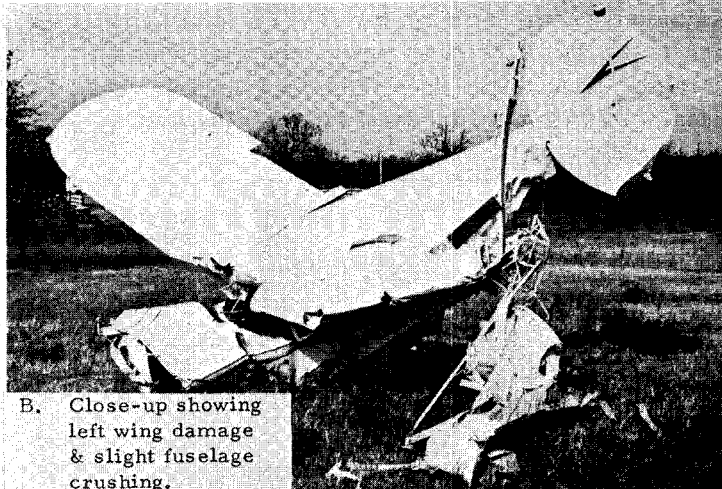
B. Close-up showing left wing damage & slight fuselage crushing.

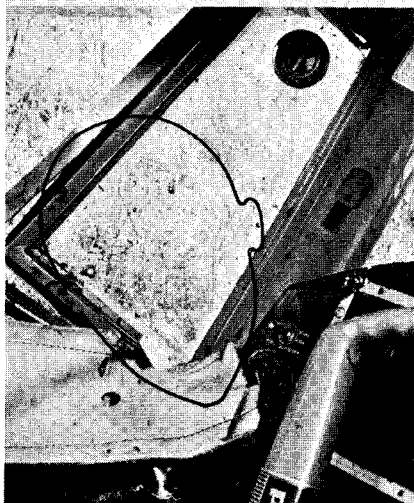
C. Area of pilot's head impact.

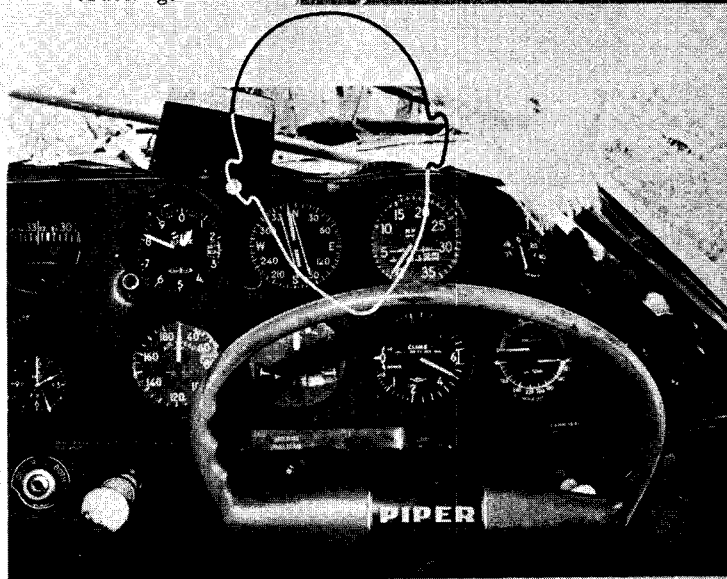
D. Dent at the top edge of instrument panel caused by copilot's head impact.

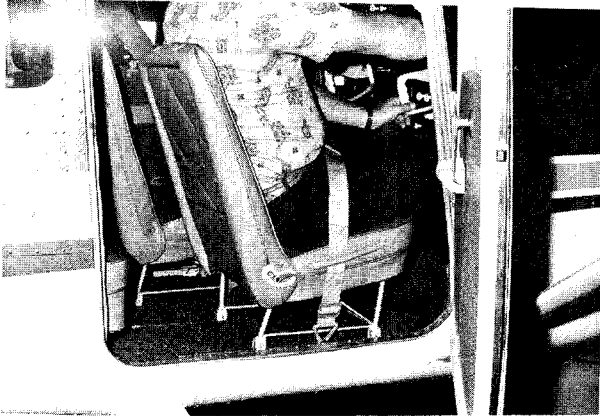
the lap belts applied around the pelvic structure. The lap belt, if worn and if it does not fail, restrains only the pelvic area and allows the rest of the body to continue in motion until stopped by impacting some portion of the container. In a number of cases in this study it was noted that even the lap belt is an ineffective restraint because of faulty installation. In numerous aircraft the lap belt goes across the thighs and straight down to the floor (Figures 3 and 4) instead of across the iliac crest and then back at a 45° angle to the floor.

FIGURE 3. Subject wearing seat belt in 1968 Cessna 150.

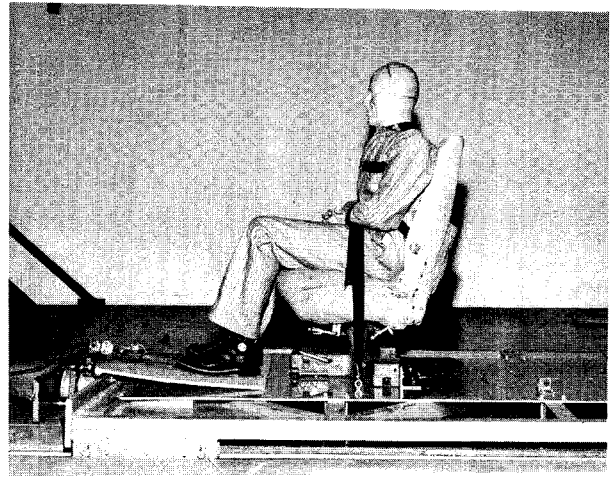
FIGURE 4. Dummy with seat belt attached straight down over thighs before crash test.

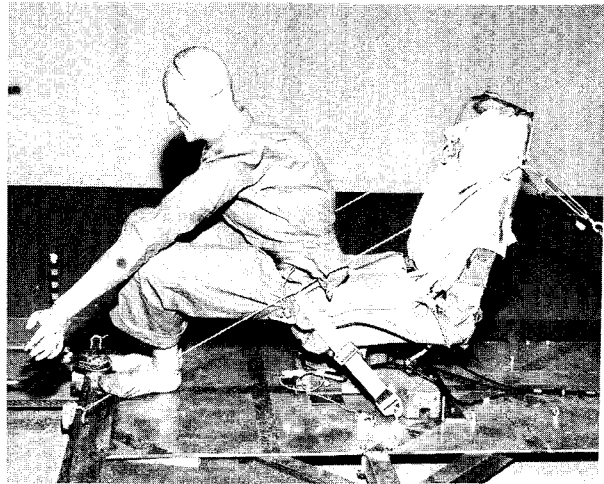
During deceleration the occupant is free to move forward until the belt is at nearly a 45° angle with the floor before the belt offers any restraint. By this time he is sliding off the front edge of the seat (Figure 5) and the forward motion added to belt stretch allows him to penetrate the firewall.

FIGURE 5. Position of dummy after crash test. Extreme forward motion is allowed by improper seat belt installation.
