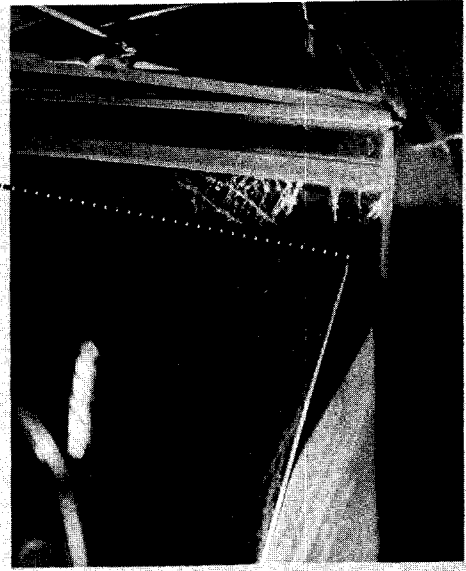
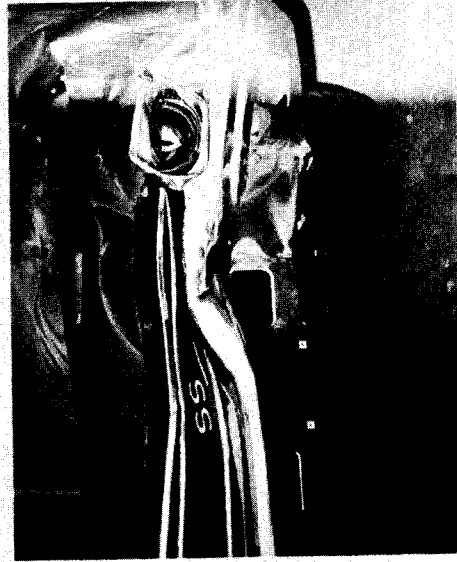
*Note: Hood hinge  
penetrated windshield*

Cervical strain, pain in trapezius muscles, pain in left arm  
and upper chest

FIGURE 7. Automobile accident in which driver was subject to 7 "g" forward deceleration.

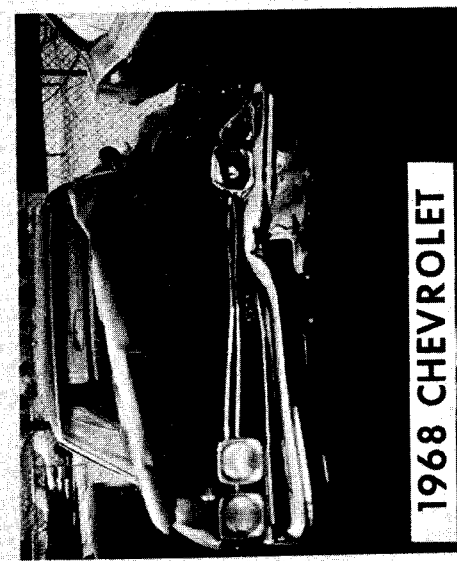
*Note: hood penetrating windshield*

Complained of neck pain — no fracture  
Pain in (R) knee and (L) elbow, no fracture, no lacerations

FIGURE 8. Automobile accident that subjected driver to 9 "g" deceleration.

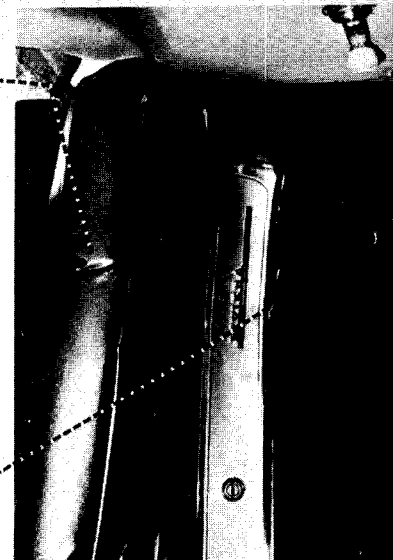
FIGURE 9. Effects on occupants in a 10.5 "g" automotive crash.

Unknown (believed to be minor)

- (No knee bruises)
- 3 bottom front teeth knocked out
- Fracture floor (R) orbit
- Both maxillary sinuses cloudy
- Fracture both zygomas
- Subcutaneous emphysema both sides of face
- LeFort 1, 2, & 3 fracture mandibular alveolar ridge
- Floating maxilla
- Nasal fracture

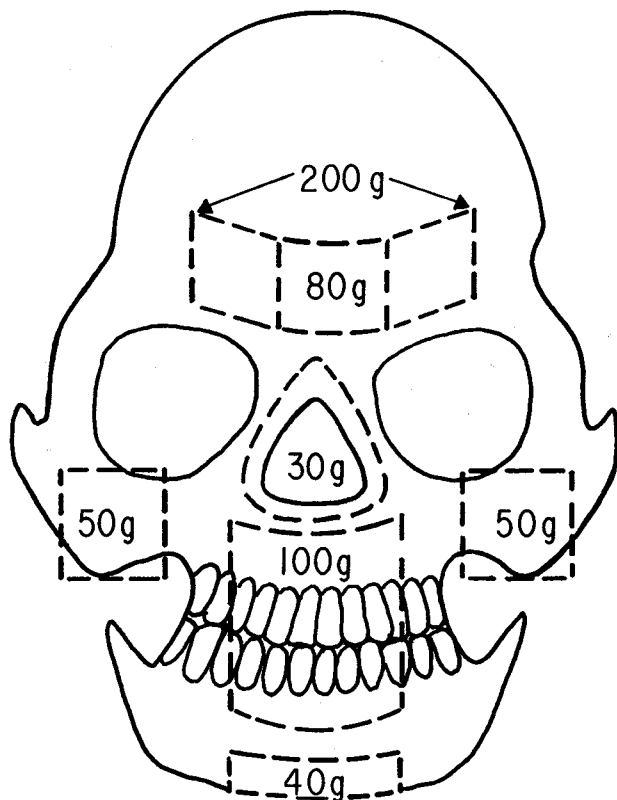
FIGURE 12. Tolerances of the human head to crash impact.

that a single square inch of the forehead is capable of withstanding an 80 "g" impact without fracture—*PROVIDED* the force is evenly distributed over the contour of the area impacted. If this area of contact is increased to 3 square inches, the frontal skull of most adults can withstand 200 "g" without fracture. Other portions of the face explored include the zygomas, nasal area, maxilla, and mandible and tolerance limits are shown in Figure 12.

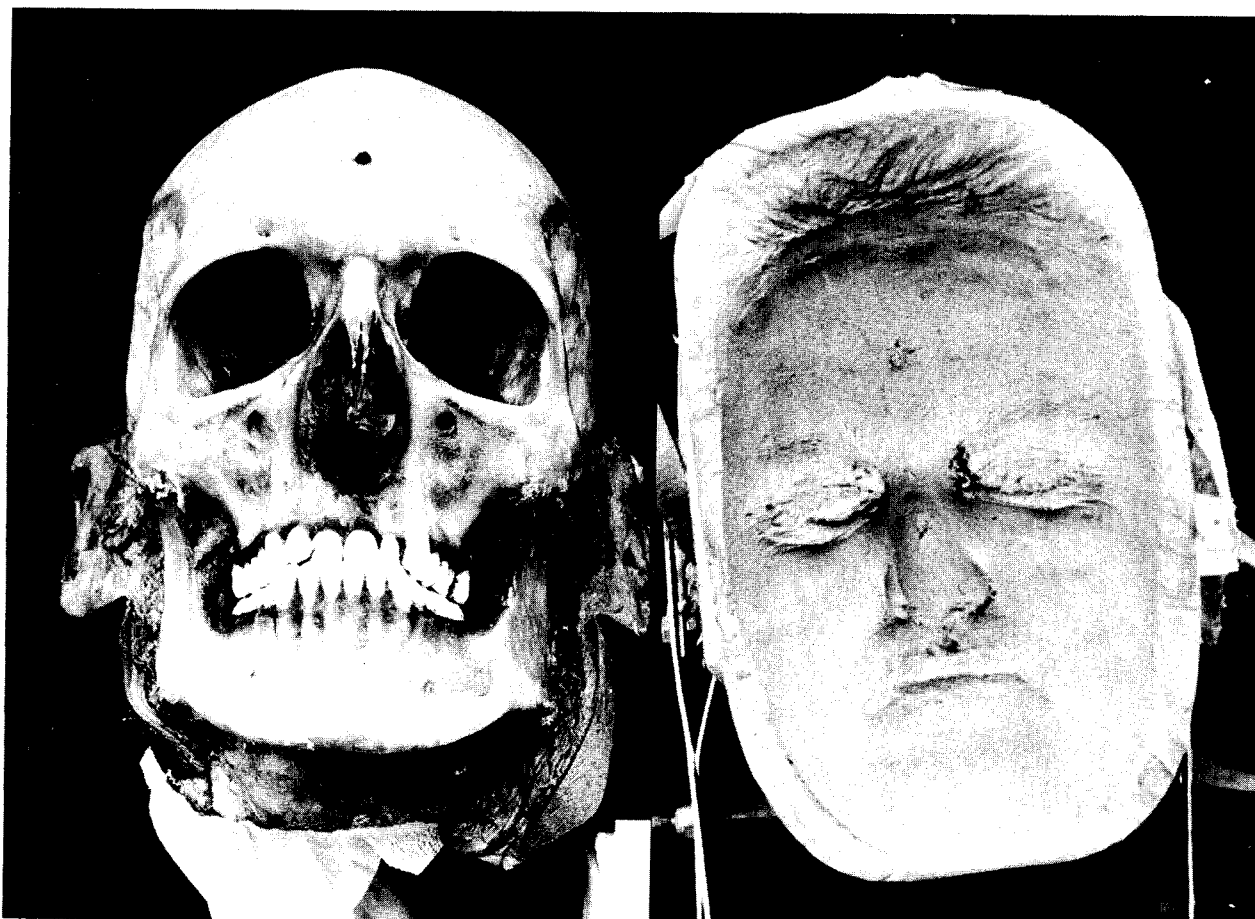
FIGURE 13. Full-face (maximum area) crash test exceed 300 "g" deceleration.

He then became curious as to whether or not these impact tolerance areas were additive. A rigid cast was made for one cadaver head to provide even distribution of force over the entire frontal face and forehead. Impact tests exceeding 300 "g" produced no signs of soft tissue laceration or bone fractures. Every tooth and even the thin turbinate bones of the nose remained undamaged (Figure 13).

This study shows conclusively that it is possible through engineering design of the inside of the container to completely eliminate lacerations and fractures of the head and face during head impact of extremely high forces (over 300 "g").

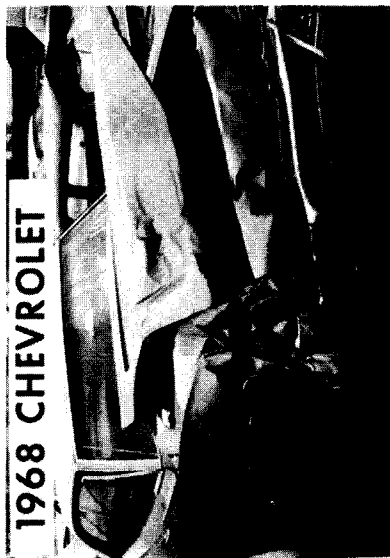
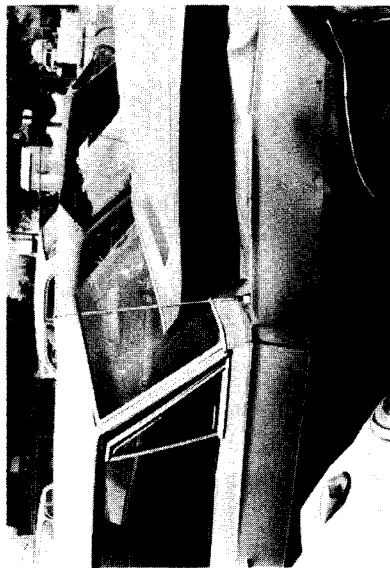
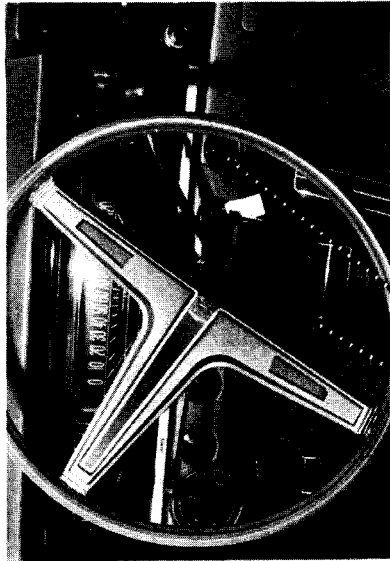
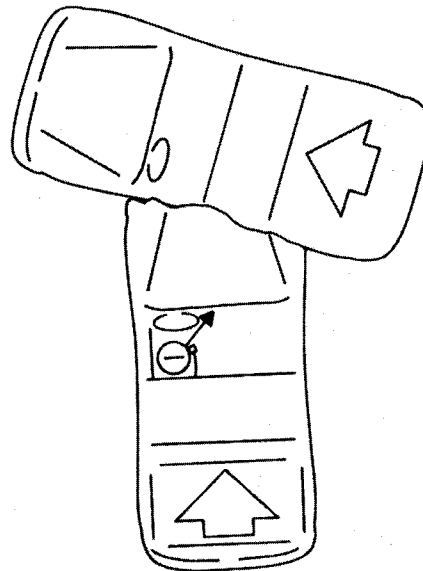
Contusions and superficial abrasions both knees  
Complains of soreness in (L) shoulder

③ RIGHT FRONT (5)  
Contusion of upper lip

FIGURE 16. Automobile accident—calculated 19 "g".

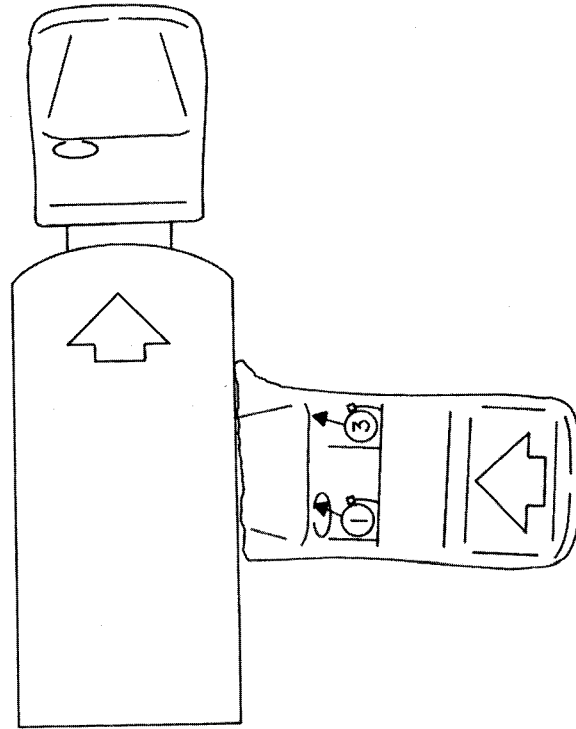
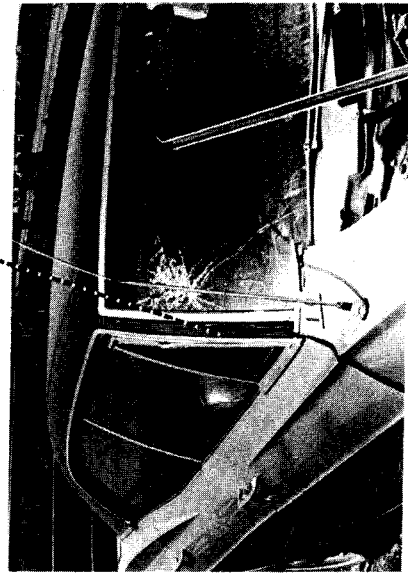
Laceration (R) leg below knee

Fracture (R) clavicle

Dislocation (R) shoulder

FIGURE 21. Deceleration = 23 "g".

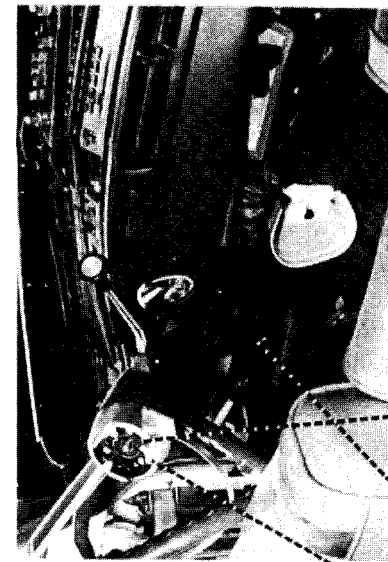
Fracture nose, cerebral concussion

Fracture (R) fibula

Fracture humerus (R)

FIGURE 25. Deceleration = 38 "g".

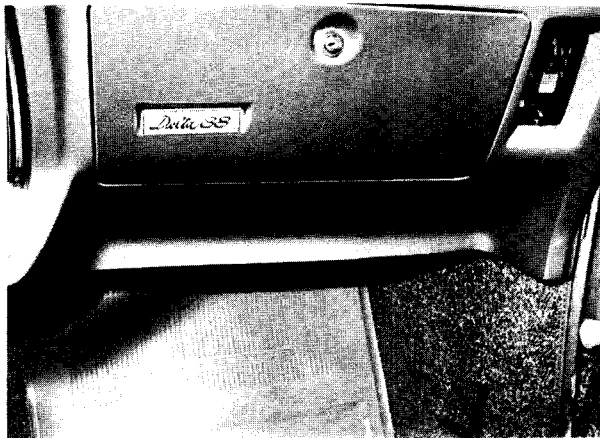
FIGURE 27. Knee impact area in late-model automobile.

pellor controls, etc.) on the lower left instrument panel (Case 11 E and G) were directly responsible for a fractured arm, fractured pelvis, and dislocated hip and knee in this accident. The author feels that the manufacturers of general aviation aircraft could significantly reduce leg and pelvic injuries by copying the design trends of the automobile manufacturers (Figure 27).

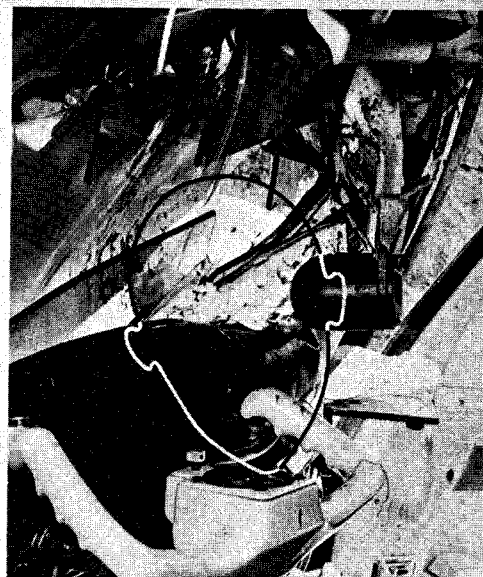
C. The left control column has been bent upward by chest impact of the pilot until the control horns rest against the light padding.

D. Pilot's head struck the broken plexiglass windshield, heavy compass, & right horn of the control wheel.

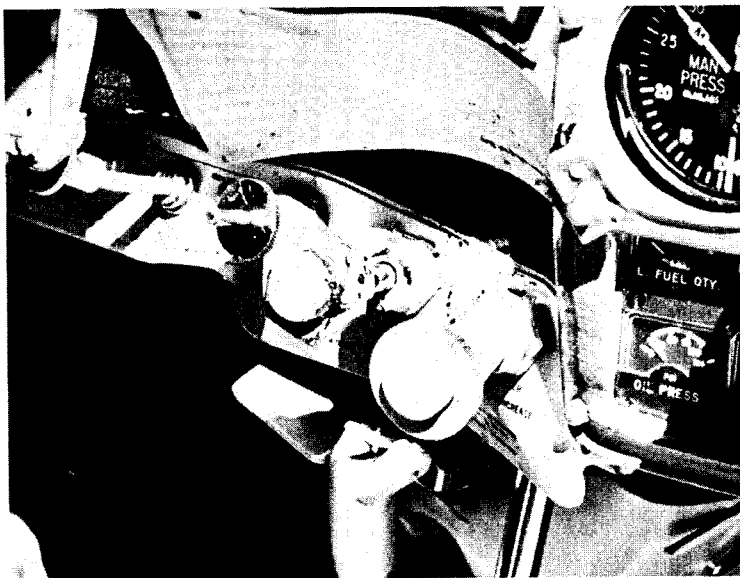
E & G Lower left instrument panel showing knobs bent and broken by pilot's legs.

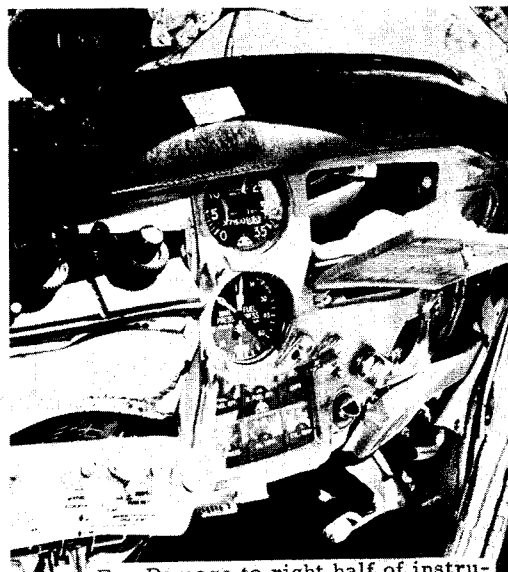
F. Damage to right half of instrument panel from unrestrained stretcher.

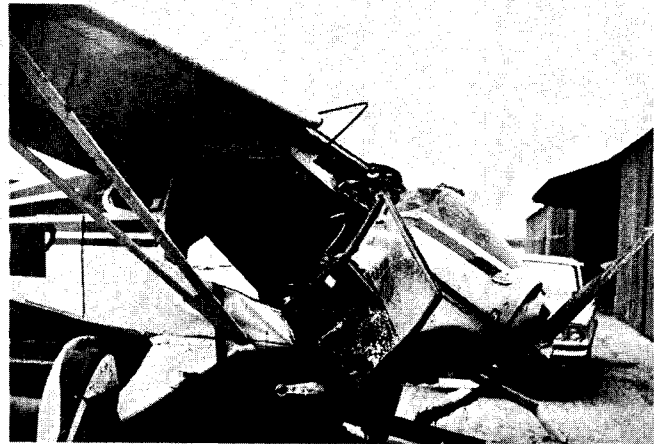
In Case Number 12 there has been a complete separation of the cabin structure at both ends of the instrument panel (Case 12 B and C) as a result of the impact. Since this 1955 Piper Tri-pacer PA 22-150 has doors on both sides, the only structure preventing the engine and instrument panel from being pushed back into the faces of the front seat occupants is the "A" post on each side of the windshield. The inboard half of each seat belt was attached to the seat while the outboard half was attached to the fuselage. Attaching lap belts to seats loads the seat tie-down attachments unnecessarily, often causing them to fail and the package contents are no longer even partially restrained. Seat attachments in this case did fail (Case 12 I, J, K and L), allowing the two front seat occupants to smash their faces into the formidable structure of the upper instrument panel and their knees and legs into the prong-studded lower panel (Case 12 D). Facial injuries were more severe in this case than in Case 11, partially because there was no padding on the instrument panel and partially because the crash impact force was slightly greater as attested to by the significant increase in lower leg injuries. The bare survival of these two oc-

C. Close-up of right side of aircraft shows complete failure of right "A" post. (Only structure resisting backward displacement of motor & instrument panel on that side).

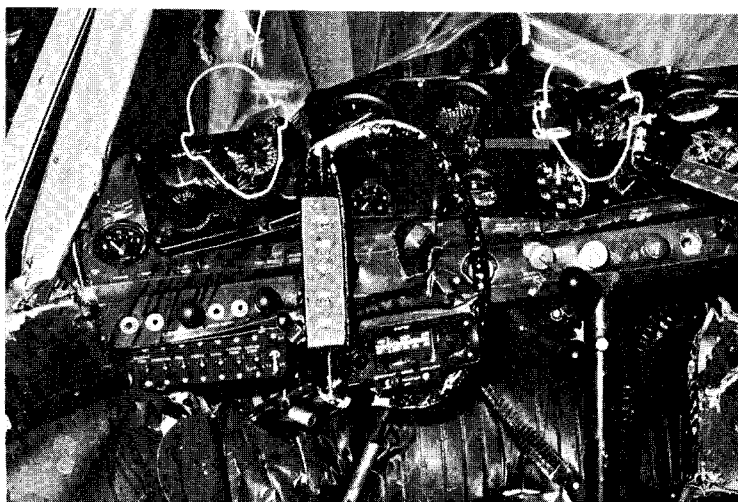
cupants could probably be attributed to well-designed control wheels for chest impact without injury. Note in Case 12 F and G these control wheels are smashed flat against the instrument panel and probably slowed the upper bodies just enough to prevent fatal crushing head injuries. Federal Aviation Regulations (FAR) Part 23 requires that all general aviation aircraft have a tie-down strength to withstand a forward static loading of 9 "g". Since this seat did fail at its attachment, one might assume the crash forces involved in this case exceeded 9 "g". However, a recent research report published by the National Aviation Facilities Experimental Center (NAFEC)<sup>62</sup> shows the unreliability of predicting dynamic strength from static testing and the author believes that the maximum crash force in this case was well below 9 "g" as measured dynamically. A cabin deceleration of 8.5 "g" would have produced head strike velocities in excess of 50 ft./sec. and the head injuries from impacting this instrument panel would have been fatal to both occupants.

D. Head outlines indicate instrument panel depression areas produced by head impacts of the two front seat occupants. Note control wheel crushed into instrument panel.

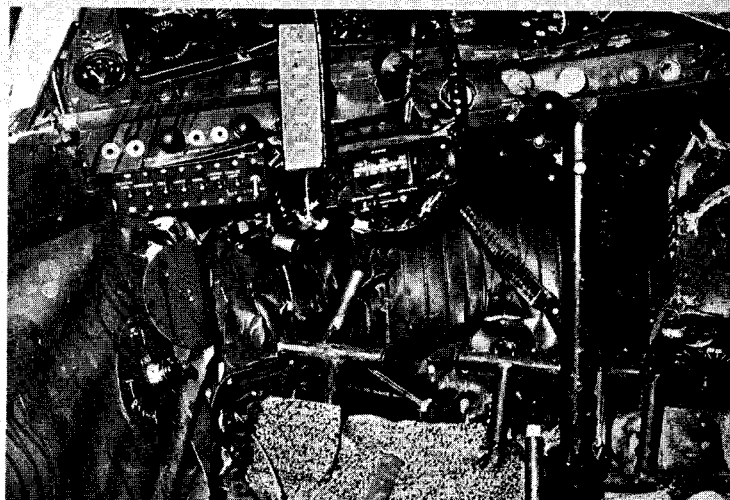
E. Lower left instrument panel conglomerate, responsible for numerous leg and ankle fractures & lacerations.

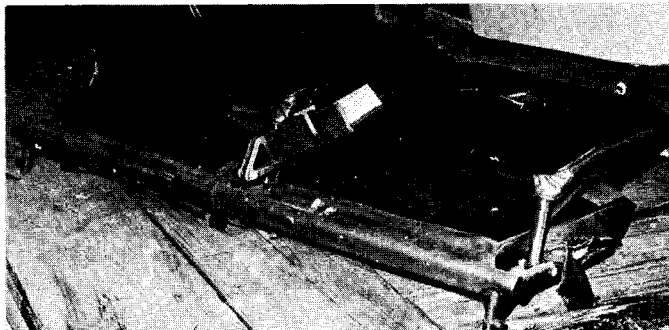
I. Inboard halves of seat belts were attached to the seat in this aircraft, transferring heavy belt loads to fragile seat tie-down structure.

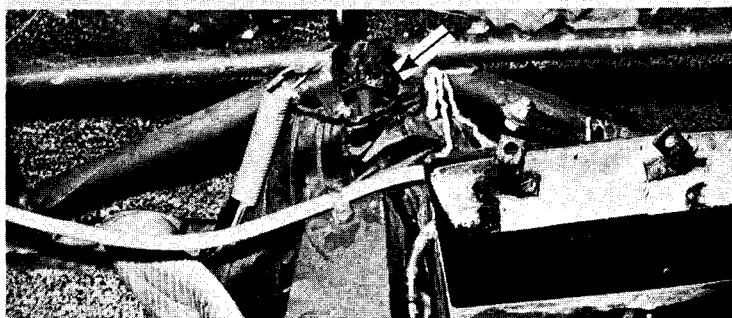
K. Adjustment pin & center tie-down flanges. Notice that the thin tie-down flanges are spread open, allowing the seat to leave the track.

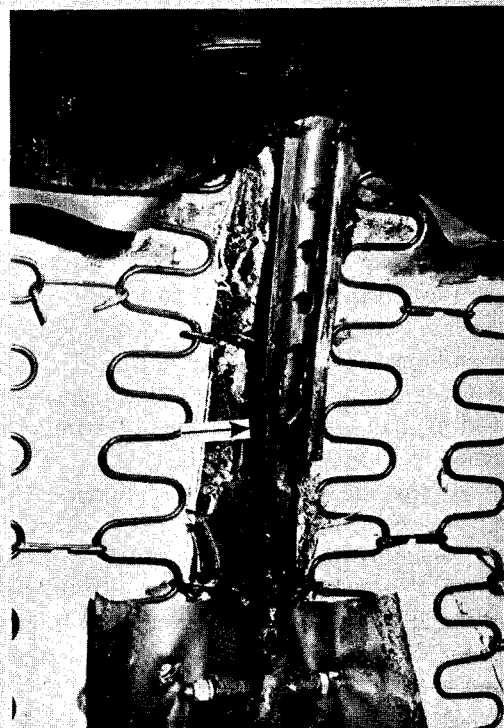
L. Tie-down & adjustment structure on bottom of seat. The thin metal on either side of the adjustment holes bent & allowed seat to tear loose.

of two occupants and the weight of the seat could fail with only one occupant in such a minor deceleration. It is possible, since this aircraft was nearly 15 years old, that deterioration of the seat attachments may have been a factor. However, since general aviation aircraft keep on flying until they disintegrate in a crash, seat tie-down attachments should be designed for long usage. If the restraint system fails under these minor conditions, certainly it is of little or no benefit in even a hard landing, let alone a minor crash.

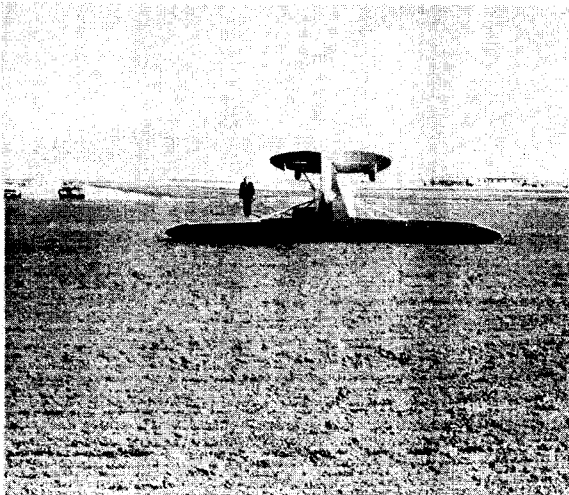
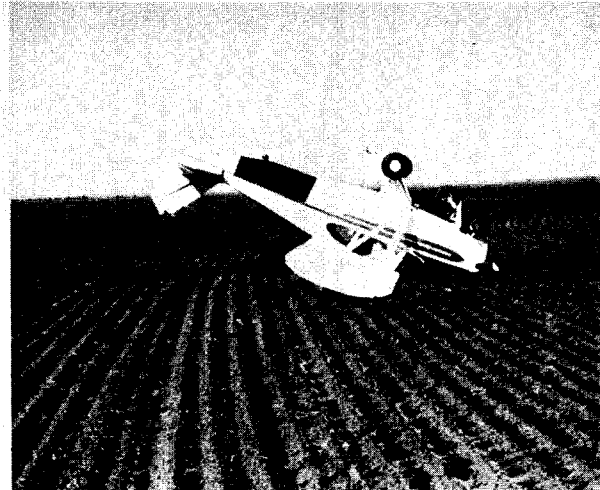
A & B Two views of aircraft that simply flipped over onto its back without damage.

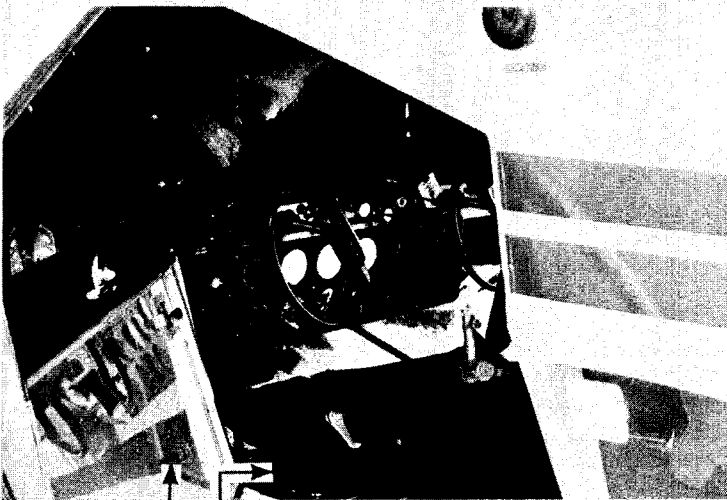
C & D Views of instrument panel and control wheels show no signs of damage & indicate deceleration forces were not of sufficient magnitude to cause pilot to be thrown forward. However note seat has torn free & is lying in the top of the aircraft.

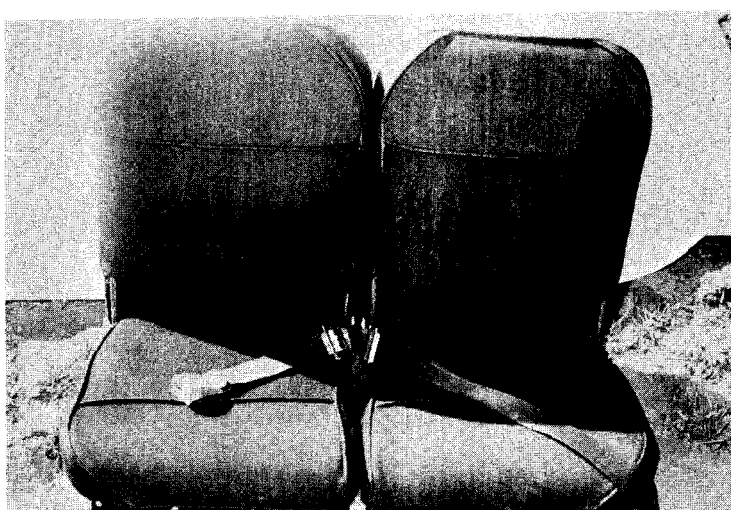
E. Seats failed in this minor incident (1) because seat belts were attached to the seat.

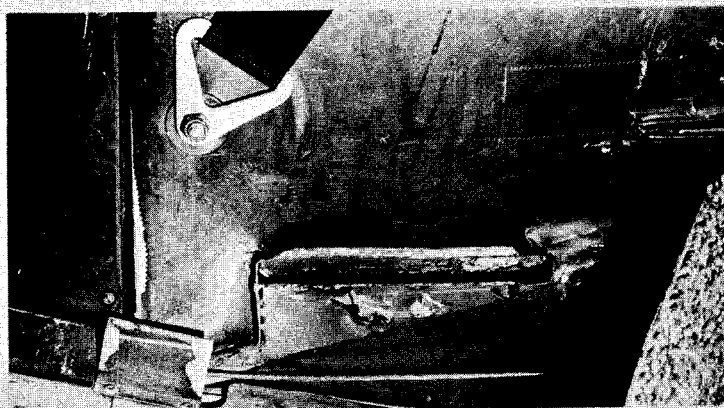
F. (2) wall track for end of seat allows seat to slip out.

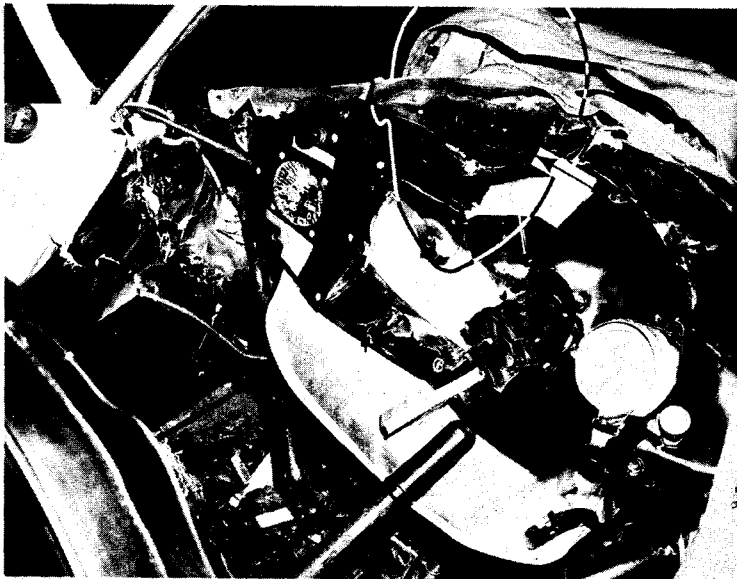
C. Impression in the top center of the instrument panel that caused fatal head injuries.

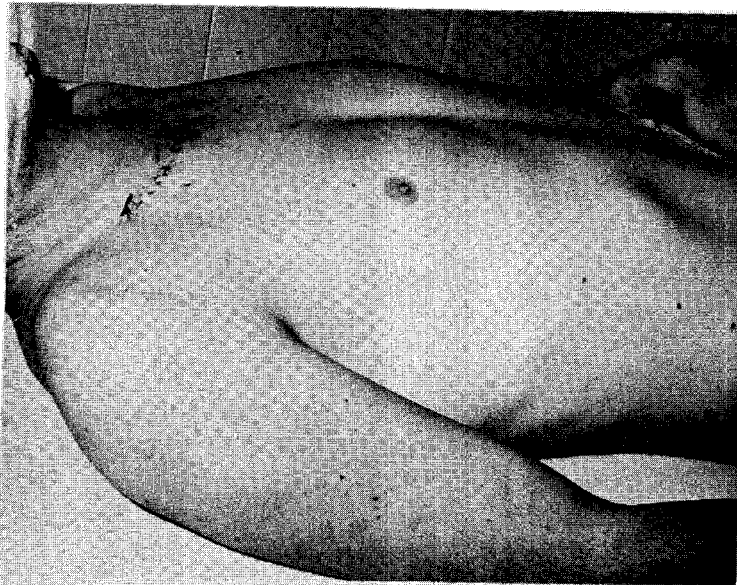
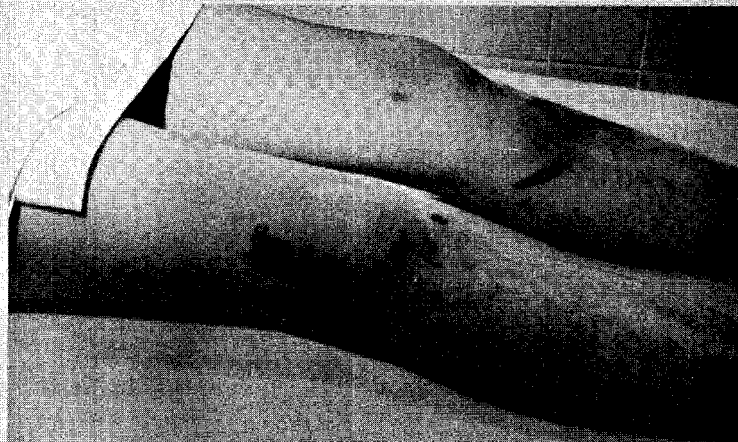
E, F & G Body pictures to show complete lack of body injuries with the exception of a broken ankle.

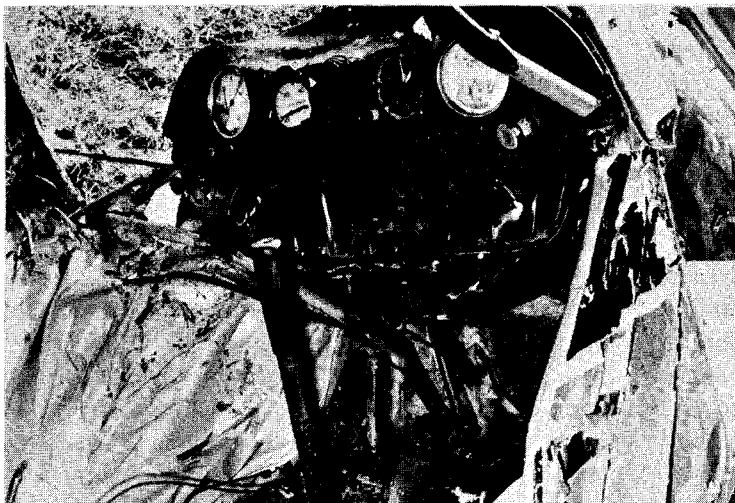
The rear seat lap belt failed at its attachments allowing the occupant of this seat to be thrown forward over and on top of the front seat occupant. His body weight may have added to the force of head impact of the front seat occupant. The fatal head injuries of the rear seat occupant were inflicted by the broken windshield and rigid edge for attachment of the windshield (Case 15 E). Failure of the rear seat belt attachments cannot be taken as indicative of severe crash forces since the ends of the seat belt are fastened by  $\frac{3}{32}$  inch wire loops to a  $\frac{3}{4}$  inch floating tube running through the canvas seat bottom. Ends of this tube are in turn fastened to the fuselage by similar wire fasteners. Failure of these latter attachments allowed the seat belt attachments to slip off the end of the tube. As in Case 14, the front seat occupant received a severe fractured ankle, almost severed (Case 15 G) from the tubular cross brace (Case 15 F) in the lower cockpit.

F. Lower instrument panel showing tubular cross brace that passes over the ankle.

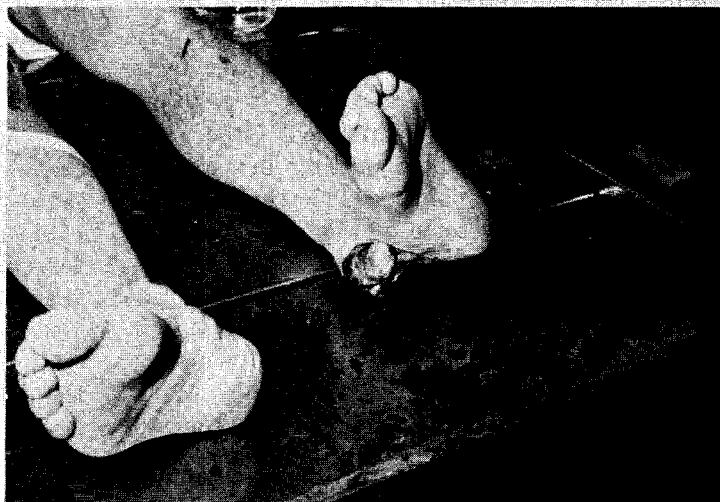
G. Typical ankle fracture from cross brace.

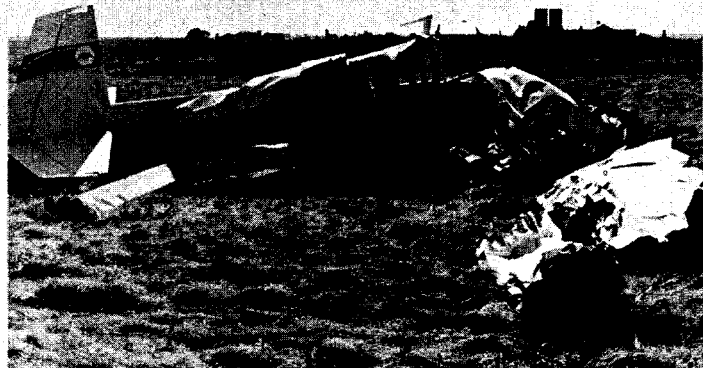
B. Right view shows cabin structure failed & opened up.

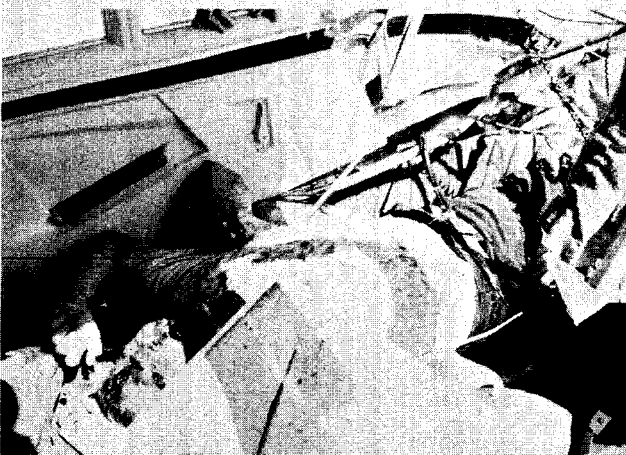
C. Pilot's body still retained by seat belt.

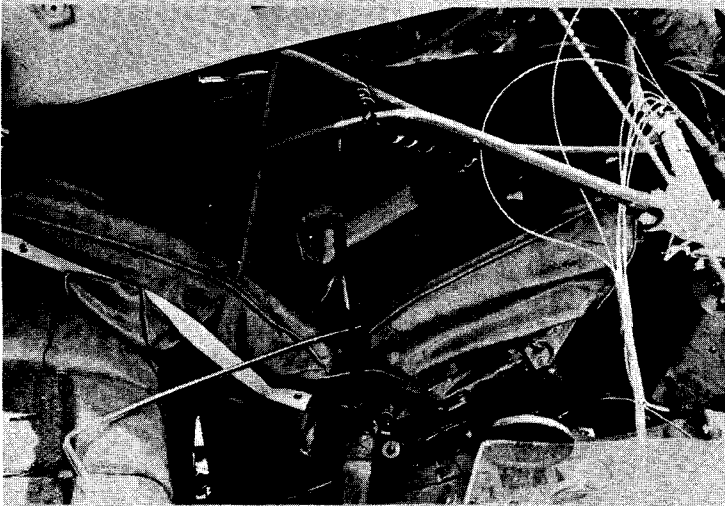
G. Seat track pulled loose from floor.

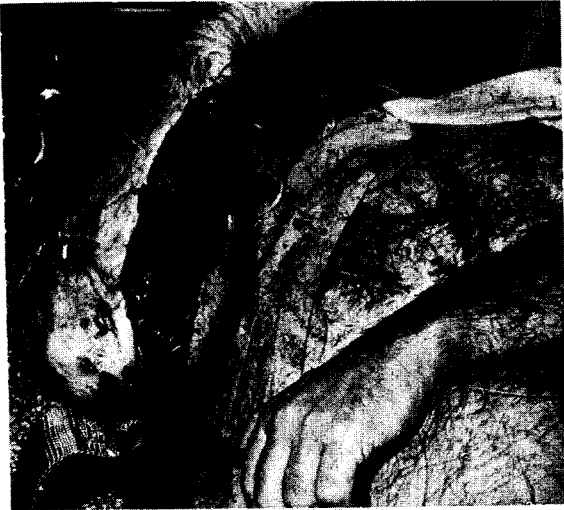
P, Q & R Severe lacerations & fractures  
inflicted when arms & legs flailed  
into broken structures.

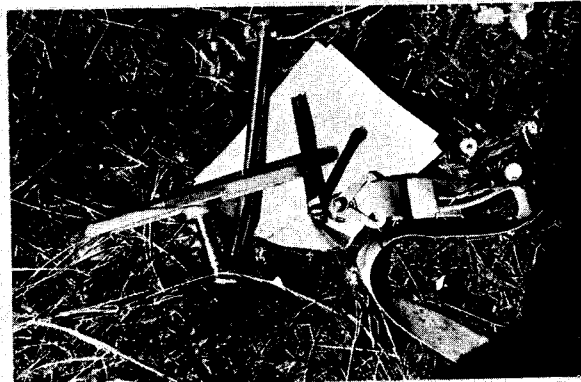
E. Pilot received massive puncture of all major body viscera when control column bent to form a spear after seat belt attachment failed.

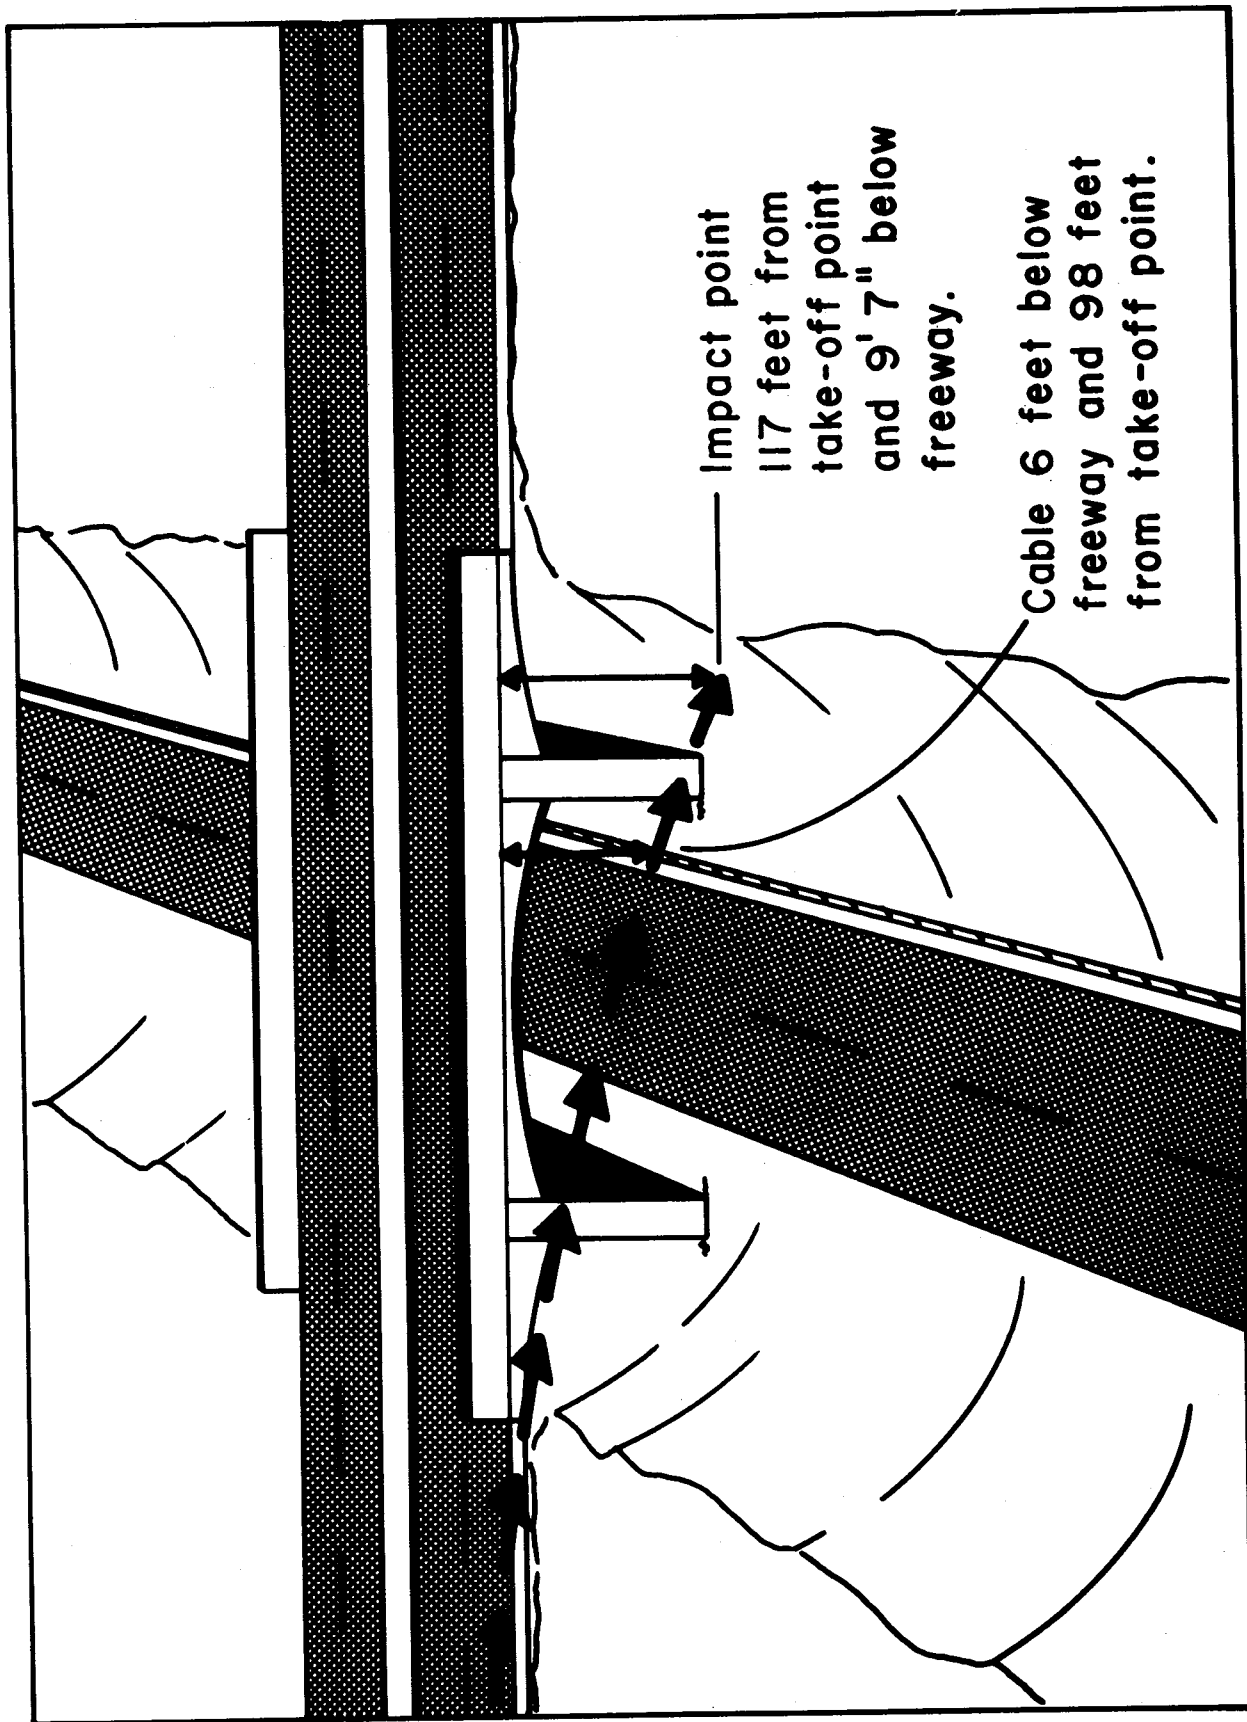
FIGURE 29. Trajectory of an automobile traveling at high velocity after it ran off the freeway.

ing 6 feet below the bridge and about 98 feet from the take-off point. Acceleration due to gravity caused a drop of only 9 feet, 7 inches, during its 117-foot flight. In this instance, one can easily calculate with accuracy that the flight velocity of this vehicle must have been slightly over 100 miles per hour. Crushing of the front of the vehicle was approximately 5 feet (Figure 30) and the depression in the hard earth embank-

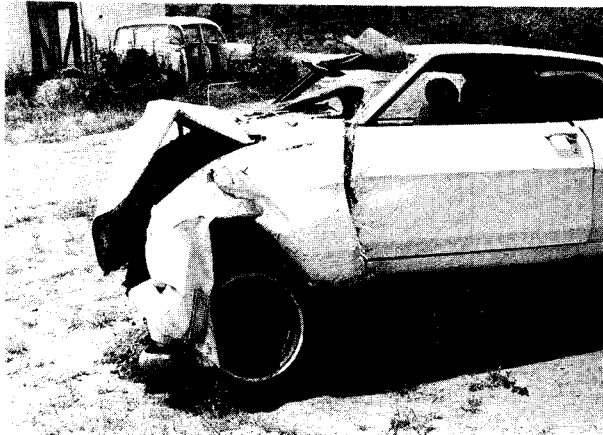
FIGURE 30. Side view of vehicle showing crushing of front end during deceleration.

ment measured 8 to 12 inches. Hence, it can be calculated that the average deceleration of the car was in excess of 50 "g". Even with these very severe impact forces, the shipping container maintained its integrity and the heavy motor was pushed back under the floor board and not into the cabin. While it is doubtful if light aircraft cabins can be designed to withstand "g" forces of this magnitude, their interior certainly could be modified to incorporate some of
