1. Report No. FAA AM- 72-7	2. Government Accession No.	3. Recipient's Catalog No.	
4. Title and Subtitle EVALUATION OF A FIBERGLASS INSTRUMENT GLARE SHIELD FOR PROTECTION AGAINST HEAD INJURY		5. Report Date February 1972

EVALUATION OF A FIBERGLASS INSTRUMENT GLARE SHIELD FOR PROTECTION AGAINST HEAD INJURY

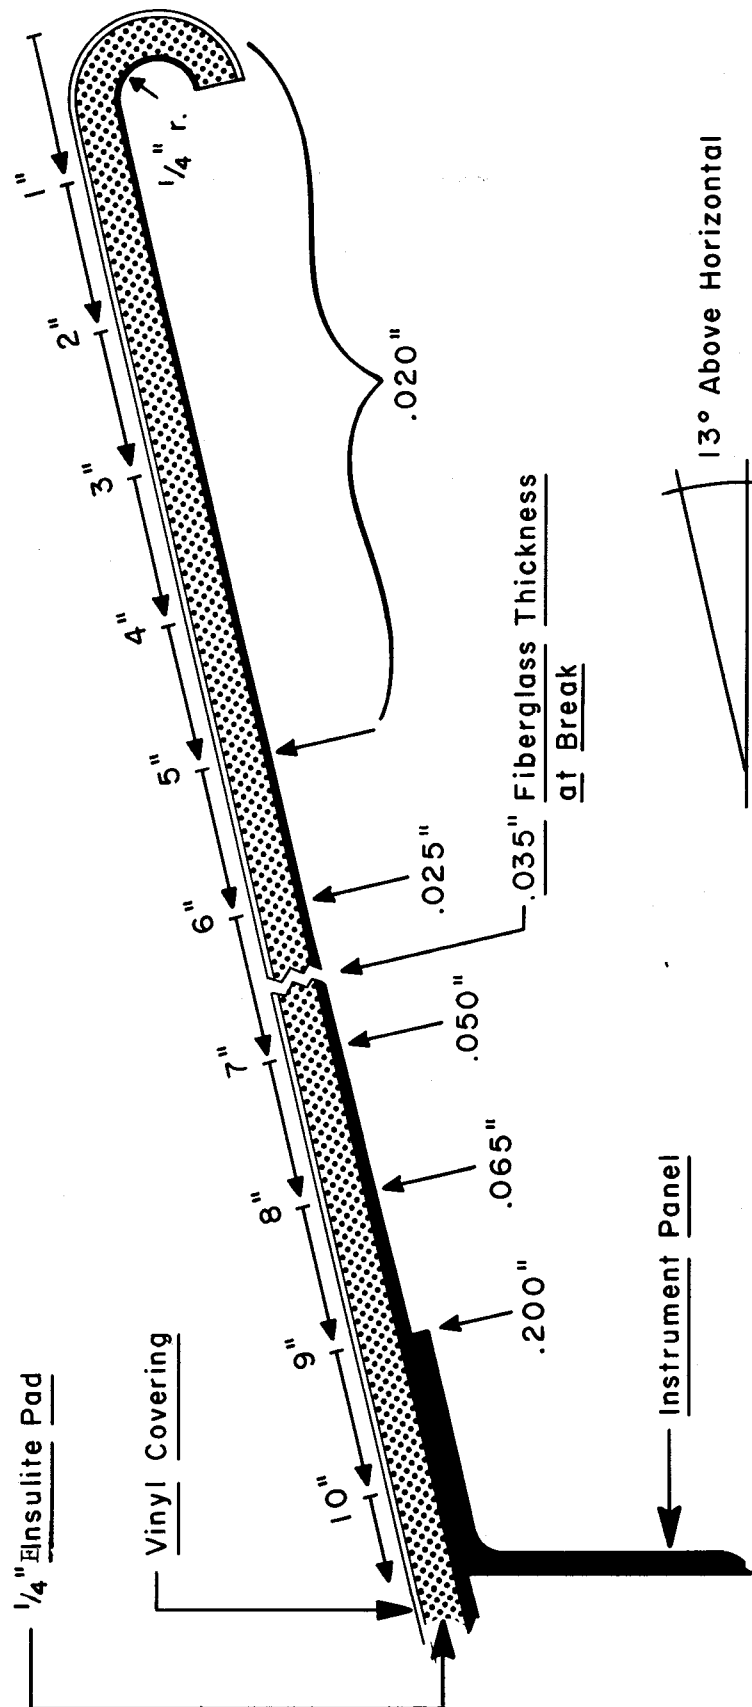
The glare shield shown in Figure 3 consisted of a basic structure of a thin fiberglass layer covered with a 1/4-inch thick layer of Ensolite and a thin layer of plastic vinyl. It extended 9 1/2 inches from the instrument panel toward the pilot and was elevated about 13 degrees above the horizontal. On the protruding edge nearest the pilot the shield was rolled down and under with an inside radius of curvature of approximately 1/4-inch. After impact testing had been completed, the covering was removed from a portion of the shield so that the thickness of the fiberglass could be measured. The first five inches (nearest the pilot) were of a uniform thickness of .020 inches, increasing to 0.025 inches at six inches, to .050 inches at seven inches, and .065 at eight. At nine inches the thickness abruptly increased to 0.200 inches due to the lap with the instrument panel.

FIGURE 3. Cross section of the glare shield showing thicknesses at various points.

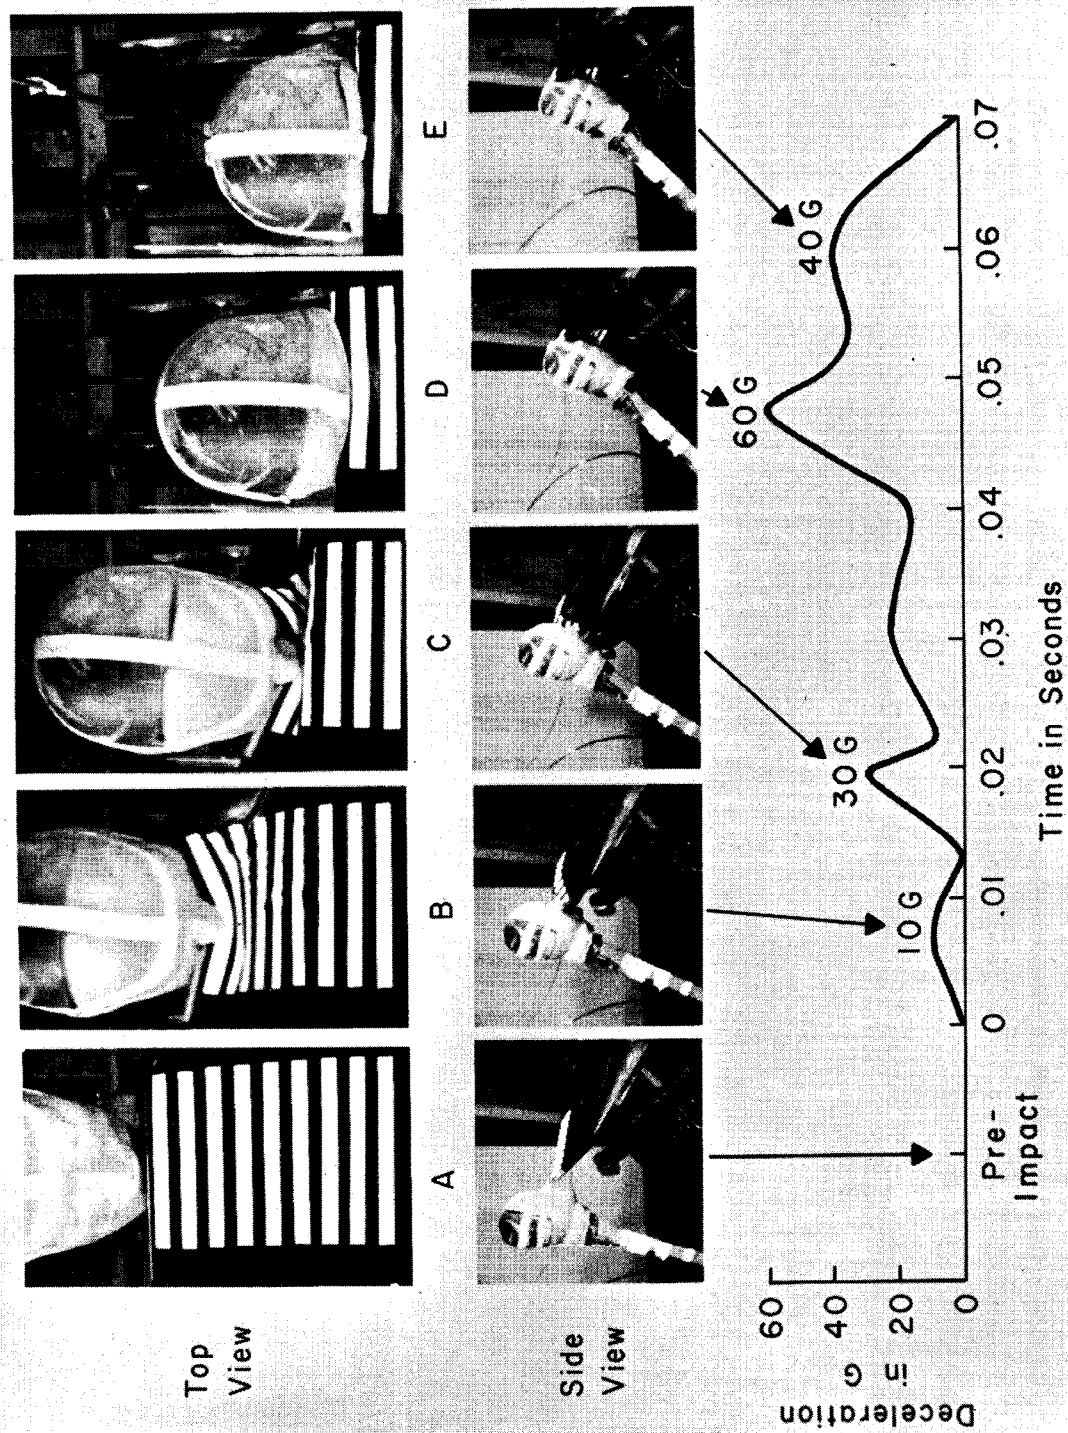
Figure 4 presents a pictorial sequence of events correlated with deceleration measured during Test One (30 ft./sec. head impact velocity). The initial head contact with the edge of the glare shield was with the maxilla just below the

nose producing an initial deceleration peak of 10 G's followed by a second peak of 30 G's as the shield began to collapse. Chalk deposited on the head form from the edge of the glare shield during this phase of the impact was lifted by means of masking tape and the area of facial contact determined to be 3.75 square inches. Based on previous research,⁷ it appears unlikely that major facial fractures would occur during this initial head impact. From 0.025 seconds to 0.04 seconds, the glare shield folded down over the instruments and prevented head contact with them. However, beginning at about 0.04 seconds, the fiberglass broke about 6½ inches from the edge of the glare shield. The thin edge of the shield, supported by the instrument panel flange penetrated the ¼-inch padding and cut the rubber head form covering, as shown in Figures 5 through 8. A peak head form deceleration of 60 G's was produced as the rigid head form contacted this thin edge. In Reference 7 it is stated that the forehead can tolerate 80 G's on one square inch without bone fracture. If we assume that the forehead contacted a four-inch length of this 0.035-inch-thick fiberglass edge, we can calculate a contact area of 0.14 square inch and any impact deceleration in excess of 12 G's would be expected to produce

FIGURE 4 Results of a 30-ft./sec. head impact against the fiberglass glare shield.

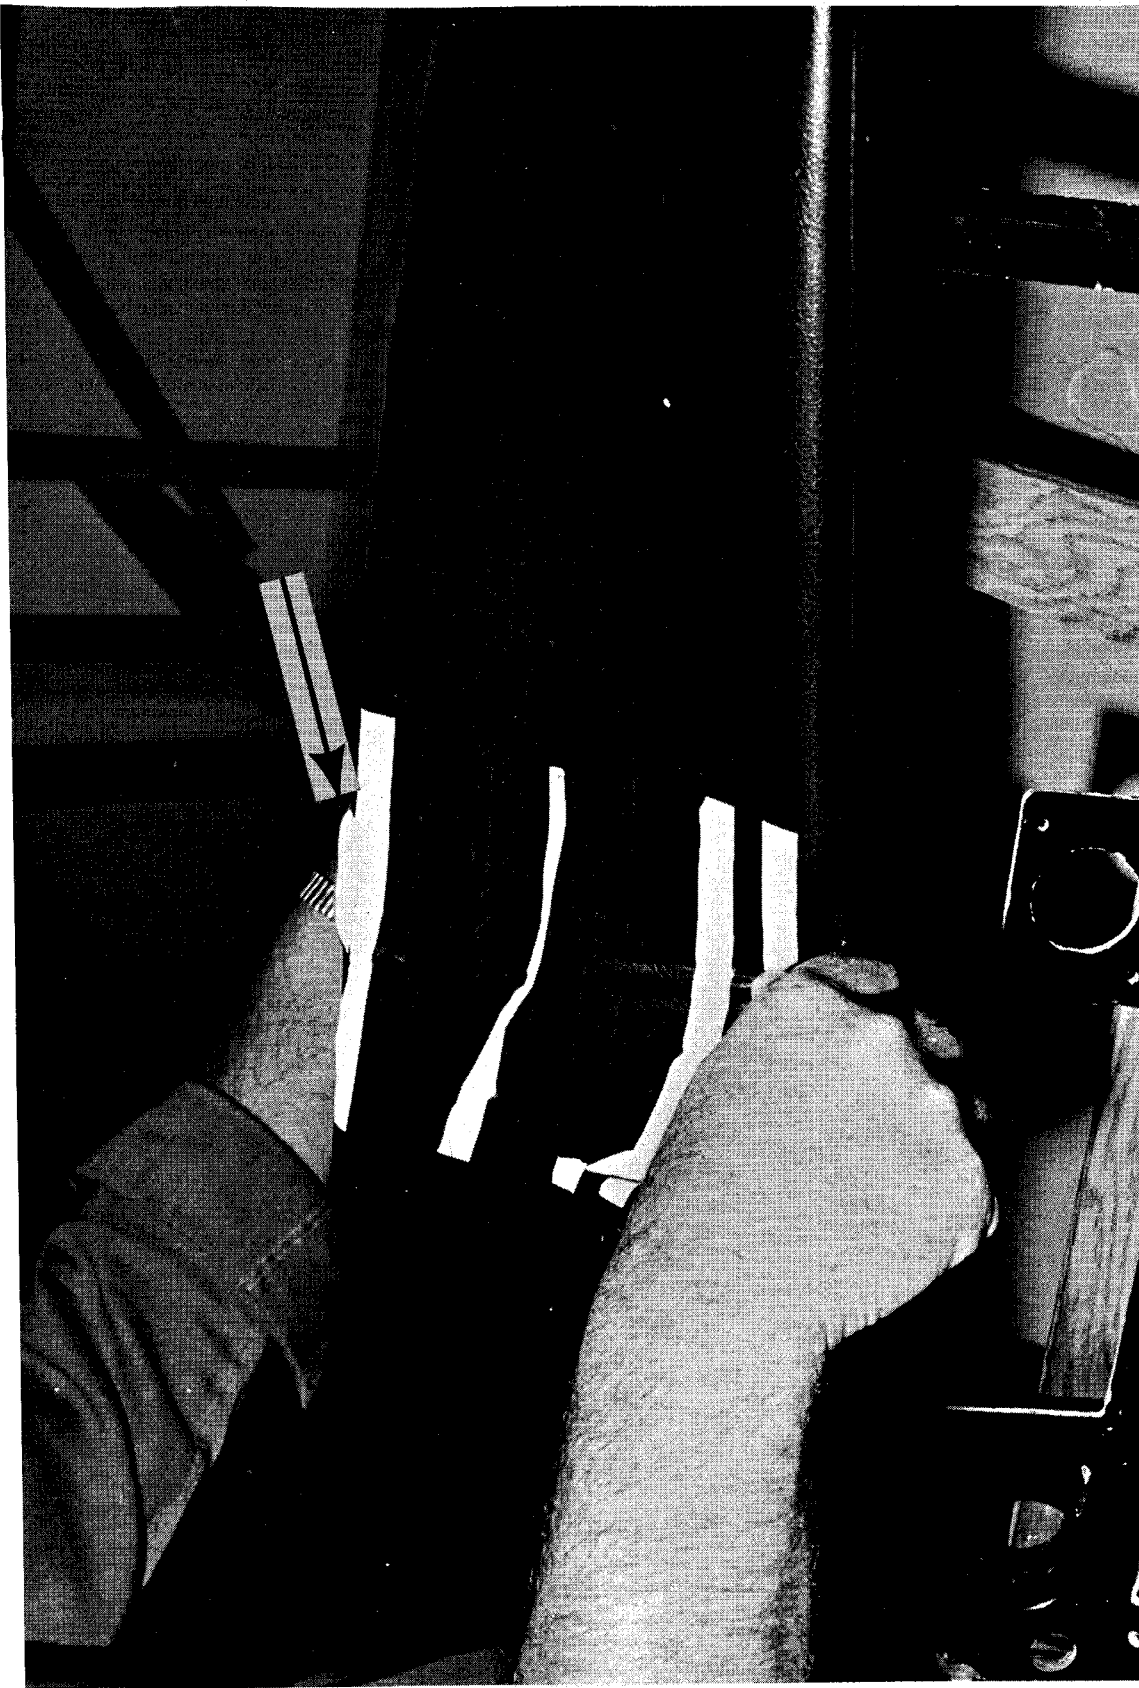
FIGURE 5. Broken edge of fiberglass cut through thin padding (note arrow).

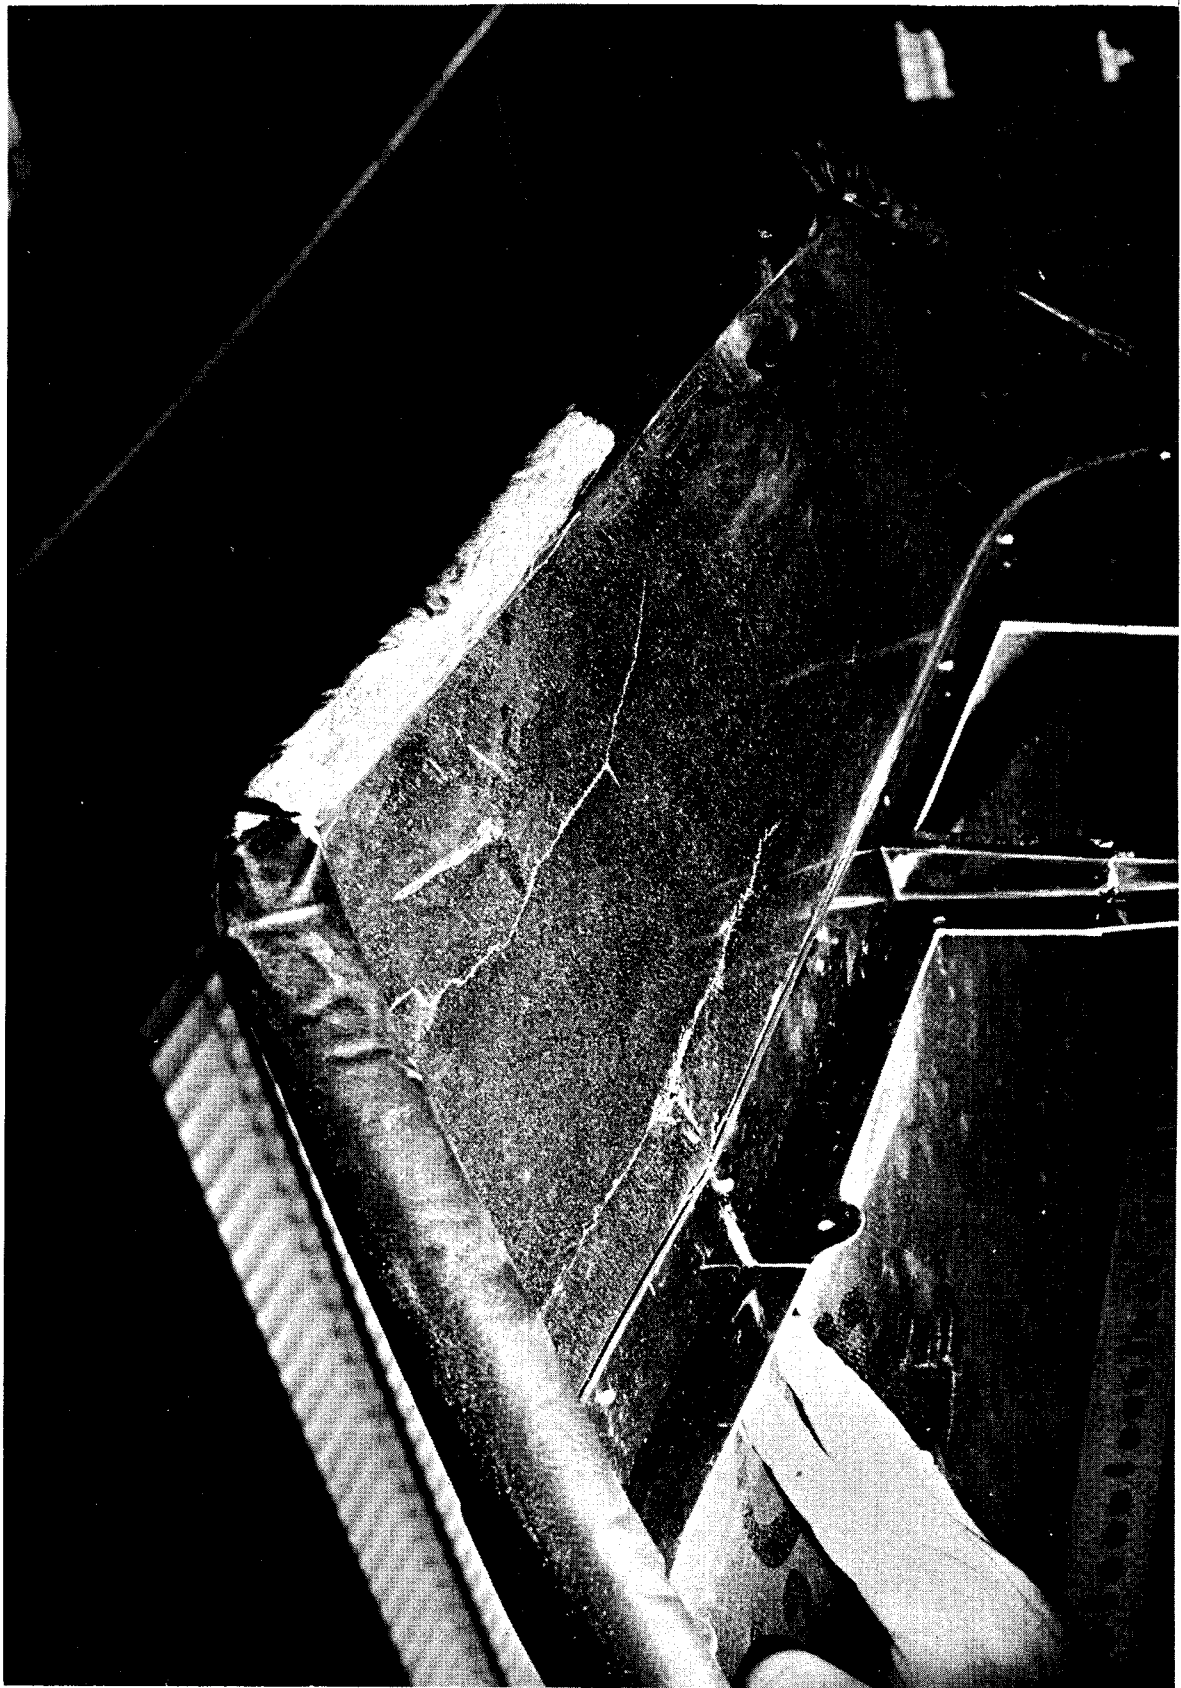
FIGURE 6. Lower view showing fractures in fiberglass.

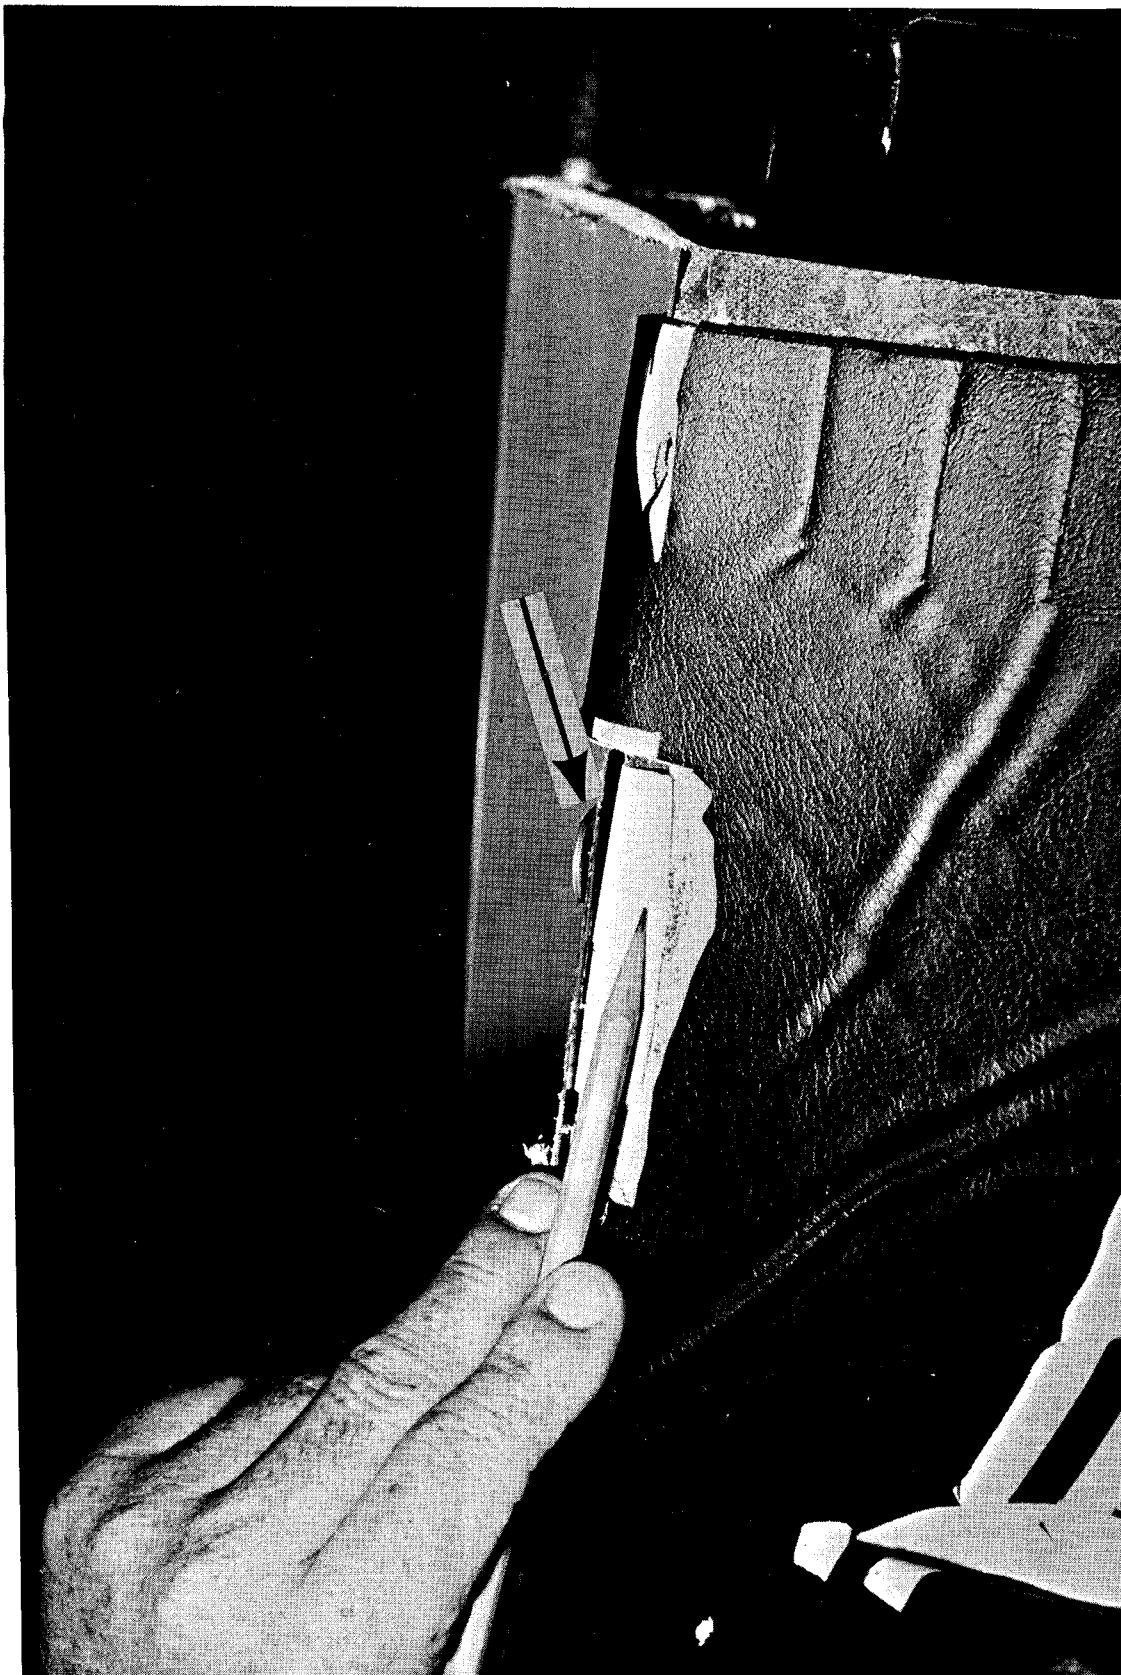
FIGURE 7. Fiberglass edge at break (see arrow). Dime is shown for thickness reference.
