| 1. Report No.<br>FAA-AM-72-15 | 2. Government Accession No. | 3. Recipient's Catalog No. | |
| 4. Title and Subtitle<br>CRASH SURVIVAL ANALYSIS OF 16 AGRICULTURAL<br>AIRCRAFT ACCIDENTS | | 5. Report Date<br>April 1972 | |
| 7. Author(s)<br>J. J. Swearingen, D. Av. T.; T. F. Wallace;<br>J. G. Blethrow; and D. E. Rowlan | | 8. Performing Organization Report No. | |

# CRASH SURVIVAL ANALYSIS OF 16 AGRICULTURAL AIRCRAFT ACCIDENTS

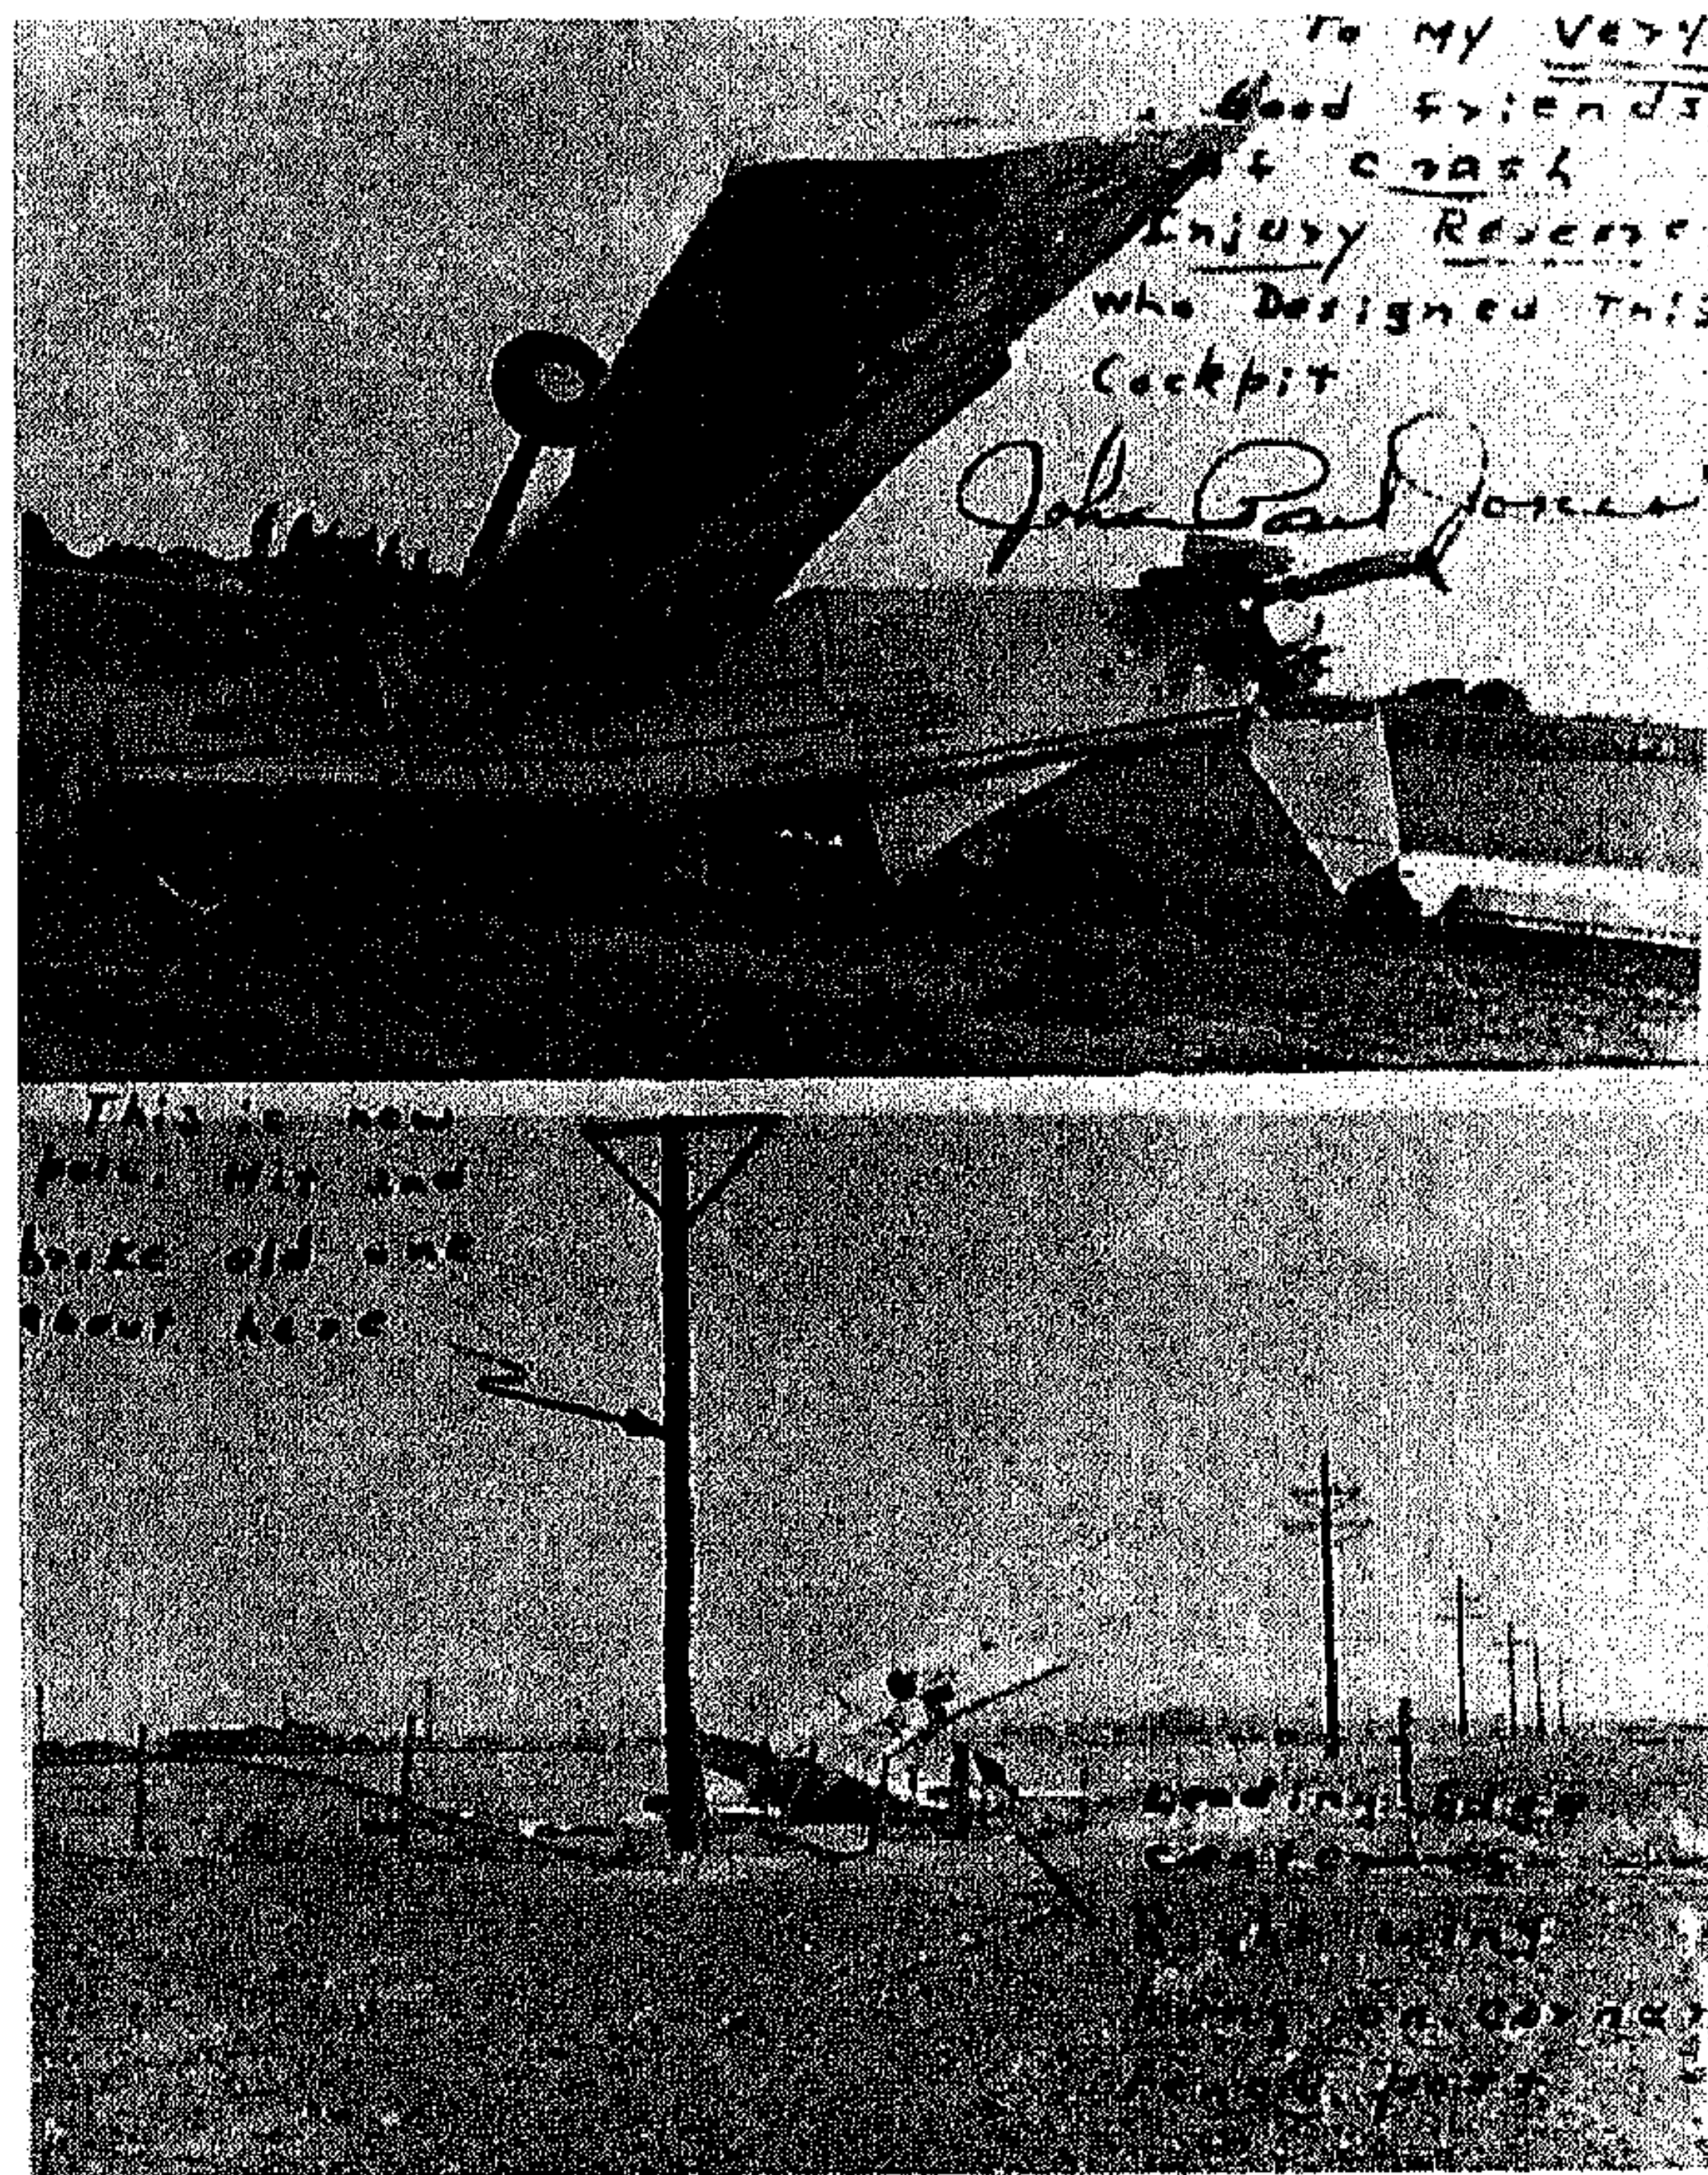
FIGURE 2. Scenes at the crash site on the AG-1.

Although only one AG-1 was built (it crashed without injuring the pilot—Figure 2), it served as a prototype for the present fleet of aerial applicator aircraft. The Piper Pawnee, Cessna

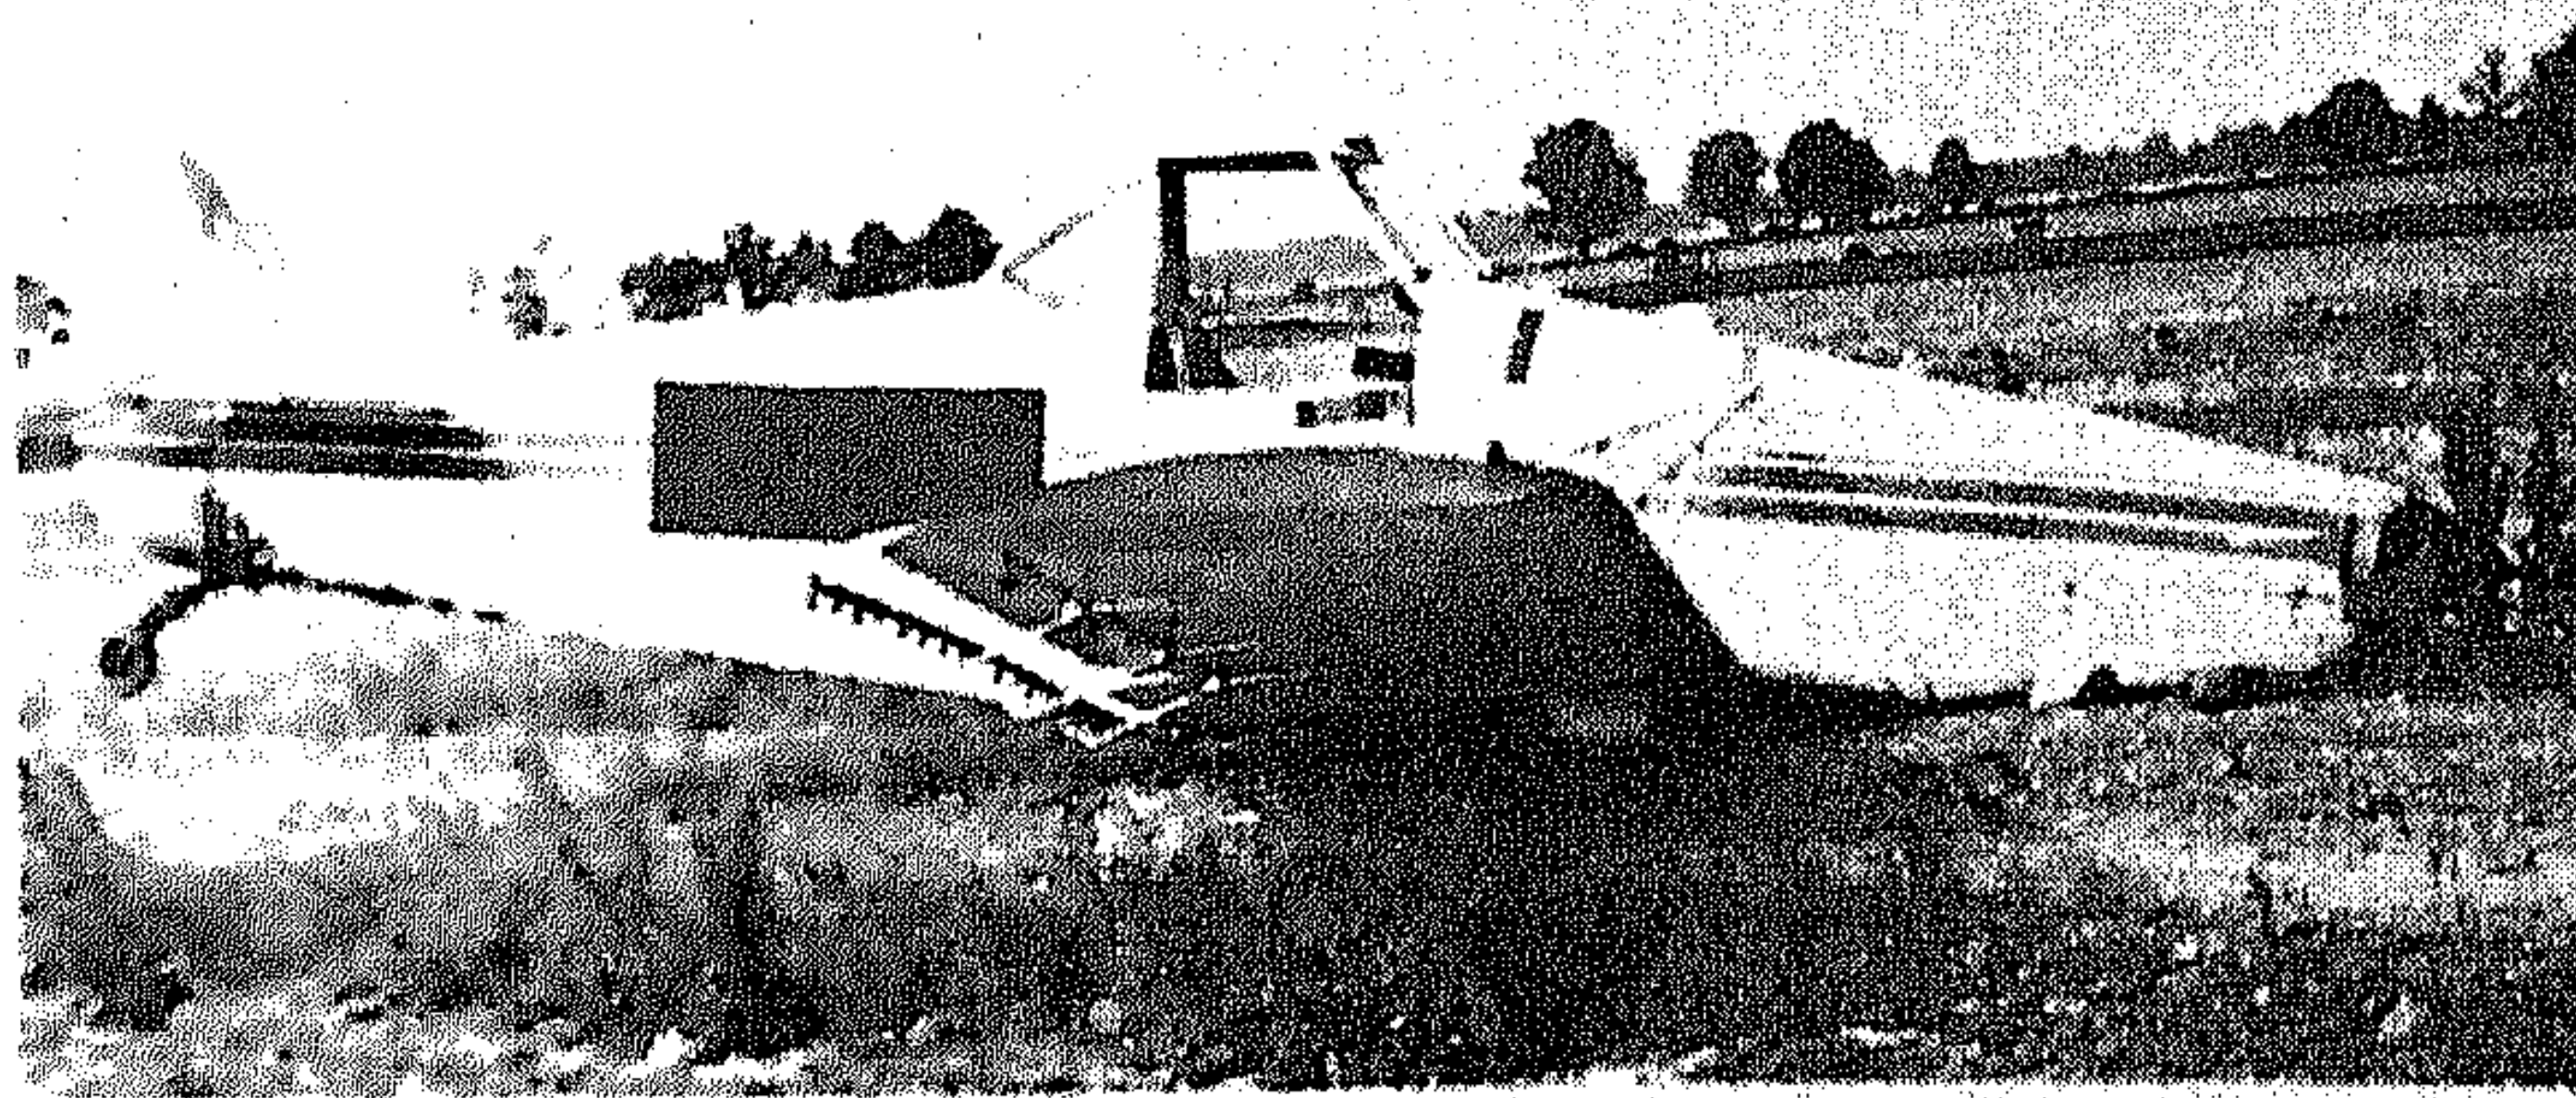
a. Side view of aircraft showing minor damage mostly to landing gear and propeller.

Minor accident of a 1968 Piper Pawnee (PA-25-235) presented to show the use of frayed shoulder straps. No injuries were inflicted in this accident.

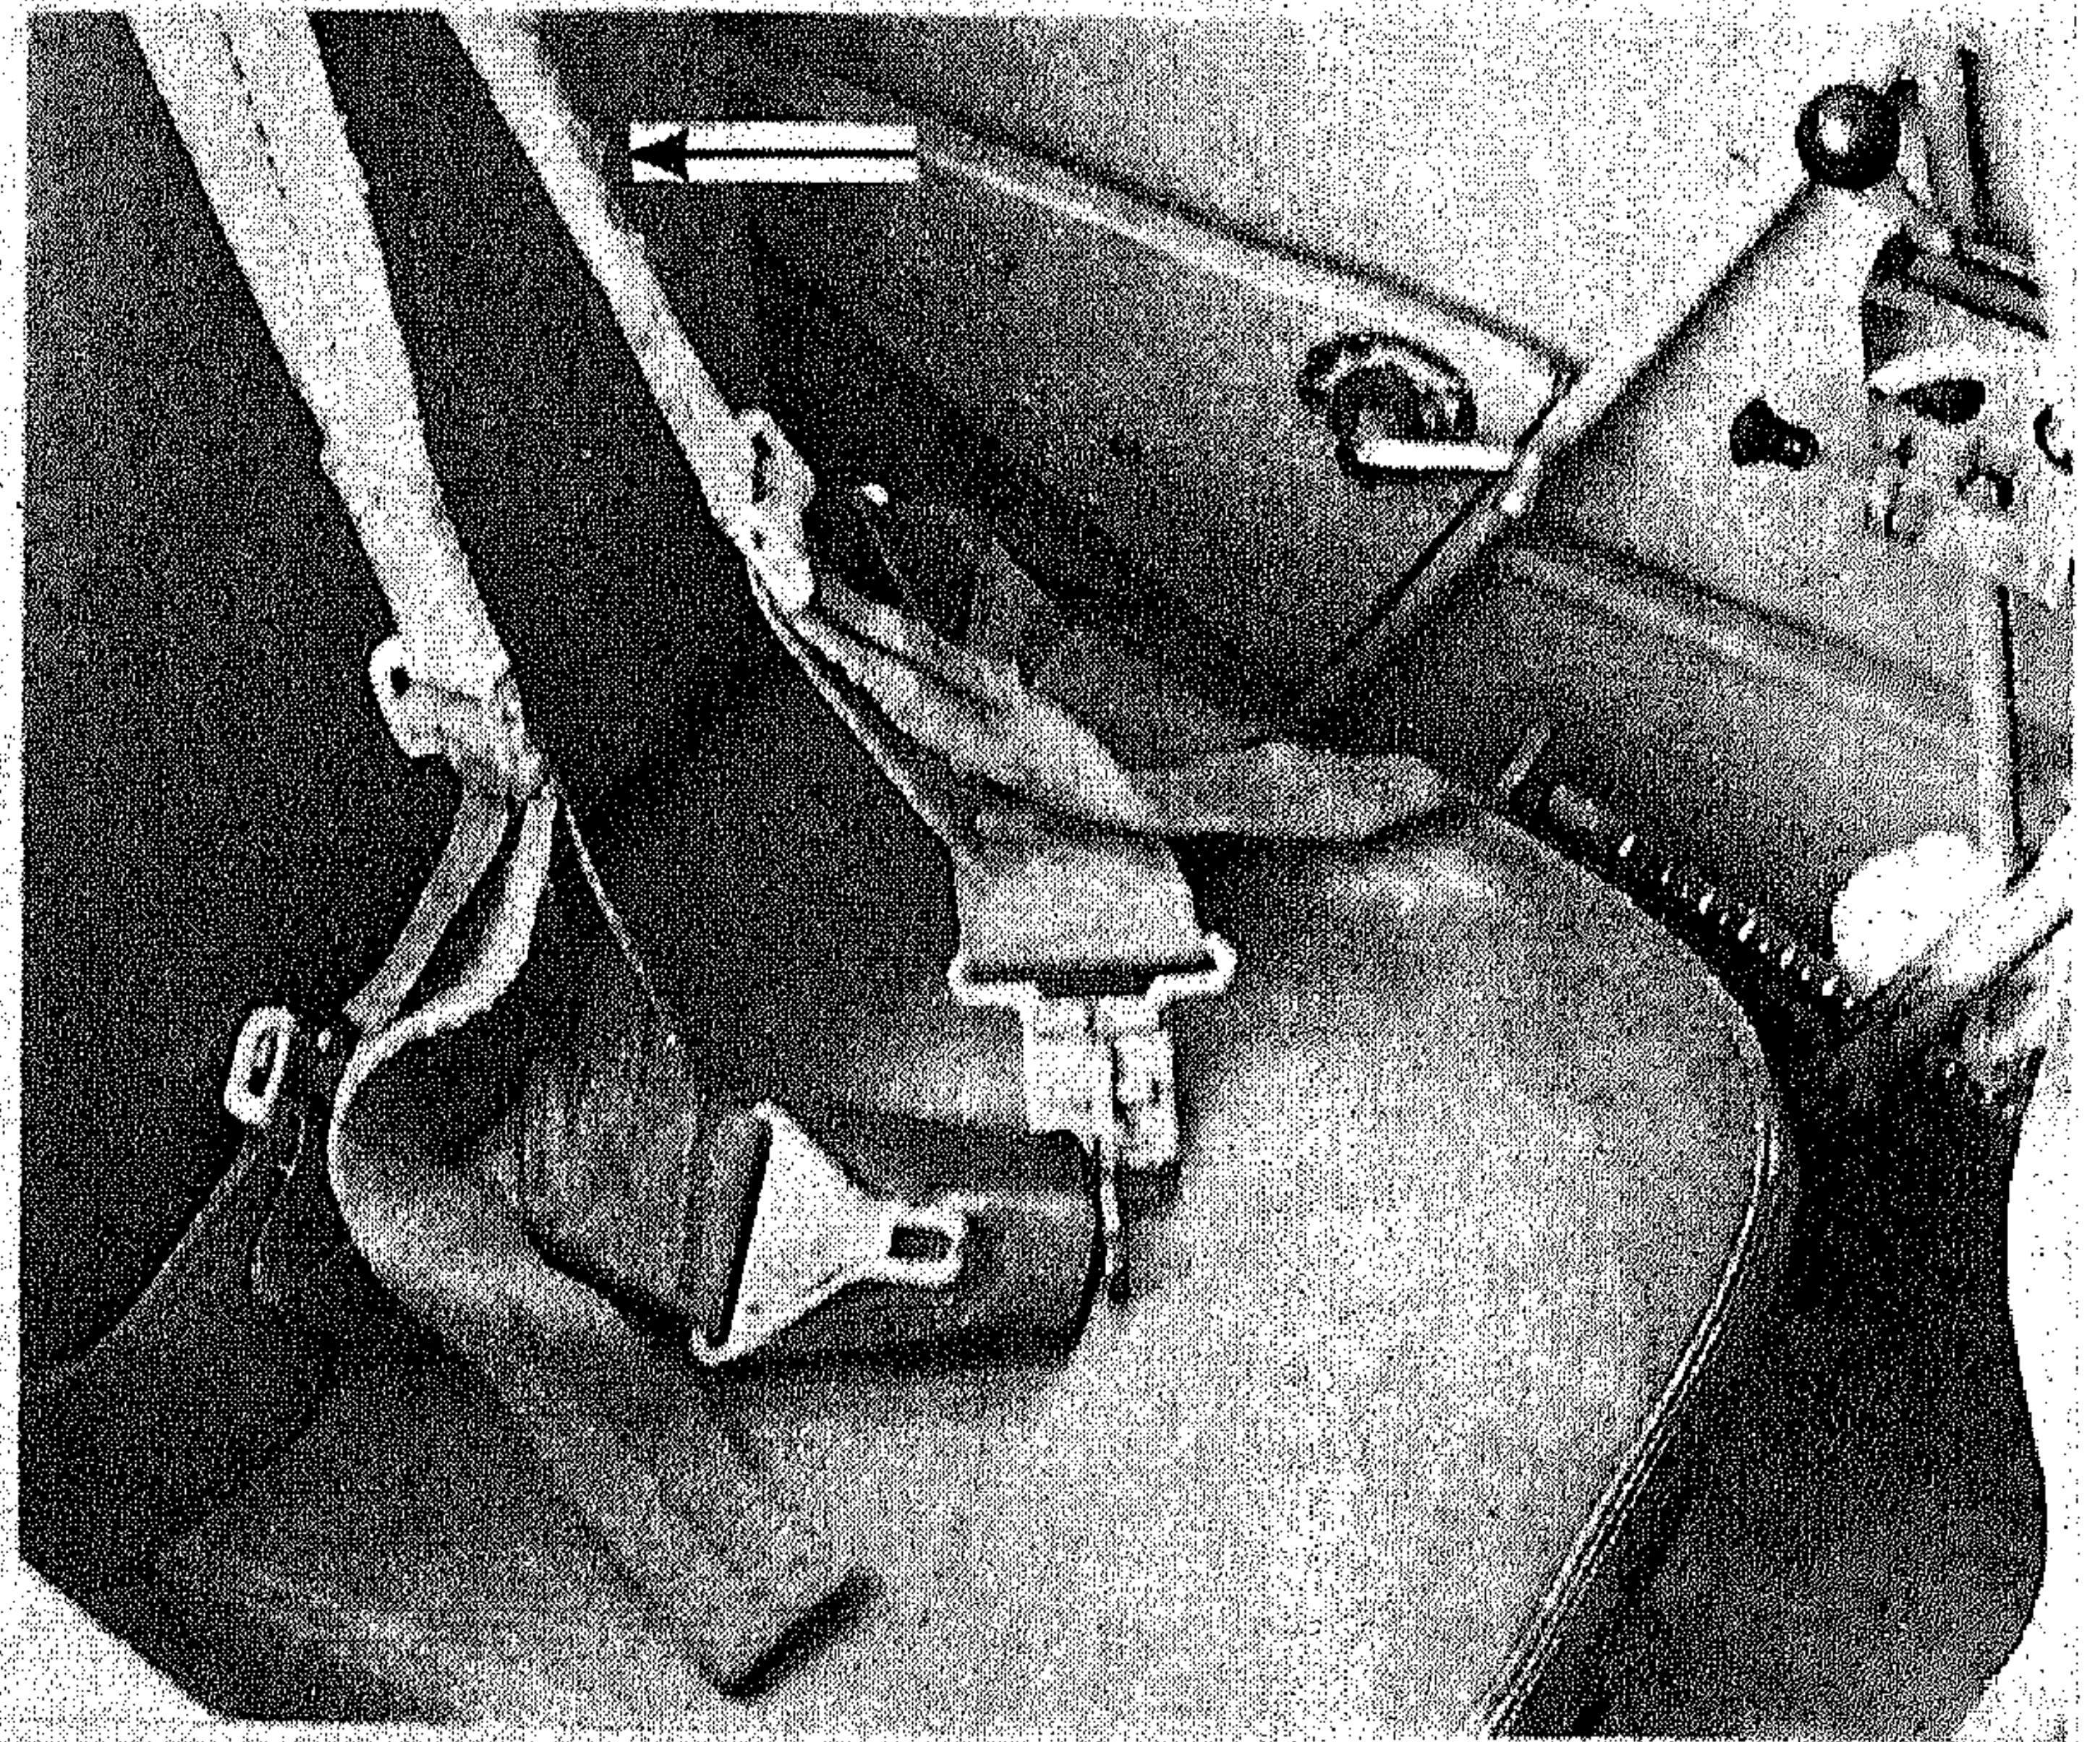
injuries. The upper torso restraint, lap belt, and crash helmet protected the pilot from injury. However, the frayed shoulder straps indicated by an arrow in Case 1-b are indicative of a potential hazard. This aircraft was less than three years old and, while the frayed straps were strong enough to hold in this accident, they probably would have failed in a more severe crash. In addition, please note the metal-to-metal attachment of the shoulder harness to the lap belt buckle.

b. Shoulder straps and lap belt held in this minor accident but it should be noted that the shoulder straps are becoming frayed (see arrow) and would be sure to fail in an accident of greater crash severity.

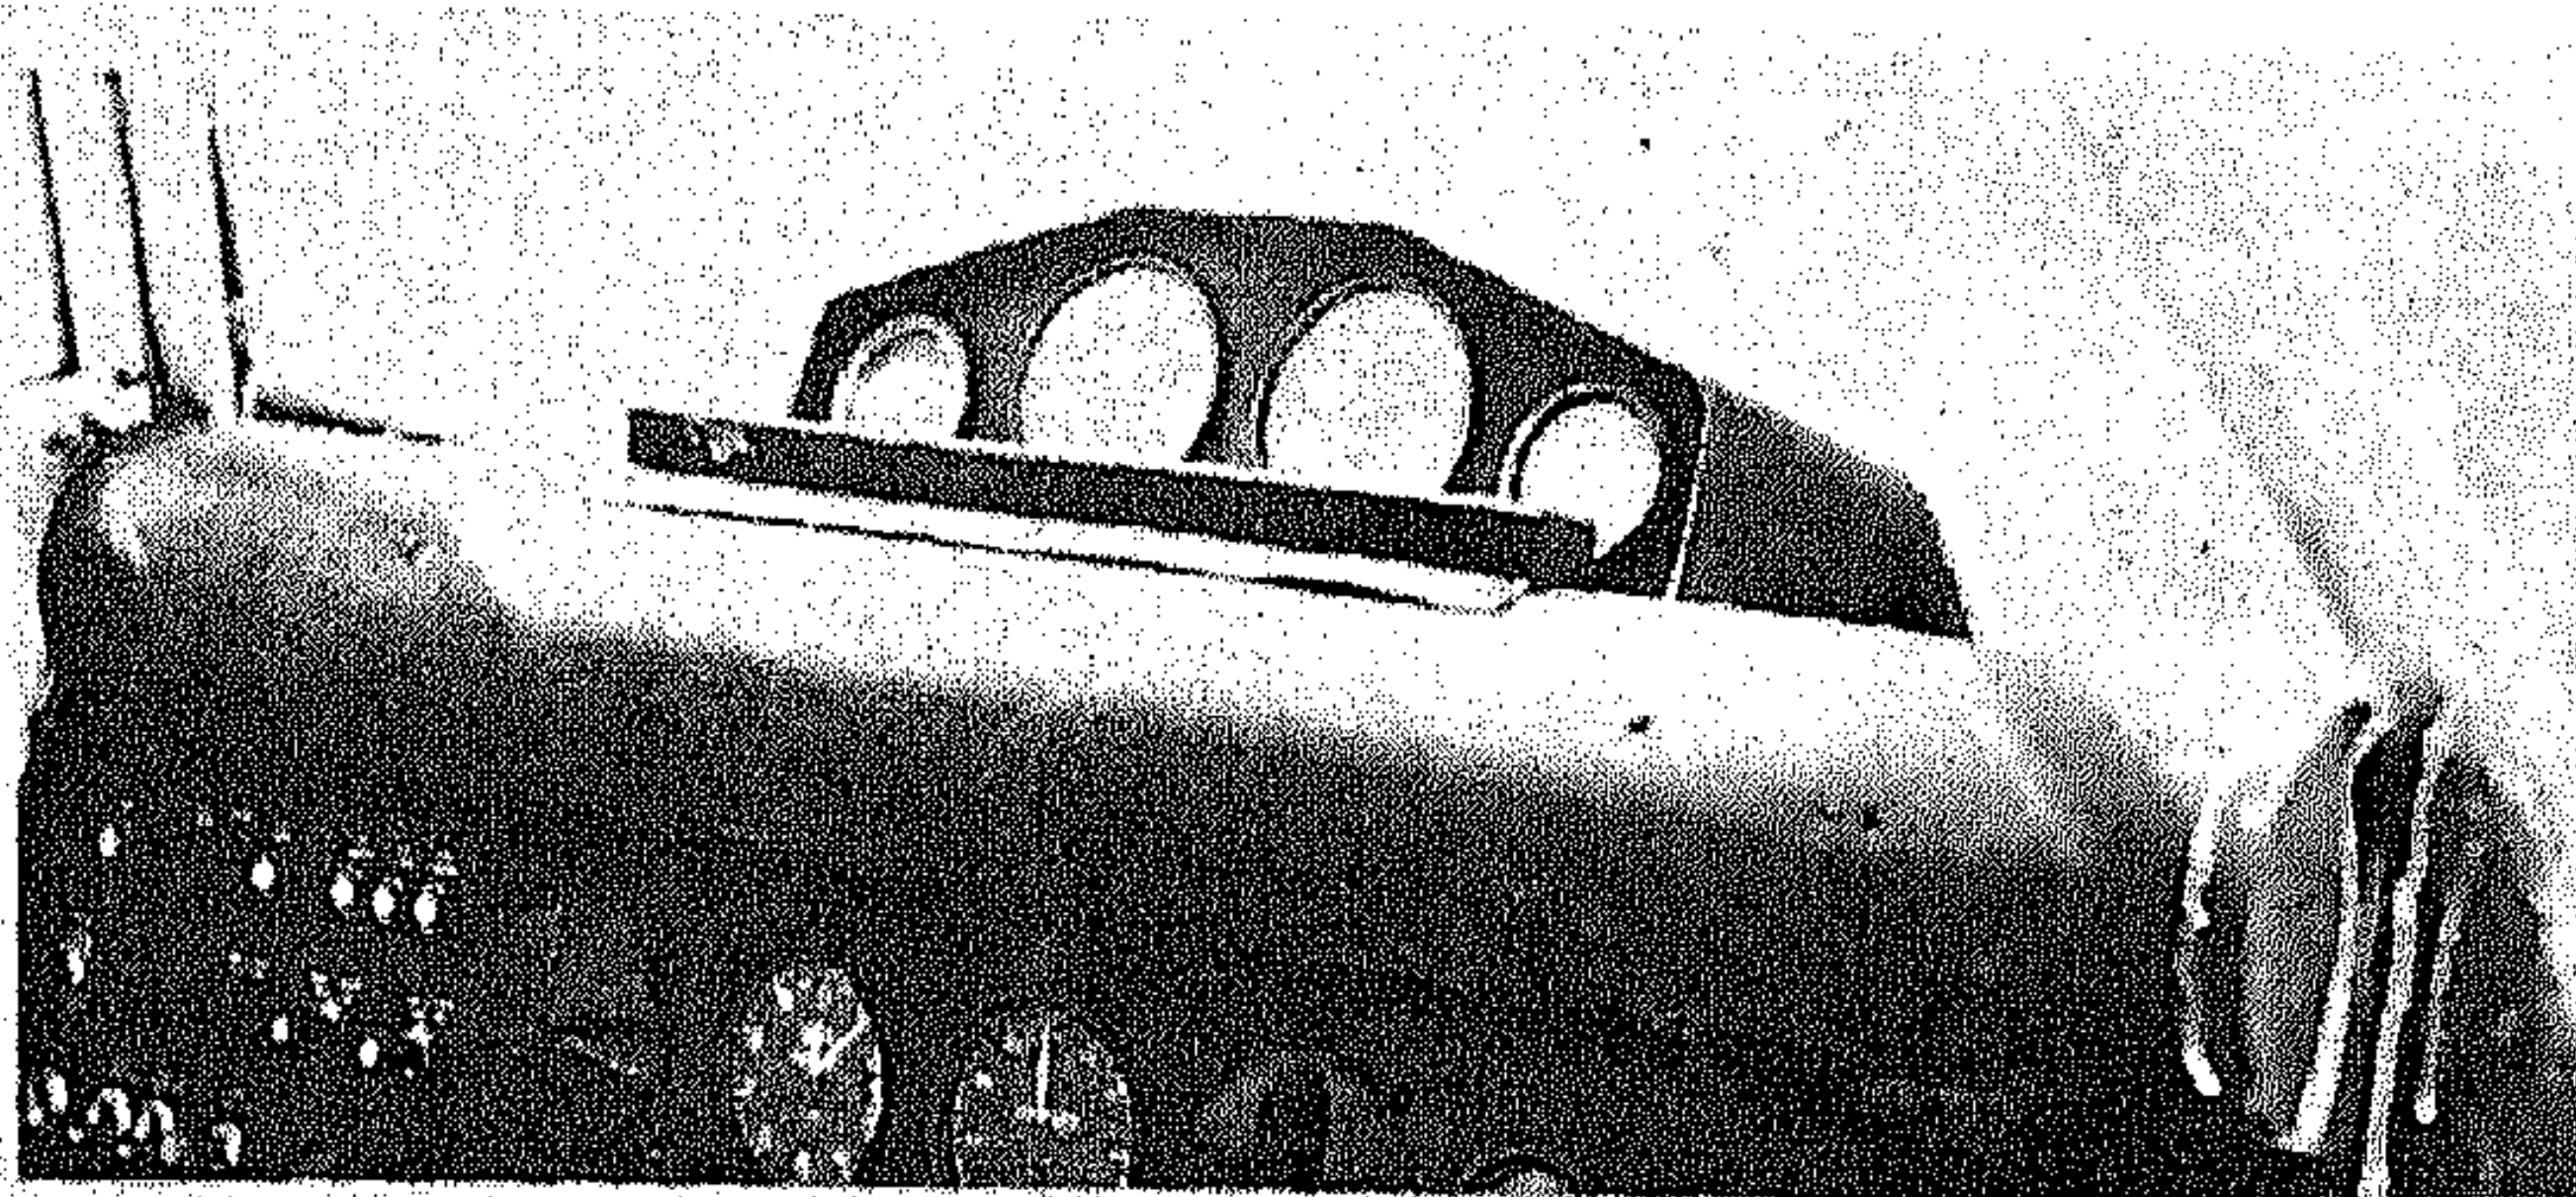
b. Like the Pawnee, the Agwagon is equipped with a light semicylinder of aluminum at the top of the instrument panel to help prevent head injury.

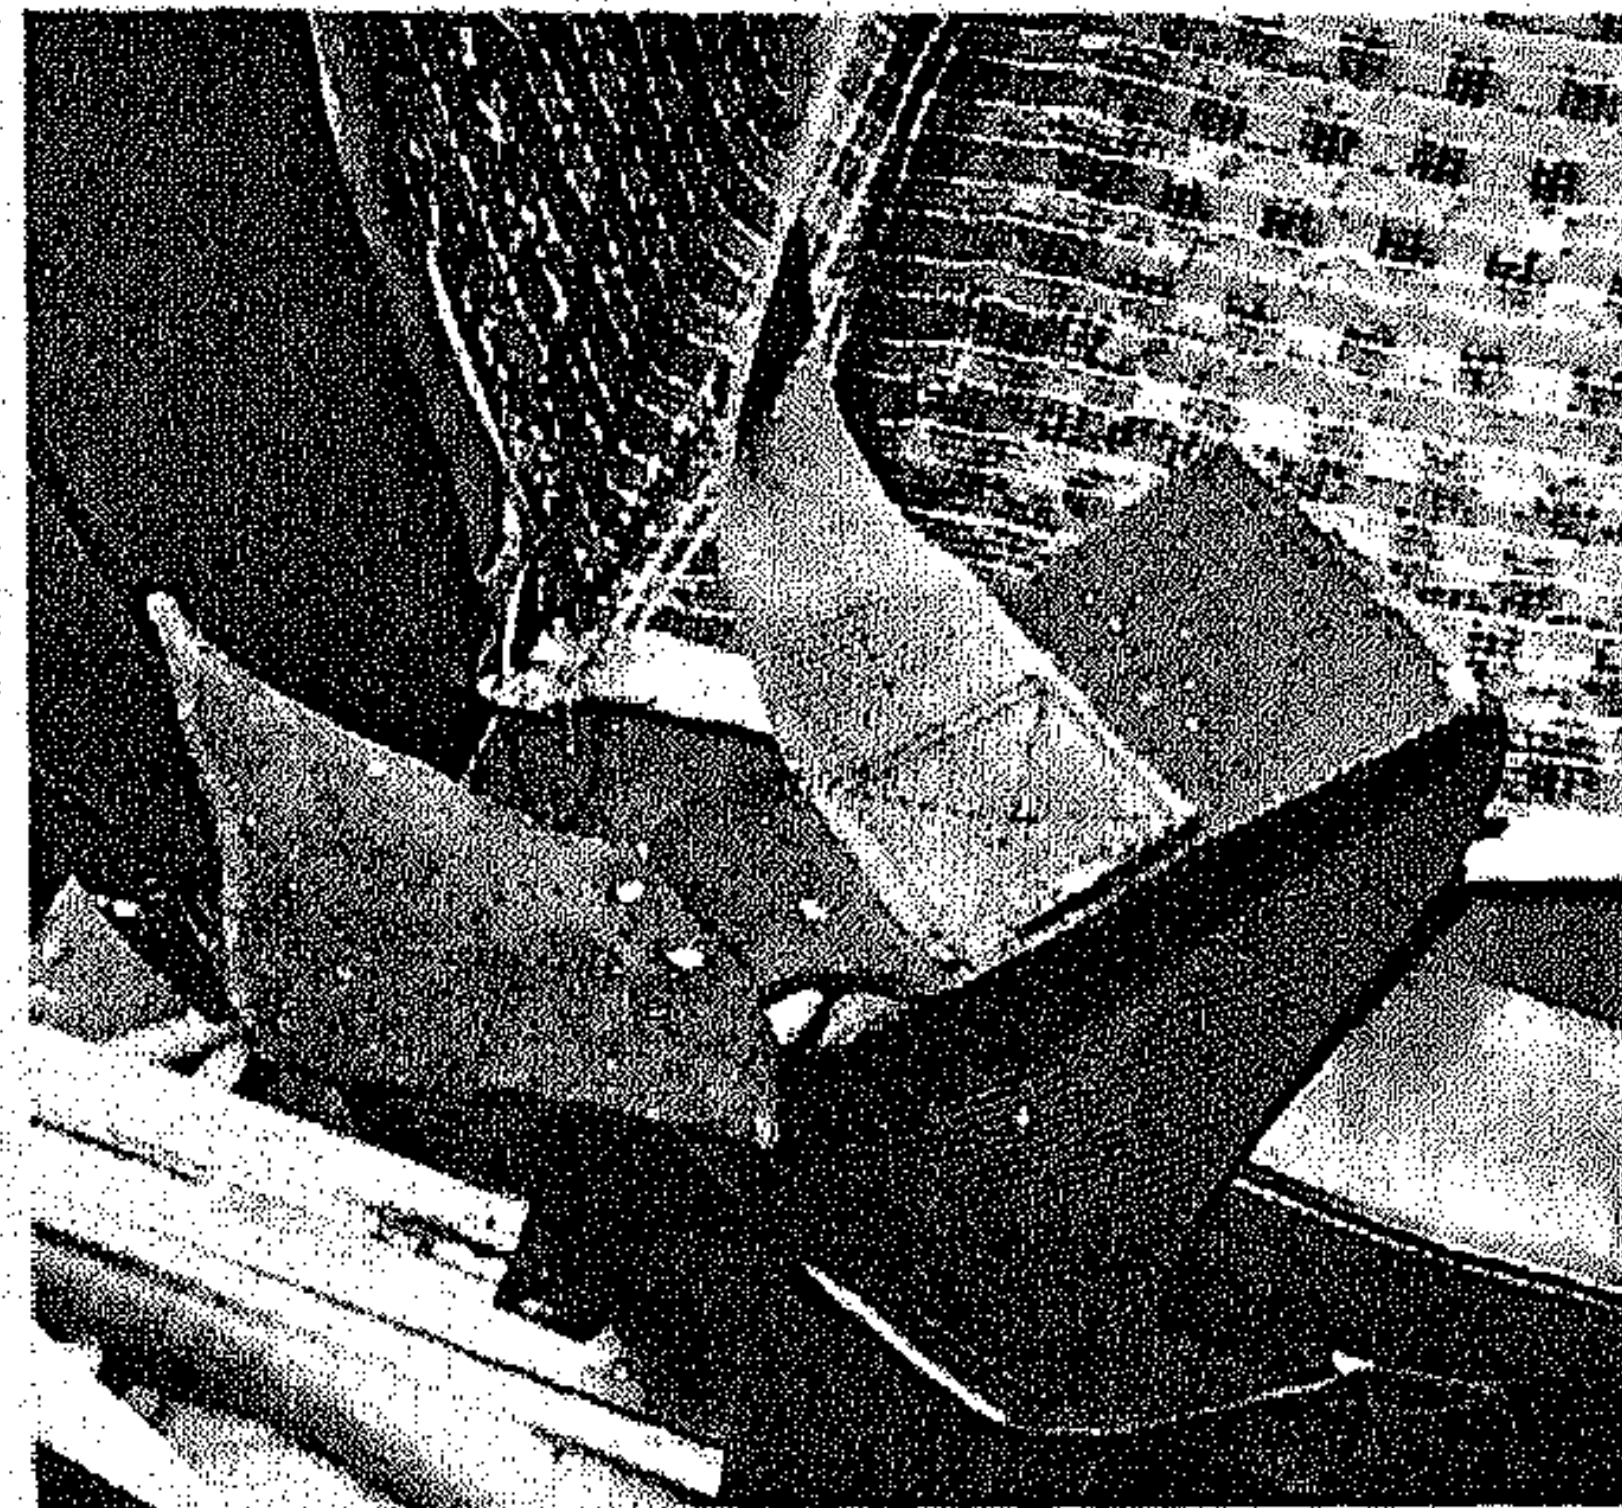
d. Stitching the ends of the shoulder straps flat to one face of the lap belts constitutes a weak point in the restraint system.

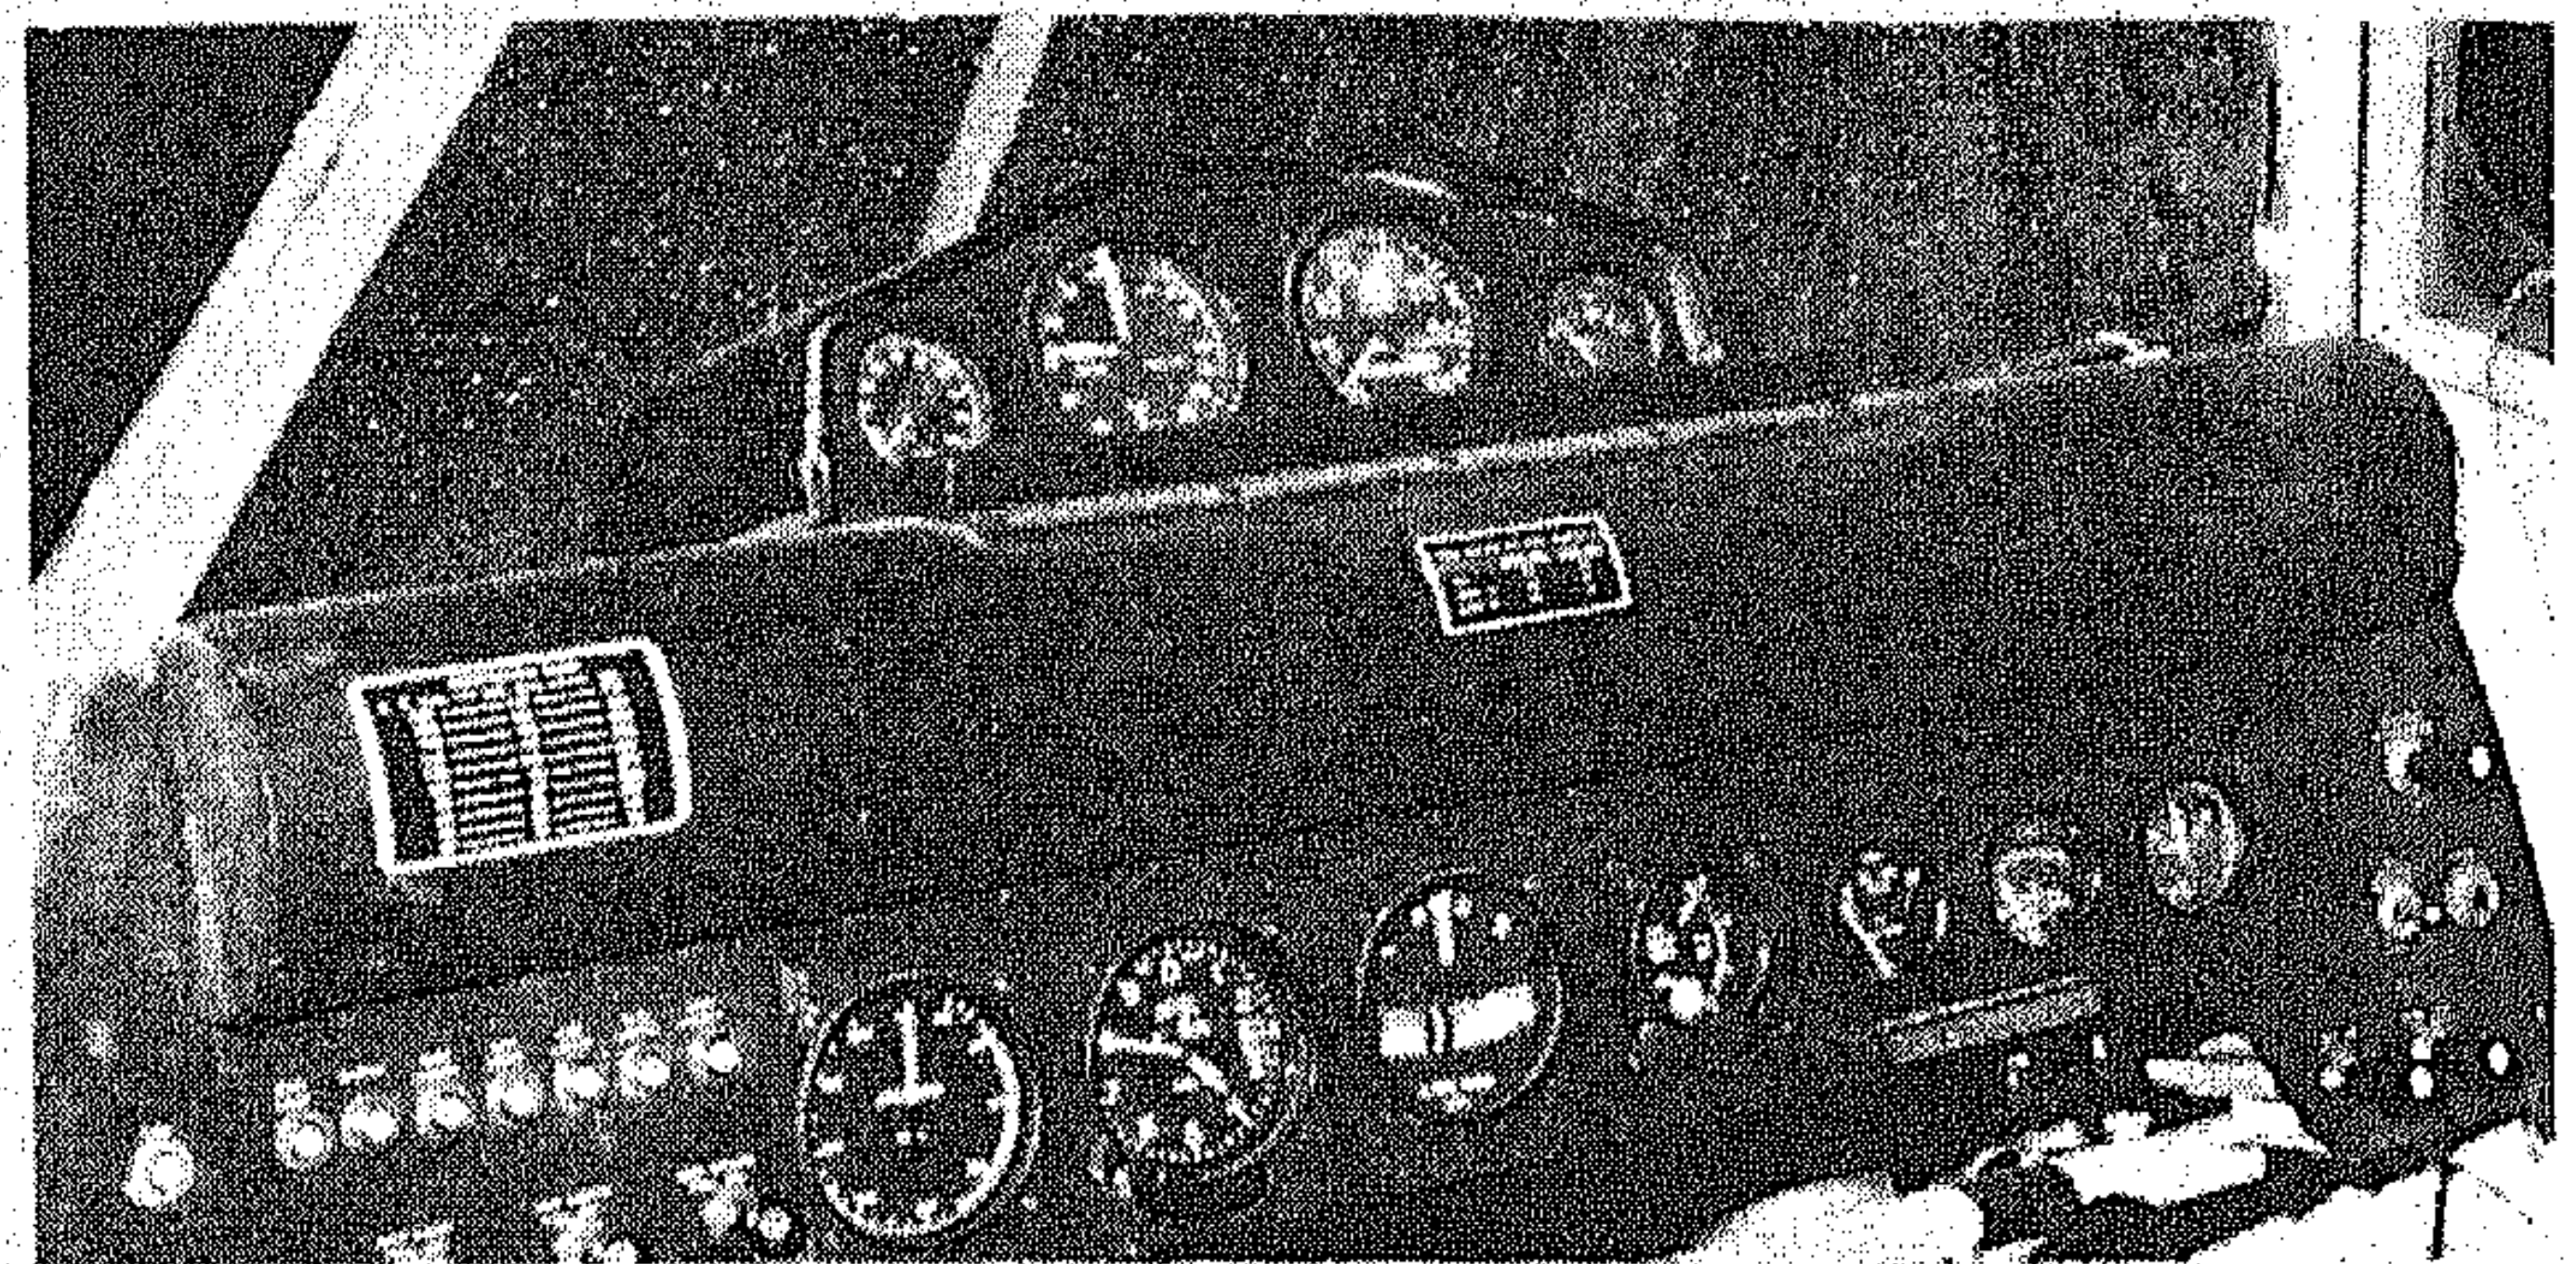
b. Protective aluminum roll undamaged.

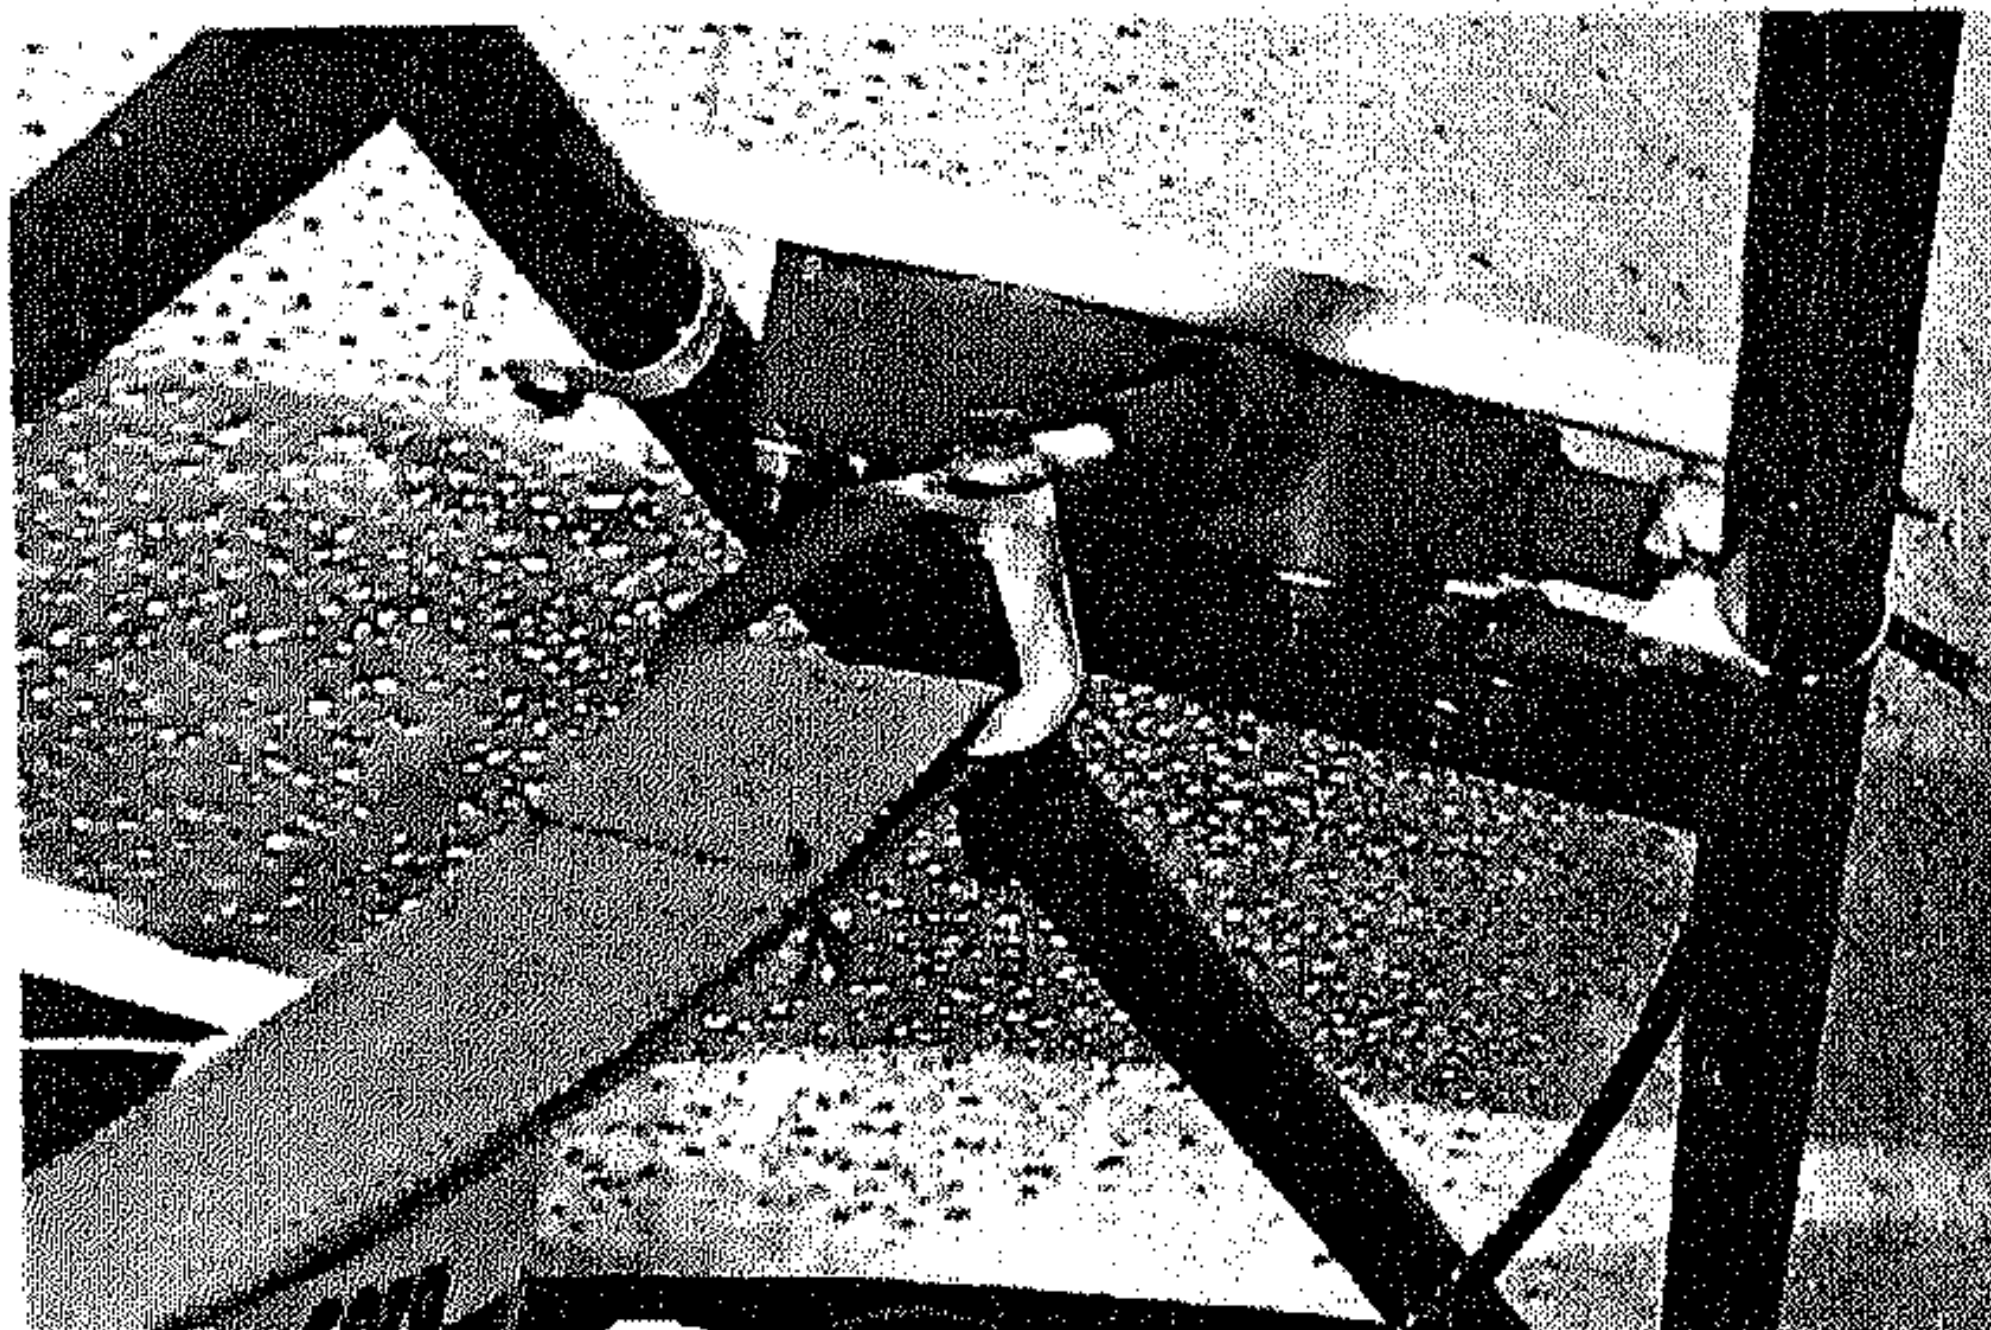
c. Shoulder straps attached to inertia reel fastened to strong tubular structure high in the aircraft.
