| 1. Report No.<br>FAA-AM-72-15 | 2. Government Accession No. | 3. Recipient's Catalog No. | |
| 4. Title and Subtitle<br>CRASH SURVIVAL ANALYSIS OF 16 AGRICULTURAL<br>AIRCRAFT ACCIDENTS | | 5. Report Date<br>April 1972 | |
| 7. Author(s)<br>J. J. Swearingen, D. Av. T.; T. F. Wallace;<br>J. G. Blethrow; and D. E. Rowlan | | 8. Performing Organization Report No. | |

# CRASH SURVIVAL ANALYSIS OF 16 AGRICULTURAL AIRCRAFT ACCIDENTS

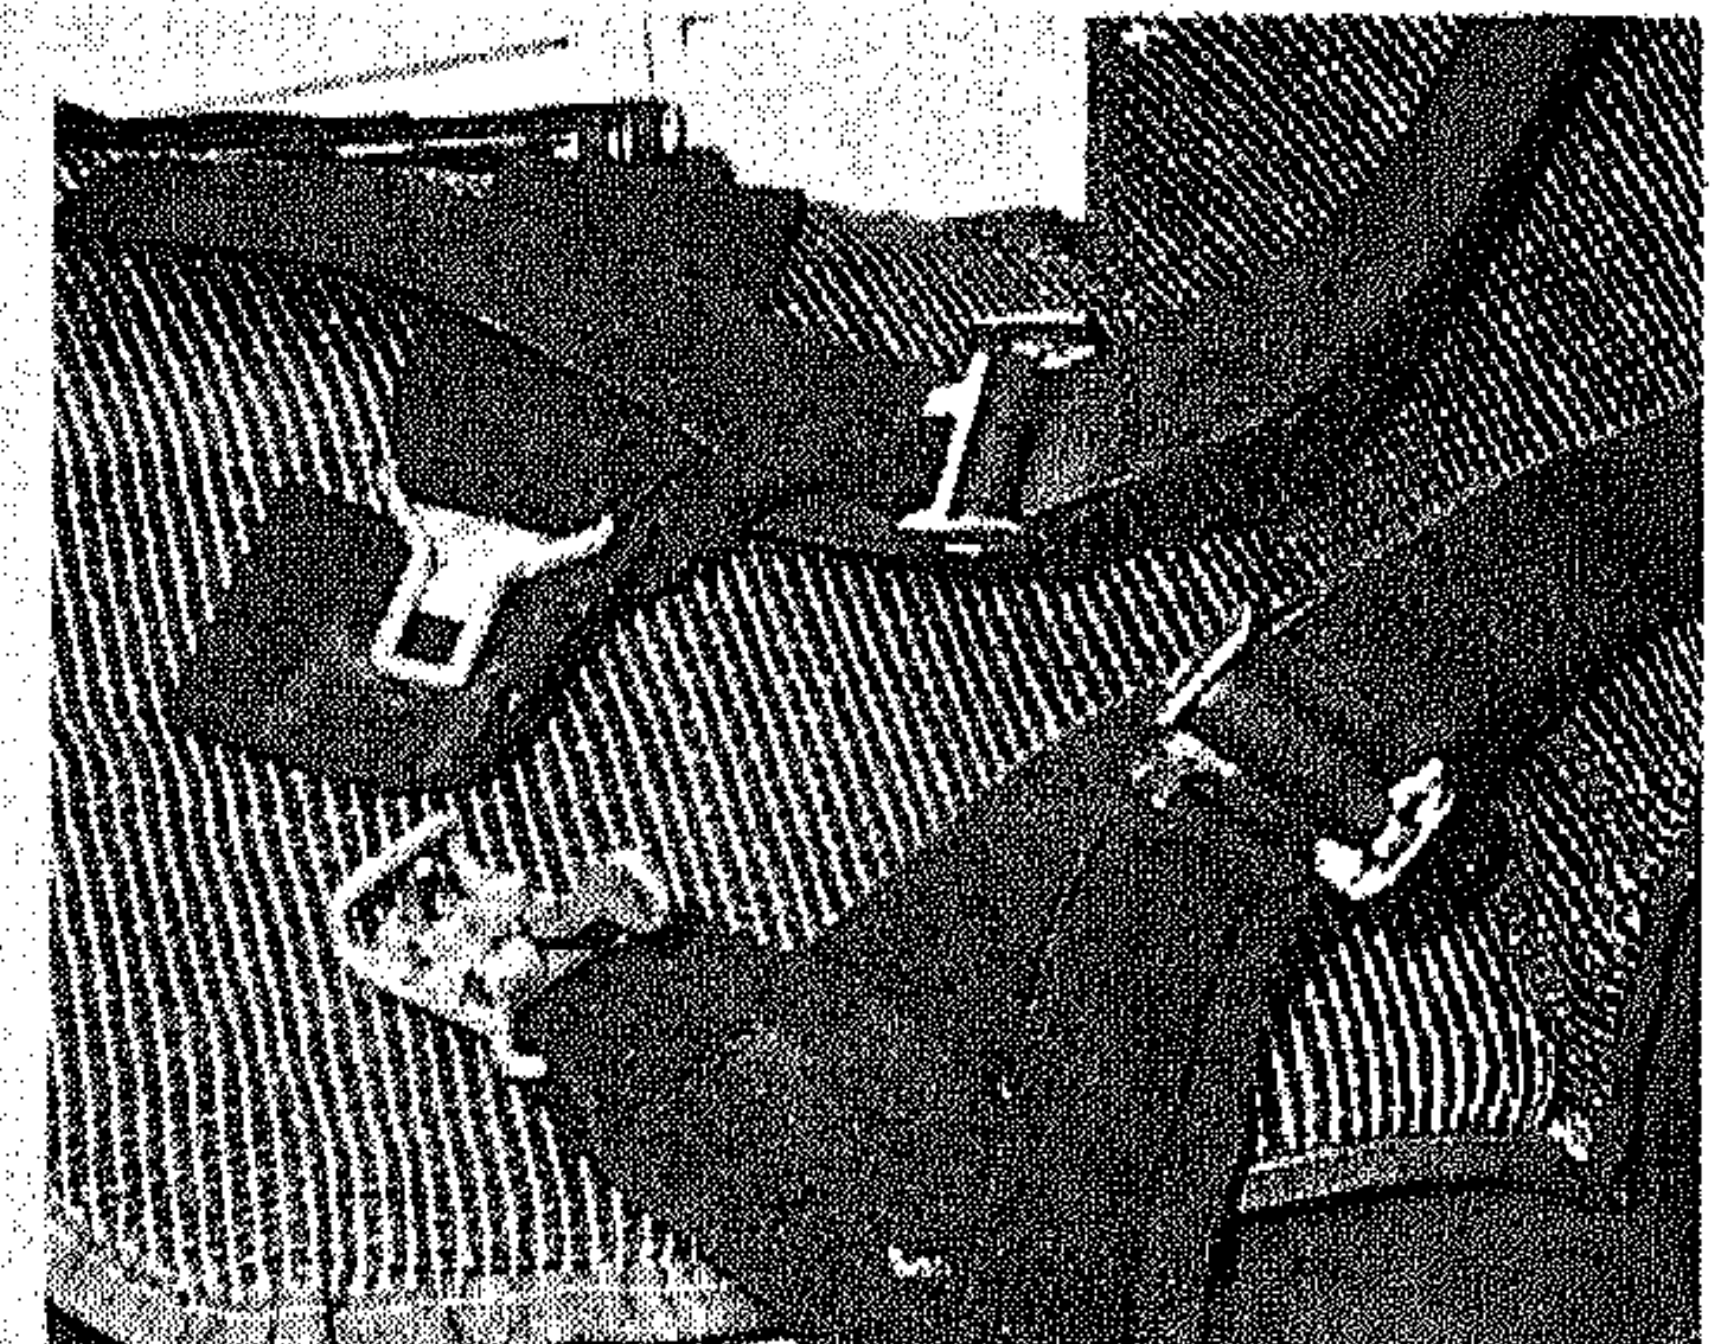
ference between this aircraft and the one discussed in Case 2 is the presence of an inertia reel (Case 3-c). Again, attention is called to the aluminum semicylinder at the top of the instrument panel (Case 3-b) and to the shoulder straps stitched to one surface of the lap belt (Case 3-d). There is no sign of failure of the stitching in this case.

d. Shoulder straps sewed flat to one face of the lap belts.

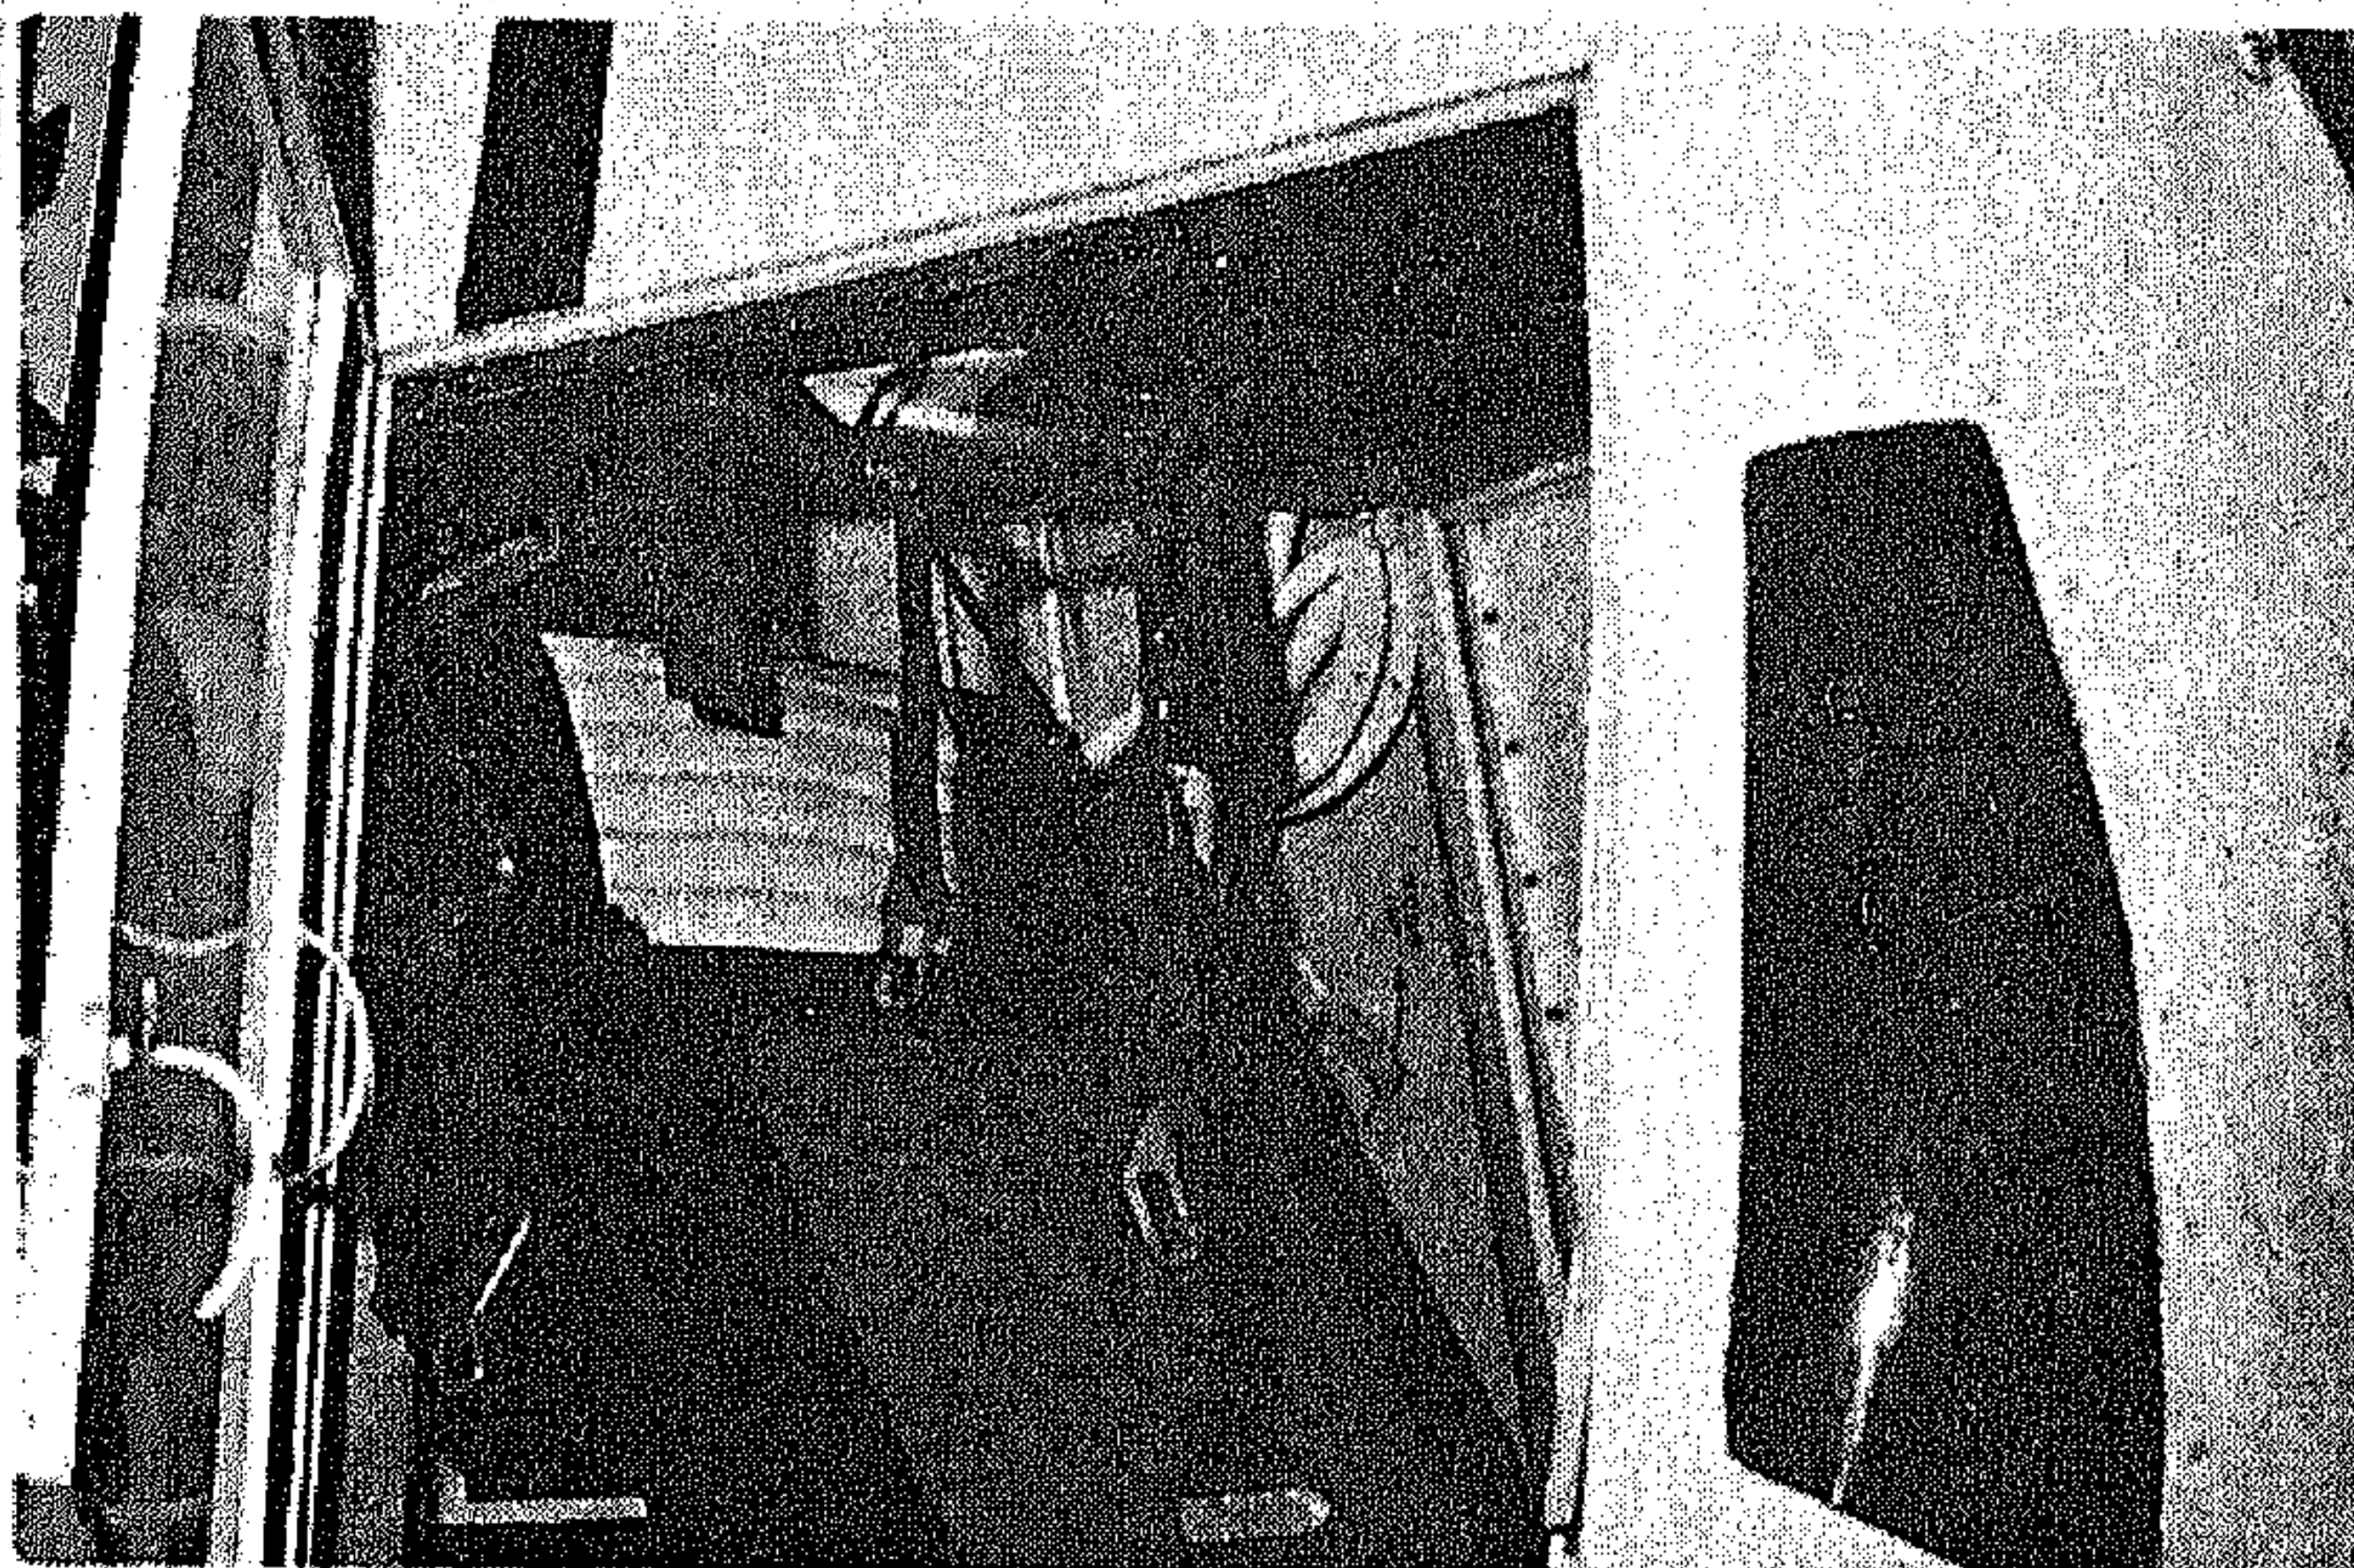
c. Aircraft was equipped with shoulder harnesses, but the pilot was not wearing them.

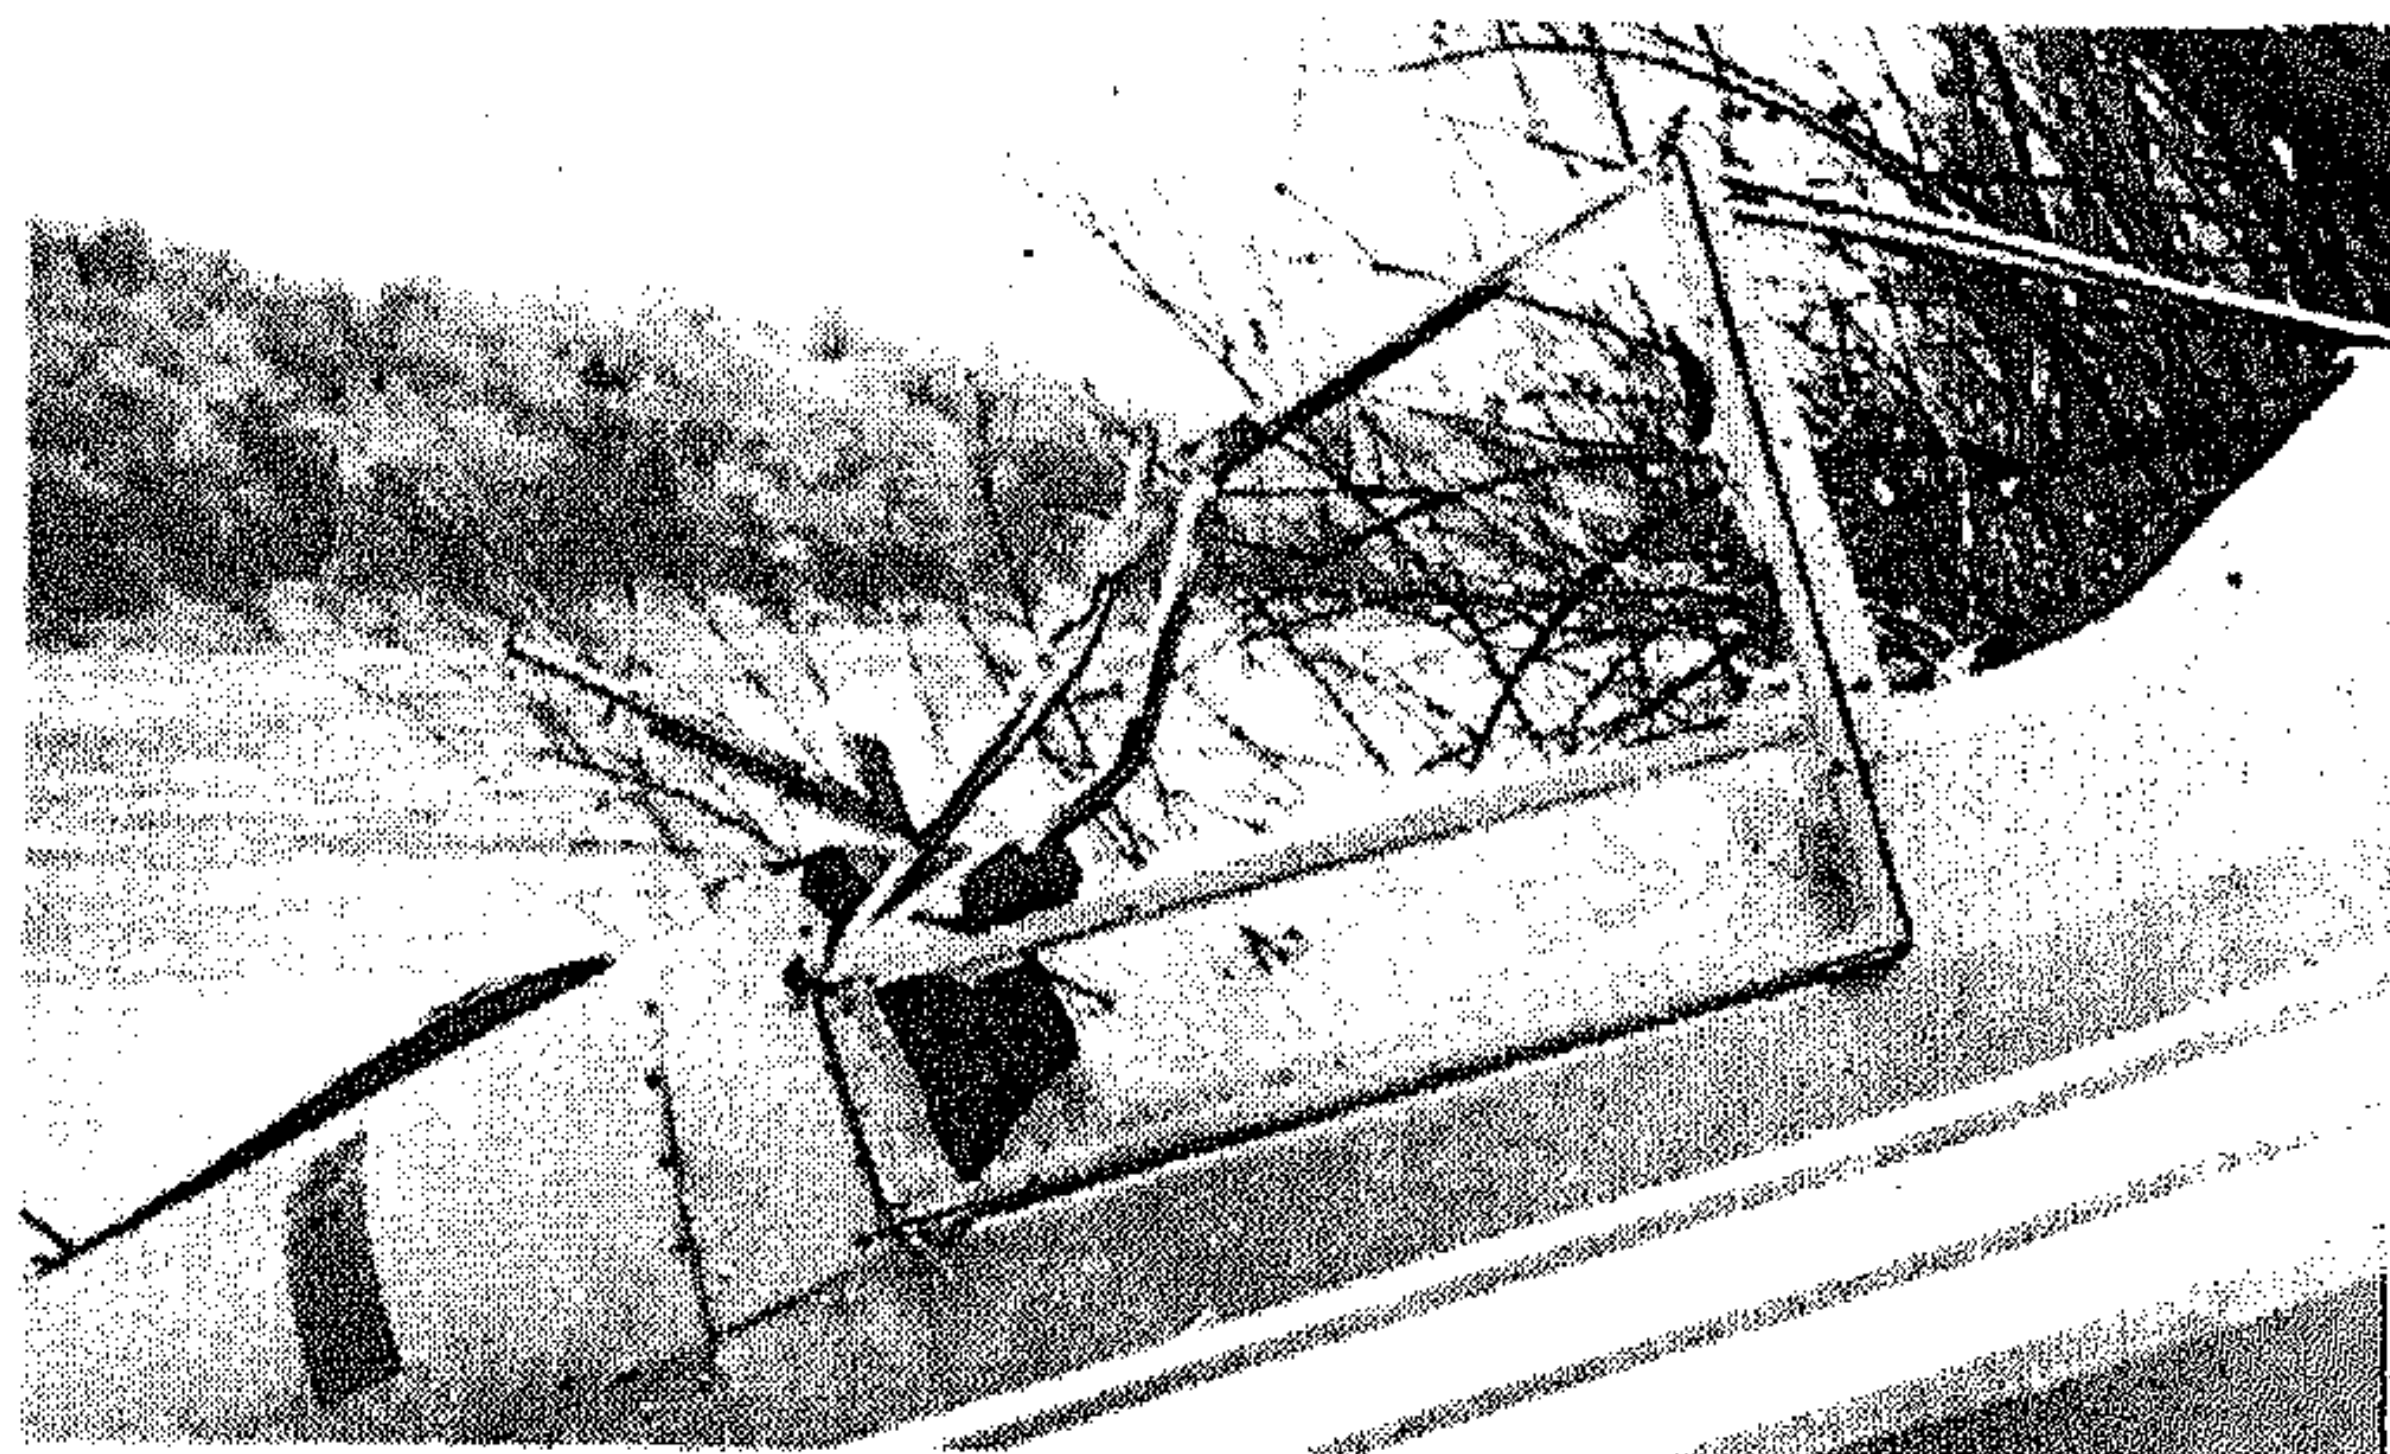
b. Close-up showing failure of roll bar structure.

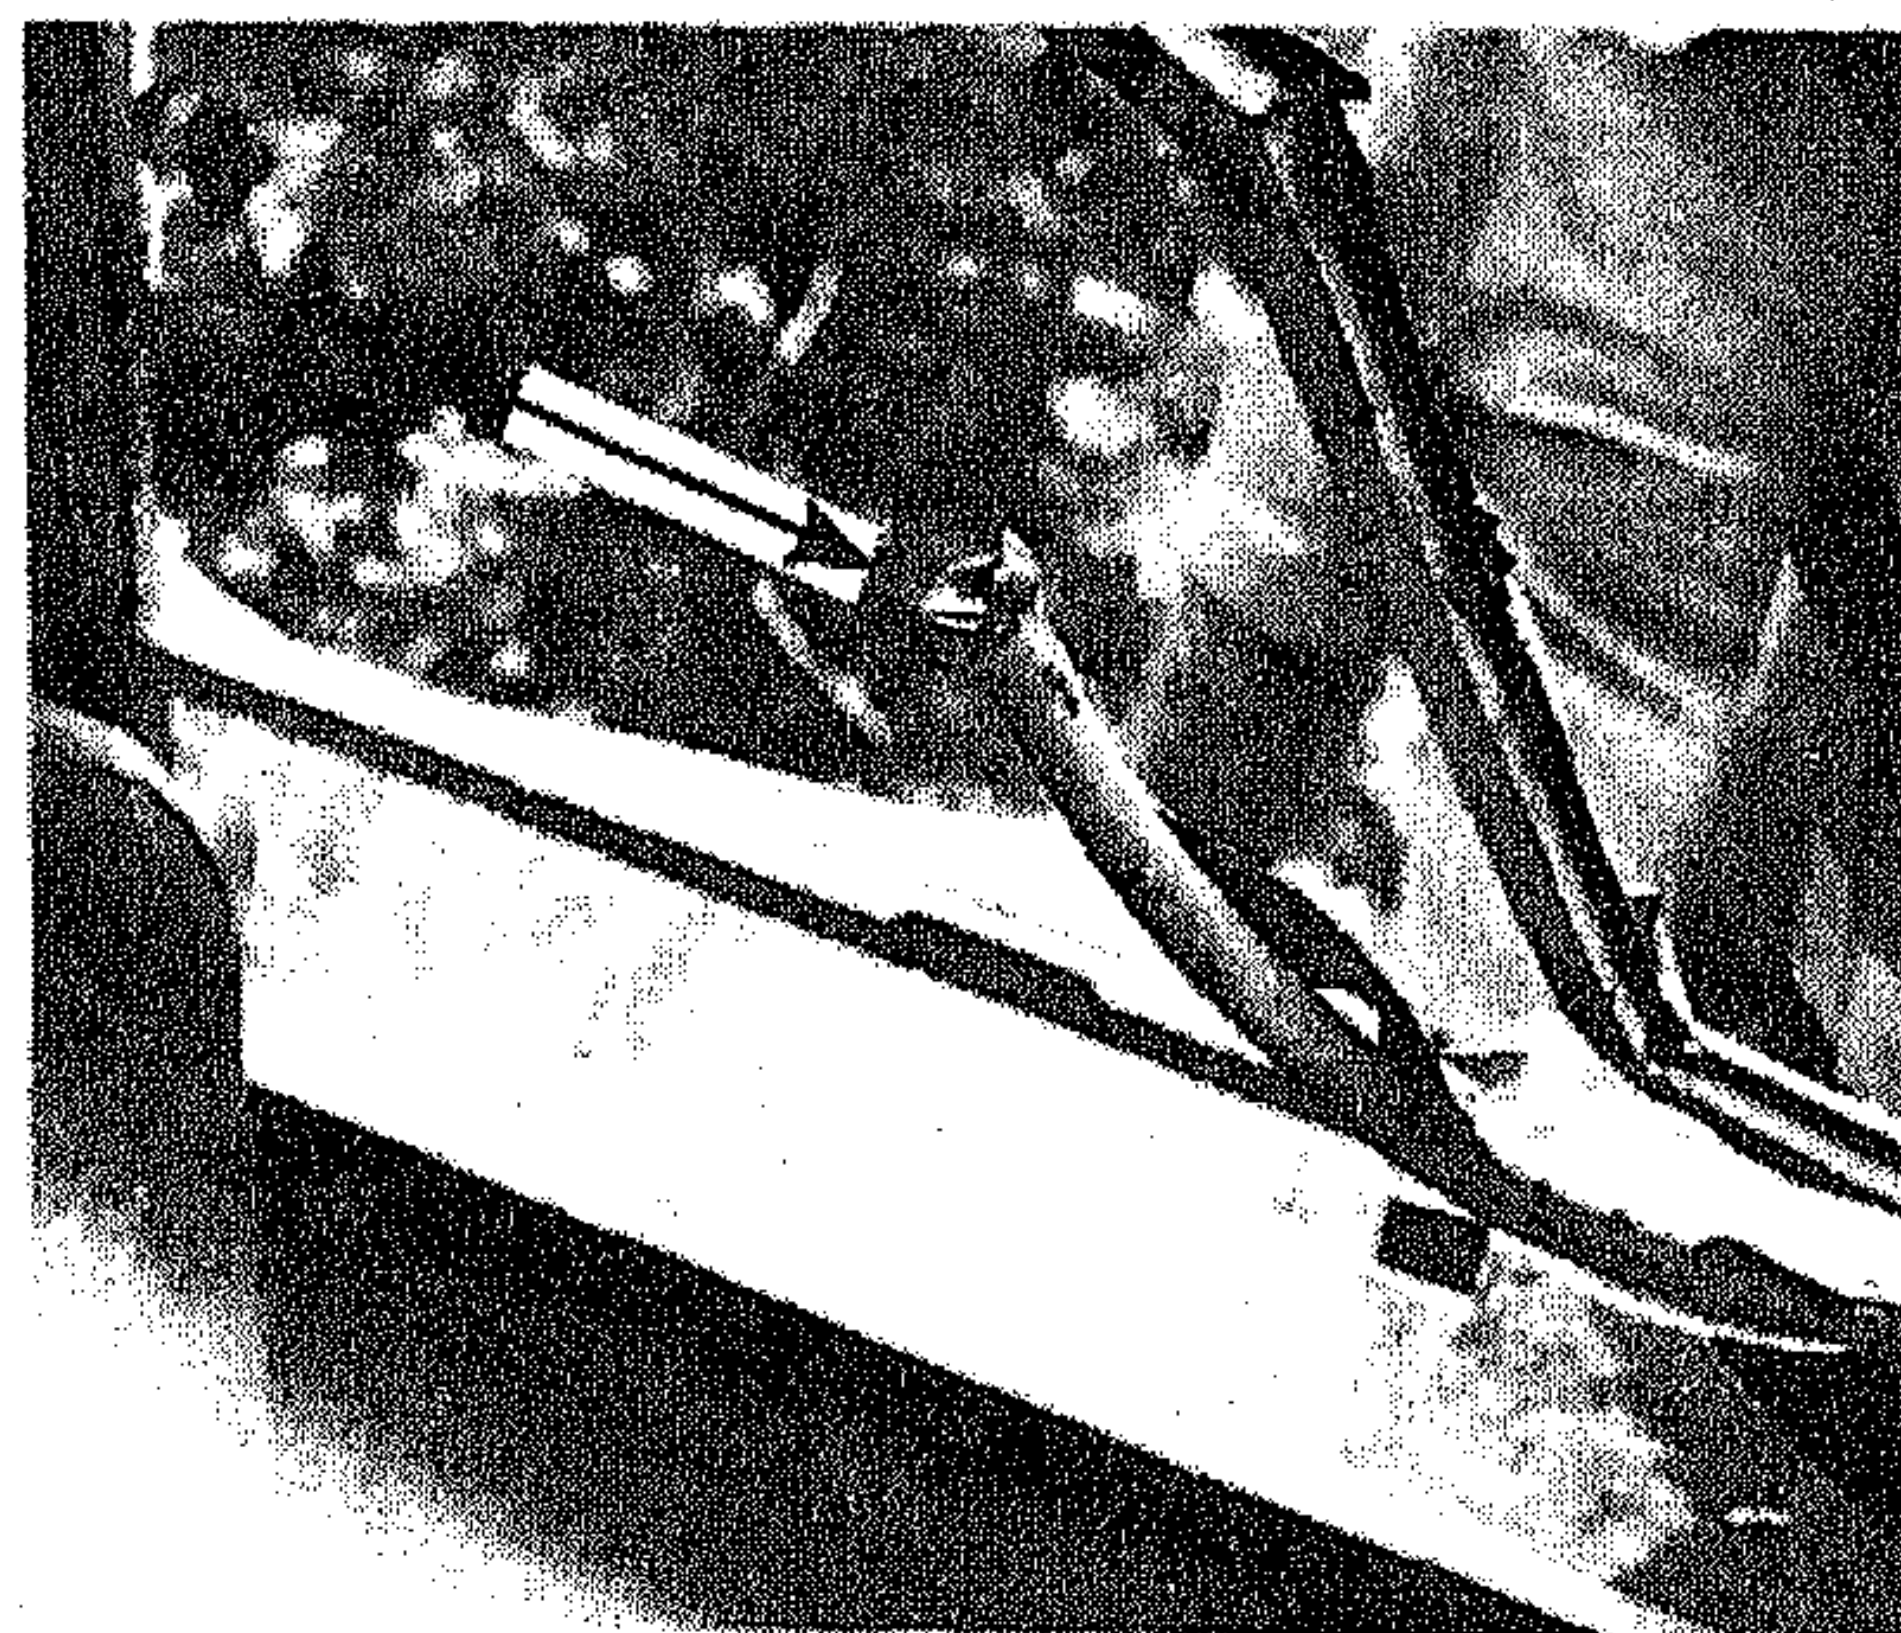
c. Broken weld joint of vertical bar formed sharp cutting edge (see arrow).

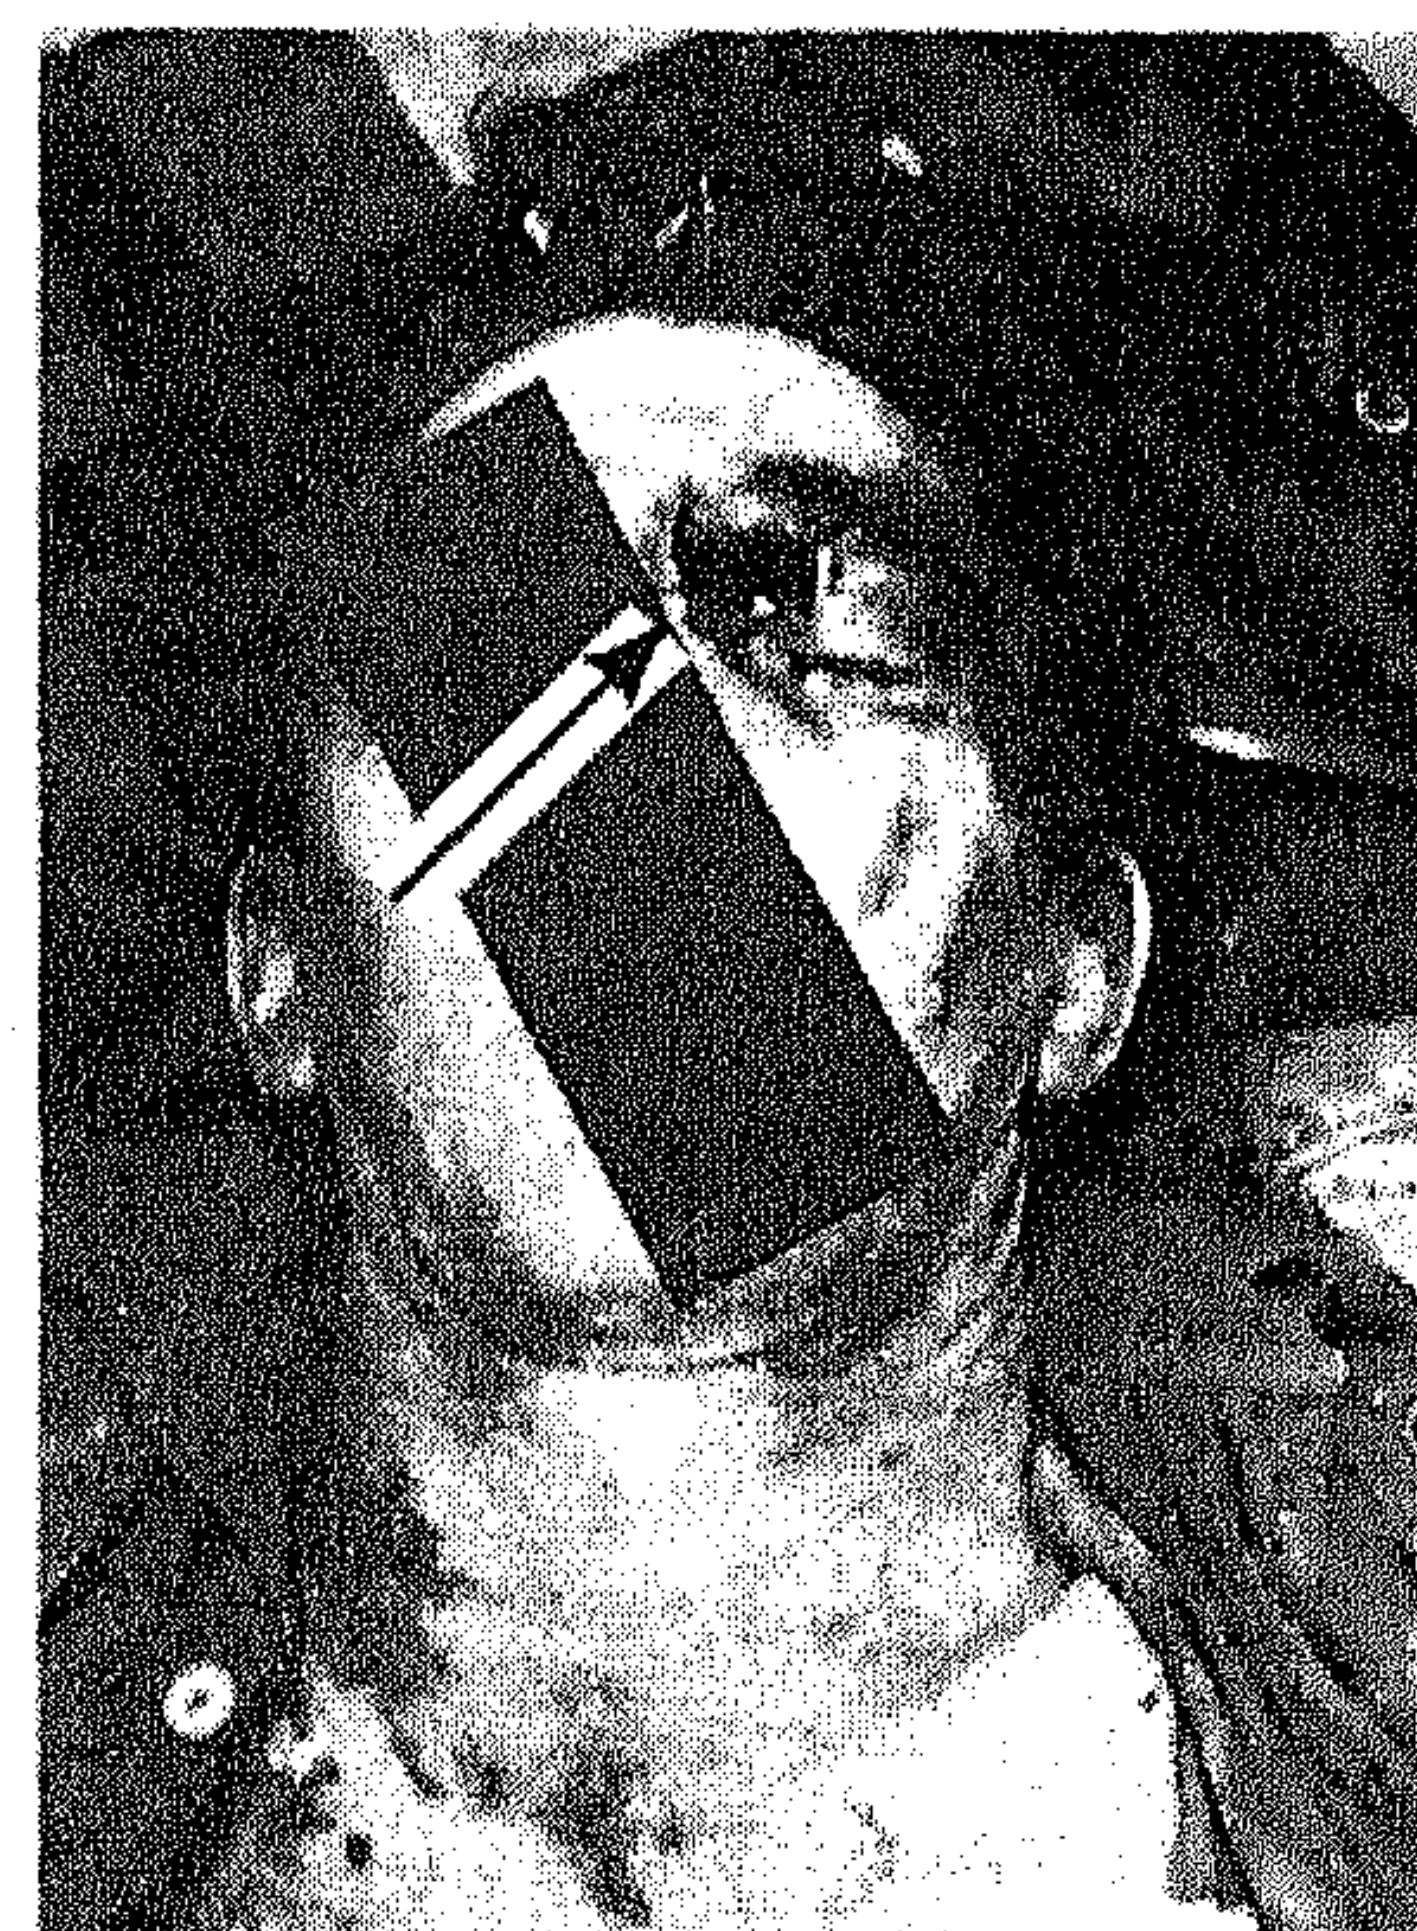
**Case 6:** A 1964 model Piper Pawnee descended through small trees and crashed in a river. The pilot, wearing his shoulder harness, lap belt and crash helmet, was subjected to relatively minor deceleration forces. However, the roll bar structure failed in the welded corners during impact with the trees forcing a sharp tube-end back into the cockpit (Case 6-b and c); the pilot sustained a fatal puncture wound just above his left eye (Case 6-d).

d. Puncture wound (fatal) just below edge of helmet inflicted as broken roll bar was forced down and to the rear into the cockpit.

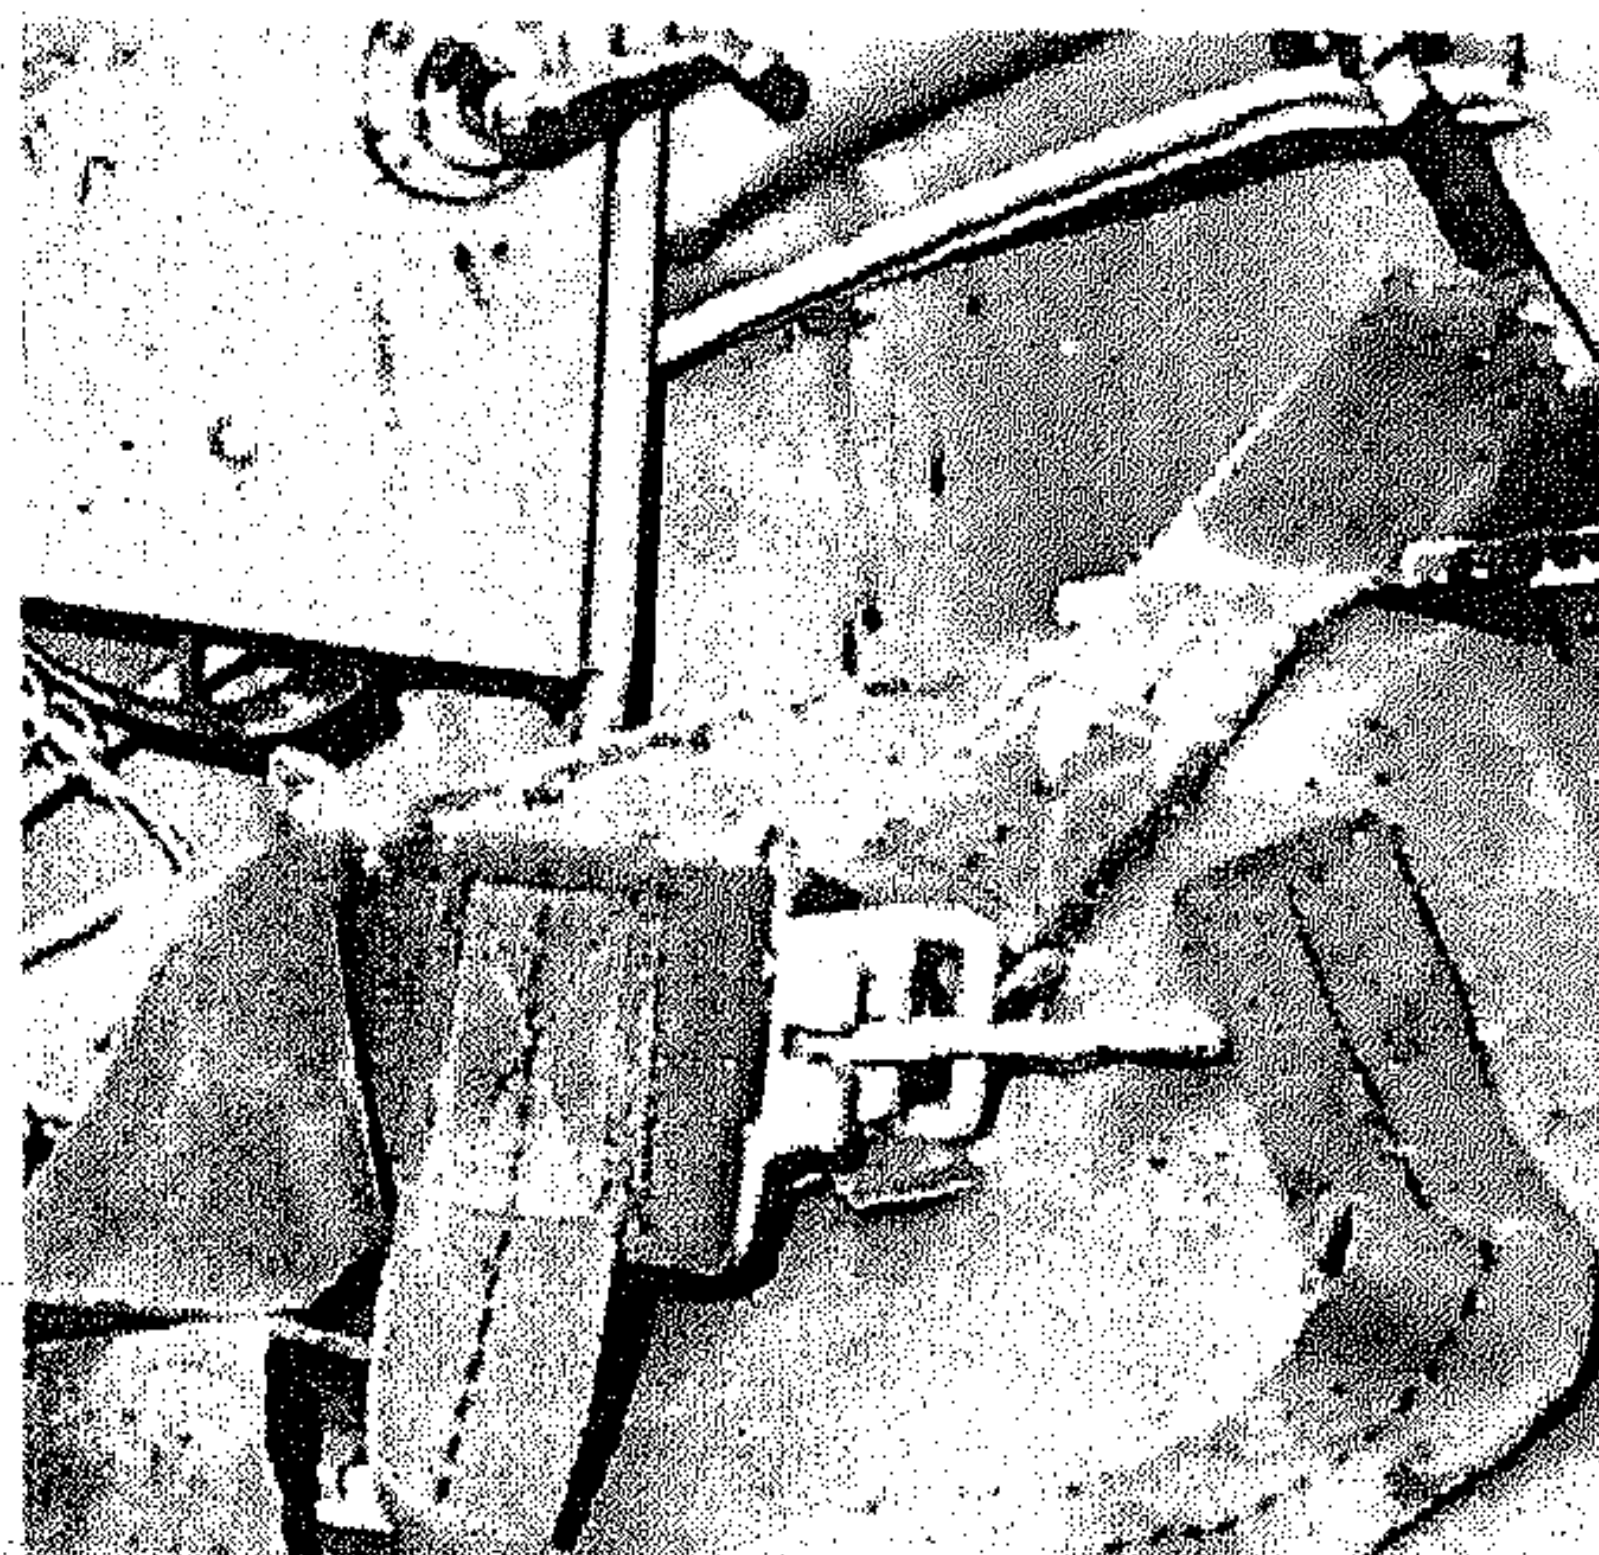
**Case 7:** Although most lap belts and shoulder harness straps are not marked with a manufacturing date, it is believed the pilot of this 1964 Piper Pawnee was wearing restraint equipment probably manufactured during World War II. If this is true, the webbing was 25-30 years old. Since the 25-G hopper (and cockpit) were undamaged, it may be assumed the cockpit deceleration was less than 25 G's—yet both shoulder straps failed about six inches ahead of the cable attachment point (The lap belt held).

b. Both shoulder straps broken, lap belt held.

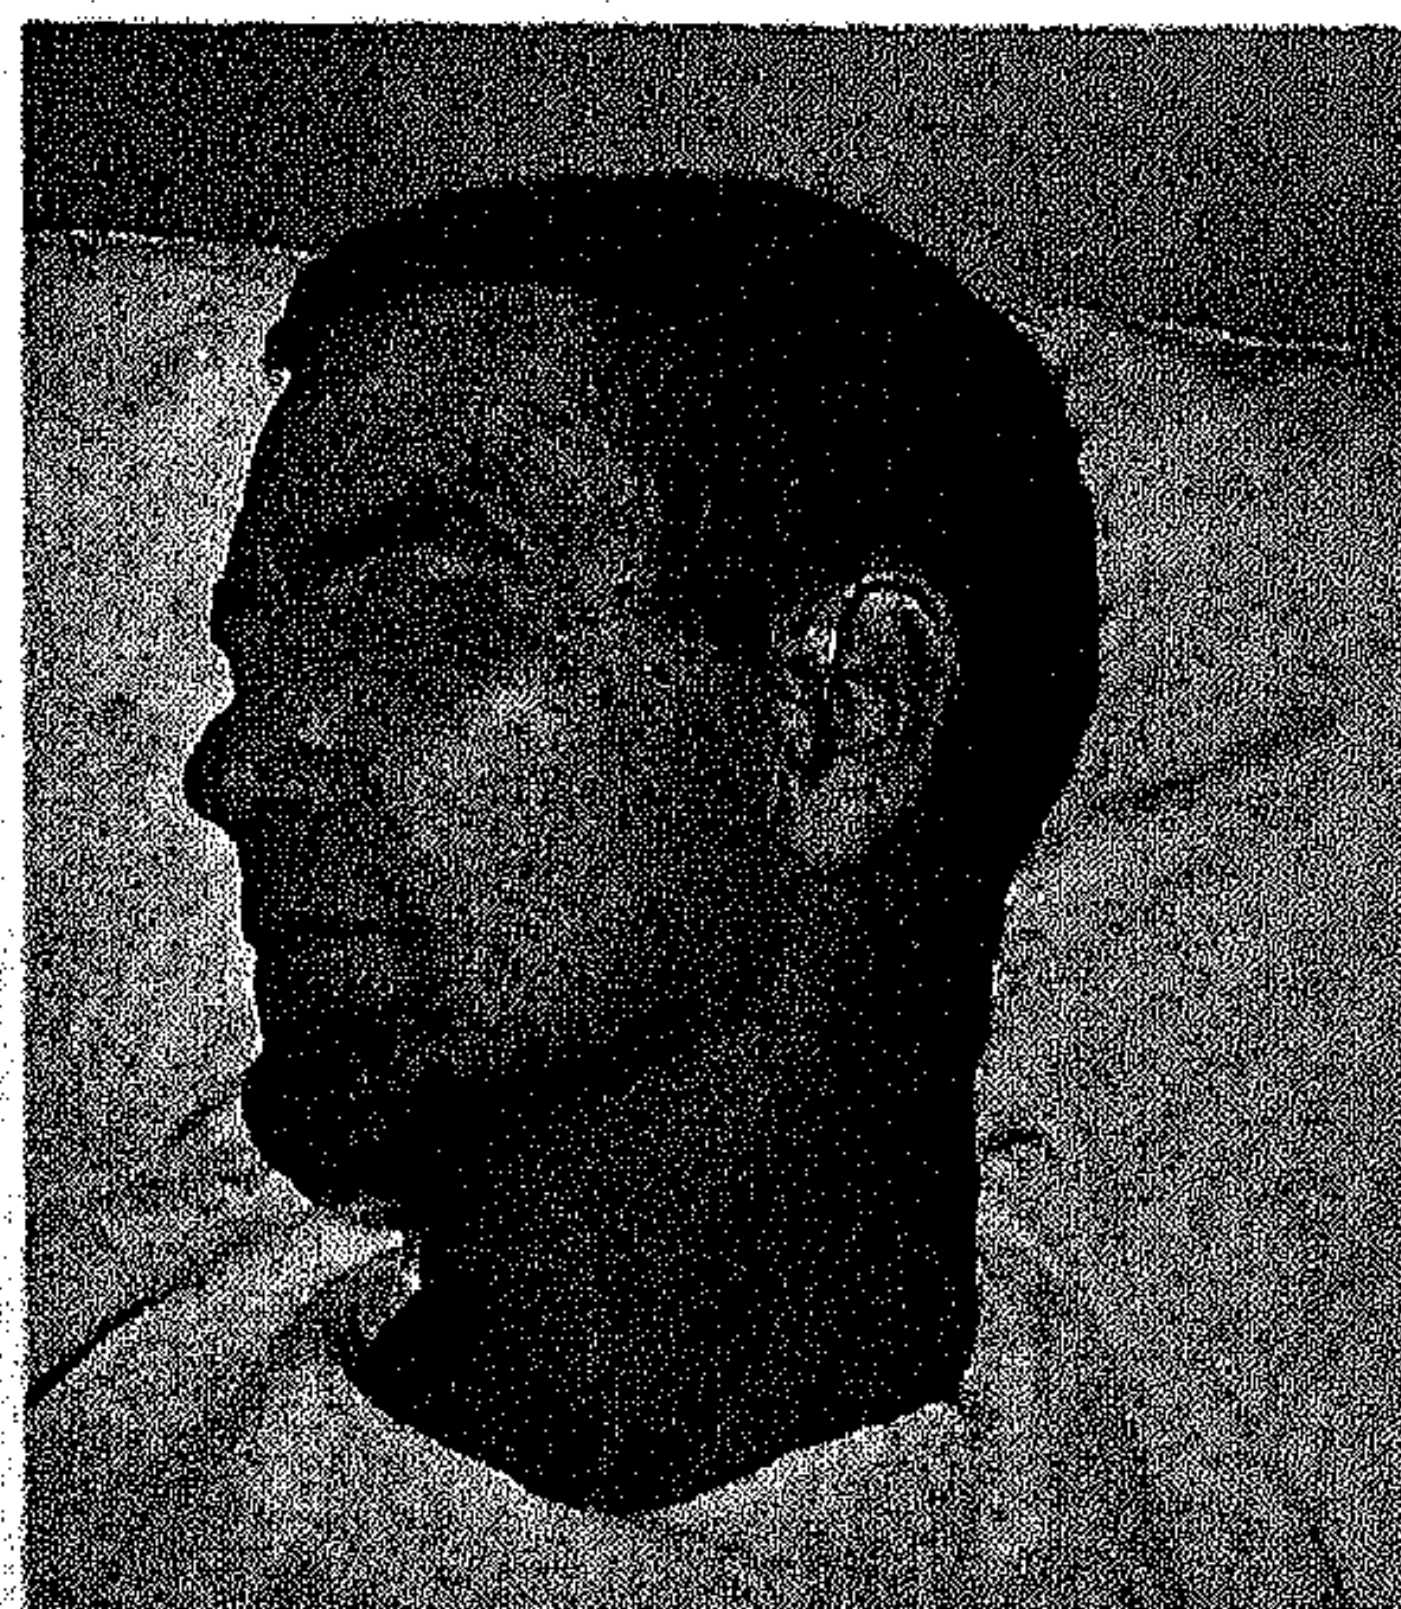
d. Photograph showing cut on pilot's chin from contact with altimeter reset knob.
