| 1. Report No.<br>FAA-AM-72-15 | 2. Government Accession No. | 3. Recipient's Catalog No. | |
| 4. Title and Subtitle<br>CRASH SURVIVAL ANALYSIS OF 16 AGRICULTURAL<br>AIRCRAFT ACCIDENTS | | 5. Report Date<br>April 1972 | |
| 7. Author(s)<br>J. J. Swearingen, D. Av. T.; T. F. Wallace;<br>J. G. Blethrow; and D. E. Rowlan | | 8. Performing Organization Report No. | |

# CRASH SURVIVAL ANALYSIS OF 16 AGRICULTURAL AIRCRAFT ACCIDENTS

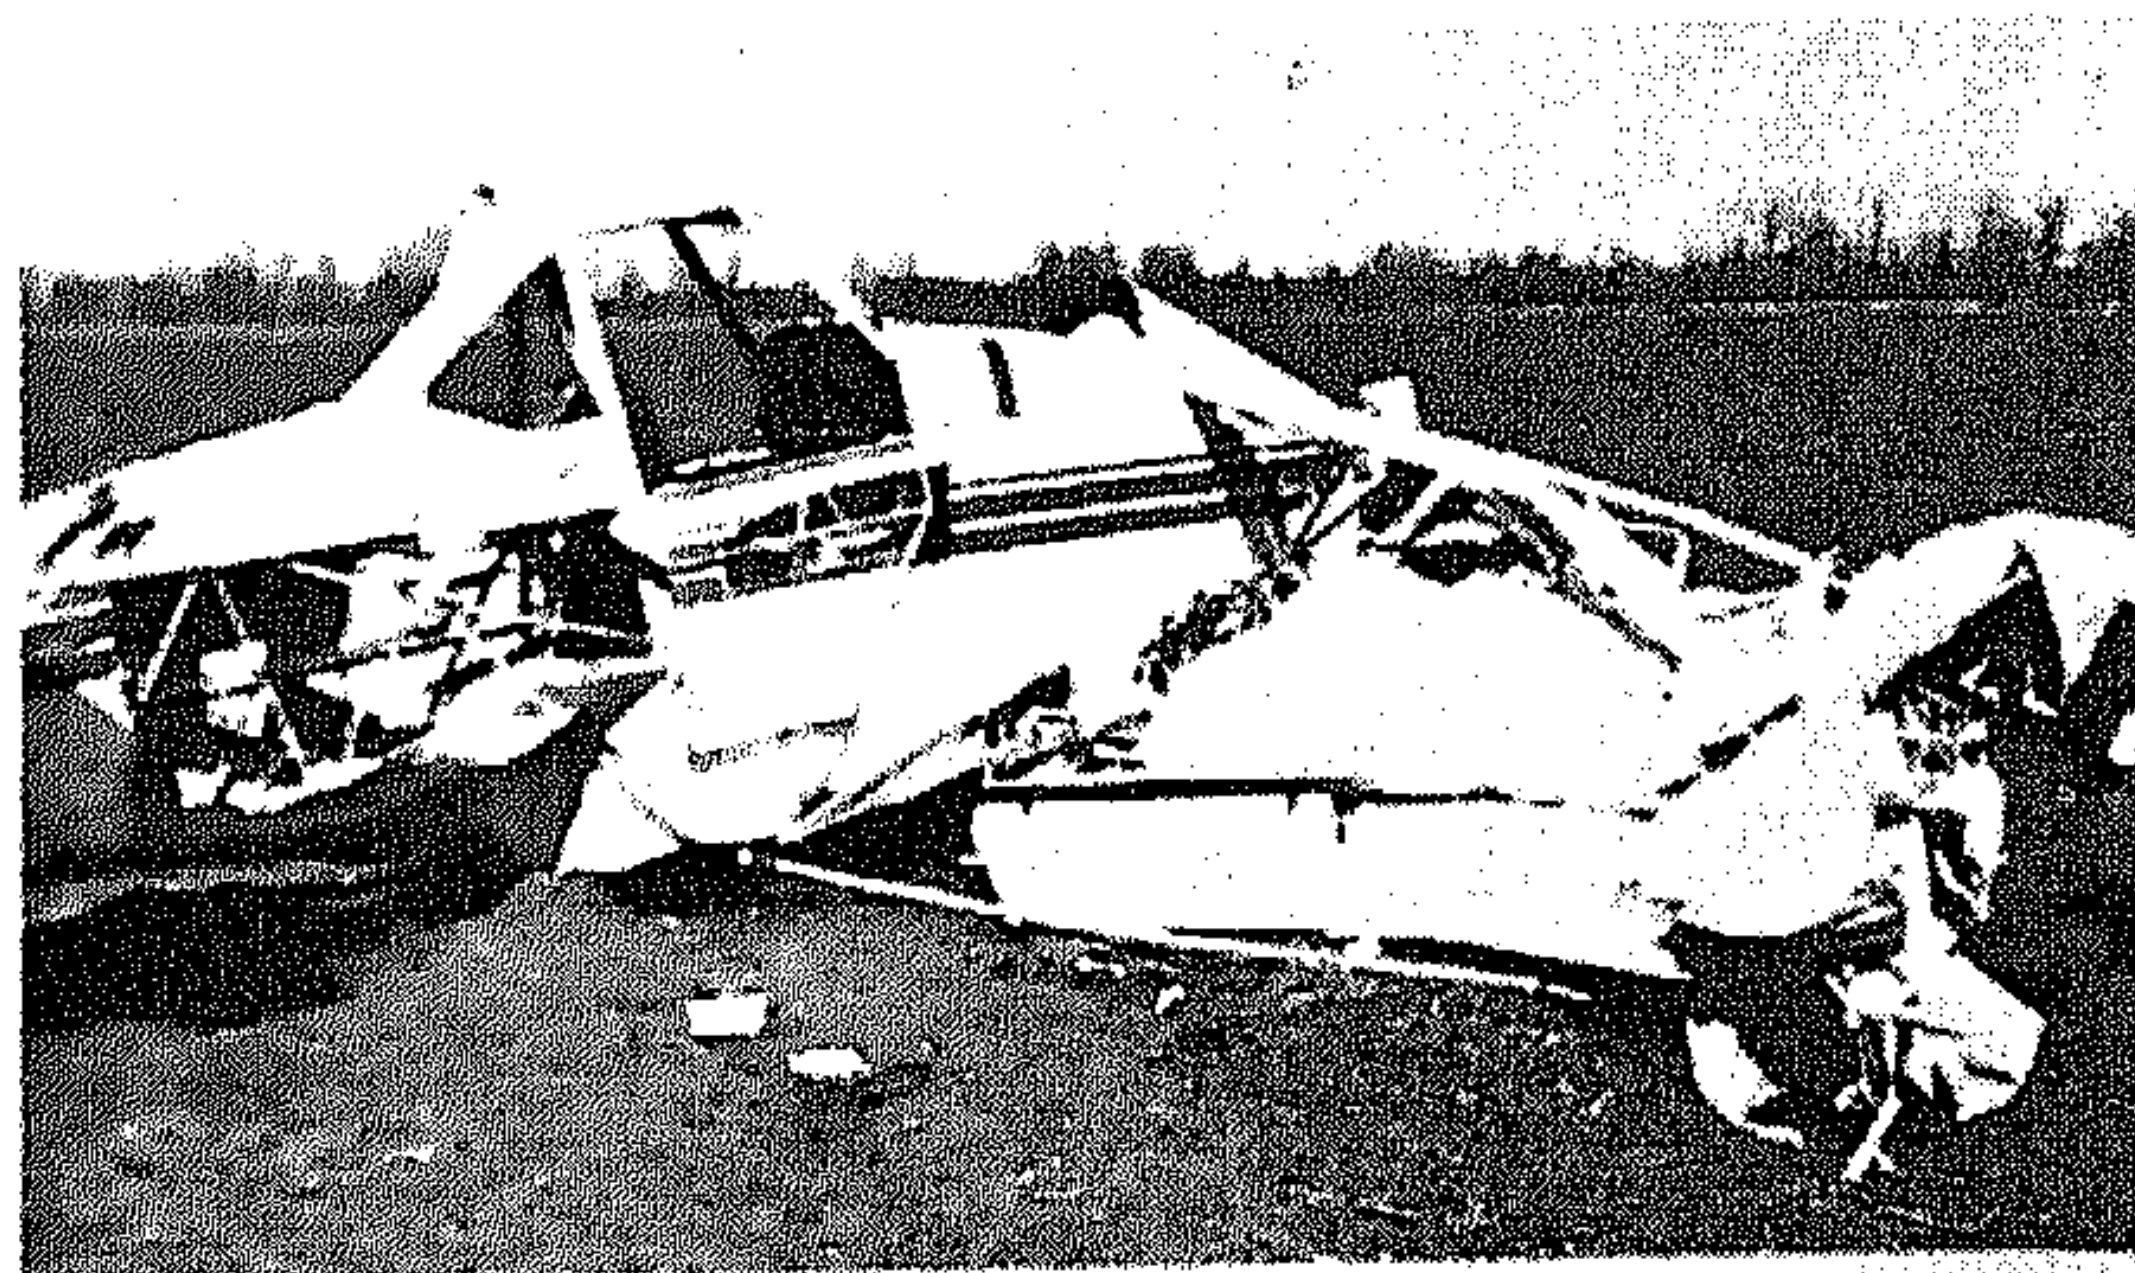
a. Side view of aircraft showing considerable damage to right wing, motor mount, and lower fuselage tubing to the rear of the cockpit.

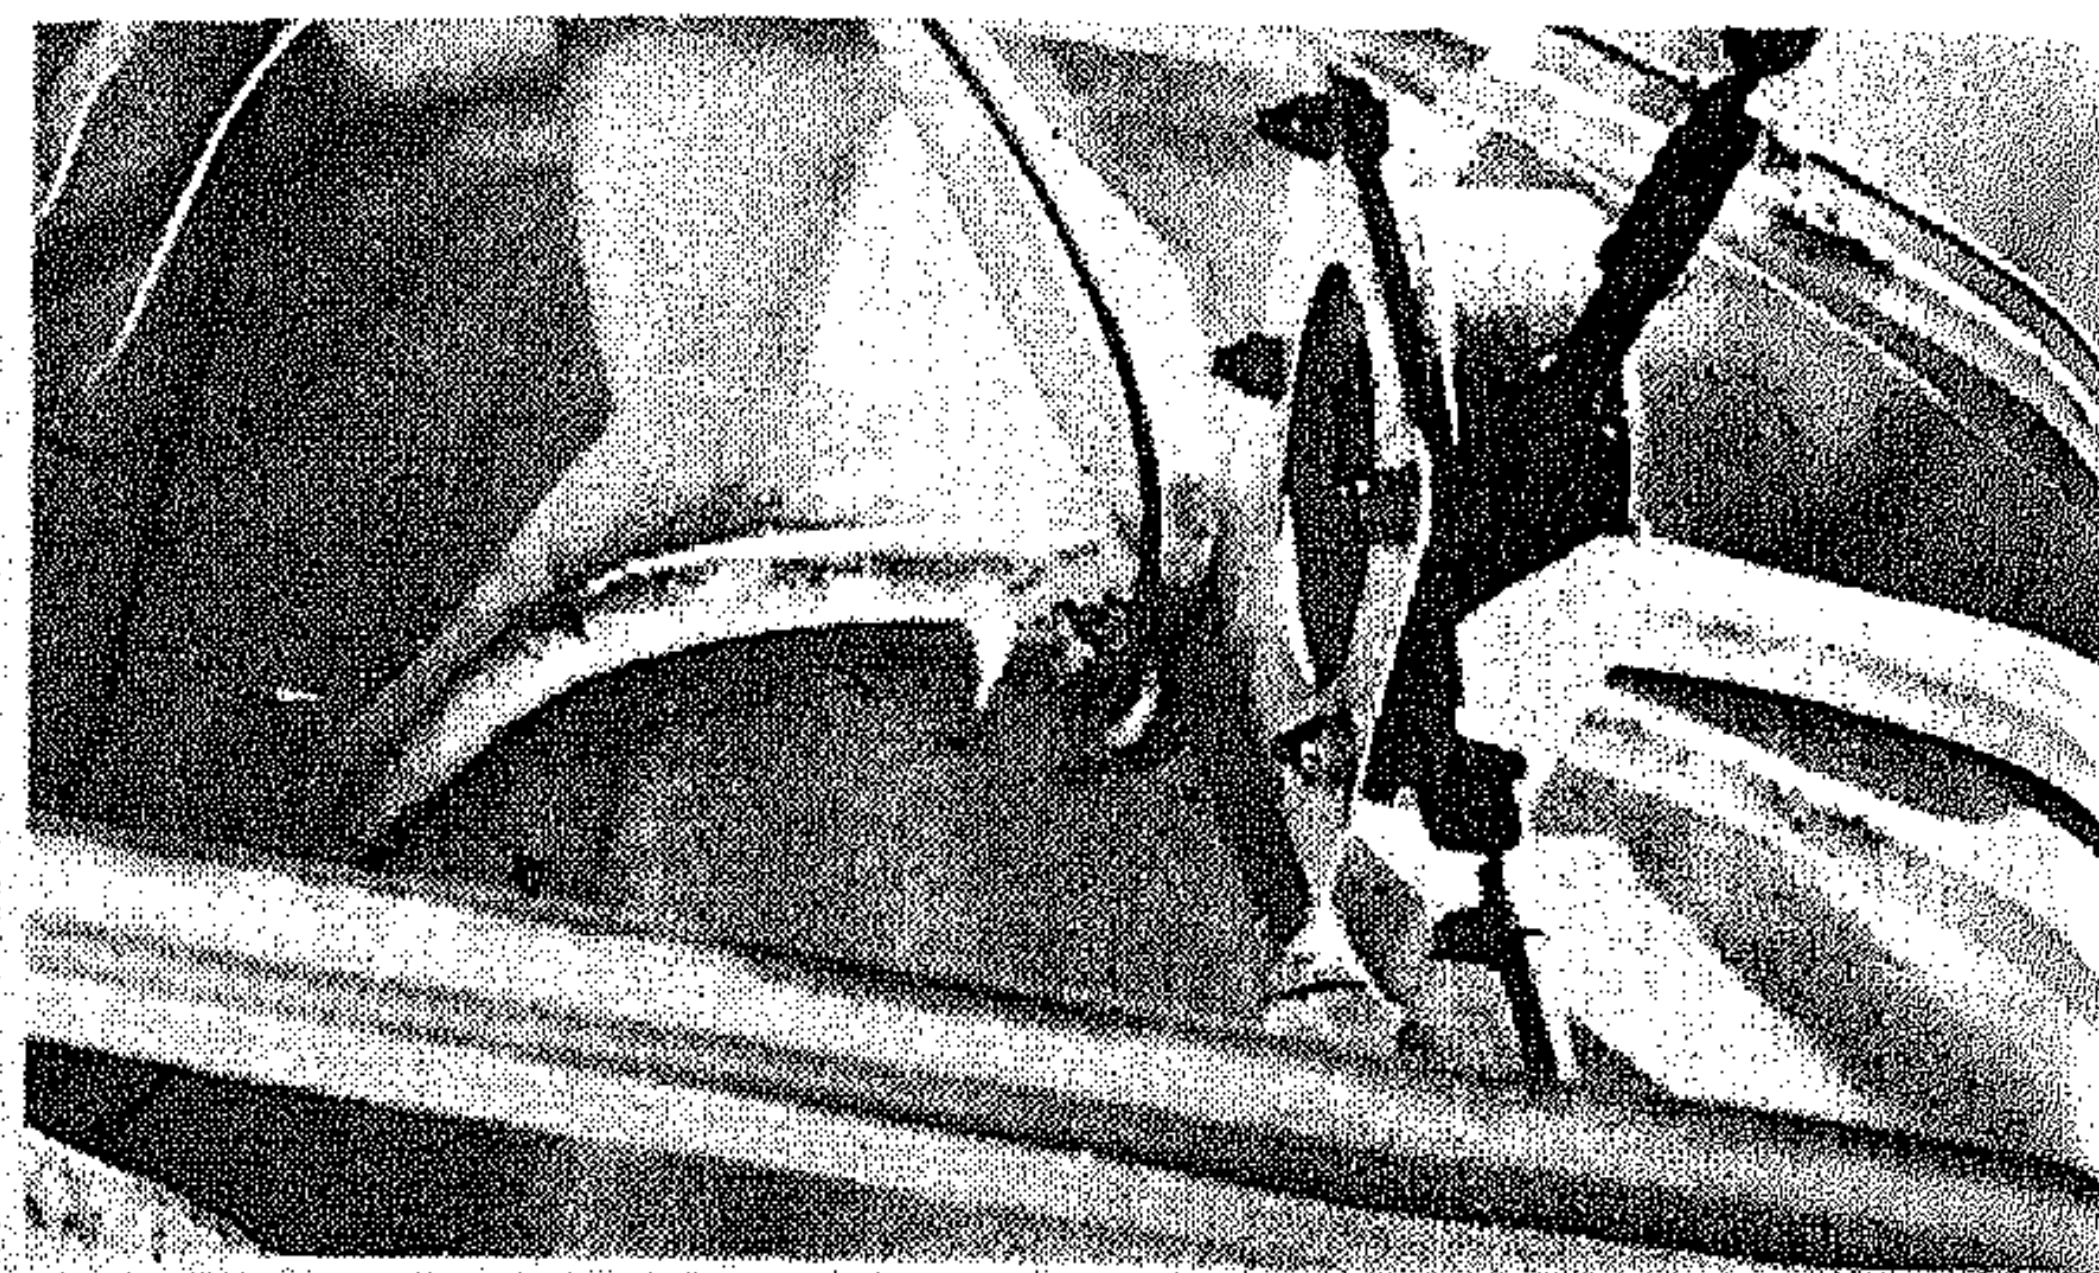
**Case 8:** The crash force and structural damage involved in the 1969 Pawnee case shown here appear to be similar to those related to the 1964 model described in Case 7. However, this aircraft (manufactured five years later) may have been equipped with a newer shoulder harness. It is also noteworthy that while the lower ends of the shoulder straps are sewn to the lap belt, they are also wrapped around the belt and sewn all the way through (Case 8-c), as compared to Cases 2, 3, and 9, in which the shoulder straps are stitched to only one face of the belt. Surprisingly, although the pilot was wearing both shoulder straps and lap belt and there was no failure of the webbing or cables, a head impact depression was found in the aluminum semicylinder at the top of the instrument panel (Case 8-d). In this aircraft the inertia reel and lap belt cables are attached to a cross tube in the lower fuselage, back of the seat. In this crash, the lower tube was buckled up (Case 8-b) allowing 10 inches of slack in the shoulder harness and

b. Upward bending of lower fuselage tubing at the attachment point of the inertia reel and right lap belt cable allowed 10 inches of slack and forward motion of the pilot.

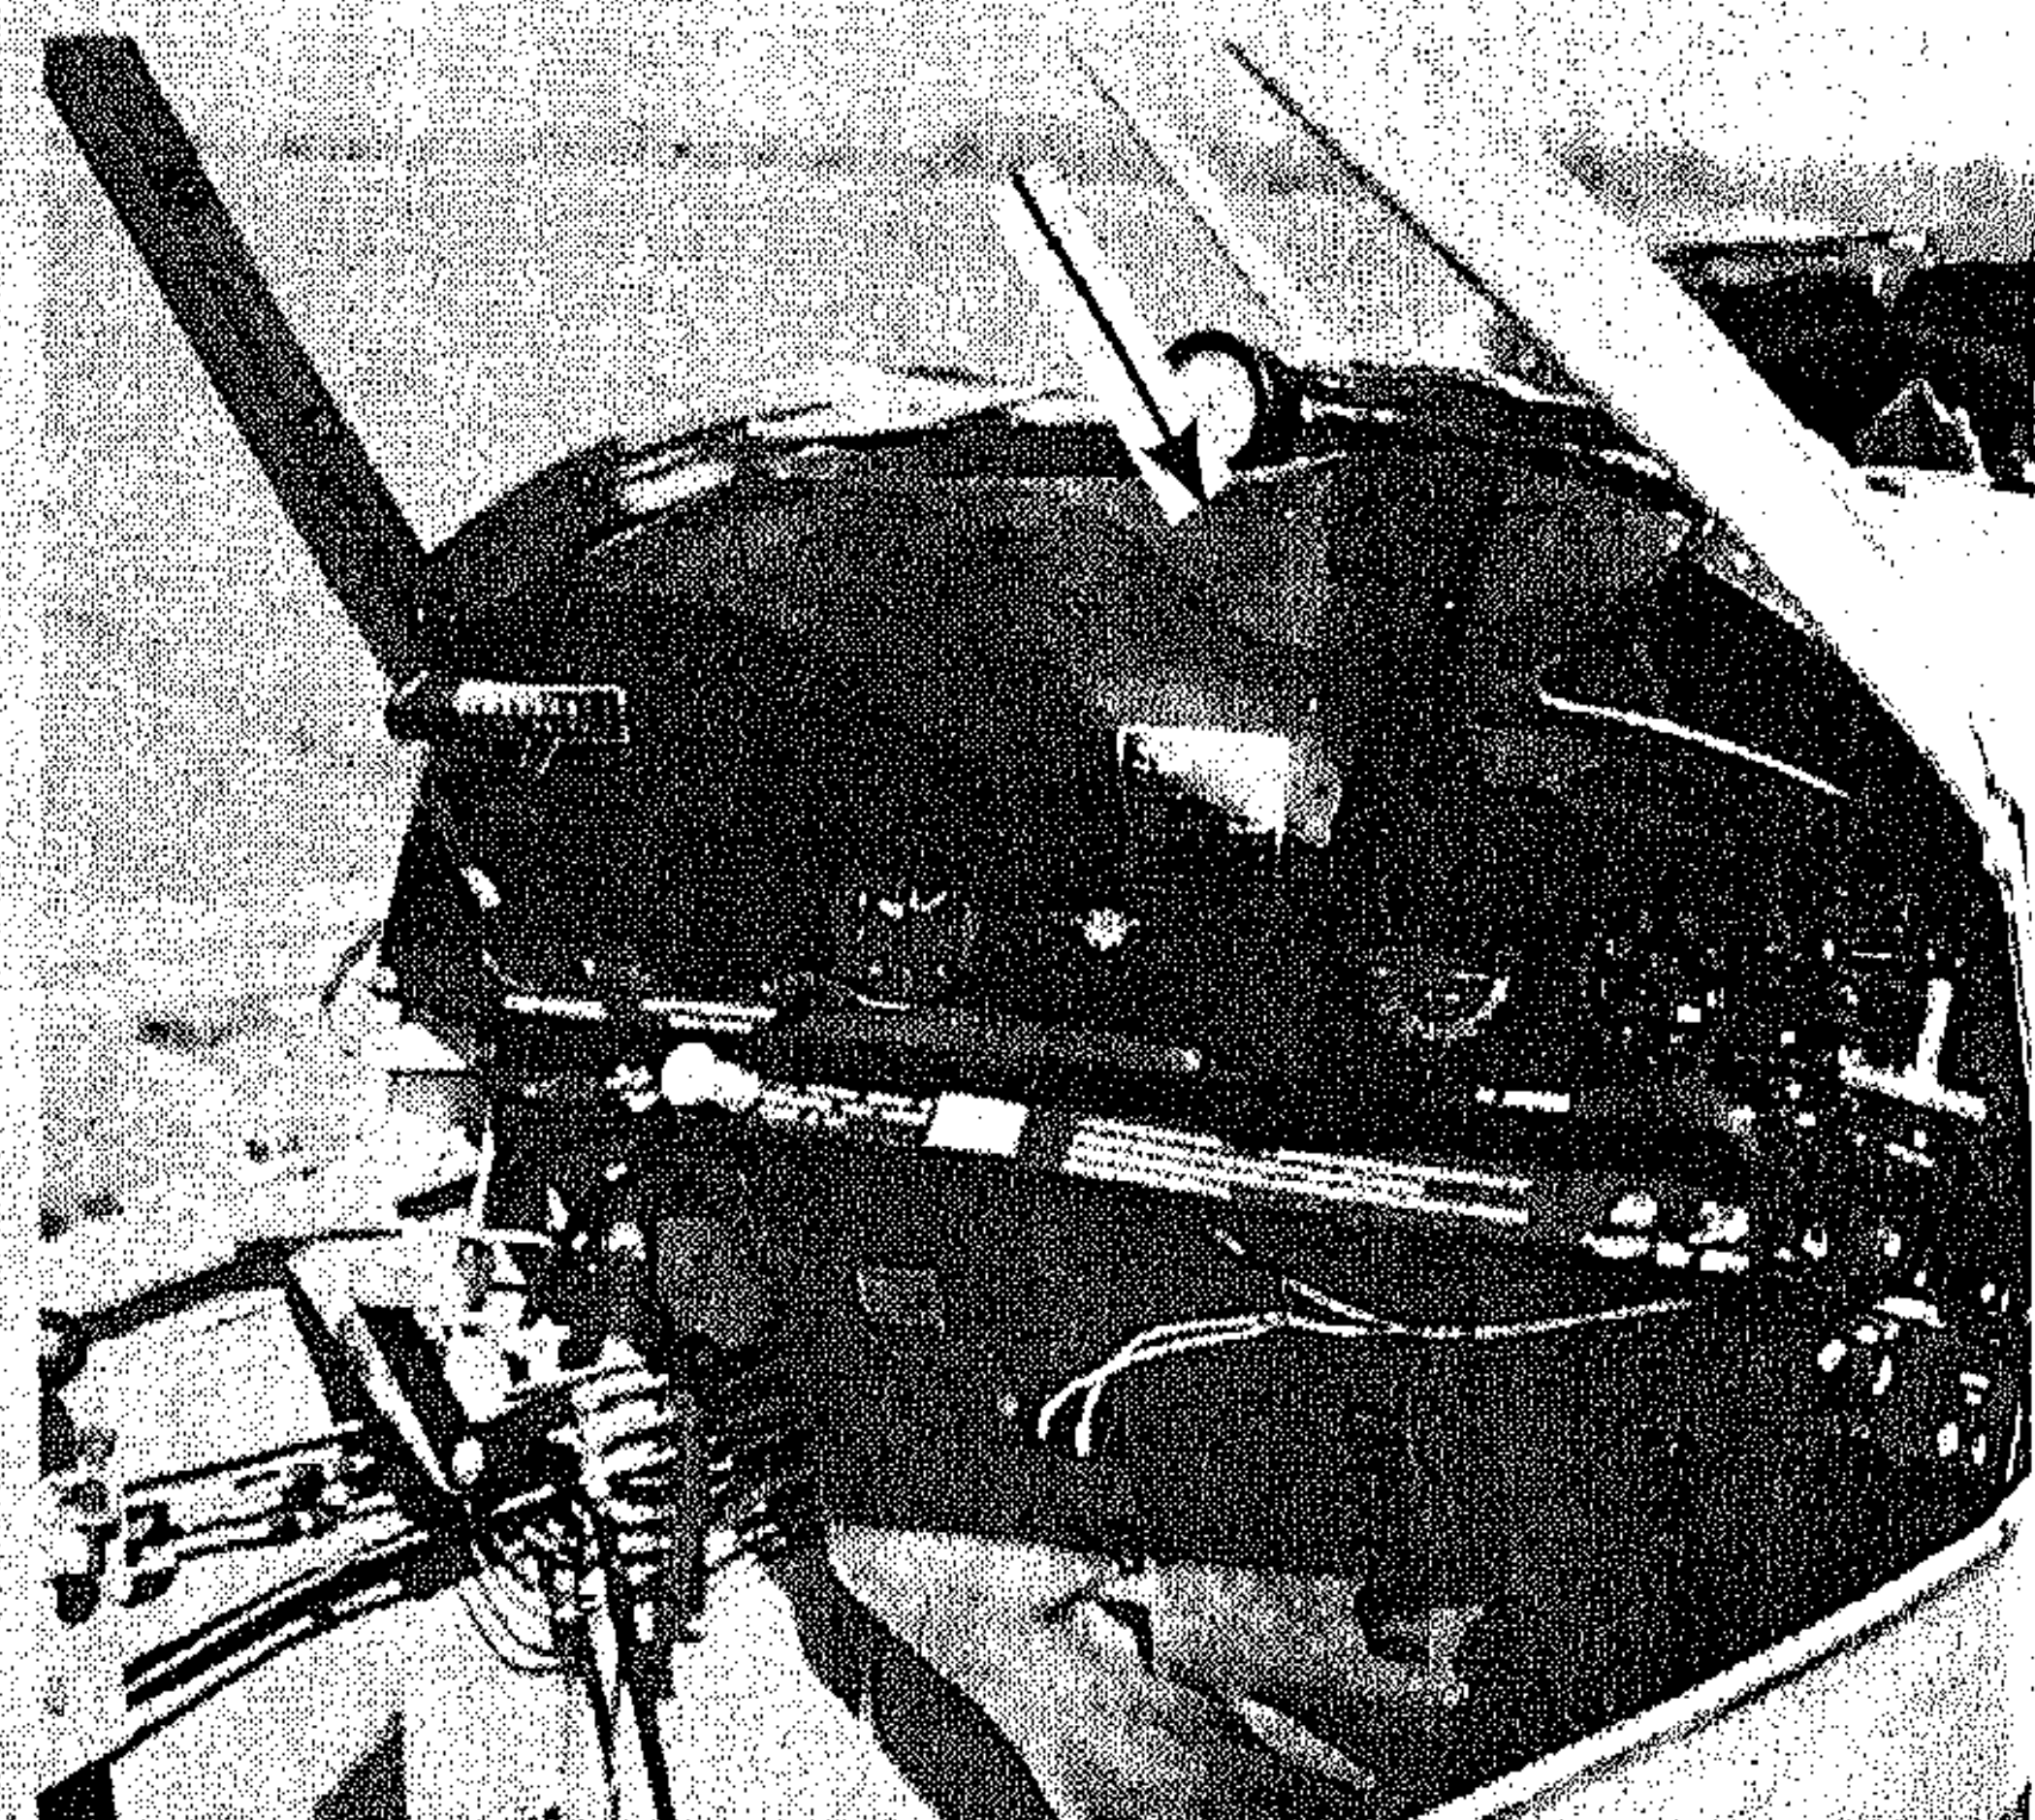
right half of the lap belt. This permitted the pilot to move forward, striking the top of his head on the broken windshield. The aluminum semicylinder undoubtedly prevented serious facial injuries.

d. As the restrained pilot moved forward and to the right in the cockpit, his head impacted the light aluminum roll at the top of the instrument panel (see arrow indicating dent) and his right knee contacted the lower instrument panel to the right of the RPM gage.

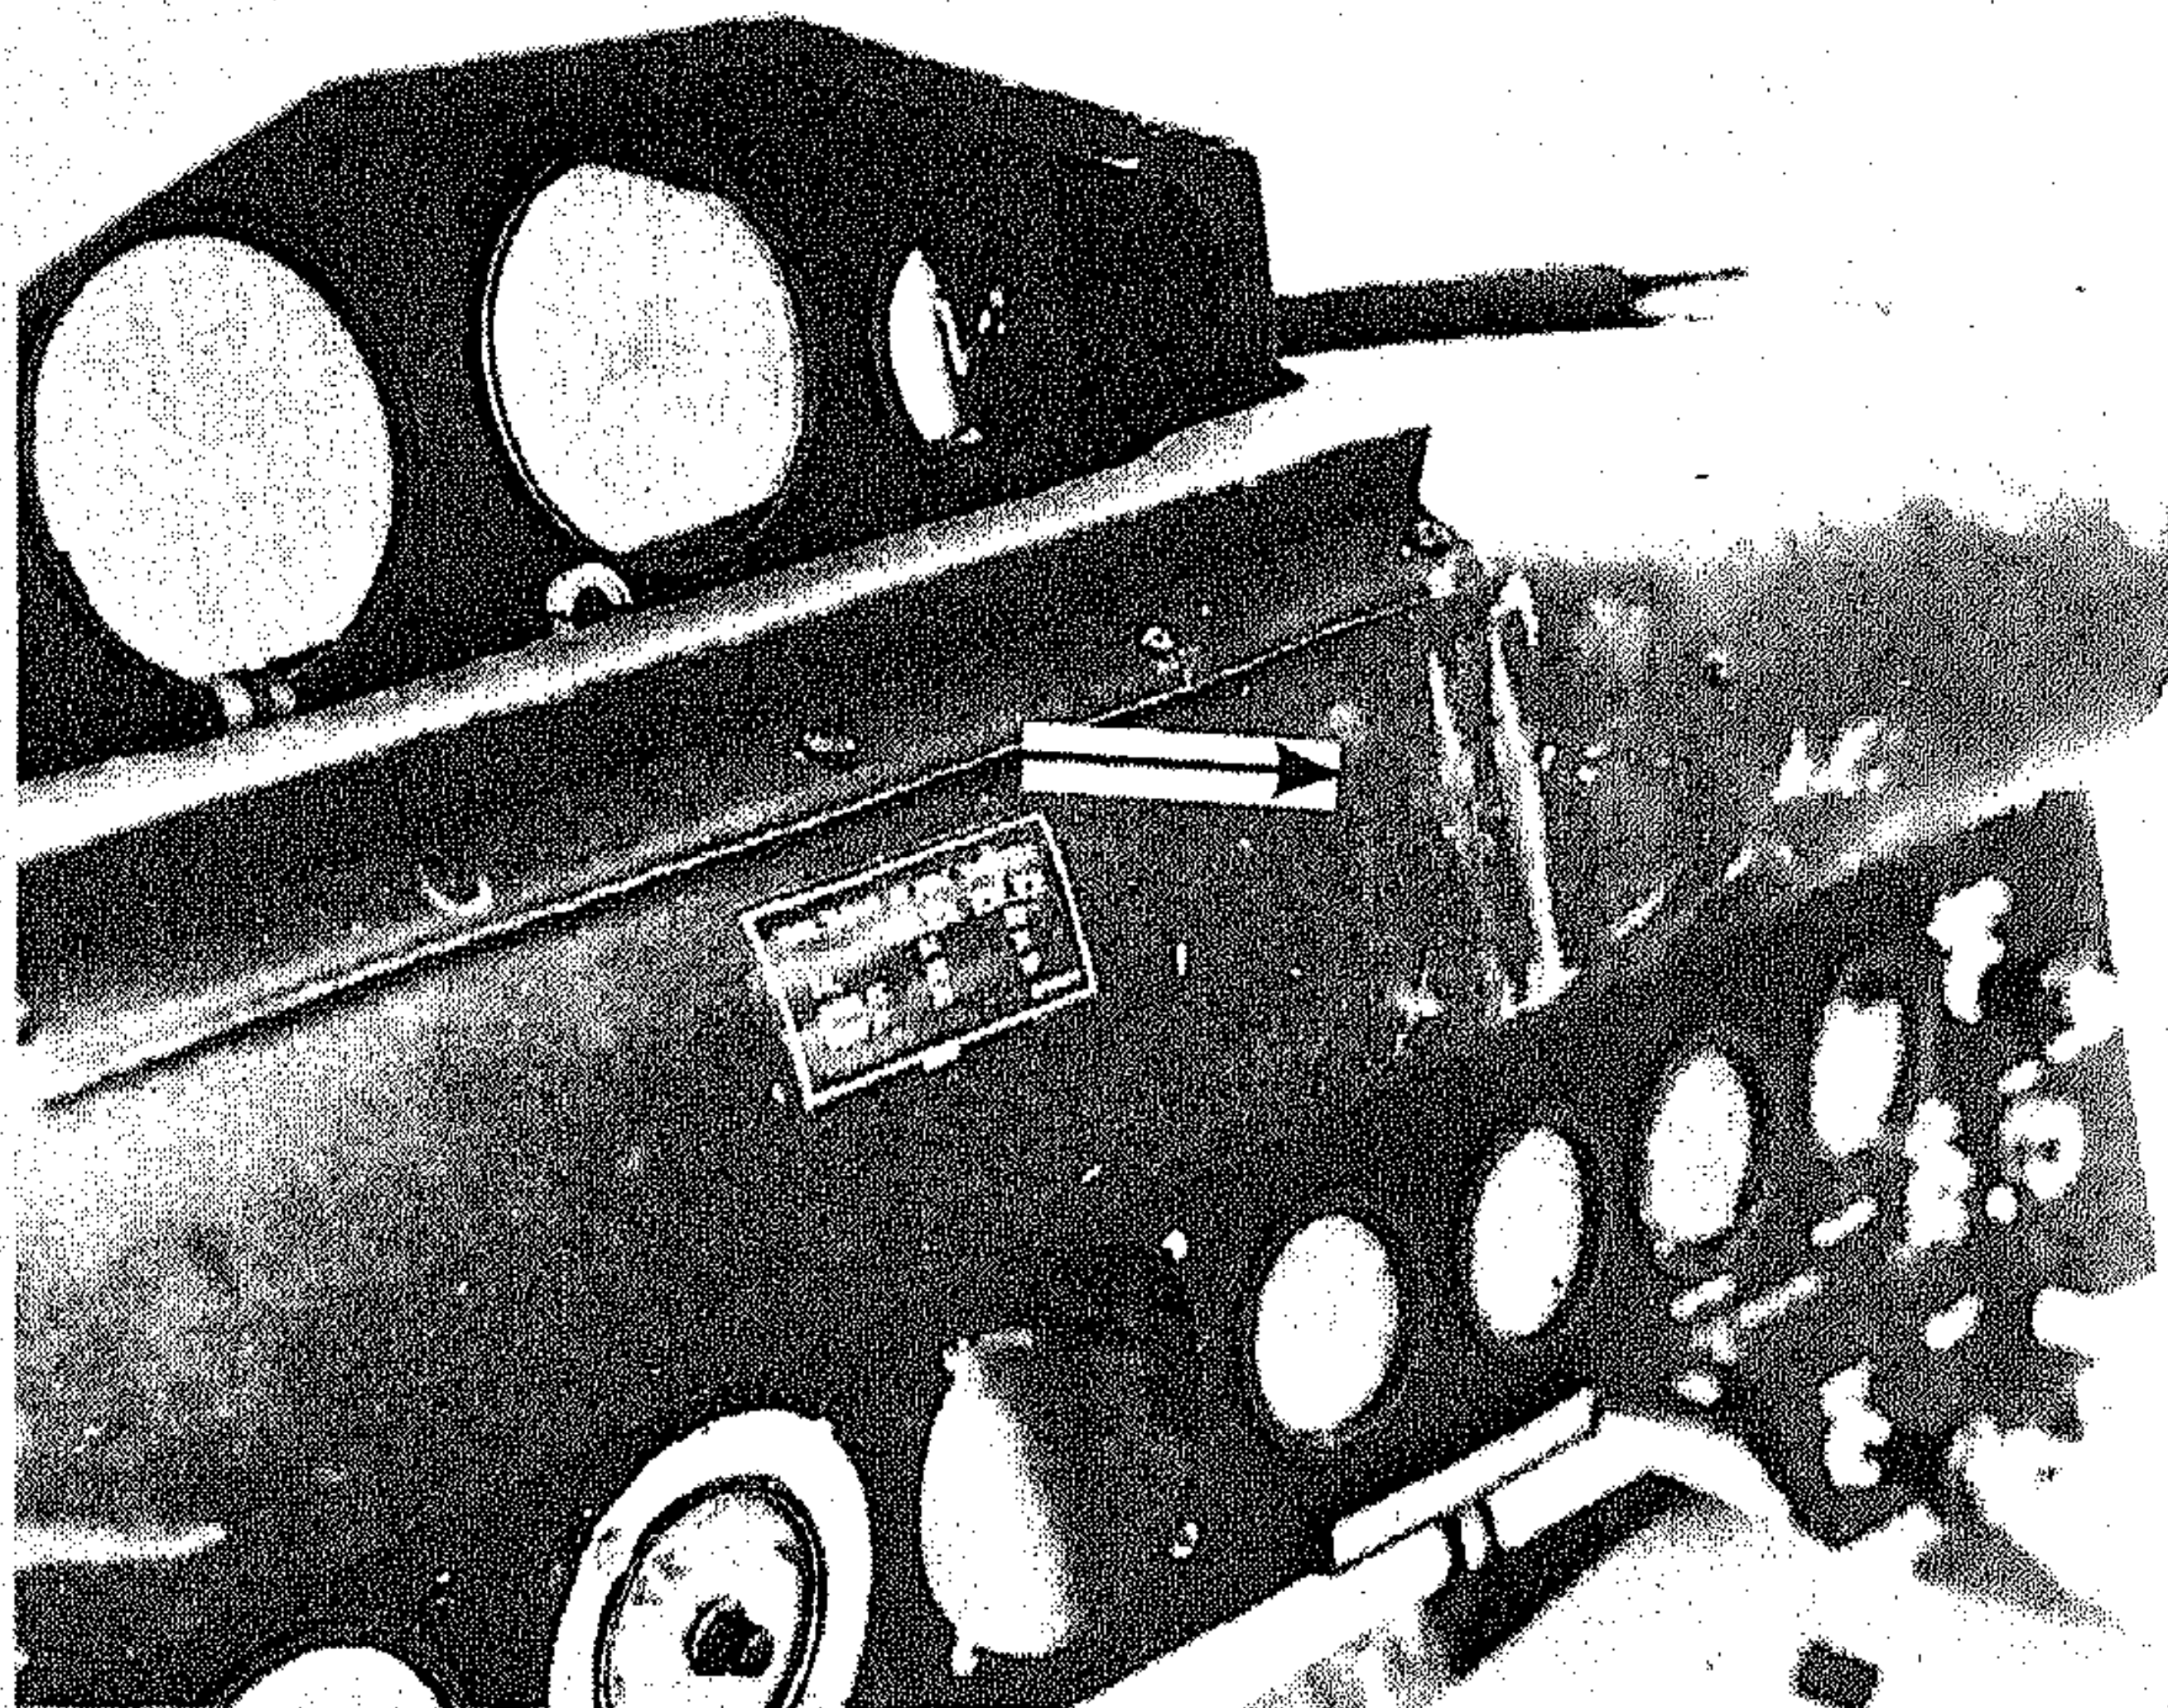
b. Pilot was wearing his shoulder straps loosely, allowing his head to strike the aluminum roll (see arrow).

Pilot of this aircraft received only minor bruises. Severe to fatal injuries could have occurred had his head struck instrument panel not equipped with the light aluminum roll. However, since the cabin & restraint systems remained completely intact, he would not have experienced a head impact had he been wearing his restraint equipment snugly. On the other hand, note that in fig. c above, this aircraft was not equipped with an inertia reel & the pilot probably wore his shoulder straps loosely for maneuverability. All shoulder straps should be attached to inertia reels to avoid this situation.

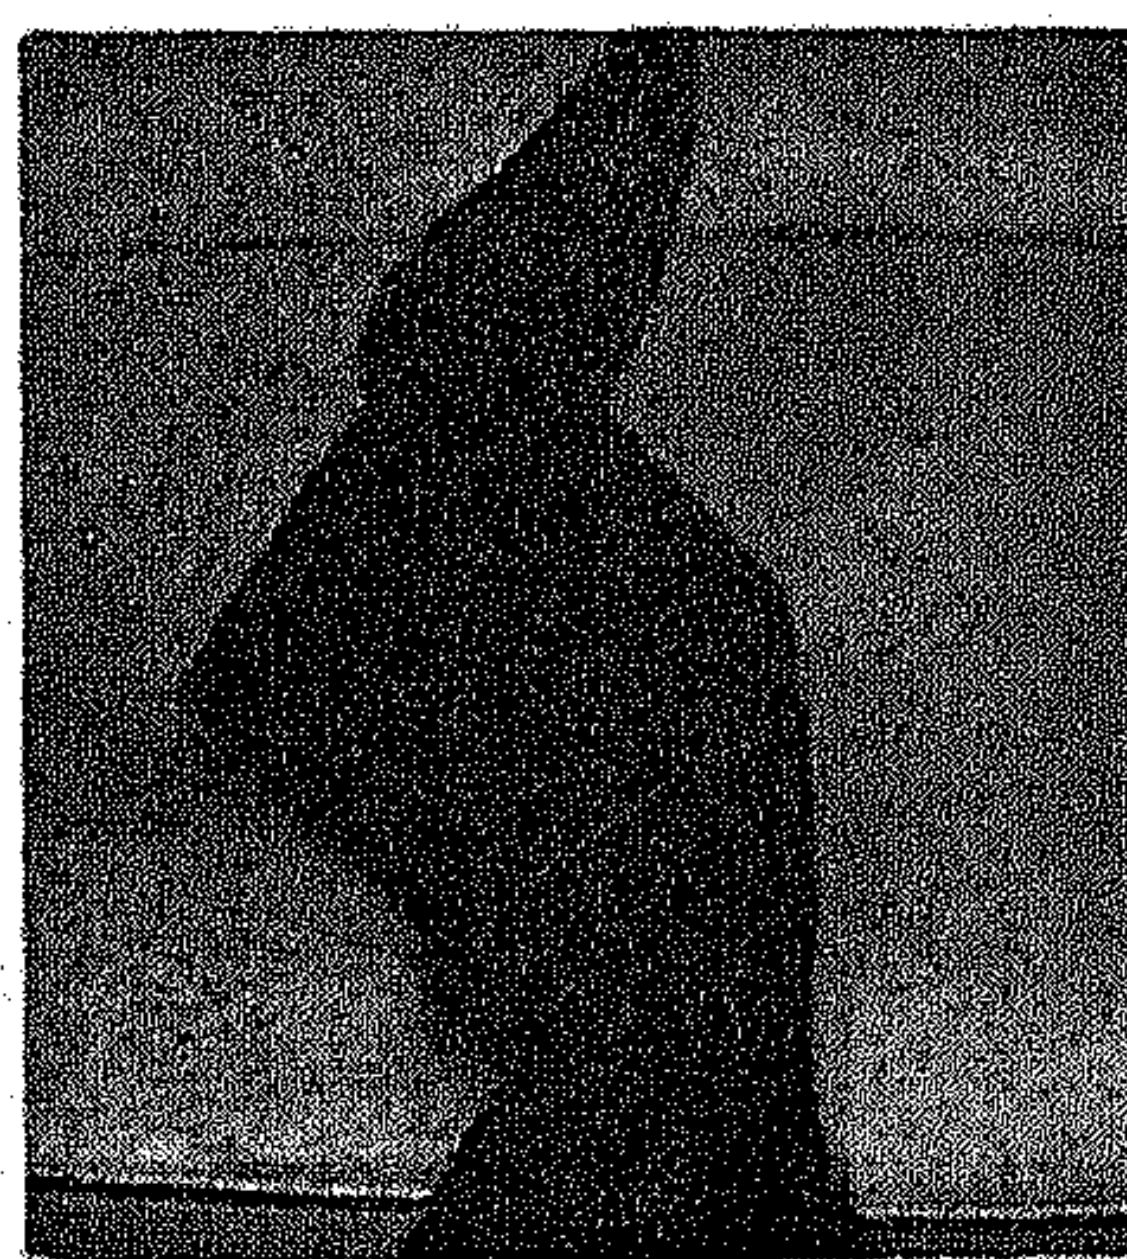
e. As in previous cases, shoulder straps stitched to belt surface, but did not fail.

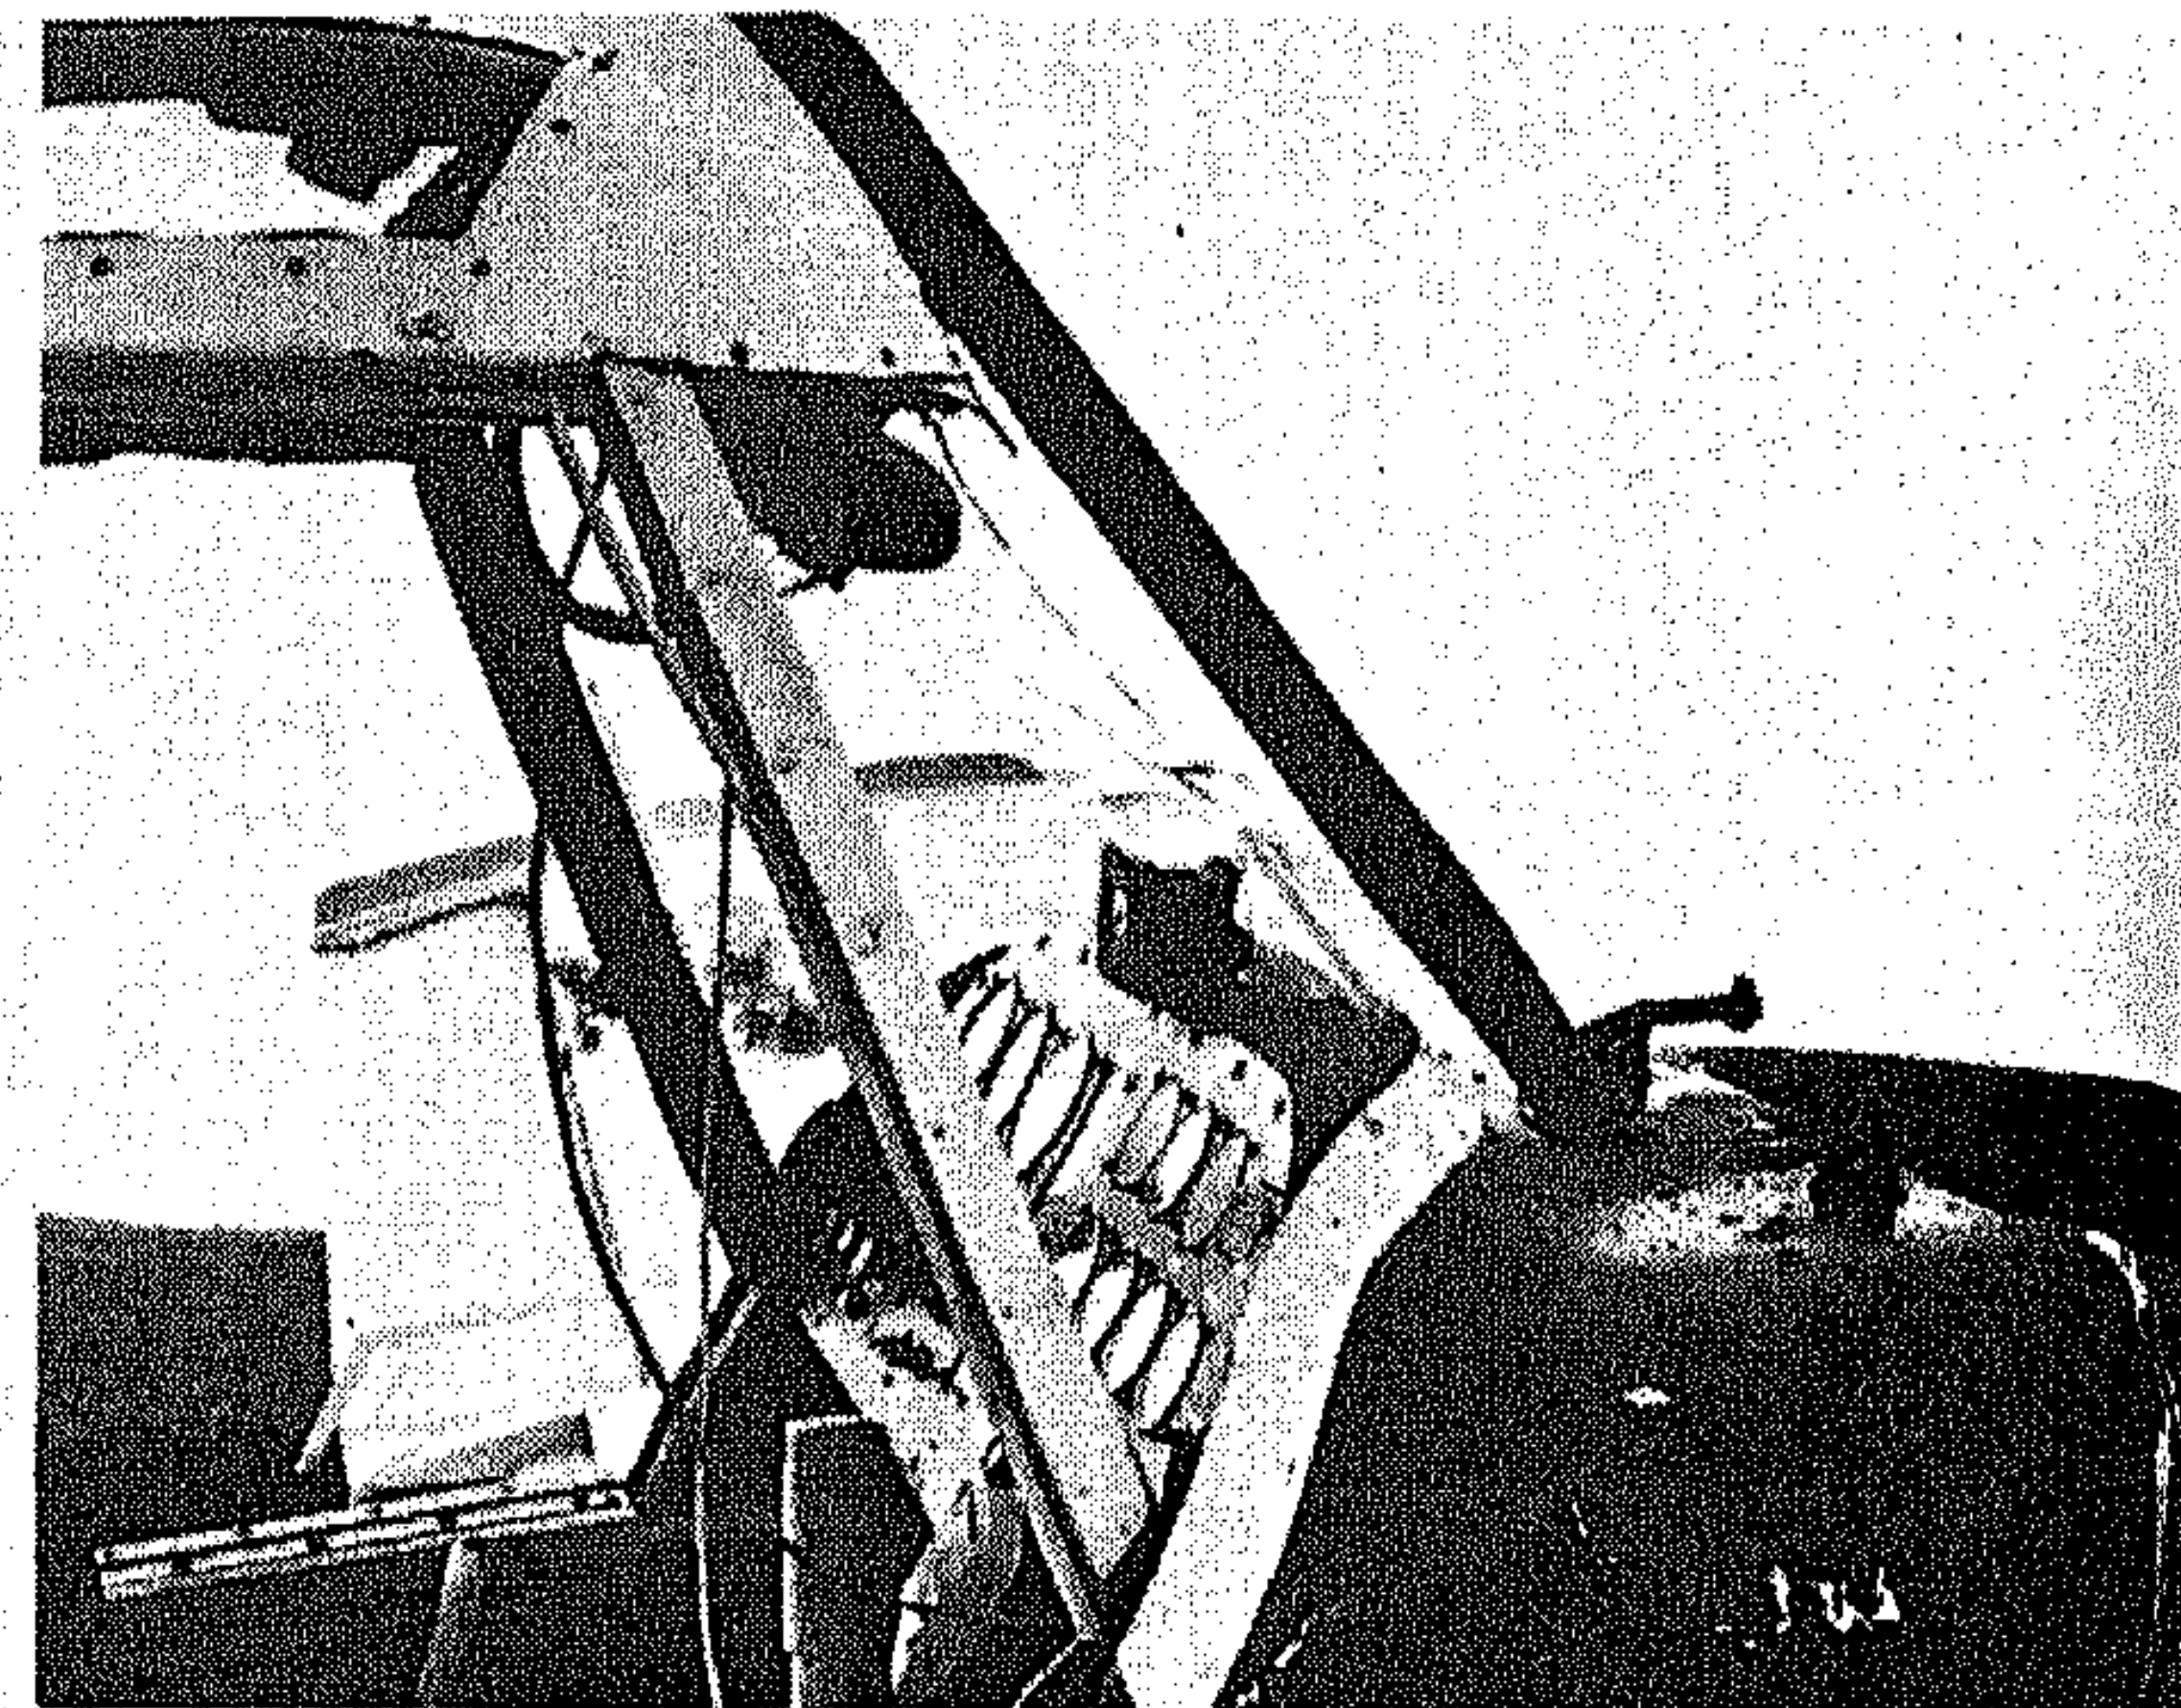
energy attenuating device (padding or aluminum roll) for head impact protection, any head strike would probably have proved disastrous (See Case 15).

b. Rigid instrument panel without head impact protection.

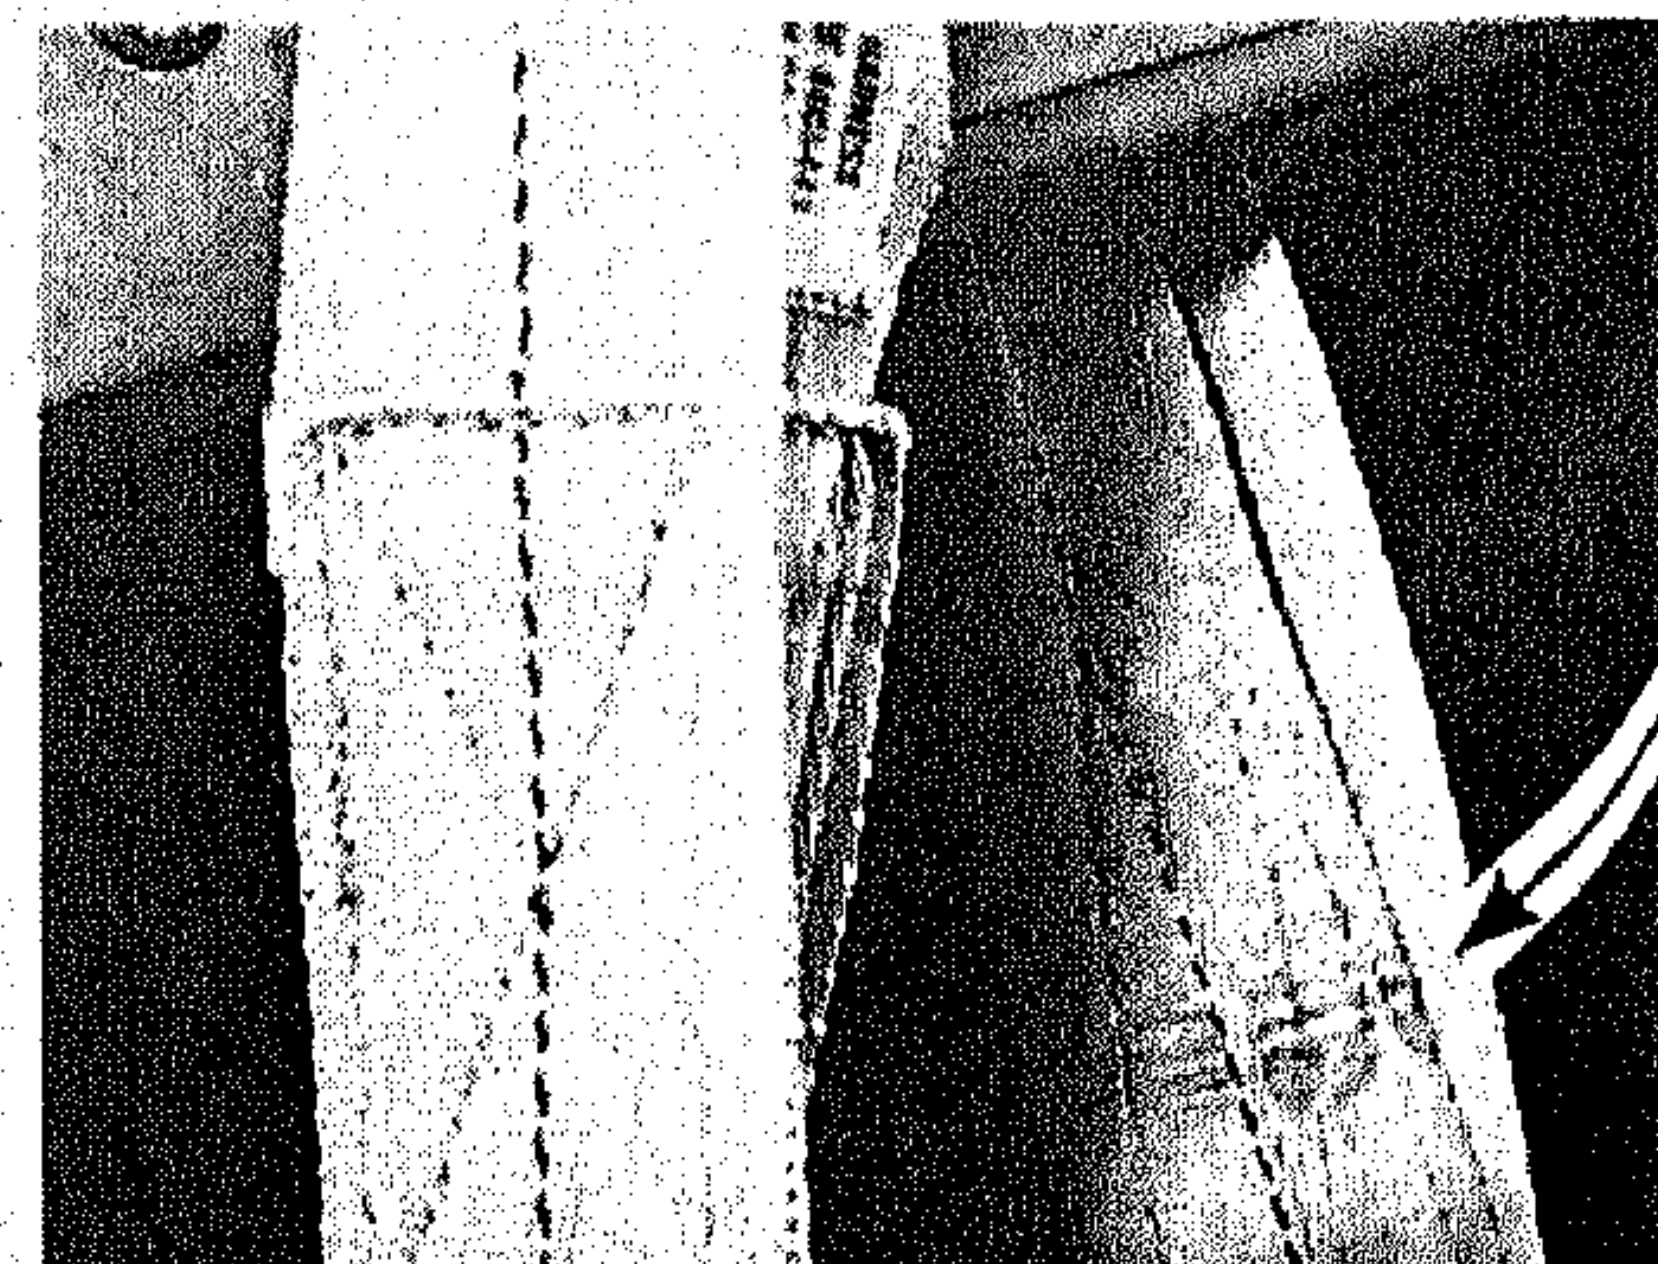
d. Shoulder strap webbing is becoming frayed and should be replaced.
