| 1. Report No.<br>FAA-AM-72-15 | 2. Government Accession No. | 3. Recipient's Catalog No. | |
| 4. Title and Subtitle<br>CRASH SURVIVAL ANALYSIS OF 16 AGRICULTURAL<br>AIRCRAFT ACCIDENTS | | 5. Report Date<br>April 1972 | |
| 7. Author(s)<br>J. J. Swearingen, D. Av. T.; T. F. Wallace;<br>J. G. Blethrow; and D. E. Rowlan | | 8. Performing Organization Report No. | |

# CRASH SURVIVAL ANALYSIS OF 16 AGRICULTURAL AIRCRAFT ACCIDENTS

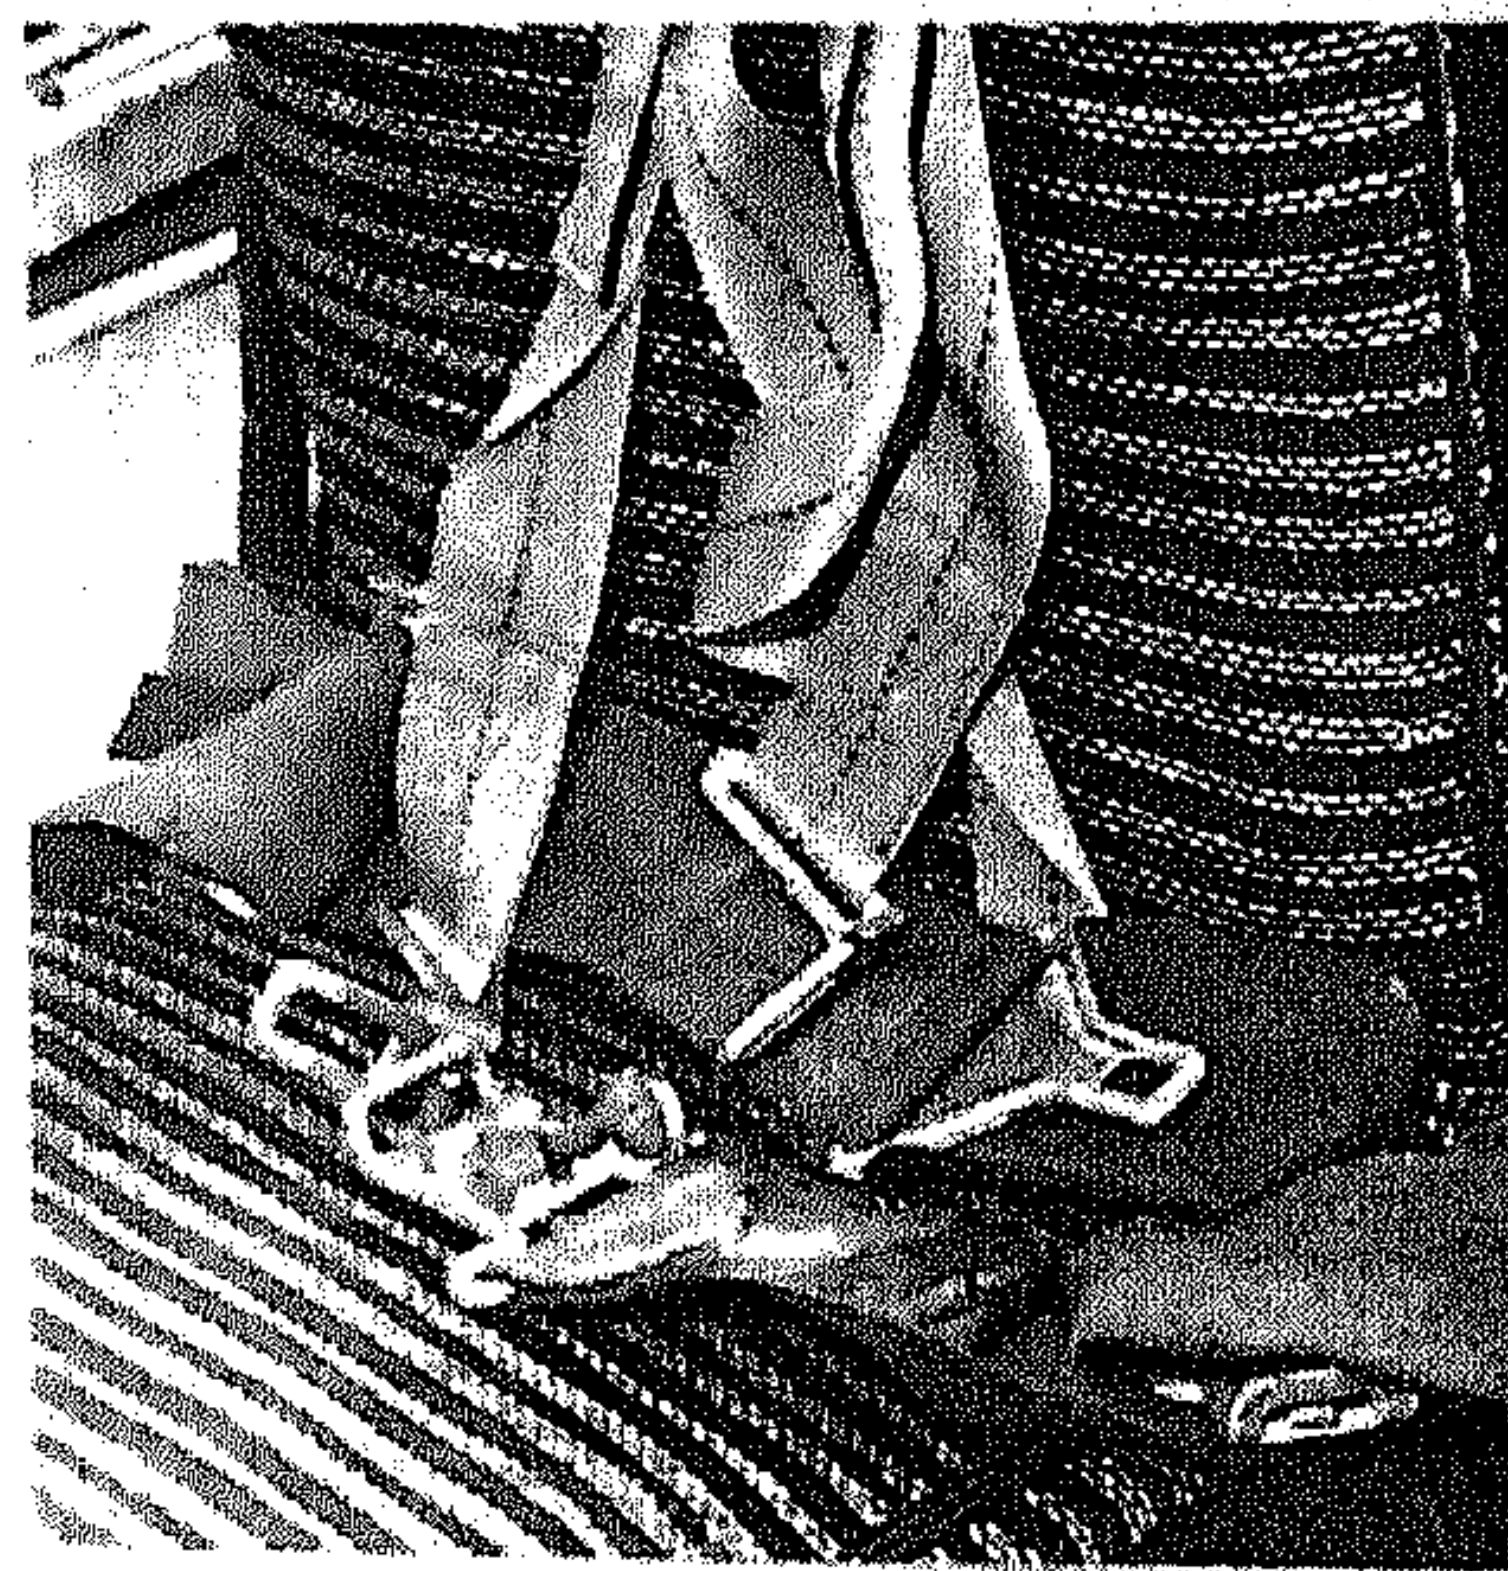
e. Metal-to-metal attachment of shoulder straps to lap belt forms a more reliable restraint system than sewing shoulder straps to one surface of the belt.

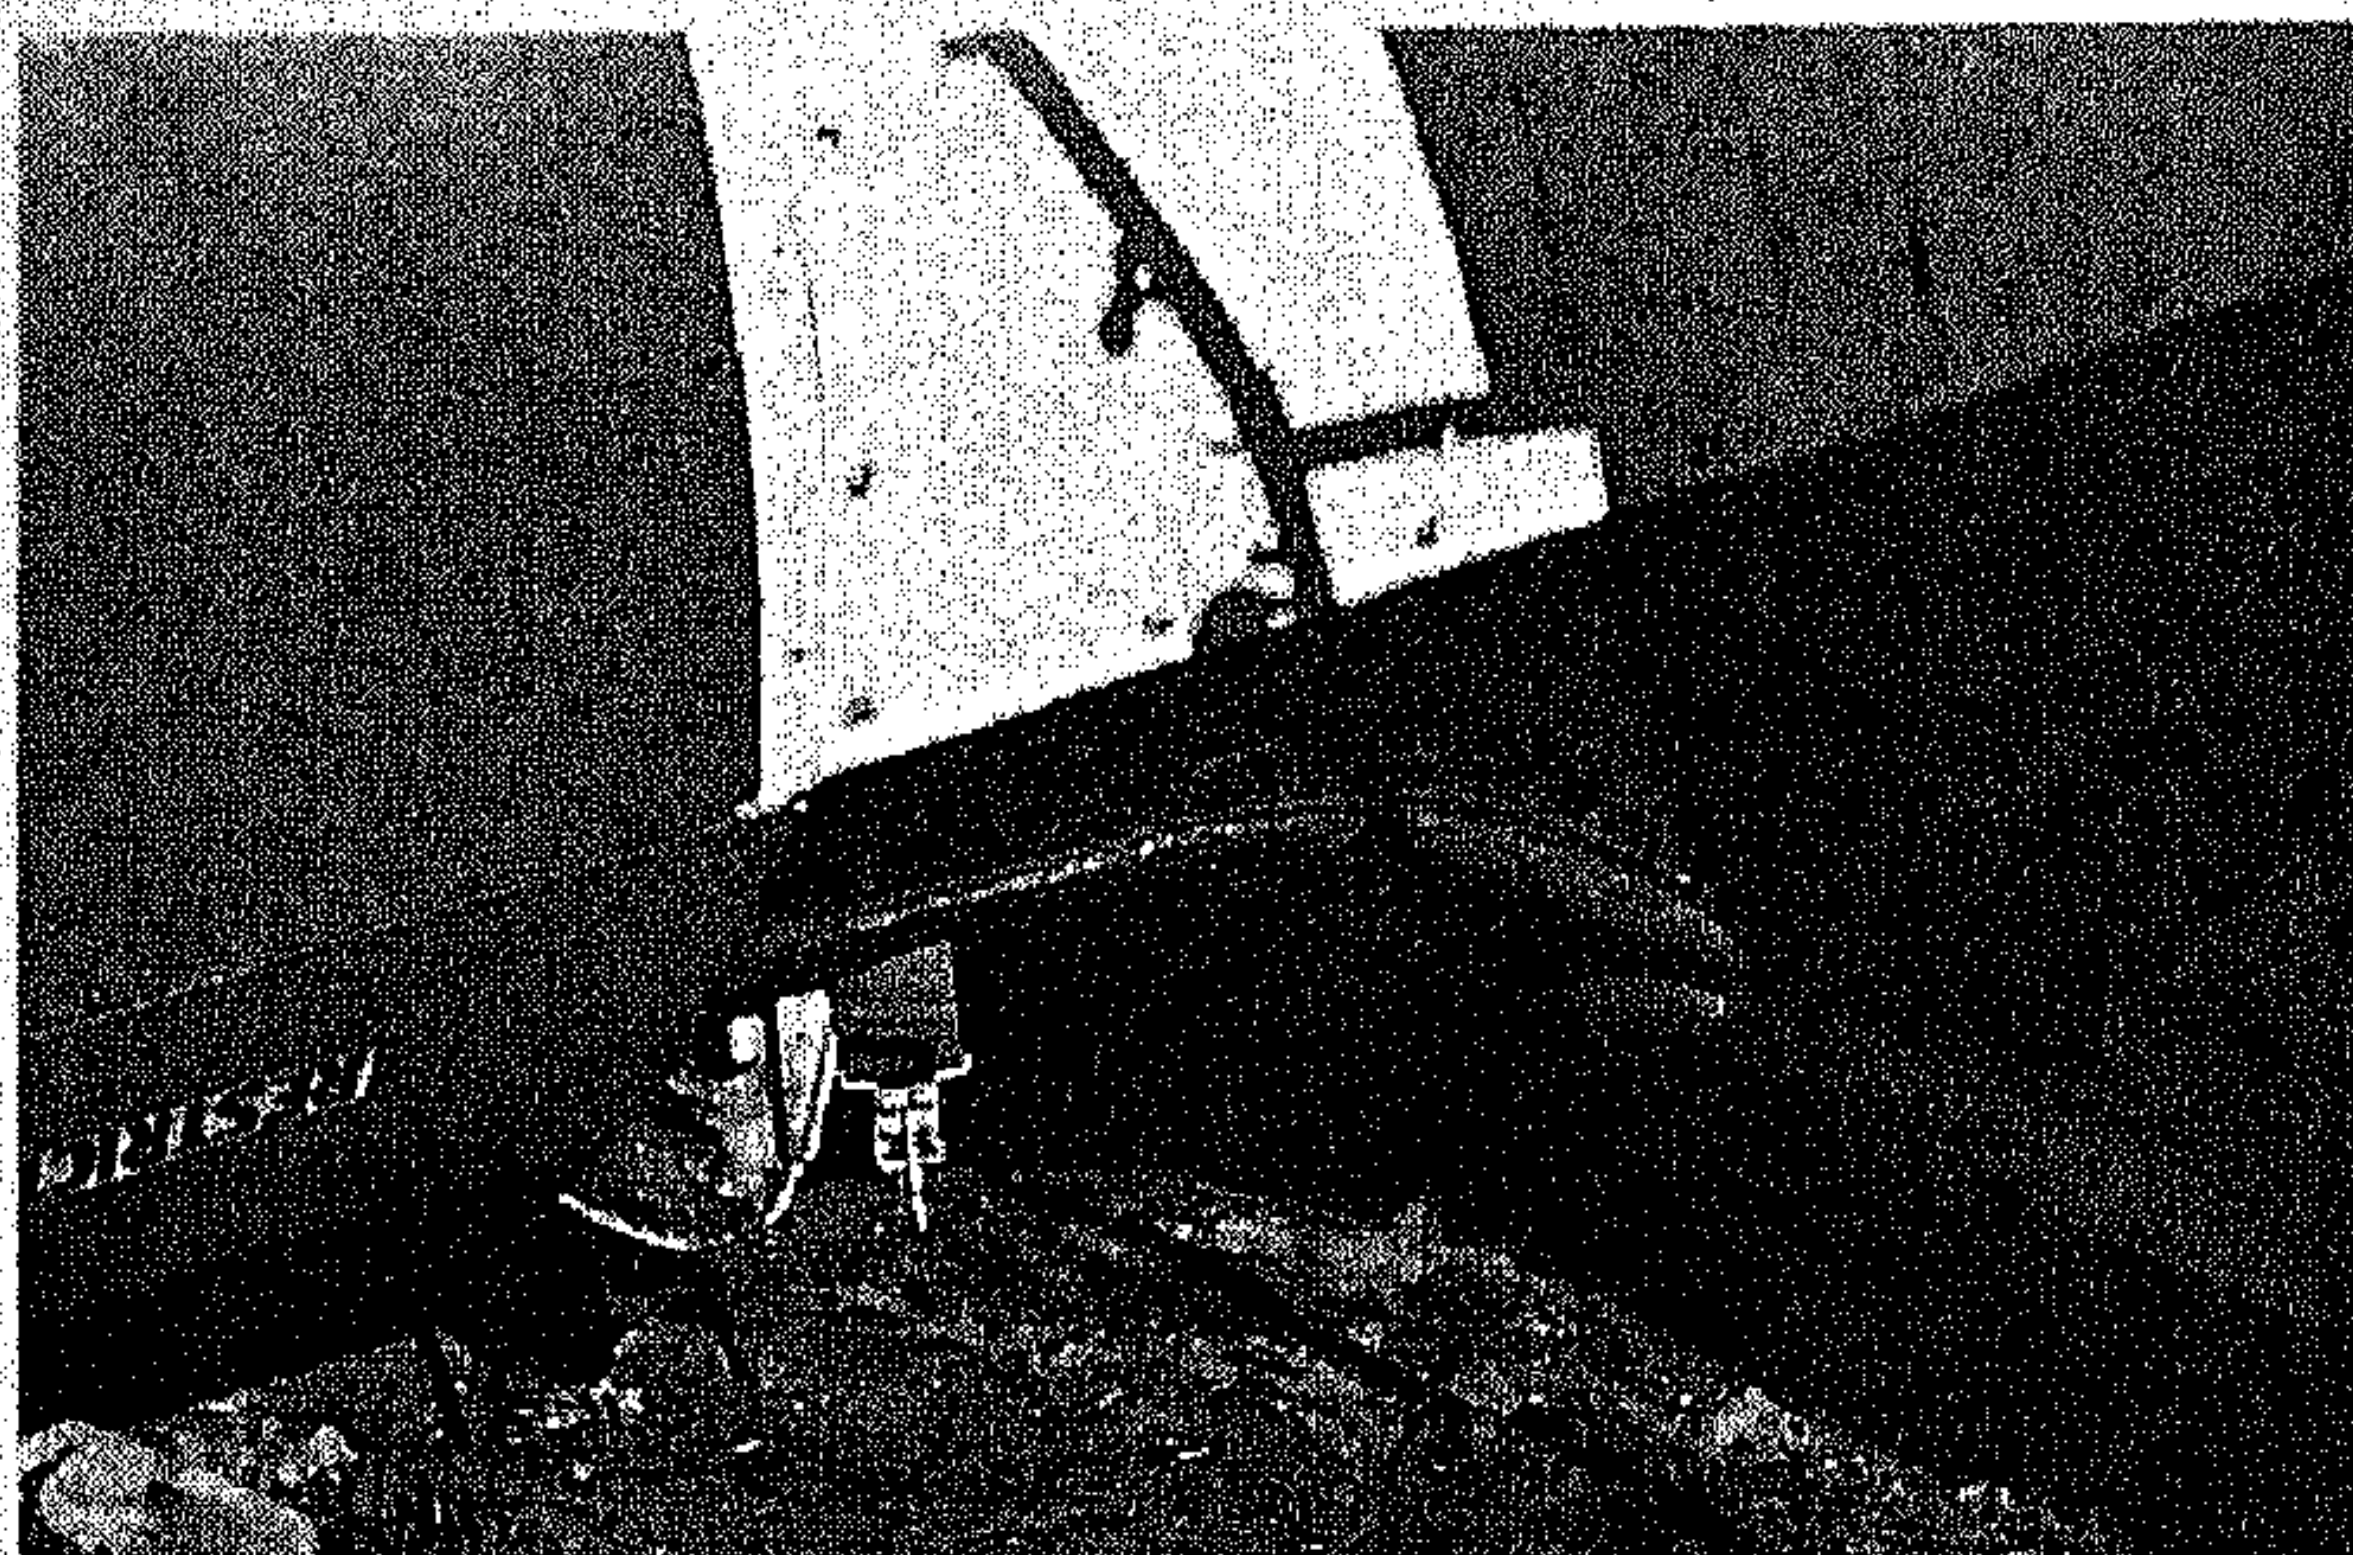
b. Open cockpit without roll bars was held off of pilot by high wing structure. Note padding on edges and front of cockpit.

c. Large padded roll at the top of panel in front of the pilot. Also note that there are no instruments in this panel.

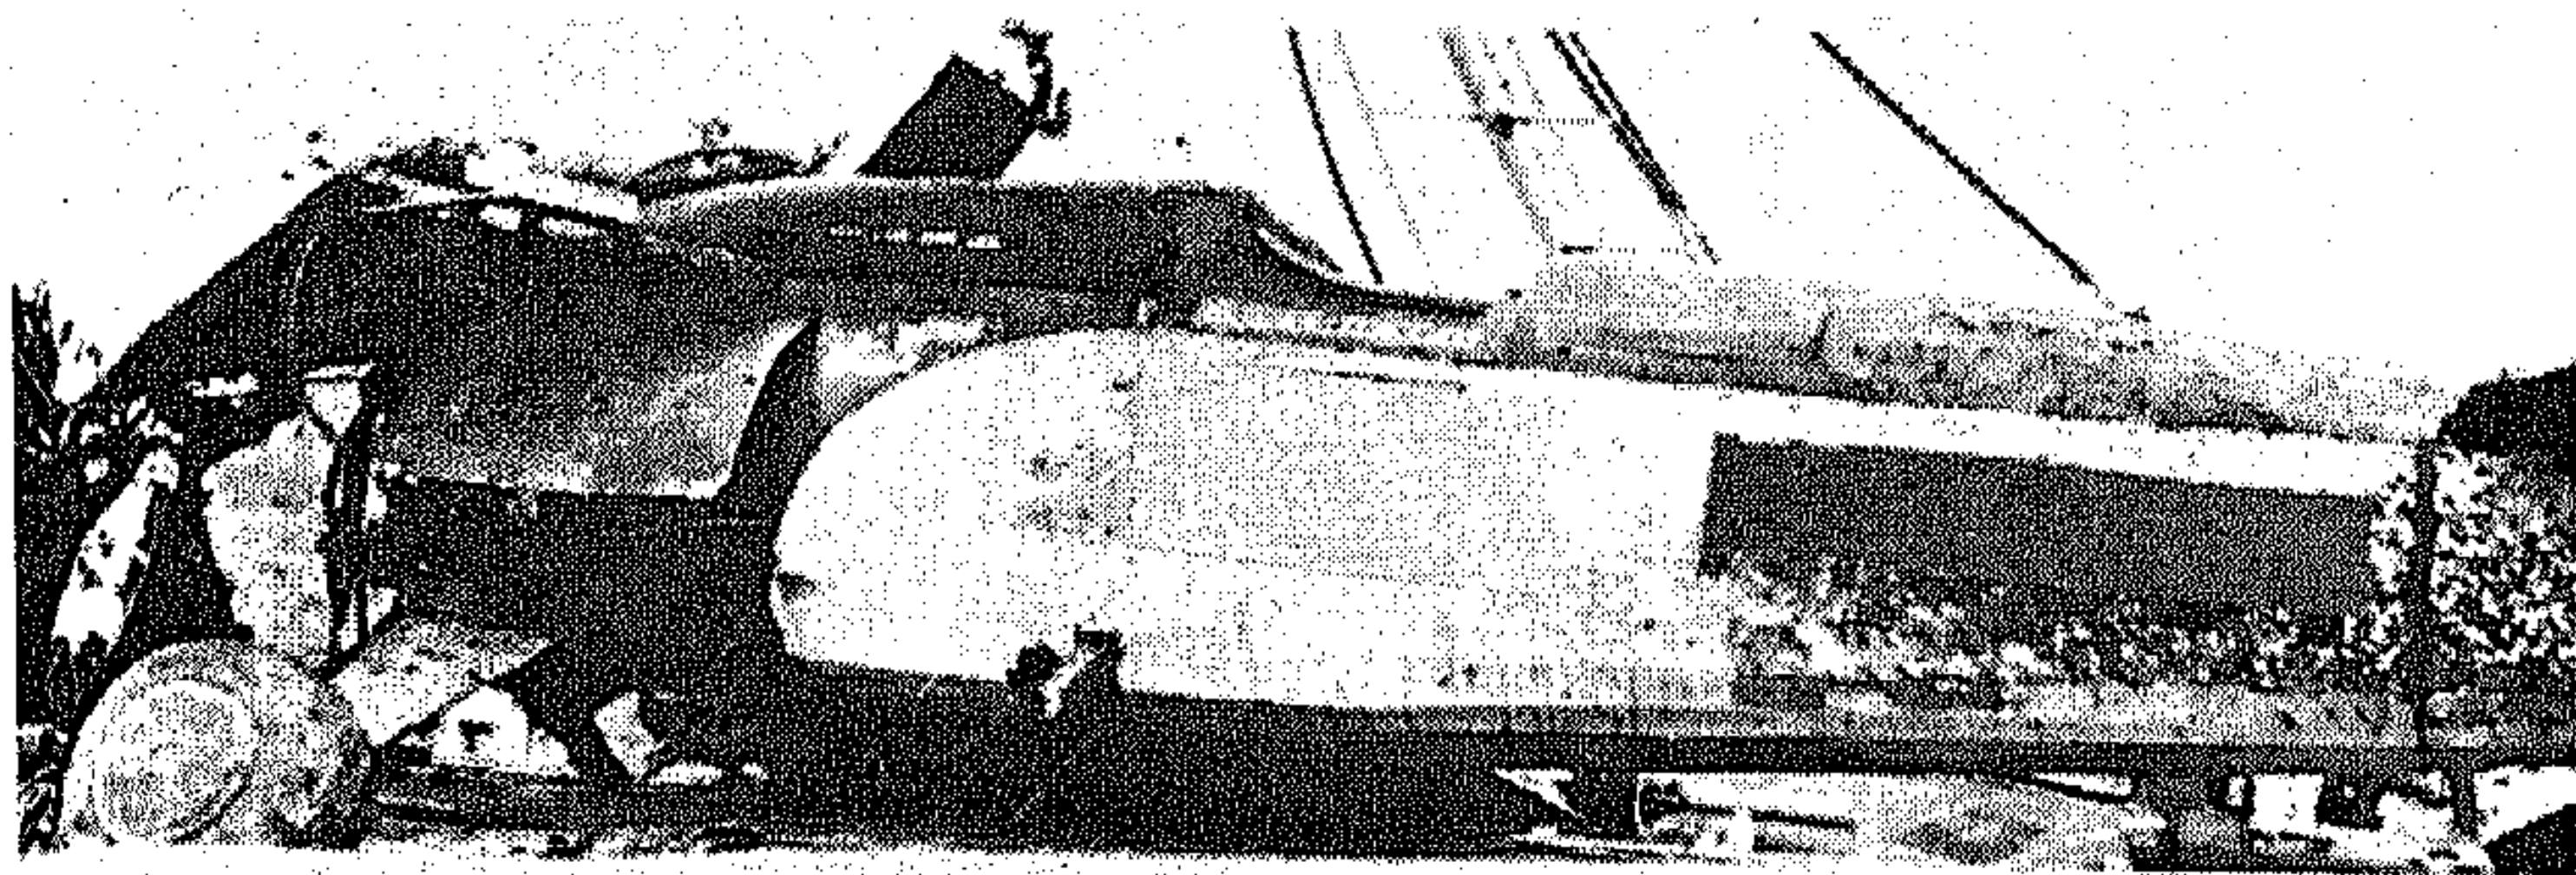
**Case 12:** This Stearman crashed at a steep angle. The top wing struts failed (Case 12-a) in a forward direction due to forward momentum. Although a shoulder harness was available, the pilot was only wearing his lap belt (loosely adjusted) and a cloth helmet. The front of the instrument panel was padded with foam rubber, but since the pilot was wearing a loosely-adjusted belt, his head was thrown above the padding and his neck impacted the top (unpadded) portion of the panel (see arrow, Case 12-c) with sufficient force to fracture the larynx, displace cervical vertebra, and completely sever the spinal cord. Since the cockpit did not collapse and the aircraft did not become inverted, the pilot probably would have survived this accident with minor injuries *had he been wearing his shoulder harness and a tight lap belt.*

a. A 1943 Boeing Stearman A-75 crashed at a steep angle with sufficient force to drive the top wing forward but did not flip over.

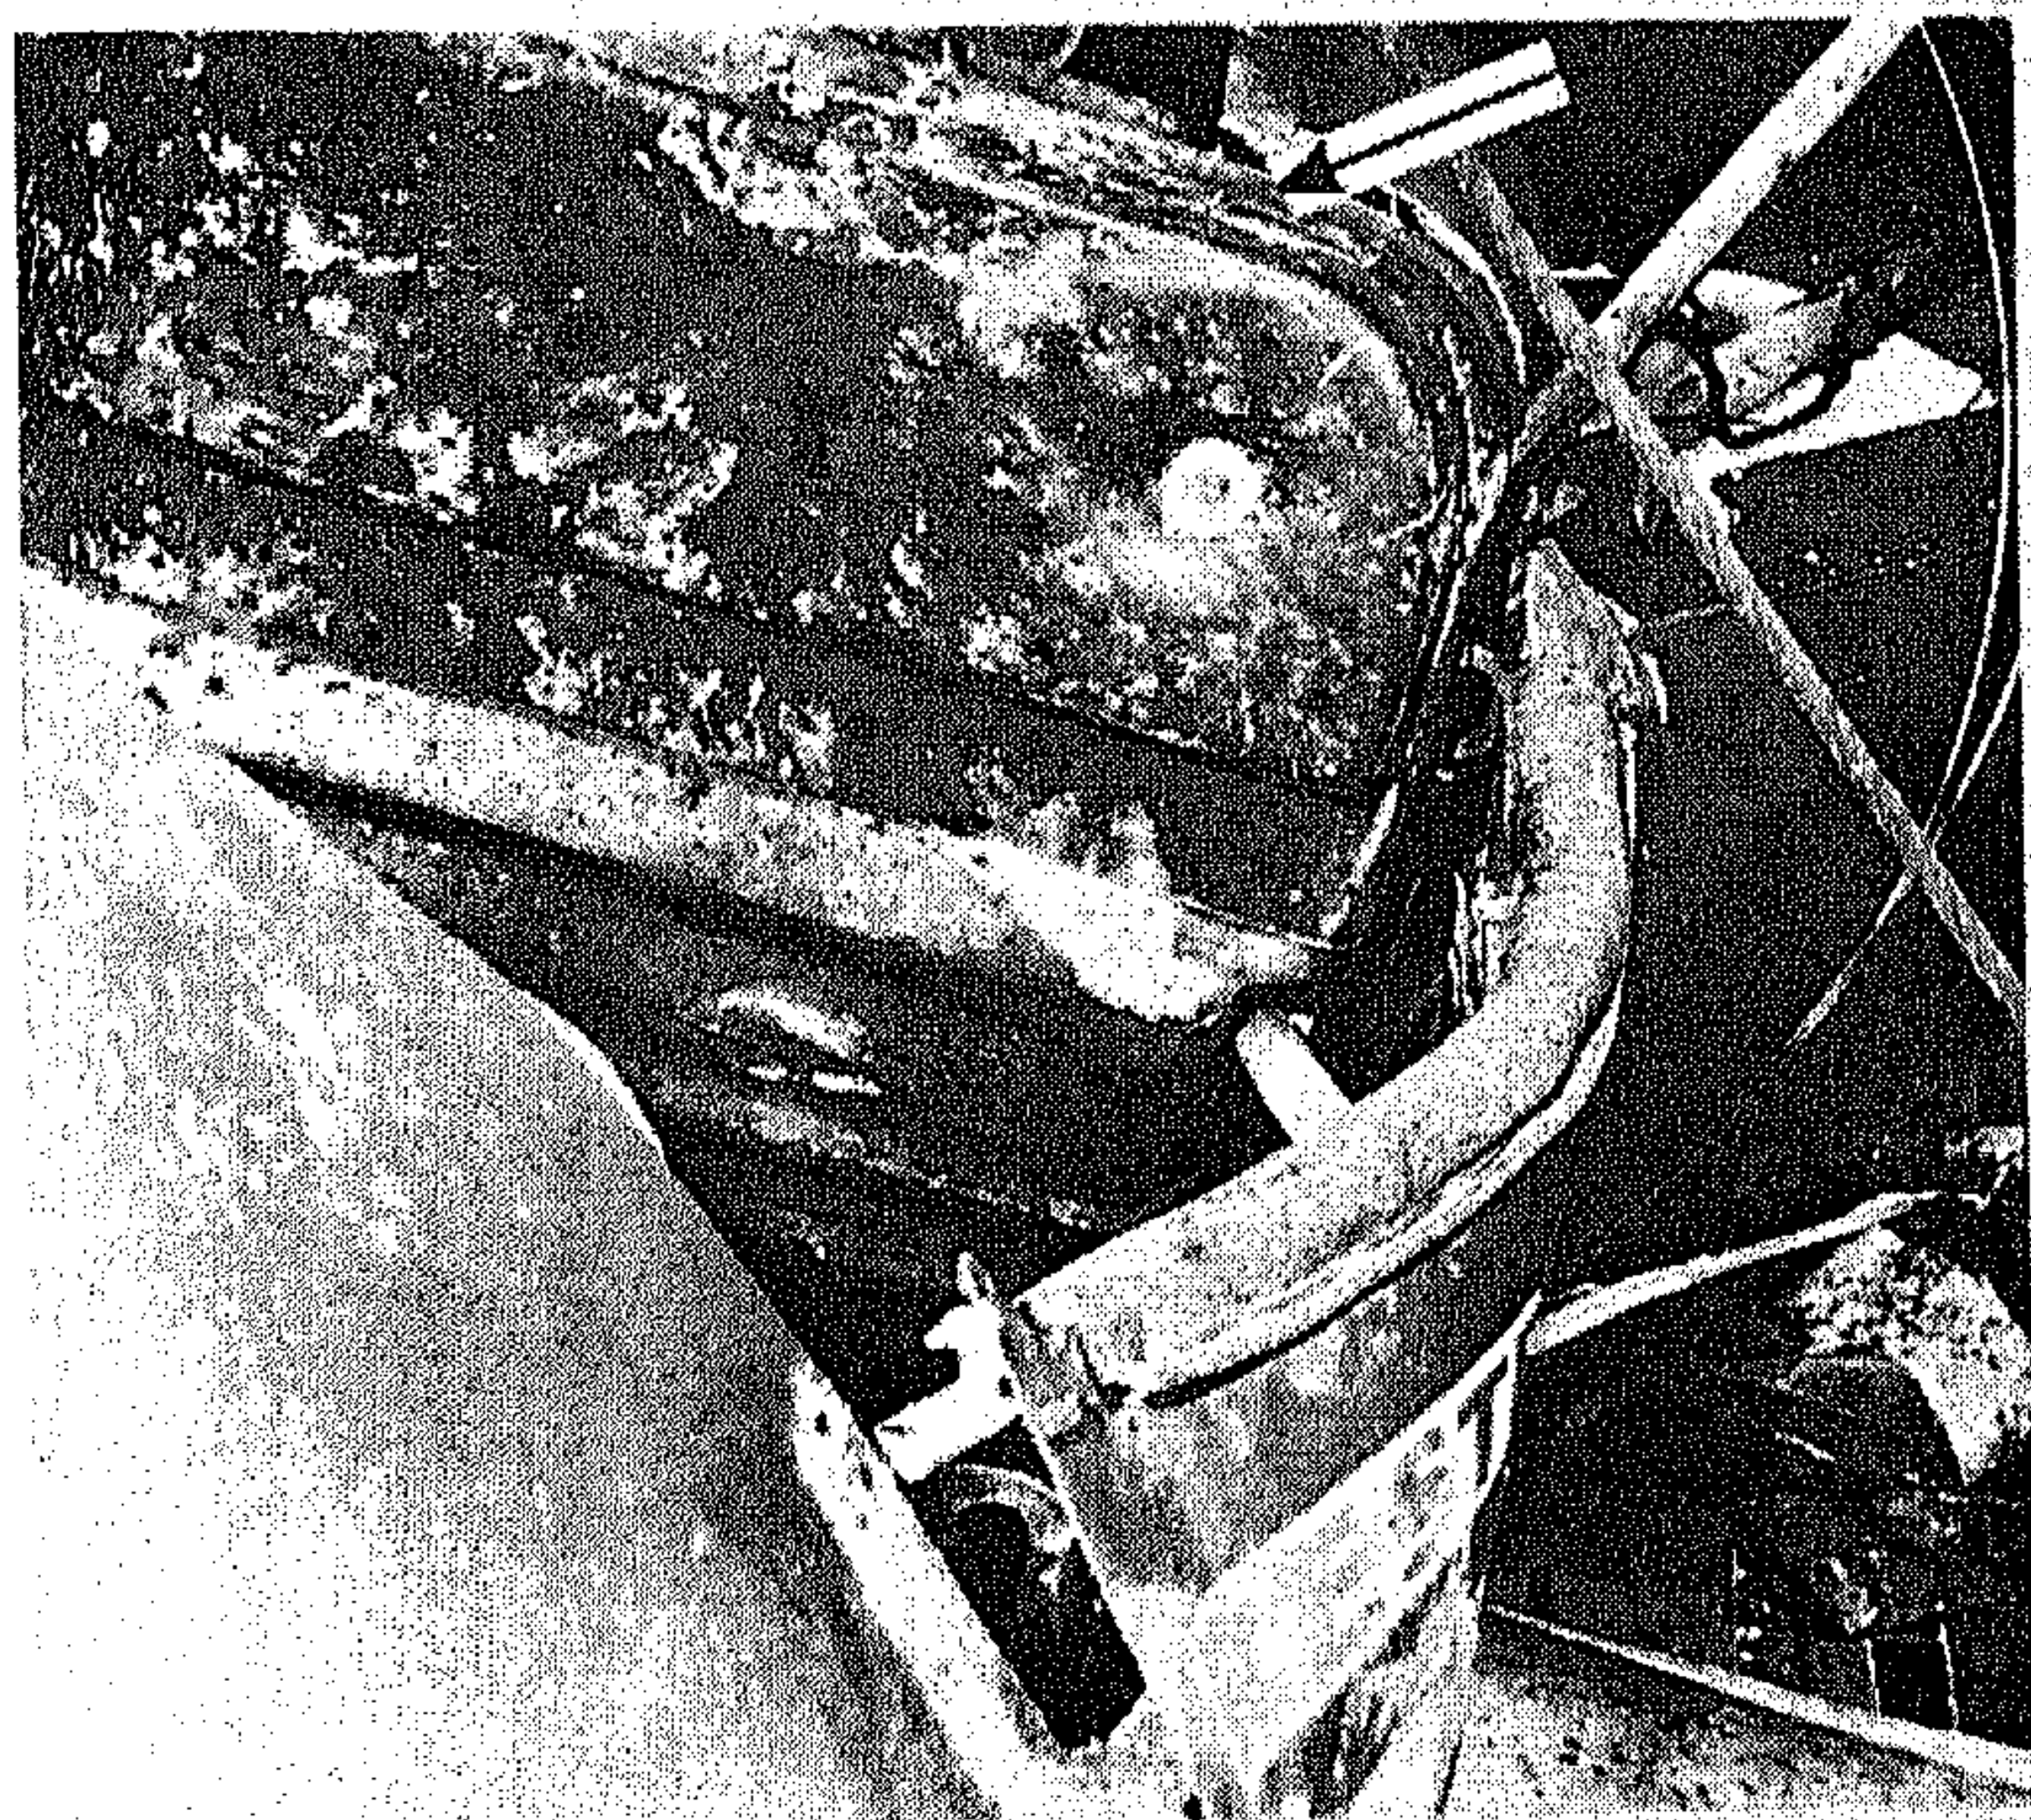
c. Pilot was thrown forward, hitting his neck on the top of the instrument panel (note arrow).

This aircraft was equipped with both shoulder harness and seat belt, but the pilot was wearing only the lap belt (loosely) and a cloth helmet. The neck impact with the top of the instrument panel fractured the pilot's larynx and drove the neck vertebra back to such an extent as to completely sever the spinal cord. He should have survived without injury if he had been wearing properly his shoulder harness and seat belt.

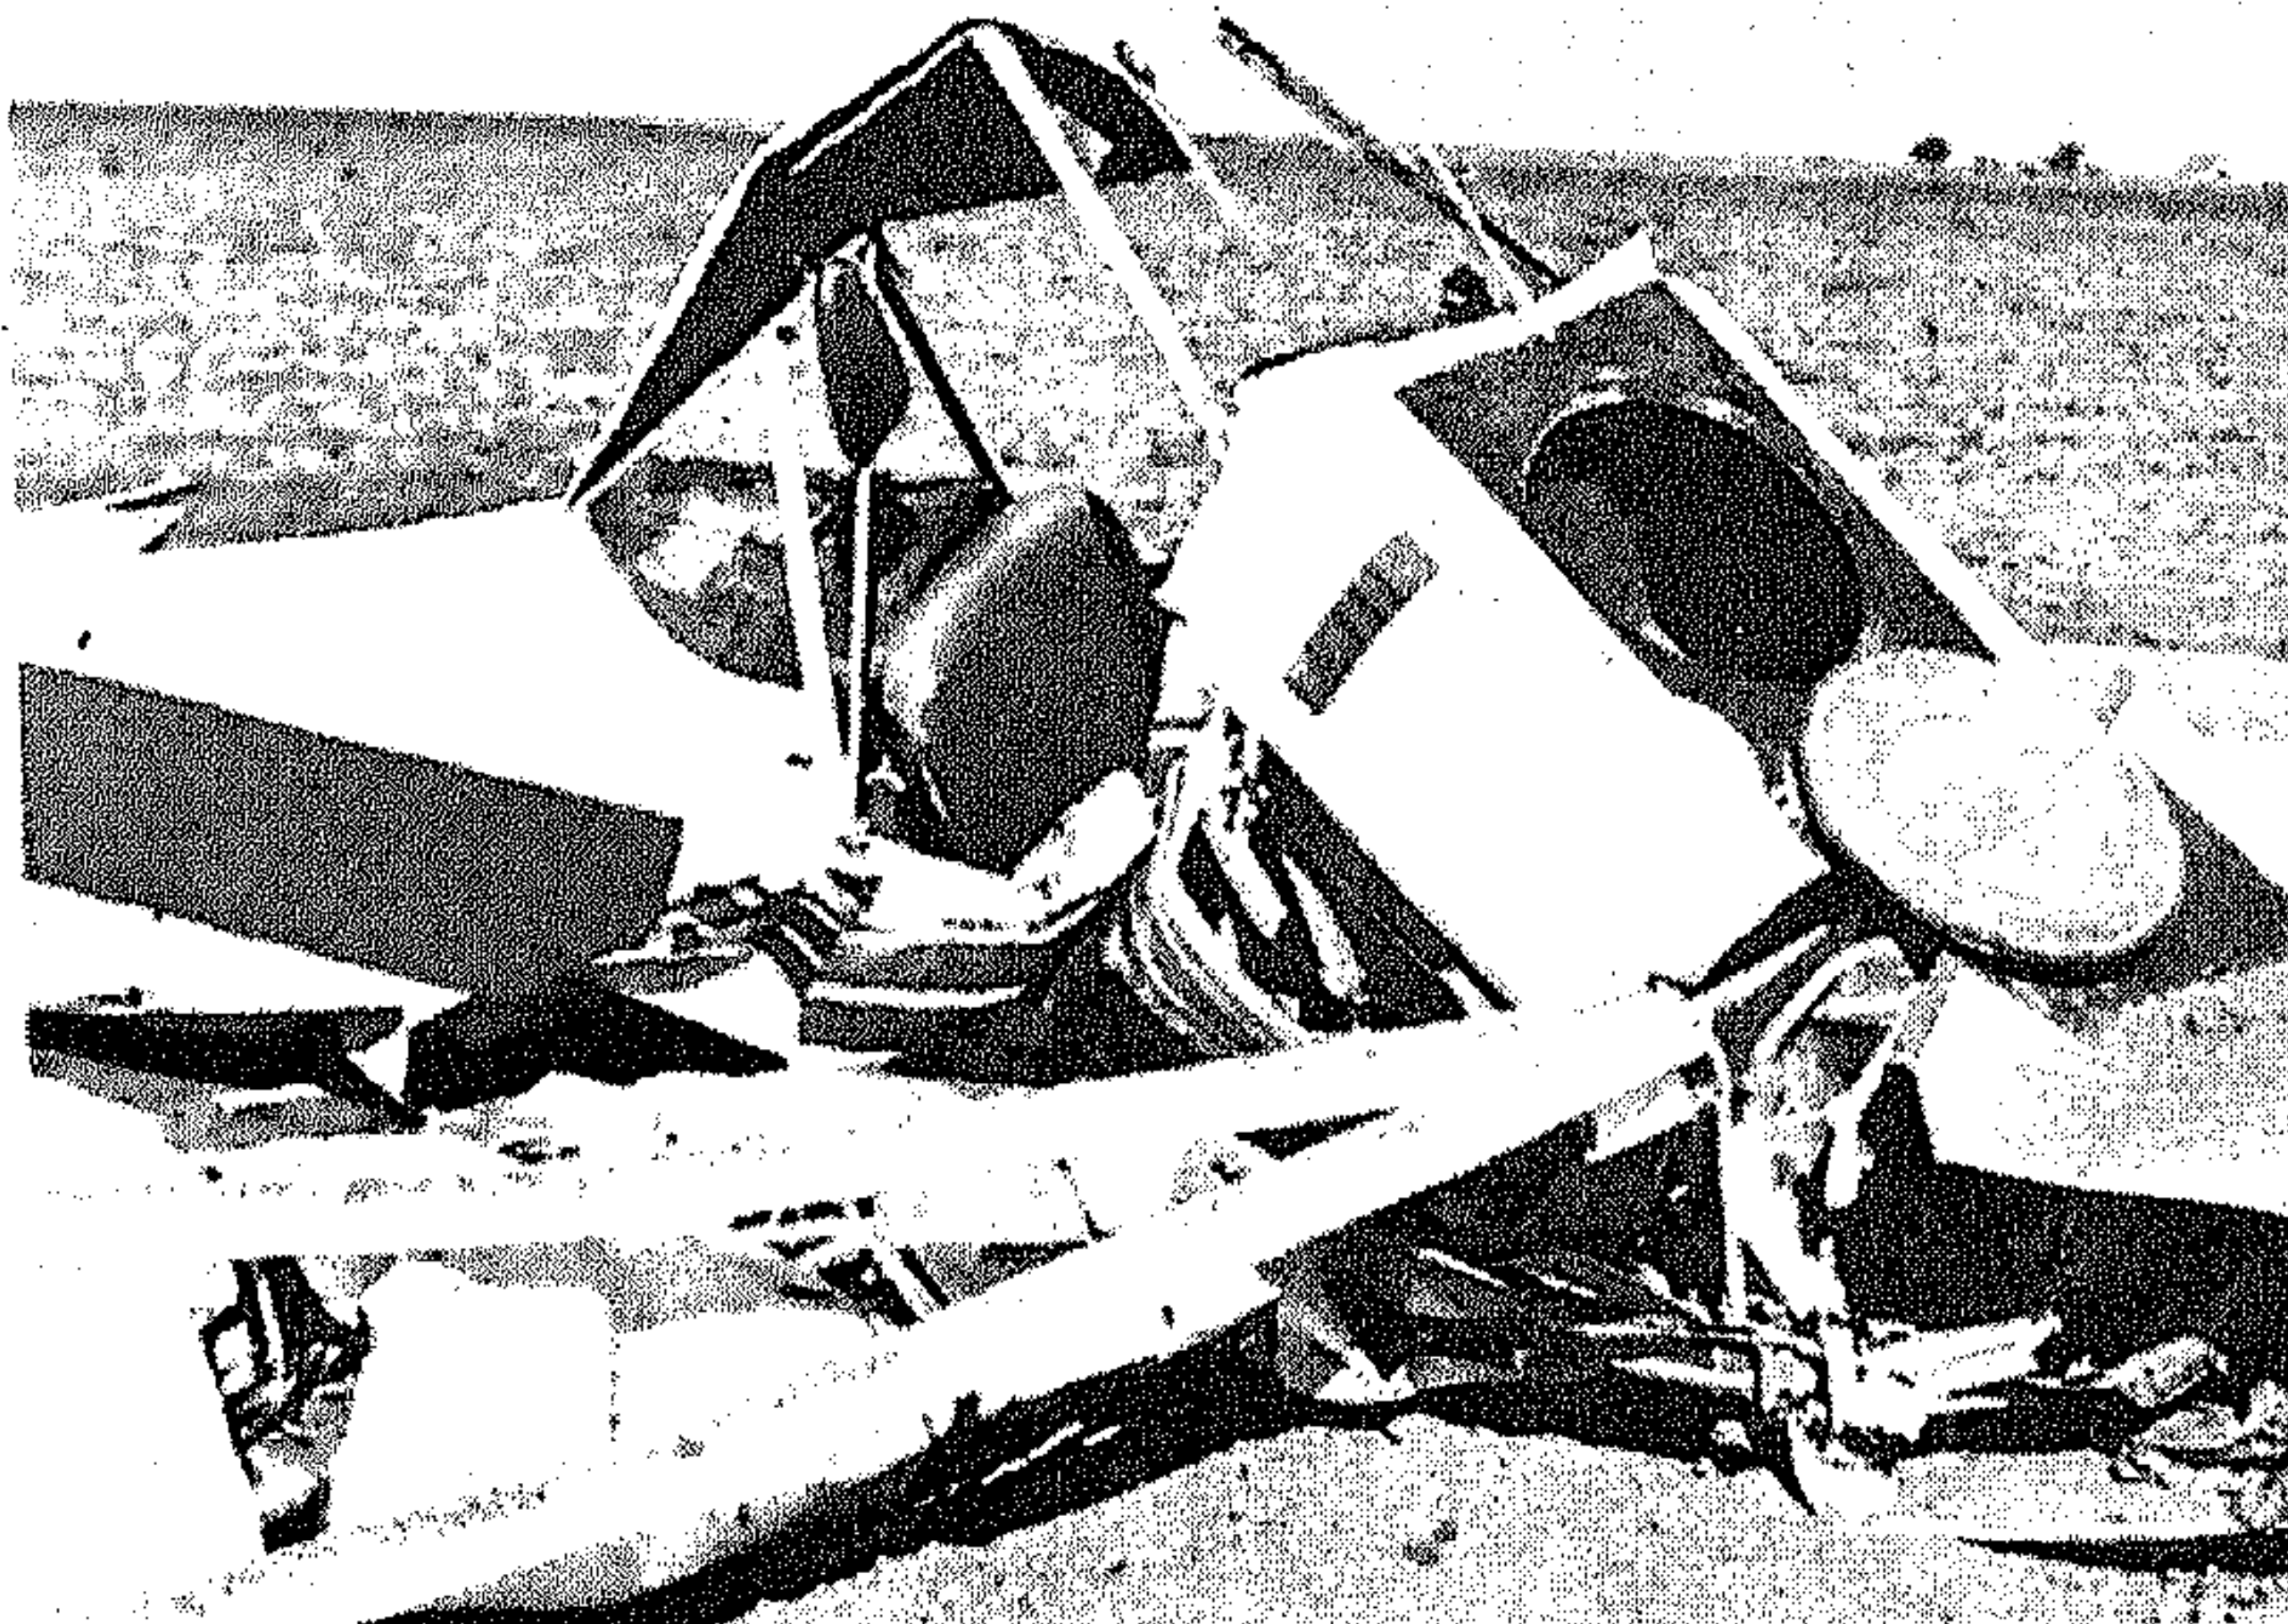
a. Side view of an aircraft involved in a severe crash. Severity of crash is indicated by failure of motor and its mounts, collapse of the hopper and partial collapse of cabin.

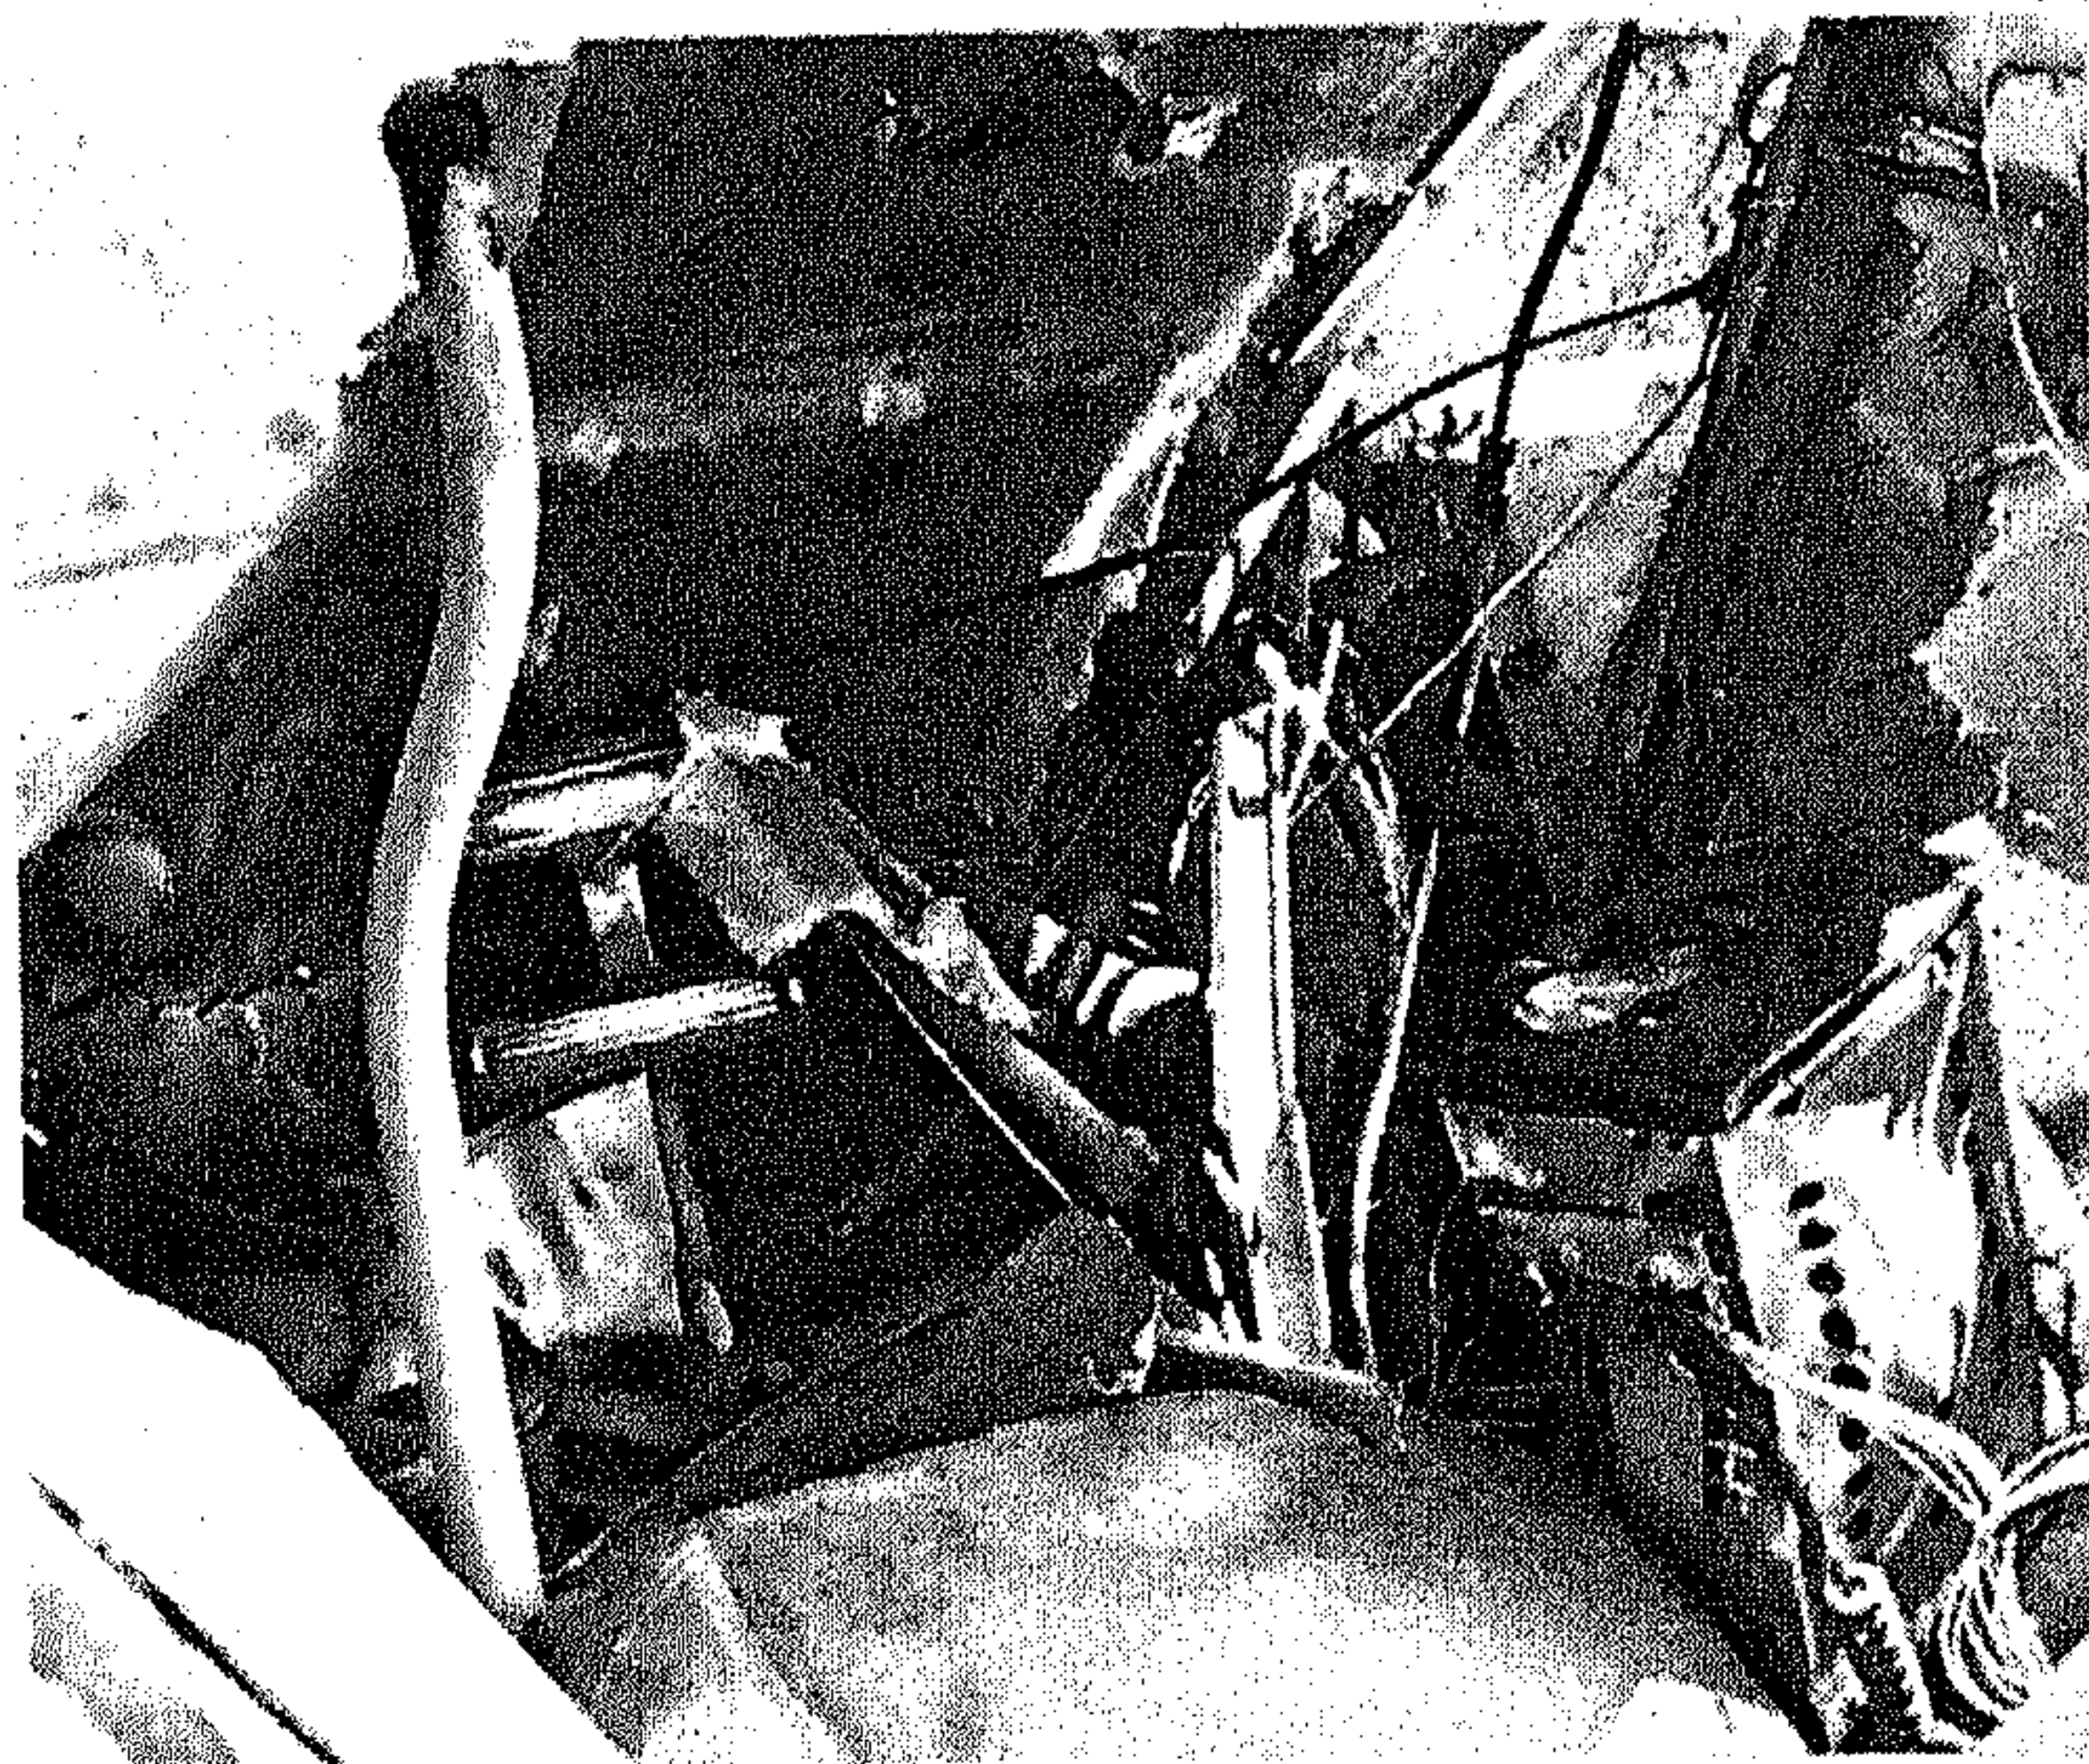
e. As shoulder harness became slack and the left seat belt cable broke, pilot was thrown into right forward corner of cockpit (note heavy radio).
