| 1. Report No.<br>FAA-AM-72-15 | 2. Government Accession No. | 3. Recipient's Catalog No. | |
| 4. Title and Subtitle<br>CRASH SURVIVAL ANALYSIS OF 16 AGRICULTURAL<br>AIRCRAFT ACCIDENTS | | 5. Report Date<br>April 1972 | |
| 7. Author(s)<br>J. J. Swearingen, D. Av. T.; T. F. Wallace;<br>J. G. Blethrow; and D. E. Rowlan | | 8. Performing Organization Report No. | |

# CRASH SURVIVAL ANALYSIS OF 16 AGRICULTURAL AIRCRAFT ACCIDENTS

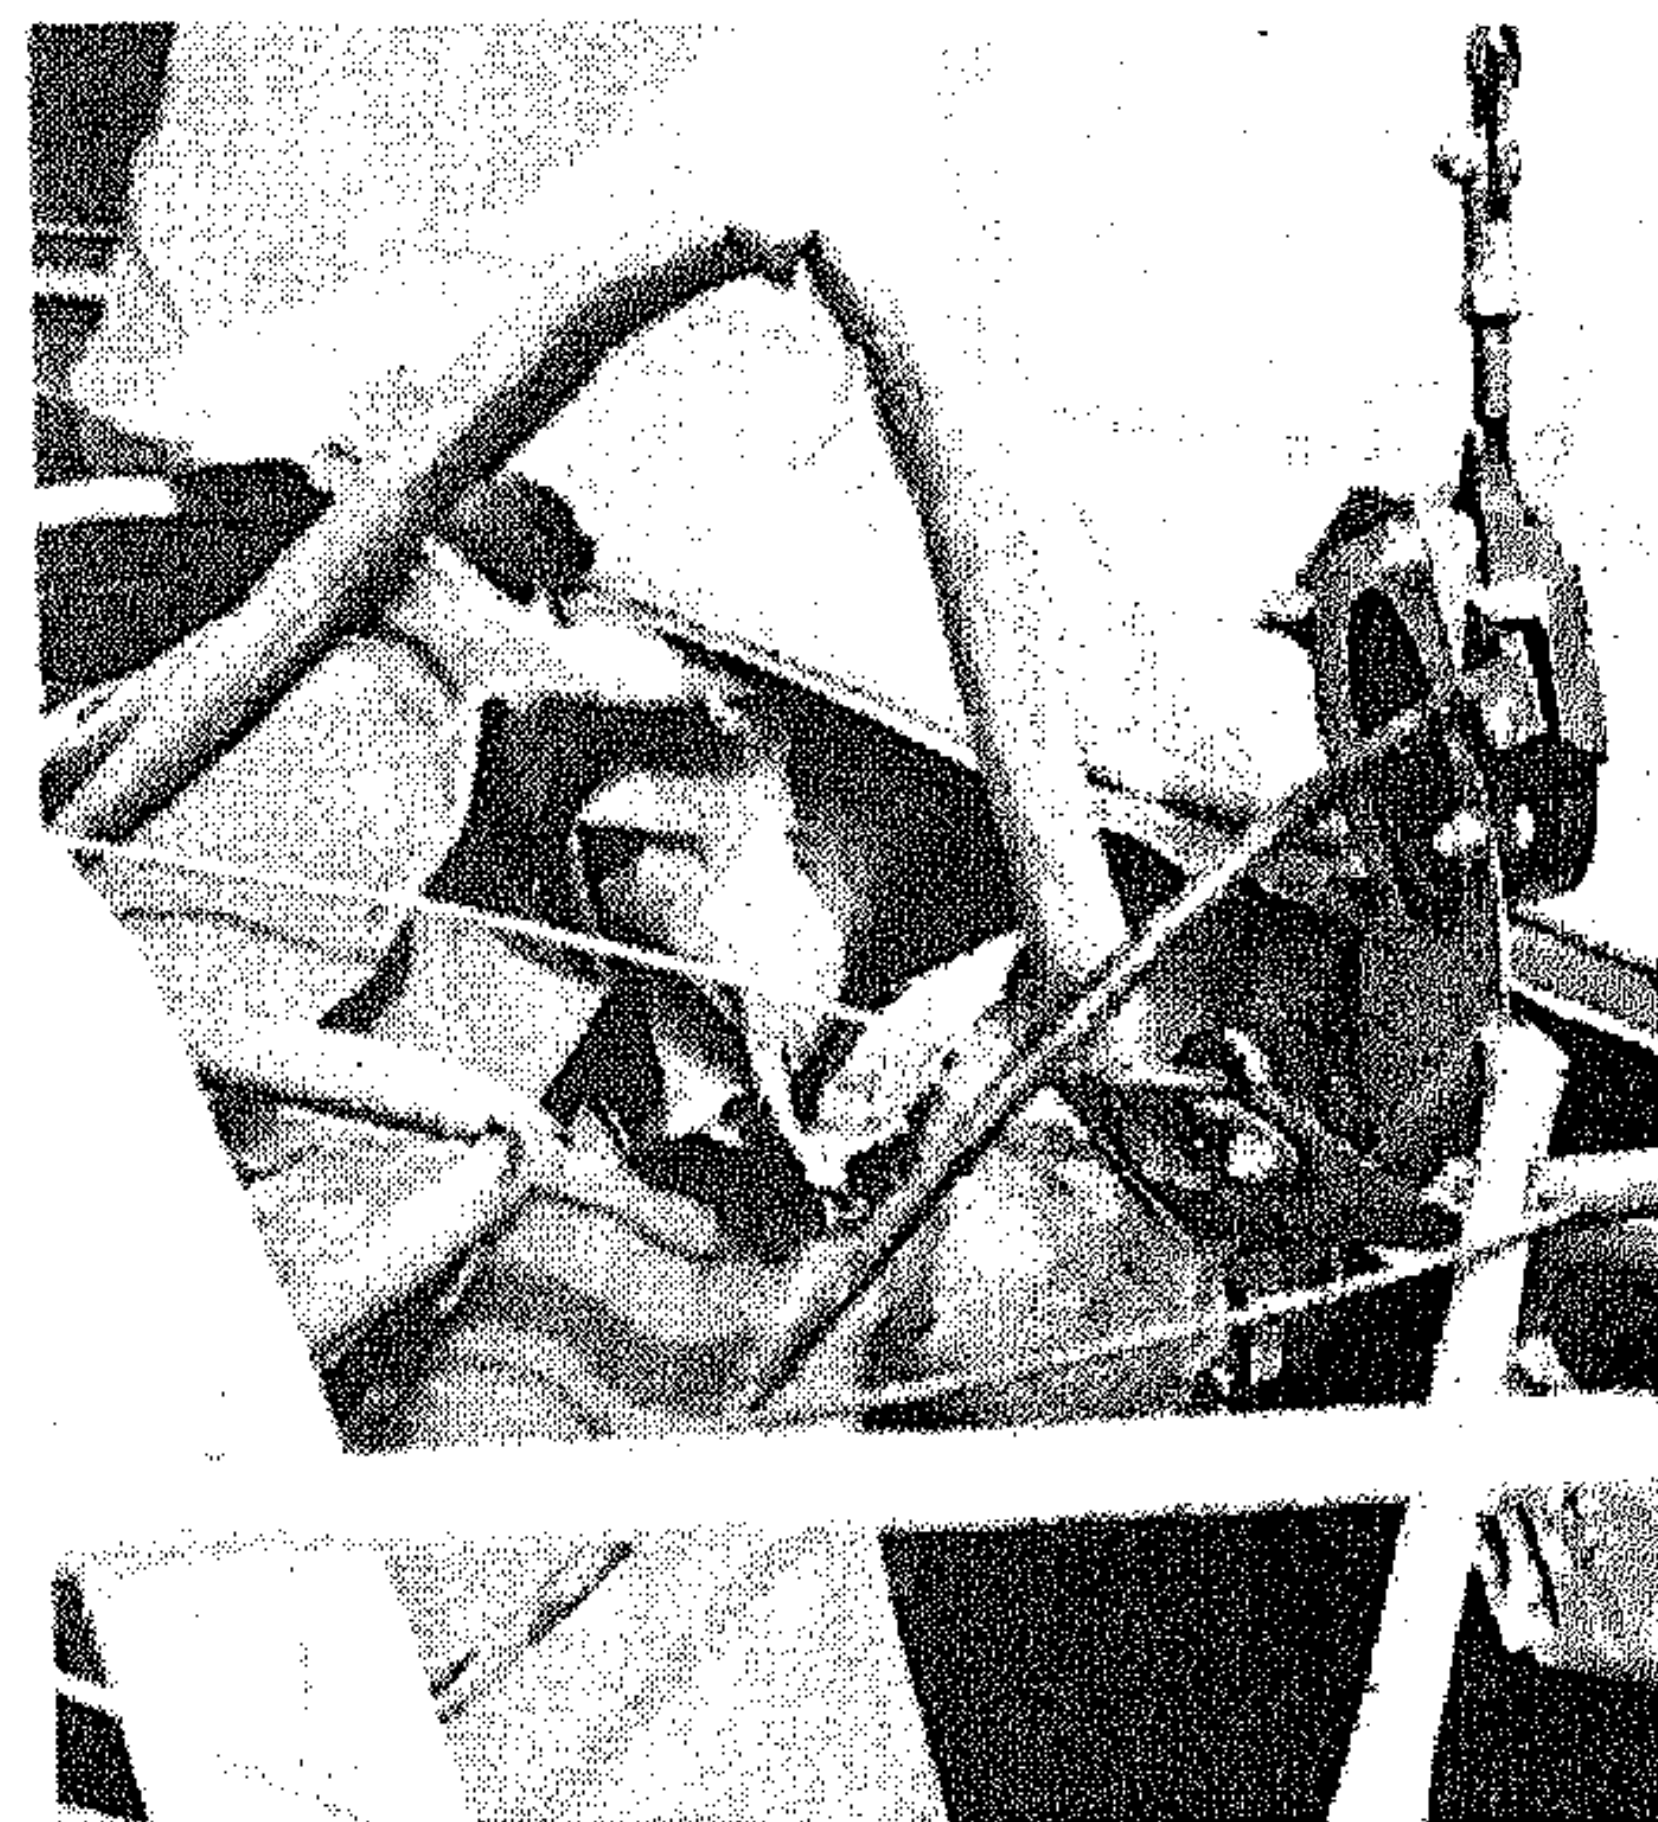
**Case 13:** This 1965 Piper Pawnee was involved in a severe accident which resulted in structural failure of the engine mounts, hopper, and part of the cockpit. The pilot was wearing his shoulder harness, the lap belt and a crash helmet. He sustained injuries of a survivable nature because of a combination of failures of his restraint system. The left cable to the lap belt broke (Case 13-c) and the attachment point of the inertia reel and right lap belt cable (lower fuselage tubing) buckled upward (as in Case 8) allowing considerable slack in the restraint system (Case 13-b). As a result of these restraint system failures, the pilot was thrown into the right front portion of the cockpit. Forceful contact of his pelvis against the heavy radio (Case 13-e) resulted in a fracture of the upper right femur and right iliac crest. He also suffered fractures of both legs below the knees and fractures of the right wrist and right elbow. Stronger lap belt cables and relocation of the attachment point of the inertia reel are indicated.

b. Upward bending of inertia reel attachment on lower fuselage tubing to rear of cockpit allowed slack in shoulder harness & forward movement of the pilot.

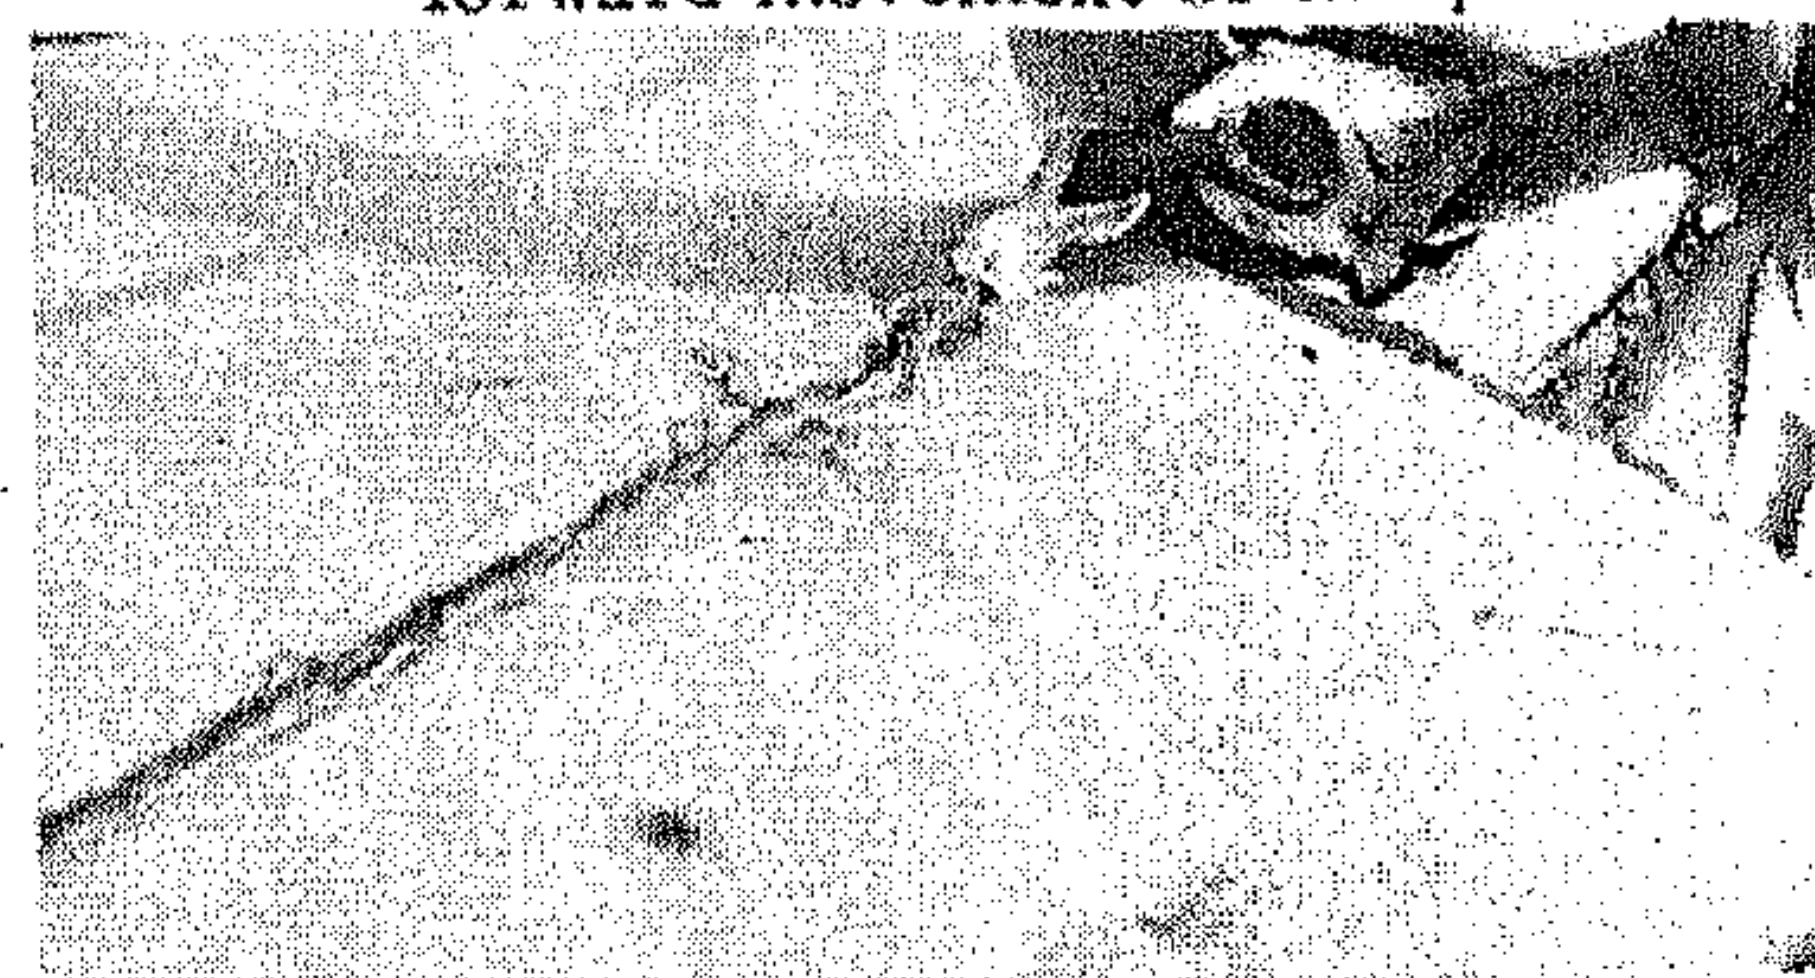
d. Right seat belt cable badly frayed but did not break.

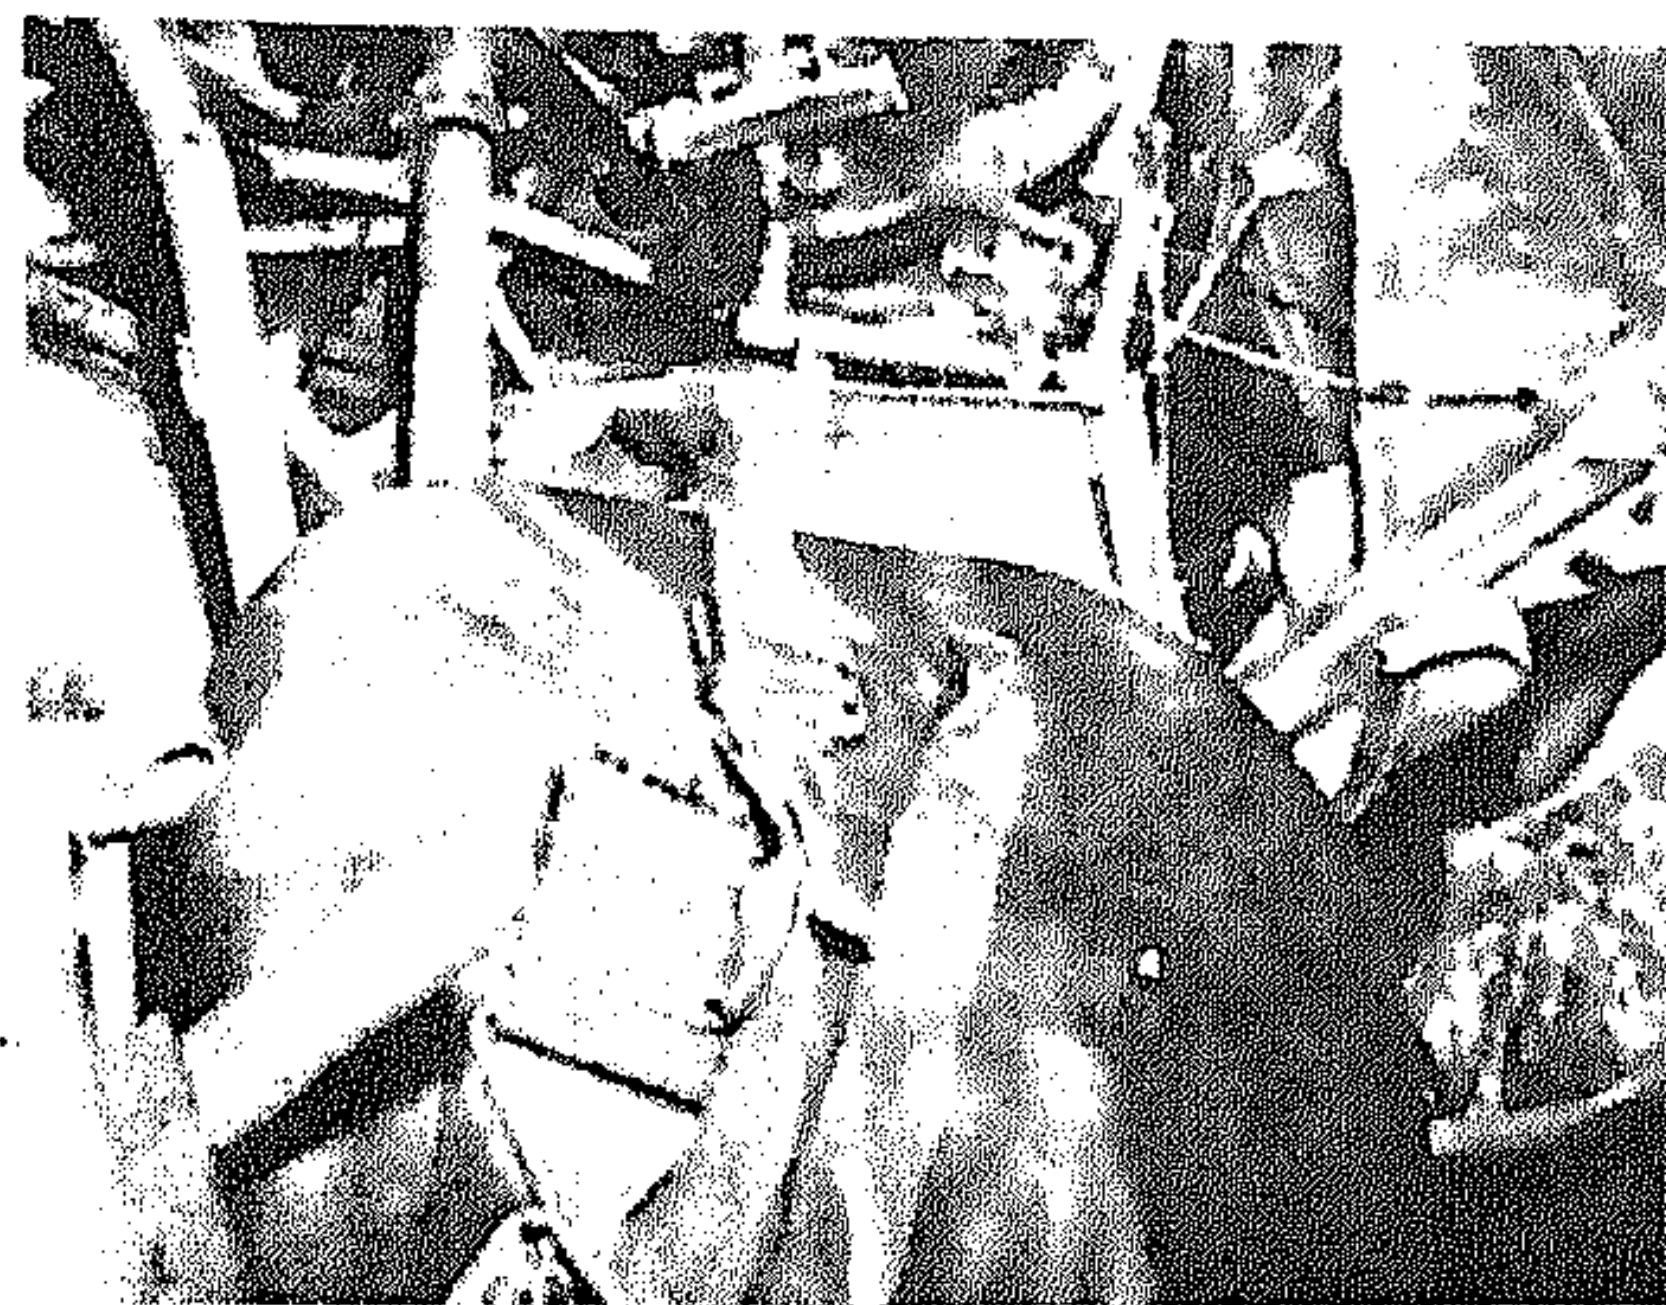
**Case 14:** This 1960 Pawnee crashed under similar circumstances as those described in Case 13. Both halves of the lap belt and both shoulder straps broke (Case 14-b) allowing the pilot to be thrown forward, burying his knees in the fiberglass hopper and his face in the aluminum semicylinder at the top of the instrument panel (Case 14-c). The yield characteristics of the fiberglass and the light aluminum roll were such as to produce only minor injuries. The condition of the lap belt and shoulder harness indicated the webbing was old and probably under-strength, again emphasizing the need for periodic inspection and replacement of the restraint system.

b. Force of impact was sufficient to break both shoulder straps and the 3-in. lap belt in two places.

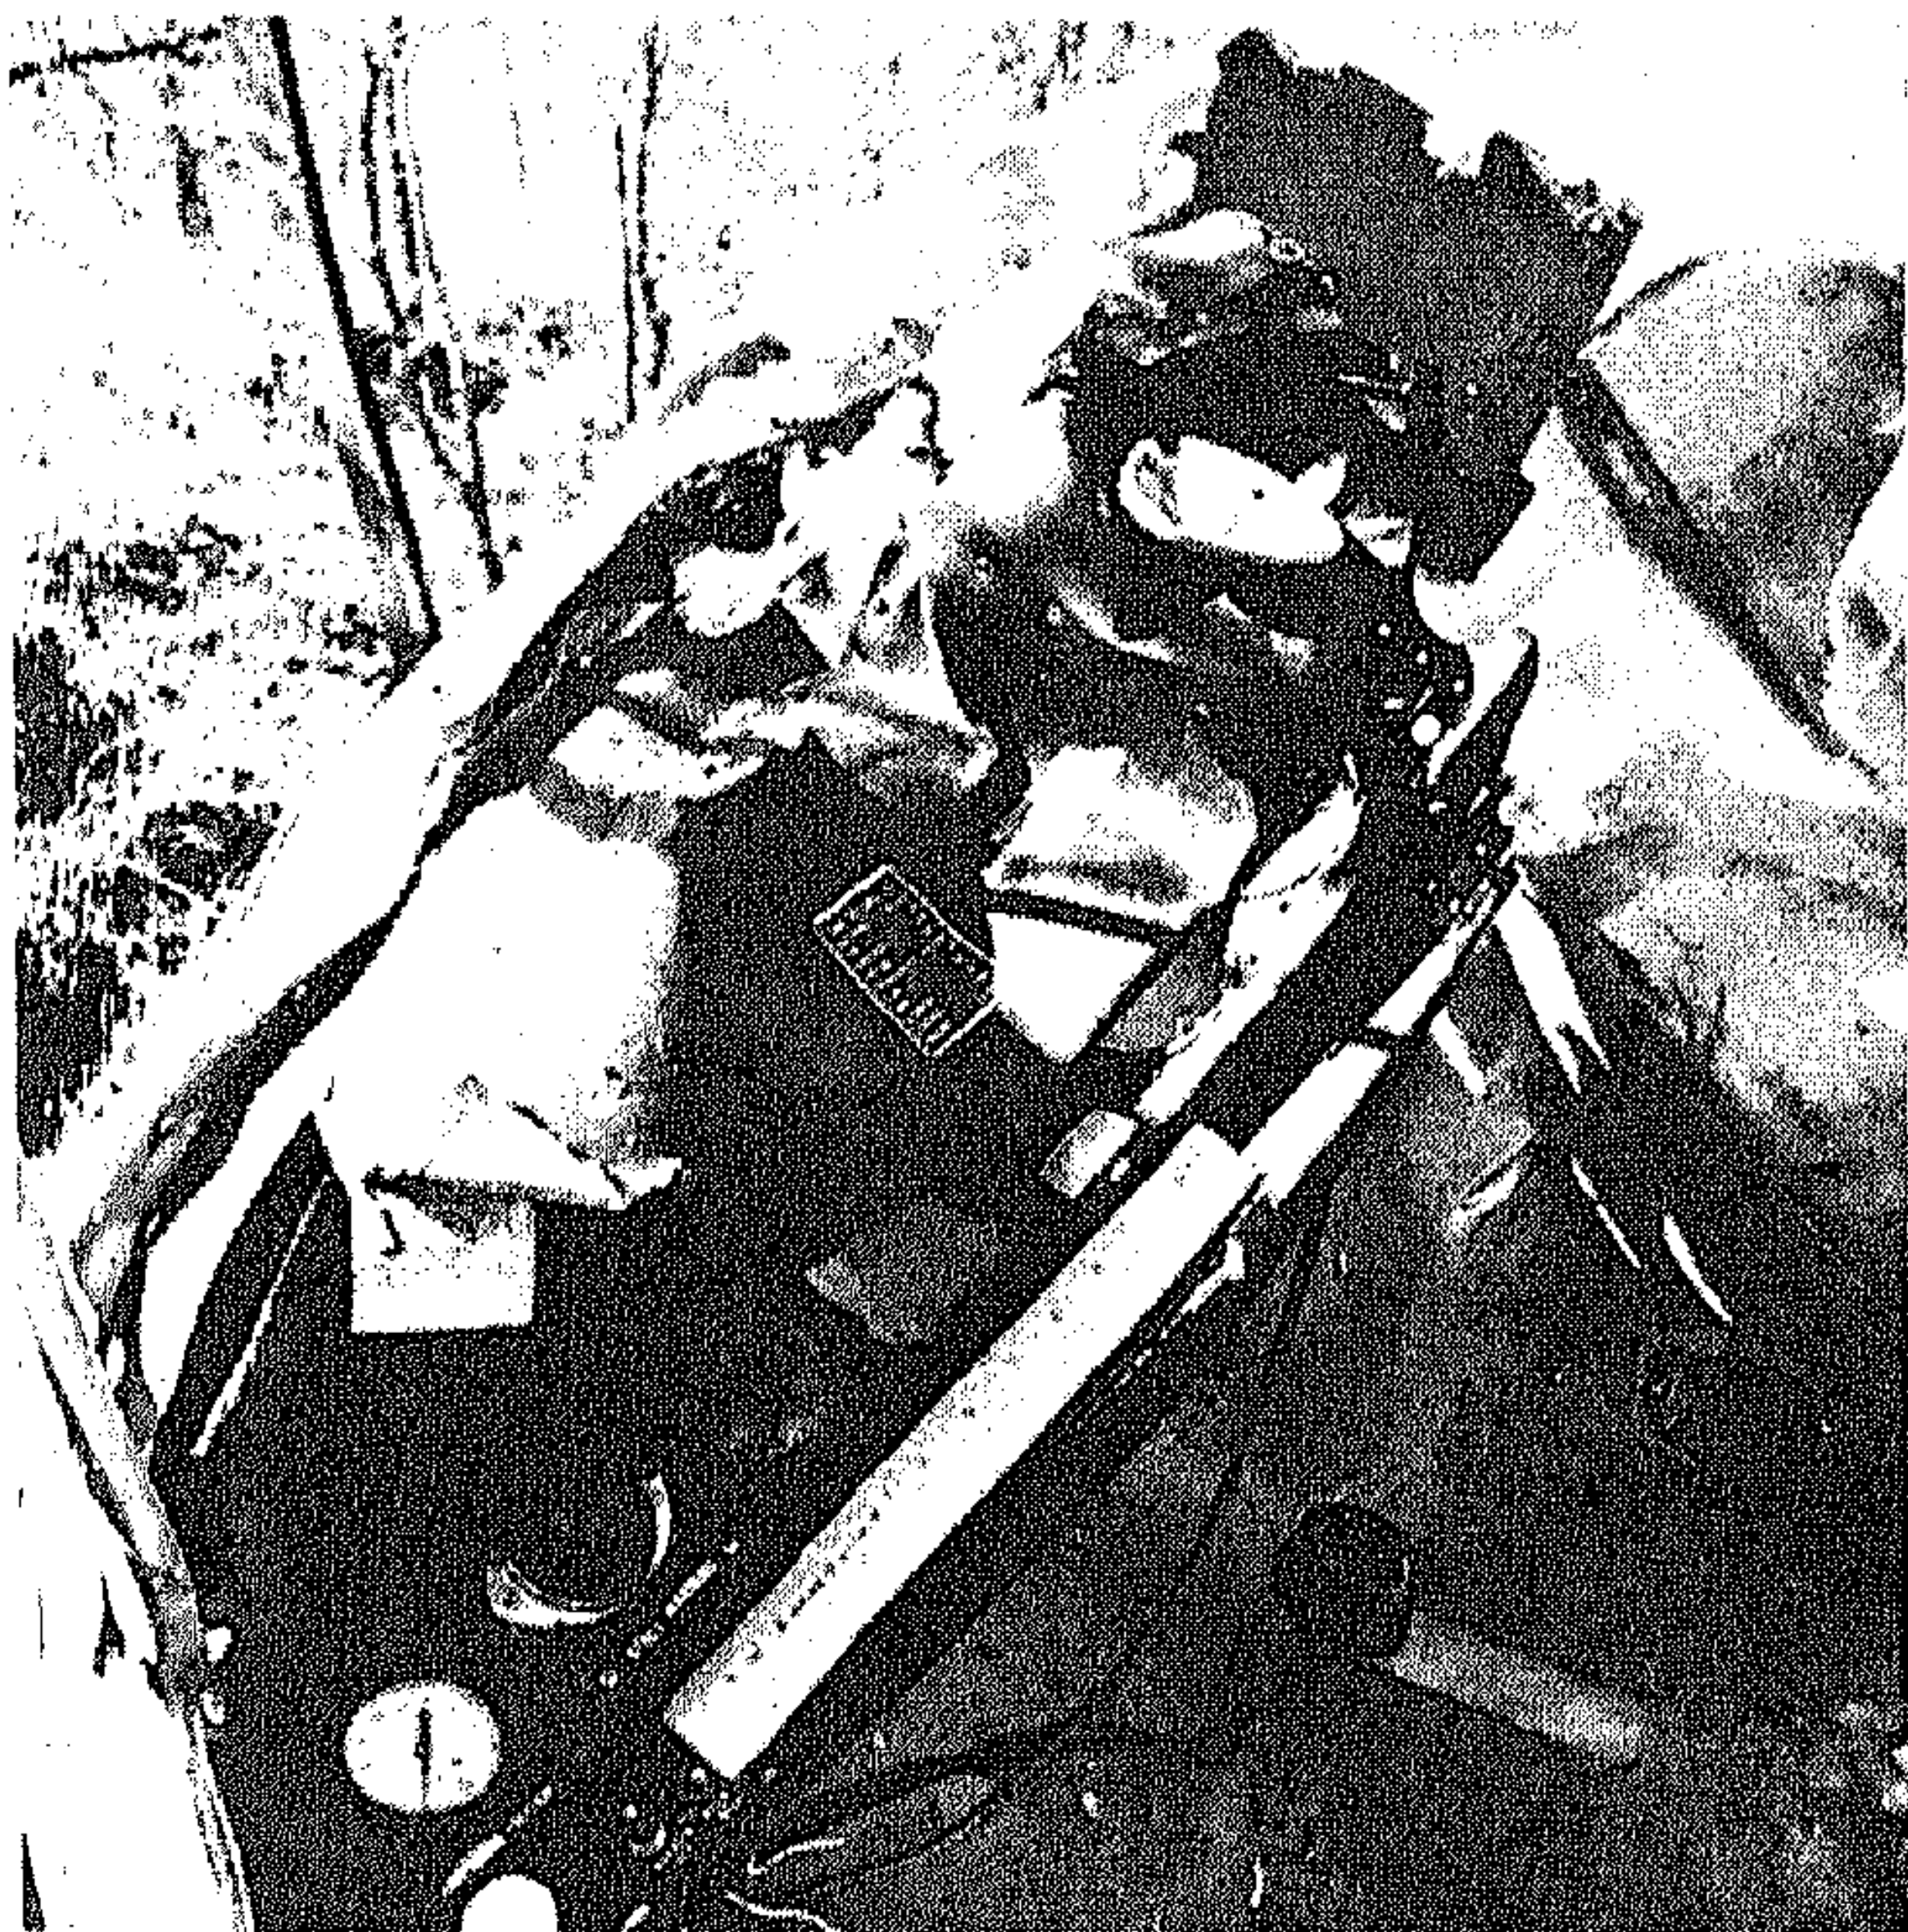
c. Dent in light semicylinder of aluminum from head impact of pilot.

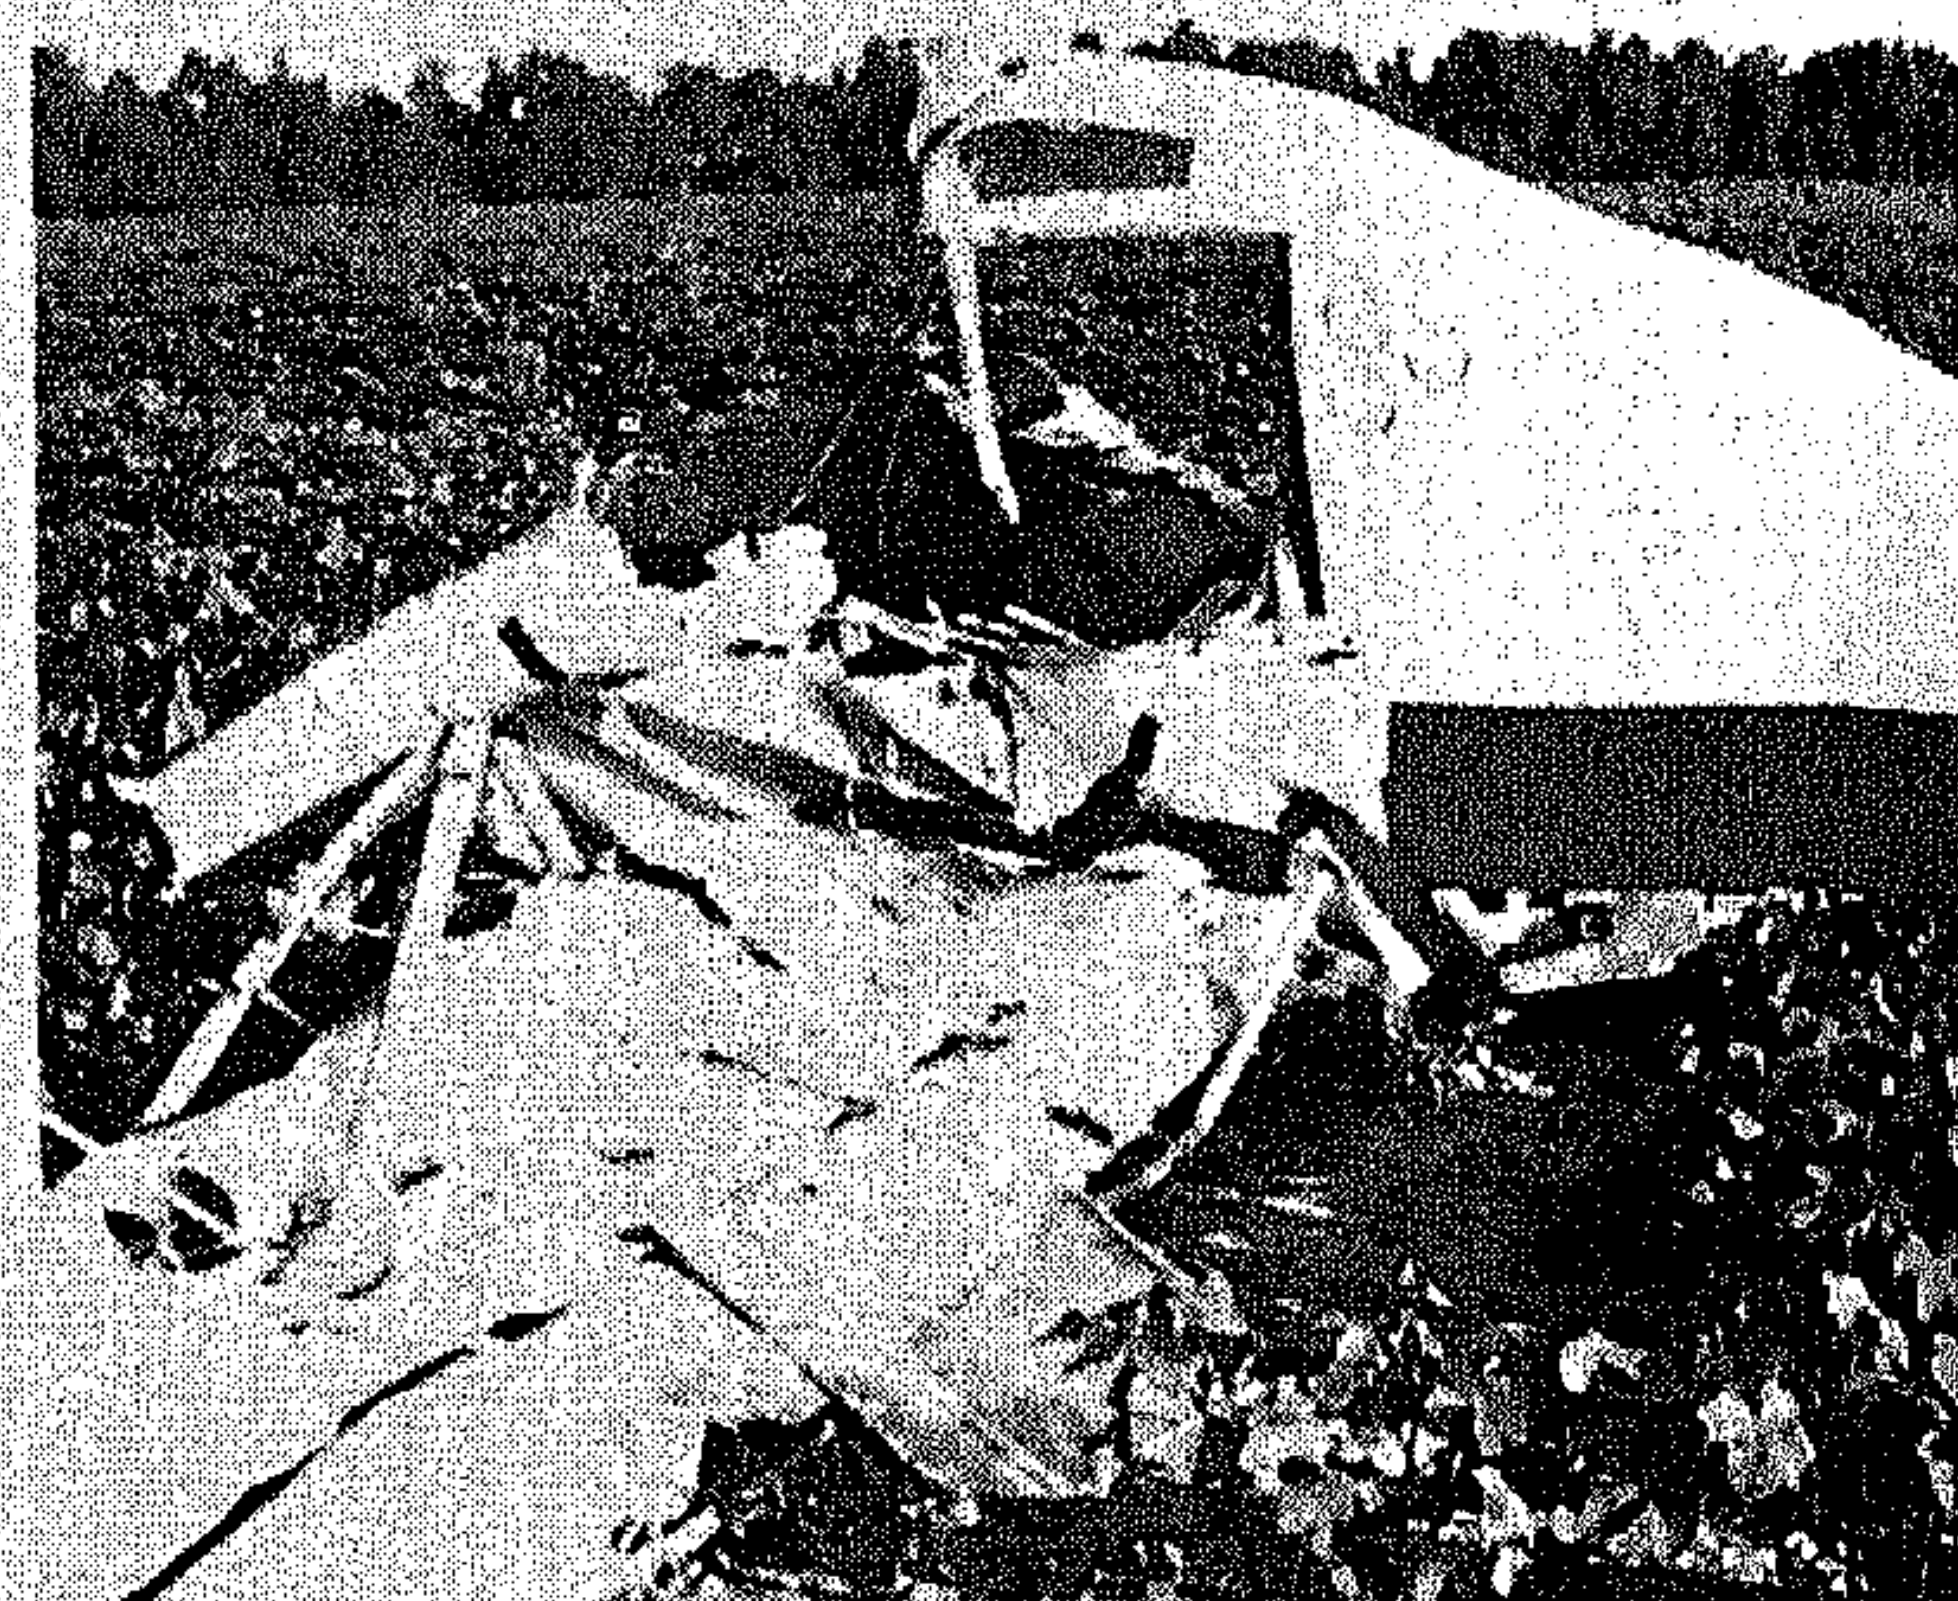
b. Severity of crash forces are indicated by the fact that the hopper has disintegrated and there is a partial failure of the cockpit.

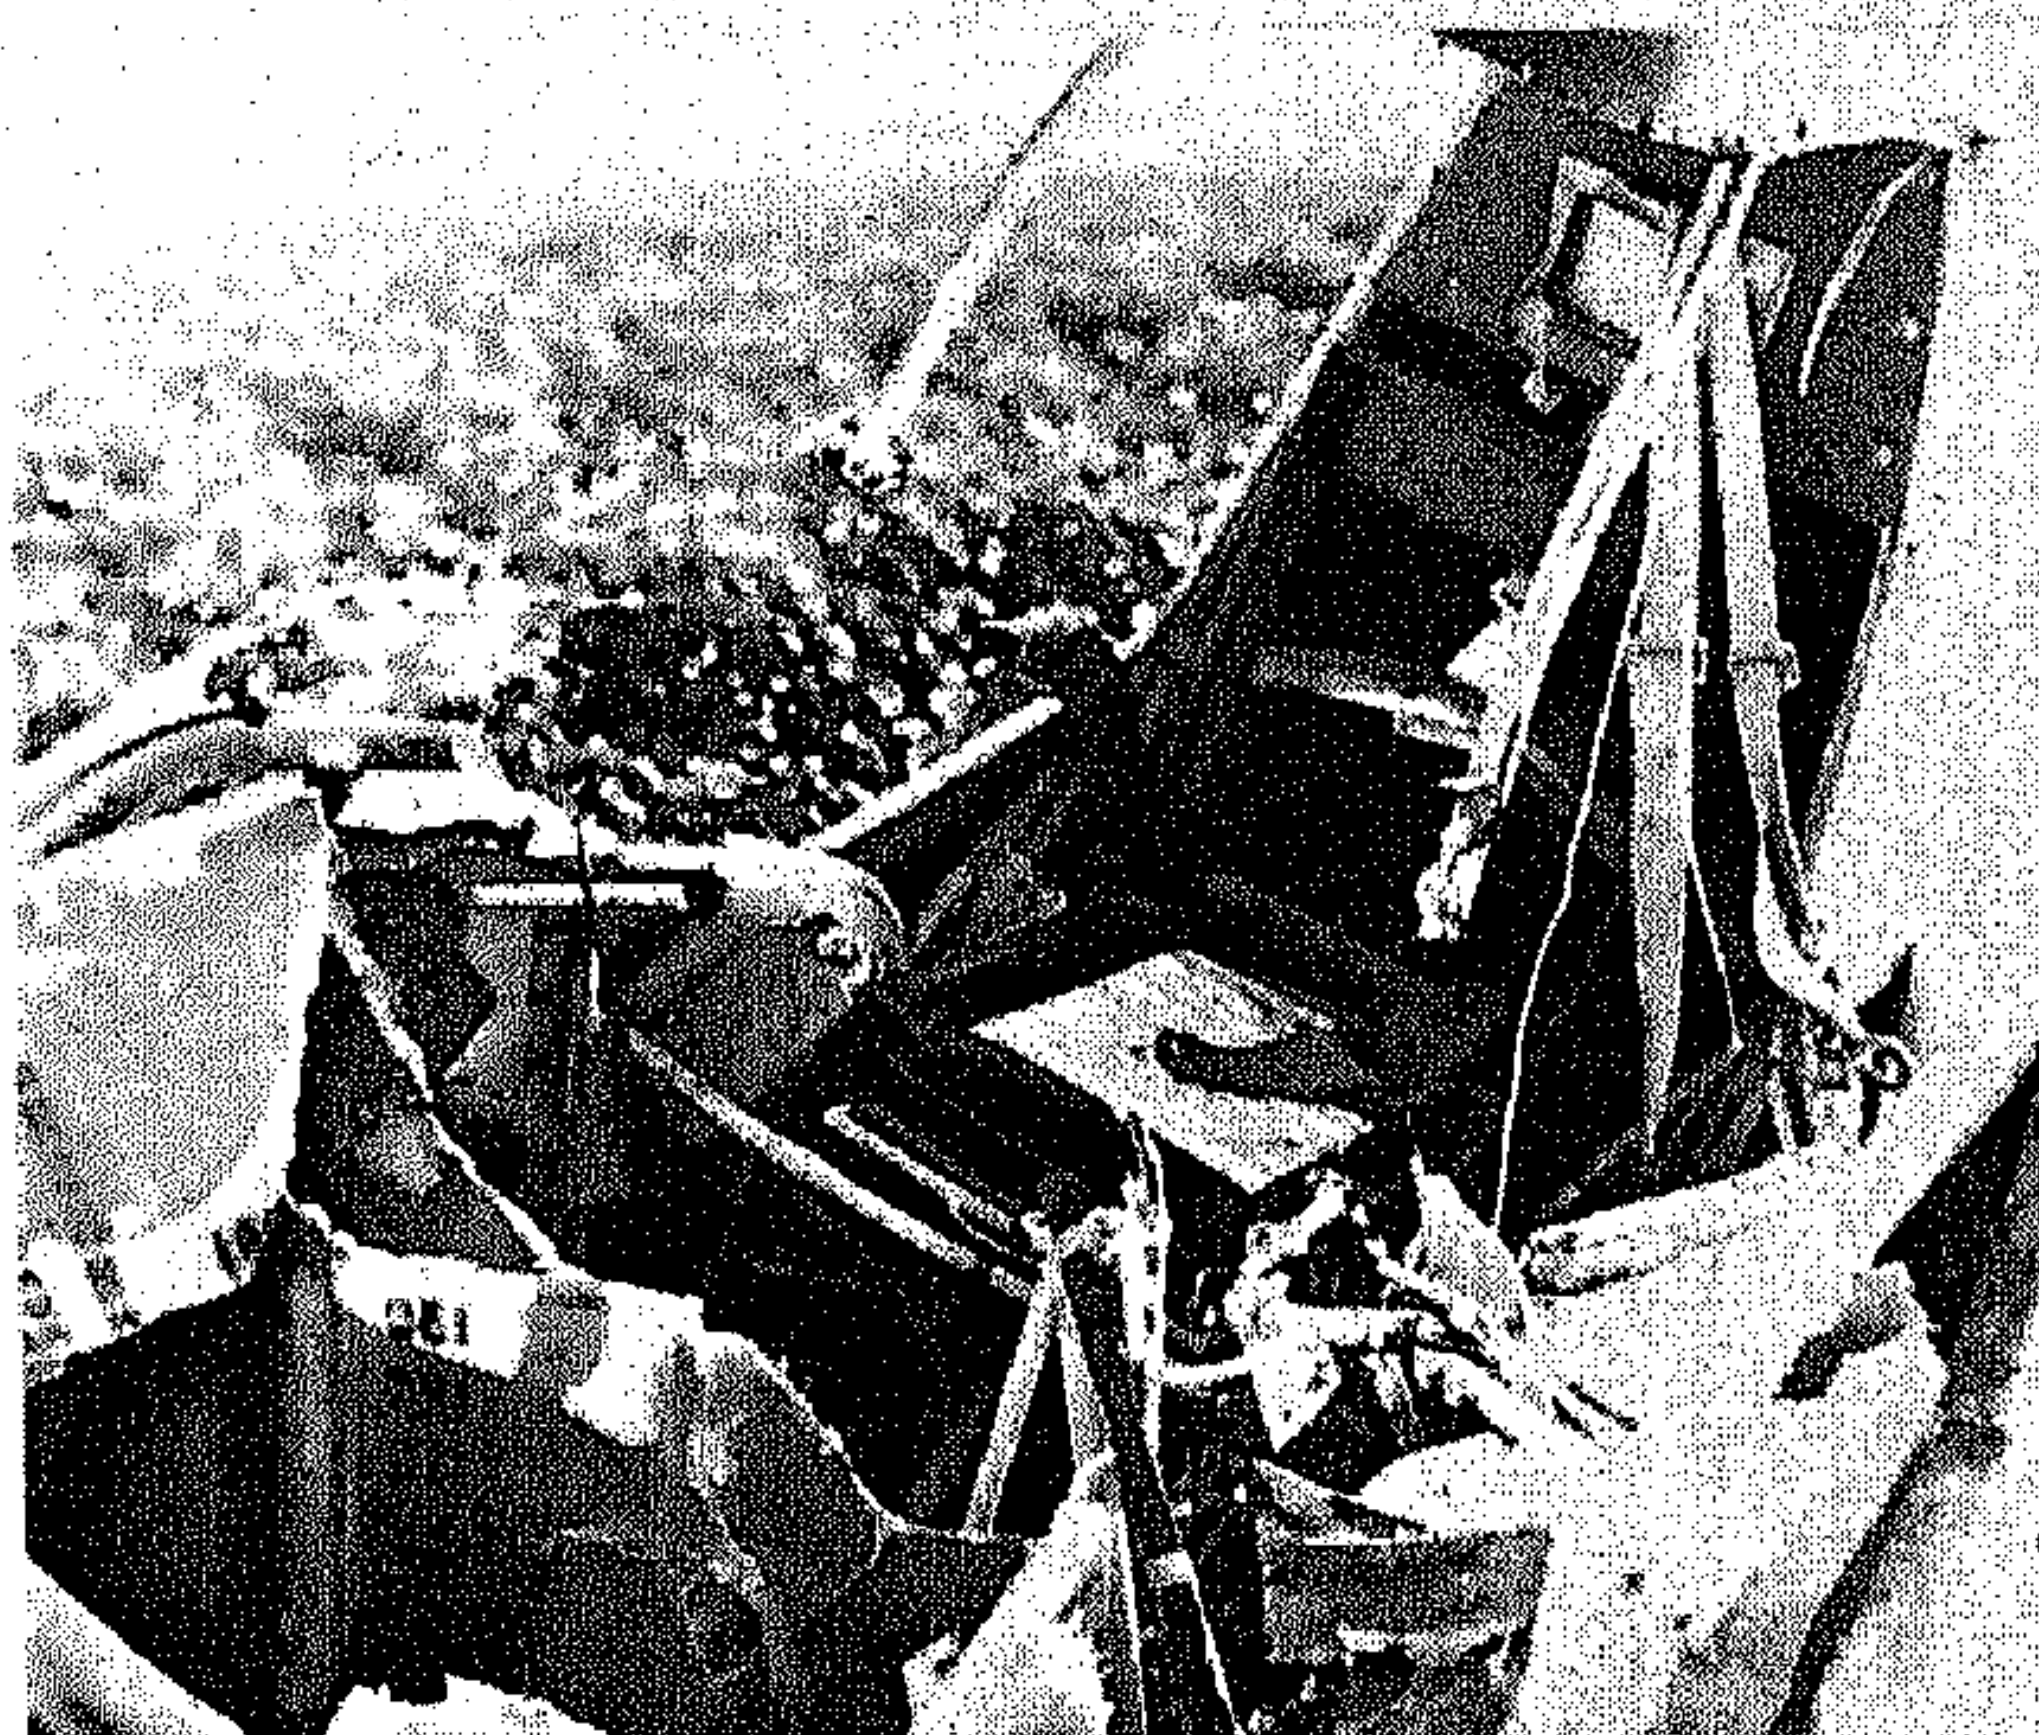
c. View into cockpit showing seat belt & shoulder straps. Pilot was utilizing only one shoulder strap tied to lap belt.

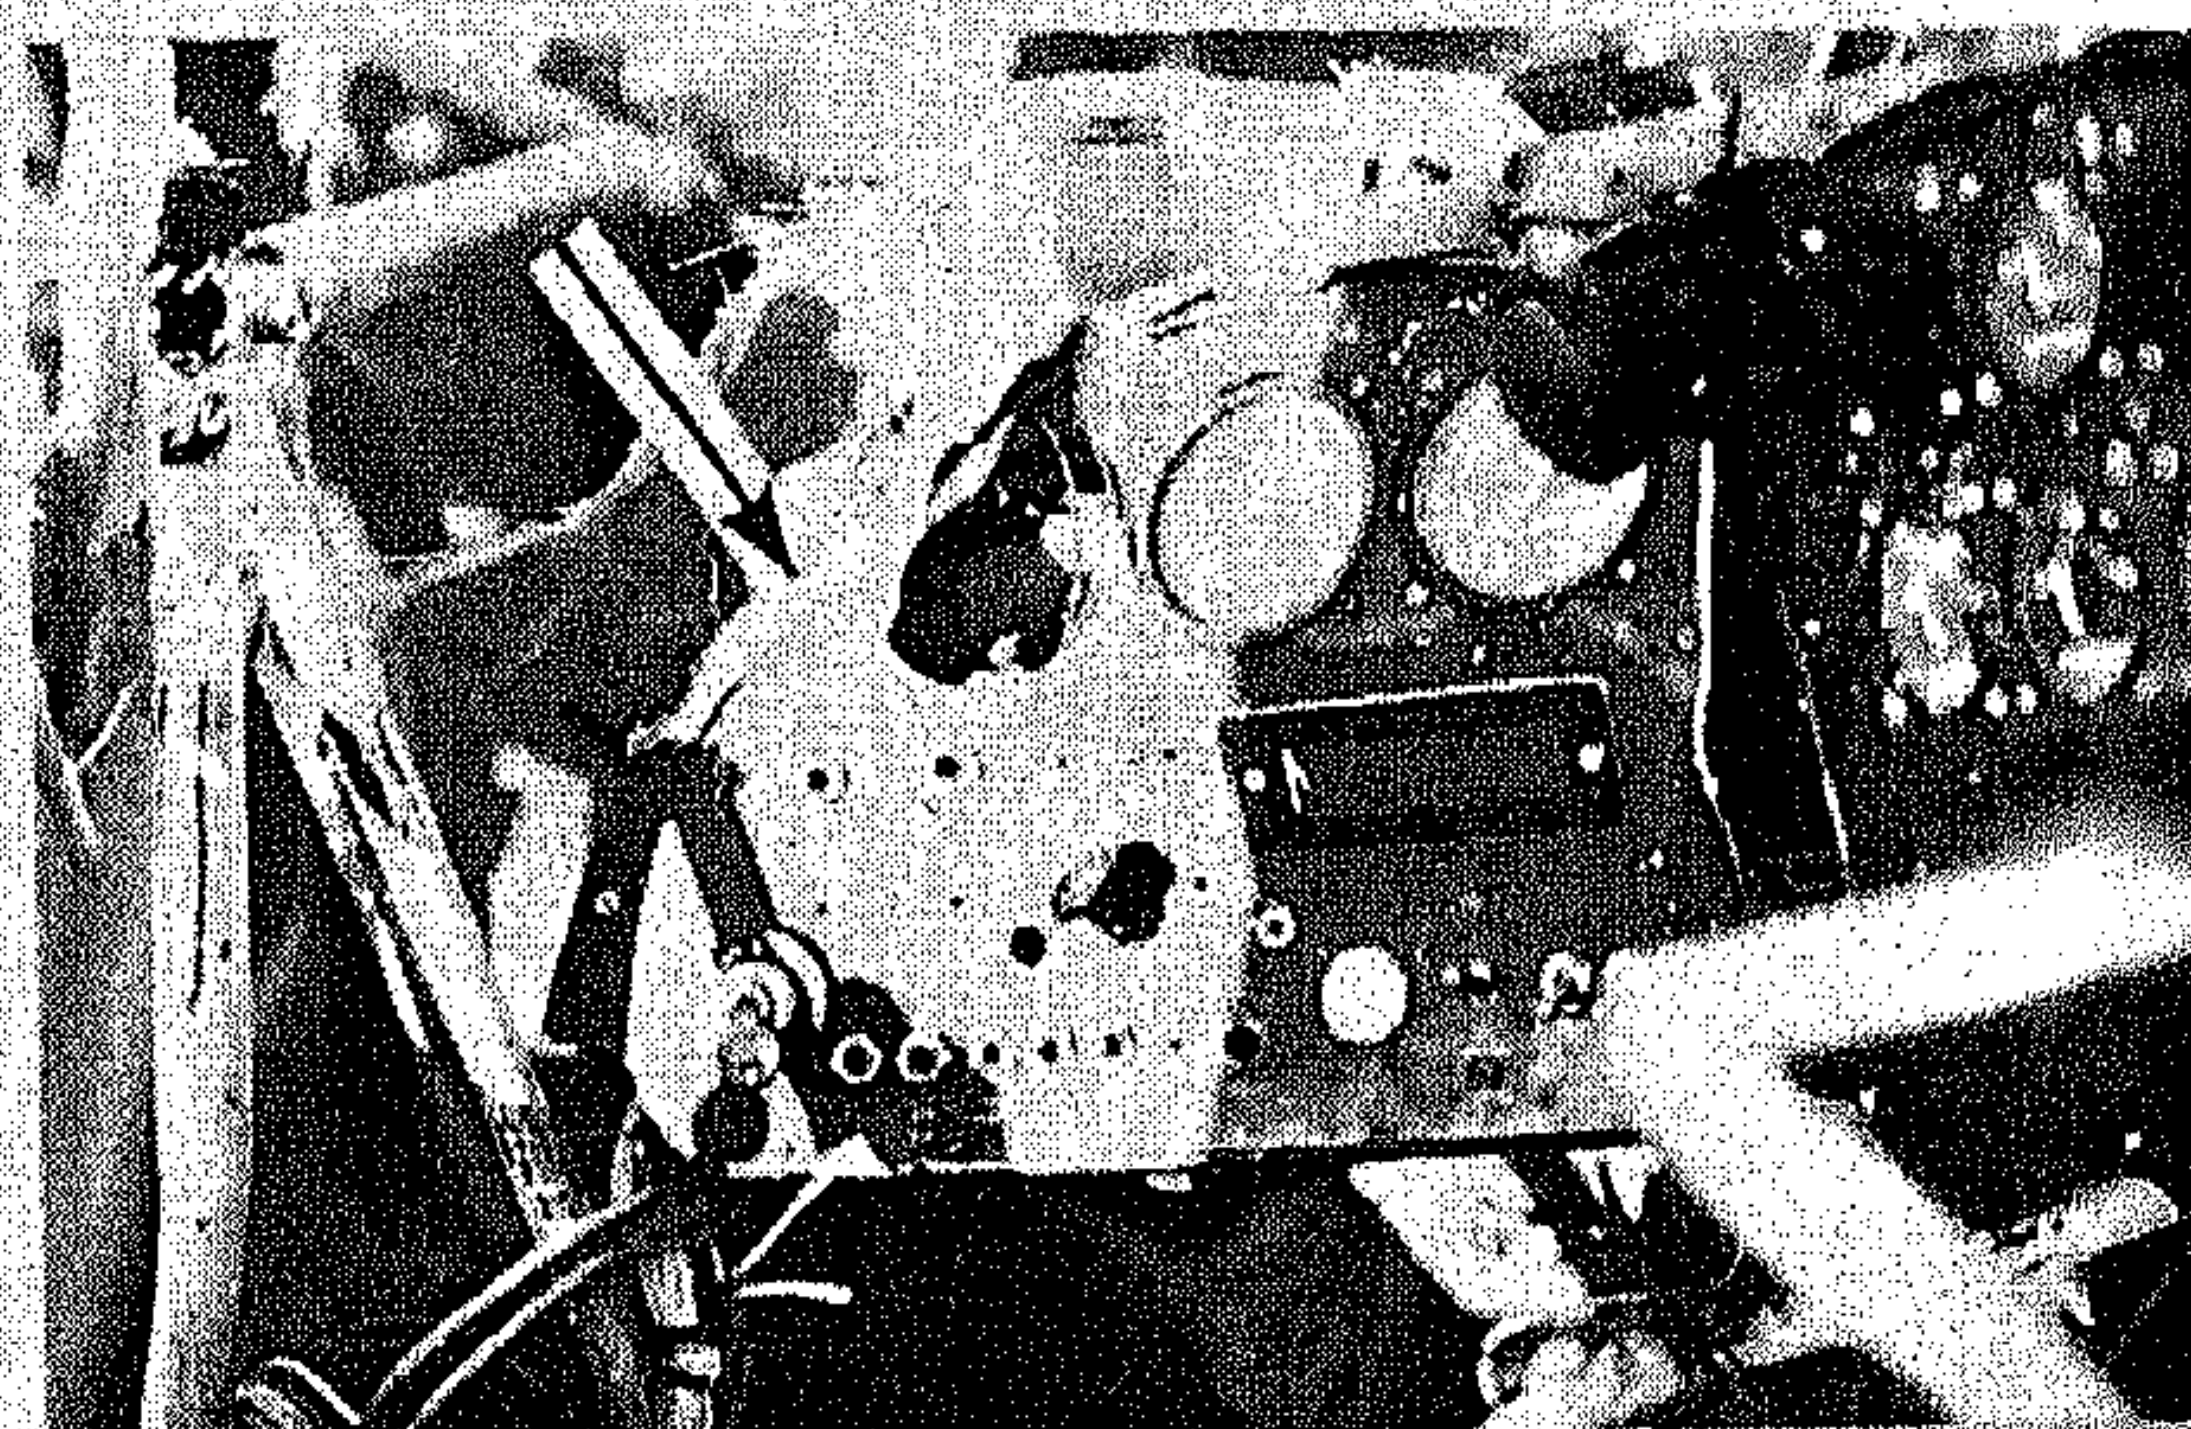
e. View of left instrument panel showing facial impact area. Note the absence of the protective aluminum semicylinder pointed out on the Pawnees & Callairs.

This was a severe crash but would probably have been survivable if both shoulder straps had been in use, if the belt had not been weakened by age, and/or if the instrument panel had been equipped with the Pawnee type aluminum roll. Pilot also suffered fractures of both arms and both legs--all from forward body motion after restraint failure.

1. Equip all aircraft with inertia reels;
2. Attach all inertia reels to structure that is least likely to deform or fail during a survivable crash;
3. Strengthen lap belt and shoulder harness cables;
4. Design the restraint system so that the pilot must wear the shoulder harness when he wears the lap belt;
5. Replace lap belts and shoulder harnesses every five years, or sooner if signs of fraying or deterioration become evident;
6. Use a more positive seat tie-down with double lock pins;
7. Incorporate light aluminum semicylinders or similar structures at the top of the instrument panels of all aerial applicator aircraft to help prevent head injuries.
