| 1. Report No.<br>FAA-AM-72-15 | 2. Government Accession No. | 3. Recipient's Catalog No. | |
| 4. Title and Subtitle<br>CRASH SURVIVAL ANALYSIS OF 16 AGRICULTURAL<br>AIRCRAFT ACCIDENTS | | 5. Report Date<br>April 1972 | |
| 7. Author(s)<br>J. J. Swearingen, D. Av. T.; T. F. Wallace;<br>J. G. Blethrow; and D. E. Rowlan | | 8. Performing Organization Report No. | |

# CRASH SURVIVAL ANALYSIS OF 16 AGRICULTURAL AIRCRAFT ACCIDENTS

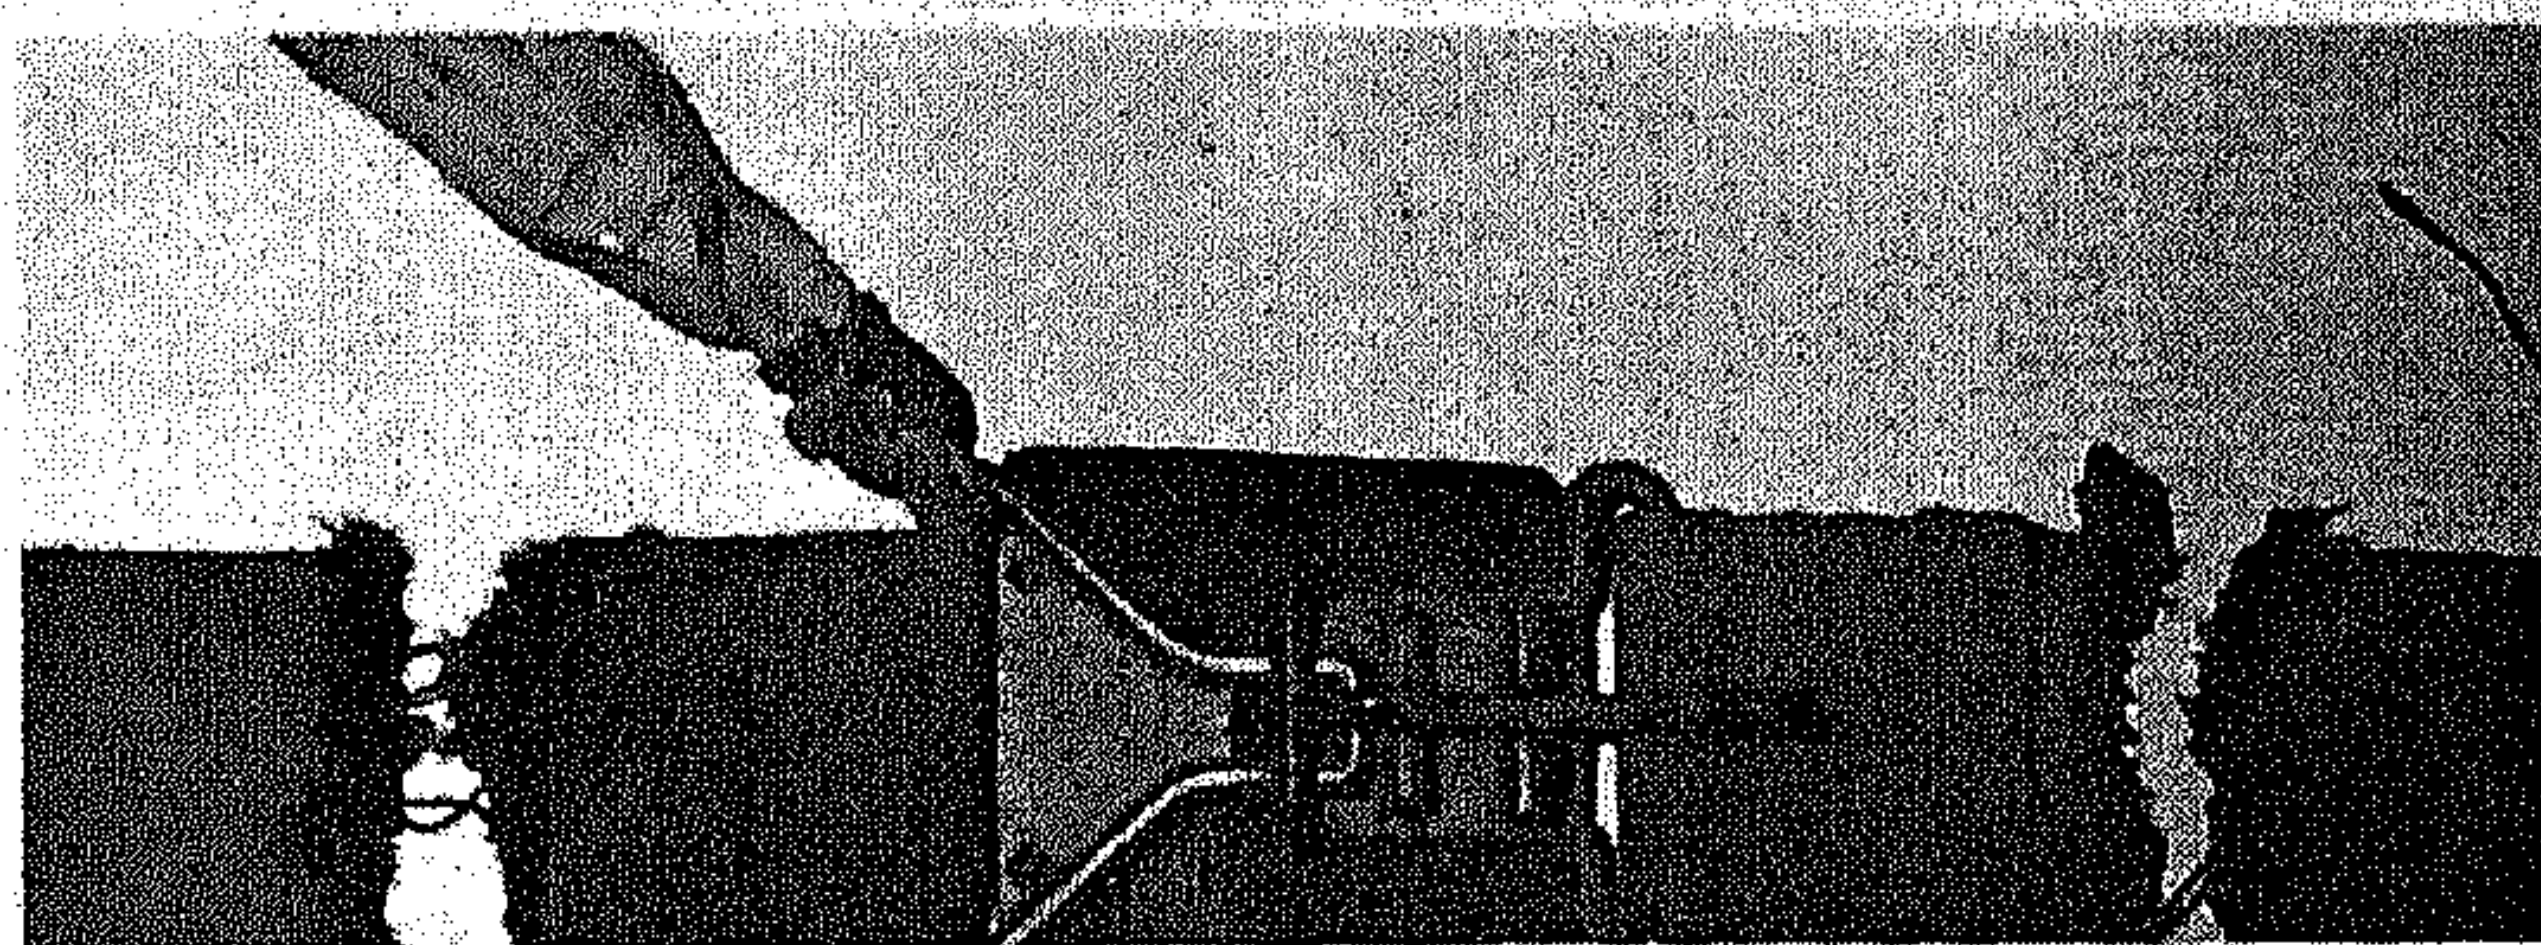
**Case 15:** This 1968 Aerocommander Callair was involved in a crash similar to the two Pawnees described in the two previous cases and, as in Case 14, the age of the webbing caused the lap belt to break in two places (Case 15-d). As the lap belt broke, the single shoulder strap (tied to the belt with nylon rope) offered no resistance to the forward motion of the pilot; his face impacted the instrument panel (Case 15-c). The need for light aluminum semicylinders at the top of the instrument panel is clearly evident when the minor head injuries of the pilot in Case 14 are compared to the fatal crushing injuries of the face and cranium of the pilot in this crash (Case 15-f). The forward motion of the pilot also caused fractures of both arms and both legs. Use of newer webbing and the installation of an impact attenuation device at the top of the instrument panel would probably have permitted this pilot to survive with minor injuries.

d. Single shoulder strap tied to lap belt. Note the 3-in. belt broke on both sides of buckle at approx. contact points of iliac crests of pelvis.

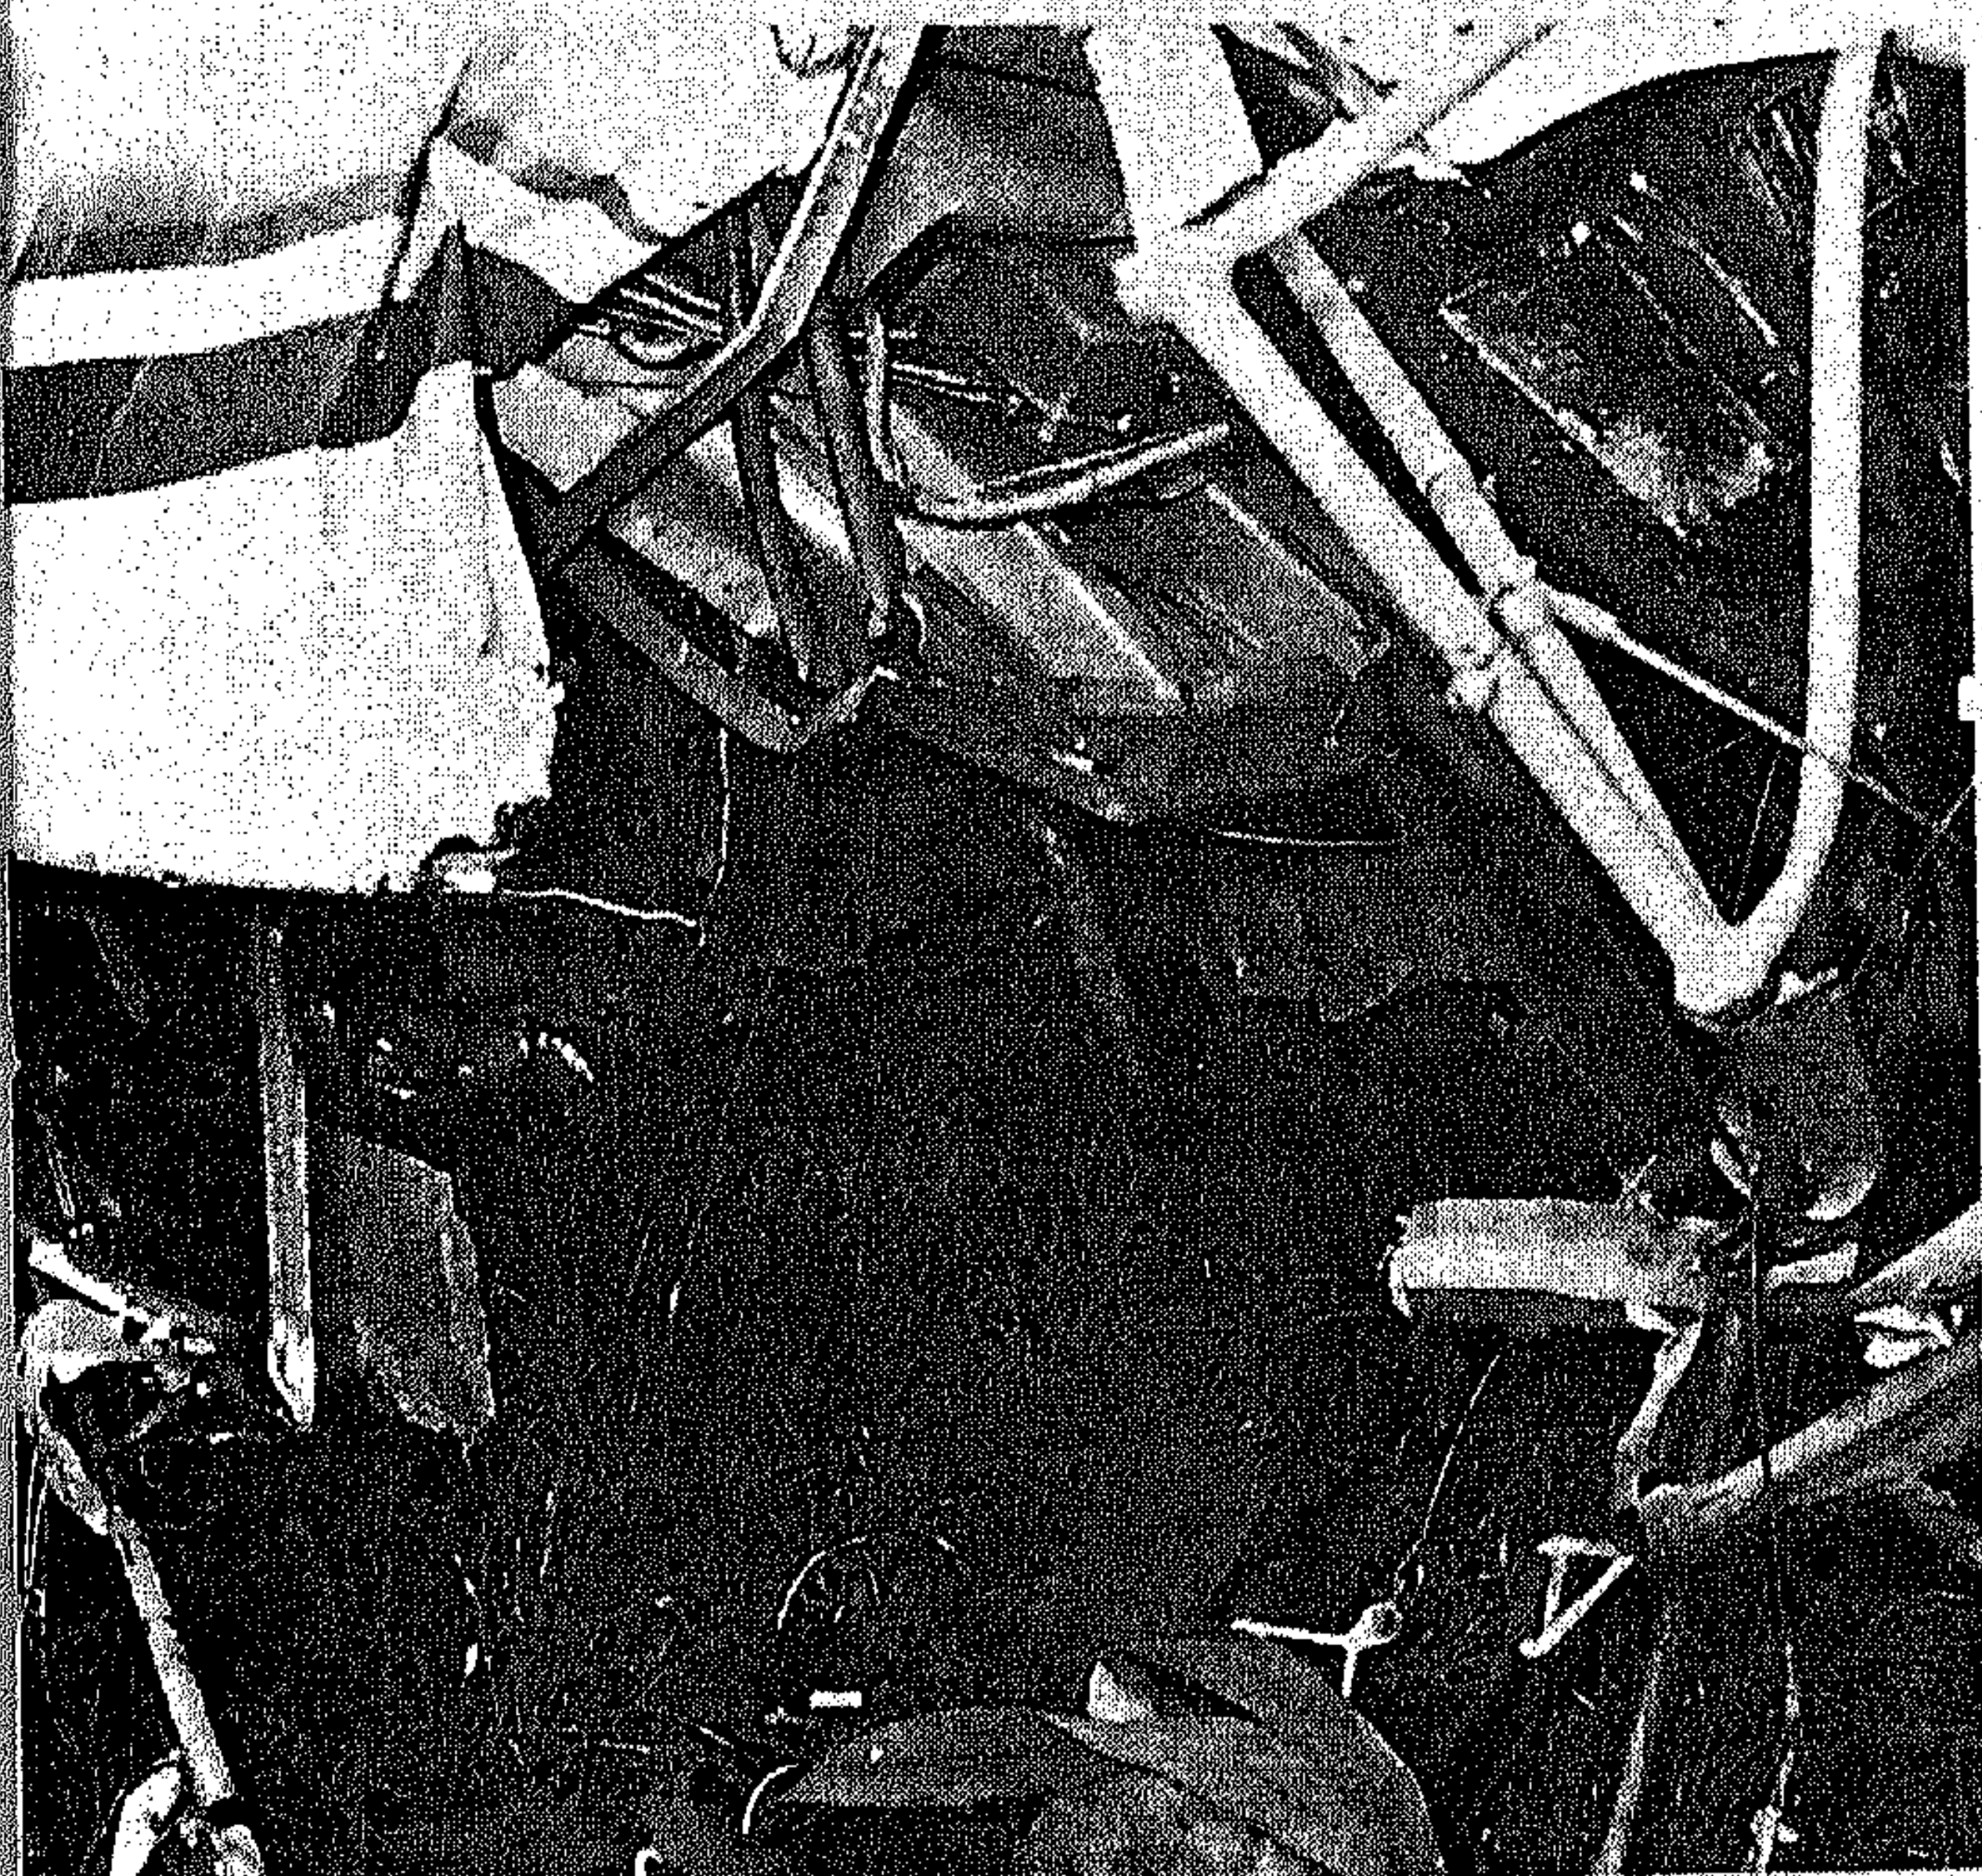
c. Almost complete failure of cockpit cabin integrity. Note that the lap belt did not fail.

This 1964 Piper Pawnee (PA-25-235) aircraft was involved in a crash of such severity that it would probably have to be classified as non-survivable. Injuries fatal to the pilot consisted of severe facial lacerations, severe fractures of both legs, fractures of all ribs on the left side, and a ruptured heart.

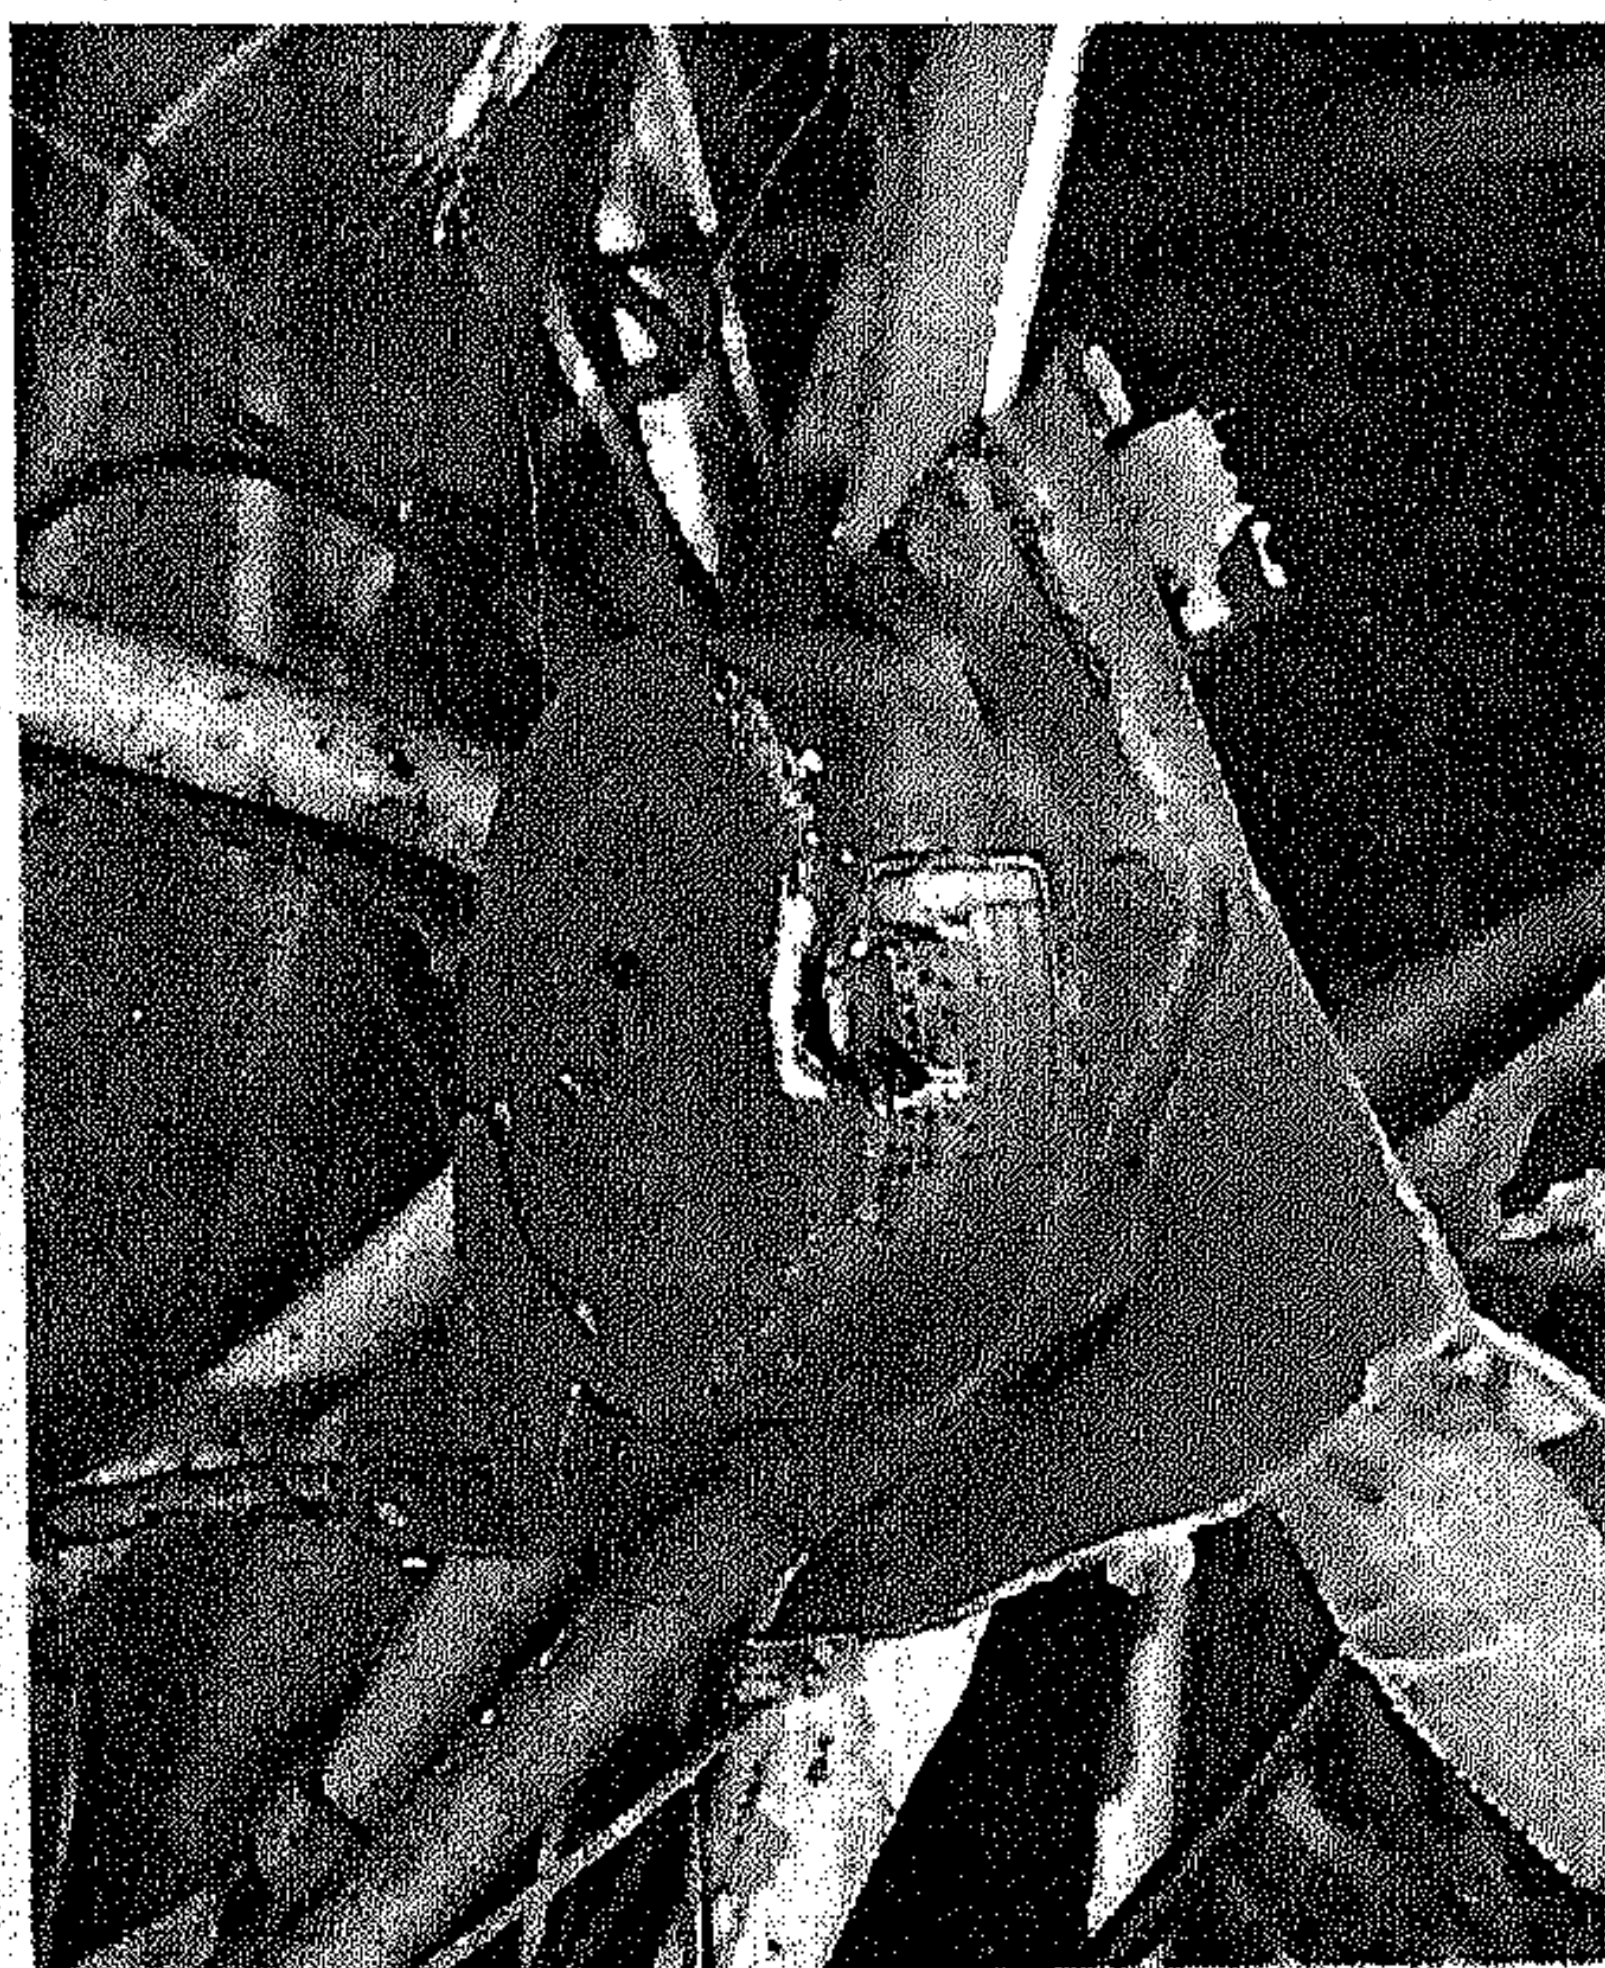
d. Inertia reel torn loose by crash forces.
