1. Report No. FAA-AM-73-1	2. Government Accession No.	3. Recipient's Catalog No.	
4. Title and Subtitle APPLICATION OF COMMERCIAL AIRCRAFT ACCIDENT INVESTIGATION TECHNIQUES TO A RAILROAD DERAILMENT.		5. Report Date January 1973	6. Performing Organization Code

# APPLICATION OF COMMERCIAL AIRCRAFT ACCIDENT INVESTIGATION TECHNIQUES TO A RAILROAD DERAILMENT

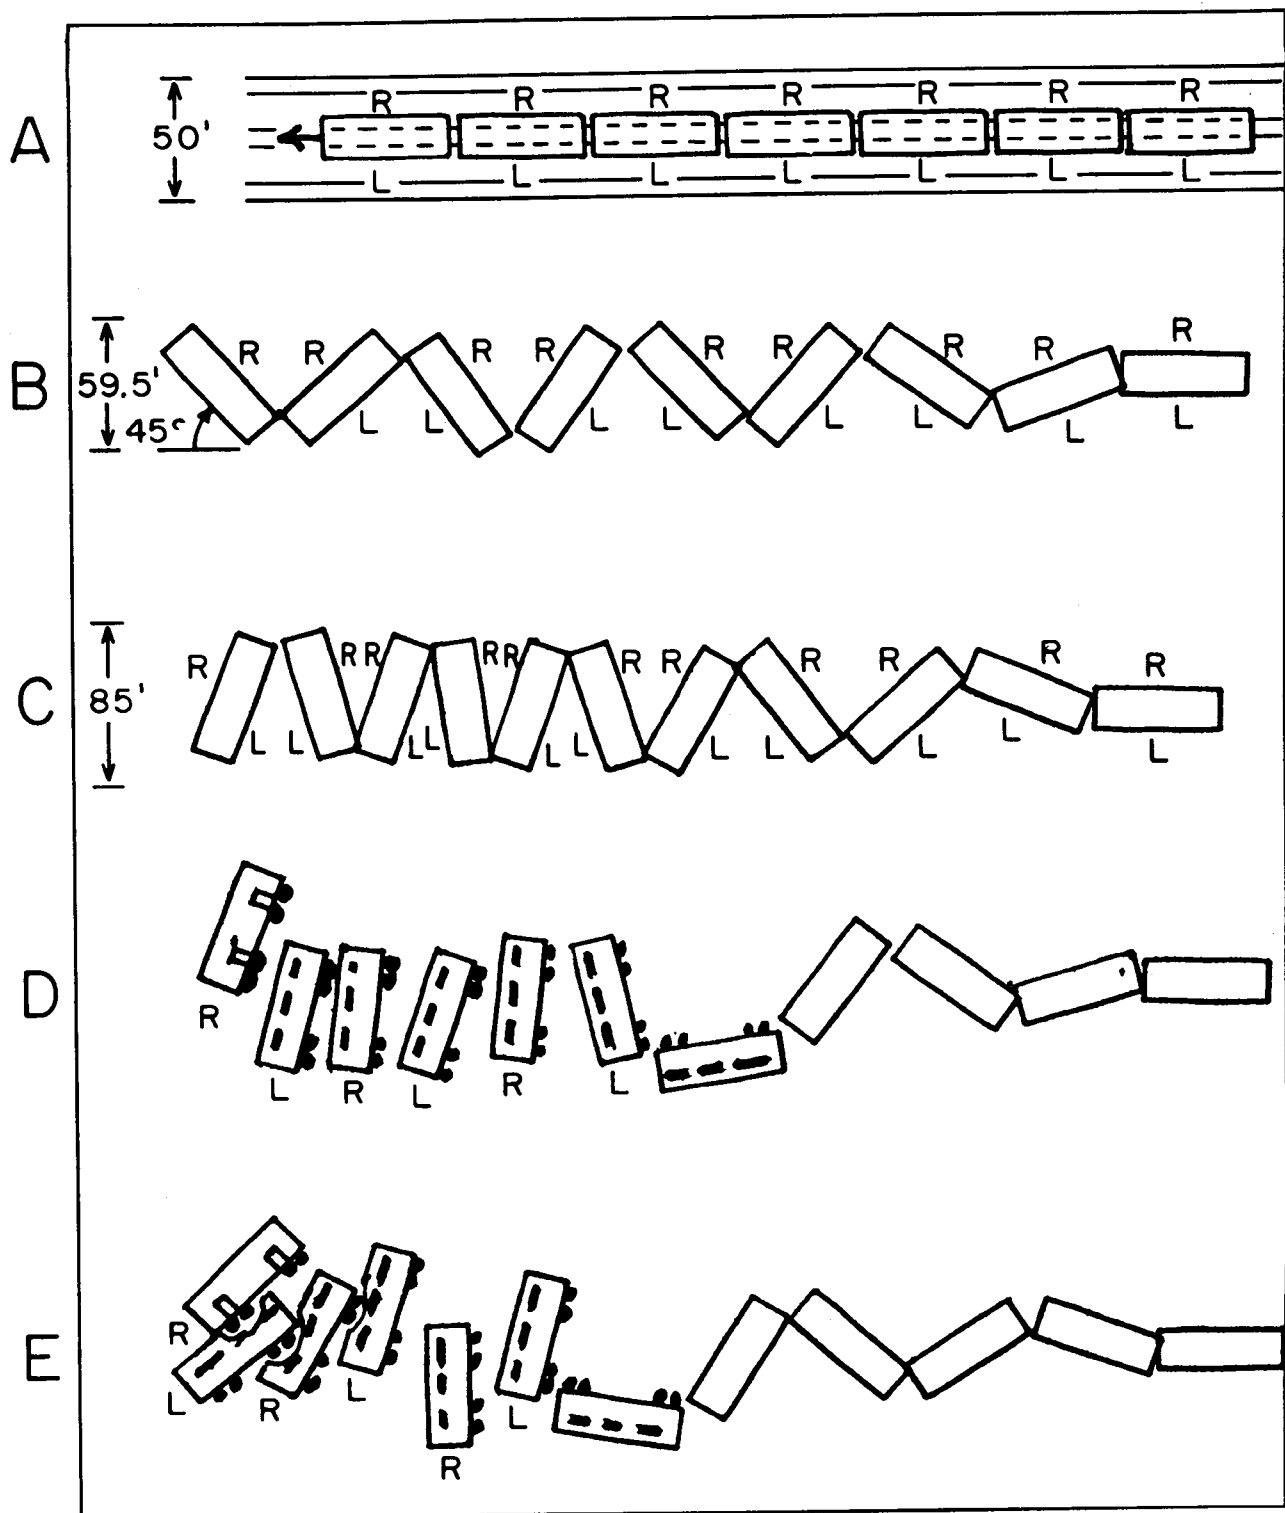
FIGURE 1. Sequence of events following derailment presented diagrammatically.

In (c) of Figure 1 the lead cars are approaching an angle of 90° to the original line of travel and are sweeping a path about 85 feet wide. At about this point the friction caused by the cars, trucks, and wheels sliding sideways and their gouging into earth, rails, and cross ties increased, causing the cars to overturn onto their sides (see step d).

It will be noted in (d) a pattern of overturn has been established. The baggage car (first car shown on the left of Figure 1d) is on its right side with front end up; the first passenger car is on its left side with front end down, and so on right-left-right-left. The cause for this arrangement becomes obvious from parts (b) and (c) of Figure 1, which show right sides approaching right sides and left sides left.

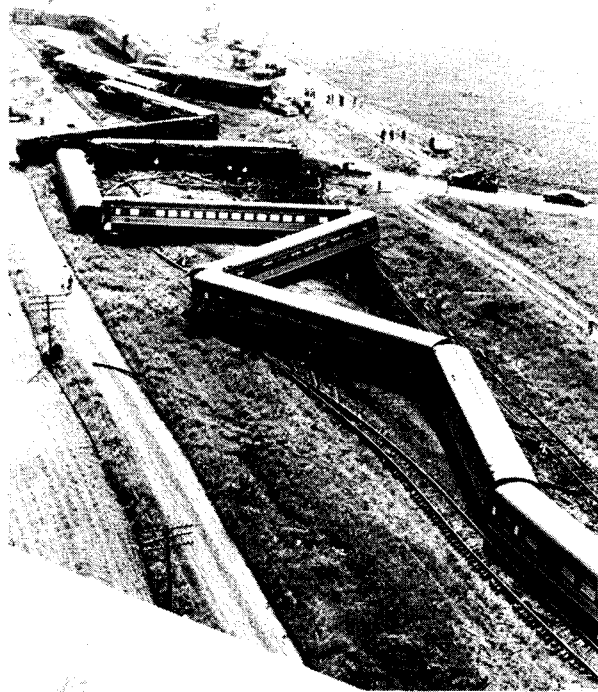
a. Aerial view of train derailment site. Of the four locomotives and 14 cars involved, it may be observed that the two lead locomotives, the baggage car, and the first six passenger cars are overturned and lying on their sides. The accident occurred at a location where three sets of tracks ran parallel to one another. Note that all rails, cross ties and road beds have been swept clean by the forward two-thirds of the train.

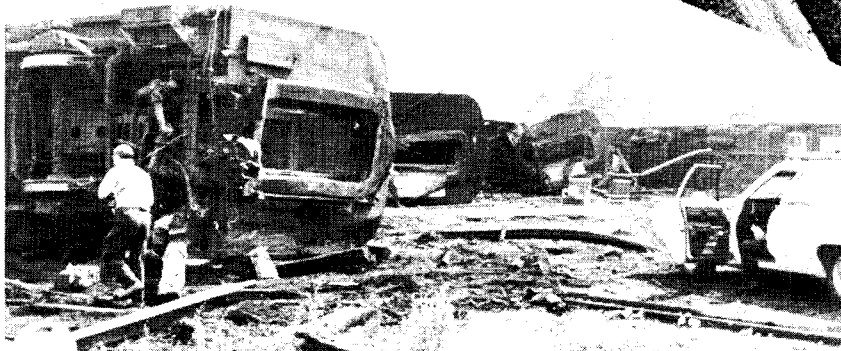
b. Close-up view of the ends of four of the overturned cars.

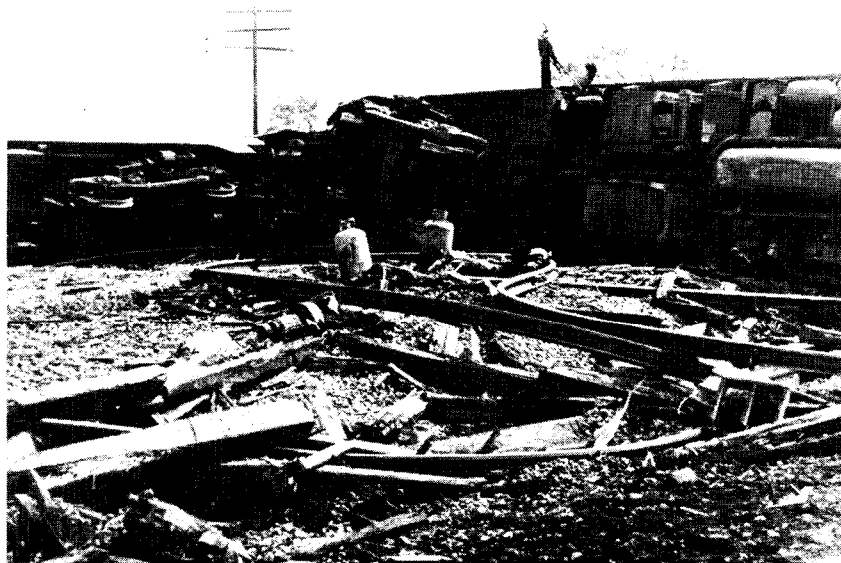
c. Twisted rails and splintered cross-ties attest to the severity of the forces involved. Note large loose gas bottles (used for air conditioning).

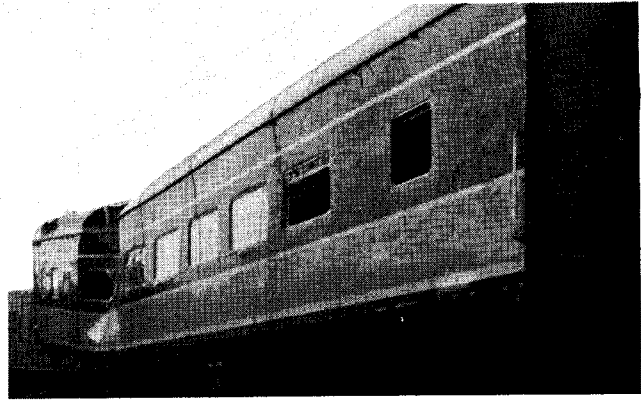
a. Passenger car number one directly behind the baggage car ended up on its left side with the top of the car against the leading trucks (wheels) of the baggage car. This view shows the right side (up side) of the car. The two missing windows were knocked out by rescue personnel in order to lift the injured up and out of the car.

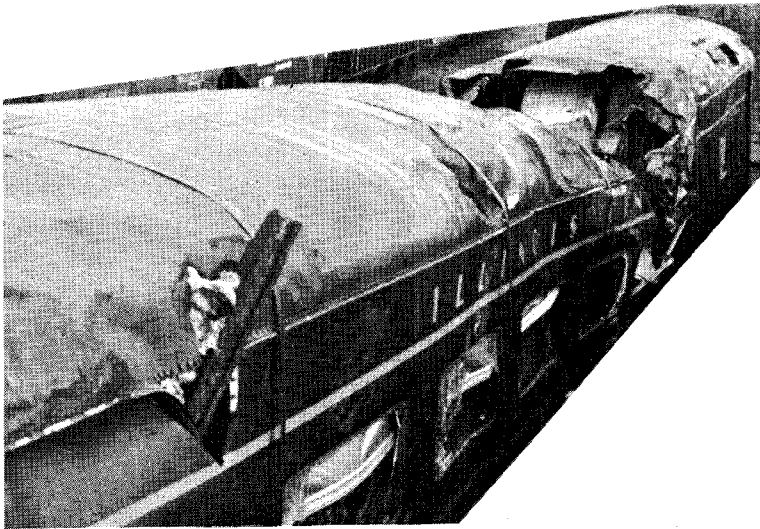
b. Damage to the left side of car number one as viewed from front to back. Note the area of the roof crushed in by contact with the wheels of the baggage car, two rail penetrations, and broken windows with window shades bent outward.

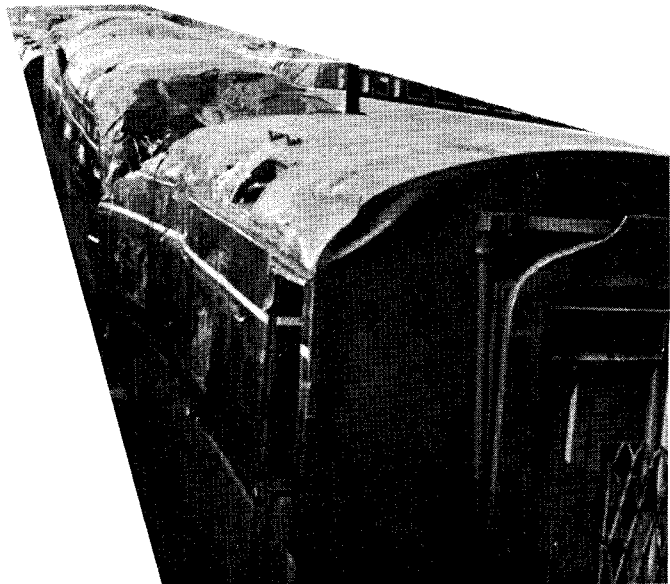
c. Left side of car number one as viewed from the rear. This car slid over 180 feet after turning over onto its side.

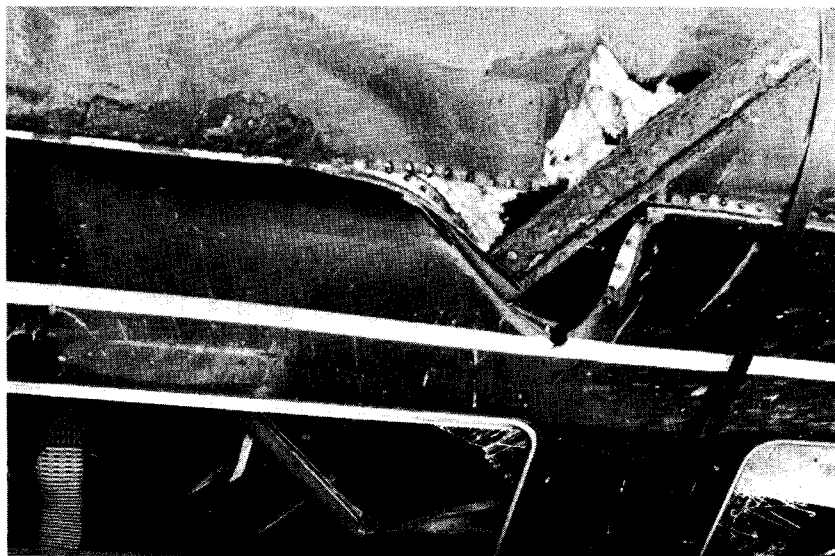
a. Rail penetration of left forward roof of car number one. The angle of penetration indicates that the car was sliding rear-end forward when it picked up the rail.

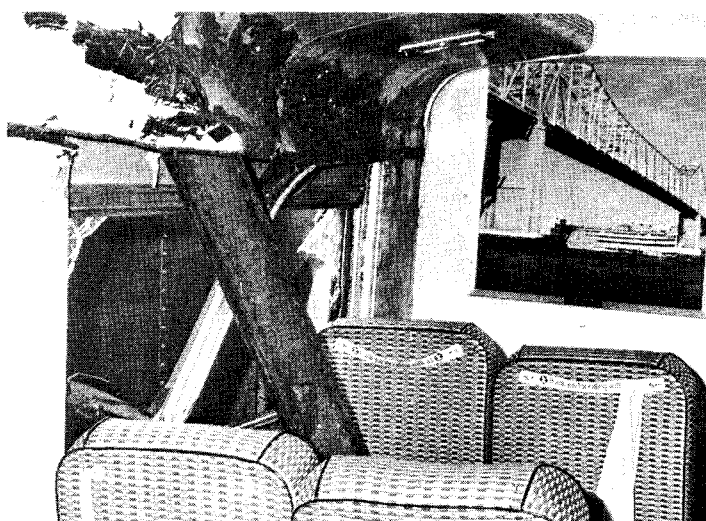
b. Rail went between first and second seats. Fortunately this area was not occupied at the time of rail penetration.

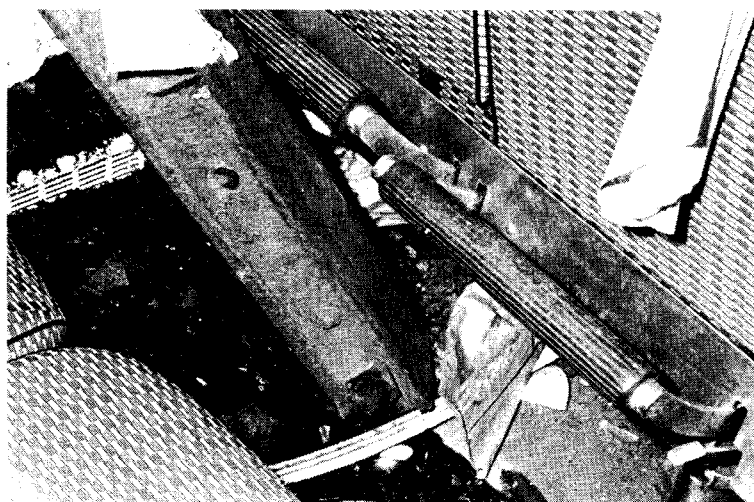
FIGURE 4. Close-up views of a rail penetration into Passenger Car No. 1.

c. Rail stopped when the end of it rammed against the floor.

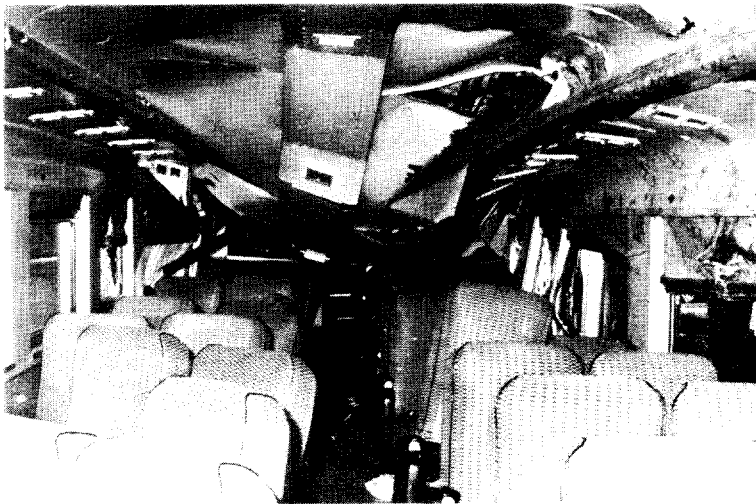
b. Inside view of car no. one looking toward the rear. Railroad seats are designed to be rotated after pulling them toward the aisle 3/4-inch to unhook a catch. Note that all the seats in the left of the picture (right side of car) are unhooked and rotated aisle-end forward.

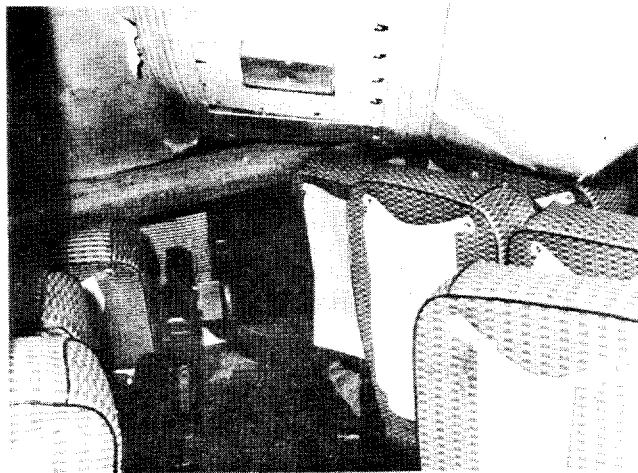
FIGURE 6. Close-up views of external damage caused when the top of Passenger Car No. 1 impacted the wheels of the baggage car.

c. Roof is depressed below the level of seat back tops. Passengers were trapped in their seats.

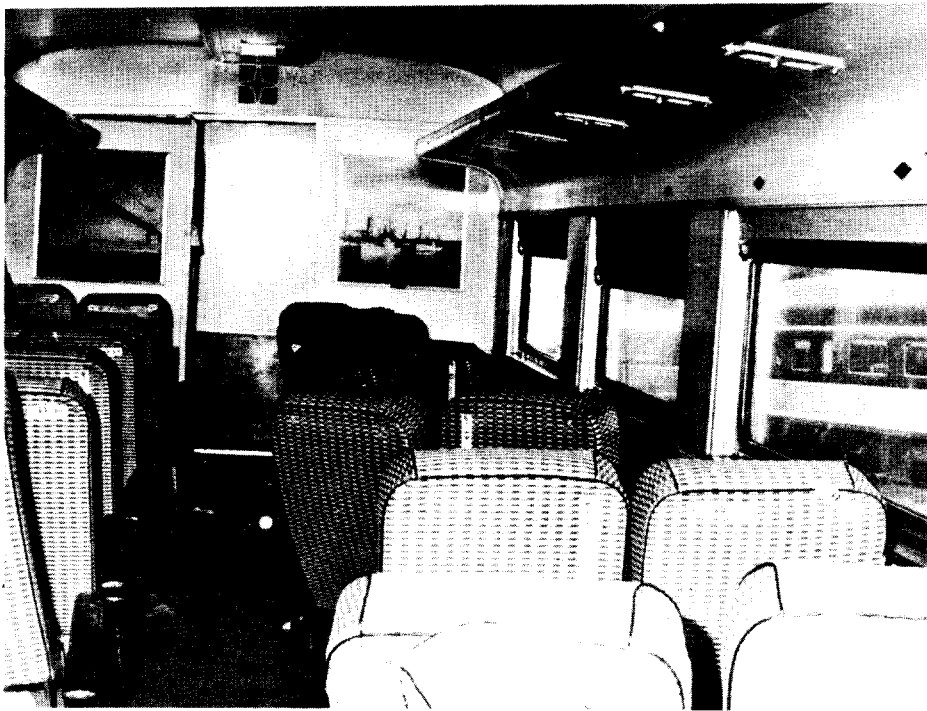
a. Right forward section--very minor damage--seats rotated.

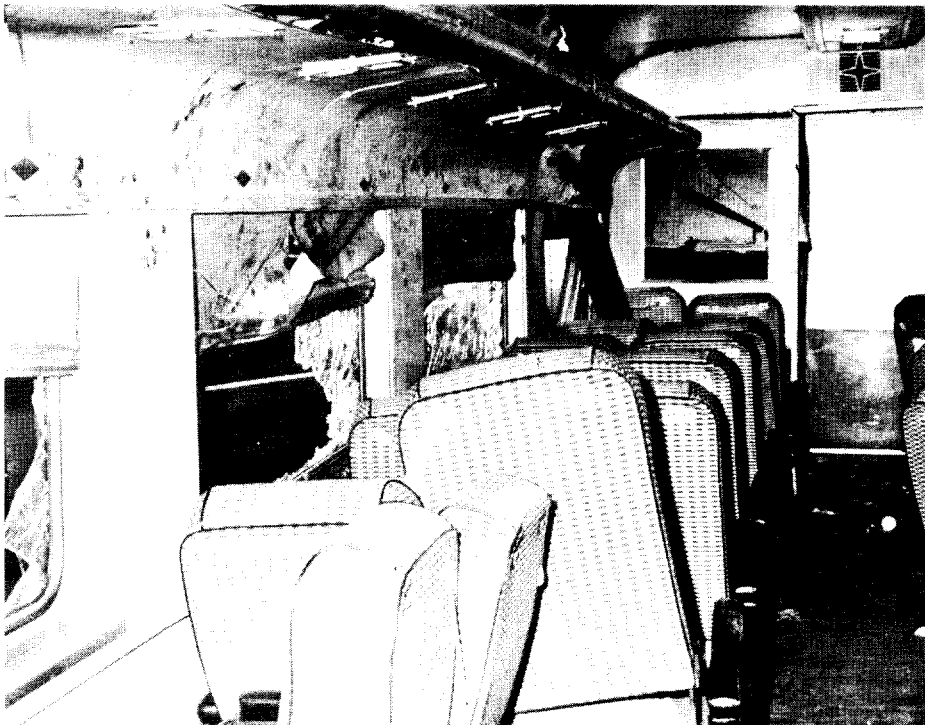
b. Large windows (5 ft. long, 2 ft. high) broken out by body impacts as car rolled over. Note seat in foreground rotated 90° to face window. Passengers ejected (at least two).

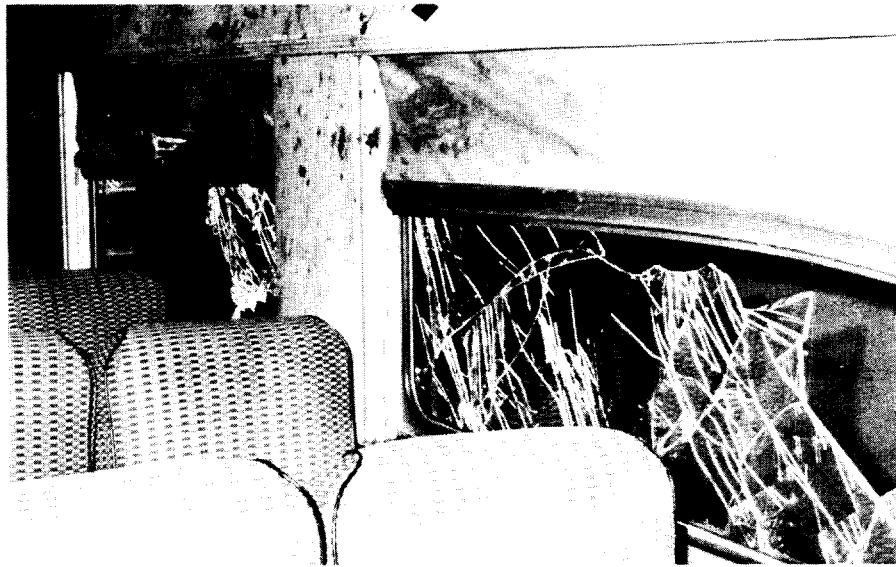
a. Window shades bent out and windows broken by body impact.

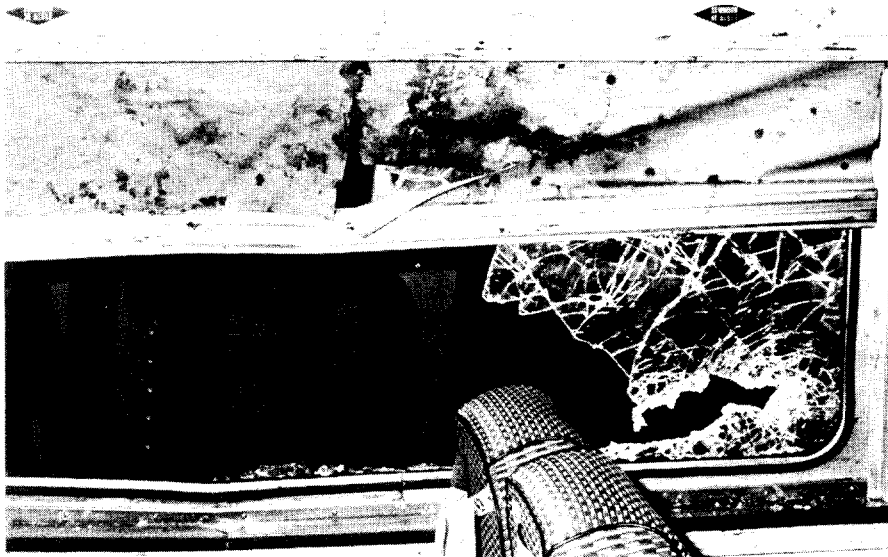
b. Close-up of dents in window shade rod and lower window sill. Since the sun was shining in the left side of the car, some shades were partly drawn and probably prevented ejection of some passengers.

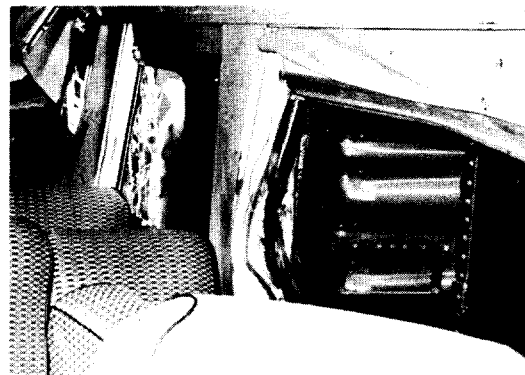
FIGURE 8. Inside views of window damage on the left side of Passenger Car No. 1.

c. Window shade rod bent upward as passenger from right side of car was thrown across the car and ejected through this window.

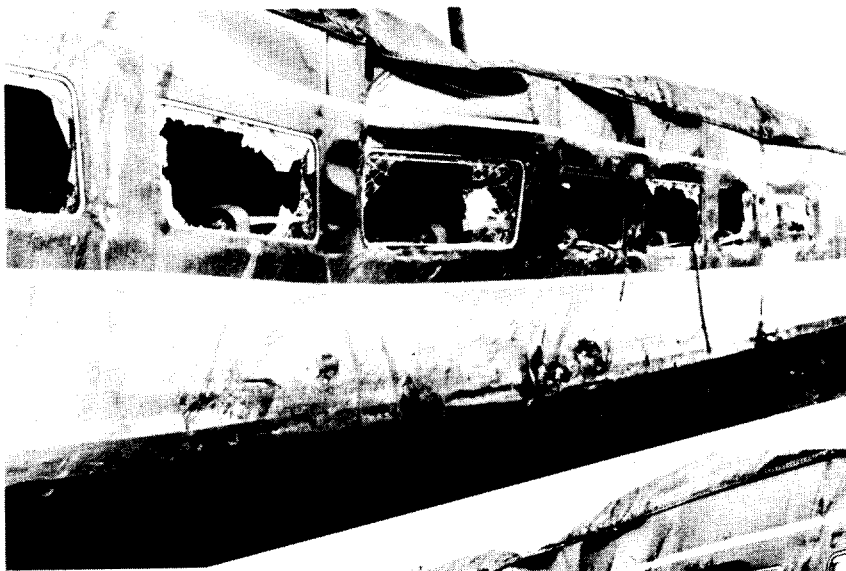
a. Right side (down side) of passenger car no. 2. Six of 7 large windows knocked out. Note window shades are up. Depression in roof is from contact with wheels of car no. one.

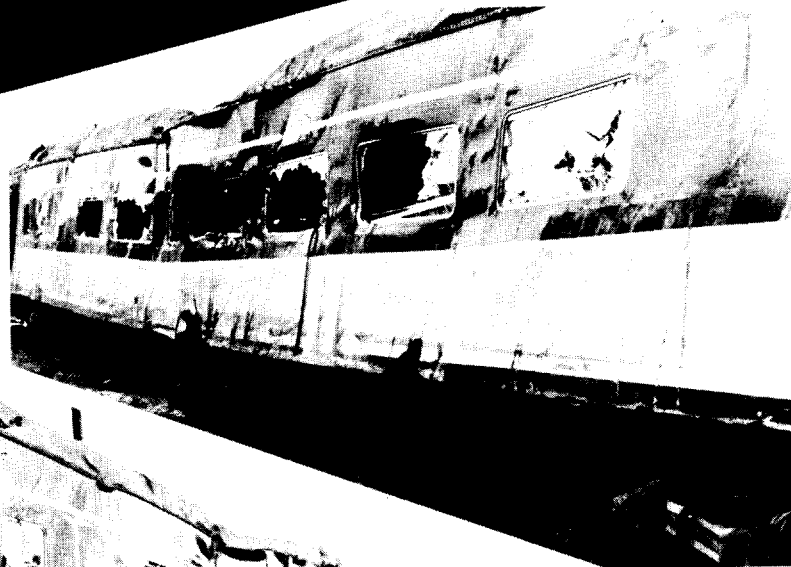
b. Angle of skid marks indicates car was sliding front end forward.

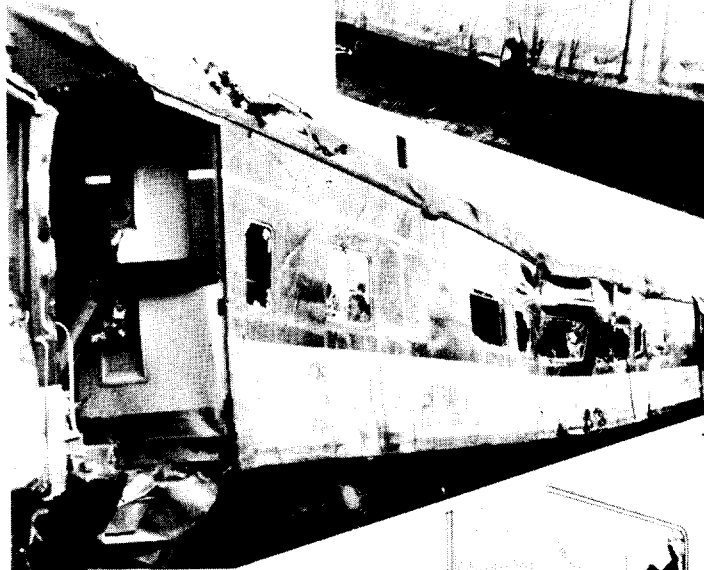
c. View of right side of car from rear end. Note rail penetration into boarding area.

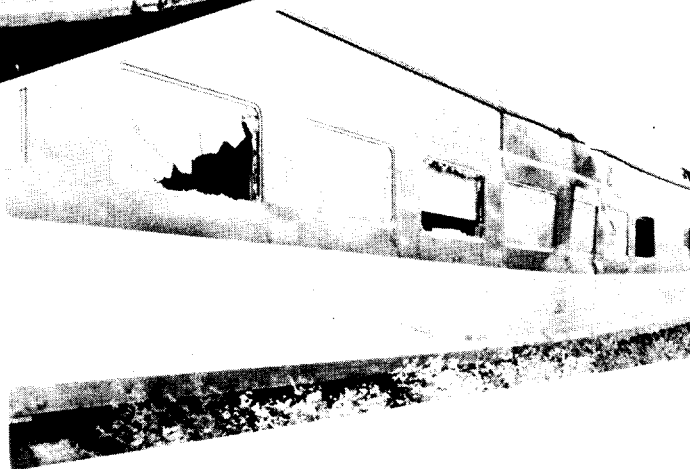
FIGURE 9. Four views of the exterior of Passenger Car No. 2 after having been set back upright.

d. Slight damage to the left side (up side) of car no. 2. Missing windows were broken out by rescue personnel. Some shades are down.

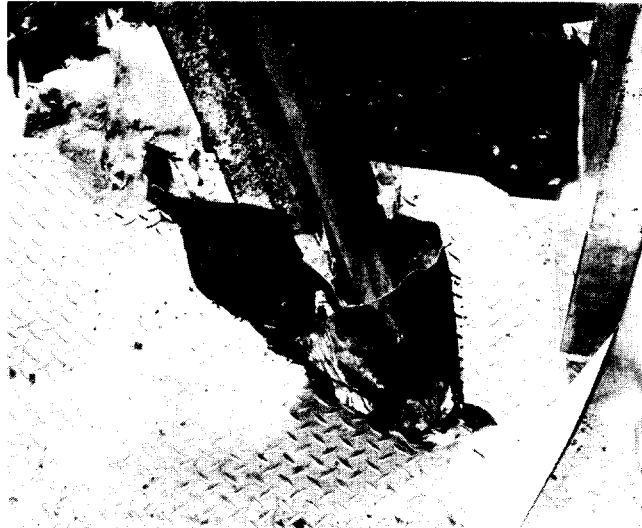
c. End of the rail shown in above picture terminated its travel against the steel floor of the right rear boarding station. Note roof metal and insulation still wrapped around the end.

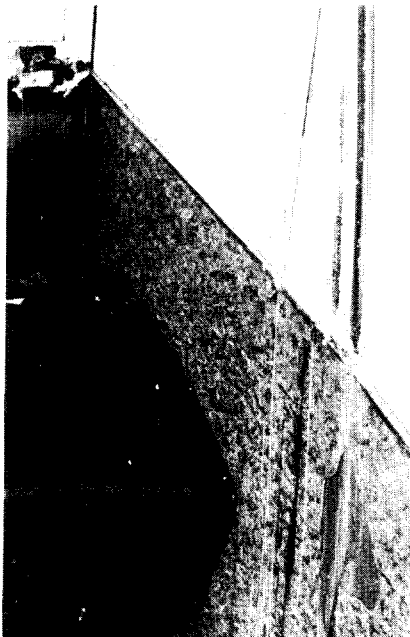
FIGURE 10. Two rails also penetrated Passenger Car No. 2.

d. Mark on rest room wall at the rear end of the passenger area made as the end of the second rail slid down the wall

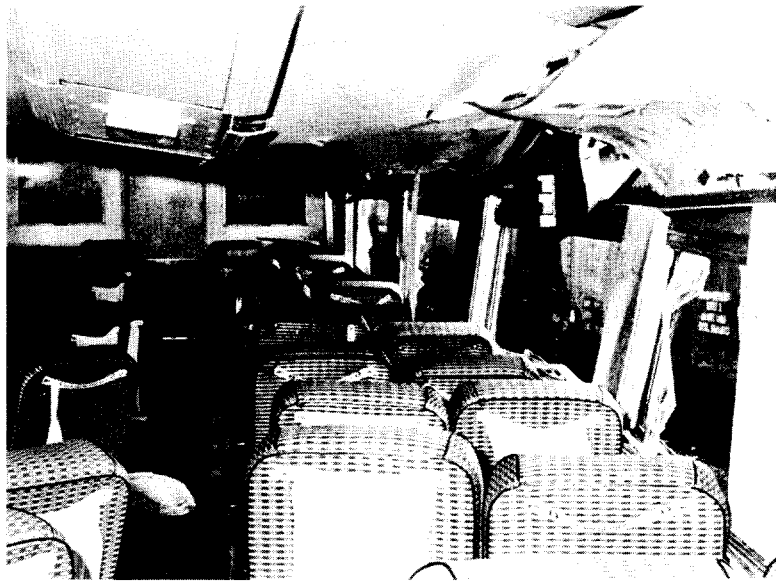
a. Interior view of the right side of car no. 2, looking from the rear. Note that the roof depression with sharp edges is not as severe as in car one, leaving about 5 feet of clearance above the floor. Seats are relatively straight, but damage to windows is severe.

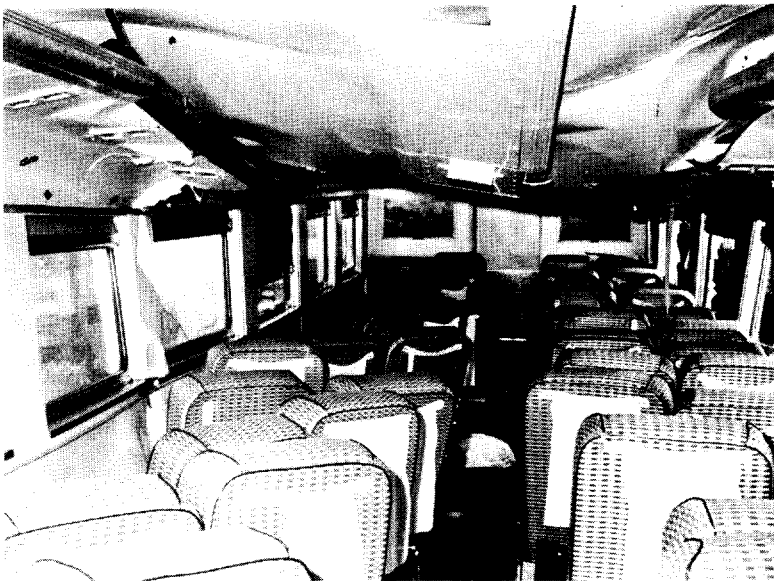
FIGURE 11. Photographs showing seat cocking and roof and window damage as viewed from the inside of Passenger Car No. 2.

b. All seats on the left side of the car are unhooked and rotated aisle side forward approximately  $45^{\circ}$ . This rotation may have protected some passengers to a degree as some were trapped in their seats and not thrown to the opposite side of the car.

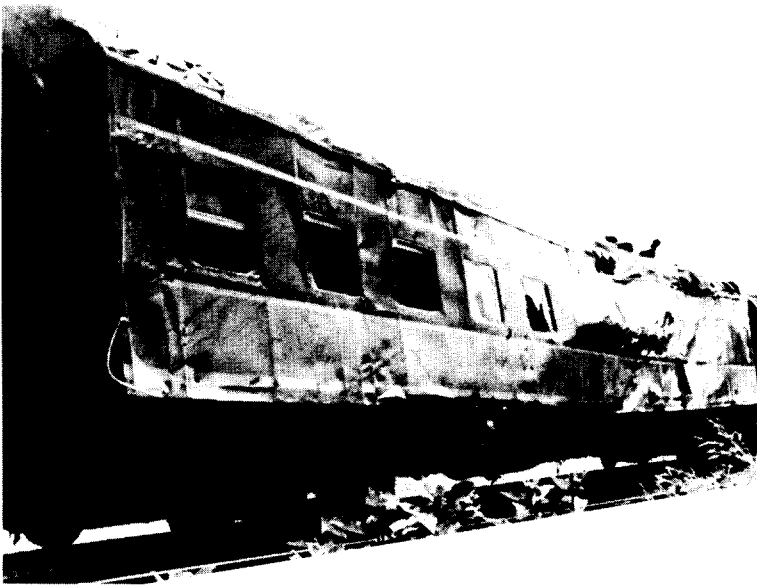
a. Left side (down side) of diner as viewed from front end. Three of the five 42"x26" windows in the dining area have been knocked out. Note car frame structure showing through side metal covering at left of picture, indicating forward end of car went up into the air as it rolled over and then impacted the ground.

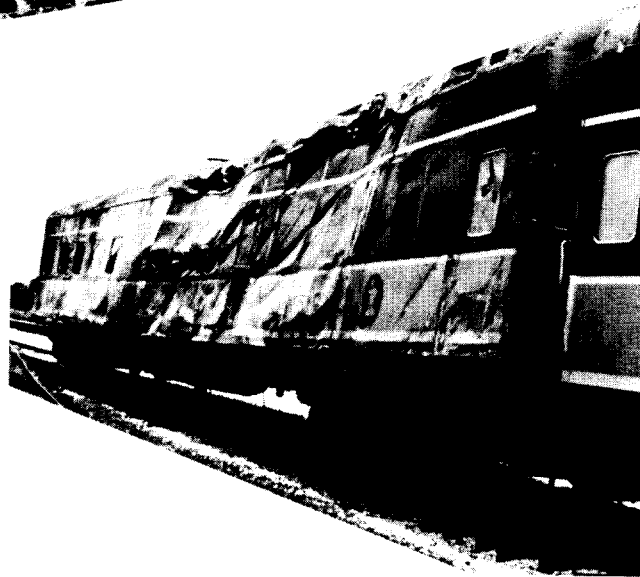
b. Skid marks on the rear end of the left side of the diner indicate that the car slid at about a 45° angle rear-end forward after it rolled over onto its side. The area of most severe damage (without windows) is the kitchen and counter serving area.

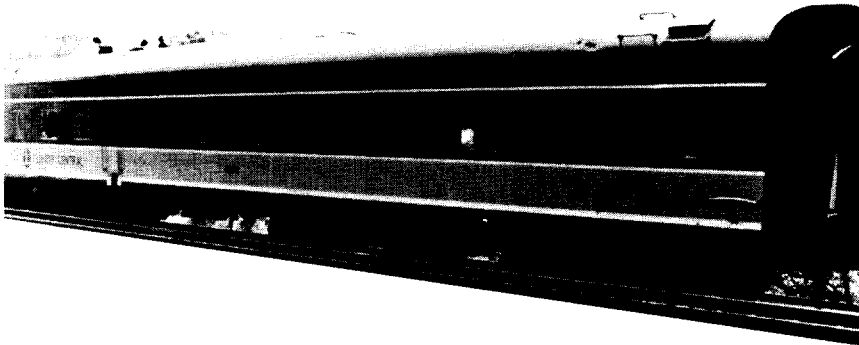
FIGURE 12. Three views of external damage to the Diner taken after this car had been righted.

c. Right side (up side) of diner had very little damage. The small window at the extreme left of the picture was broken out by rescue personnel after a passenger had climbed into the narrow passageway alongside the kitchen.

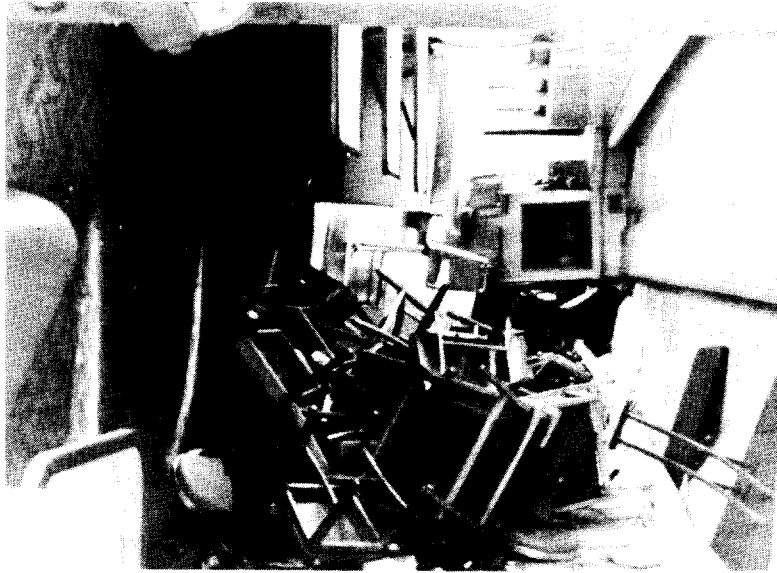
a. Inside view of diner looking toward the rear of the car while it was still on its left side. Passengers, loose chairs and broken tables were all thrown into a pile.

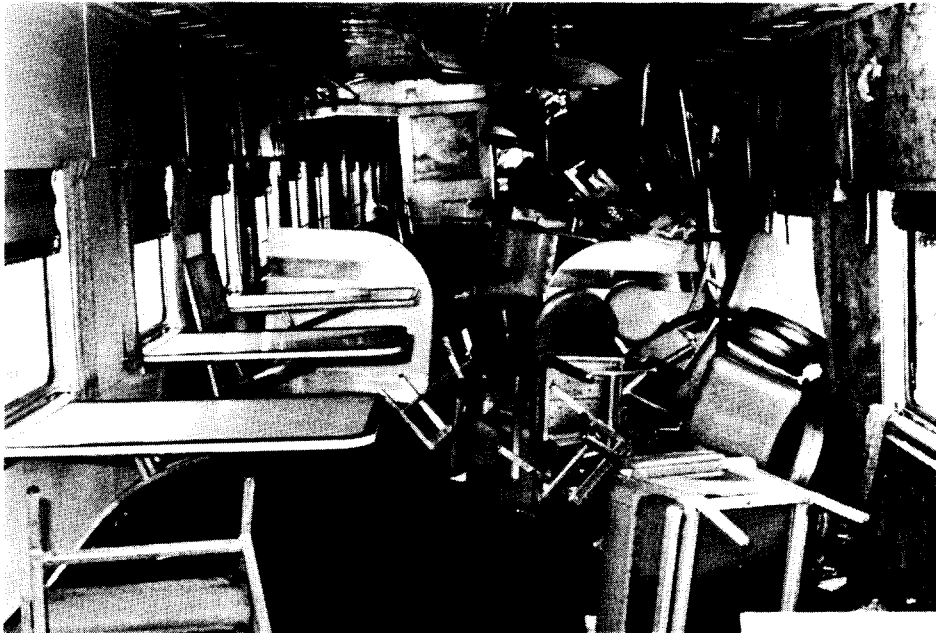
FIGURE 13. Loose chairs inside the Diner were thrown into a pile.

b. Same view as a above except that the car has been righted. At least two passengers were ejected through one of the windows in the right of the picture.

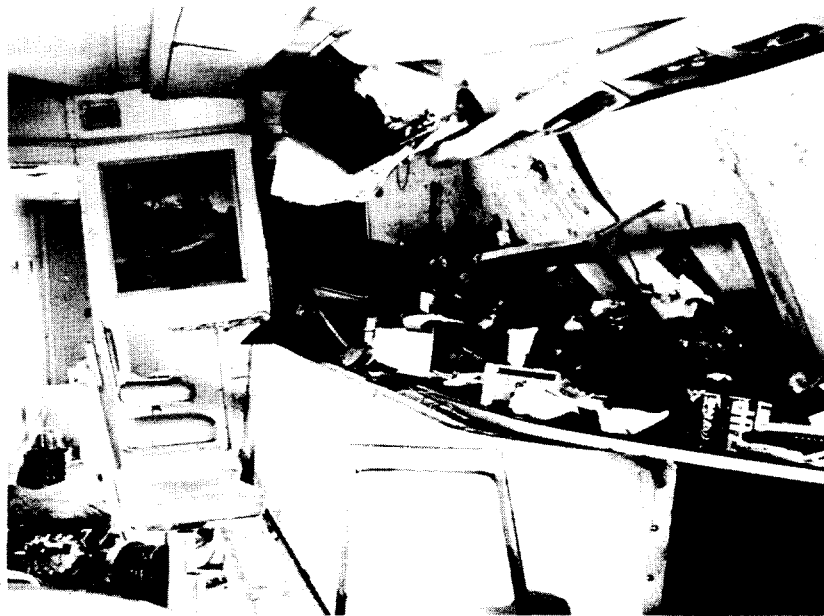
a. The diner was not penetrated by any railroad rails, but a heavy compressor entered through the upper left corner of the car above the counter serving area and hit one of the stools, breaking it off. Hole and compressor are visible in the picture.

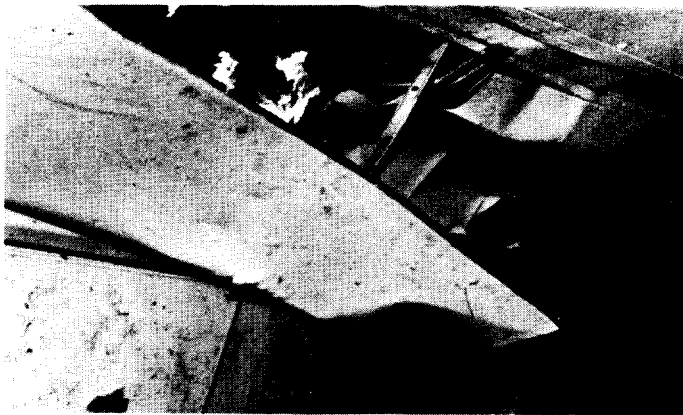
b. Close-up of hole made by entrance of the compressor. Fortunately, no one was struck by this heavy missile since most of the passengers had been thrown to the front of the car before the car turned over and picked up the compressor.

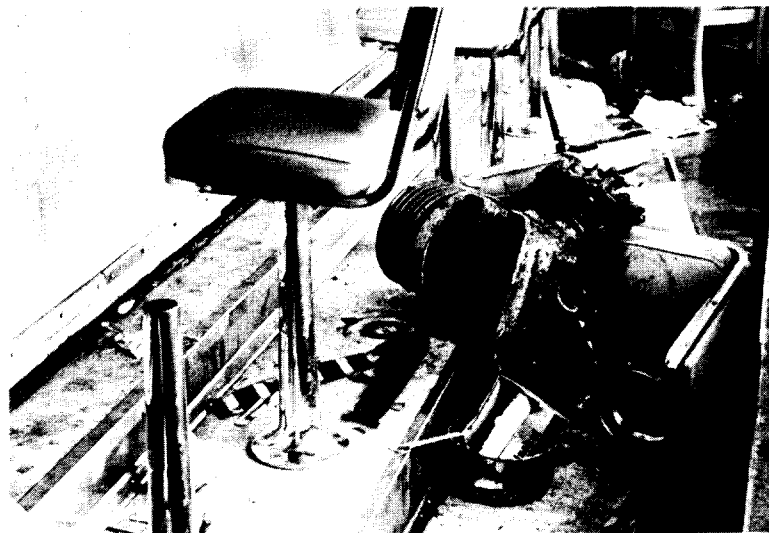
FIGURE 14. A heavy compressor penetrated the roof of the Diner just above the counter service area and broke off one of the stools at the counter.

*B. Crashworthiness Design.* The electrical equipment and table storage cabinet doors were the type that could be lifted up and off the hinge pins. When the cars overturned, the doors moved free of the hinge pins and the doors and cabinet contents fell into the aisle, blocking escape routes and possibly causing injury. Another example of similar design was found on the bar stool seats in the Diner. Attached to the under side of the seat pan was a shaft  $1\frac{1}{2}$  inches in diameter and 6 inches long. This shaft rested inside the pedestal column and was free to rotate. It was also free to slide out of the pedestal column when the Diner car overturned as shown in Figure 14c.

c. Close-up view of compressor and broken stool.

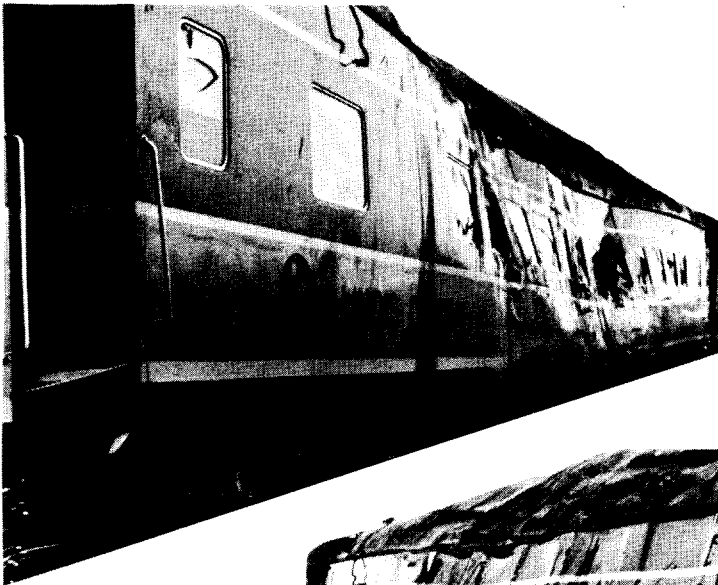
a. Right side of passenger car no. 3, showing the most severe damage was to the central portion. This area near the roof was pushed in over 2 feet. Note windows in this car are smaller (34" long, 24" high) and less glass is broken out.

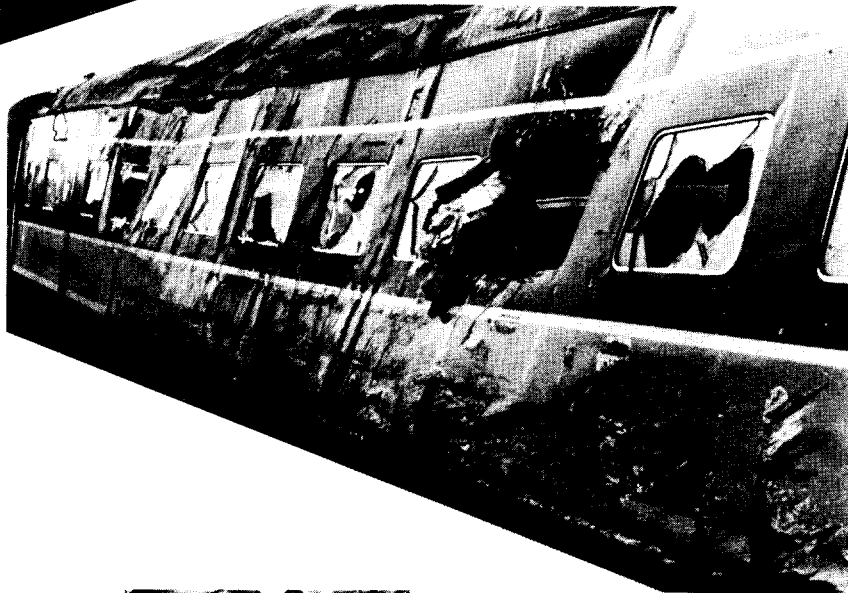
b. One passenger was killed when a cross-tie came into the car through the hole near the center of the picture.

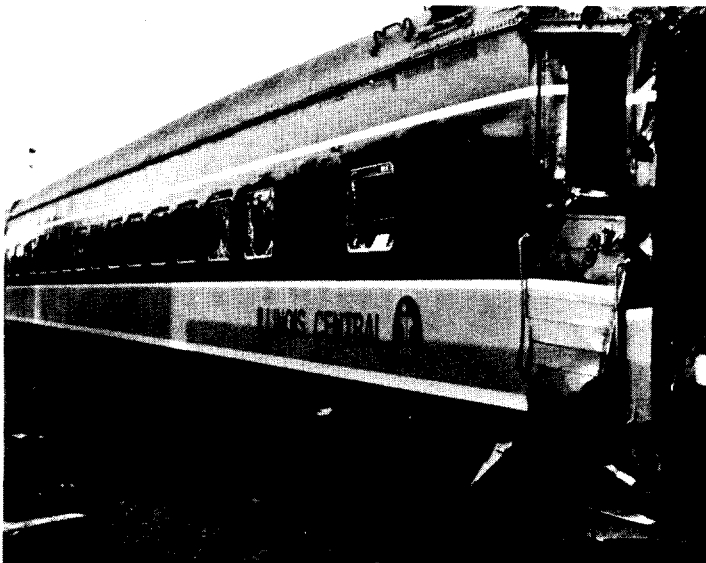
c. Left side (up side) of passenger car no. 3 shows little damage. Missing windows were knocked out by rescue workers.

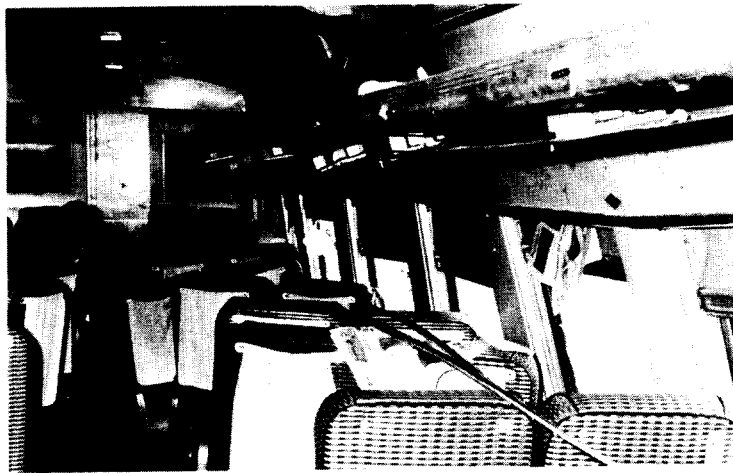
a. Interior view of the right side of car no. 3 showing heavy damage to seats where the wall was crushed in.

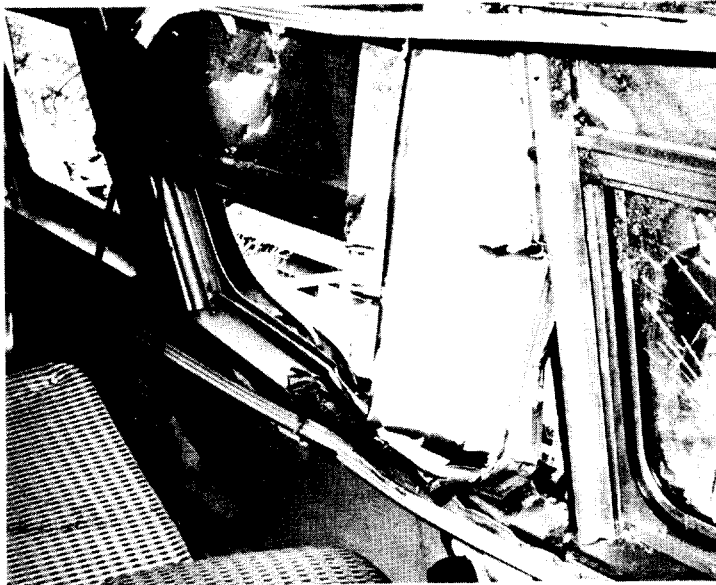
b. Close-up view of damage caused by intrusion of a cross-tie.

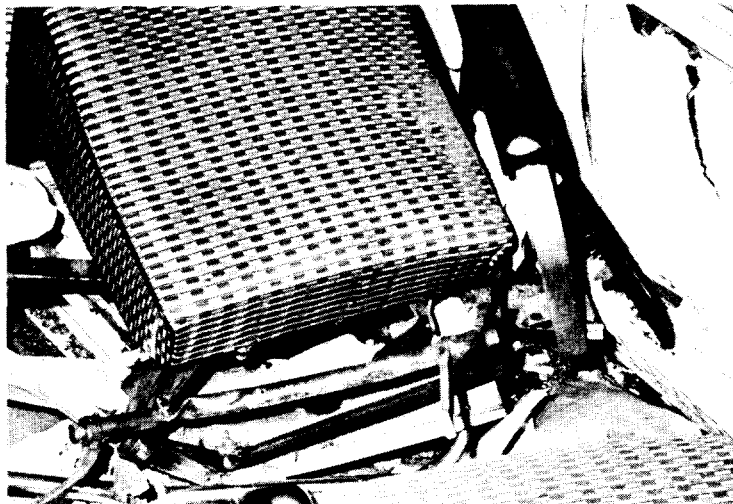
FIGURE 16. Seat and window damage inside Passenger Car No. 3.

c. One seat was almost completely demolished.

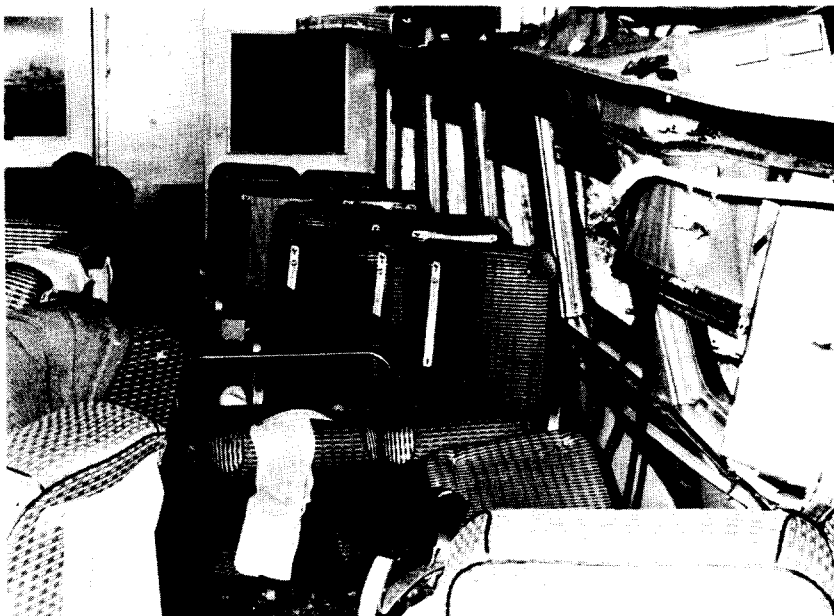
a. Seats are unhooked and rotated aisle end forward as in previous cars. As upper right wall was pushed in, the baggage rack broke down and left numerous sharp edges. Passengers received severe injuries when thrown against these edges as car rolled over.

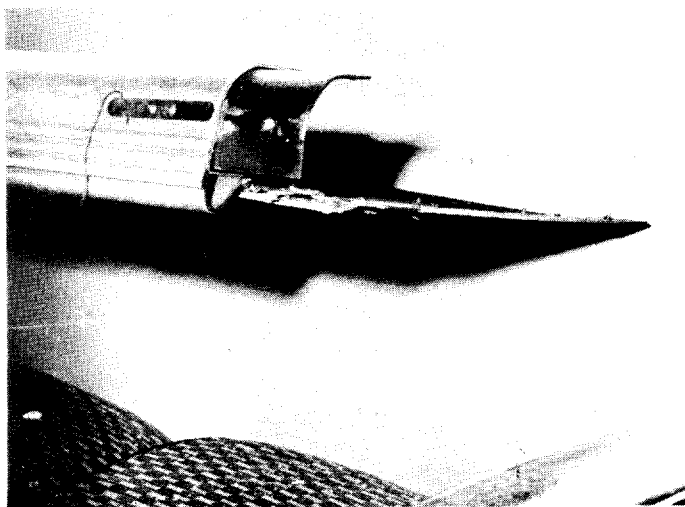
b. Close-up view of sharp end of baggage rack.

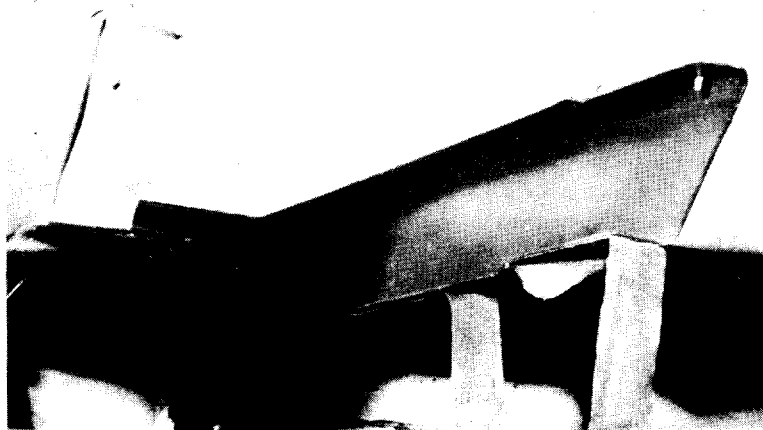
FIGURE 17. As the luggage rack failed on the right side of Passenger Car No. 3, sharp structures were exposed.

c. Sharp baggage rack support structures exposed when rack collapsed.

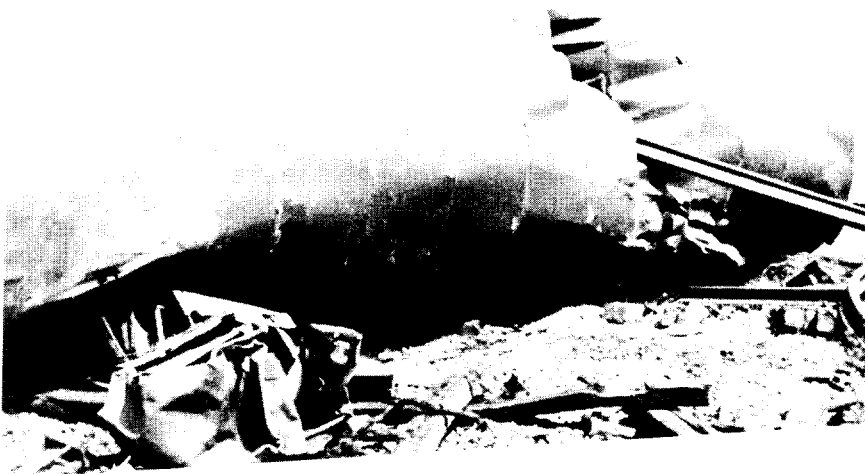
a. Passenger car no. 4 down on its left side with two rail penetrations. One passenger crawled through the hole made by the rail and walked down the rail to the ground.

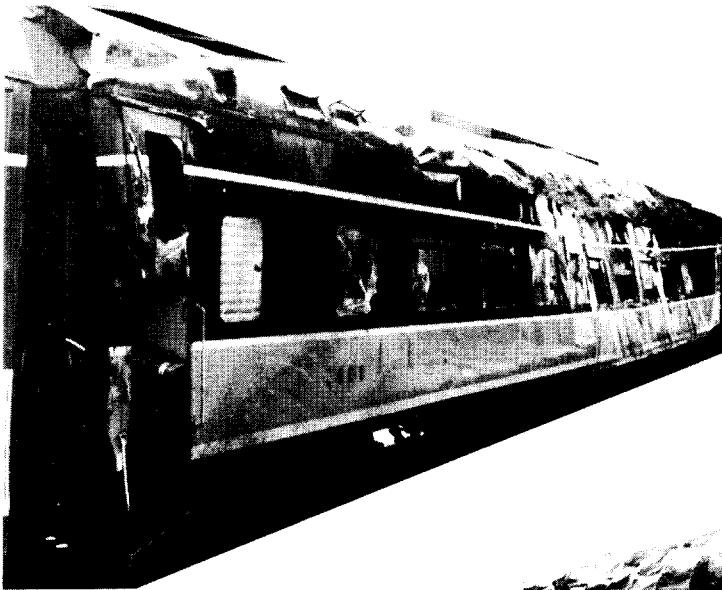
Bodies 9 and 10 were found just inside the forward end (the boarding area) of Passenger Car Number 4. Both bodies received crushing injuries, but those of Number 9 were more severe than Number 10's. Number 9 had been decapitated and mangled. Injuries of Number 10 included head injuries and fractures of the left leg, right arm, and right knee. Since Bodies 8, 9, and 10 were all found in or just outside the boarding area of Passenger Car Number 4 and were the remains of a woman and two children, all with the same last names, it is possible that these three were caught in the boarding area on their way to or from the Diner and died from crushing injuries as the front end of the car was crushed in (see left side of Figure 18b).

b. View of left side after it had been righted shows side caved in similar to car no. 3. The number of deaths and seriously injured in this car was greater than in any other single car.

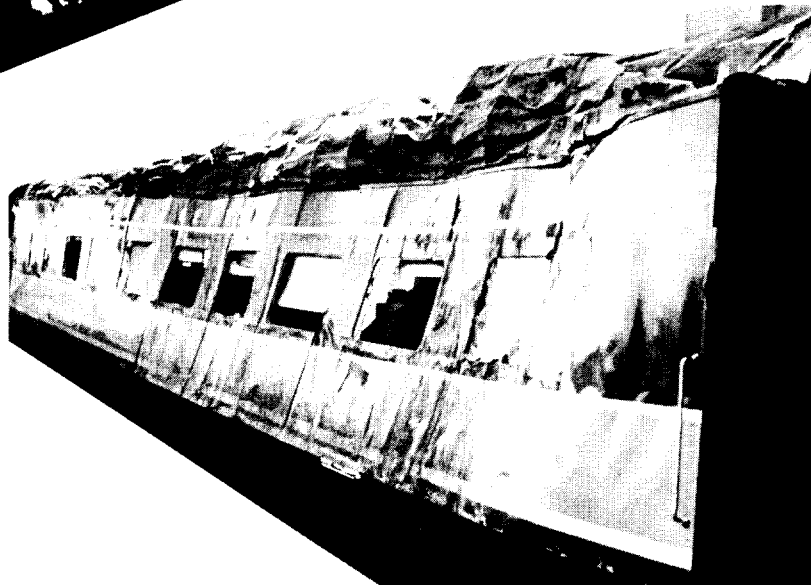
FIGURE 18. Views showing rail penetrations and external damage to Passenger Car No. 4.

c. Close-up of severely damaged end shows scratch marks to indicate that the car was sliding perpendicular to the tracks after it turned over.
