1. Report No. FAA-AM-73-1	2. Government Accession No.	3. Recipient's Catalog No.	
4. Title and Subtitle APPLICATION OF COMMERCIAL AIRCRAFT ACCIDENT INVESTIGATION TECHNIQUES TO A RAILROAD DERAILMENT.		5. Report Date January 1973	6. Performing Organization Code

# APPLICATION OF COMMERCIAL AIRCRAFT ACCIDENT INVESTIGATION TECHNIQUES TO A RAILROAD DERAILMENT

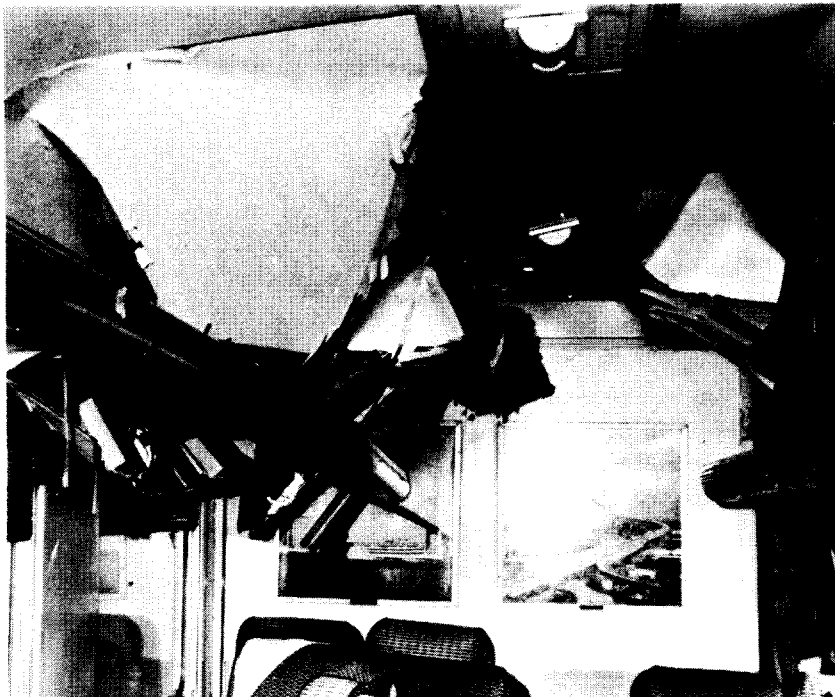
a. Hole made by the second rail penetration in passenger car no. 4. Note also outside wall collapse has almost completely obstructed aisleway under ladies rest room.

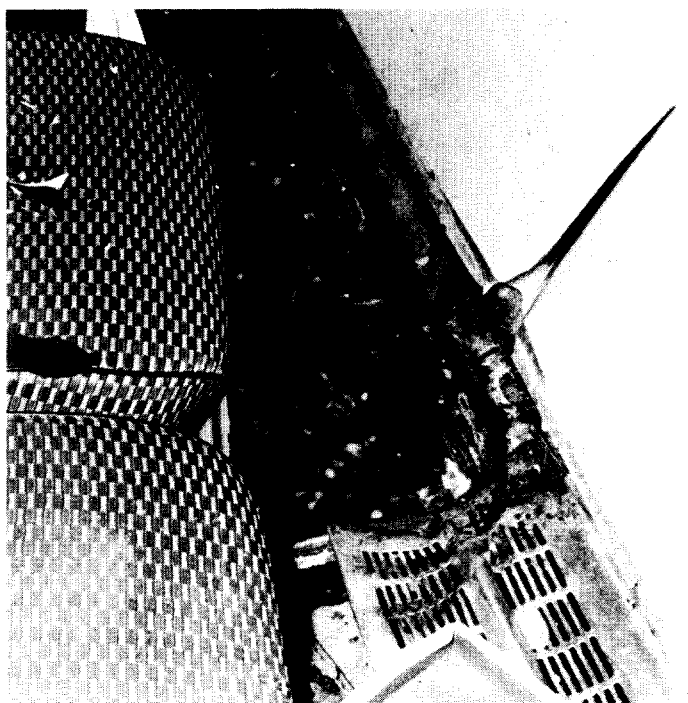
FIGURE 19. Internal damage from a second rail penetration into Passenger Car No. 4.

b. End of rail slid down the wall and pinned a woman's dress to the floor, but did not injure the woman.

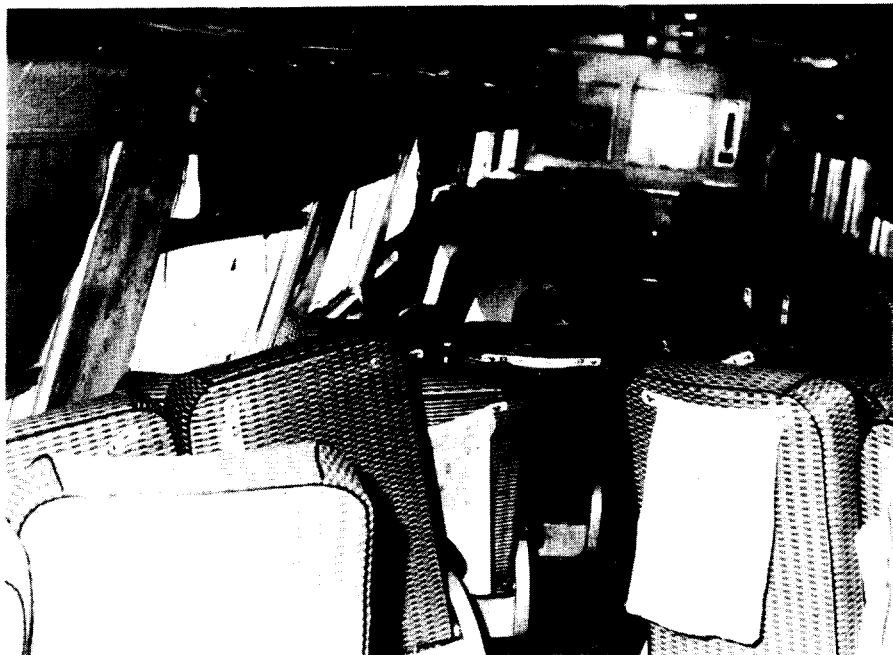
a. Interior view of passenger car no. 4, looking forward. Most of the seats are unhooked and rotated aisle end forward.

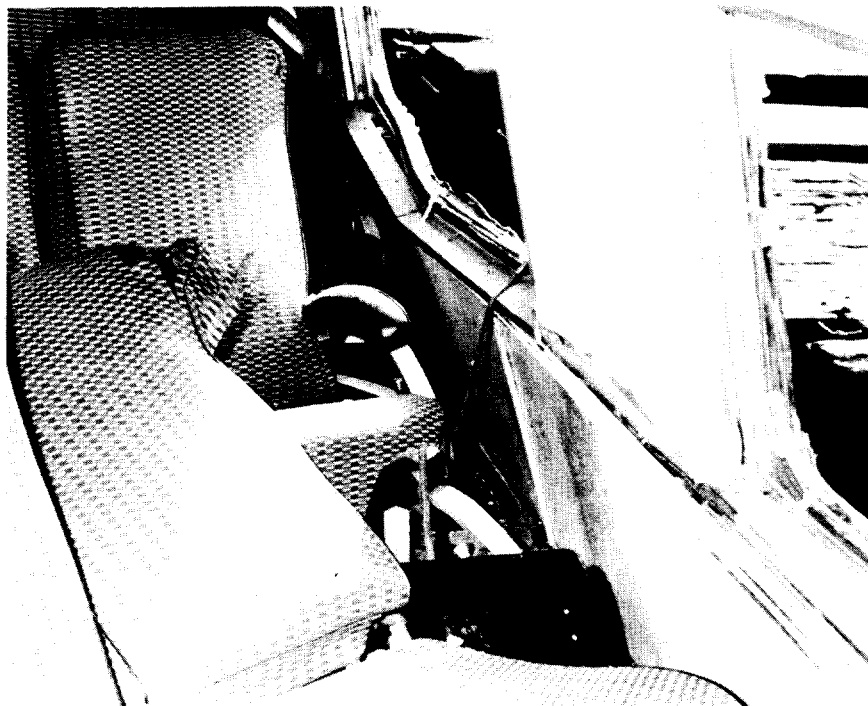
FIGURE 20. Seat and window damage in Passenger Car No. 4.

b. Seat damage in the area where the side wall was pushed in.

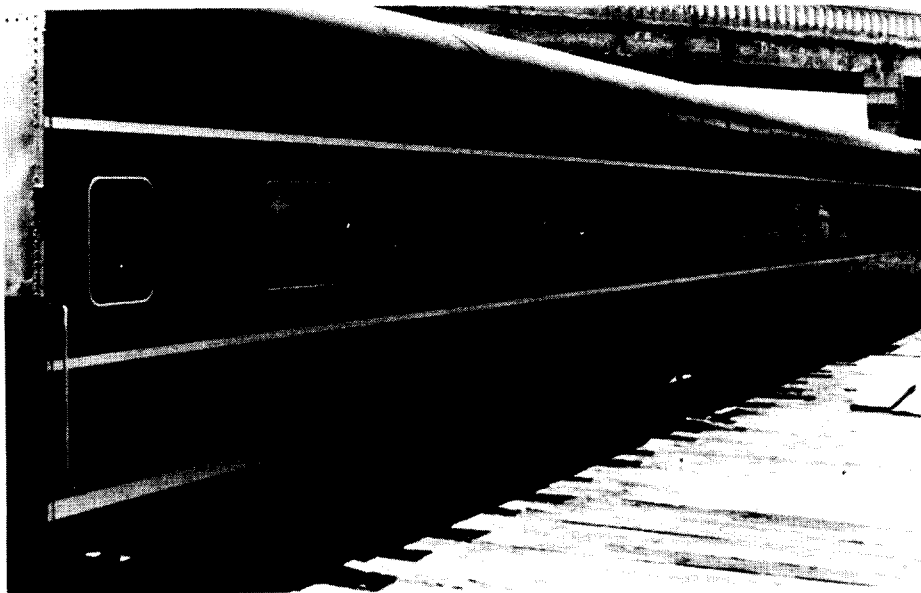
a. Passenger car no. 5 overturned but was unoccupied and is not shown. This is passenger car no. 6. It remained upright as did cars 7, 8 and 9 with passengers and cars 10, 11, 12 (empty). Damage is slight and injuries to the passengers were minor or none.

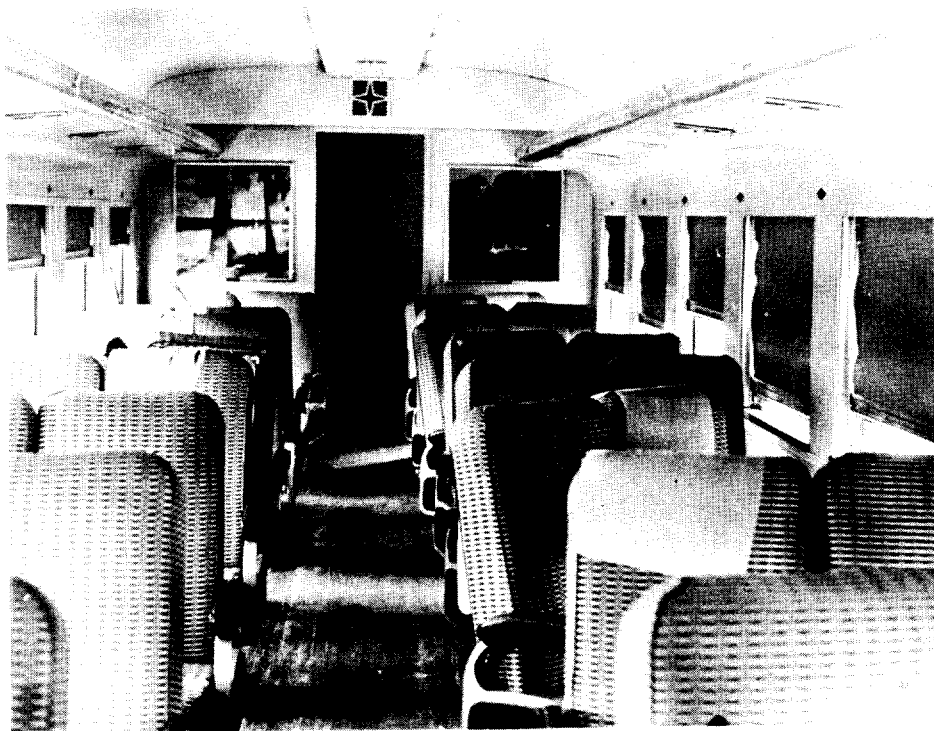
FIGURE 21. Passenger Cars 6, 7, 8, and 9 did not overturn and Passenger Car No. 6 is shown here to depict relatively minor damage to these cars.

b. Even though the car remained upright, some seats became unhooked and rotated. The passengers in these cars stated they were able to remain in their seats by holding on.

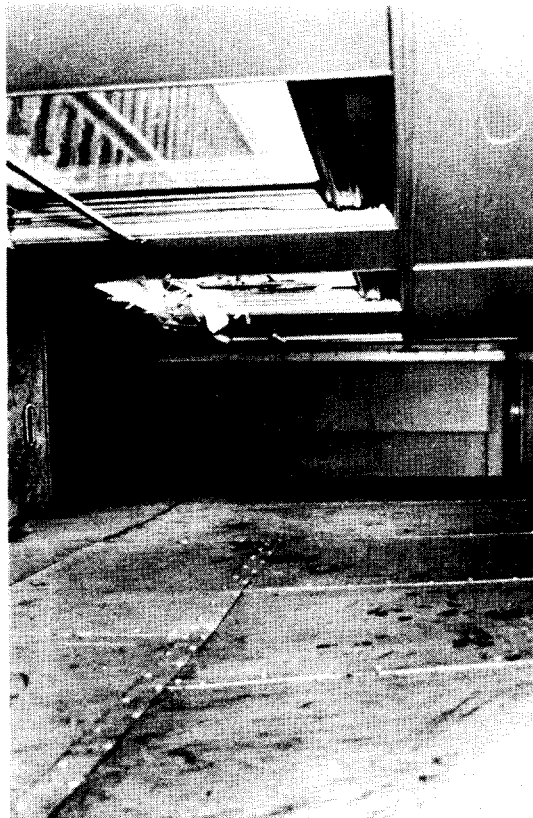
FIGURE 23. Photographs showing escape routes from the Diner.

b. Rear end of diner on its side offered a more difficult escape route. One passenger climbed up into the 2-ft. high tunnel shown here and was rescued through the small broken window.

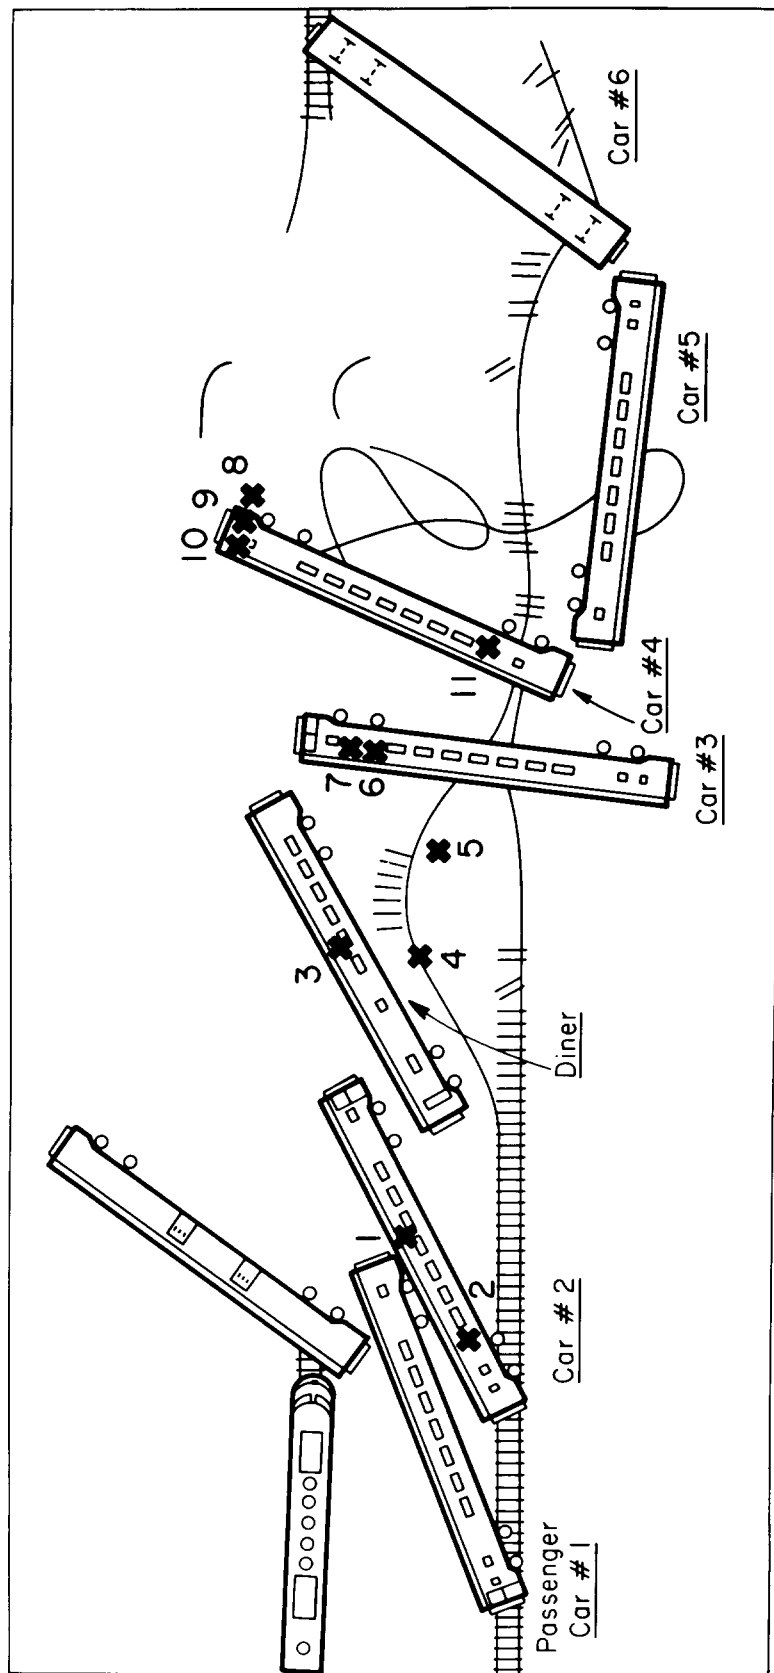
FIGURE 24. Diagram of crash site showing location of the bodies of the ones who were fatally injured.

Body Number 1 was ejected through a window of Car Number 2 and pinned beneath the car. Injuries included scalp laceration with possible skull fractures and fractures of the right shoulder, right upper arm, left forearm, and both knees.

Body Number 2 was found inside the second passenger car with fractured skull, severe lacerations of scalp and forehead, lacerations under both arms and across the chest, and severe lacerations of the right hip around to the groin. This passenger was probably ejected partly through a window and then fell back, or was pulled back, into the car.

Body Number 3 was found under the Diner. Injuries include massive skull fracture with drag marks on the side of the face and head and lacerations of the left knee and chest. This passenger was ejected through one of the windows of the Diner and dragged under the car as it slid on its side.

Body Number 4 was ejected from Car Number 1 as the car rolled onto its side; the body then became pinned under a rail between the Diner and Car Number 3. This person suffered head injuries, fractured pelvis, and lacerations of the shoulder, hip, and both lower legs. In addition, there was evidence of peritoneal bleeding.

Body Number 5, found between the Diner and Car Number 3, was crushed and torn beyond recognition. The body was ejected from one of the cars and was crushed as one or more cars slid over it.

Body Number 6 was found inside Passenger Car Number 3. Injuries included severe scalp lacerations and possible skull fracture, and lacerations of both arms and the left side of the neck. Lacerations indicate that the head and upper trunk were partially ejected through a window.

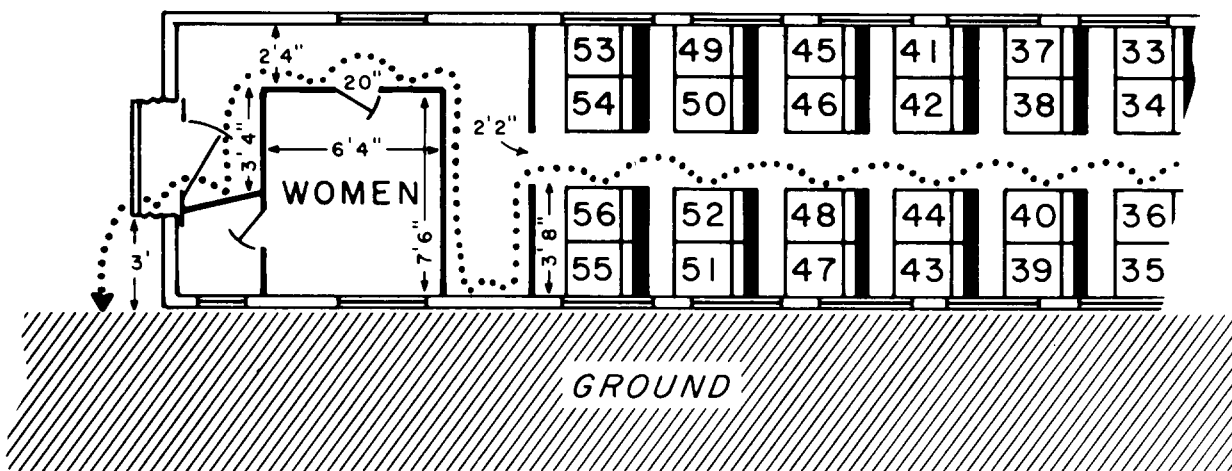
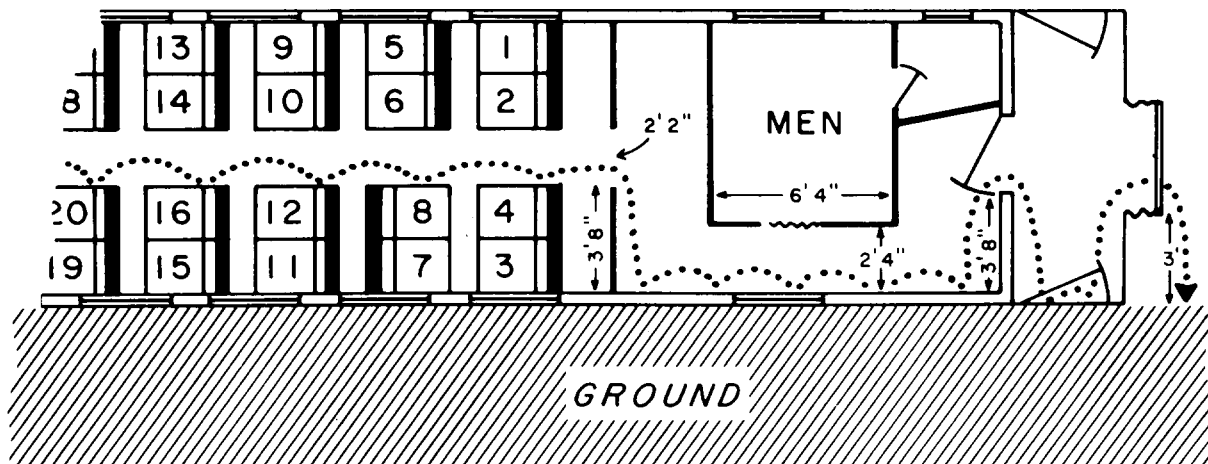
FIGURE 25. Diagrams showing two possible escape routes from a railroad passenger car that has rolled over onto its side.

95th percentile adult male, and some of the large adults will be forced to scoot through the tunnel under or over the restrooms on their bellies. (3) The third and last means of escaping an overturned railroad car is to climb up on the seats using the seat arms as steps and break out one of the double-pane windows on top of the car (Note none of the top windows of the overturned cars in this crash were broken out during the crash). Only those passengers with minor or no injuries were able to utilize one of these three difficult routes of escape on their own initiative.
