INJURIES IN AIR TRANSPORT EMERGENCY EVACUATIONS

Donell W. Pollard
Civil Aeromedical Institute
Federal Aviation Administration
Oklahoma City, Oklahoma

February 1979

1. Report No. FAA-AM-79-6	2. Government Accession No.	3. Recipient's Catalog No.	
4. Title and Subtitle INJURIES IN AIR TRANSPORT EMERGENCY EVACUATIONS		5. Report Date

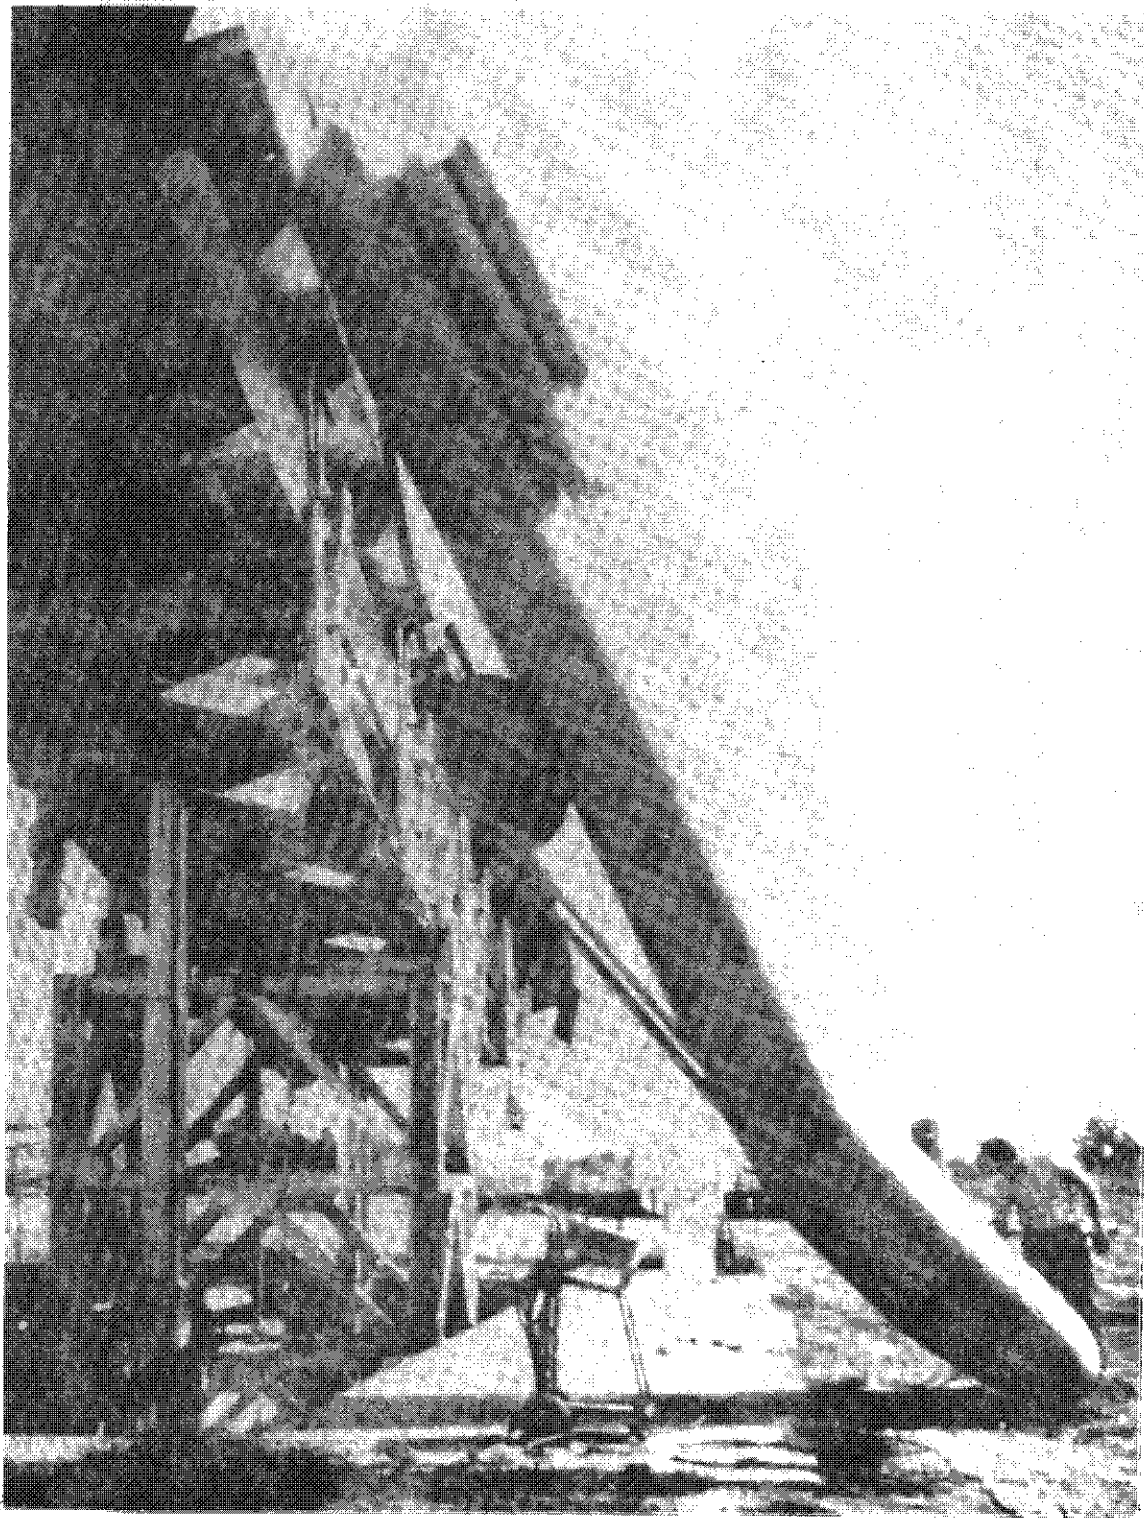
FIGURE 1. CAMI evacuation simulator showing slide deployed at a 68° angle.

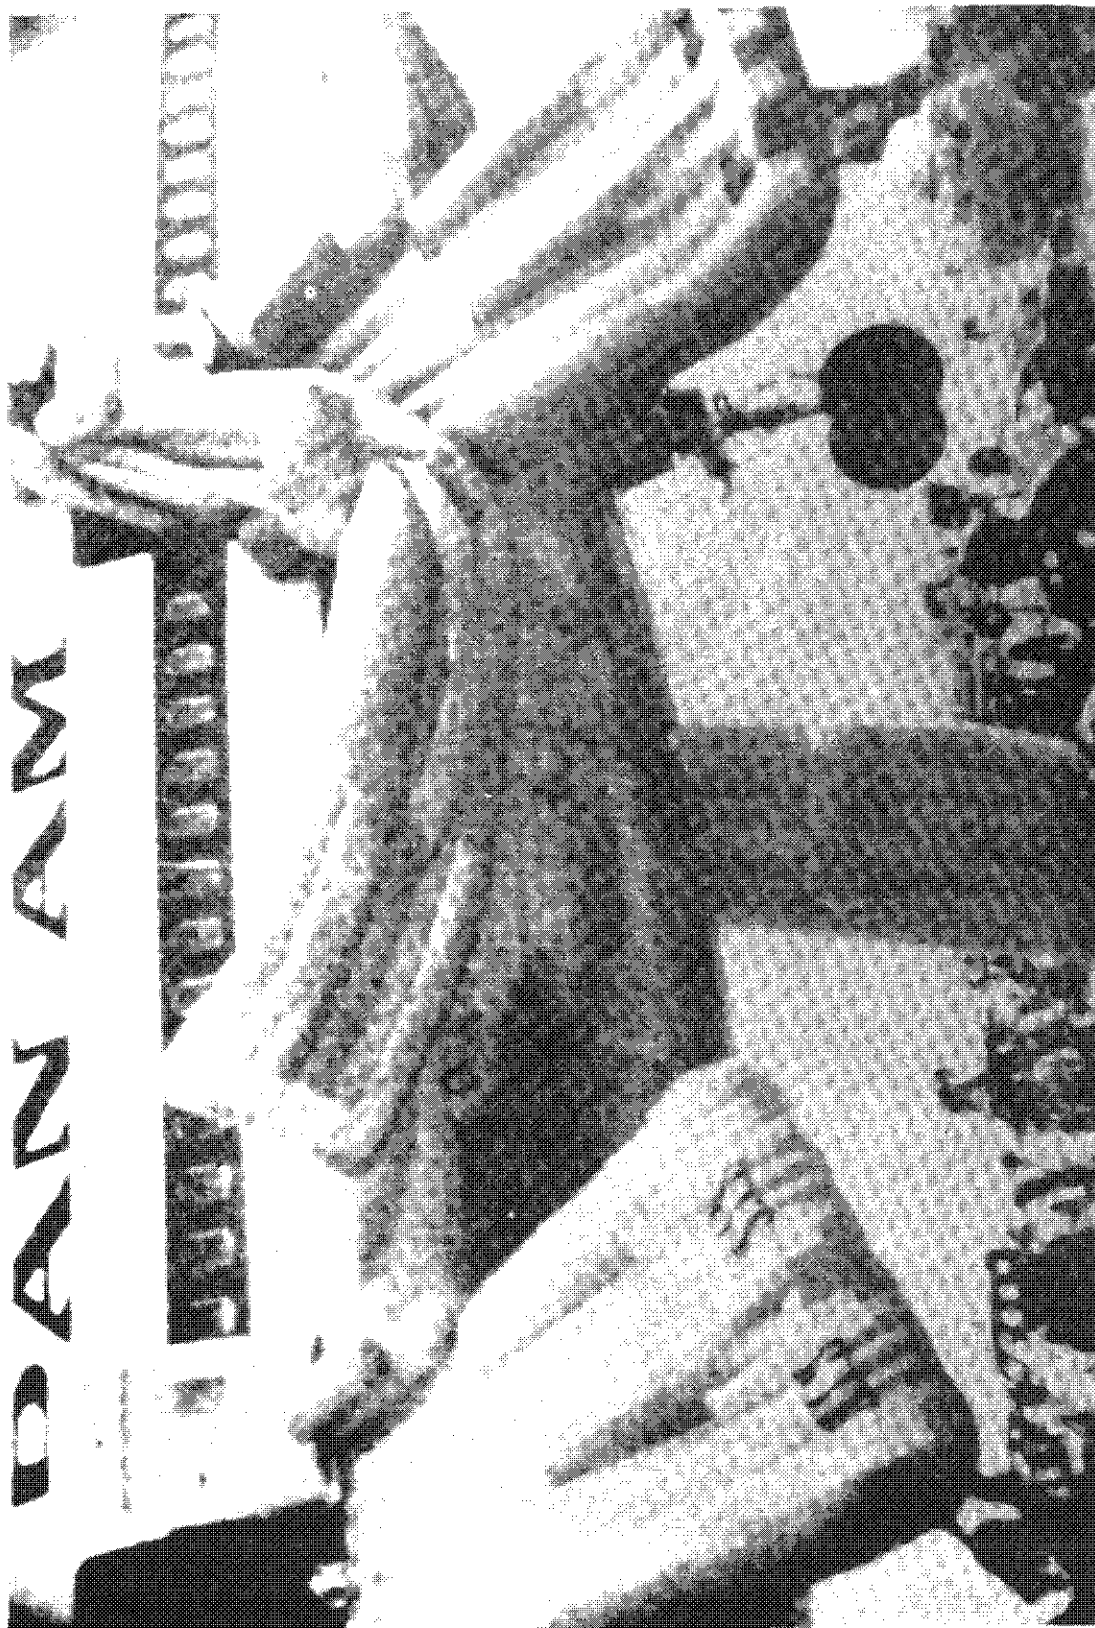
On July 30, 1971, after sustaining structural damage during takeoff, a Pan American World Airways (PAA) B-747 circled, landed at San Francisco International Airport and, after stopping, came to rest on its nose gear. It then gradually rotated and after 70 s rested in a nose-high attitude that caused the forward emergency slides to assume an angle of 68° as opposed to a normal angle of 37° to 40° . The crewmembers were confused about the responsibility and signal for evacuation initiation, and the evacuation did not start until 30 s after the airplane came to a stop. At this time the forward doors were opened by members of the flight deck crew. The other doors were then activated front to rear as cabin crewmembers observed the evacuation activity at the doors in front of their assigned positions. The aft doors were opened 70 s after the airplane stopped. "There is no record of the elapsed time to complete evacuation (3)." Motion picture film shows that at least four passengers used the right front door after the airplane rotated, and it is known that several other passengers also used the right front door at this time. However, the portion of the 199 total passengers who used the forward escape slides is not clear. Eight of those who did sustained serious back injuries and reported that the slide was quite steep.

FIGURE 2. PAA B-747 after rotation of aircraft and following evacuation. Slides at the right and left front doors, number 2 exit slide, and slide at lounge area exit are shown.
