FAA-AM-80-3

AIRCRAFT CRASHWORTHINESS STUDIES: FINDINGS IN ACCIDENTS
INVOLVING AN AERIAL APPLICATION AIRCRAFT

William R. Kirkham, M.D., Ph.D.
James M. Simpson
Terry F. Wallace
Paula M. Grape
Civil Aeromedical Institute
Federal Aviation Administration
Oklahoma City, Oklahoma

April 1980

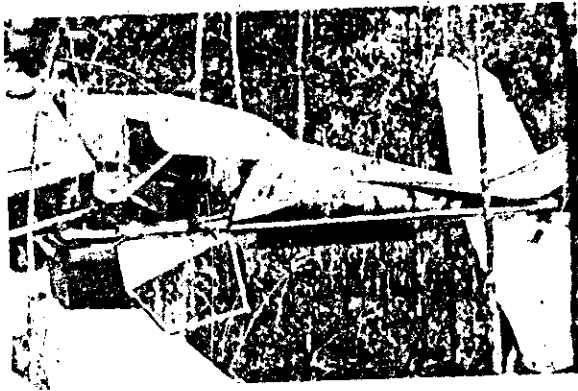
Figure 1-1. 1967 model aircraft partially suspended above ground. Cockpit structure and empennage were relatively undamaged.

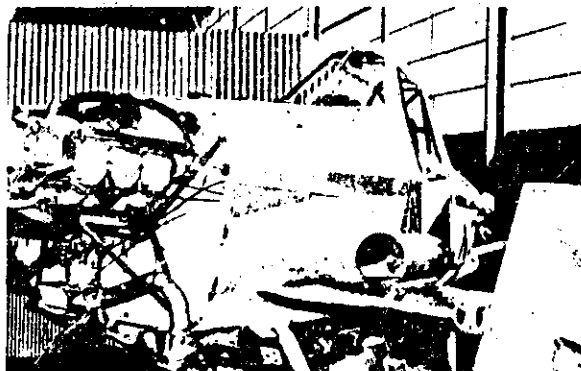
Case 2. This 1968 model aircraft crashed into trees. Both wings and the empennage were torn off (Figure 2-1). The pilot was wearing a helmet, shoulder harness, and lap belt.

Figure 2-1. Empennage and wings were torn off this 1968 model aircraft in a crash into trees.

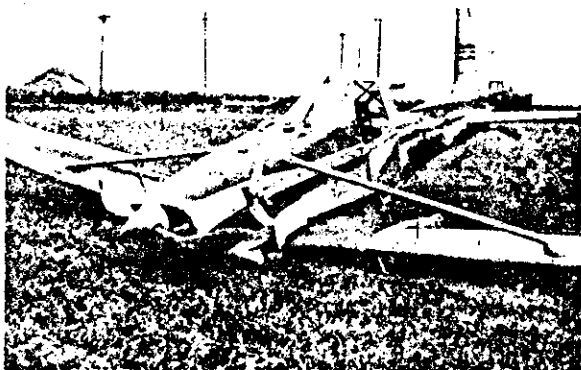
Case 3. This 1968 model aircraft stalled at 100 to 150 feet and struck with relatively minor forces in a soft wheat field. There was slight damage to the wings and fuselage (Figure 3-1). Both landing gears were torn off. The pilot was wearing a crash helmet, shoulder harness, and lap belt. The shoulder harness, lap belt, and seat showed no evidence of impact damage. The seat remained on the track (Figure 3-2). The pilot hit the right window with his head but received no injuries in this accident.

Figure 3-1. 1968 model aircraft with minor damage of wings and fuselage.

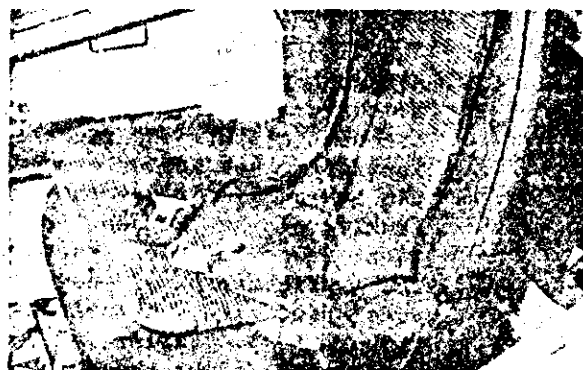
Figure 3-2. Seat and restraint systems undamaged.

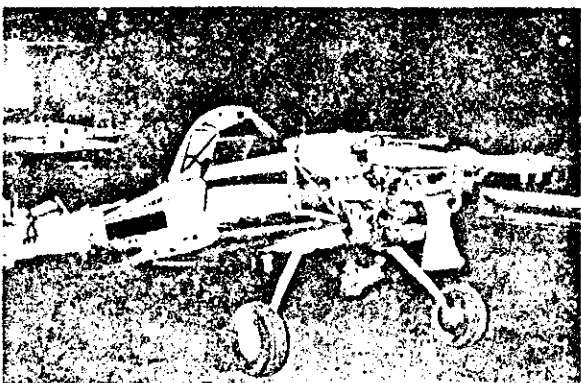
Figure 4-1. 1969 model aircraft in minor impact nosed over damaging propeller, overhead canopy and vertical stabilizer.

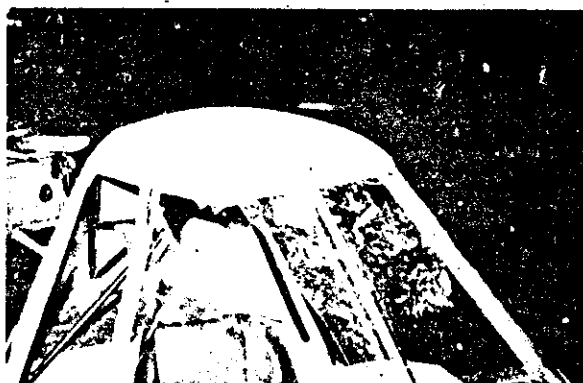
Figure 4-2. Damage to overhead canopy.

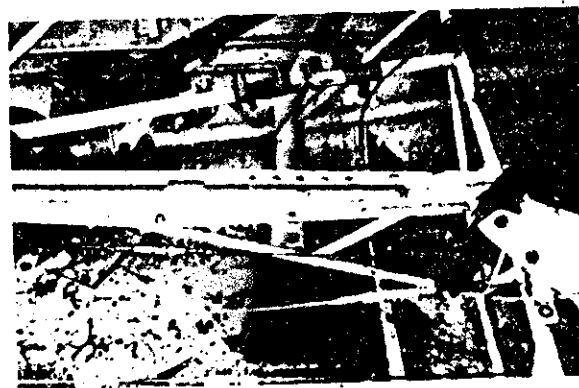
Figure 5-2. Left seat track with elongation of seat pin retaining hole and gouging of the metal forward of this hole.

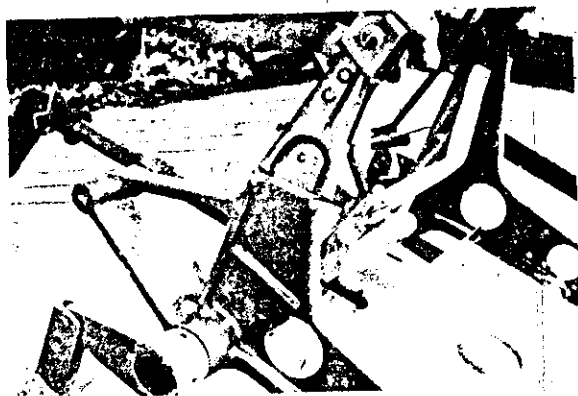
Figure 5-3. Mid-shaft break in right front seat leg. The seat was detached from the seat track.

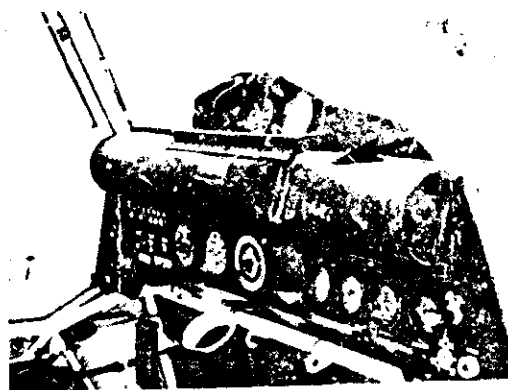
Figure 5-4. Indentation on the panel consistent with a mild head strike.

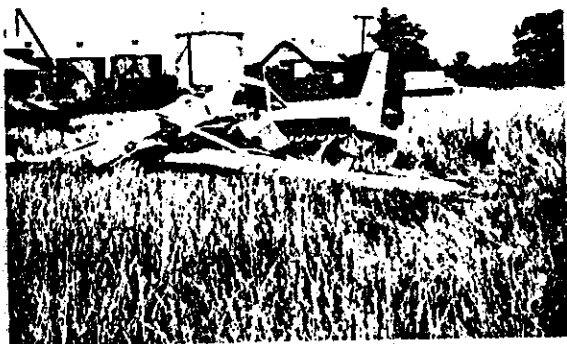
Figure 6-1. 1971 model aircraft with damage to engine and hopper area. Cockpit showed little structural damage.

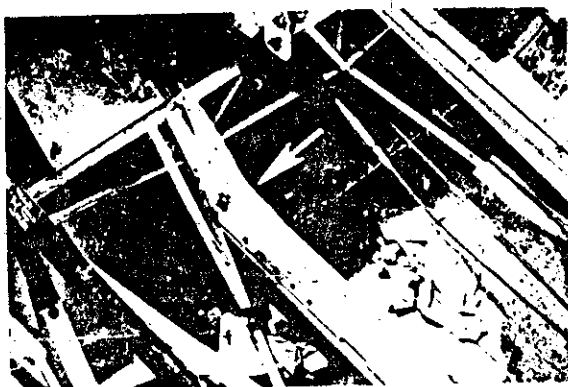
Figure 6-3. The left seat track and its support were twisted to the left.

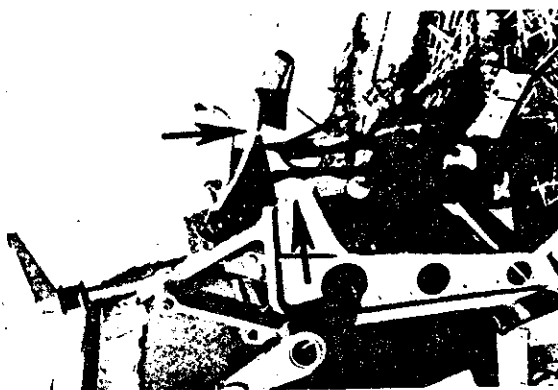
Figure 6-4. Both forward seat legs were fractured. The rivets of the leg-to-seat-track attachment were sheared.

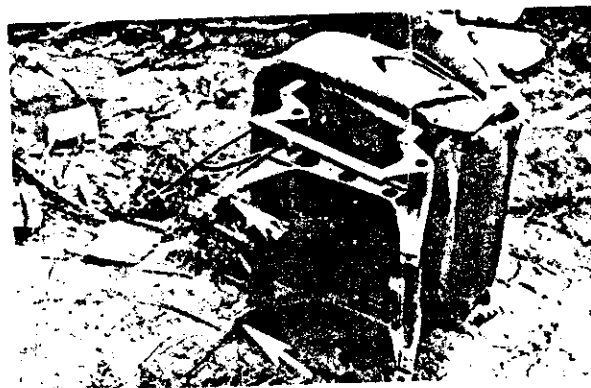
Figure 7-4. In the area of fixation of the seat track attachment to the forward seat leg the rivets were sheared and the seat legs broken.

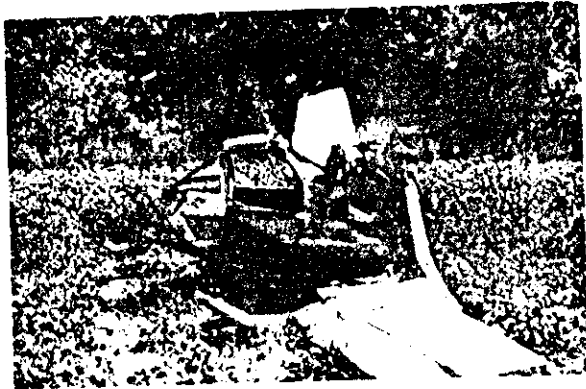
Figure 8-1. Severe impact of this 1972 model caused extensive damage but cockpit integrity was maintained.

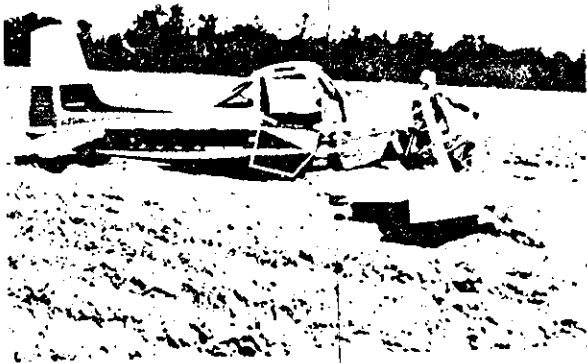
Figure 9-1. 1972 model with substantial engine, hopper and wing damage but intact cockpit.

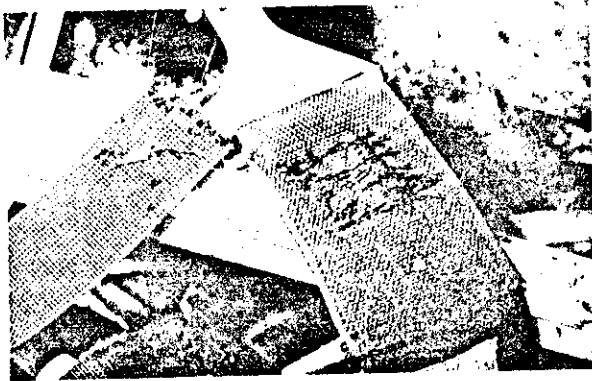
In this severe nosedown, right-wing-down impact, the pilot during deceleration was thrown forward and to the right. The failure of the right shoulder strap where attached to the right limb of the lap belt probably permitted the pilot to travel forward and to the right striking his head on the right side of the instrument panel and cockpit frame. Separation of the seat from the track probably added to the freedom of the pilot to travel forward. The slack in the lap belt customarily used by this pilot probably increased the peak loading on the right shoulder strap. Use of a crash helmet undoubtedly would have lessened the extent of head injuries.

Figure 10-3. The right shoulder harness was detached from the right side of the lap belt. The torn threads were evident.

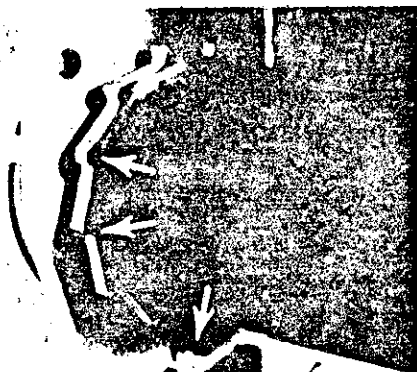
The forces in this accident caused the pilot to travel forward against the shoulder harness. Failure of the inertia reel to completely engage and hold, thereby letting the shoulder harness fully extend, probably accounts for the pilot's head striking the instrument panel. Fracture of the forward legs of the seat and the seat separation probably added to freedom of the pilot to come forward.

Figure 11-3. The reel ratchet gears were flattened and the engaging pall was grooved.

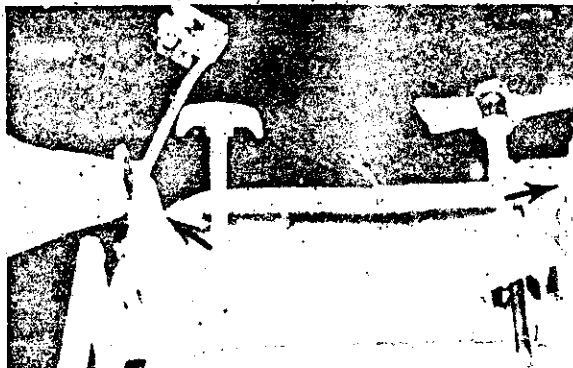
Figure 11-4. The front legs of the seat were broken.

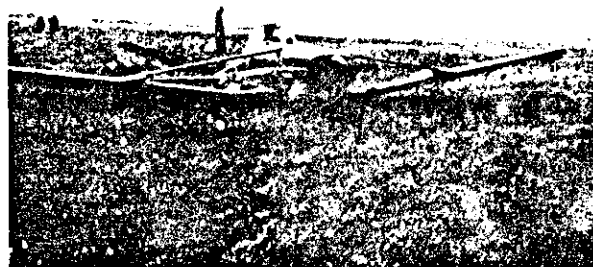
This was a relatively minor impact with peak loading when the aircraft struck the terrace, collapsing the gears and apparently causing significant vertical loading at that time to cause a compression fracture of a vertebra.

Figure 12-1. 1973 model with smoke from engine obscuring pilot's vision struck the ground in near horizontal attitude. Gears collapsed as aircraft hit a terrace. Restraint systems functioned normally but pilot received a compression fracture of a thoracic vertebra.

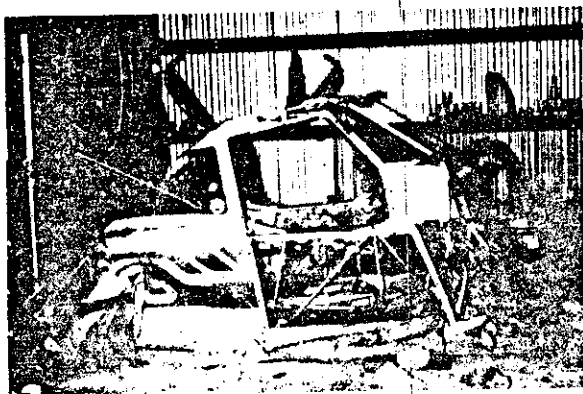
Although the aircraft was severely damaged, the structural integrity of the cockpit was maintained (Figure 13-1). There was no damage of the instrument panel. The seat tracks were undamaged. Both right seat and left front seat legs were broken above the seat-to-track attachment. The remaining portion of the right seat legs punctured the floor. The left rear seat track attachment was spread. The lap belt and shoulder harness were intact.

Figure 13-1. Only the structural integrity of the cockpit is maintained in this aircraft.

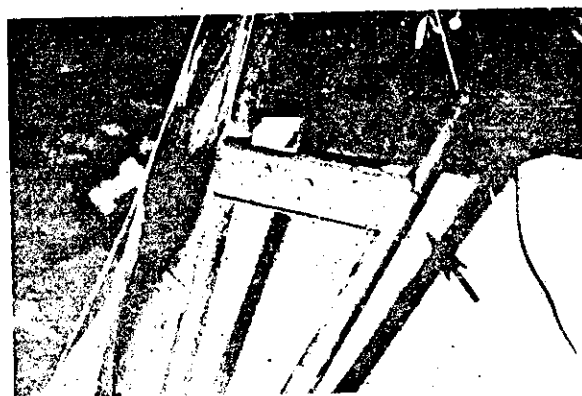
This accident was investigated primarily to examine the shoulder harness attachment bracket in an accident with such severe aircraft damage. The modified attachment (see discussion) apparently held the load well during the deceleration (Figure 13-2). The seat broke but the pilot was restrained and protected sufficiently to avoid serious injury.

Figure 13-2. The shoulder harness attachment bracket has been modified and adequately supported the shoulder harness and pilot in the deceleration.

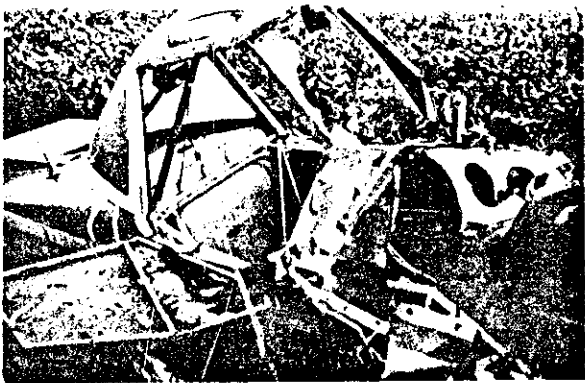
Figure 14-1. Severe impact of this 1974 model caused fracture of left structural member of the cockpit.

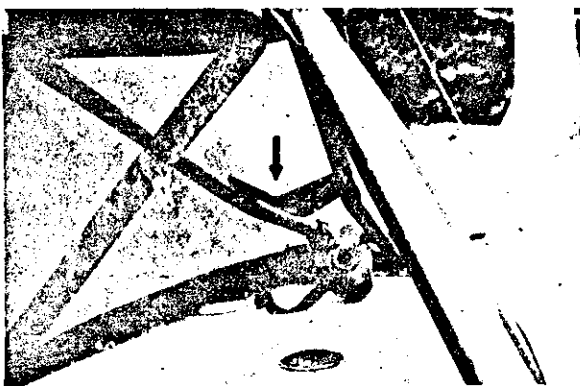
There was a broad impact area on the instrument panel (Figure 14-2). The shoulder harness attachment bracket was bent forward and the shoulder harness had failed at its attachment to this bracket (Figure 14-3). There were fractures of all but the right rear seat leg (Figure 14-4).

In this severe accident the forward force of the pilot's body during deceleration probably caused forward deformation of the shoulder harness attachment bracket and overloading to an extent that caused failure of the attachment of the shoulder harness to the attachment bracket. The pilot was thereby allowed to come forward and strike the instrument panel. Breakage of the legs of the seat probably gave additional freedom for the pilot's body to move forward.

Figure 14-3. The shoulder harness attachment bracket was bent forward and the shoulder harness attachment to the bracket had failed.

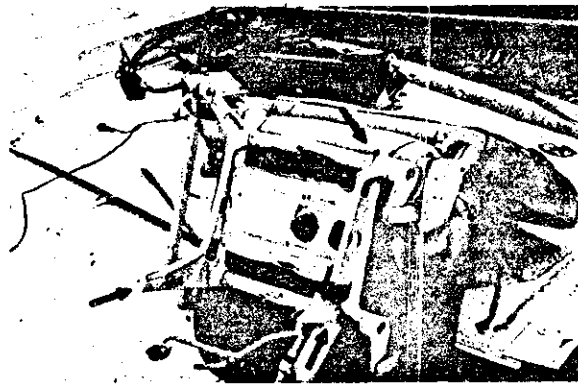
Figure 14-4. Three seat legs and seat pedestal were broken.

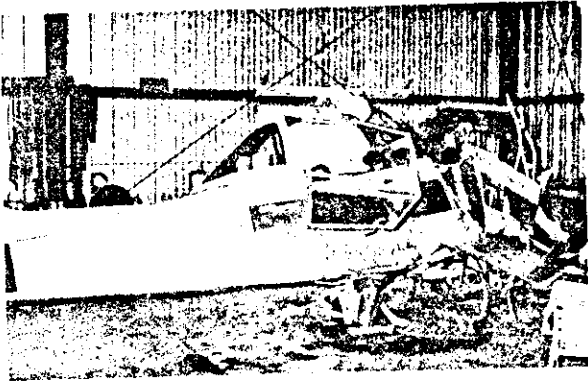
Figure 15-1. The engine and hopper were broken downward and to the left. The overhead cockpit structure was deformed downward on the right.

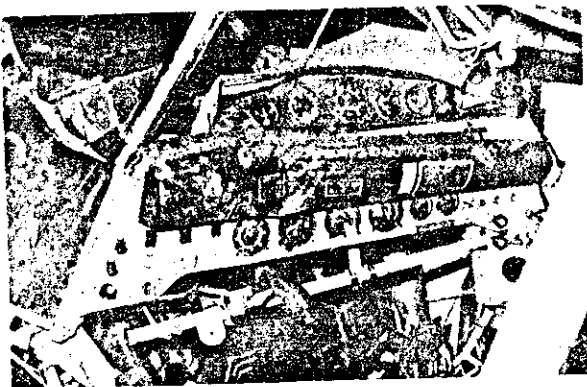
Figure 15-3. The roll of aluminum on the instrument panel was deformed forward.

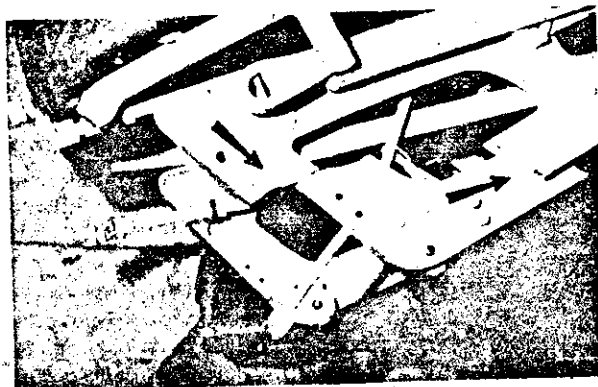
Figure 15-4. The left seat pedestal was fractured in two places and the seat locking pin was displaced aft. The seat was loose in the cockpit.

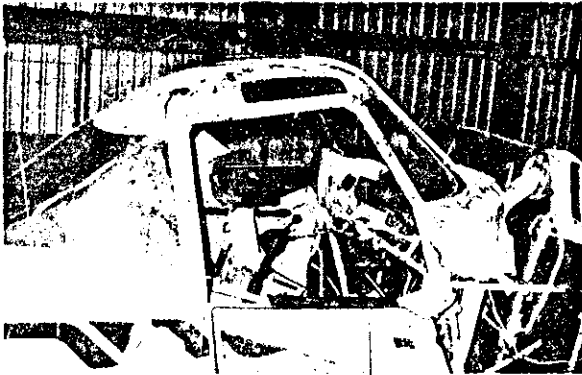
Figure 16-1. Severe impact on this 1974 model broke engine and hopper downward. The structural integrity of cockpit was preserved.

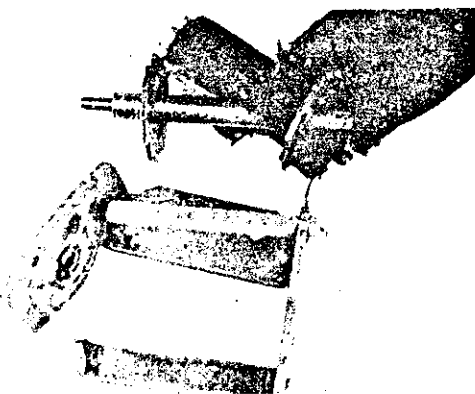
With impact forces down and to the right, the occupant probably traveled forward against the shoulder harness and the inertia reel stopping mechanism engaged momentarily, but the inertia reel housing failed, allowing the belt to spool out and separate from the reel housing. This let the pilot's head strike the instrument panel where he received the head injuries. During the impact the rear seat legs apparently detached; the locking pin broke allowing the seat to go forward and probably rotate upwardly increasing loading on the shoulder harness. The left-to-right tear in the shoulder harness webbing is consistent with the occupant's being thrown forward and to the right causing greater loading on the left shoulder harness. The compression fracture of the lumbar vertebra was probably incurred at the time of peak loading at initial impact but might have occurred when the aircraft struck trees on its slide backwards.

Figure 17-3. Inertia reel housing was broken and spool was completely separated.

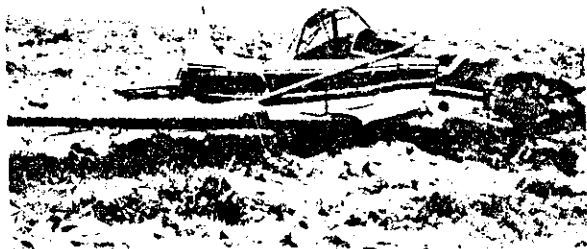
Figure 18-1. This 1977 model aircraft struck the ground in a flat spin. Downward deflection of structures indicated considerable vertical loading.

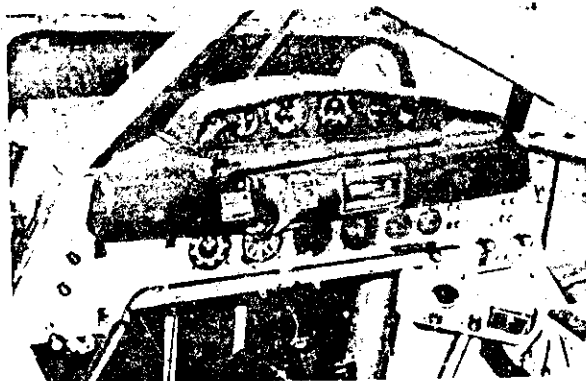
Figure 18-2. Instrument panel showed forward deformation probably caused by pilot's head.

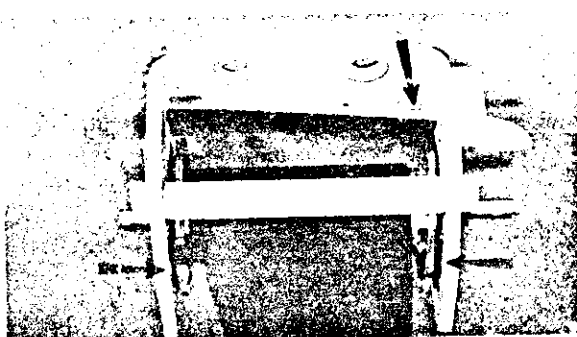
Figure 18-5. Teeth on the ratchet were blunted. On the left, the toothed gear was jammed between the engaging pail and the housing and on the right the locking bar was broken as it passed through the reel housing.

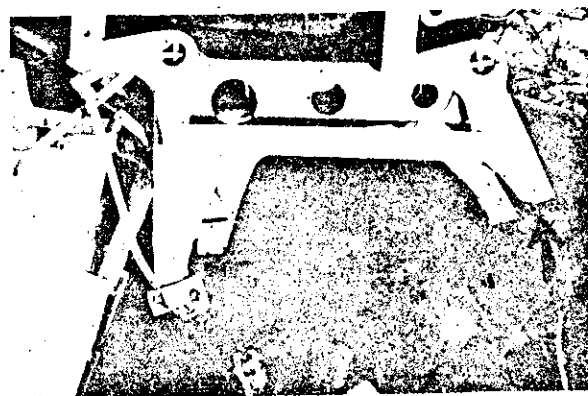
Figure 18-6. Both front legs and the right rear leg were broken near seat track attachment. Seat track engaging mechanism was bent and the pin was deformed rearward.
