1. Report No. FAA-AM-81-10	2. Government Accession No. AD-A103 316	3. Recipient's Catalog No.
4. Title and Subtitle IMPROVING THE CRASHWORTHINESS OF GENERAL AVIATION AIRCRAFT BY CRASH INJURY INVESTIGATIONS,	5. Report Date MAY 1981	6. Performing Organization Code

7. Author(s) William R. Kirkham	8. Performing Organization Report No.	10. Work Unit No. (TRAIS)
9. Performing Organization Name and Address FAA Civil Aeromedical Institute P.O. Box 25082 Oklahoma City, Oklahoma 73125	11. Contract or Grant No.	13. Type of Report and Period Covered

## IMPROVING THE CRASHWORTHINESS OF GENERAL AVIATION AIRCRAFT BY CRASH INJURY INVESTIGATIONS

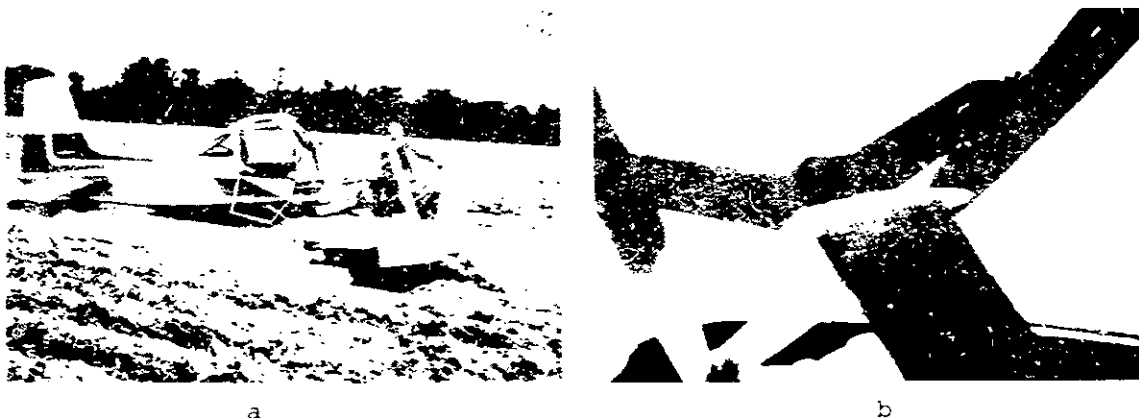
Many aerial application aircraft have been built with a strong crashworthy cockpit frame. Pilots are provided a seat, lapbelt, a shoulder harness, and in many aircraft a large metallic roll on the panel to distribute impact forces over the pilot's body should he strike it in an accident. Further, the pilot usually wears a helmet. The crashworthiness of an aerial application aircraft was illustrated when, on fuel exhaustion, the aircraft stalled and struck the ground in a 45° nosedown attitude. As illustrated in Figure 1a there was moderately severe damage to the engine and hopper. The pilot, who was wearing a lapbelt and shoulder harness, received lacerations above the right eye and a fractured left arm and left knee. He had conspicuous shoulder harness and lapbelt abrasions and contusions. A notable finding was the forward bending of the shoulder harness attachment bracket and cracking of the bond where the bracket had been welded to the cockpit structural bars (Figure 1b). During deceleration the force of the pilot's body against the shoulder harness apparently caused this deformation. Fracturing of the seat pedestal and detachment of the seat from the seat track probably increased the freedom of the pilot's body, allowing it to come forward and strike the instrument panel. The intact upper torso restraint probably prevented the pilot from receiving lethal injuries.

Figure I. In this accident damage was limited and cockpit was intact (a). However, shoulder harness attachment brace showed v-shaped deformation (b) due to force of pilot's body against restraint during crash.

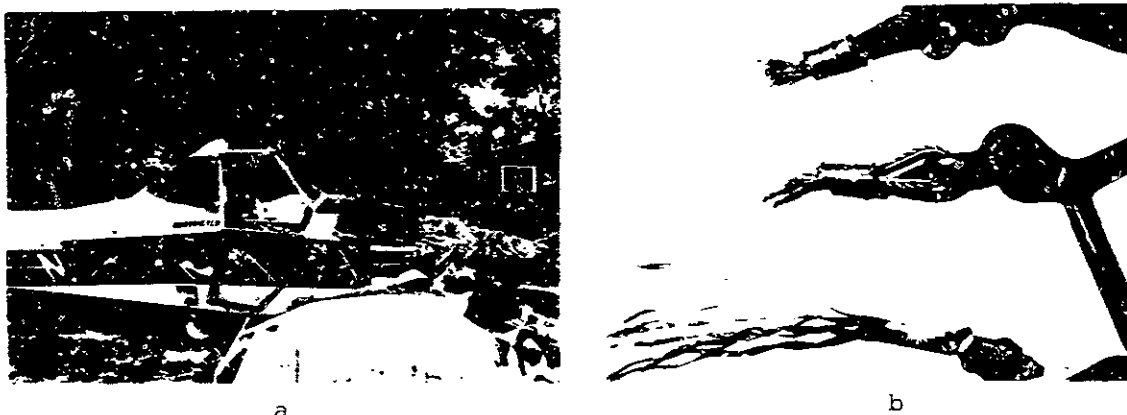
The pilot of an aerial application aircraft inadvertently dipped his right wing in some wheat and, on recovering, struck a parked cotton trailer with the left wing tip. The aircraft hit the ground and came to rest inverted. The cockpit remained intact (Figure VIa) but the seatbelt attachment cables and the shoulder harness cable failed (Figure VIb), allowing the pilot to come forward. His head struck the metallic wirecutter in front of the windscreen and his chest made a broad impact on the panel. The pilot's helmet sustained a large vertical cleavage corresponding to the impact with the wirecutter and the pilot suffered a corresponding laceration of the forehead.

Figure VI. Pilot of aircraft (a) received head and chest injuries as, on impact, he came forward into windscreen, wirecutter, and instrument panel. Cables used on shoulder harness and lapbelts all failed (b). Stronger cables and modified routing apparently rectified the condition.

the pilot) and the cables were fixed to the frame of the aircraft. In both places, over the pulley and where cables pass through the bulkhead, they were subjected to wear and considerable recurrent acute bending. In some operational aircraft, filaments of the multistrand cable were found to be broken. This configuration of the cable attachments for the shoulder harness and lapbelts appeared to subject them to wear and bending that weakened and broke strands of the cable. Thus, in the aircraft accident investigated, the cables probably had been preweakened by wearing, bending and breaking of filaments; and during the impact the pilot's body probably exerted force on the restraint system sufficient to break the cables.

These observations were reported to others in the Federal Aviation Administration and published in General Aviation Inspection AIDS (3), a bulletin that calls technical matters to the attention of inspectors in the field. The manufacturer was also informed of the finding in this accident. Subsequent to the publication of this notice for inspectors, the manufacturer issued a service bulletin by which stronger and different cables were put in the aircraft and the configuration of the lead-in through the bulkhead was modified so as to eliminate most of the bending. Since the modification, there have been no accidents in which we have observed the cables to have broken and an examination of operational aircraft in the field has revealed no flaws in the cables.

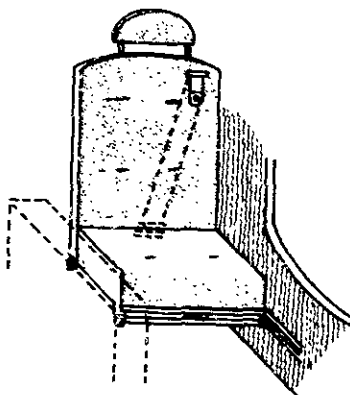
seat back and attaches to the lapbelt. The strength of the shoulder harness depends upon the strength of the seat-back latch to keep the seat upright during an impact. If the seat back were to break forward the shoulder harness would be of reduced value. Furthermore, the seat is mounted on rollers that extend from the seat frame to tracks on the sidewall and a center console (Figure VII). There are no legs or pedestals under this seat. The seat and upper torso restraint arrangement is such that the forward decelerative forces of the occupant transmitted to the shoulder harness must be borne by the seat attachment.

Figure VII. Schematic of side-mounted seat.

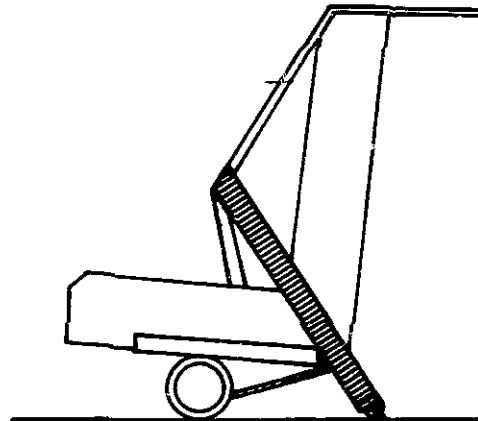
An additional crashworthiness feature involves an aircraft in which the main spar is a large aluminum tube that passes through the cockpit. This hollow tube serves also as a fuel cell. The two-seat aircraft has both seats mounted side by side on a small metallic track directly on top of the main spar. The bottom of the seat is plywood and the seat cushion consists of 2 inches of foam rubber. This arrangement appears to offer little attenuation of impact forces by the seat. During impact, forces, particularly vertical forces, would tend to be transmitted through the main spar to the pelvis and the axial spine of the occupant.

Figure XI. Schematic of aircraft seat showing mounting directly over large tubular main spar with little space or structure to attenuate vertical impact forces.

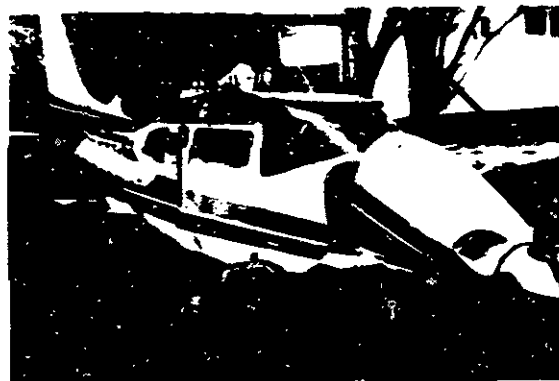
application aircraft as illustrated in Figure XII. The six people in this aircraft all received moderate to severe injuries. The pilot and person in the copilot position had facial injuries and spine fractures. The forward four seats were partially or completely separated from the seat tracks and the pilot's and copilot's seats had fractured seat pedestals as shown in the figure. Cast seat legs and parts are strong and meet all FAA requirements but in accidents when the failure point is reached they appear to break exposing the occupant to possible high peak decelerative forces in secondary impacts rather than deforming under the occupant and attenuating the energy of impact. At present we do not know how pervasive failures of seats are in general aviation aircraft or how such failures add to the severity of injuries. This is a matter of continuing crashworthiness investigations.

Figure XII. On impact, the occupants of this aircraft received serious injuries. Cast alloy seat pedestals were found to be fractured as can be seen in photograph.
