# NATIONAL TRANSPORTATION SAFETY BOARD

## SPECIAL INVESTIGATION REPORT

SAFETY ISSUES RELATED TO  
WAKE VORTEX ENCOUNTERS  
DURING VISUAL APPROACH  
TO LANDING

Special Investigation Report NTSB/SIR-94/01  
Notation 6264

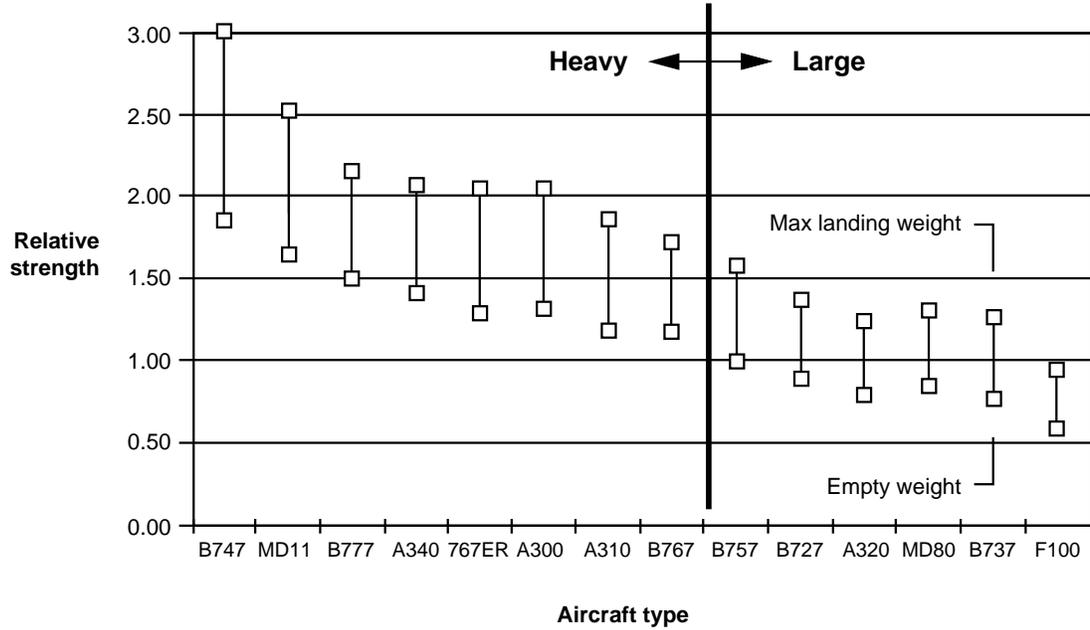
The Safety Board's investigations of the preceding cases initially focused on why the B-757 appeared to be involved in a disproportionate number of wake vortex encounters. Several reports indicated that the B-757 generated wake vortices that were more severe than would be expected for an airplane of its weight. However, as a result of a thorough study and analysis of the issue, the Safety Board found little technical evidence to support the notion that the wake vortex of a B-757 is significantly stronger than indicated by its weight. Figure 1 presents the calculated initial relative vortex strength of the B-757 and other airplanes. The calculated initial vortex strength is closely related to the weight of the airplane. Of note, the B-757 is the heaviest airplane in its weight category, and there are no other airplanes of similar weight.

Figure 1—Calculated initial vortex strength of aircraft types. (Courtesy of the National Aeronautics and Space Administration.)

Conduct additional tests of the Boeing 757 to determine the persistence and strength of its wake vortex and the effects of atmospheric conditions on B-757 vortices. (Class II, Priority Action) (A-94-55)

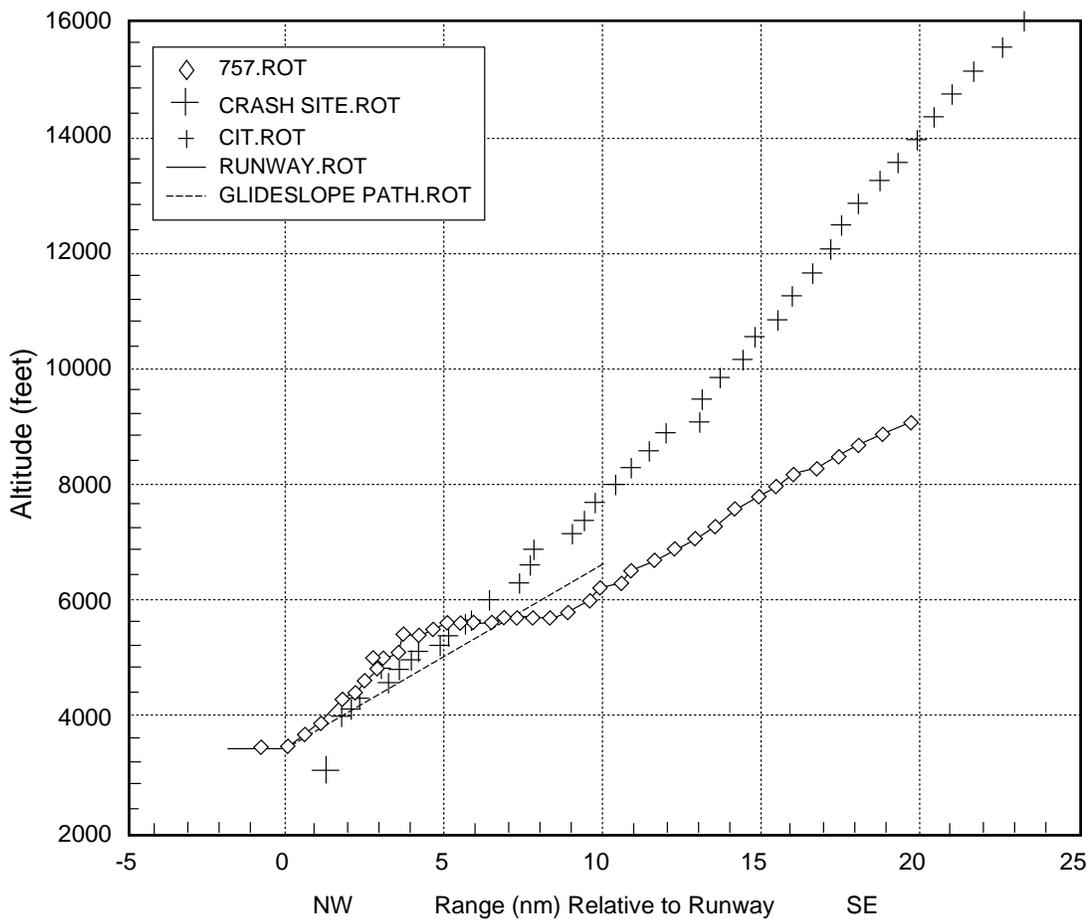
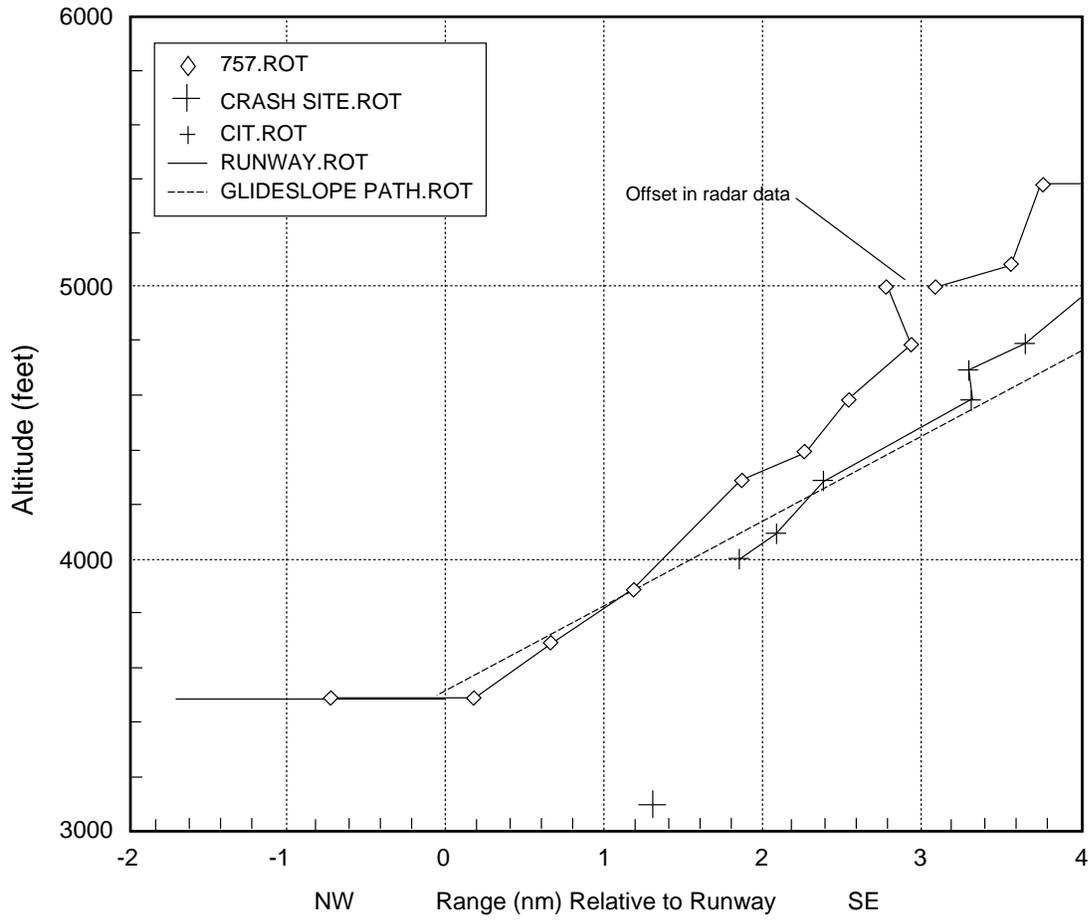
**Appendix C**  
**Altitude Profile of B-757 and Cessna Citation 550**  
**at Billings, Montana, on December 18, 1992**

The Citation’s rapid and extreme departure from controlled flight occurred when the airplane was about 2.78 nm (about 74 seconds) behind the B-757. Calculations indicate that an additional 0.22 nm (about 6 seconds) would have provided the required 3 nm of longitudinal IFR separation had the pilot not requested the visual approach clearance. However, available data show that under the existing atmospheric conditions, a vortex would not likely have diminished an appreciable amount in the next 6 seconds. Consequently, this accident indicates that lighter weight airplanes in the large category, such as the Cessna Citation, require a separation distance greater than 3 nm when following heavier airplanes in the large category, such as a B-757.

The only cue available to the Citation pilot to determine his flight path relative to the flight path of the B-757 would have been the Citation pilot’s visual alignment of the B-757 and objects on the ground. For example, assuming that the B-757 was on a relatively constant flight path, the Citation flight path would have been similar to that of the B-757 if the Citation pilot had observed that the B-757 was aligned with the runway touchdown zone. If the B-757 were aligned with the far end of the runway, the flight path of the Citation would have been lower than the flight path of the B-757. If the B-757 were aligned with the approach lights, the flight path of the Citation would have been above the flight path of the B-757.

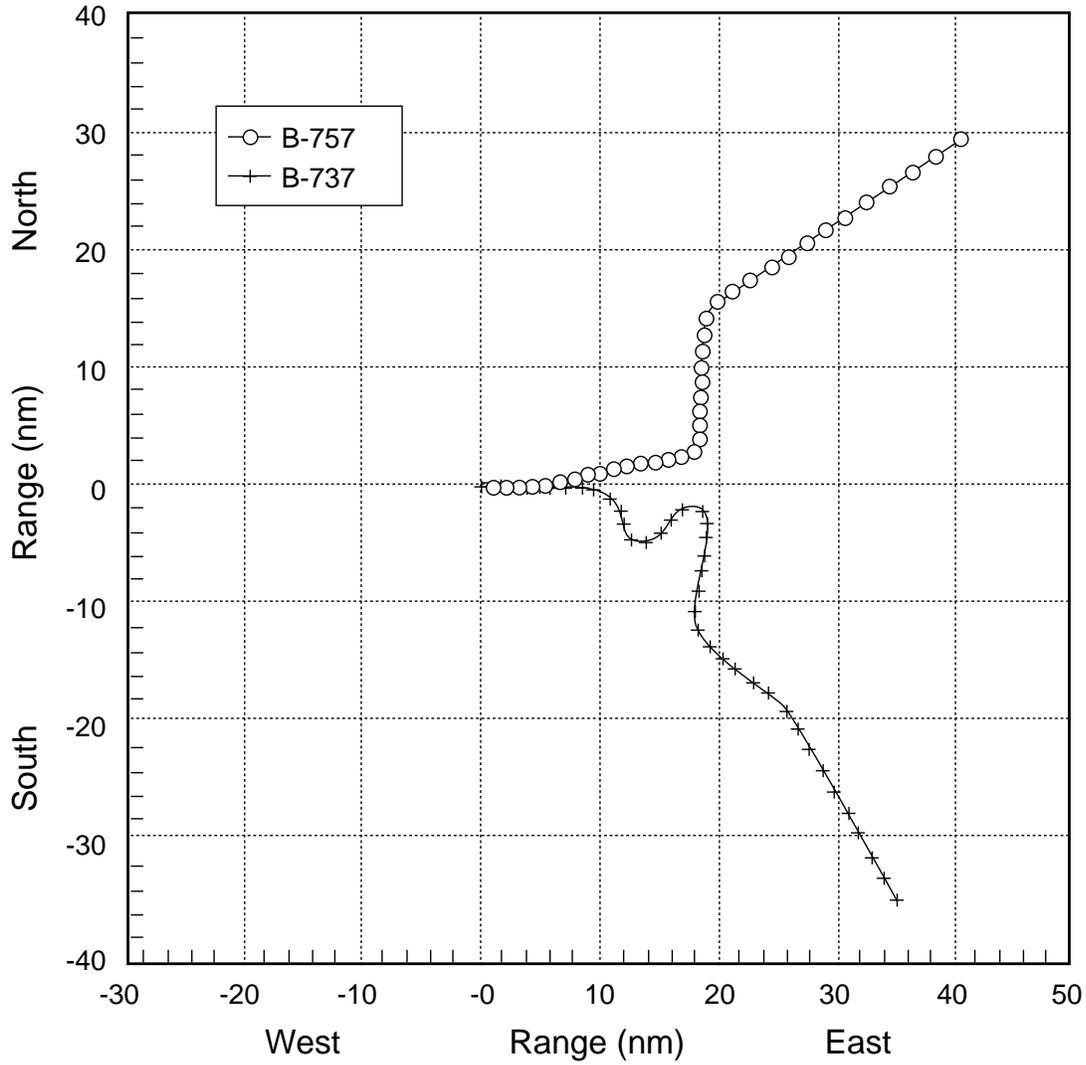
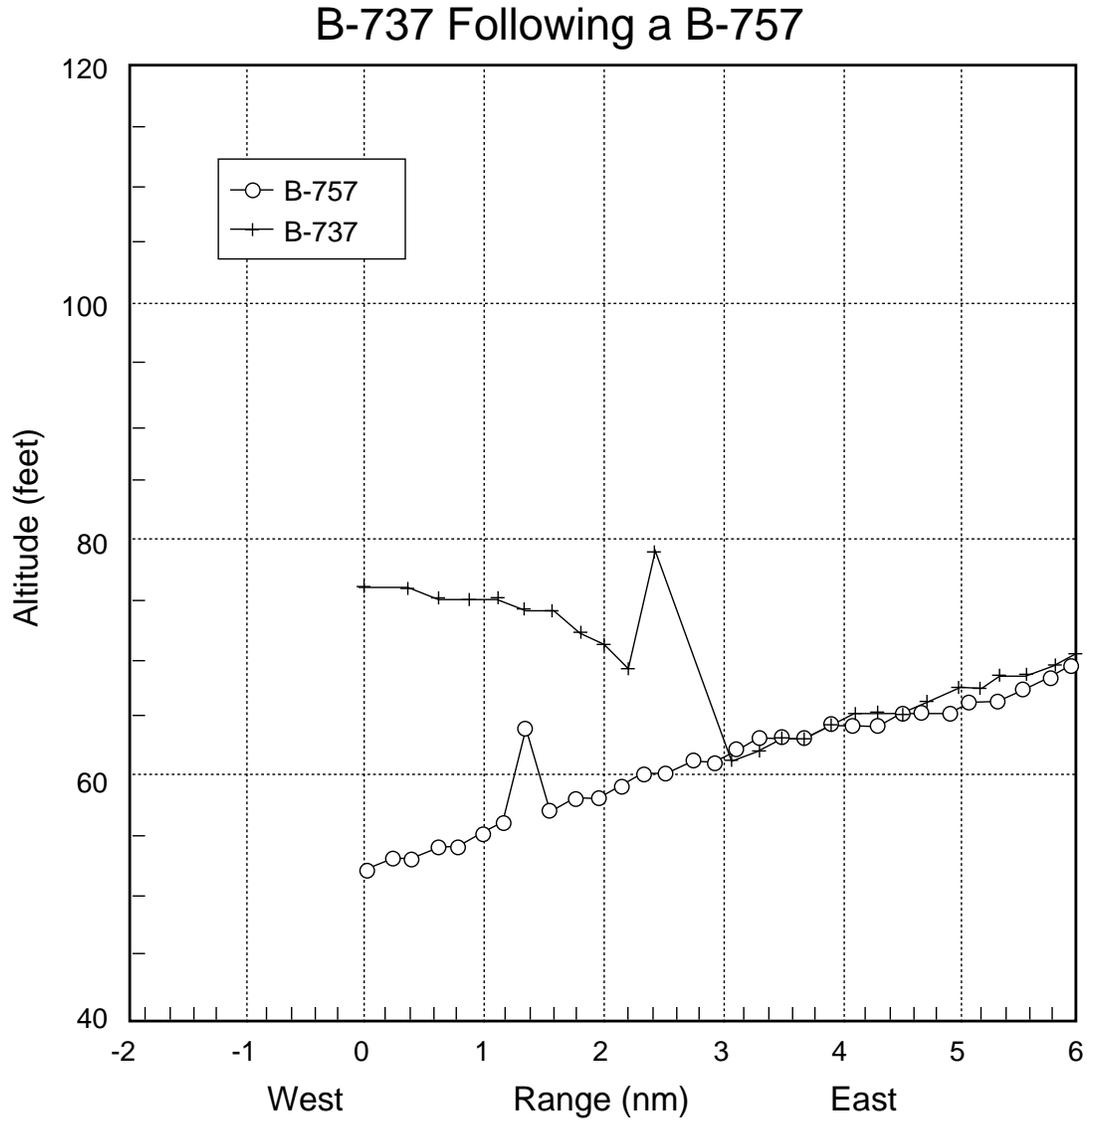
**Appendix D**  
**Ground Track of B-757 and B-737**  
**at Denver, Colorado, on April 24, 1993**

Runway 26L is parallel to, and displaced 900 feet south of runway 26R. The threshold of runway 26L is offset about 1,300 feet to the east of the threshold of runway 26R, resulting in a flight path to 26R that is about 70 feet higher than the flight path to 26L. Under the existing wind conditions, a wake vortex from the B-757 would descend and move to the south, toward a standard flight path to runway 26L.

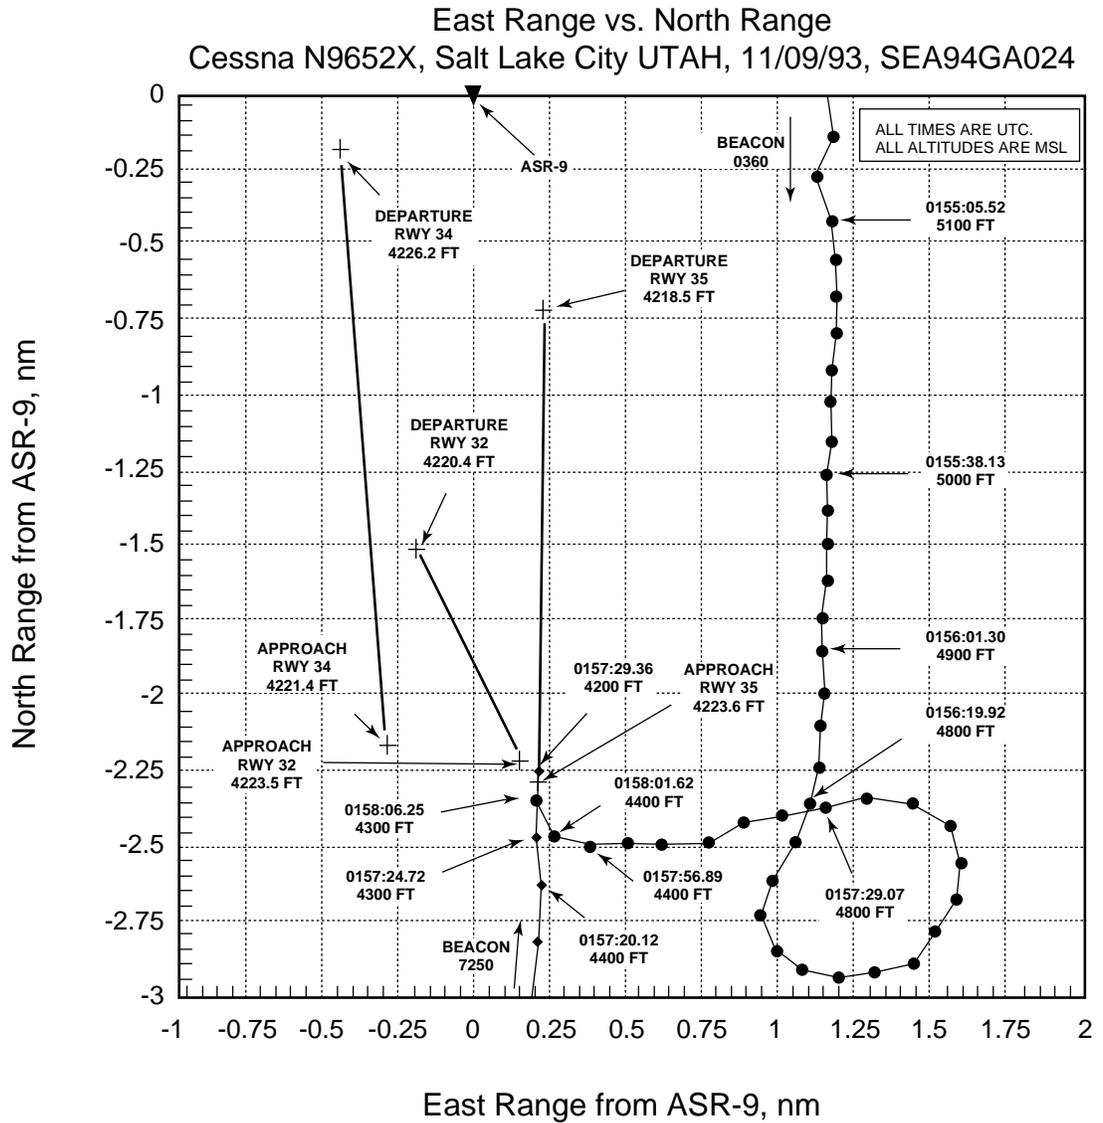
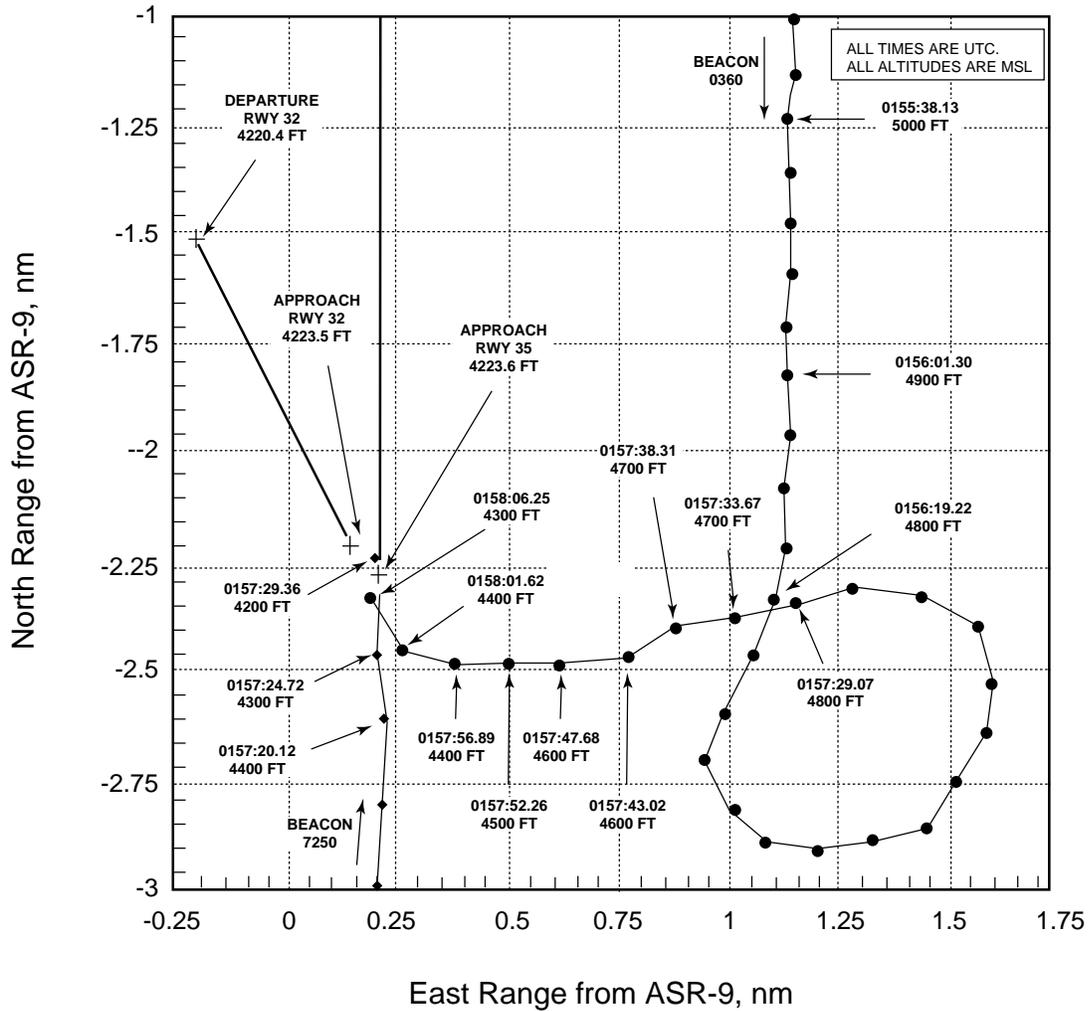
**Appendix F**  
**Ground Track of Cessna 182 and B-757**  
**at Salt Lake City, Utah, on November 10, 1993**

East Range vs. North Range  
 Cessna N9652X, Salt Lake City UTAH, 11/09/93, SEA94GA024
