**Airframe Breakout Session**  
Seattle DER Recurrent Seminar – November 6, 2003  
**“Lusaka: An Accident Worth Revisiting”**

**LOOKING AT LUSAKA’S  
LESSONS**

Seattle DER Conference  
6 November 2003

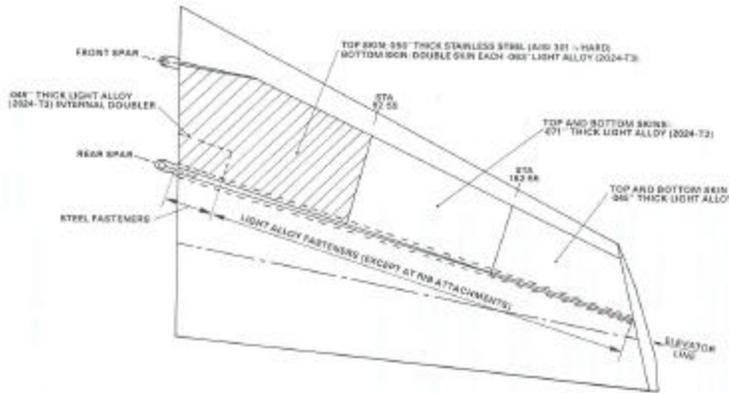
- Upper and lower cover skins beefed up after flight testing showed inadequate torsional stiffness

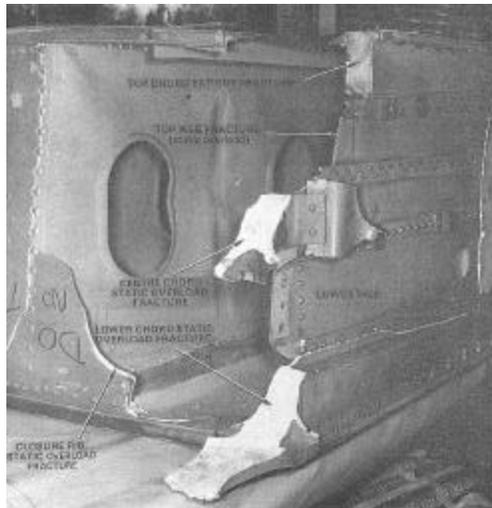
- Top chord failed due to fatigue cracking leading to static down bending failure of remaining structure

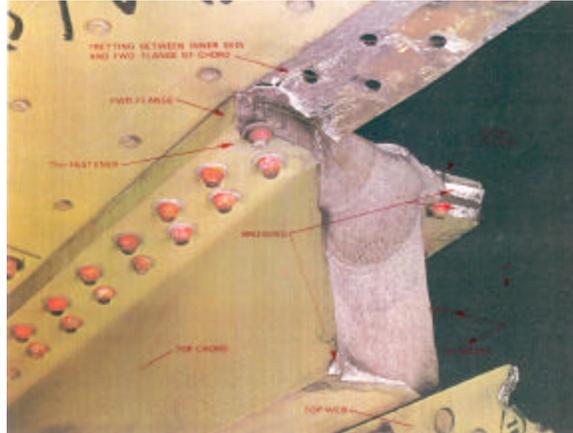
Upper Chord Fracture Looking Outboard

- Crack origin at upper edge of 11<sup>th</sup> fastener hole in forward flange
- ? 7200 flights of crack growth from initiation to chord failure
- ? 100 flights from chord failure to stabilizer separation

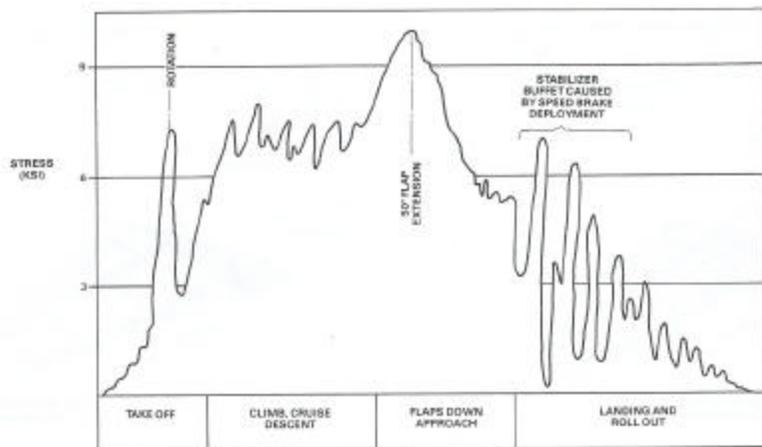
- Post accident loads testing validated flight loads but revealed significant oscillating loads during normal landing roll due to speed brake deployment.

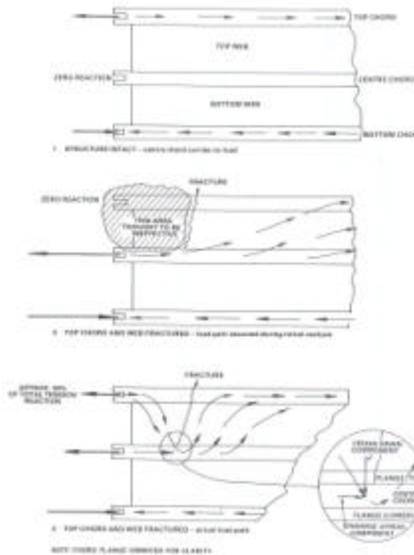
- Post accident fail safe testing:
  - Showed structure not capable of residual strength loads with chord severed at 11th fastener hole.
  - Produced static overload failure mode very similar to G-BEPP.
  - Revealed that actual behavior of structure with chord failed at 11<sup>th</sup> fastener hole was significantly more complex than assumed for certification analysis
