Section 9 Approval and ASE Examples

September 2023

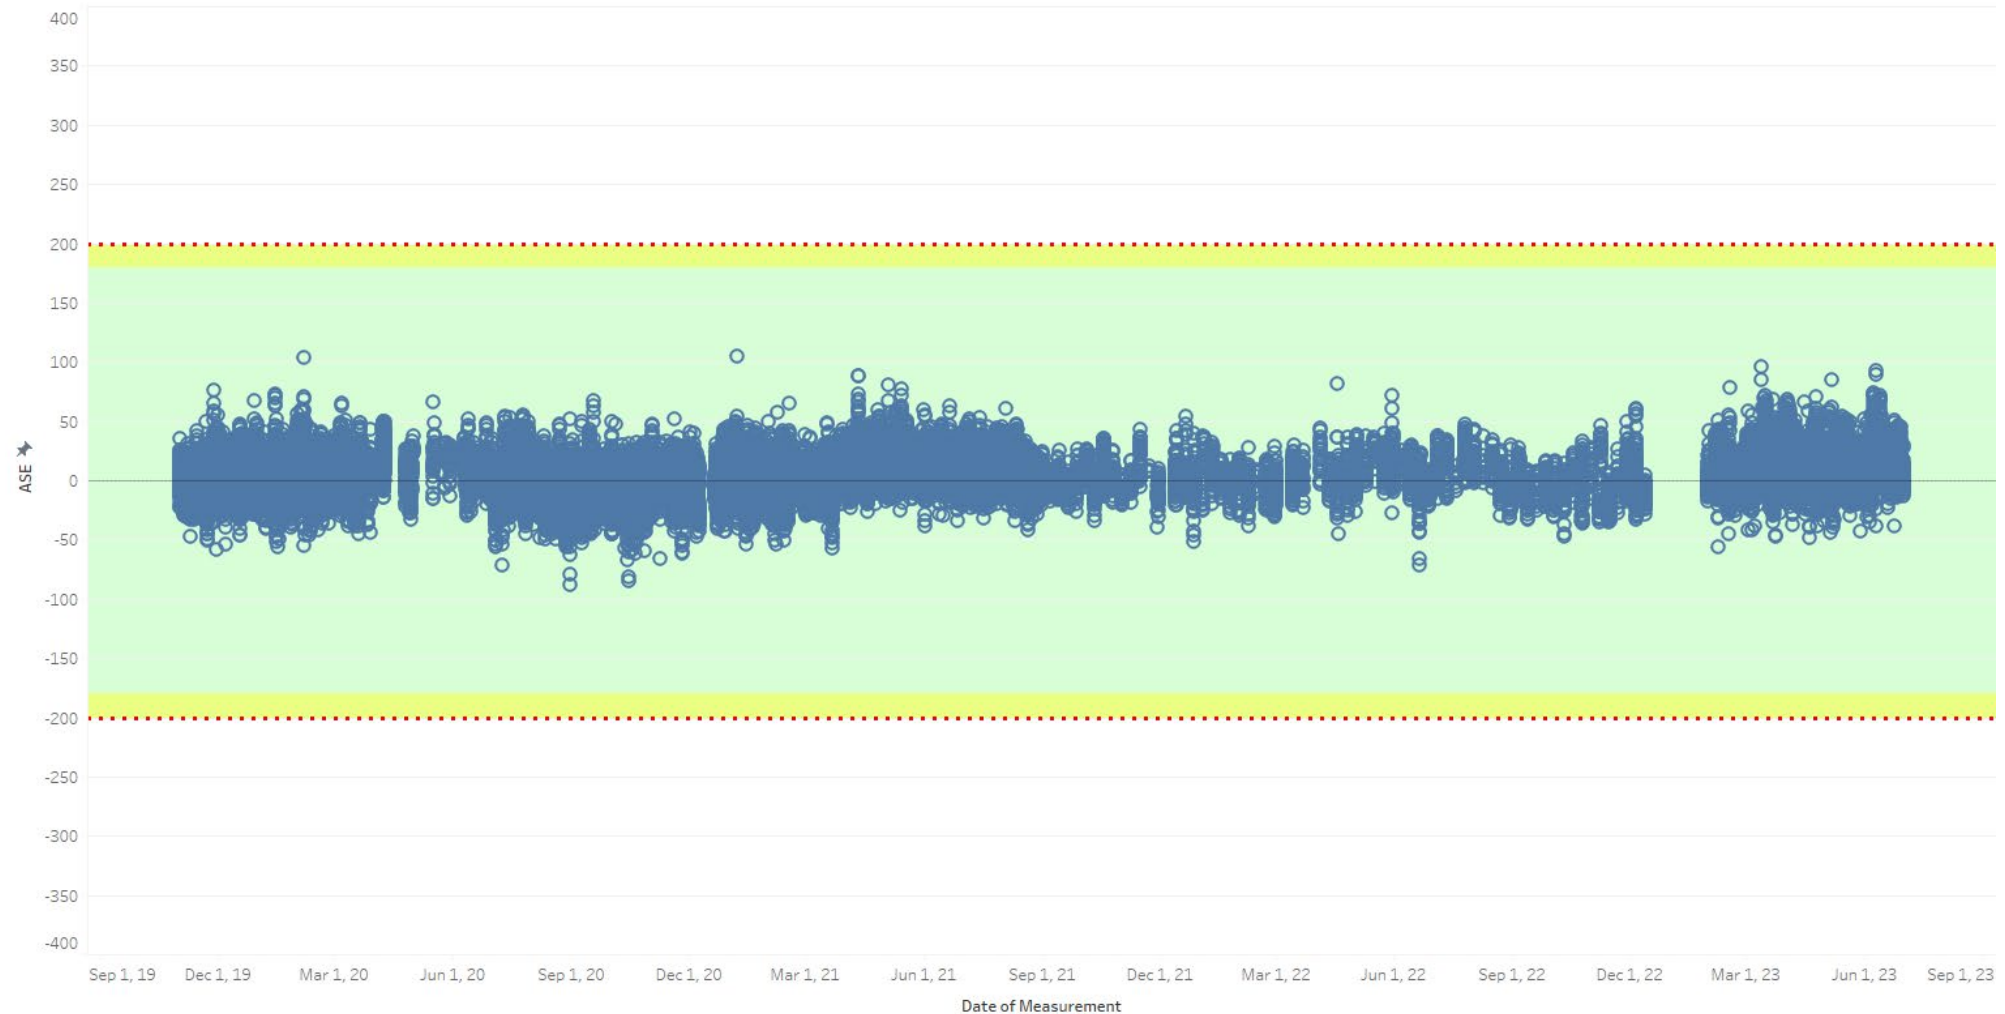
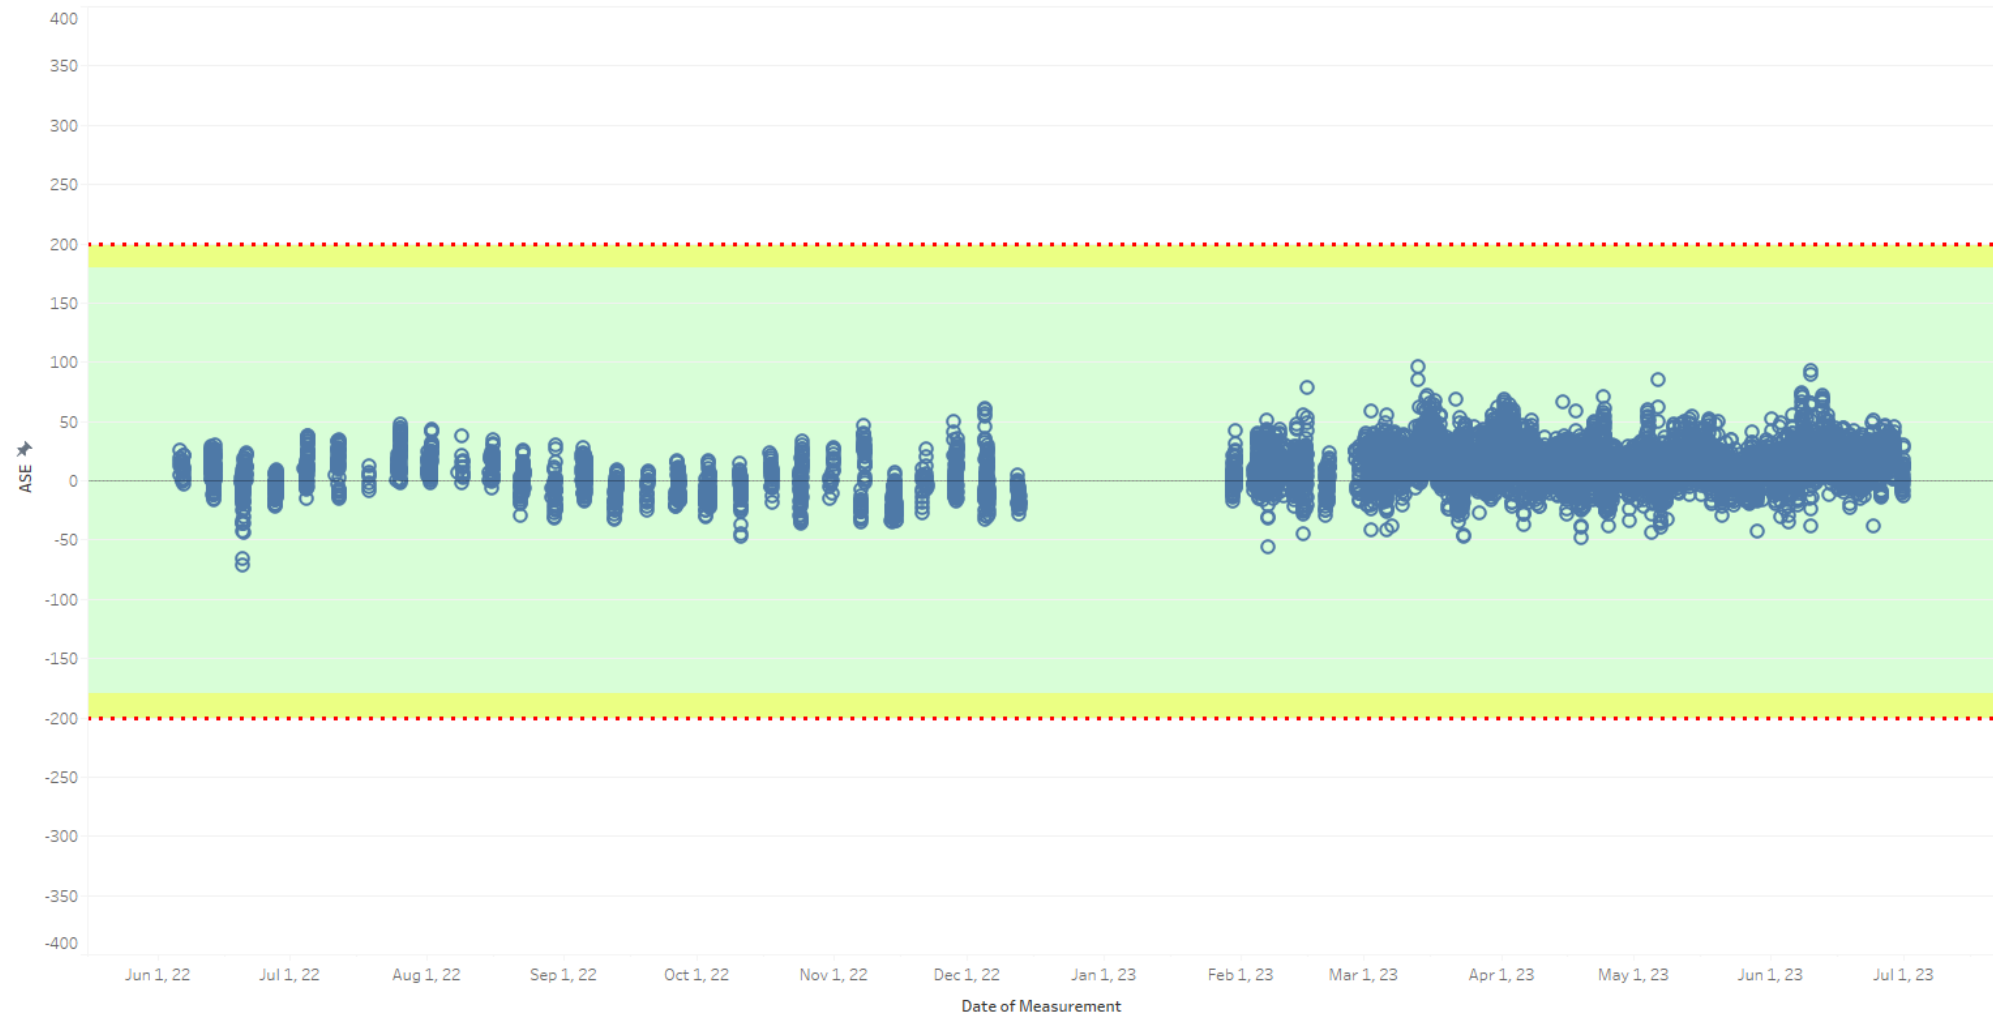
- This example showed an aircraft that flies frequently with very good ASE performance.
- The 1-year view shows the period of time in which NAARMO only calculated ASE once per week.
 - Previous to 2023, the ASE is displayed in vertical lines, depicting only one day of data per week.
 - 2023 shows the full dataset with daily monitoring.
 - The break in measurements is due to maintenance or down time only, not an actual lack of data.
- No difference in ASE between the 4-year view and 1-year view.
 - Ideal performance for all aircraft !

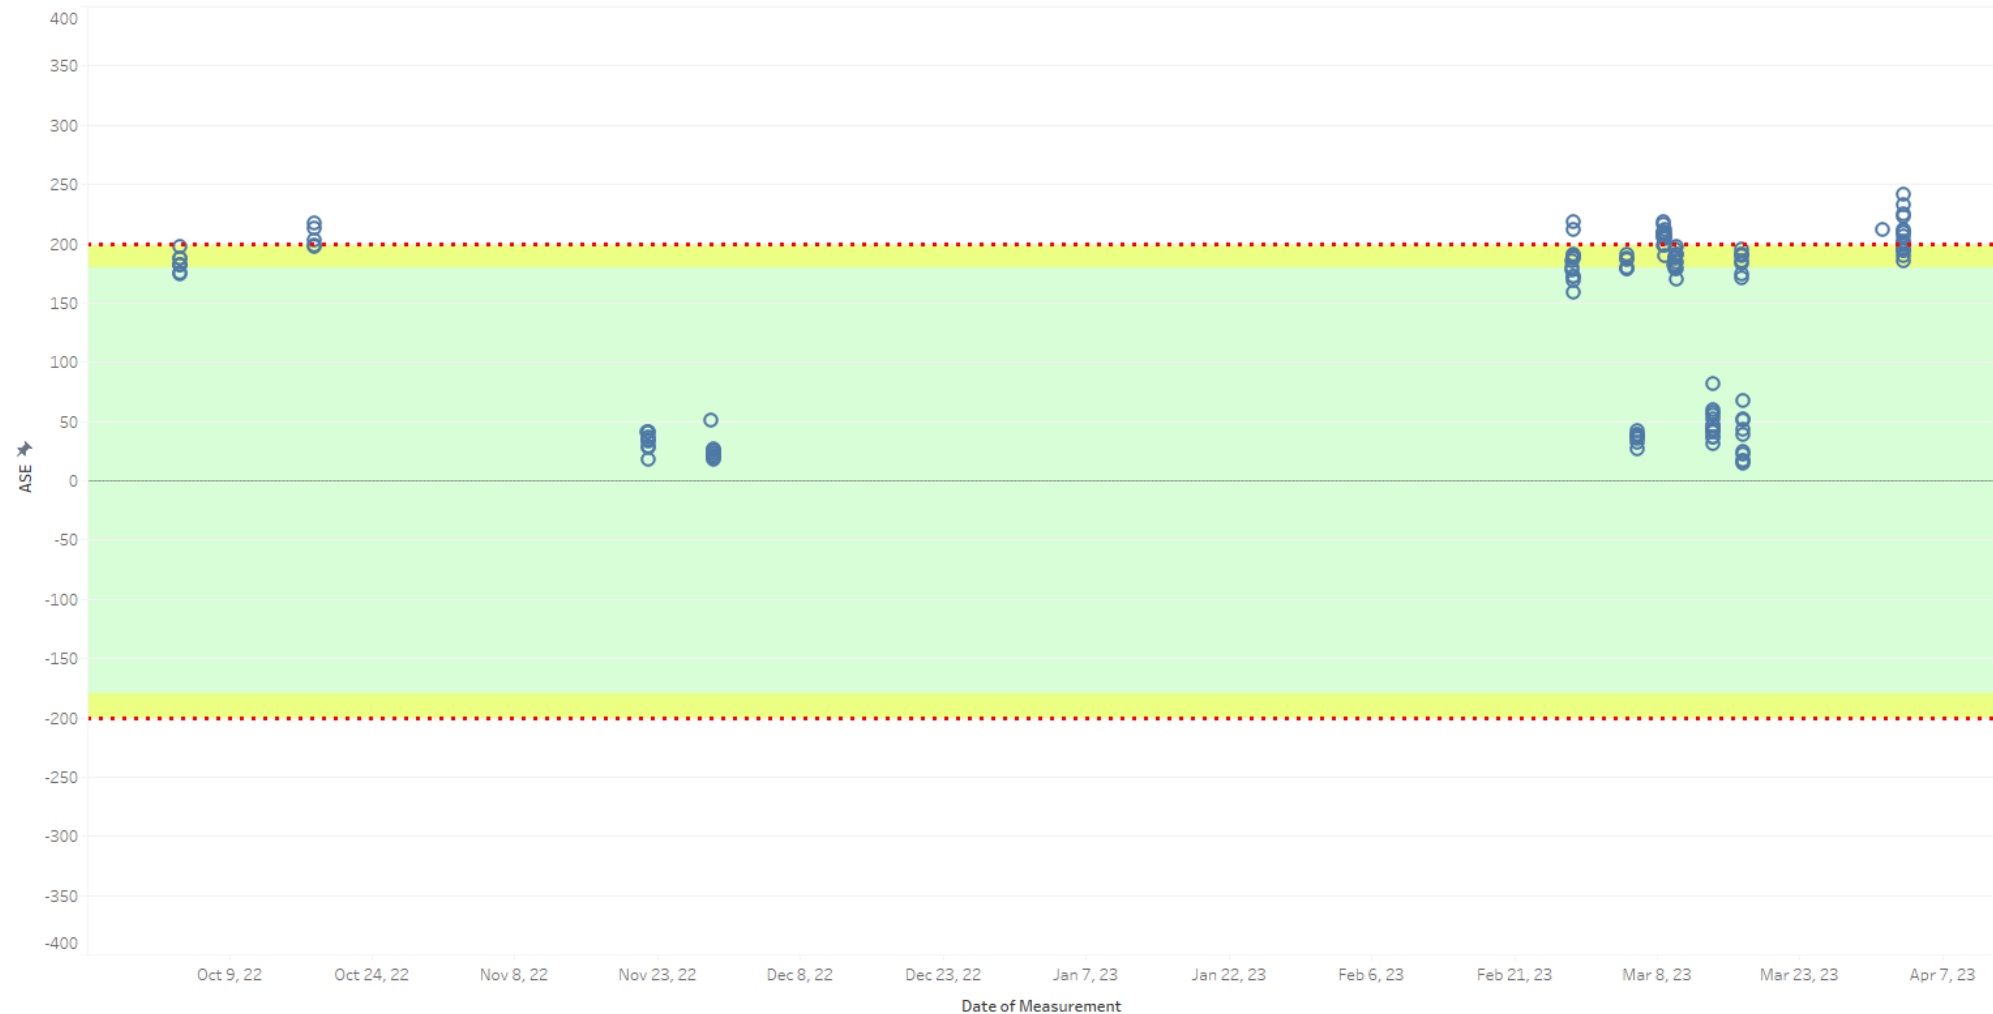
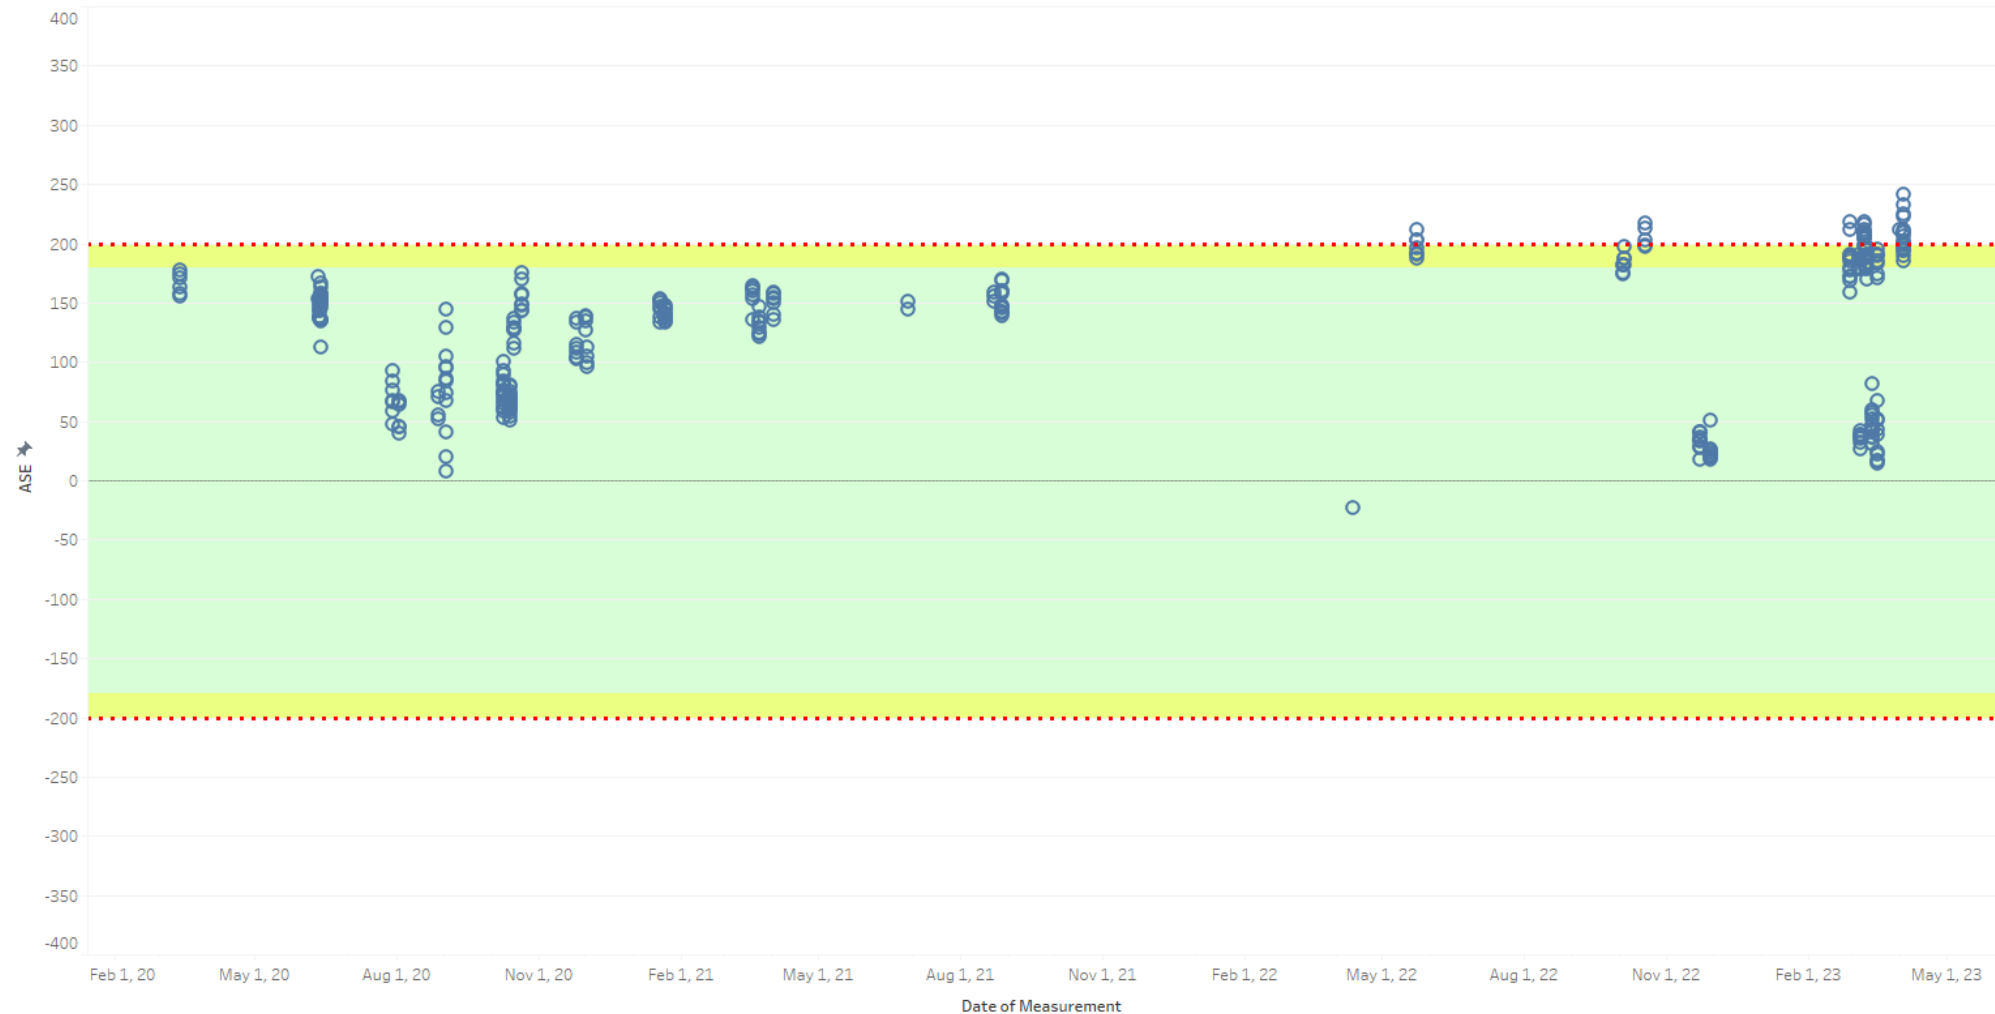
Case 1: Altimetry System Disagreement or "Split"

Appears to improve in 2022
Identified as a split in 2023

- Aircraft appeared to be performing well prior to November 2022.
 - It may have been performing well, or there may not have been enough data to detect a split.
 - The magnitude of the split increased in 2023, triggering the detection.
- This aircraft did not trigger the Watch List threshold because there was so little data, and half of that data was good, during that 6-month review.
- More monitoring in 2023 helped make it clear that there was a split in the altimetry system.
 - Missed perception of ASE improvement with a 6-month view.

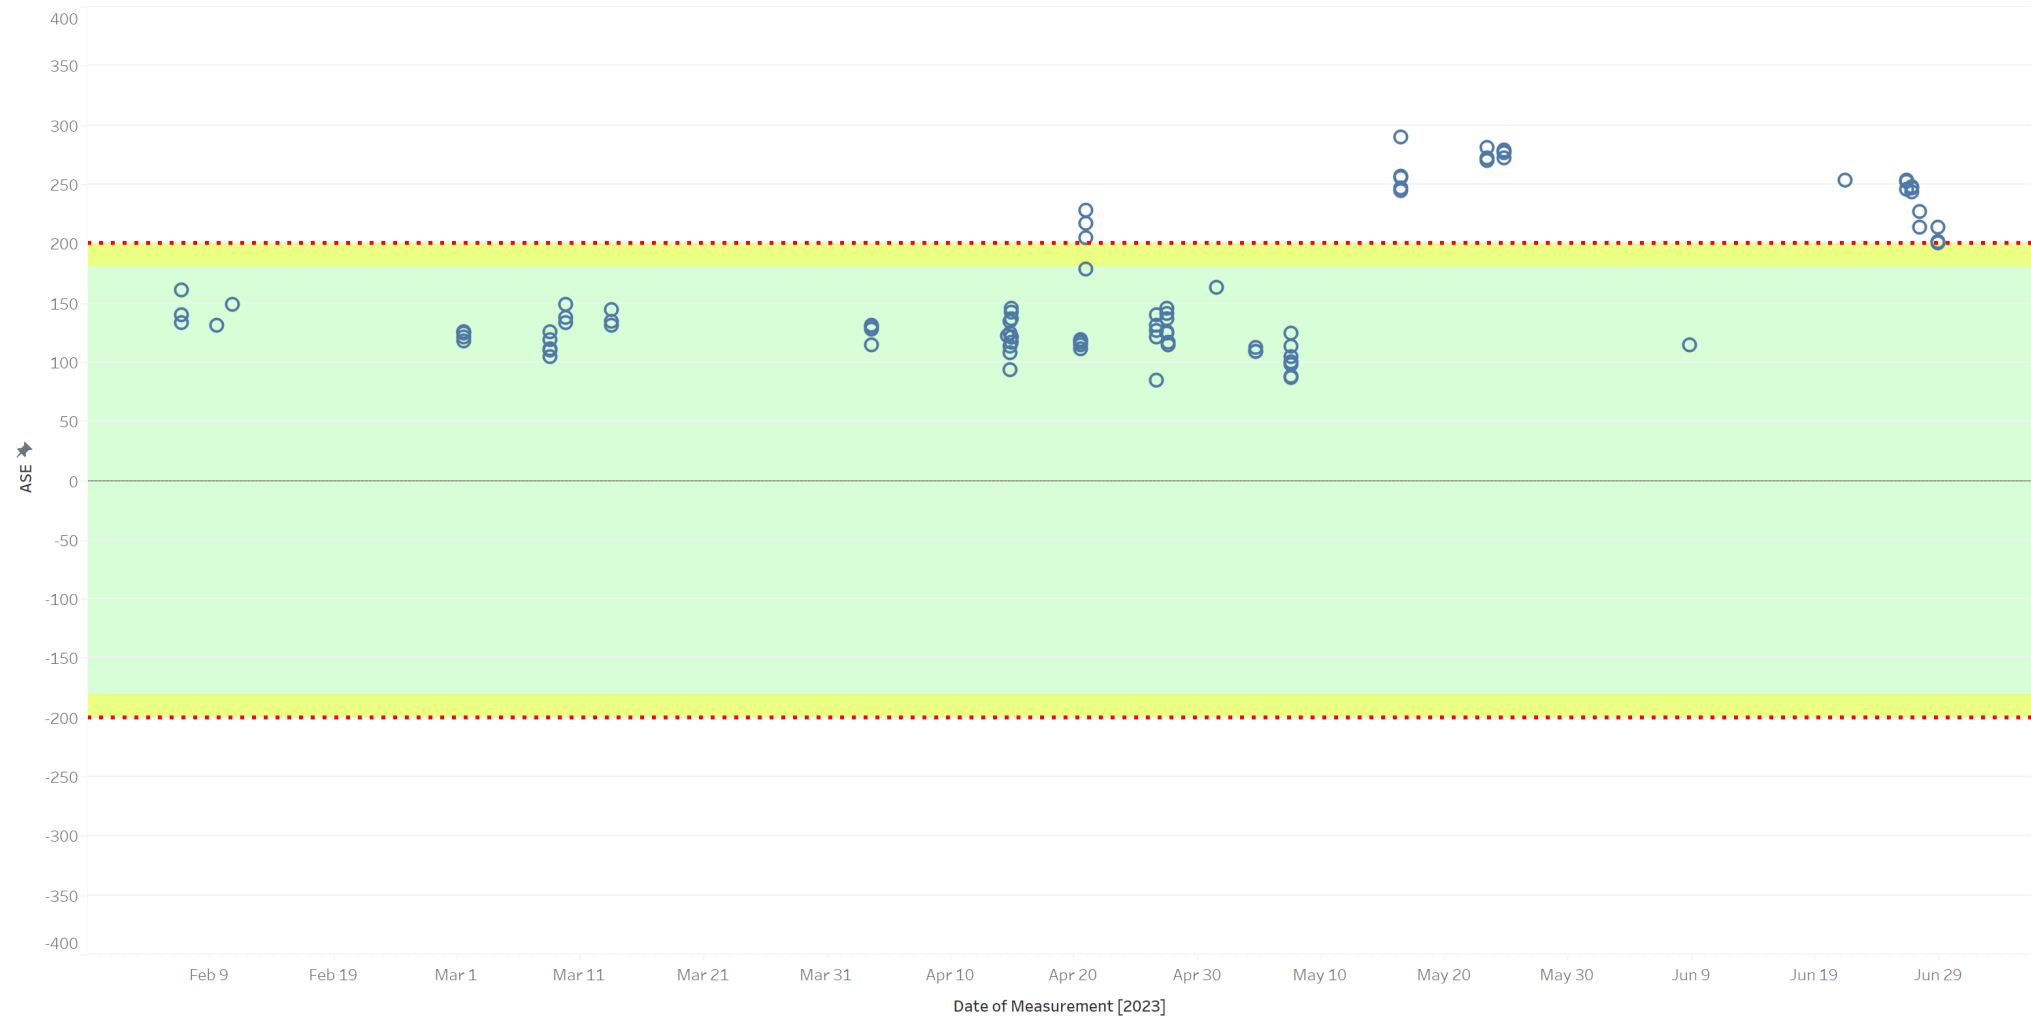
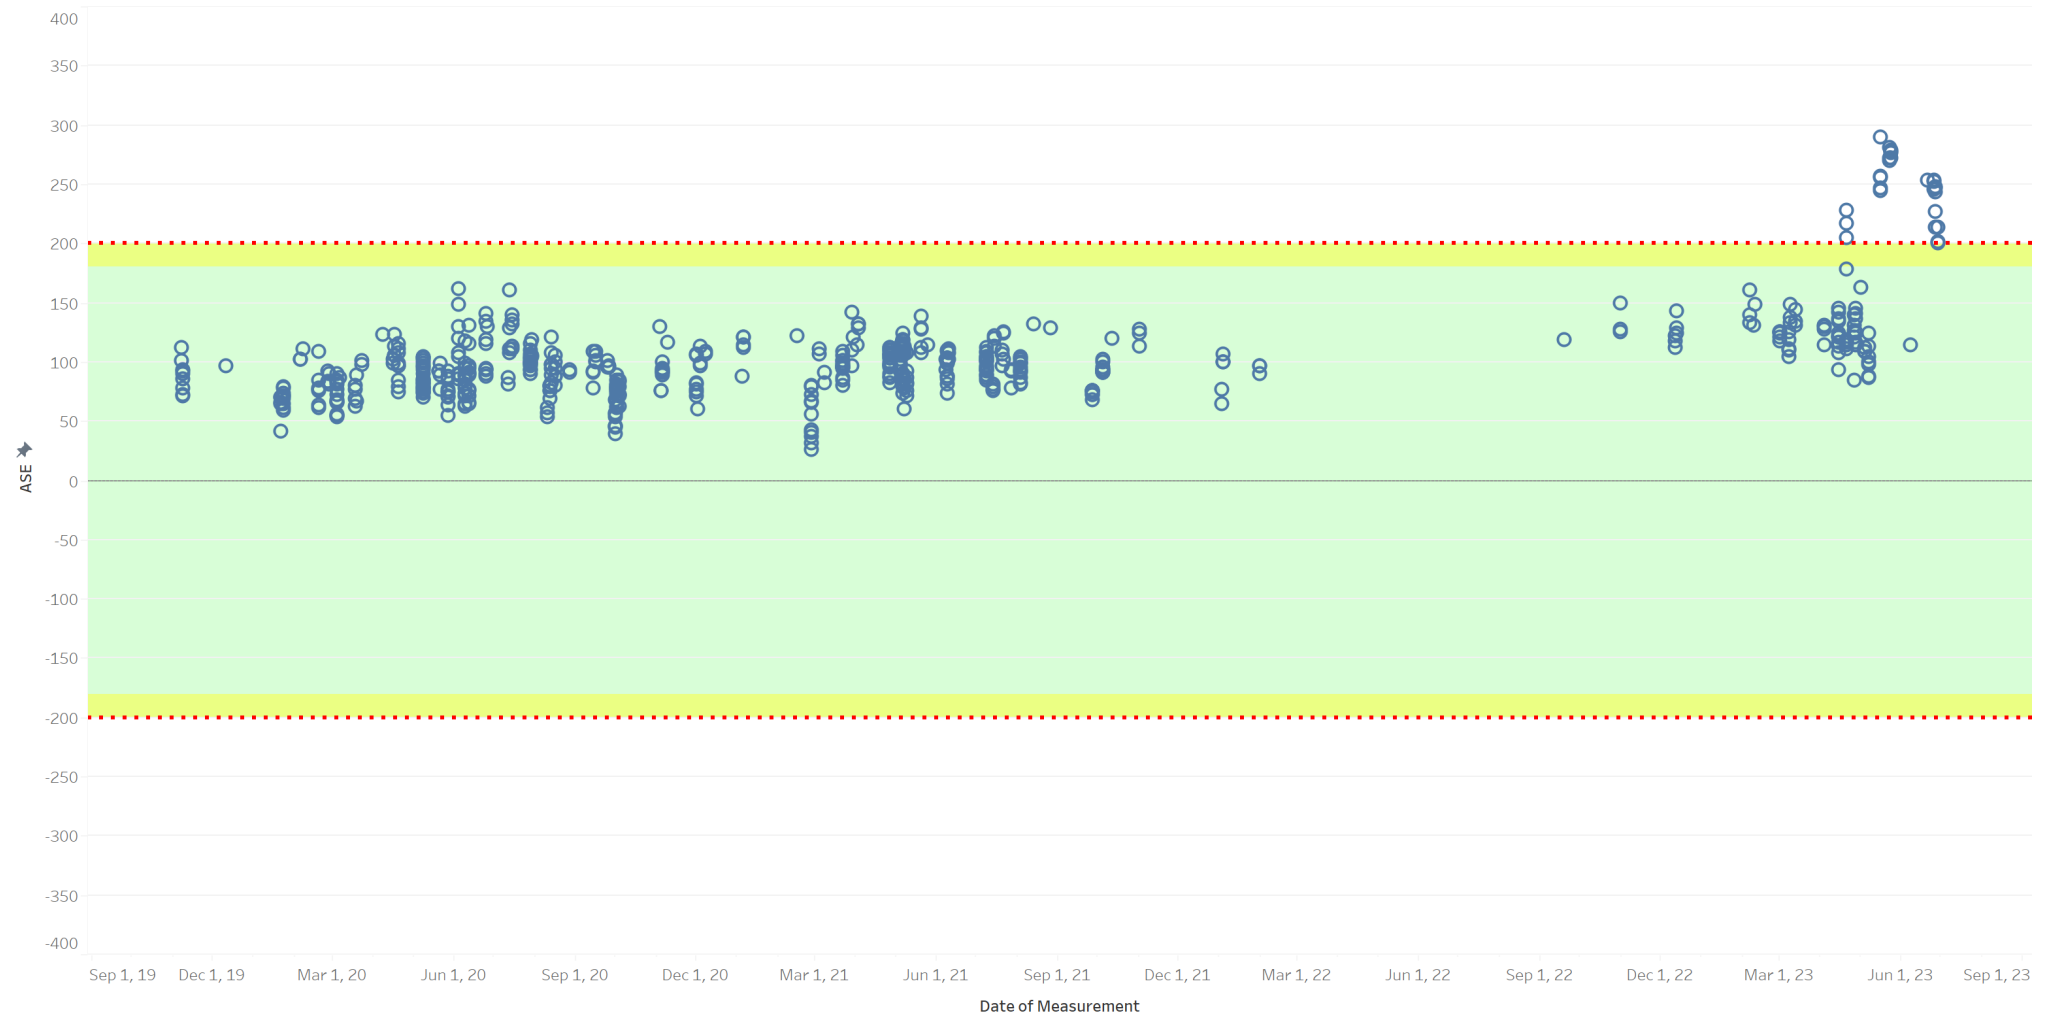
Case 2: Sudden Increase in ASE

- Without daily monitoring, the ASE increase may have been more difficult to detect.
- This sudden ASE increase was detected during the 6-month review.
- Extended averaging may have taken longer to detect an ASE jump because of infrequent flights during recent months.
 - Using 1 year of data rather than 6 months to detect large ASE would not have identified this aircraft for a large ASE case.

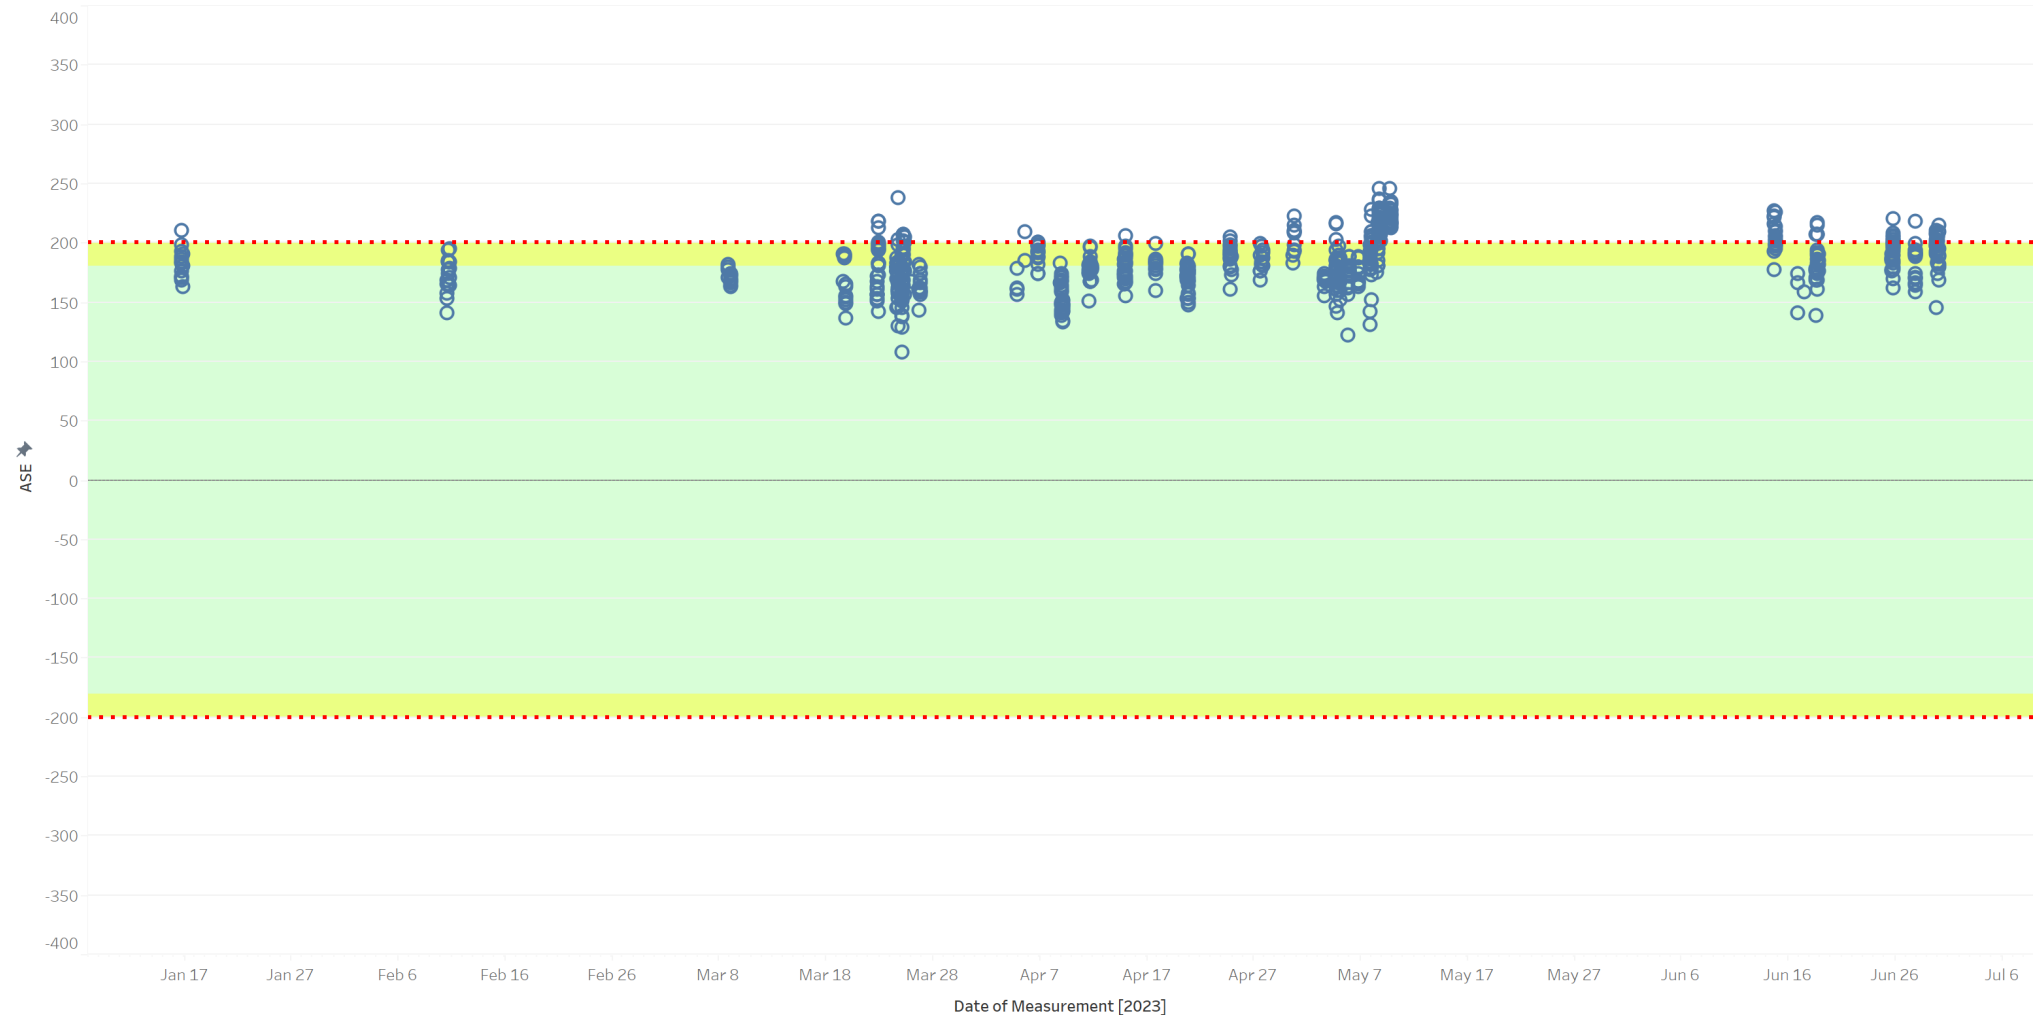
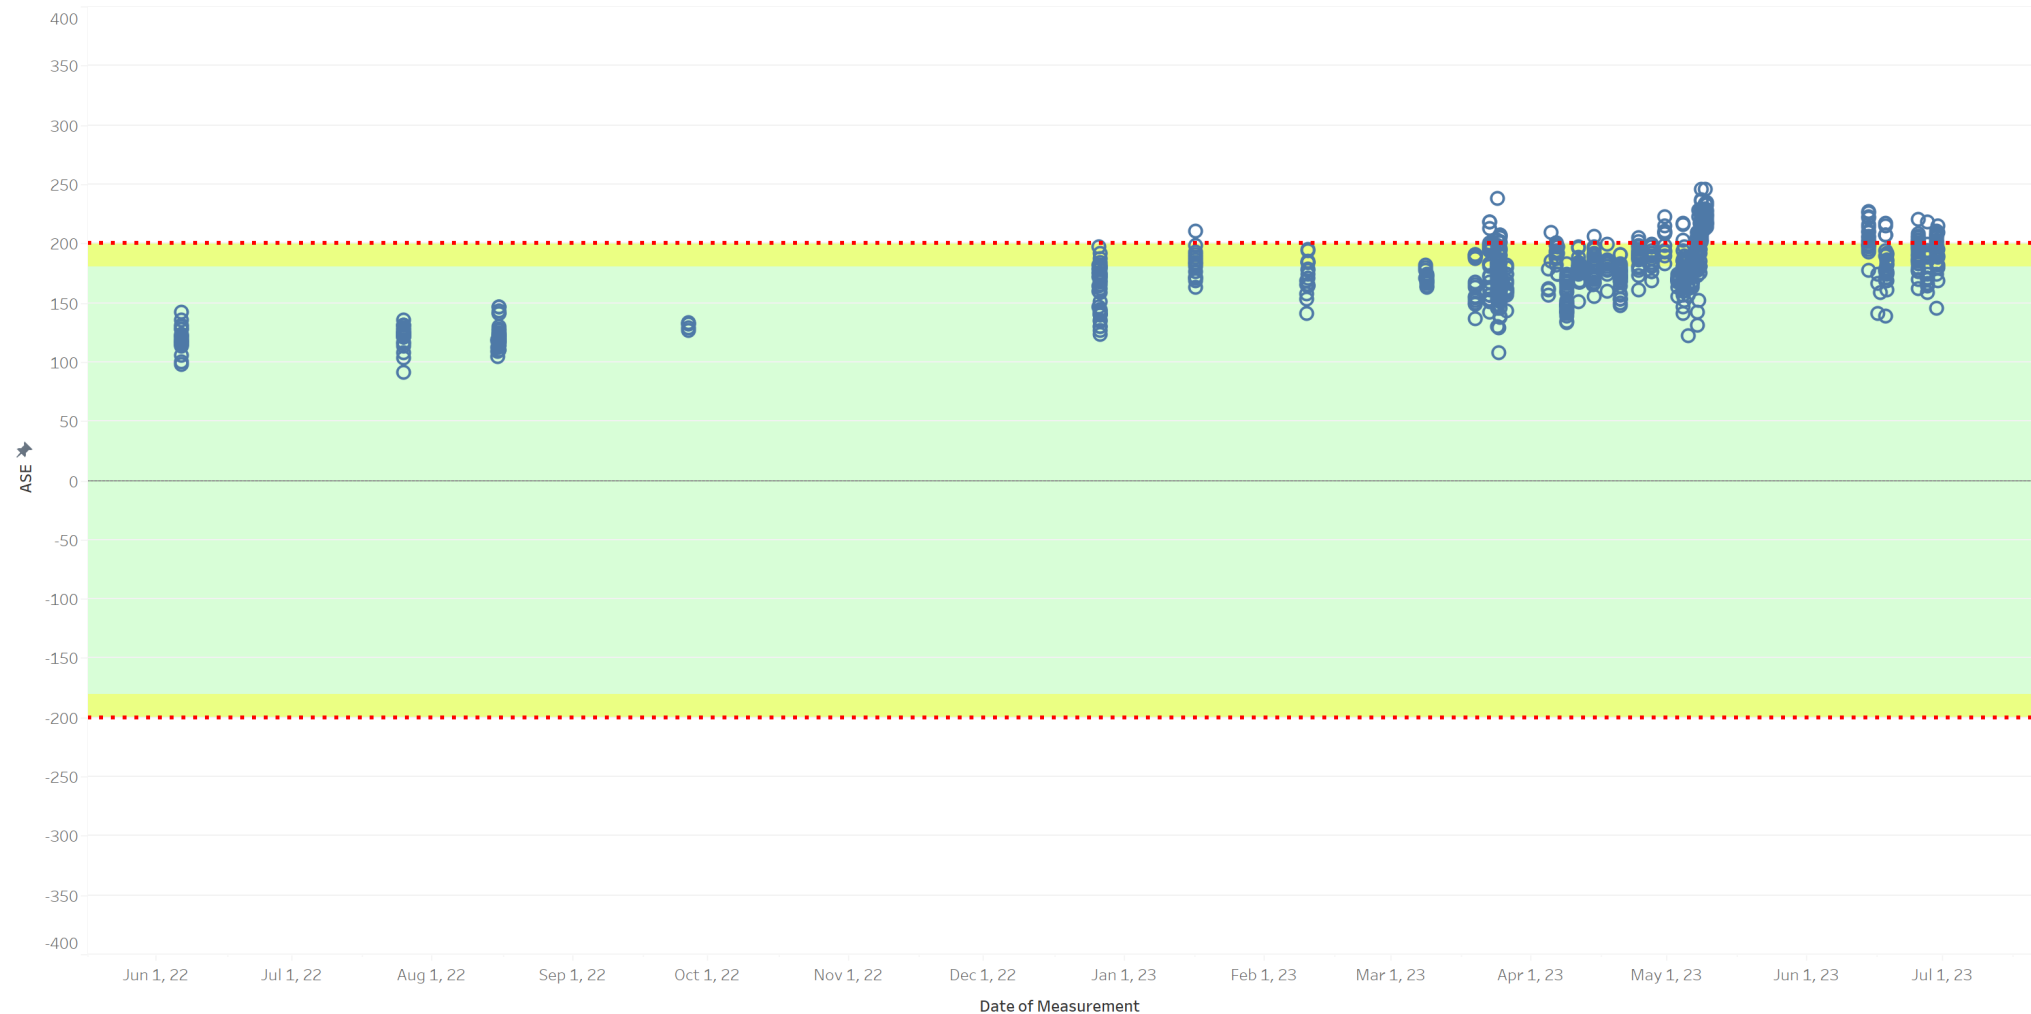
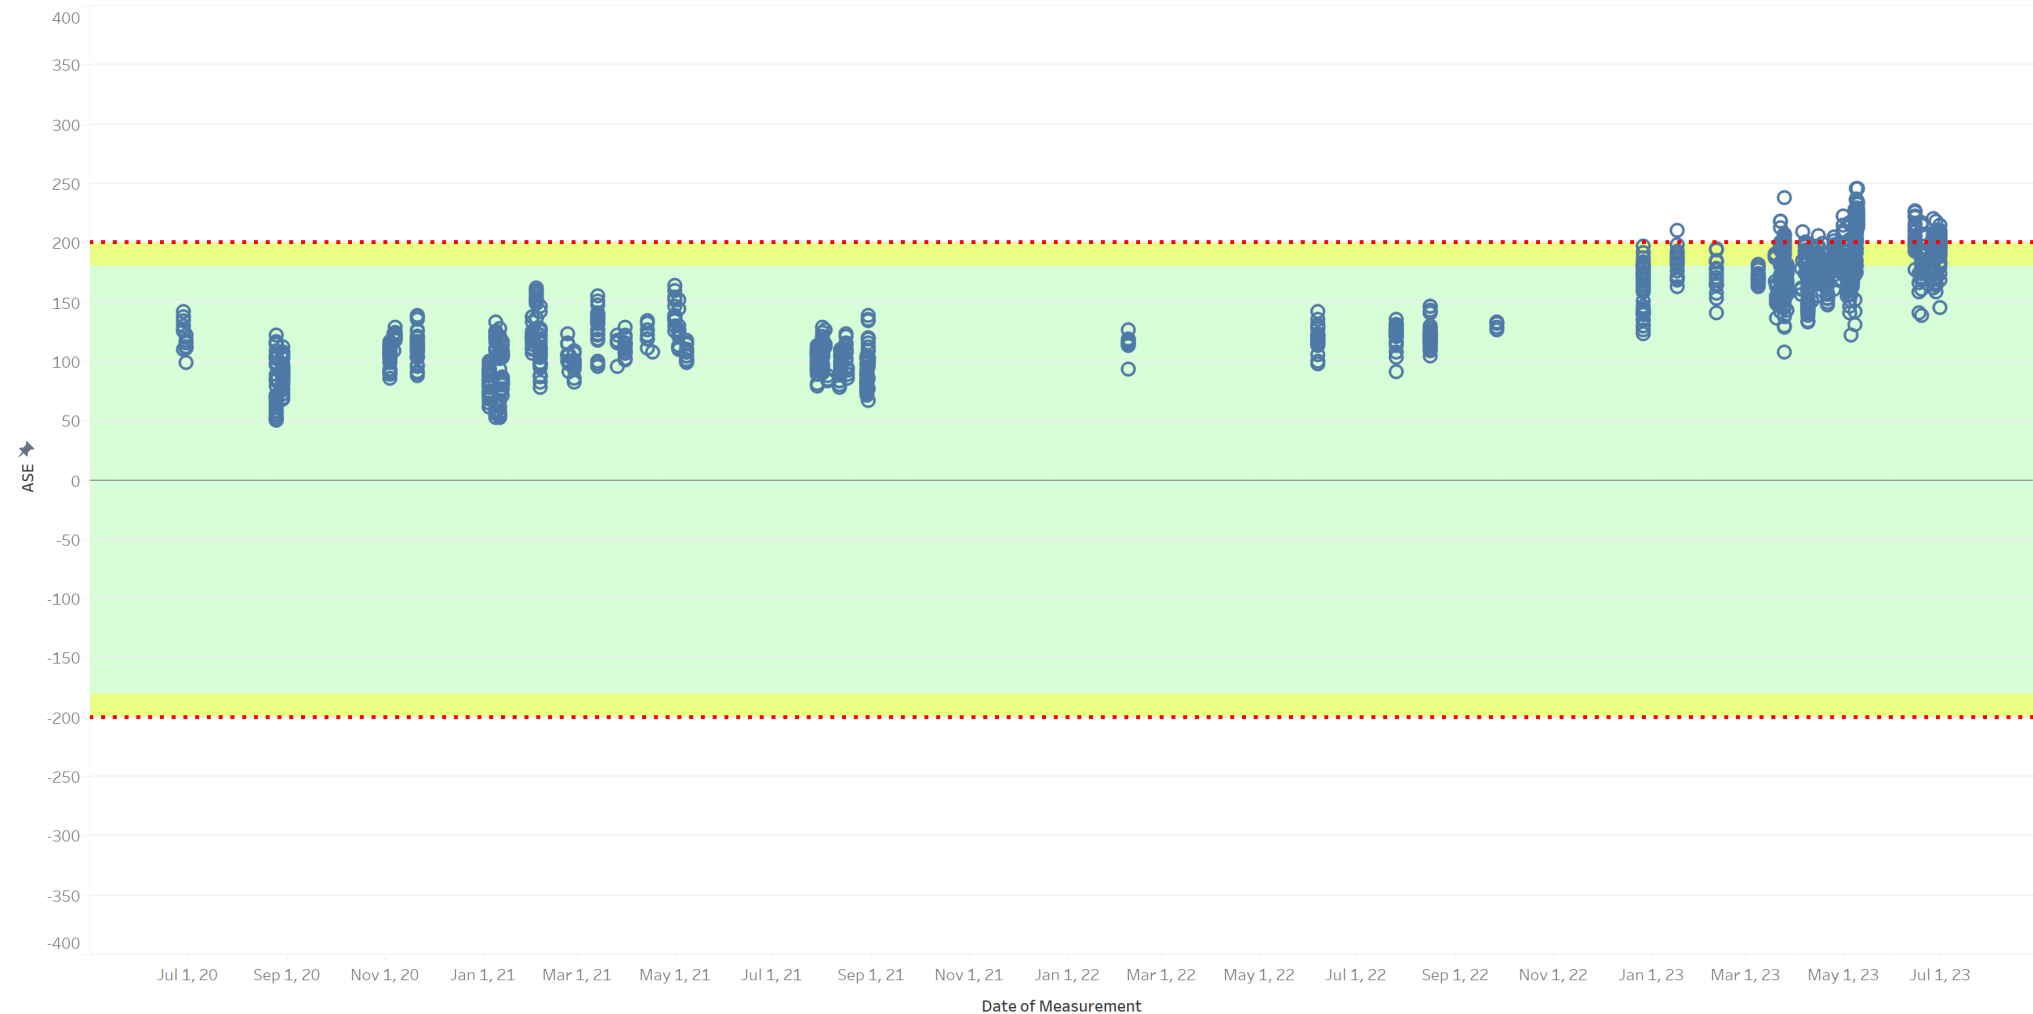
Case 3: Gradual Increase in ASE

- The 6-month Watch List review detected the large ASE.
- Reviewing more data from 1 year and 3 years shows the gradual increase in ASE.
 - No increase had been shown with only 6 months of data.
- Observing the longer 1-year and 3-year periods confirmed the large ASE, and verified the practice of using 6 months of data for the Watch List.
 - More data reinforced the recent poor performance by showing that earlier performance was good.
 - If a longer period were used for the Watch List, averaging might have resulted in this case going undetected.
