Section 9 Approval and ASE Examples

September 2023

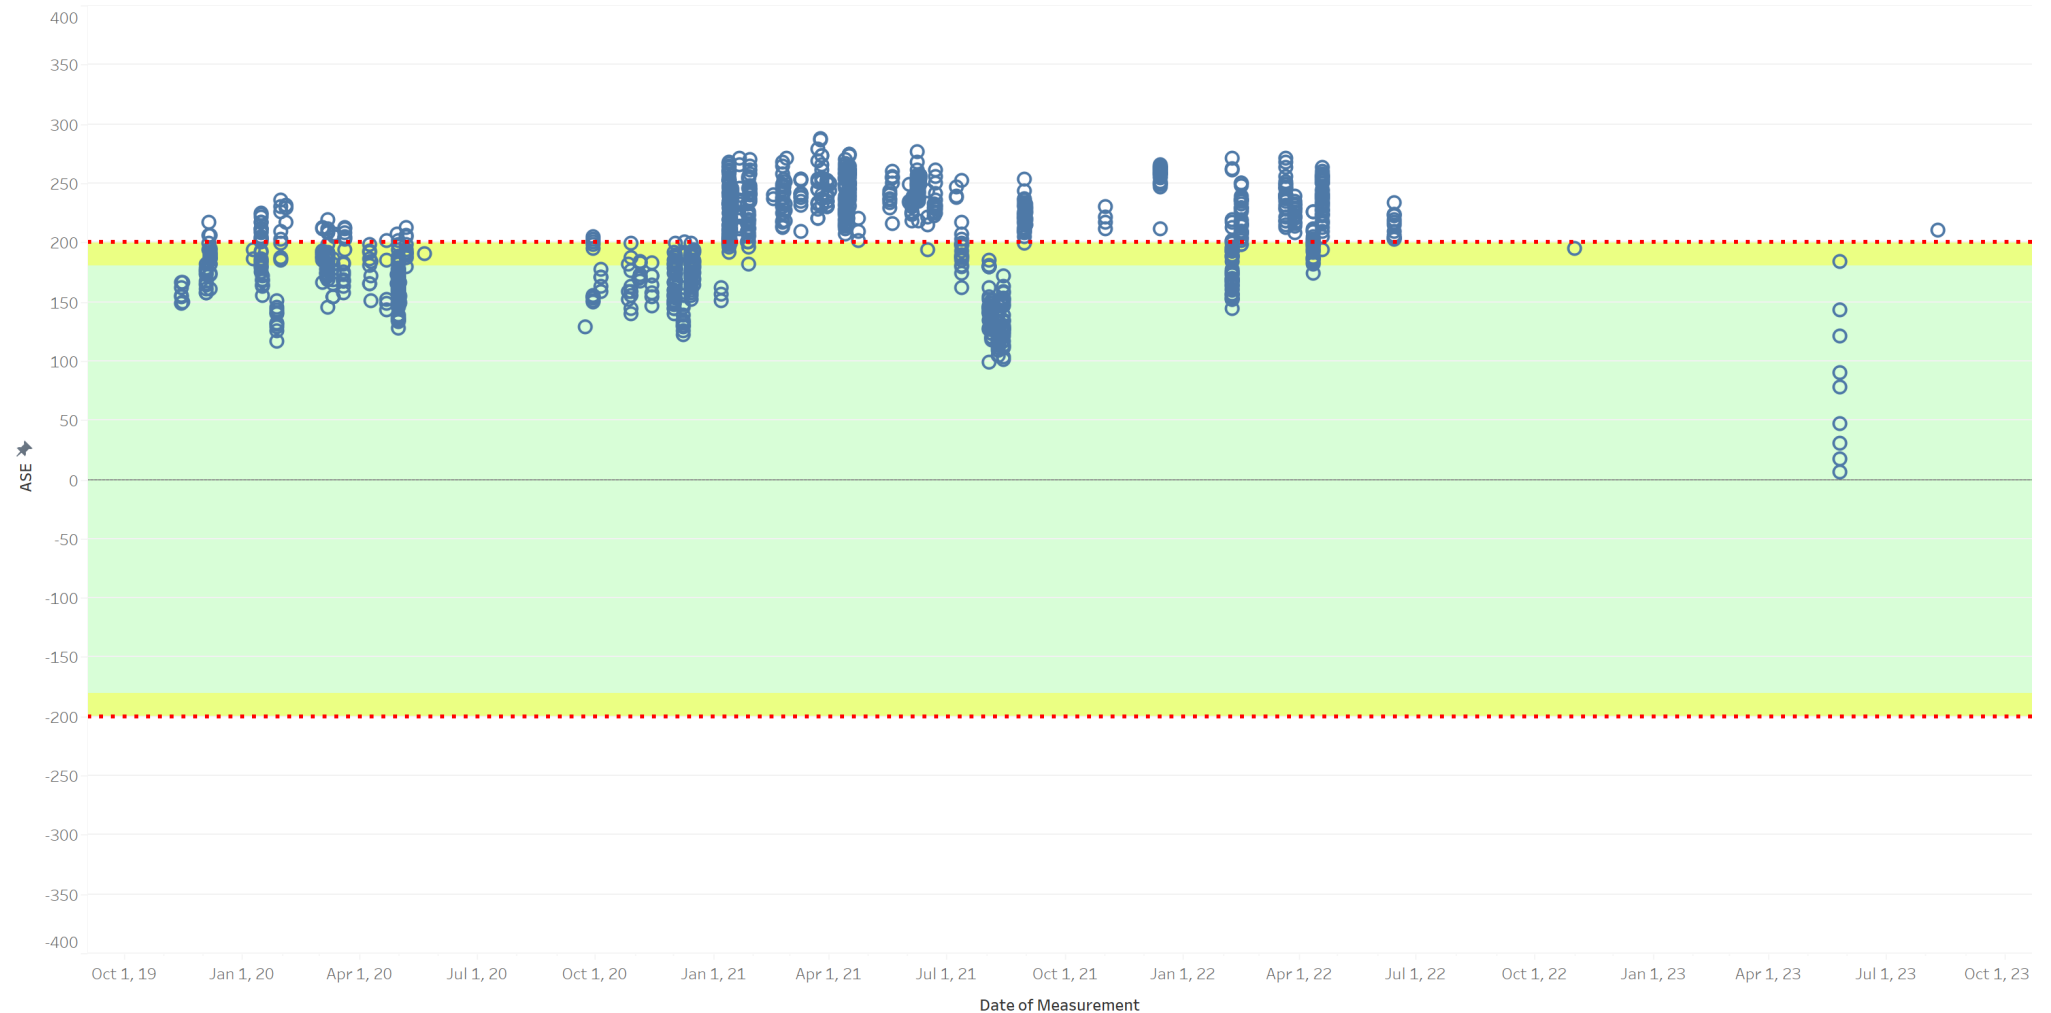
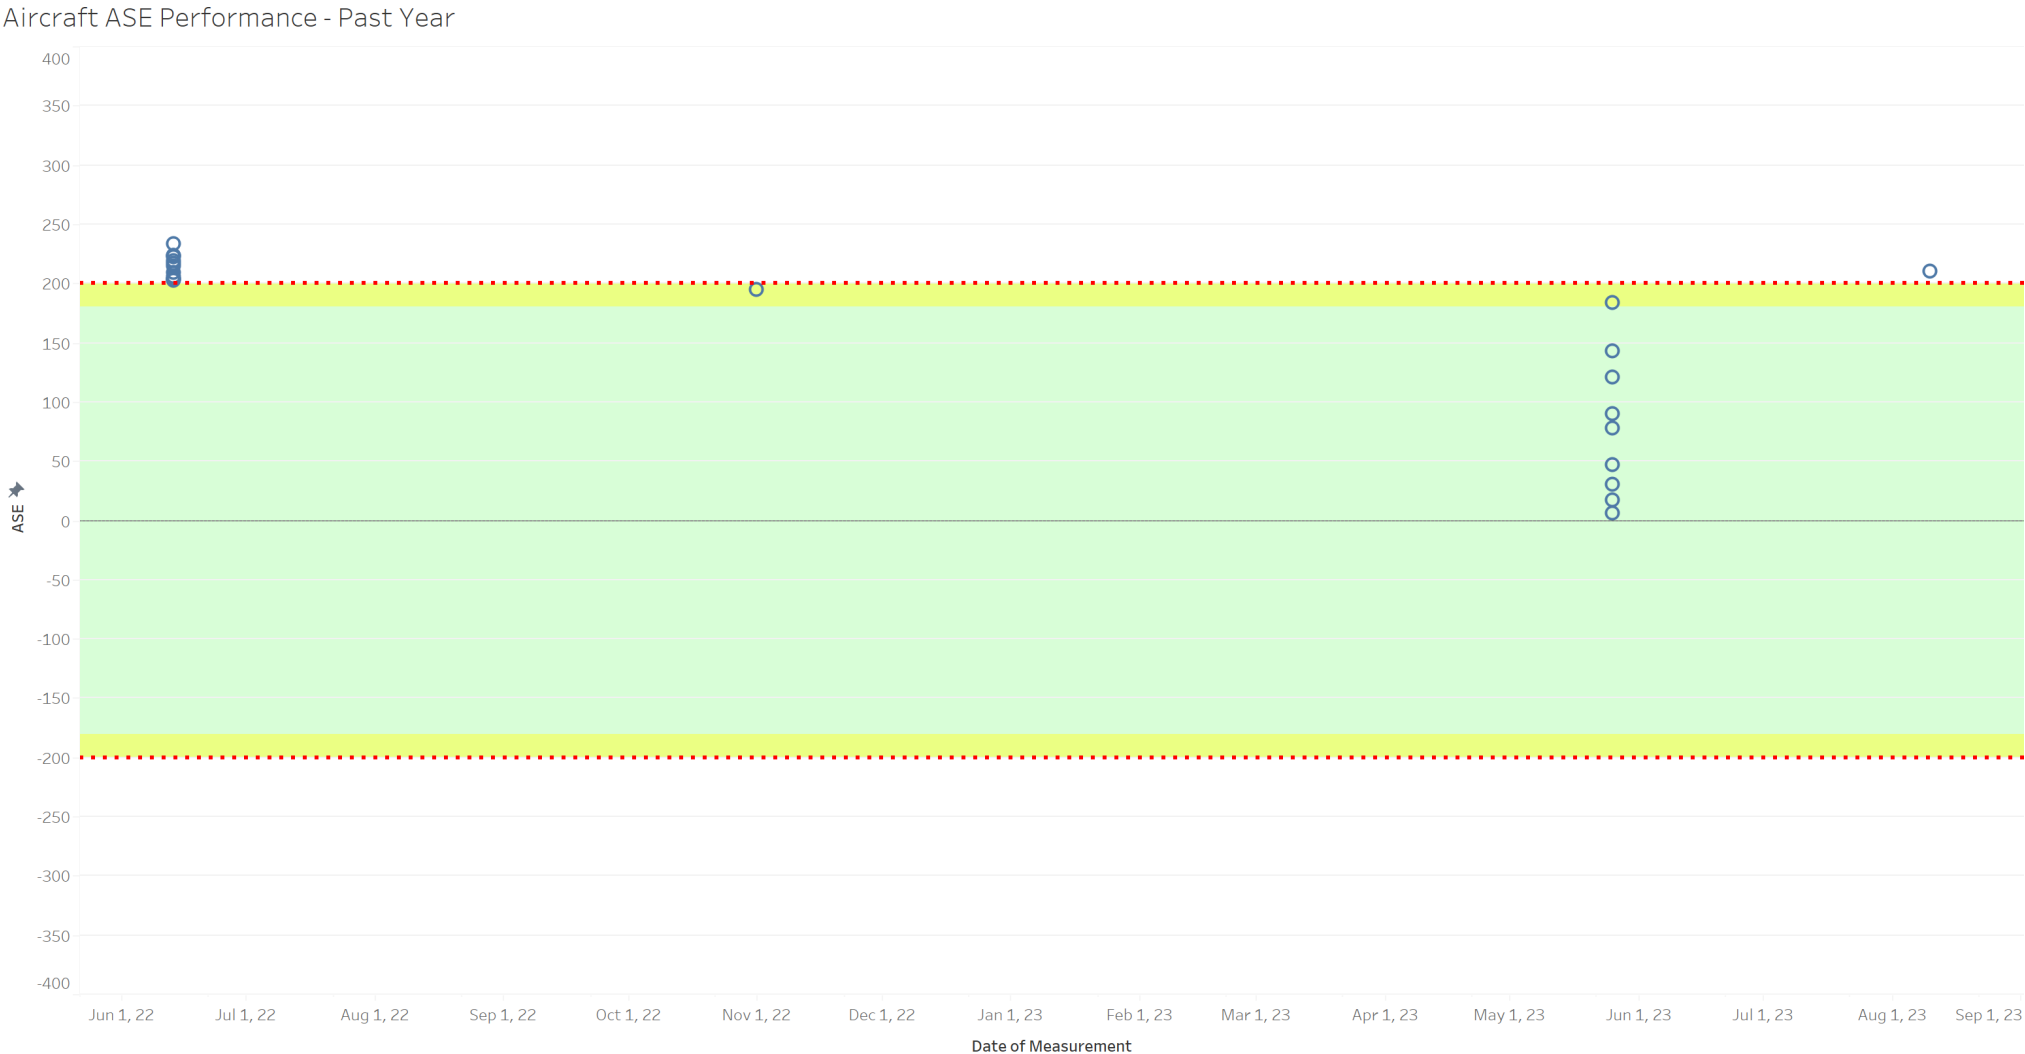
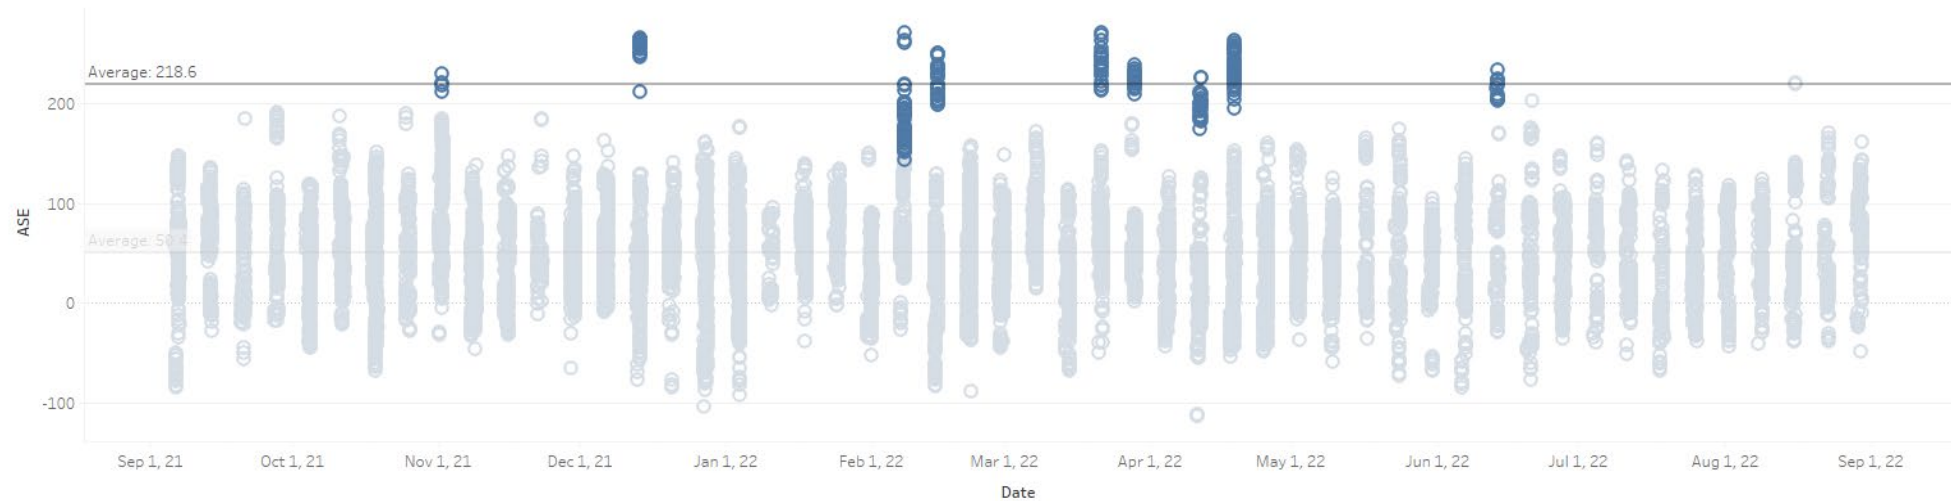
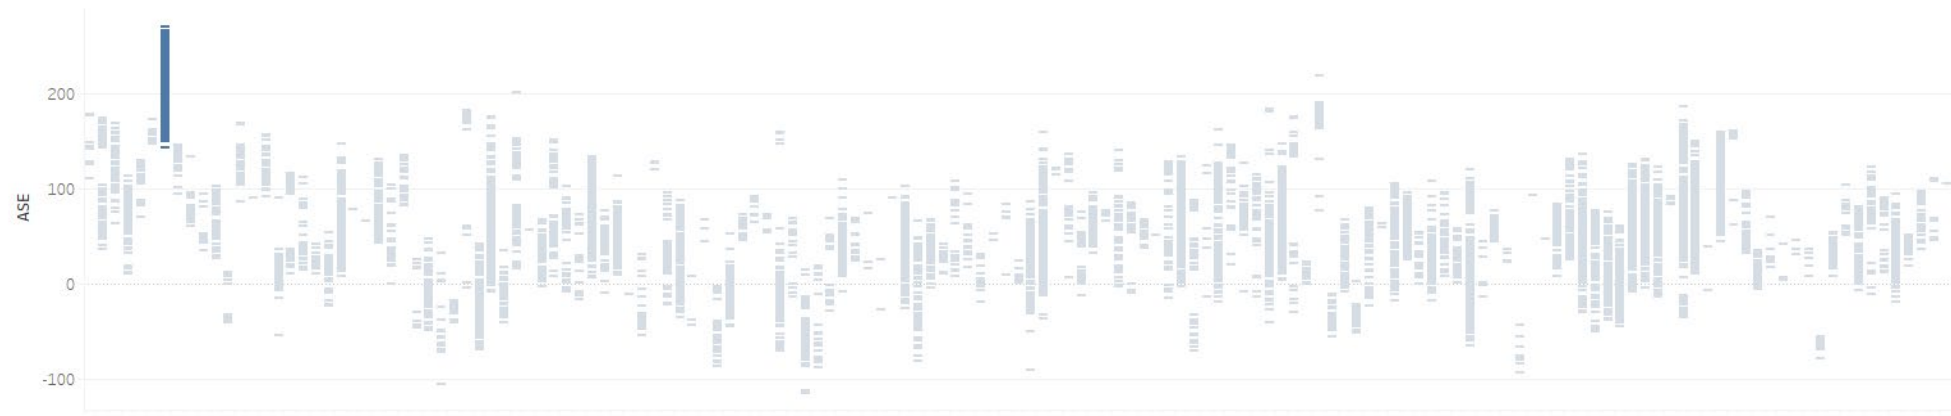
Case 4: Delayed Detection of Poor ASE

- 2019 data shows moderate performance.
- 2020 measurements show an apparent improvement, however it was likely only measurements from one altimeter were being detected.
- For an unknown reason, NAARMO started seeing more data from the other altimeter in early 2021.
- Around August 2021, NAARMO detected the large ASE, but it appeared to have improved.
- After that brief period, more poor performance was detected and the operator was notified of the large ASE.
 - the operator reported that they had been perceiving a split in the cockpit for a long time.
- Maintenance was completed and the operator reported that the split in the cockpit was reduced, but it appears the good altimeter actually got worse.
- Large ASE was detected in June 2022 and data in 2023 continues to be poor as the operator works on the aircraft.

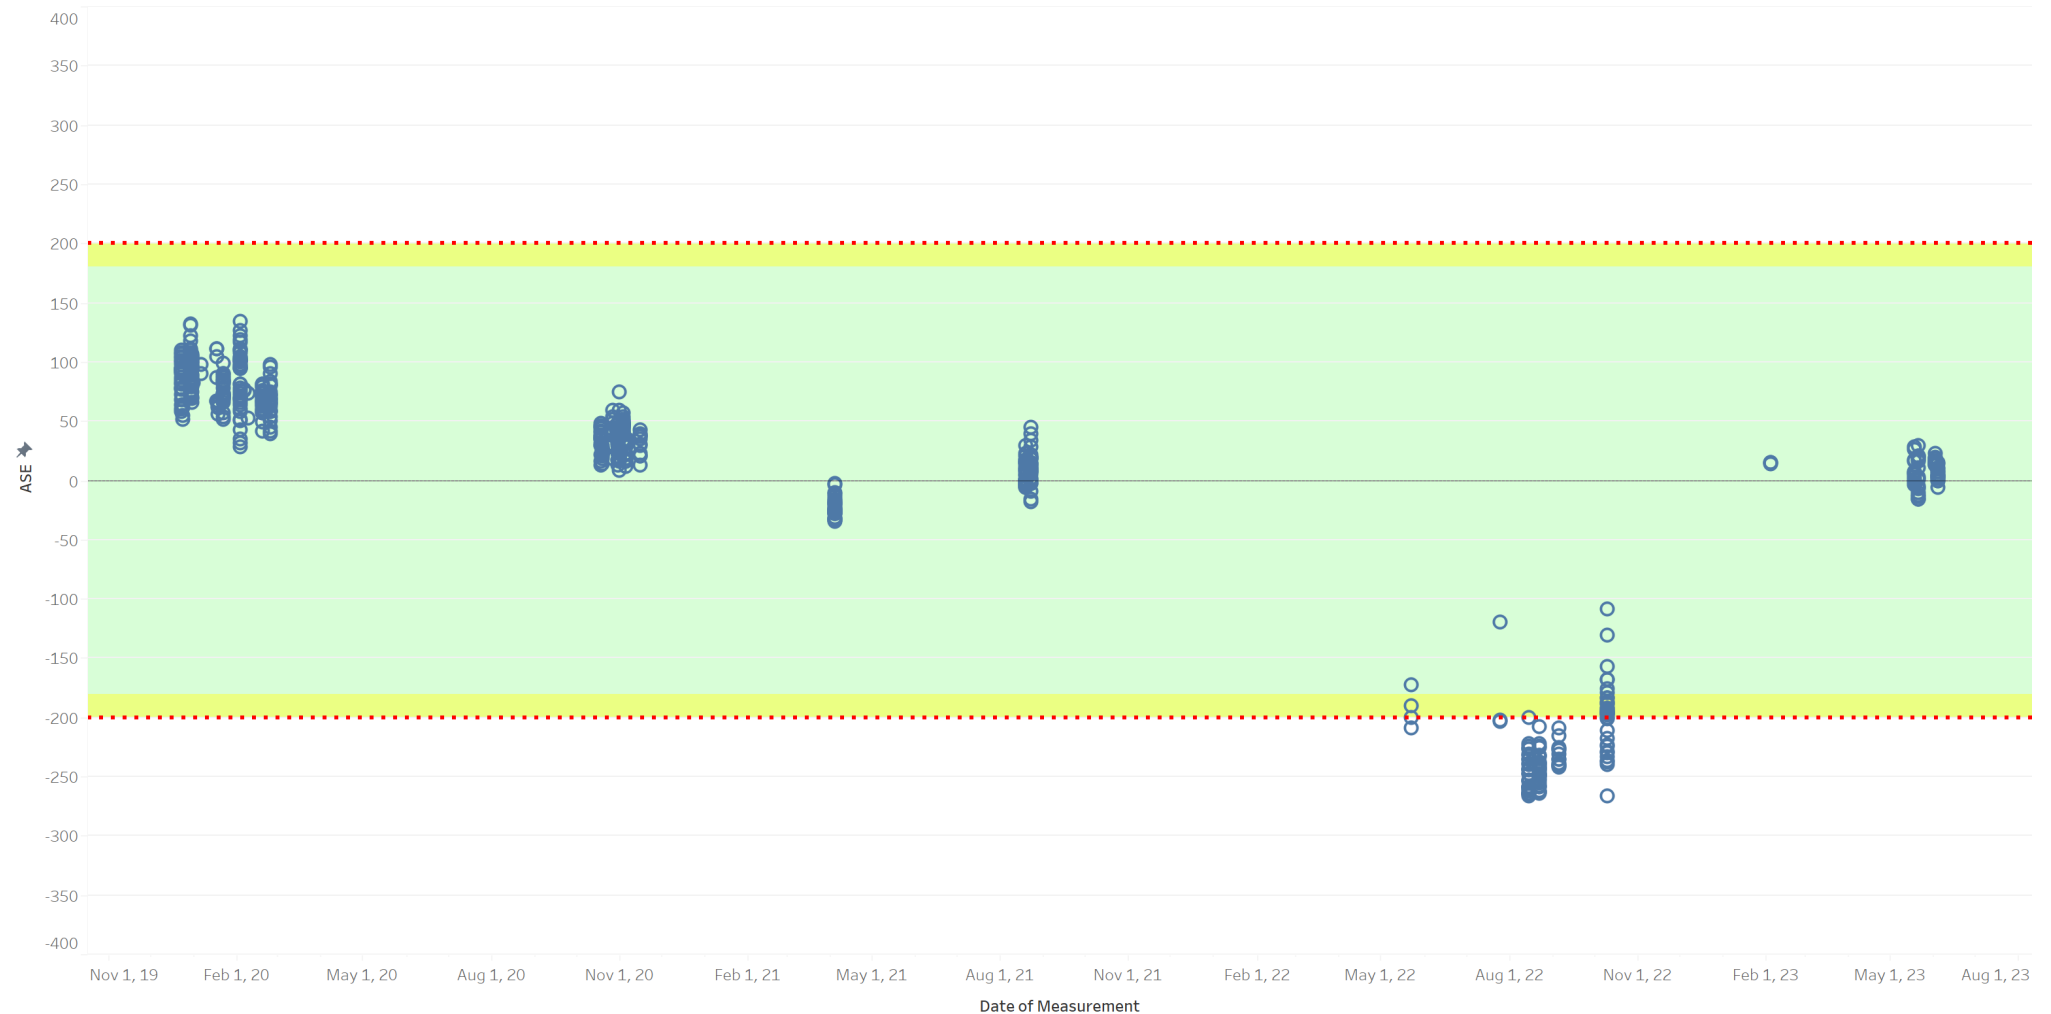
Case 5: Aircraft Repaired – ASE Performance Restored

- After large ASE was detected, operator was notified.
 - In early 2022, an issue during maintenance caused the large ASE.
- In late 2022, maintenance was performed that put the aircraft back into the correct configuration.
 - The installation of Garmin avionics for use in RVSM requires aircraft specific software including the loading of RVSM enablement cards. The operator reported that one of the corrective actions for this aircraft was reloading of the RVSM enablement feature per the supplement type certificate (STC).
- While this aircraft did fly in RVSM, most flights did not align with the previous monitoring policy to monitor once a week, so there were no flights monitored for some time before NAARMO could confirm that the aircraft was repaired.
- In early 2023, all measurements indicated that the aircraft performance had been restored, with an ASE near 0 feet.
