U.S. Department
of Transportation
**Federal Aviation
Administration**

Re: Interpretation Concerning Use of a Minimum Equipment List (MEL) For Components Not Specifically Listed in the MEL and Whether a Missing Item Can Be Deferred in Accordance with the Non-essential Equipment and Furnishings (NEF) Process

EMB 190 – S/N ALL – ATA 26-21 – Engine Fire Shutoff & Extinguishing Handle - Missing O-ring

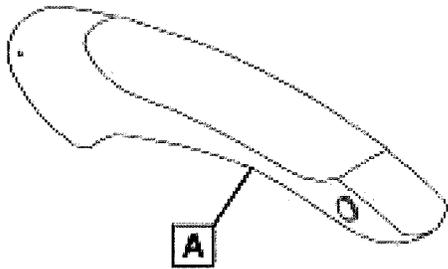
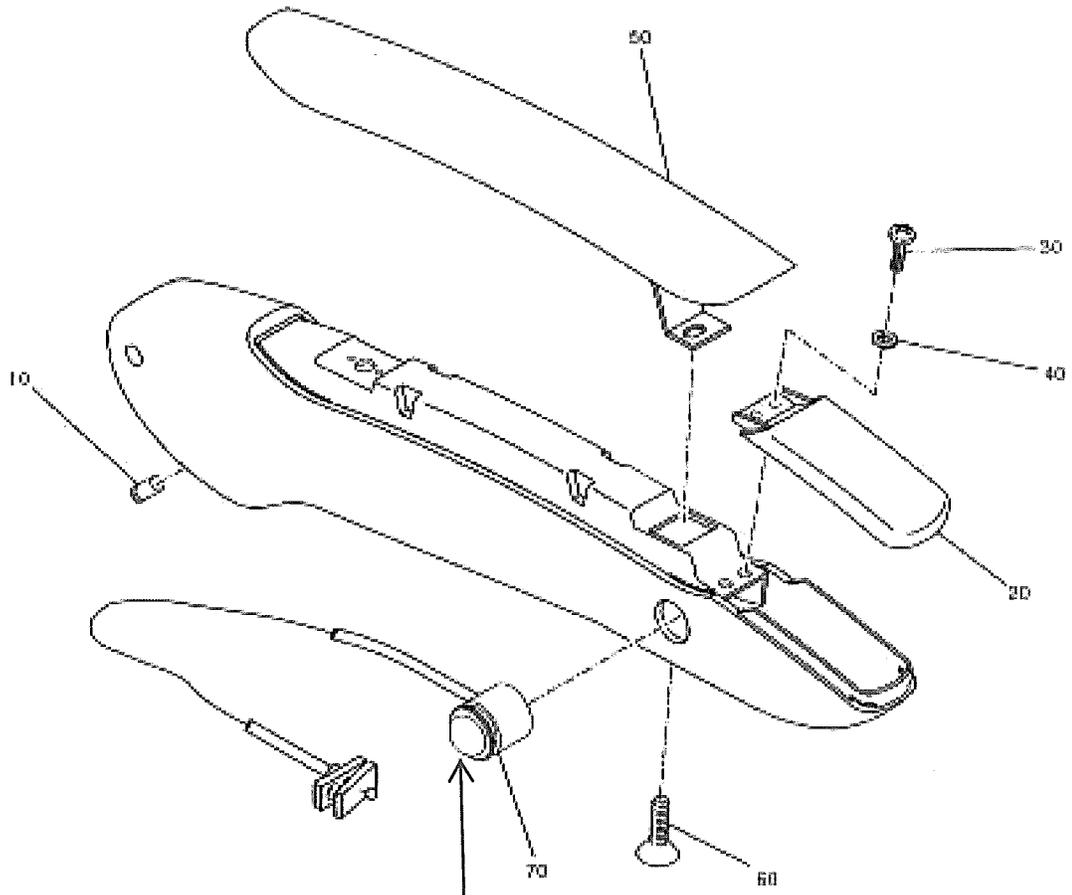
Attachment 1
Seat Recline

- Scenario 1; E-170 Passenger seat recline mechanism button is found missing, which leads to a malfunctioning seat recline. (See Attachment 1) Our MEL 25-21-10-2 states -

In this scenario the recline button is directly responsible for the function that is included in the MMEL. Passenger Seat Recline Buttons are installed to activate the recline actuator; with a missing button the seat recline function is

This button head
pops off.

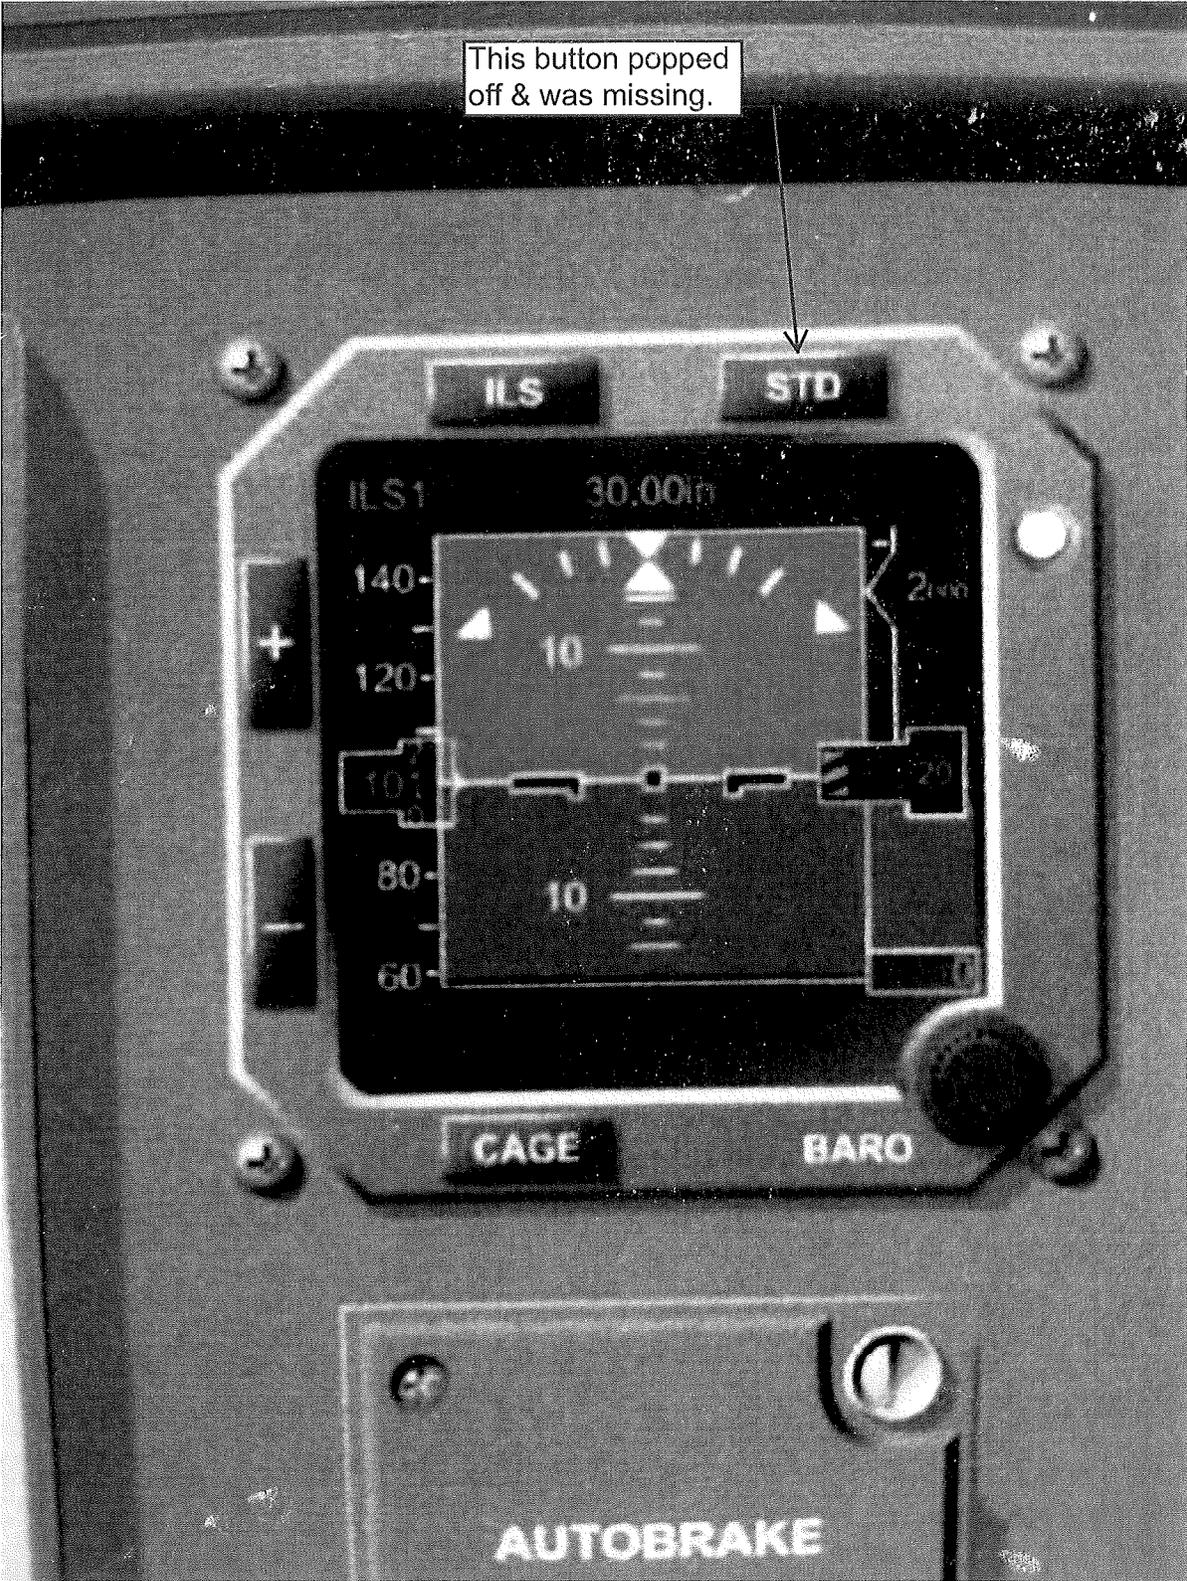
Attachment 2
I ESS Indicator

- Scenario 2; E-170 Integrated Electronic Standby System (IESS) Standby Attitude Indicator was found to be missing its STD button. (See Attachment 2) Our MEL 34-11-00-1, states -

In this scenario, with a missing the STD button, we feel that the entire instrument is rendered inoperative since the flight crew cannot switch to the Standard Barometric Pressure mode from the normal BARO-corrected altitude indication, therefore should be deferrable under MEL in accordance with 34-11-00-1.

This button popped off & was missing.
