**Twenty-First Meeting of the Cross Polar Trans East Air Traffic Management Providers'
Work Group (CPWG/21)**

B787 FANS Issues with Fast Responses - Embedded ACKs

(United Airlines)

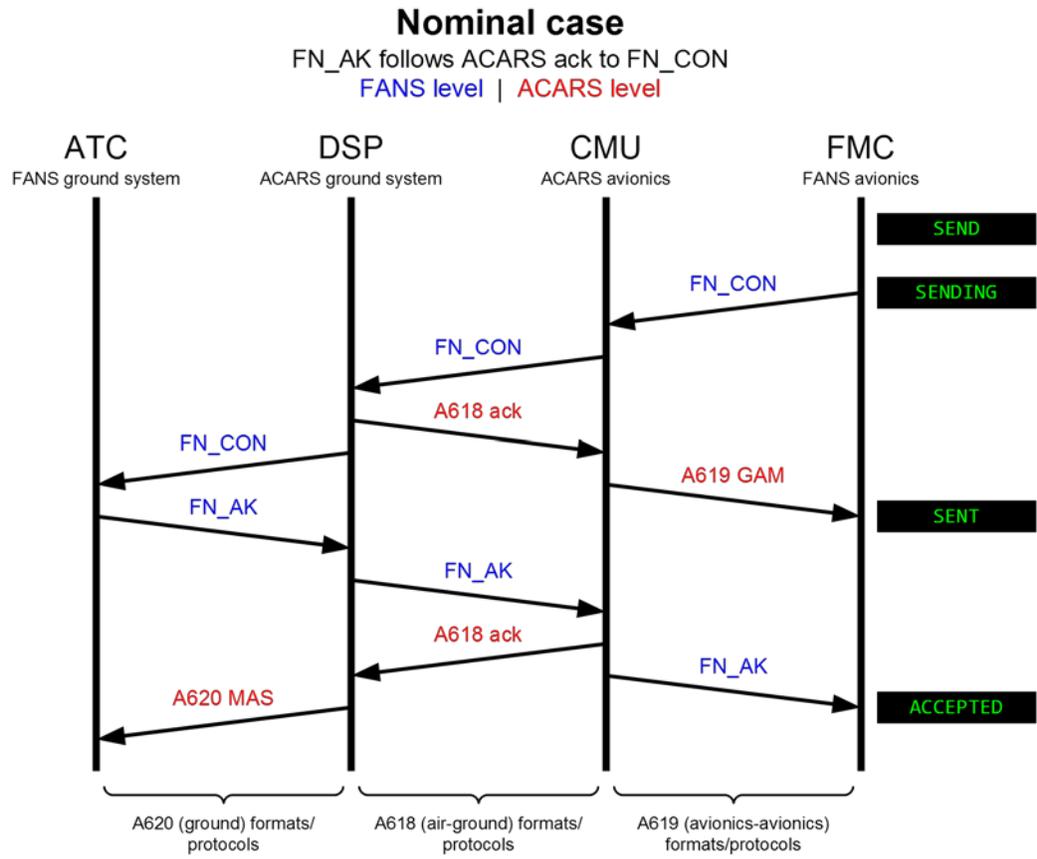
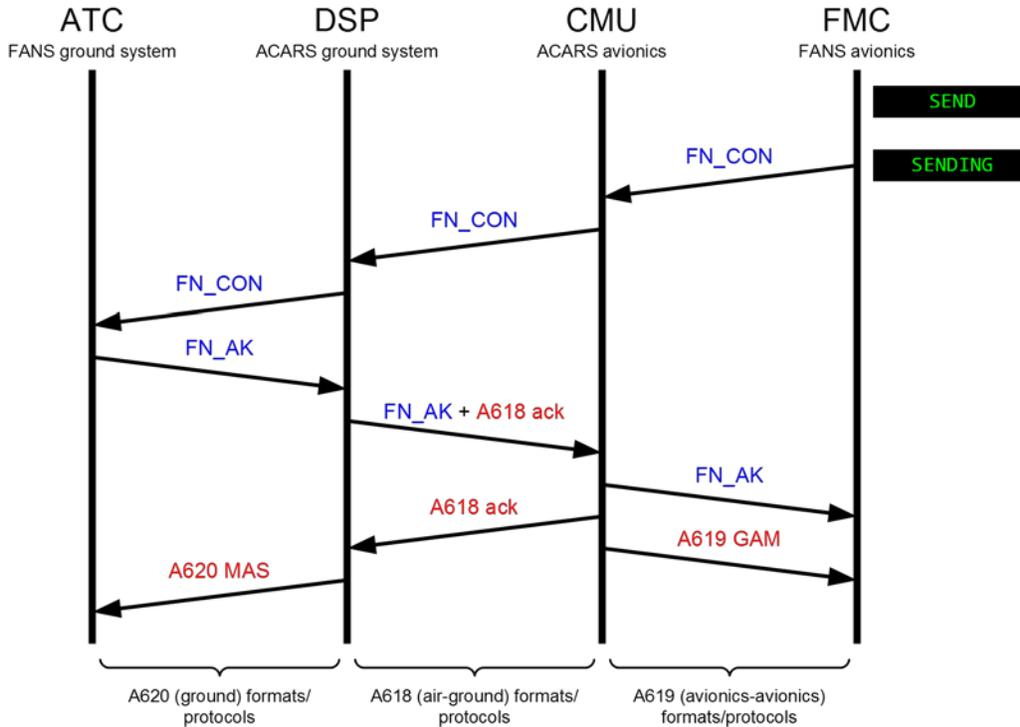
Off-nominal case

2.5. On Boeing 757 and 767 airplanes, it has been observed that when the AFN Acknowledgement (FN_AK) uplink message contains an embedded ACARS (technical) acknowledgement for the corresponding AFN Contact (FN_CON) downlink message, then the CPDLC connection may fail to establish. When this occurs, the avionics responds to the CPDLC connect request (CR1) uplink with a DR1 containing dm64 with a center ID consisting of all spaces. This has been noted on a number of occasions with the FAA Departure Clearance (DCL) program.

ACARS ack to FN_CON embedded in FN_AK
 FANS level | ACARS level
