AC NO: 20-78 DATE: 11 July 72

MAINTENANCE INSPECTION NOTES FOR MCDONNELL DOUGLAS DC-8 SERIES AIRCRAFT

DEPARTMENT OF TRANSPORTATION FEDERAL AVIATION ADMINISTRATION

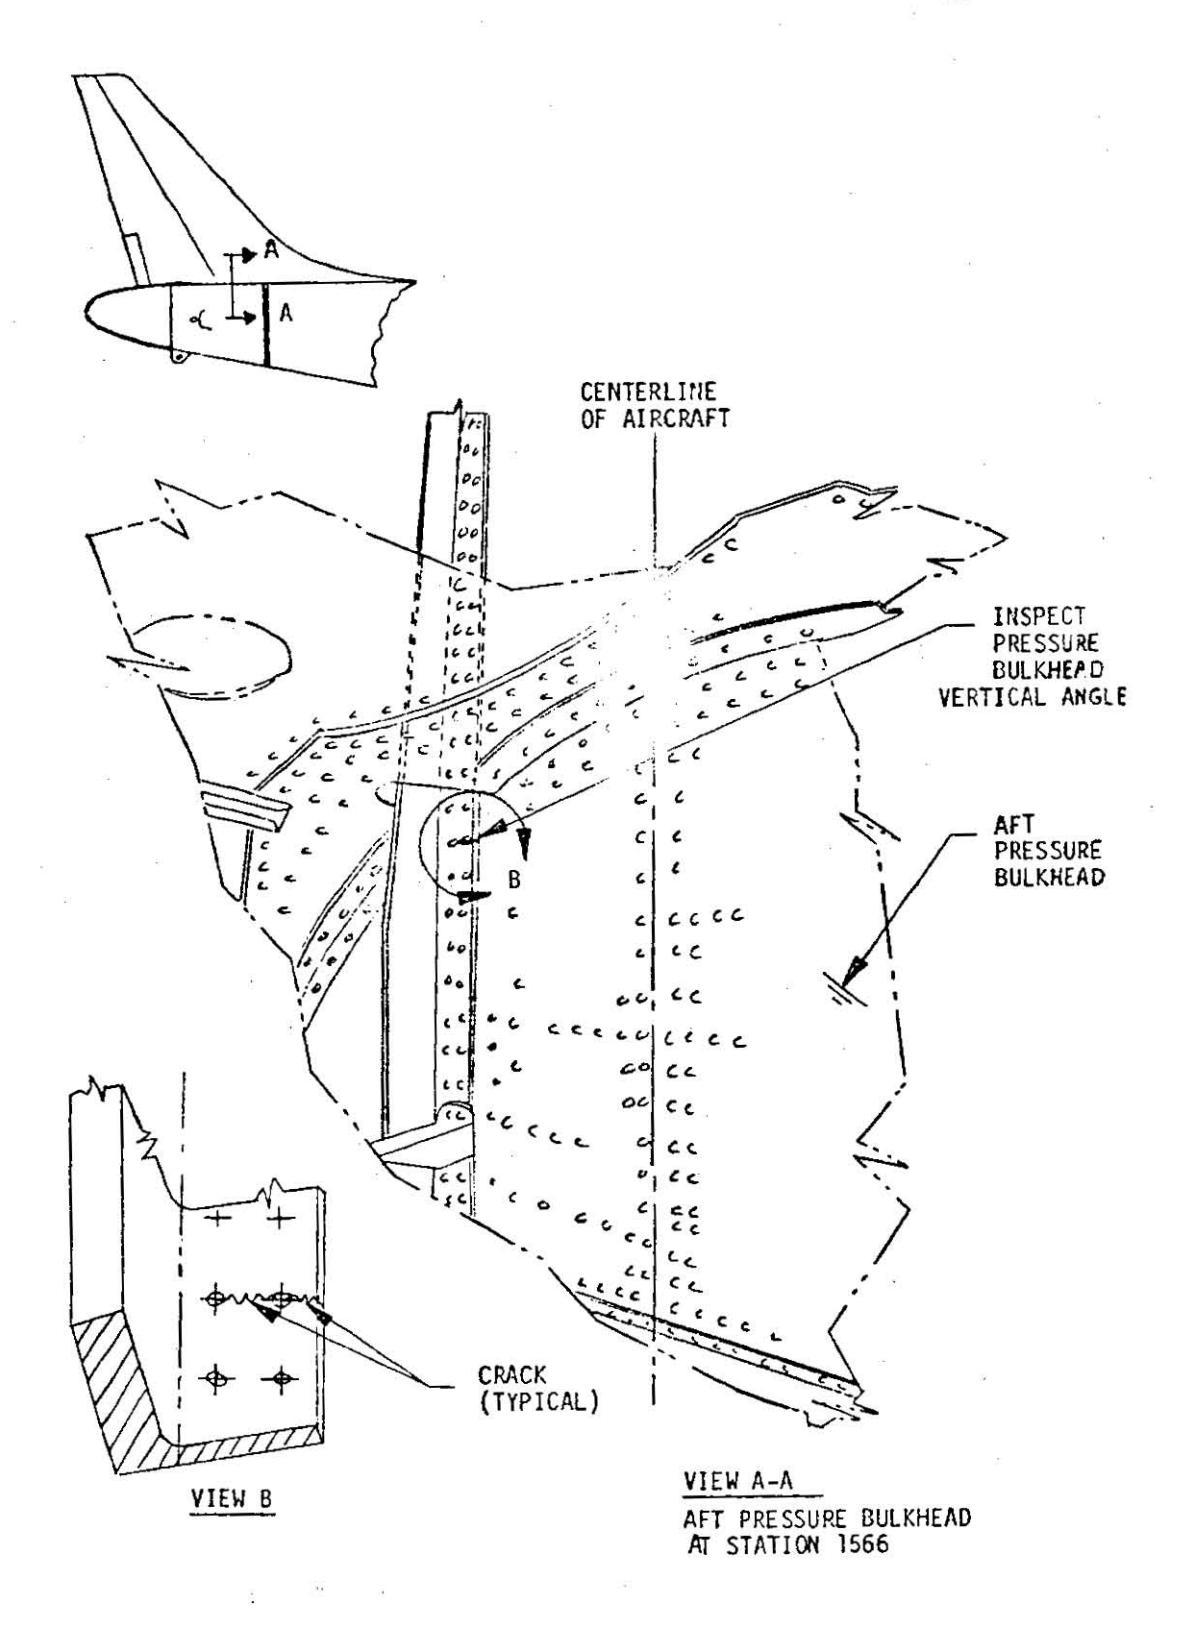
Fig. 8 Fuselage Aft Pressure Bulkhead

| a. | Tail cone structure has been found cracked. The cracks are a result of sonic vibration which is prevalent in the tail cone area during operation of the aircraft. | SB 53-17 10/5/60 SB 53-11 Rev 2 5/1/61 SB 53-13 Rev 2 3/24/61 SB 53-19 11/1/60 SB 53-25 Rev 1 2/27/62 |
|---|--|--|
| f. | Cracks in the domed aft pressure bulkhead have been reported. Cracks were a result of fatigue and occurred at approximately 15,000 flight hours. | SB 53-41 10/17/67 |

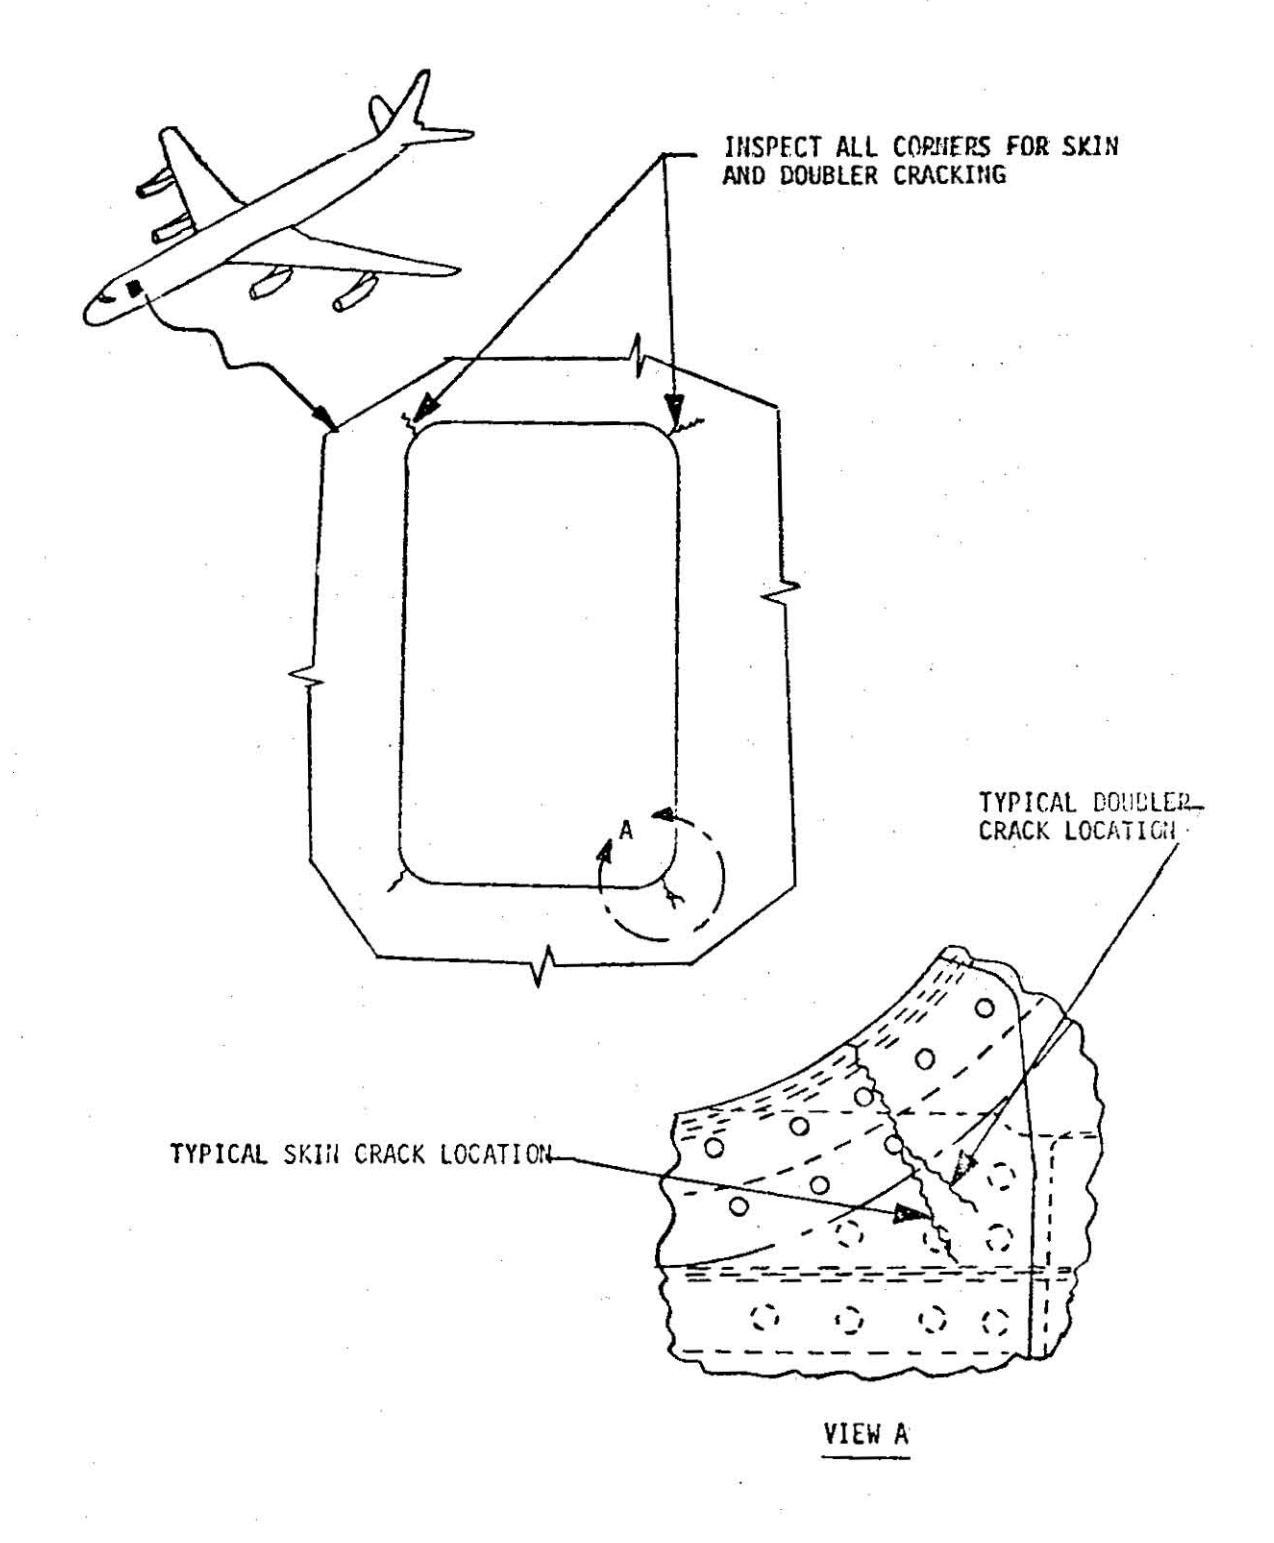
- (5) <u>Recommendations</u>. Periodically inspect to assure continued structural integrity.
 - c. Forward Passenger Door Area.
 - (1) Location. Forward fuselage, left hand side (See Figure 10, Appendix 3).

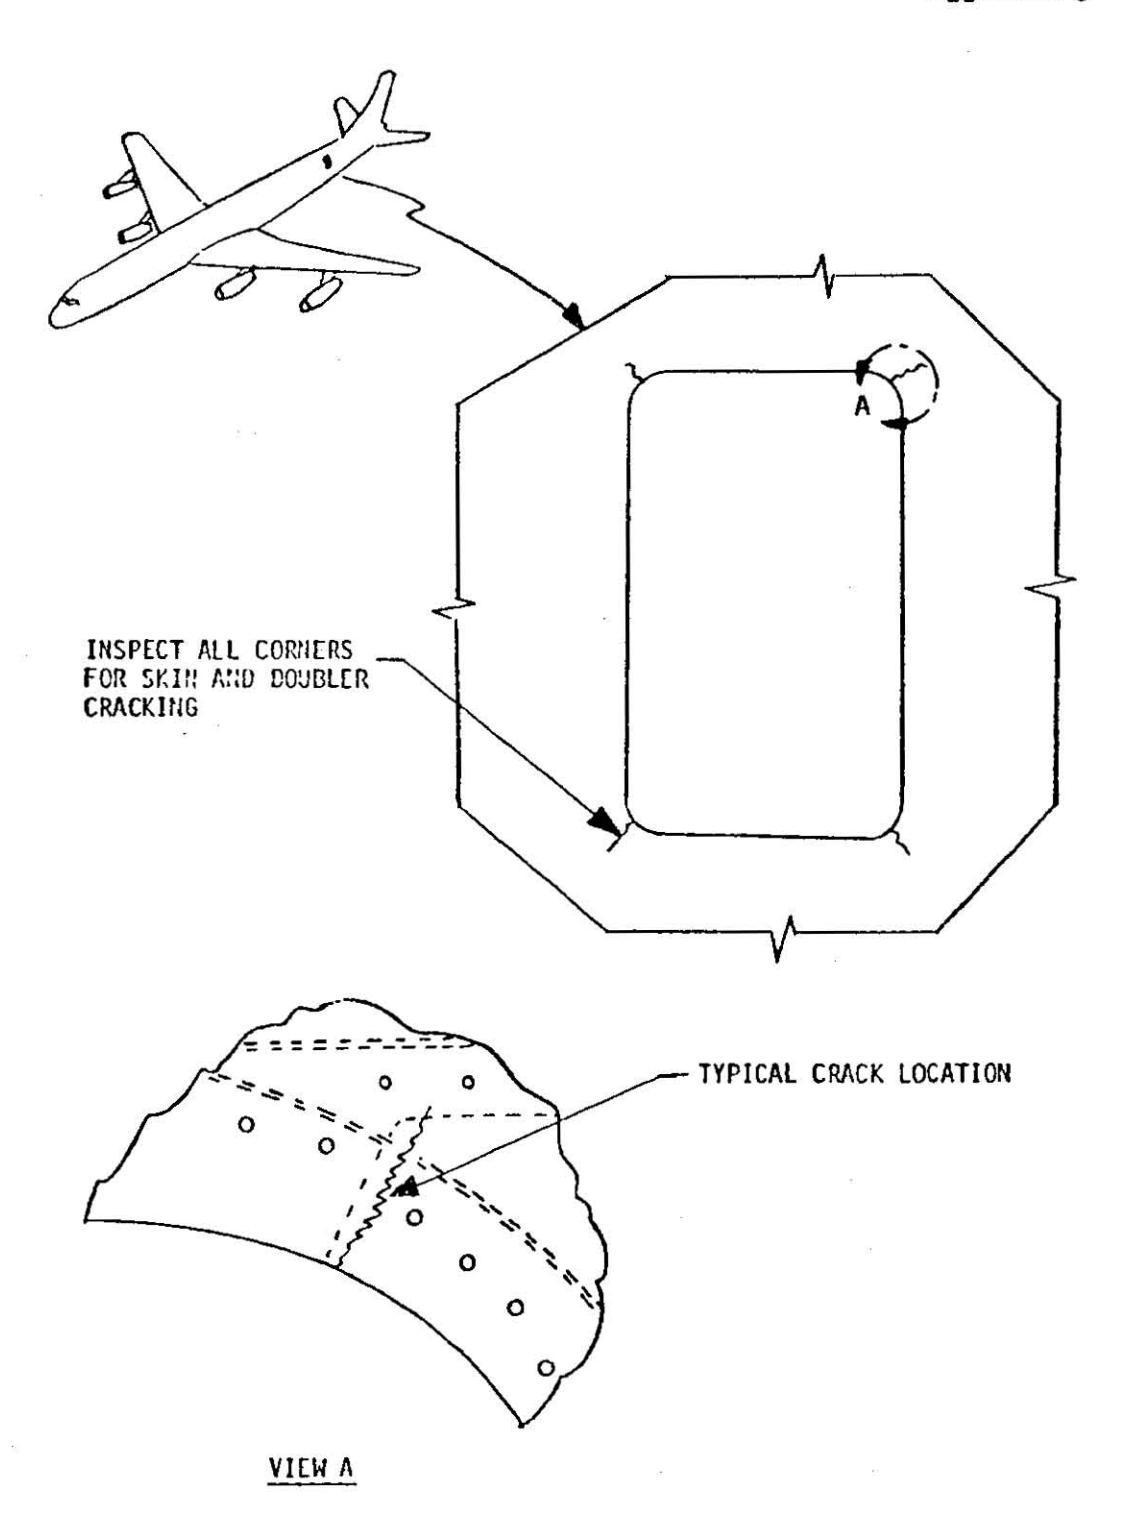
Fig. 11 Aft Passenger Door Area

- (4) Probable Consequences. Extensive fuselage cracks in this area may lead to more serious structural damage.
- (5) <u>Recommendations</u>. Periodically inspect to assure continued structural integrity.
