# NATIONAL TRANSPORTATION SAFETY BOARD

WASHINGTON, D.C. 20594

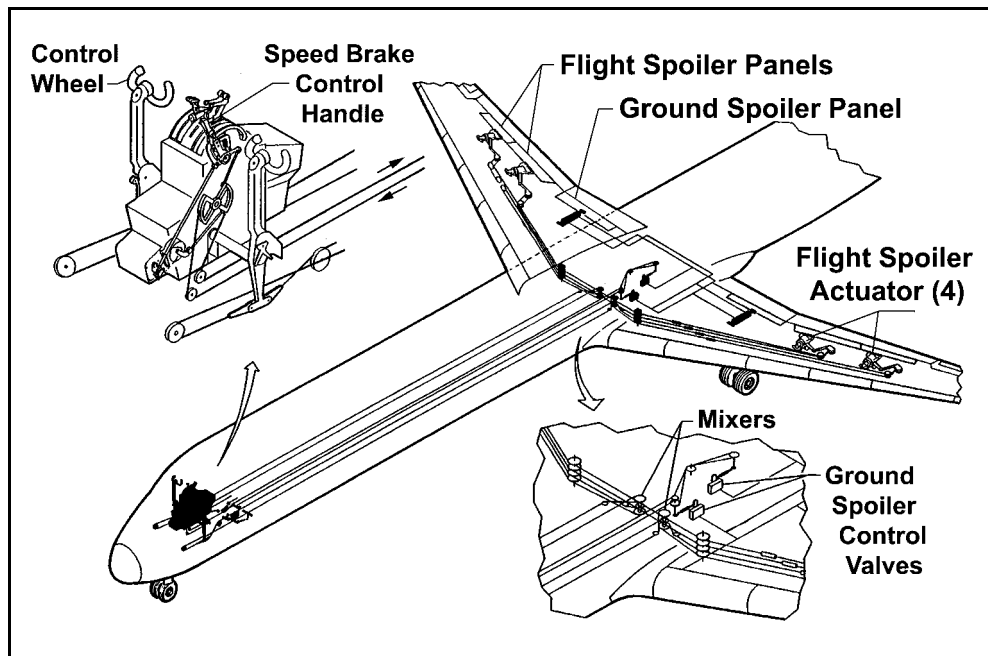
Figure 2. Spoiler Control System

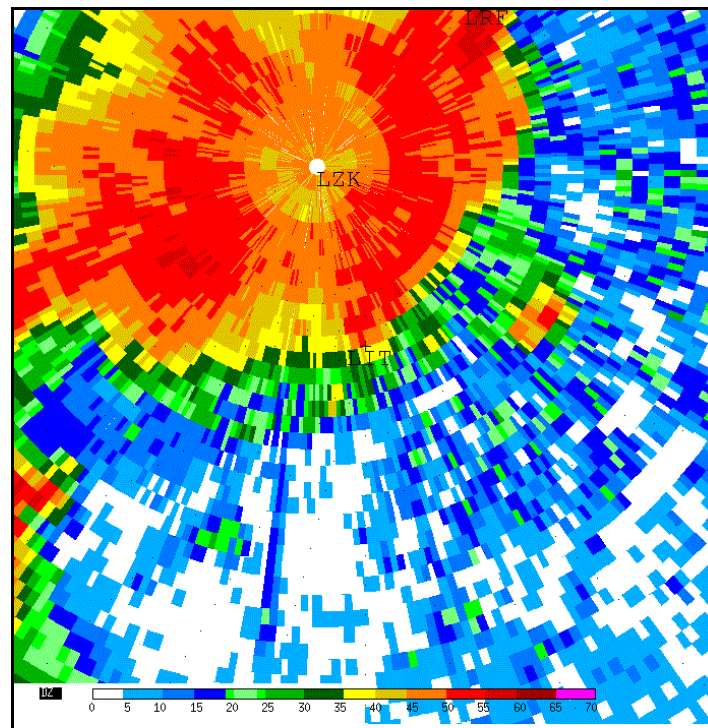
Figure 7. 0.4° Base Reflectivity Scan at 2334:27

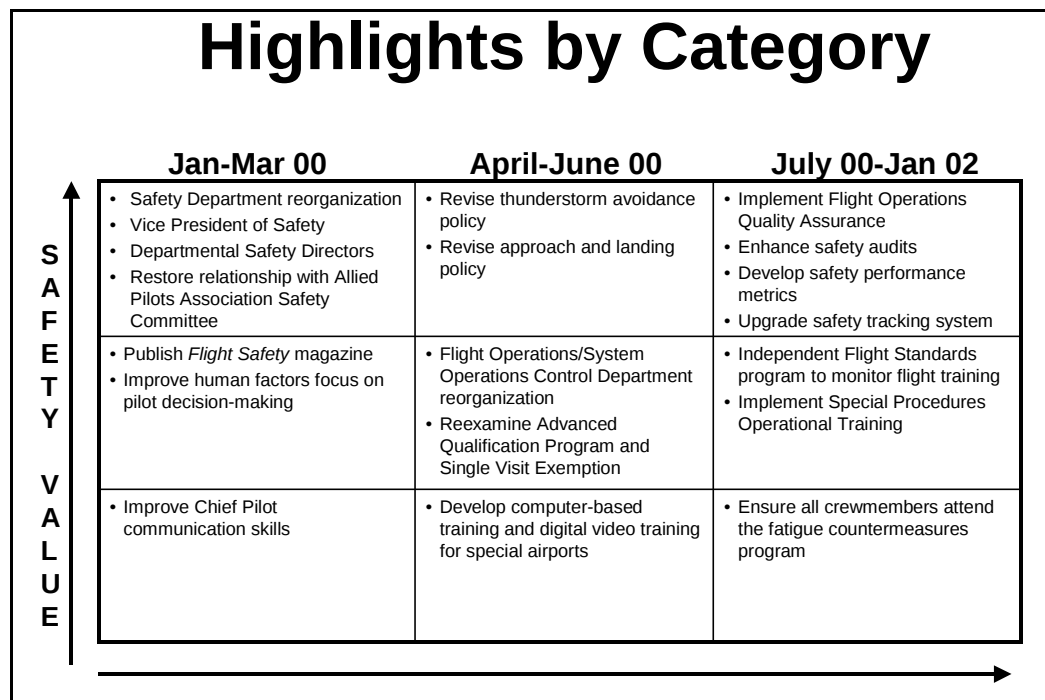
**Figure 17.** Categories of the Postaccident Audit Recommendations According to Expected Completion Date and Safety Value

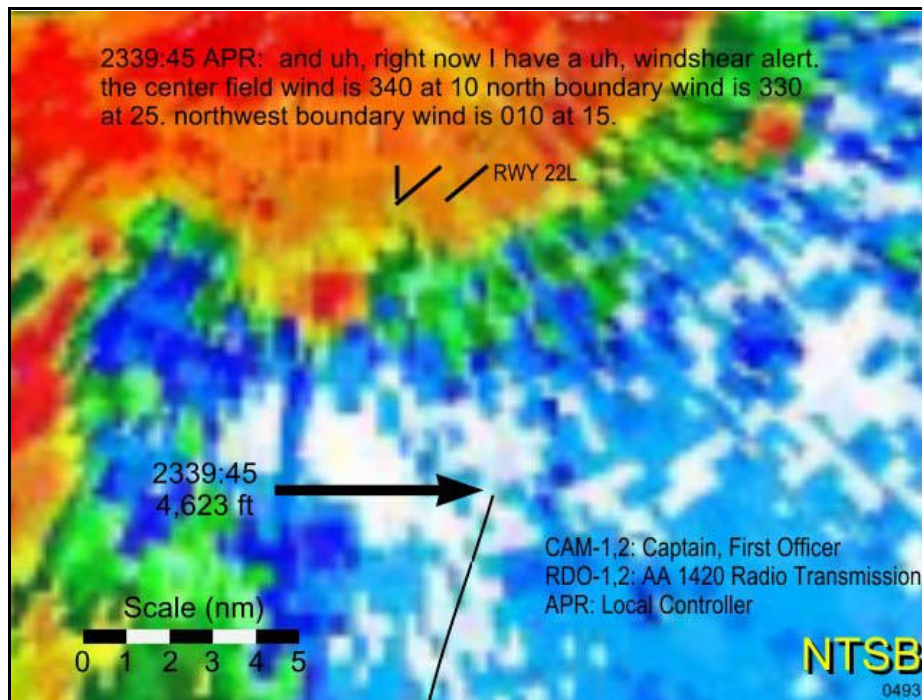
**Figure 19.** Weather and Flight Information for 2339:45

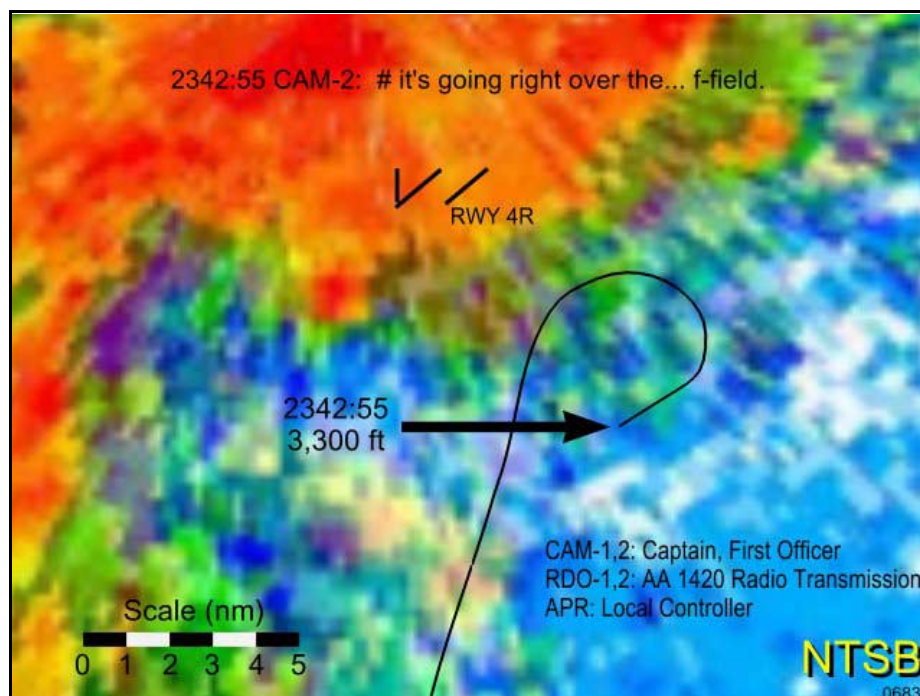
**Figure 20.** Weather and Flight Information for 2342:55

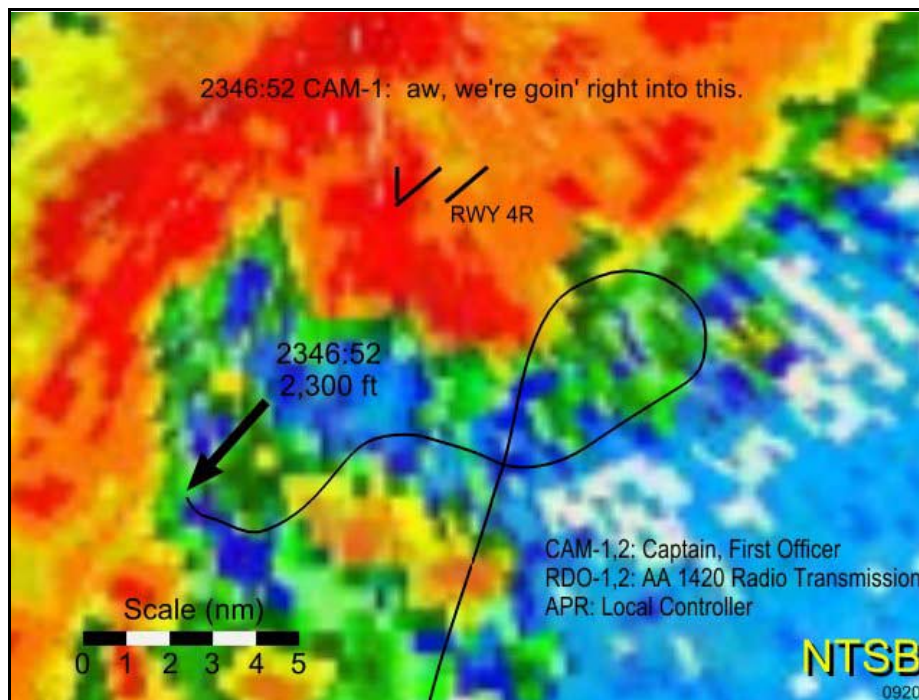
**Figure 23.** Weather and Flight Information for 2346:52

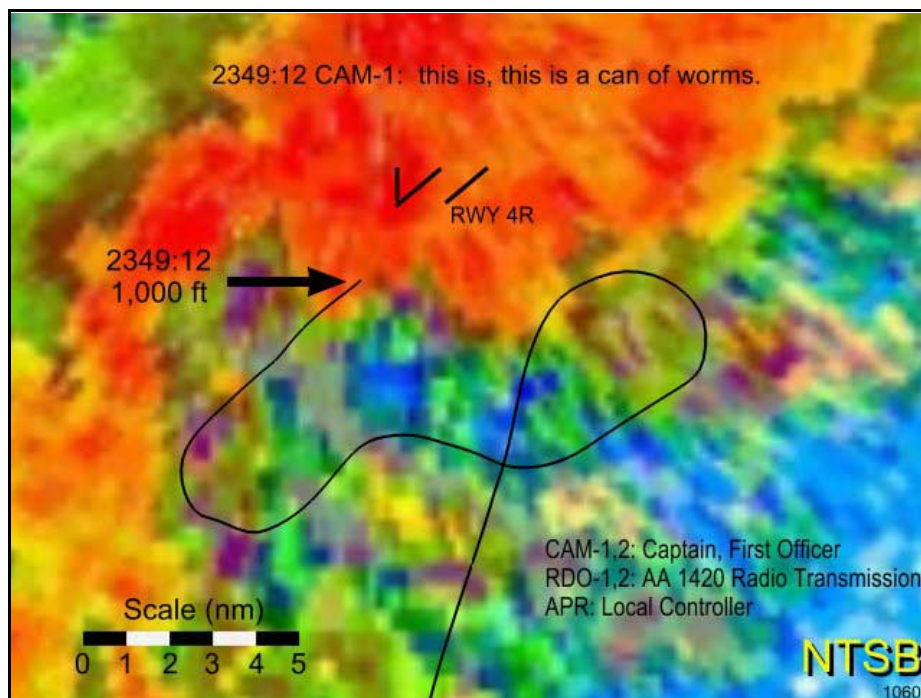
**Figure 25.** Weather and Flight Information for 2349:12
