Air Accidents Investigation Branch

Report on the accident to Aerospatiale (Eurocopter) AS332 L2 Super Puma, registration G-REDL 11 nm NE of Peterhead, Scotland on 1 April 2009

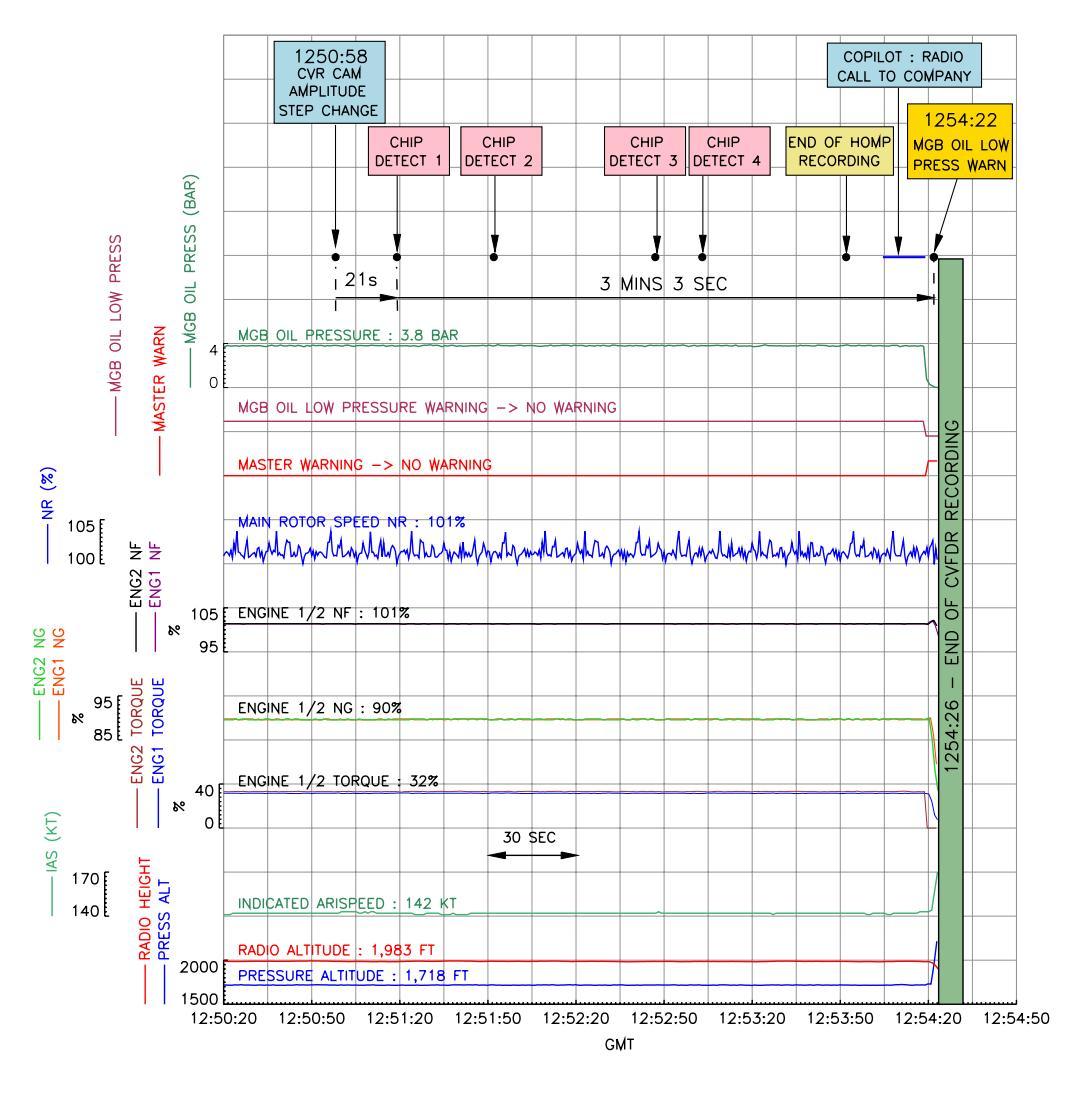
Figure 16 G-REDL recorded flight data

Spectral analysis of the CAM recording revealed an amplitude step change, in a frequency consistent with damage to the second stage epicyclic ring gear, occurring at 1250:58 hrs, (see Figure 16). This change in acoustic signature was inaudible on all the recorded channels. At approximately 1251:19 hrs an epicyclic chip detection warning was recorded on HUMS. Over the next minute and 43 seconds, three further chip detector warnings were recorded.

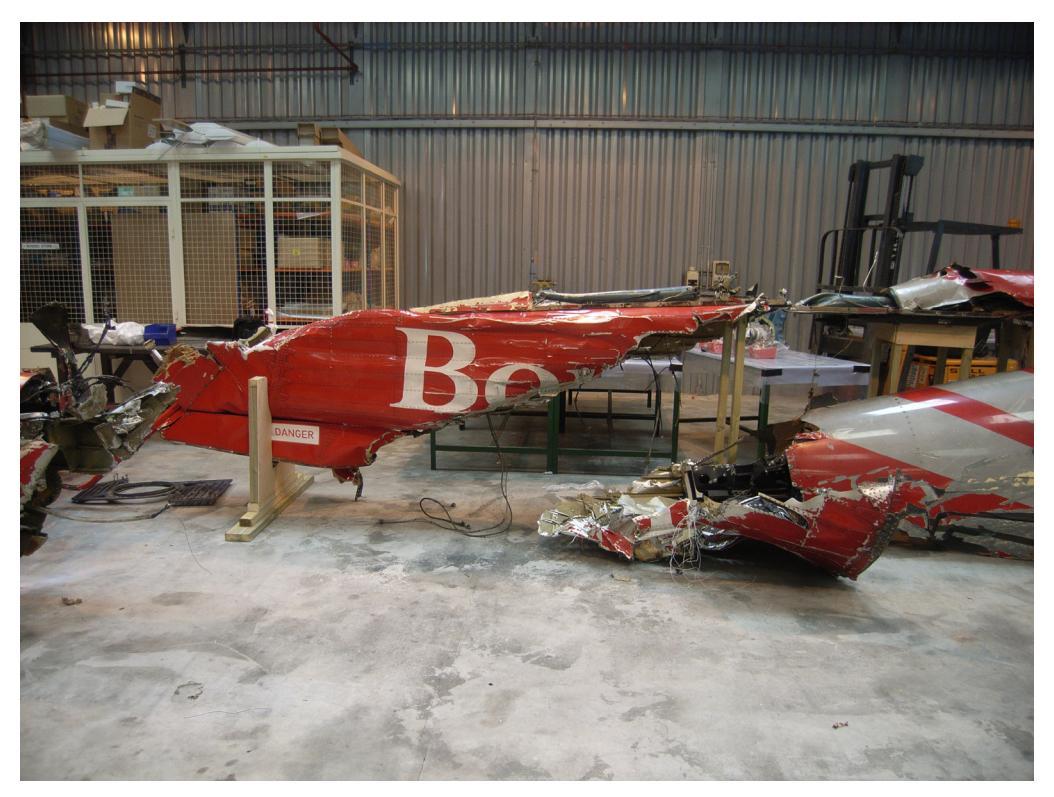
Figure 19 Helicopter tail boom after recovery

Damage to the tail boom of the helicopter confirmed that it had separated from the fuselage prior to the impact with the sea. It had suffered from multiple main rotor blade strikes on the boom and at the base of the fin, (see Figure 19). Damage to the tail rotor drive shaft was consistent with the shaft rotating when it was struck by the main rotor blades.

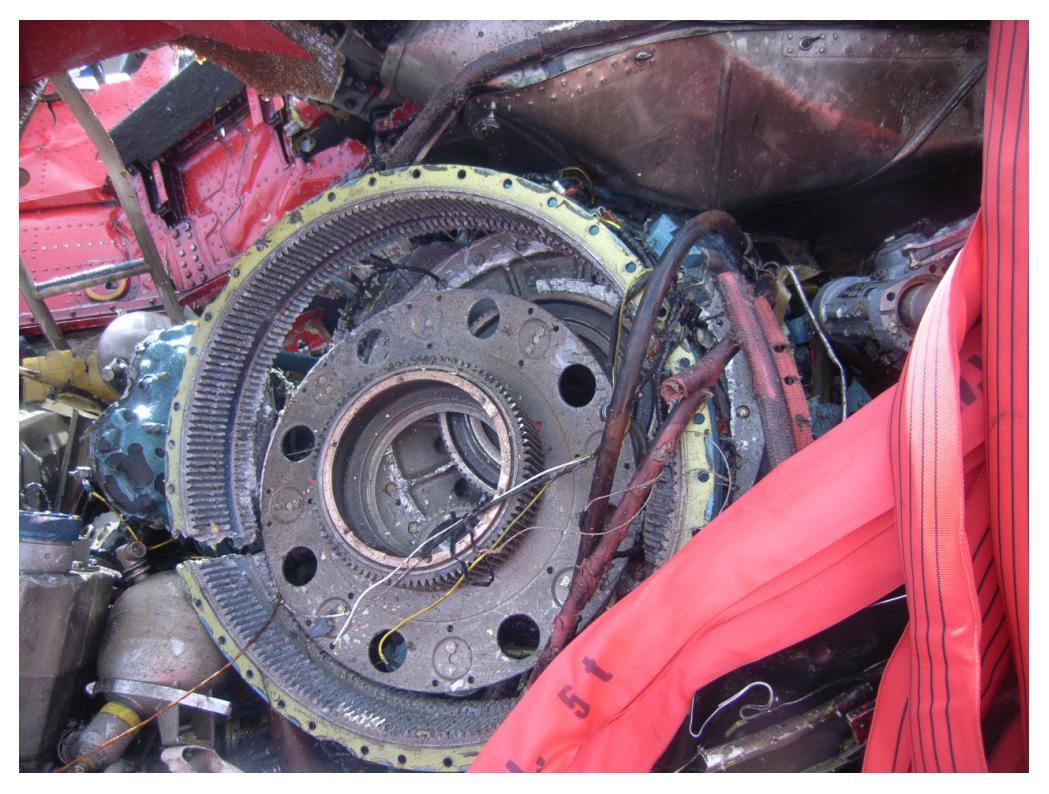
Figure 20 The epicyclic module ring gear shortly after recovery from the sea

the remains of the main module and the remains of all eight first stage planet gears, together with pieces of a second stage planet gear, were recovered from within the MGB main module and its surrounding area.

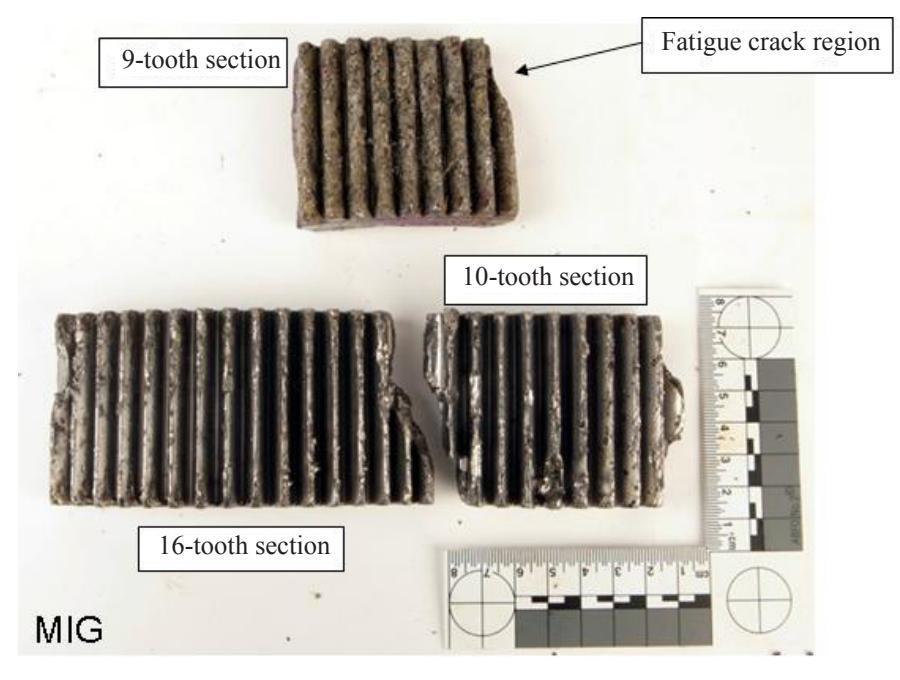
Figure 23

Initial inspection of the three recovered sections of the gear showed that the 9-tooth section did not fracture match with the other two sections. The 10-tooth and 16-tooth sections shared a common fracture face. In addition, the 9-tooth section exhibited a distinct 'flattening' of its curvature when compared with the other sections.

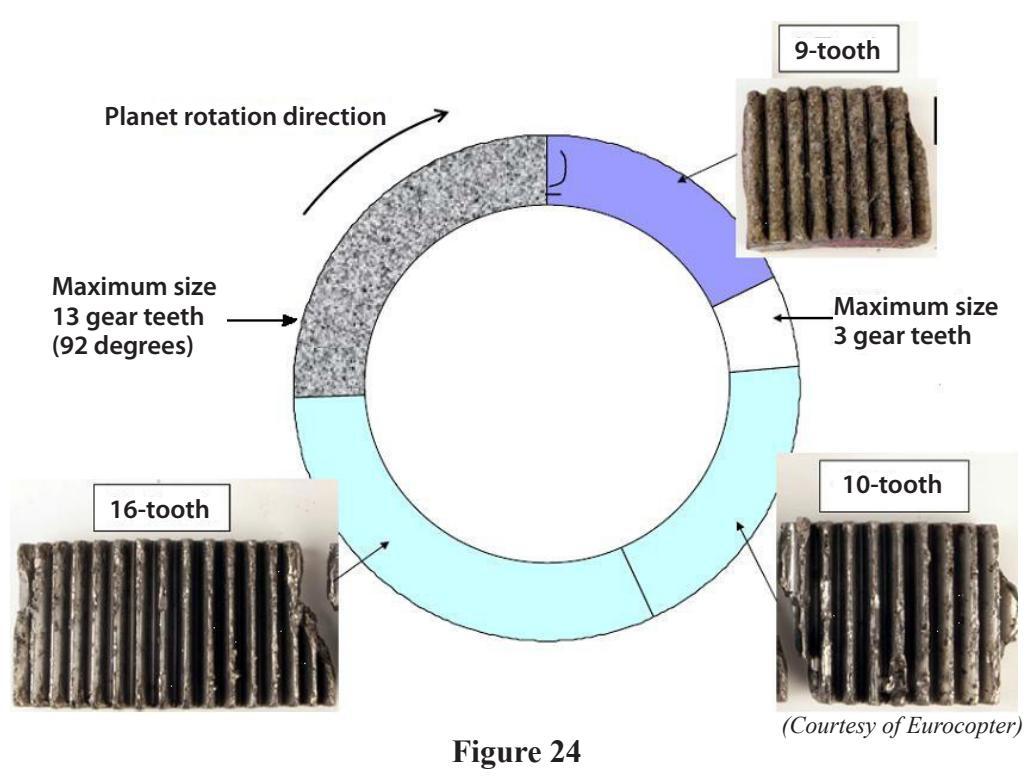
Relative position of recovered second stage gear sections

Examination of the recovered pieces allowed their relative positions around the circumference of the gear to be determined. The 16-tooth and 10-tooth sections comprised approximately one half of the gear, with the 9-tooth section being positioned somewhere in the remaining half. Stress analysis showed that the minimum separation of the 9-tooth section from the 16- and 10-tooth samples was equivalent to the span of three gear teeth, and the maximum separation was equivalent to 13 gear teeth, or approximately 25% of the circumference (see Figure 24).

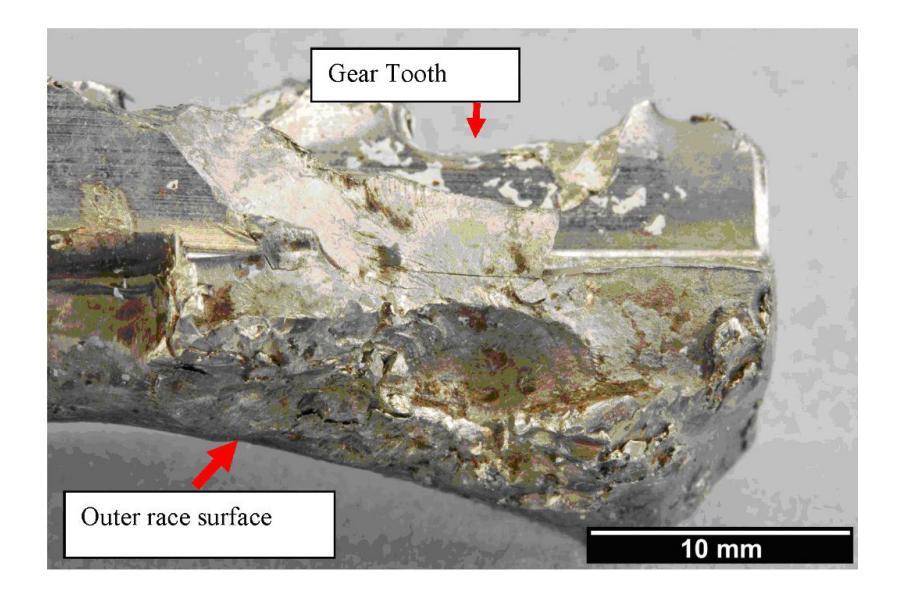
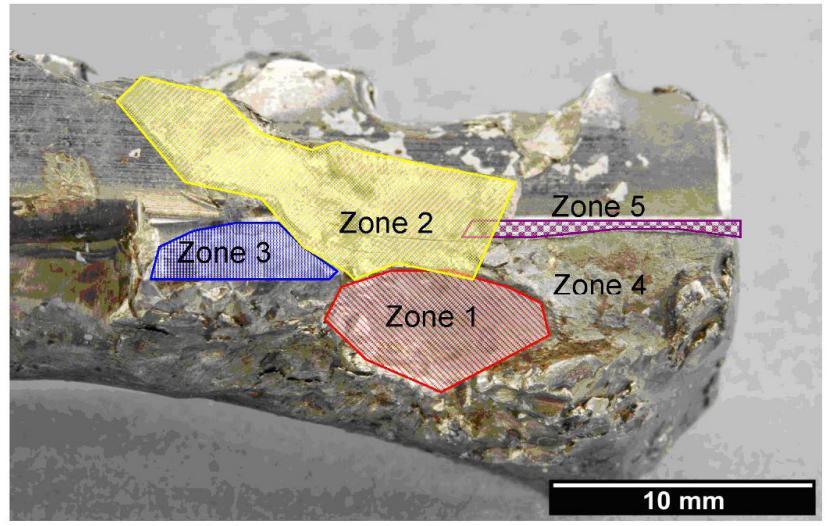
Figure 25 Fatigue crack regions on the 9-tooth section

The Zone 4 fracture had originated on the outer edge of the Zone 1 facture and progressed towards the edge of the gear. Zone 5 was a fatigue crack at right angles to the Zone 2 fracture face.

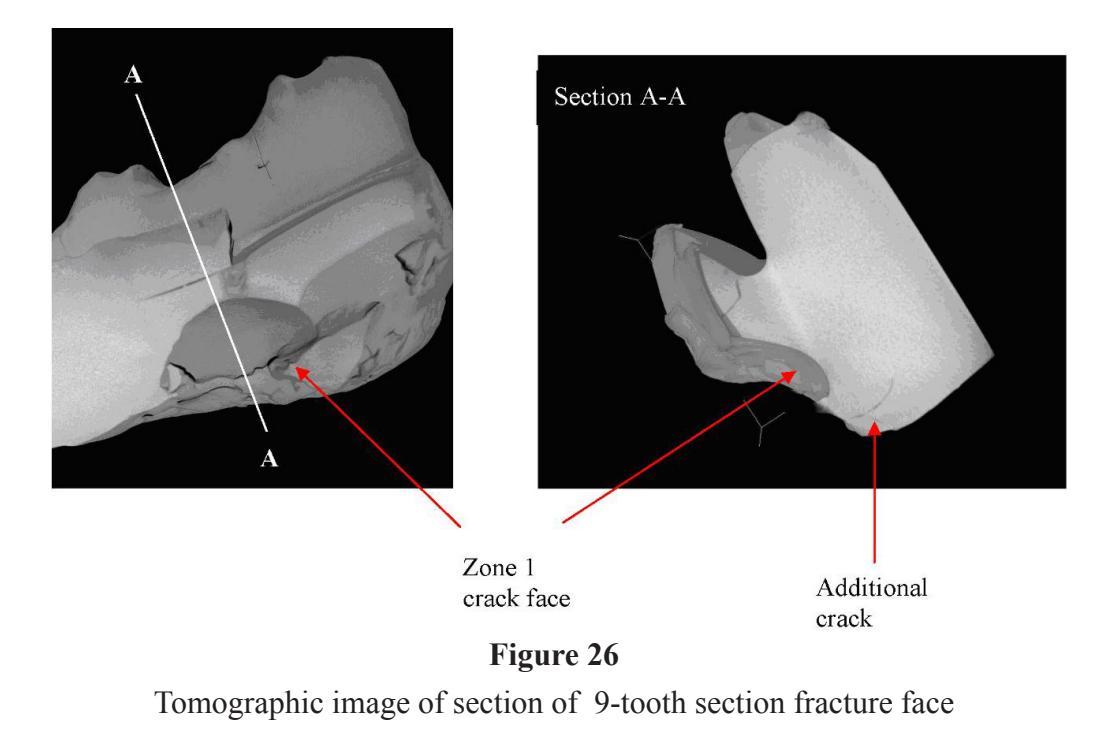
After examination, the 9-tooth sample was sectioned to allow detailed inspection of the fracture surfaces. Three dimensional tomographic images of the area surrounding the fracture faces showed the presence of an additional crack in the area of material immediately below the Zone 1 crack face, (see Figure 26), which was not apparent during the visual examination.

The extent of mechanical damage in this area prevented visual identification of the crack. No other material defects could be identified in the 9-tooth section.

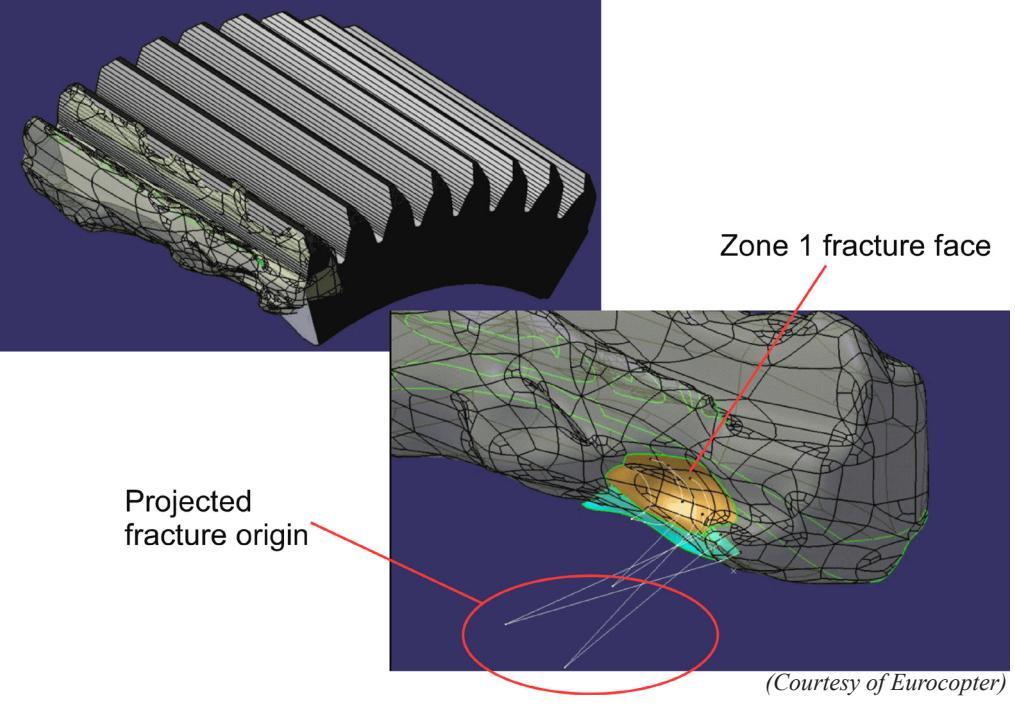
Figure 27

In order to determine the possible location of the origin of the Zone 1 crack, the dimensions of the fracture face were recorded and projected into a computer generated model of a second stage planet gear. The results showed that the origin of the Zone 1 fracture face was approximately 2.5 mm forward of the nine tooth sample, in a section of the gear which had not been recovered (see Figure 27).

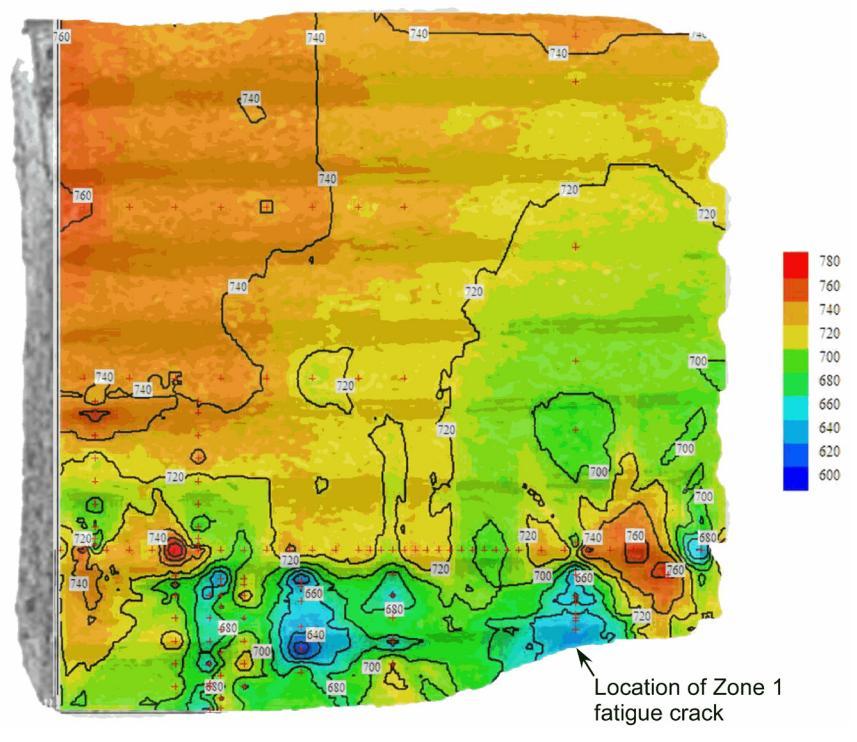
Figure 28 Hardness plot of the 9-tooth section

A detailed metallurgical examination of all the recovered sections of the failed gear confirmed that they complied with the material specification of 16NCD13 steel and no other abnormalities were identified during this examination. The hardness of the raceway of the 9-tooth section was also measured to identify any variation in the material hardness which may have contributed to the failure of the gear. These measurements were taken 0.15 mm below the surface of the raceway where the nominal material hardness, for a new second stage gear, was expected to be greater than 660 on the Vickers Hardness scale. The results were plotted onto an image of the 9-tooth section (see Figure 28). This showed that there appeared to be a relative hardening of the gear material throughout the bulk of the section.

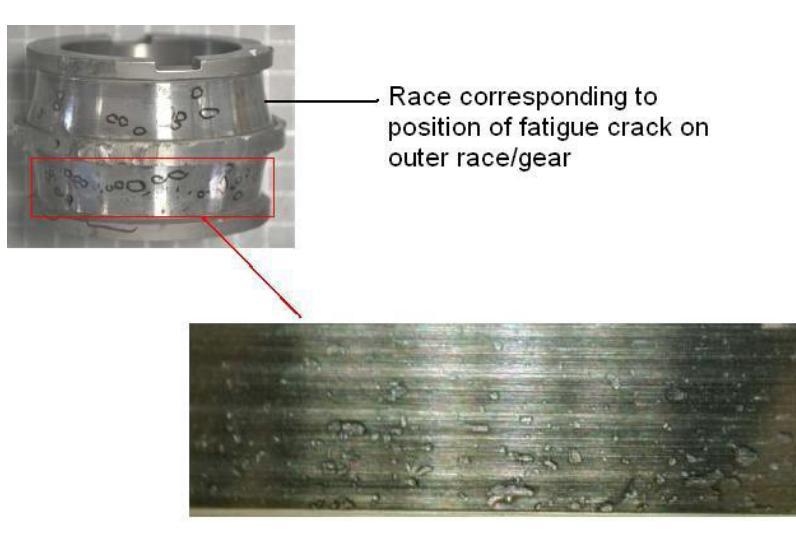
Examination of the inner race of the failed gear, which had remained attached to the second stage planet carrier, showed numerous small pits around the circumference of the race. This pitting was found predominantly on the highest loaded section of the inner race bearing tracks. The extent of this pitting was less evident on the bearing track corresponding to the position of the fatigue crack on the outer race/gear, (see Figure 29).

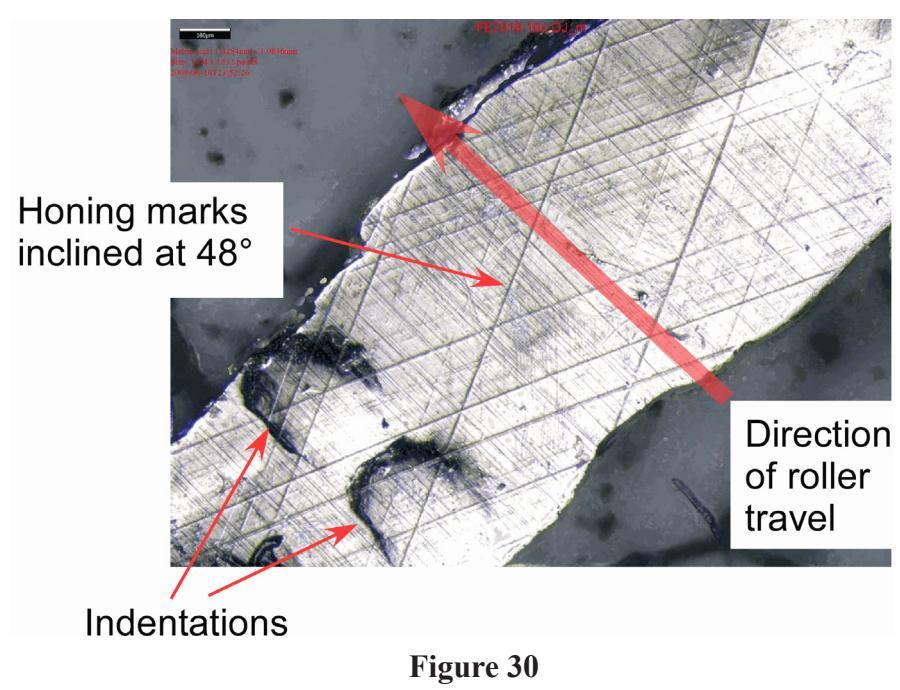
Metallic particle of 25 March 2009

Detailed examination was performed on the metallic particle removed from the epicyclic module magnetic chip detector on 25 March 2009; 36 flying hours before the accident. The particle measured 2.88 mm by 0.8 mm. SEM analysis confirmed that the particle was 16NCD13 steel, planet gear outer race/gear material. On one side, the particle exhibited evidence of honing marks, a characteristic of the surface of the outer race of a second stage planet gear bearing. Comparison of these marks with an identical intact second stage planet gear established that it came from a location on the raceway in the wear track of one set of rollers. This was close to where the maximum surface loading from the rollers was to be expected, 14 mm from the edge of the gear, (see Figure 30).

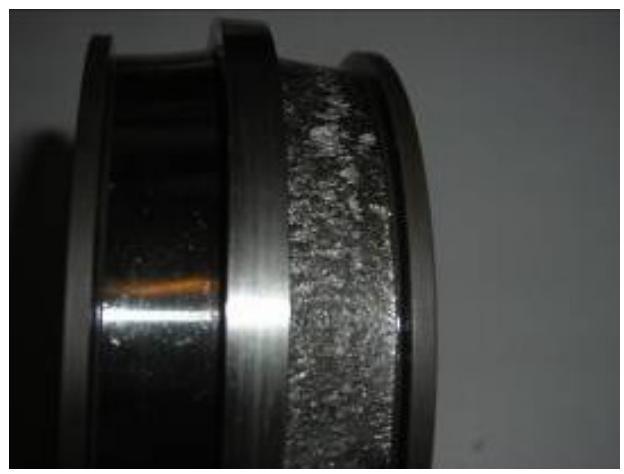
The inner raceway of the 2009 cracked first stage planet gear showed that the inner race roller track corresponding to the damage on the outer race had also suffered from significant amounts of spalling on the loaded arc, (see Figure 34). In addition a number of smaller 'pits' were present on the second bearing track of the inner race. Minor pitting was the only damage observed on either bearing track of the 2005 cracked second stage gear's inner race. This pitting was consistent with the presence of particles within the planet gear bearing and was probably caused by spalled debris.
