Accident Investigation Board Norway

REPORT SL 2018/04

REPORT ON THE AIR ACCIDENT NEAR TURØY, ØYGARDEN MUNICIPALITY, HORDALAND COUNTY, NORWAY 29 APRIL 2016 WITH AIRBUS HELICOPTERS EC 225 LP, LN-OJF, OPERATED BY CHC HELIKOPTER SERVICE AS

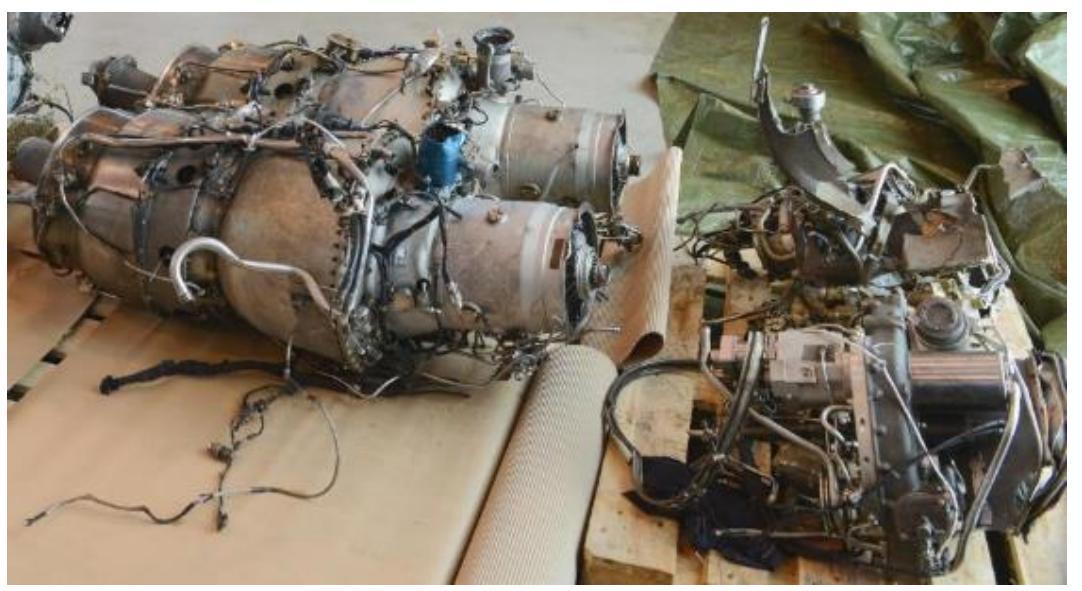
Figure 23: The engines at the AIBN hangar. They had similar damage to a large extent. Both intake sections (Module M01) which had separated from the front part of the engines can be seen to the right of the photo. Photo: AIBN

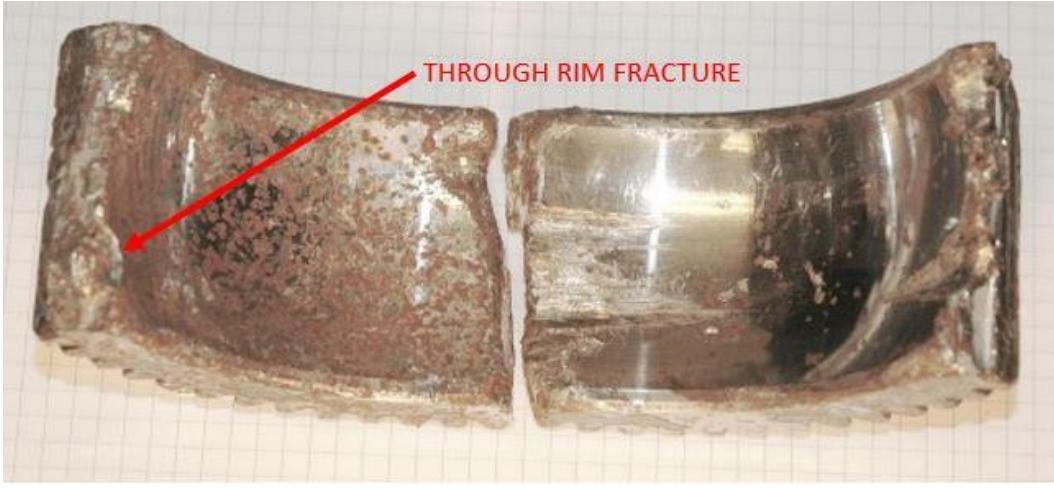
Figure 27: The two segments of the fractured second stage planet gear (serial number M4325). The fatigue fracture through the rim (through-thickness fracture) started in the outer upper race of the planet gear wheel where the red arrow is pointing (spall 4). Photo: AIBN/NDL

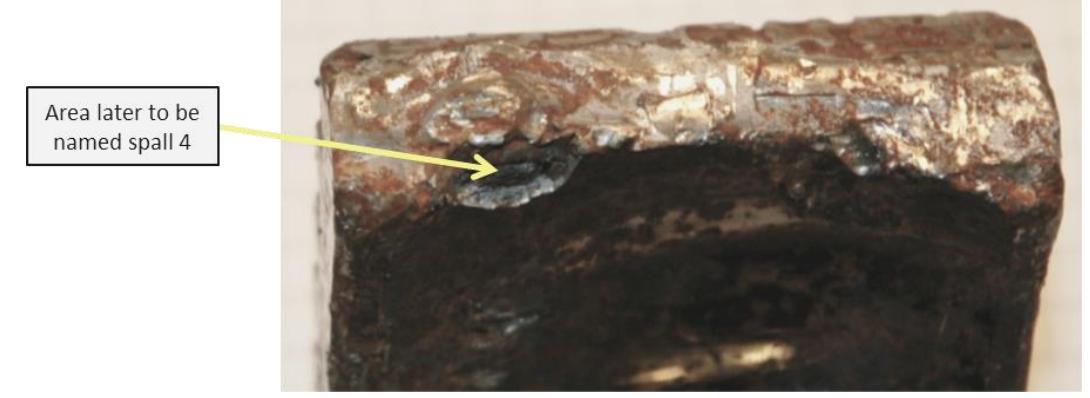
Figure 28: The fracture surface to the left in Figure 27. This surface appeared not to be ductile overload, but possibly fatigue. Photo: AIBN/NDL

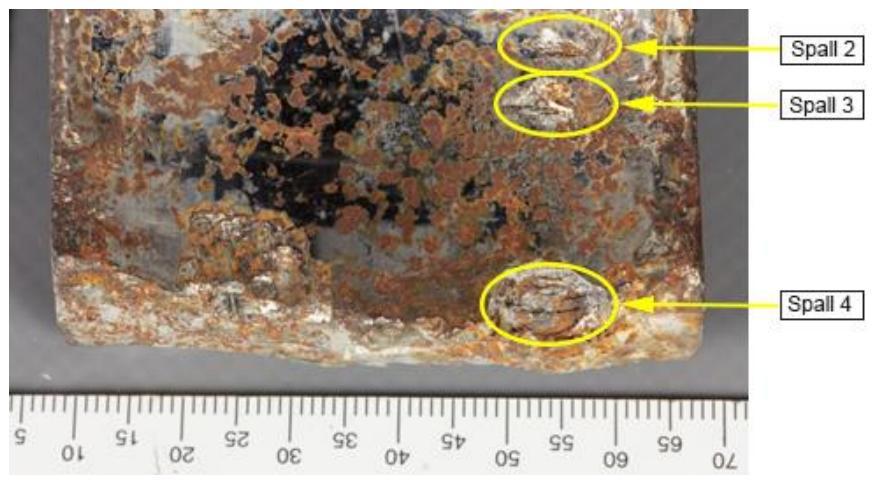
Figure 29: The fatigued surface as received at QinetiQ before cleaning. Along a line approximately 14 mm from the upper surface of the gear (right hand edge in photograph) some holes or spalls are observed, with the largest (named spall 4) located at the edge of the through thickness fracture. Photo: AIBN/QinetiQ

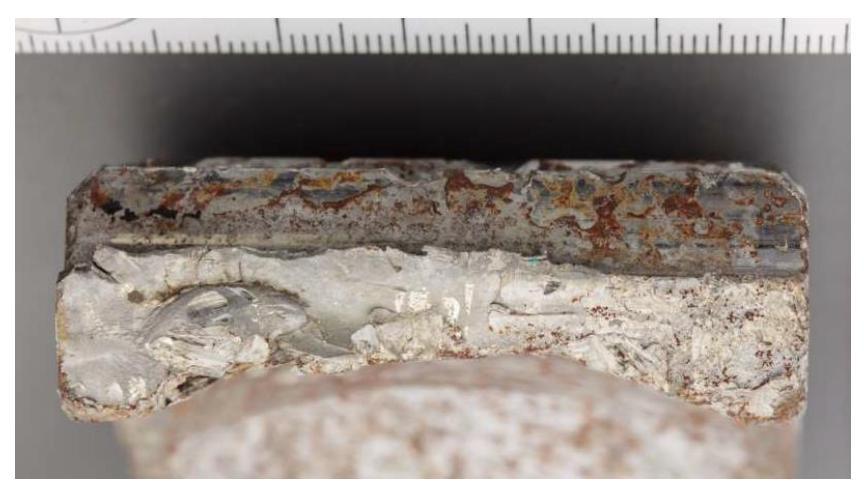
Figure 30: The cleaned through-thickness fracture surface. Macro marks (beach marks) are visible towards the upper edge of the gear (left hand side in photograph). Photo: AIBN/QinetiQ

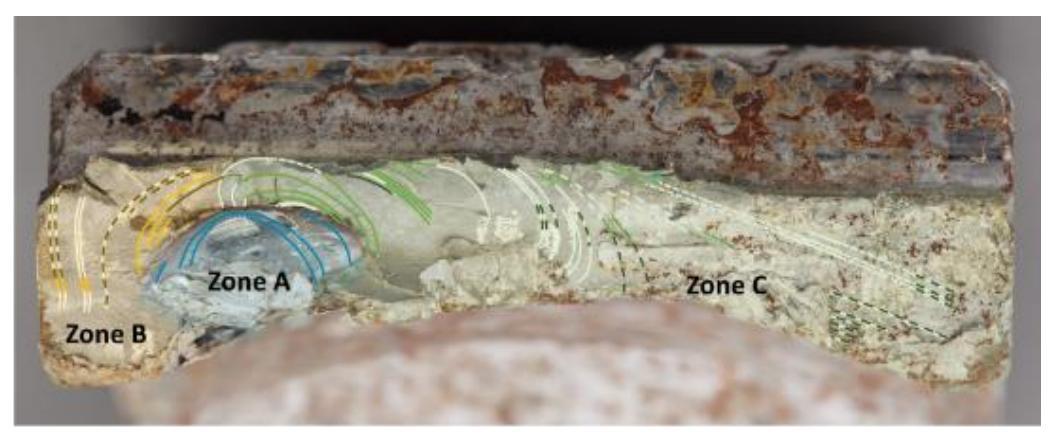
Figure 31: The fracture surface divided into three different zones. The macro marks/features observed are indicated: solid line – well defined, dashed line – less well defined. Photo: AIBN/QinetiQ

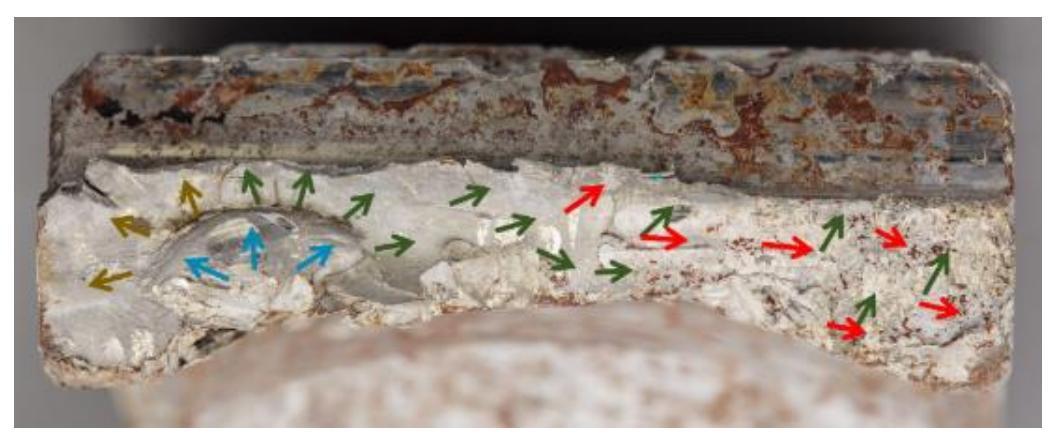
Figure 32: Crack propagation directions concluded from macro mark orientations in zones A (blue), B (brown) and C (green). Propagation in zone C concluded from striation and micro-crack orientations is shown by the red arrows. Photo: AIBN/QinetiQ

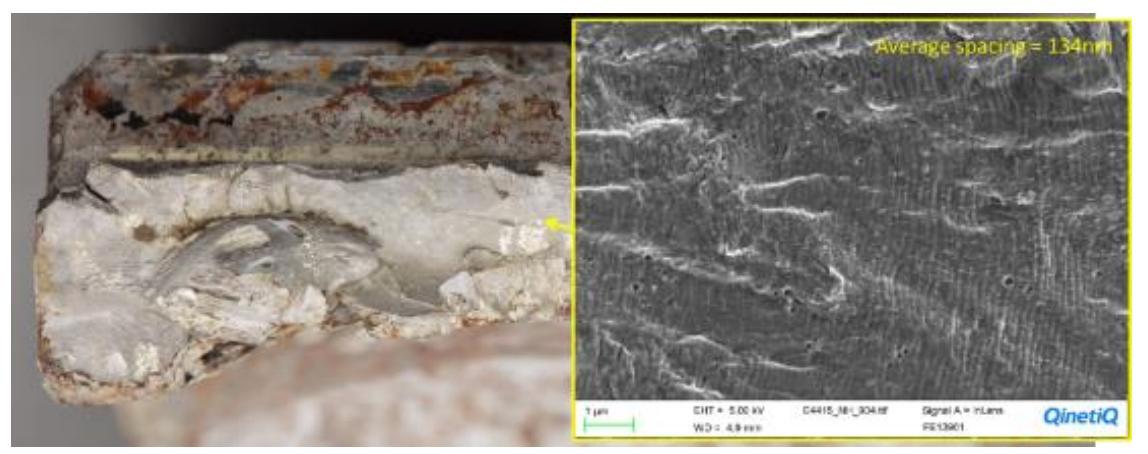
Figure 33: Fatigue crack progression marks – striations. Average spacing between the striations in this area are 134 nm. Photo: AIBN/QinetiQ

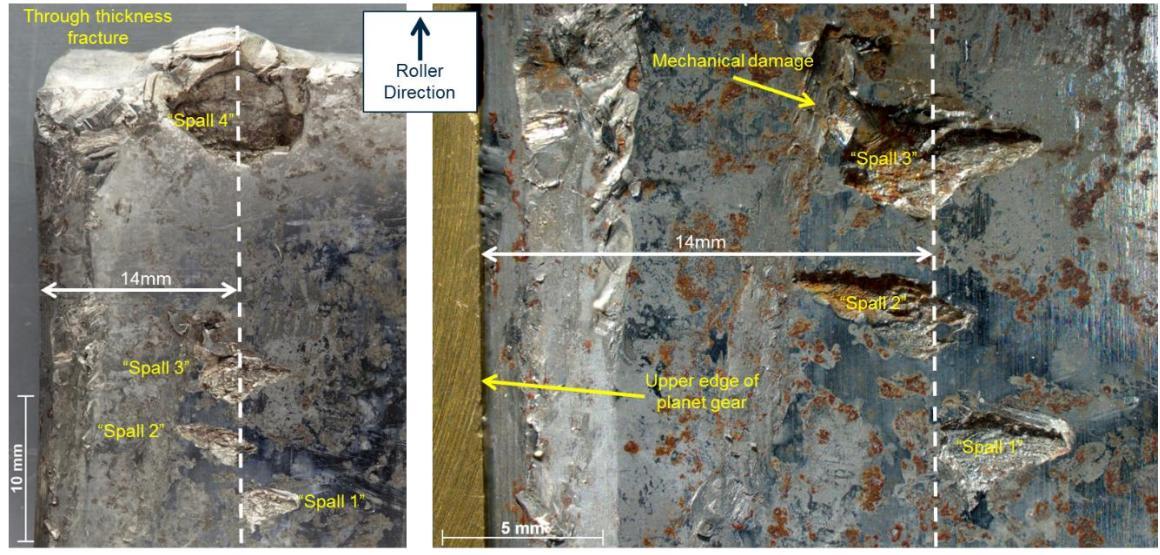
Figure 34: Showing spall 1, 2, 3 and 4 together with the max Hertzian stress line of 14 mm. Photo: AIBN/QinetiQ

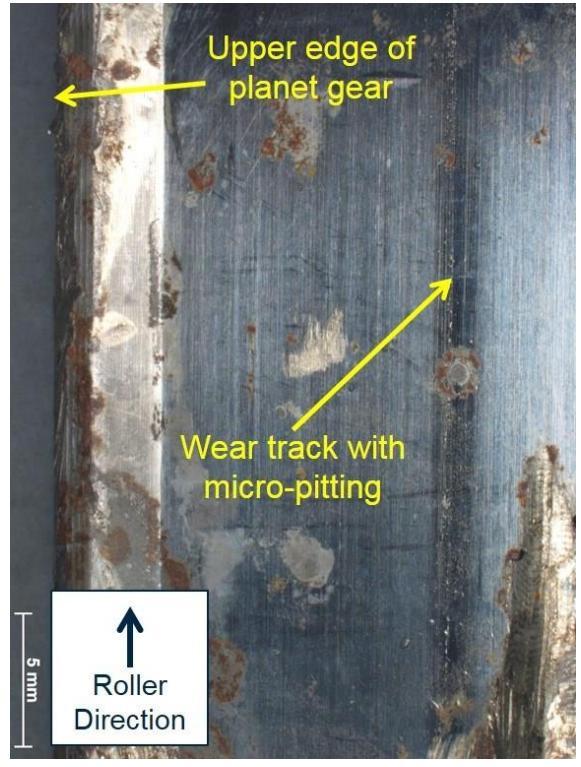
Figure 35: A wear track containing micro-pitting is also observed on the upper outer-race surface of the second planet gear fragment. Photo: AIBN/QinetiQ

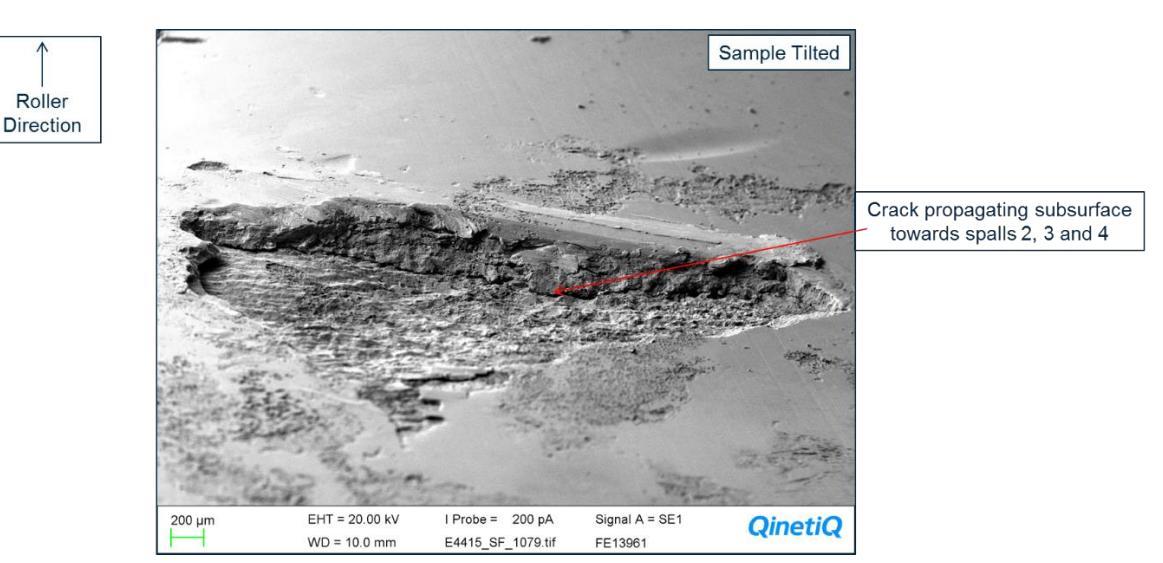
Figure 36: Spall one looking in the direction of spall two (in roller direction). A crack continuing under the surface is observed. Photo: AIBN/QinetiQ

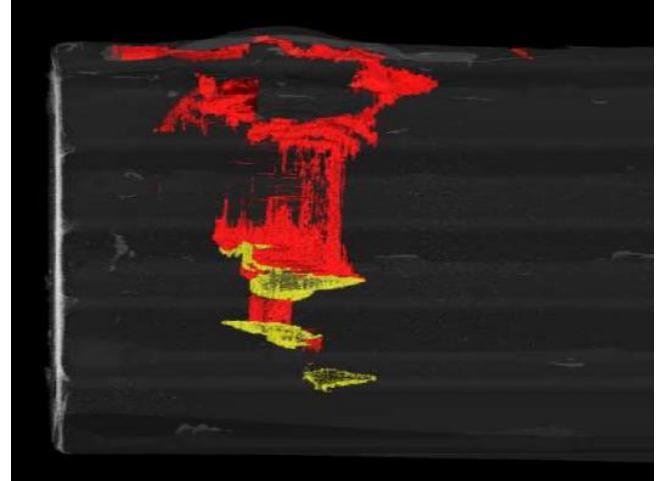
Figure 38: CT-scan of the specimen in Figure 34. The yellow areas are spall one, two and three. The red area indicates the resolvable part of the subsurface crack. Photo: Threshold CT-scan image from AIBN/Southampton University

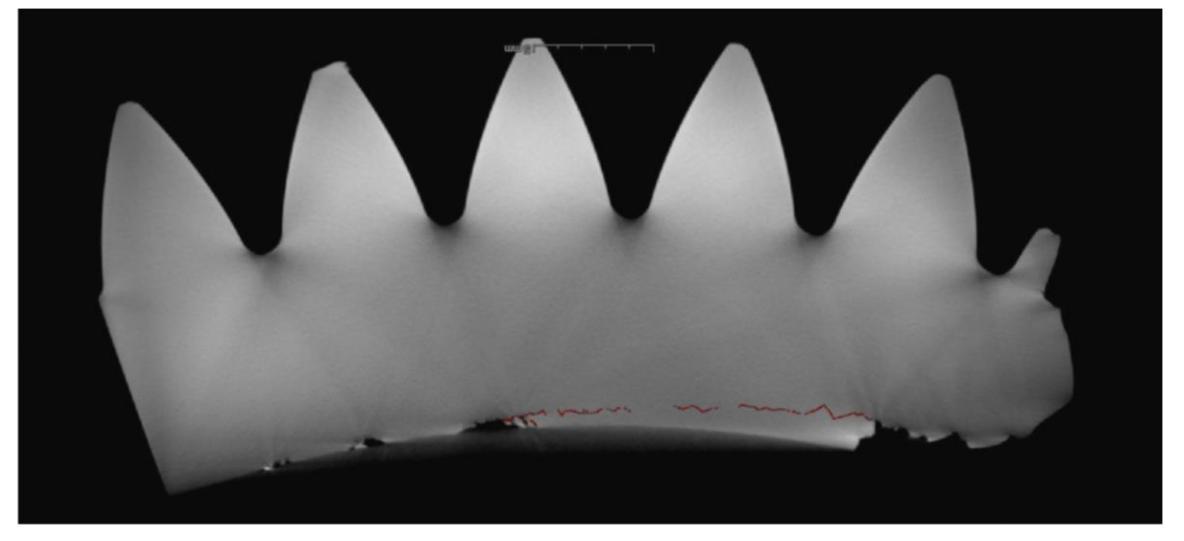
Figure 39: Longitudinal slice from CT-scan showing several cracks below the surface of the outer race. One crack runs below the surface between spalls (areas of surface damage). The main crack is marked in red. Photo: CT-scan from AIBN/Southampton University/QinetiQ

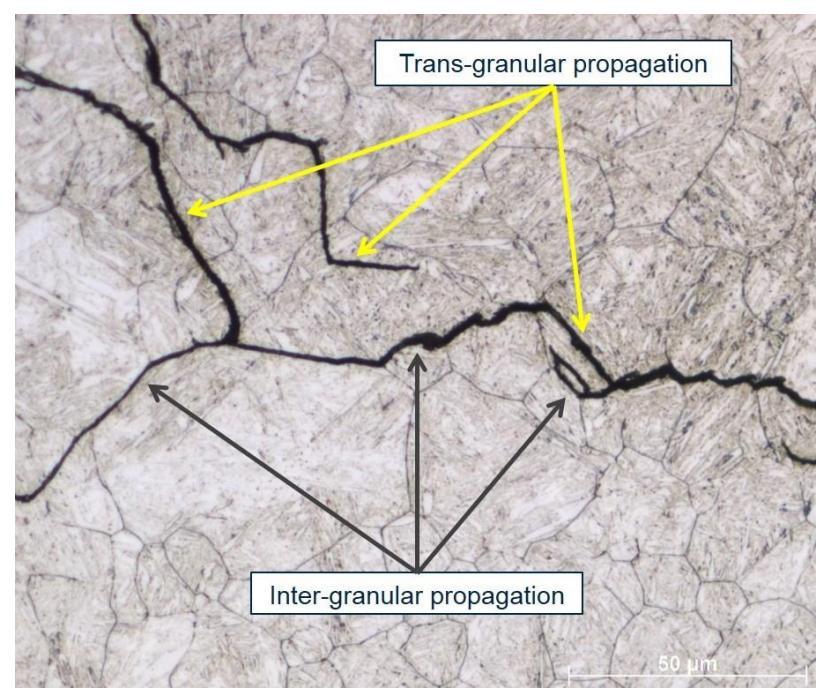
Figure 41: The subsurface crack propagation is both trans- and inter-granular. Roller direction to the left. Photo: AIBN/QinetiQ

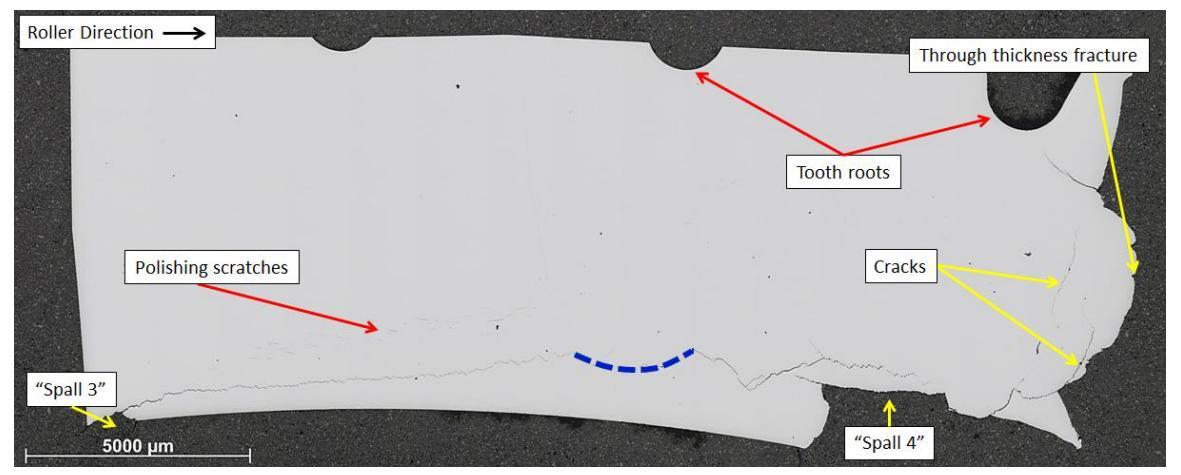
Figure 42: Sample FE13961 (see Figure 40). The micro-section is 16.8 mm from upper edge. Cracks deviating towards the race surface stop and thus do not release particles. Photo: AIBN/QinetiQ

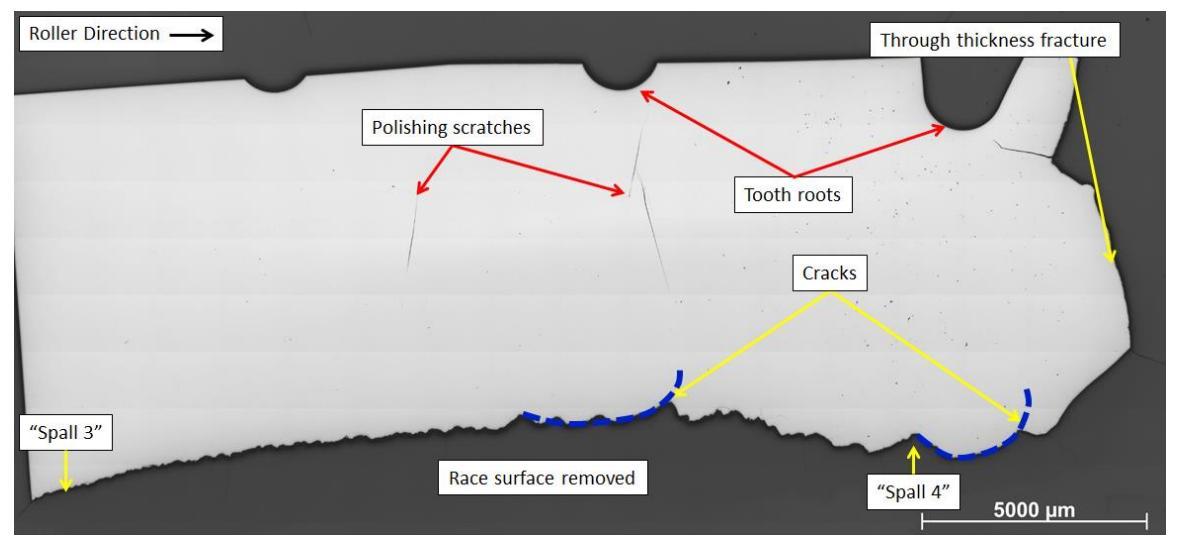
Figure 43: Sample FE13961 (see Figure 40). The micro-section is further polished to 15 mm from upper edge with the raceway removed. The micro-section shows deviations towards the gear teeth. Photo: AIBN/QinetiQ

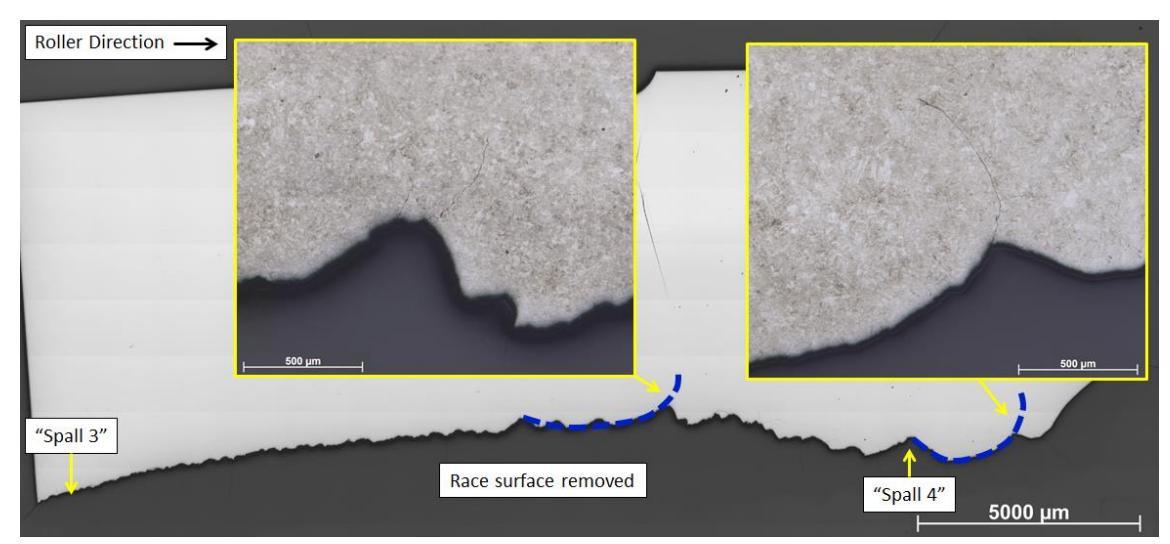
Figure 44: Sample FE13961 (see Figure 40). The micro-section shows a close up of deviations towards the gear teeth. Photo: AIBN/QinetiQ

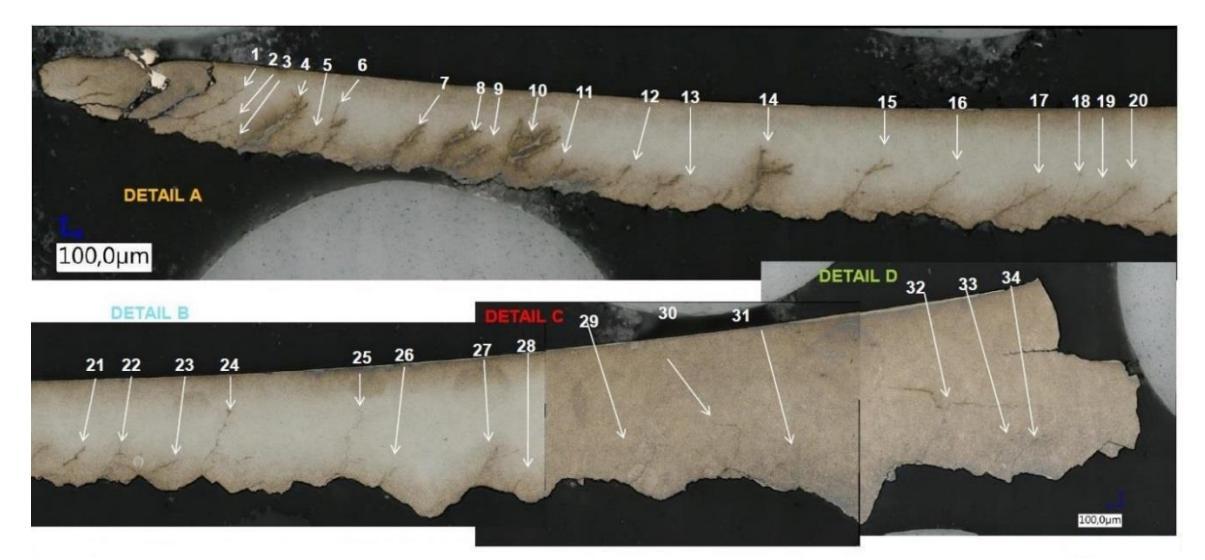
Figure 45: Polished section at the 14 mm line of the removed area (cap/calotte) between spall 3 and 4. Photo: Airbus Helicopters

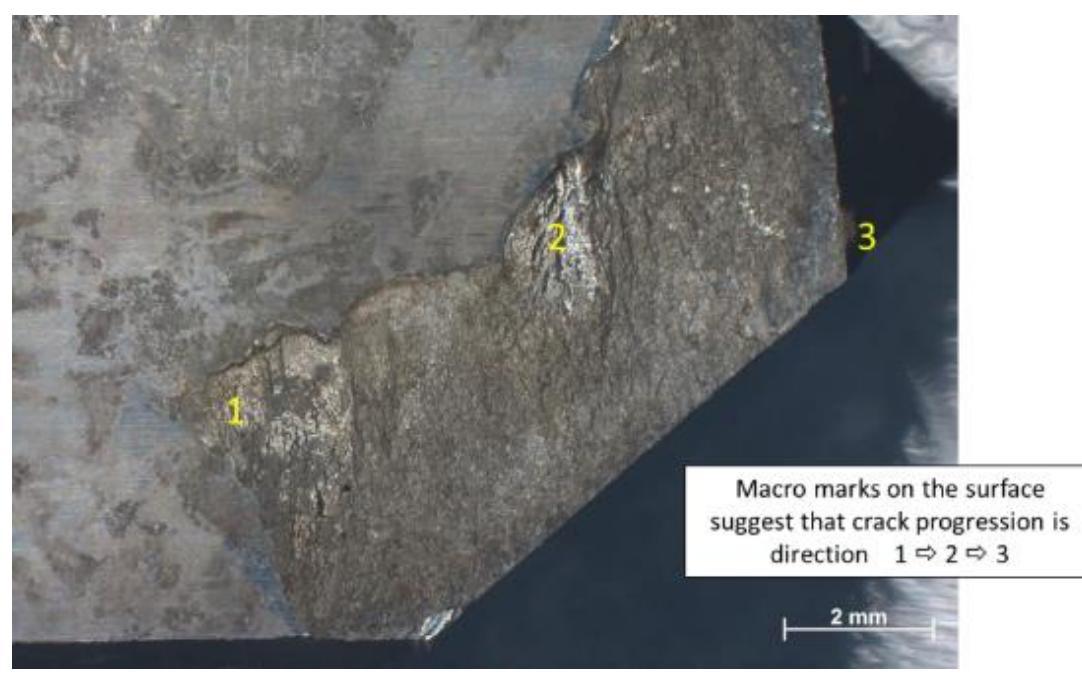
Figure 47: Figure showing the crack between spalls 1, 2 and 3 after removal of the race surface. Photo: AIBN/QinetiQ

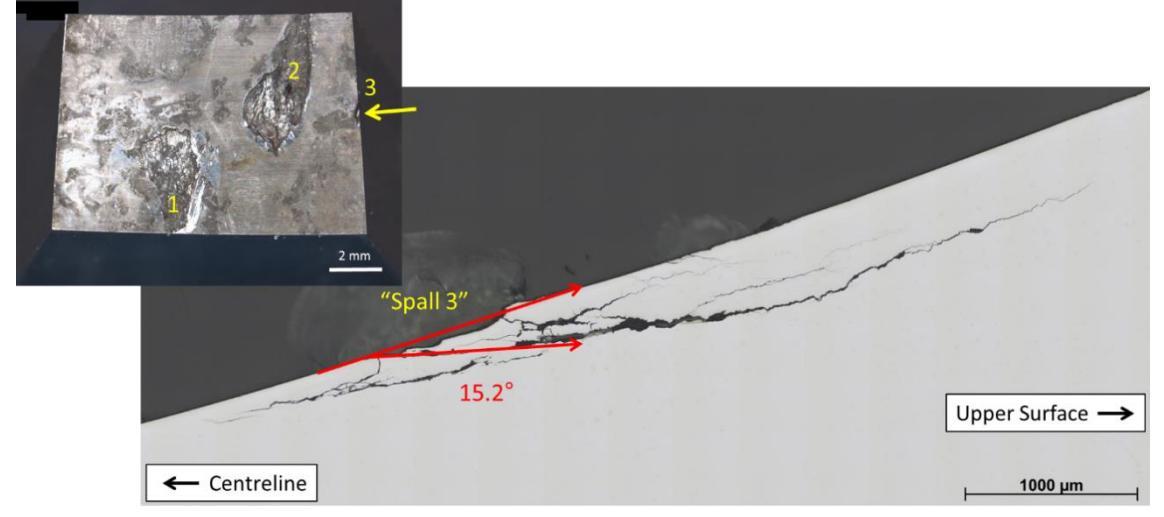
Figure 48: A transverse micro-section of spall 3 with the angle crack propagation of 15.2°. Photo: AIBN/QinetiQ

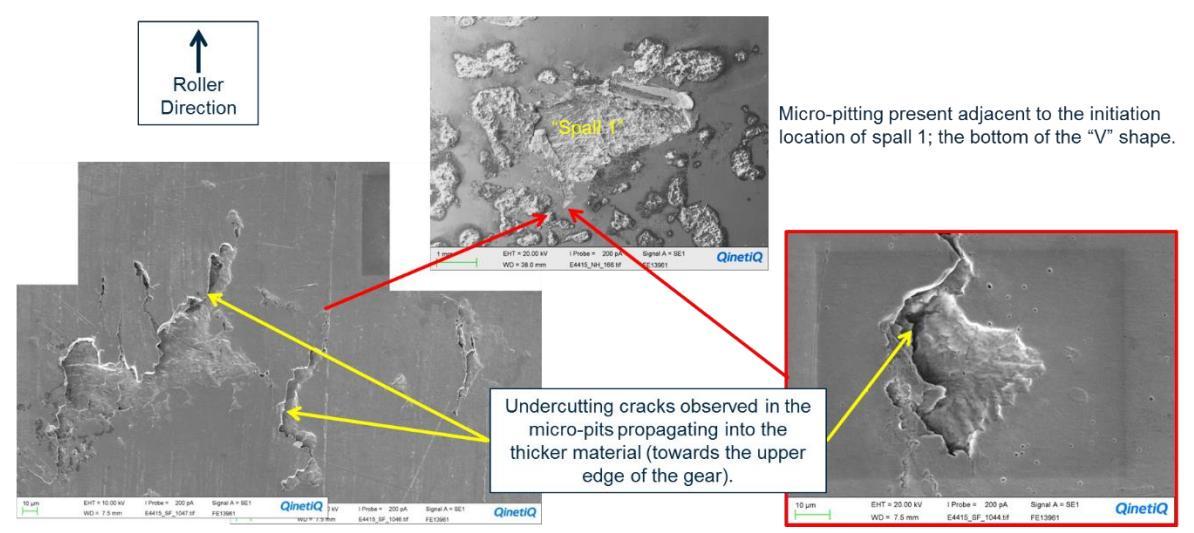
Figure 49: The micro-pits in the area in front of spall 1 Photo: AIBN/QinetiQ

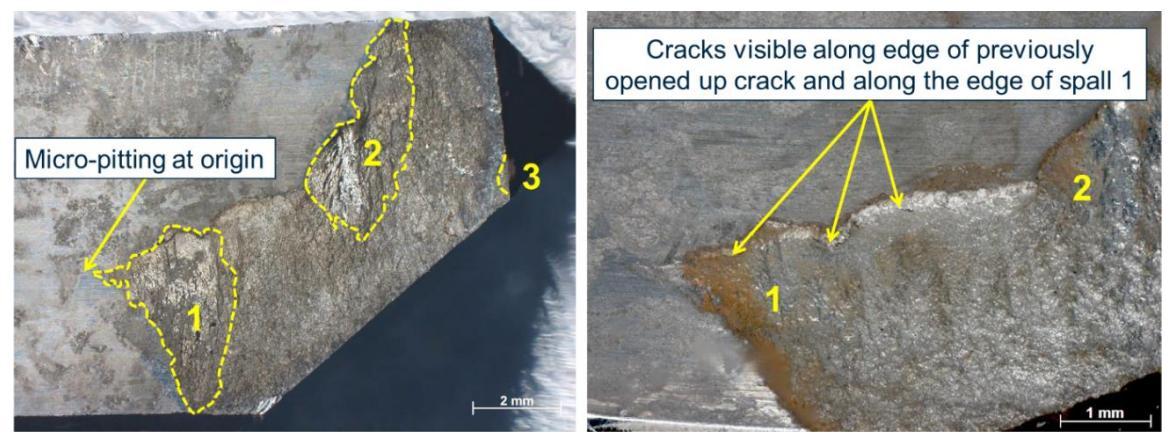
Figure 50: Fracture surface showing the extent of spalls 1 and 2. Photo AIBN/QinetiQ

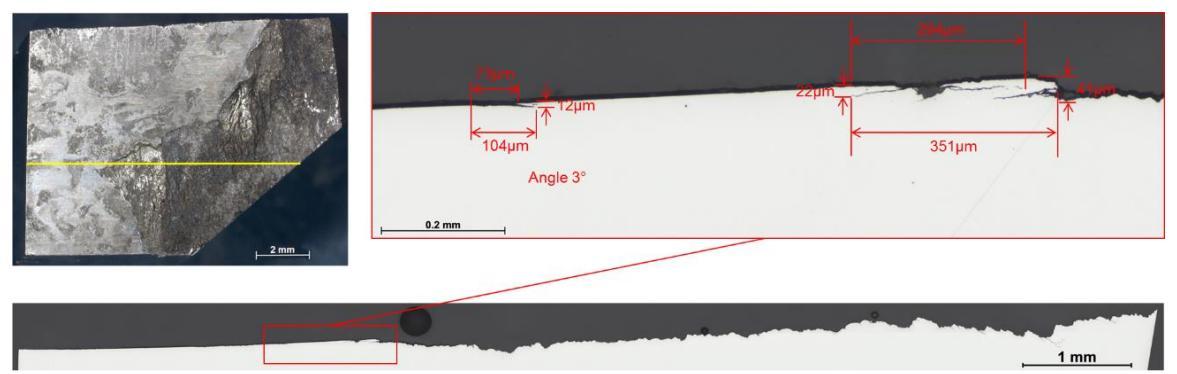
Figure 51: Micro-section 14.8 mm from top of gear showing Spall 1 and adjacent micro-pits with small cracks. The micro-cracks emerge from the micro-pits at a shallow angle into the material in the roller direction and inclined towards the upper edge of the gear. Photo AIBN/QinetiQ

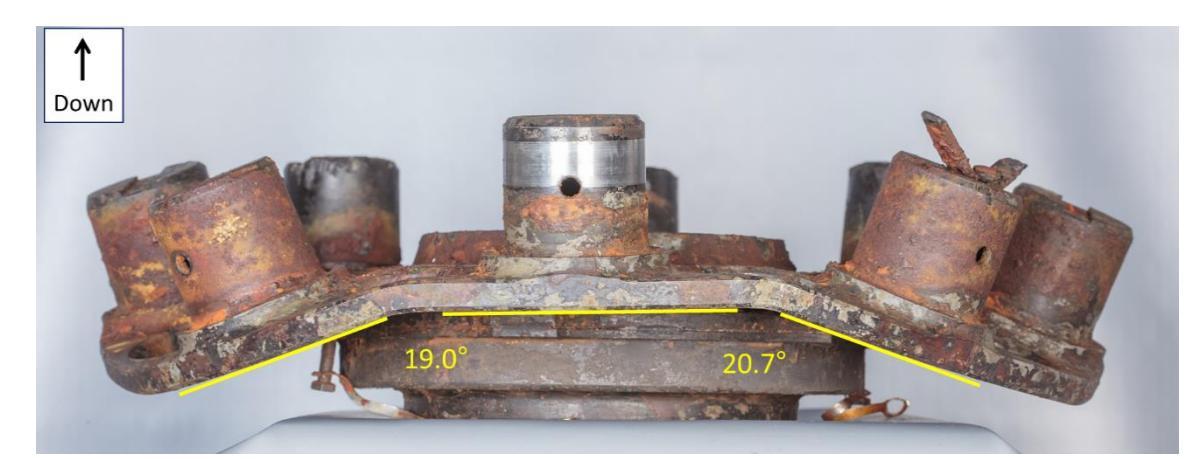
Figure 55. Deformation of carrier is symmetrical around the fractured planet gear. Photo: AIBN/QinetiQ

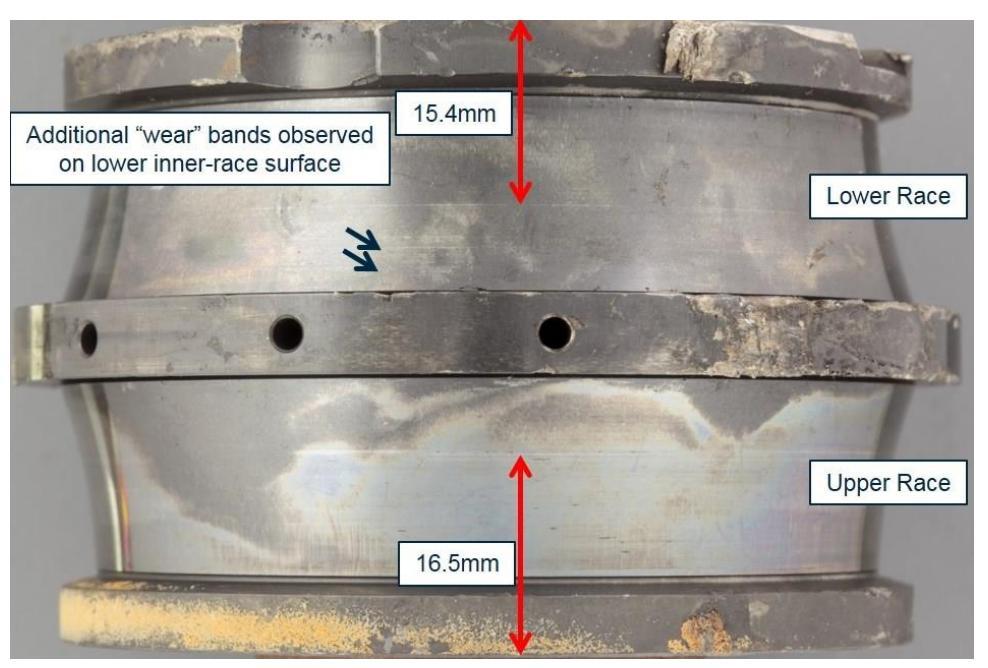
Figure 56: Circumferential 'wear' bands on the second stage planet gear inner race observed on both upper and lower race surfaces after cleaning. Photo: AIBN/QinetiQ

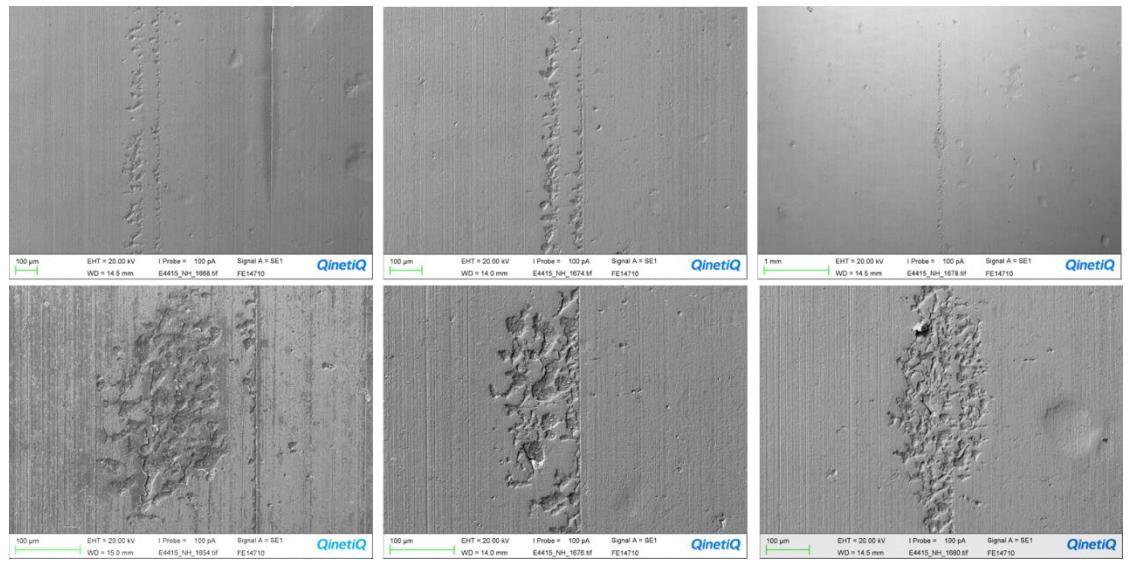
Figure 57: Examples of imperfections on the upper race surface. Photo: AIBN/QinetiQ

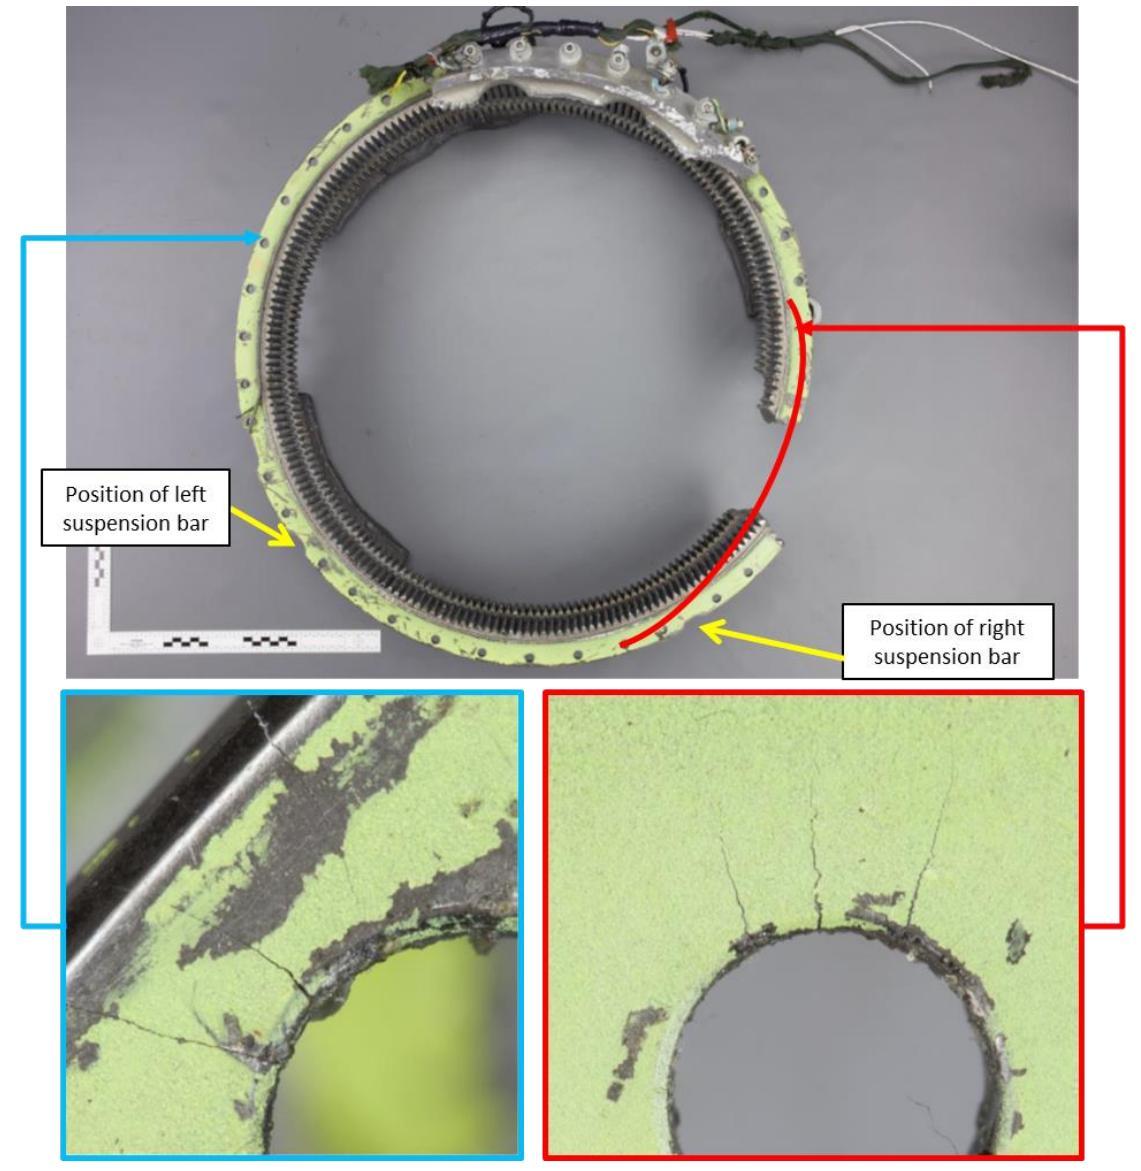
Figure 59: Epicyclical ring gear. Cracks at fastener holes suggests the flange of conical housing were intact when the fixed ring split and moved outwards. Photo: AIBN/QinetiQ

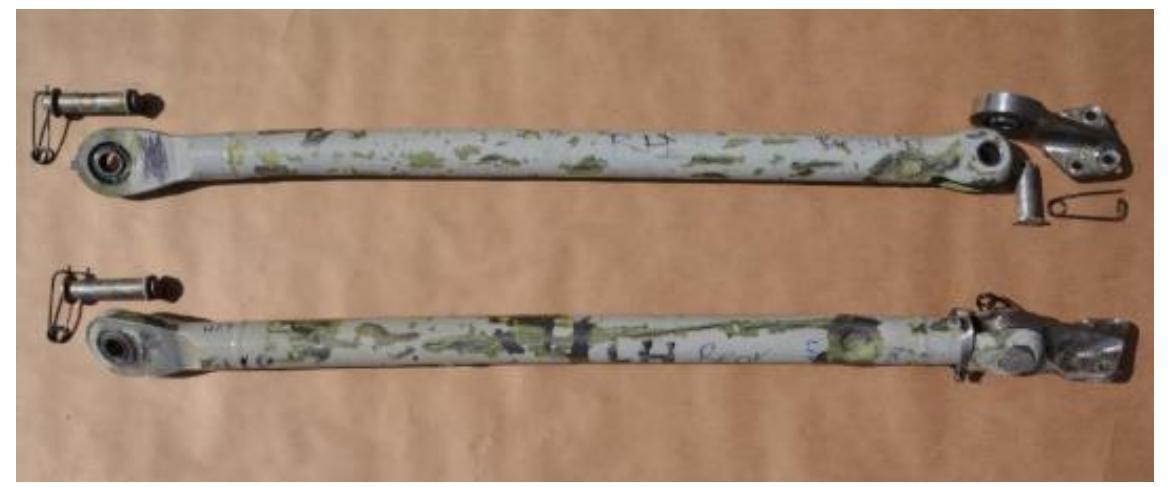
Figure 61: Left and right aft suspension bars with clevis pins, safety pins (only one shown in each position) and fuselage fittings. Both suspension bars have indentations from gear teeth. Photo: AIBN

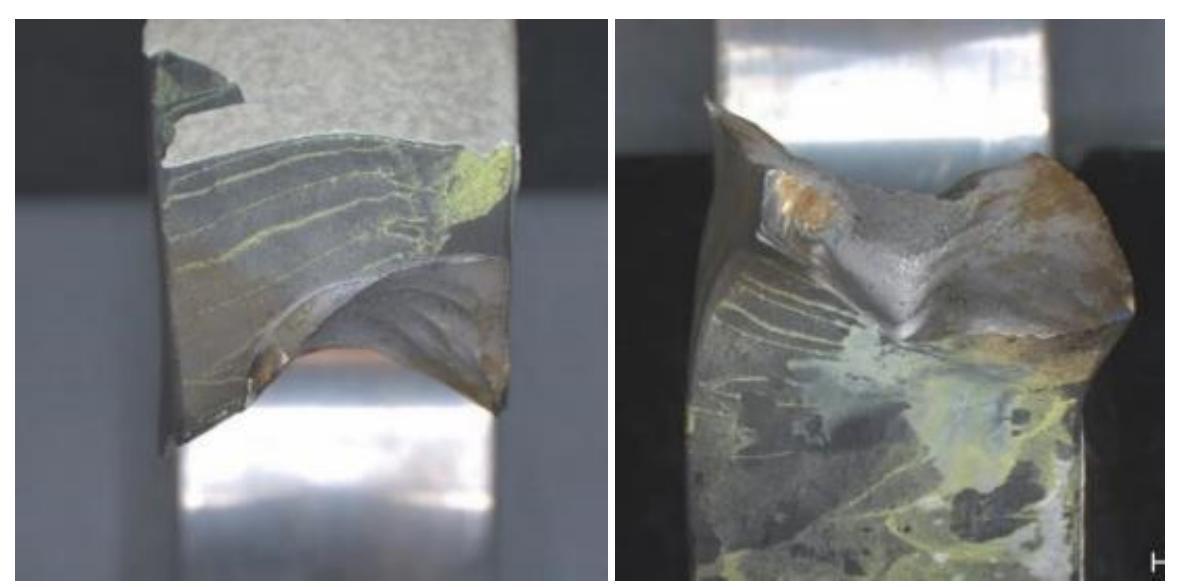
Figure 64: Upper forward suspension bar, mounting lug. Top fracture viewed from above (left photo). Bottom fracture viewed from below (right photo). Photo: AIBN/QinetiQ

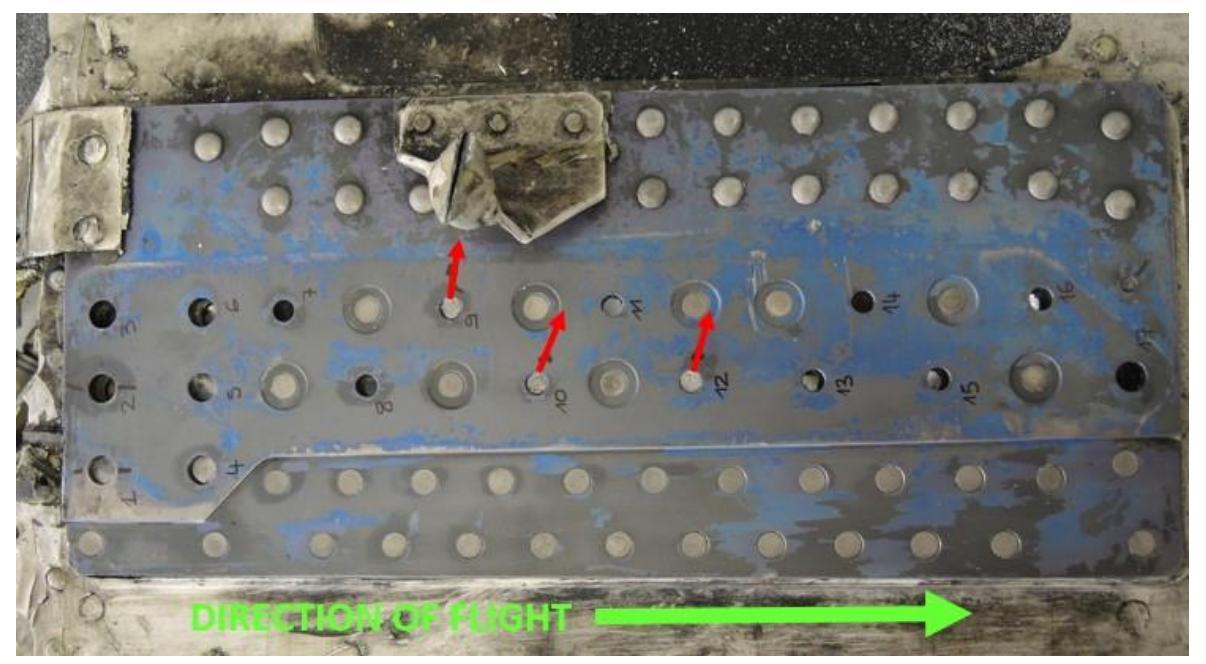
Figure 66: The flexible plate aft attachment had detached from the fuselage plate. The photo shows the support plate at the transmission deck. 7 out of 17 broken bolts were still in place. Red arrows indicate direction of overload in shear (towards the port side of the helicopter). Photo: AIBN

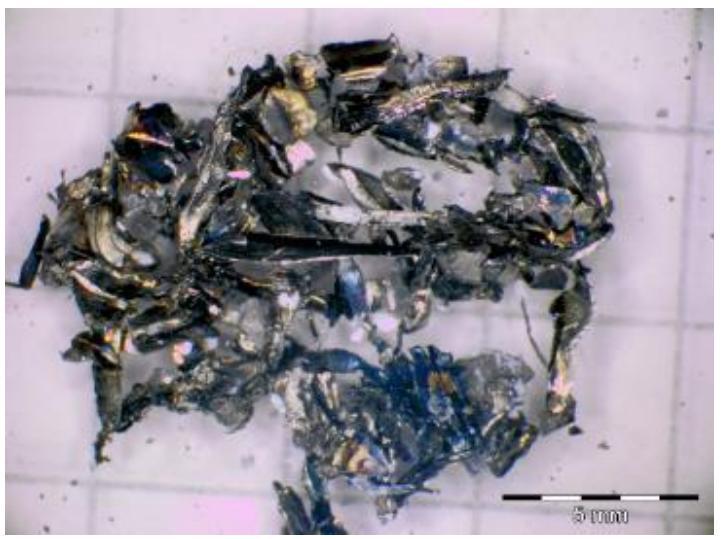
Figure 67: Metal debris from the MGB magnetic plug. Photo: AIBN/NDL

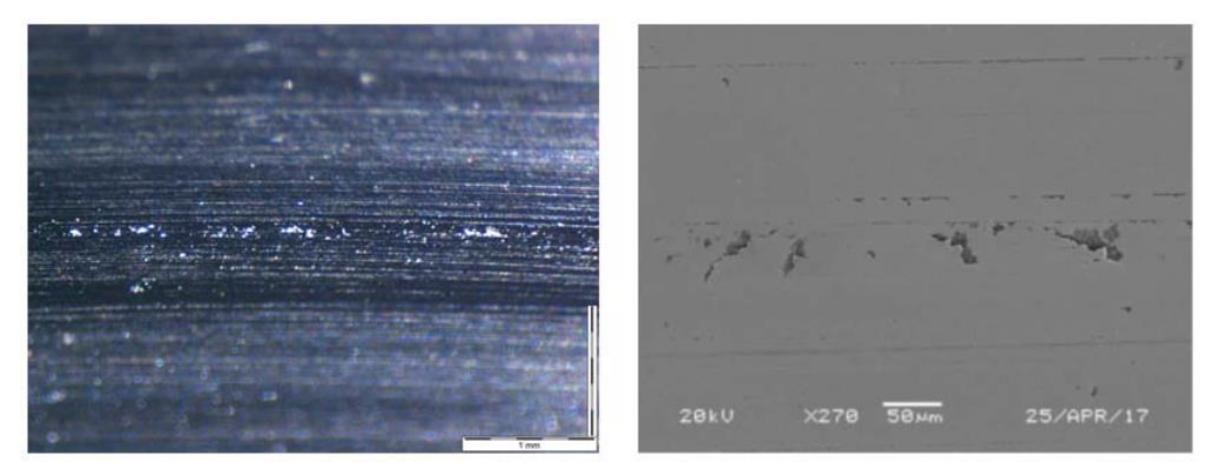
Figure 72: Micro-pitting within the dark line on gear M5769. Photo: Airbus Helicopters
