National Transportation Safety Board (Aviation Accident Final Report (

Location:	Brunswick, North Carolina	Accident Number:	ERA16LA209
Date & Time:	June 10, 2016, 09:00 Local	Registration:	N2283M
Aircraft:	WSK PZL MIELEC M 18A	Aircraft Damage:	Destroyed
Defining Event:	Aircraft structural failure	Injuries:	1 Fatal
Flight Conducted Under:	Part 137: Agricultural

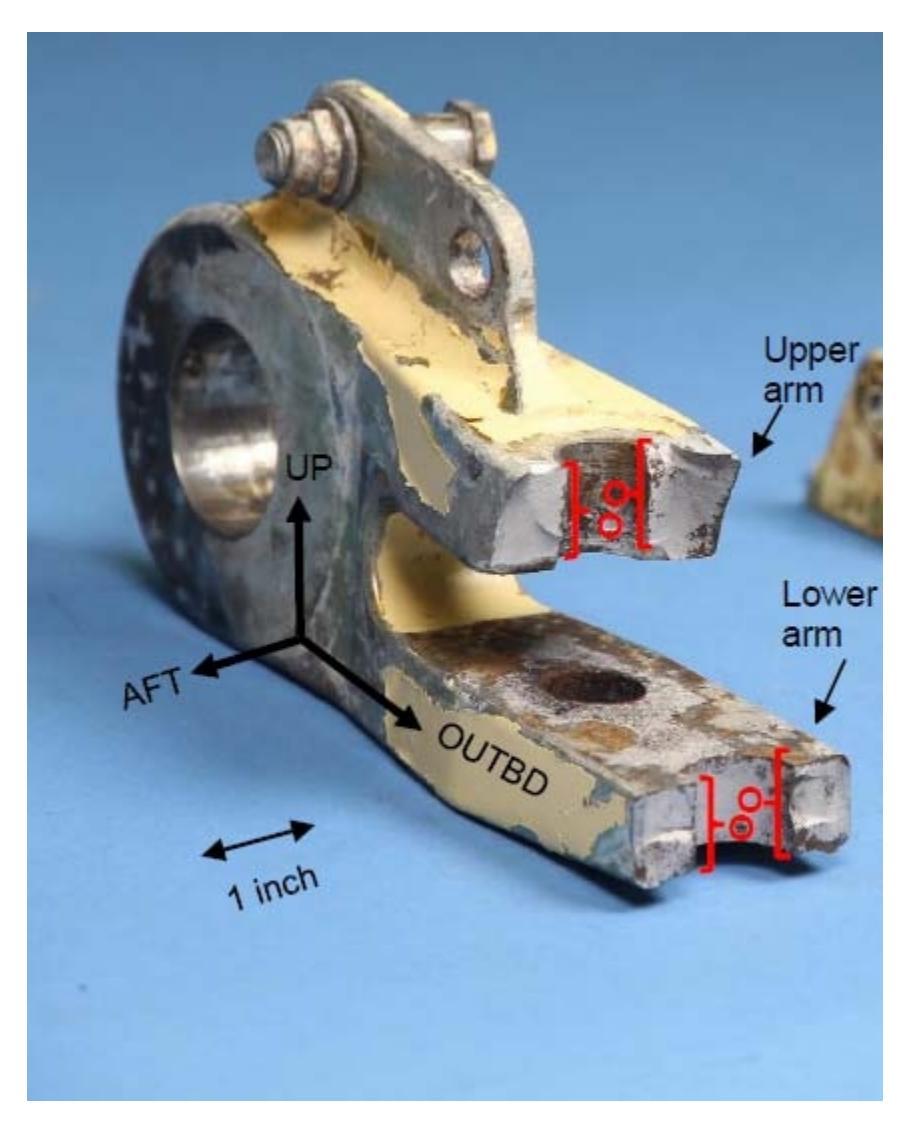
The right outboard wing forward spar lower fitting fractured through the upper and lower arms in the areas indicated by arrows in figure 1. Each arm contained six vertical bolt holes used to attach the fitting to the outboard wing forward spar. The fracture in the upper arm intersected the inboard vertical bolt hole, and the fracture in the lower arm intersected the second vertical bolt hole from the inboard end. Bench binocular microscope of the fractured arms revealed all the fracture faces contained fatigue cracks that emanated from the bore of the holes on diametrically opposite sides of each hole, in the areas indicated by brackets "O" in figure 1.

Figure 1. Right outboard wing forward spar, lower fitting.

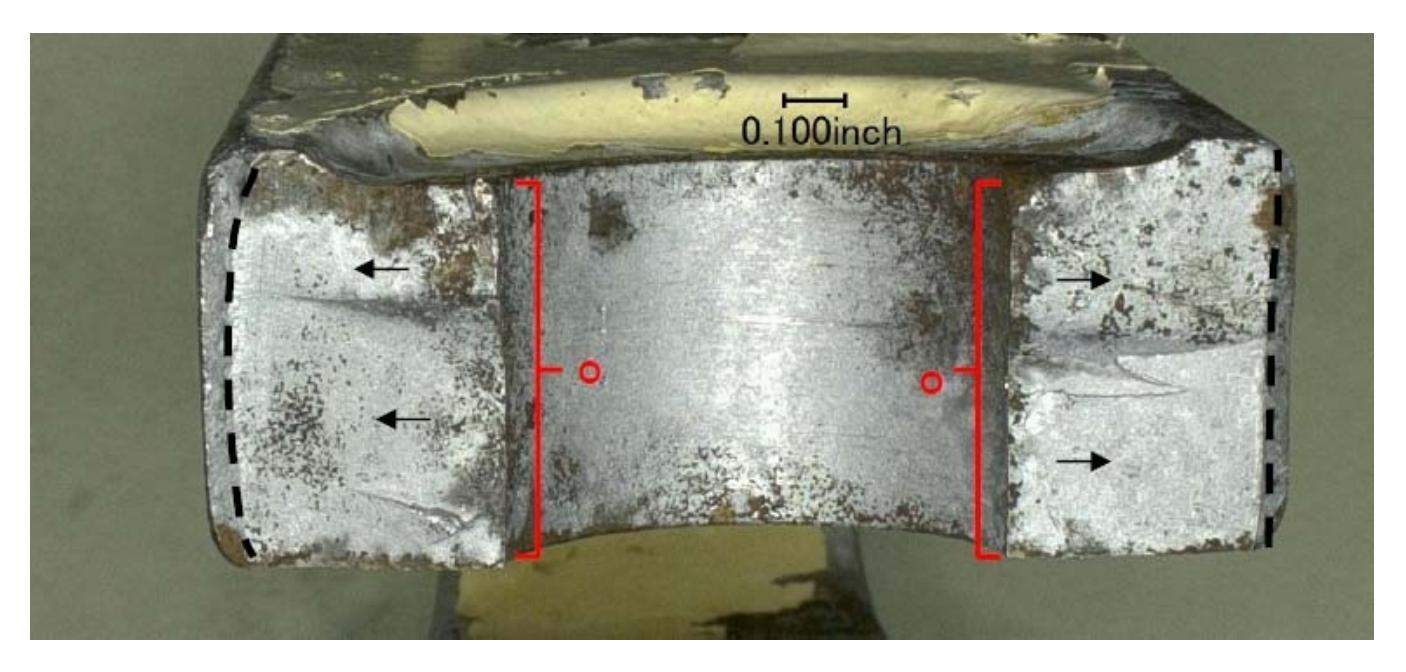
Figure 2 shows a photograph of the lower arm fracture faces. The fatigue cracks in the lower arms initiated from multiple origins along the entire length of the bolt hole, in the areas indicated by brackets "O" in figure 2. Most of the fatigue crack origins were associated with corrosion pitting in the bore. Fatigue propagation on each side of the hole was through a 90% of the thickness and terminated in the areas indicated by dashed lines in figure 2.

Figure 2. Right outboard wing forward spar, Lower fitting, Lower arm.

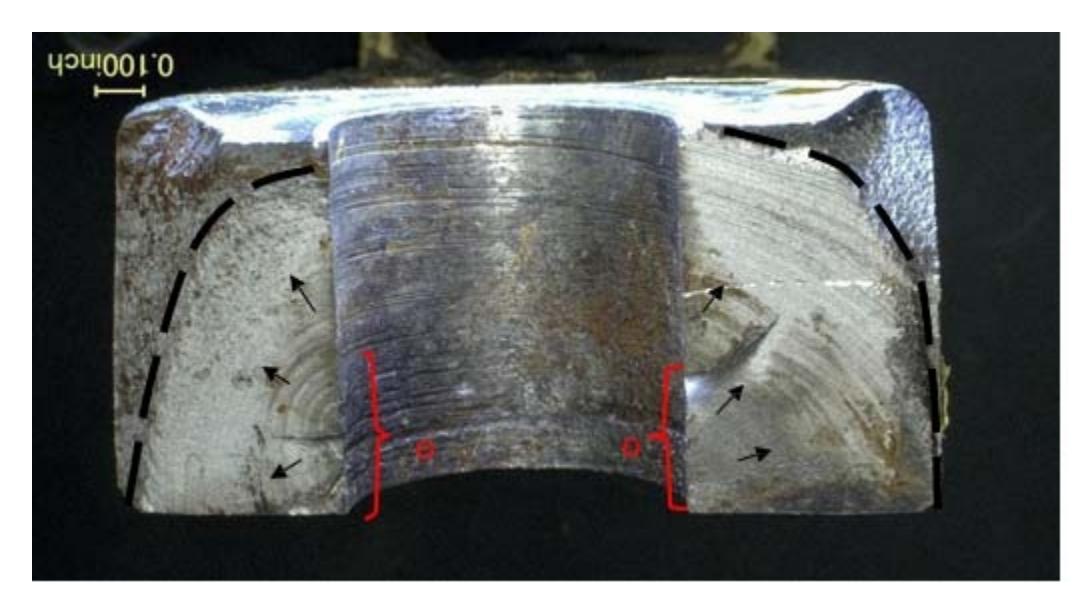
Figure 3 shows a photograph of the upper arm fracture faces. The upper arm fractures contained similar fatigue cracks with the exception that the fatigue cracks initiated from multiple origins near the lower portion of the bolt hole. Most of the fatigue crack origins were associated with corrosion pitting in the bore. The fatigue cracks in the upper arms exhibited better defined fatigue fracture features than those on the lower arms.

Figure 3. Right outboard wing forward spar, lower fitting, upper arm.

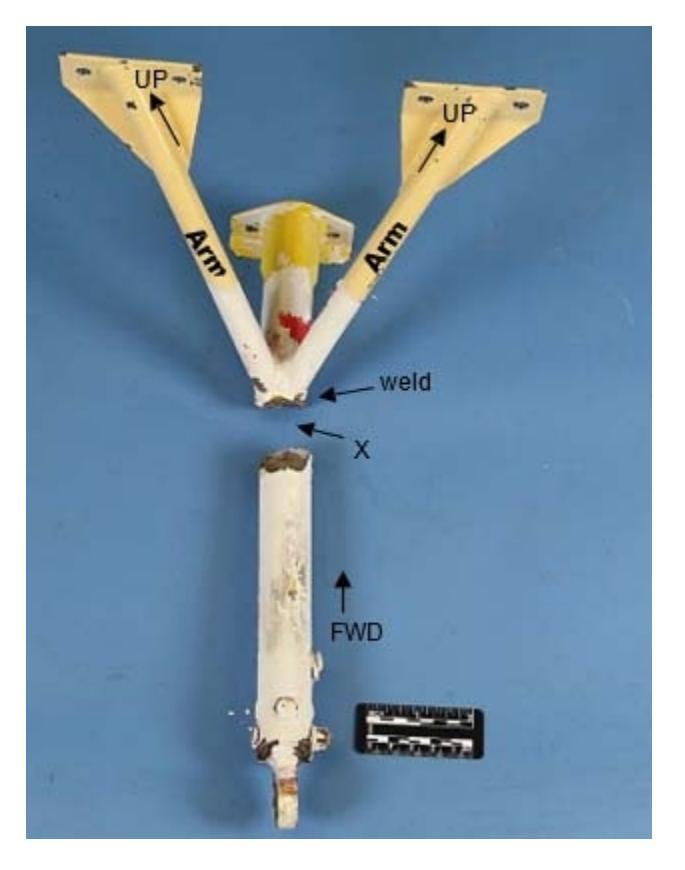
Figure 4 shows a photograph of the right outboard aileron attach bracket, which contained a circumferential fracture in the main tube portion, near the location where the two upper arms were welded to the main tube. The fracture intersected the aft edges of the welds at the base of the two arms, indicated by arrows "X" in figures 4. Bench binocular microscope examination of the forward face of the main tube fracture revealed multiple fatigue cracks that emanated from the outer surface of the main tube at the aft edges of the welds. Fatigue propagation was through about 50% of the thickness and extended around about 30% of the tube circumference. Corrosion was noted on the outboard tube surface.

Figure 4. Right outboard aileron attach bracket.
