Aerodynamic Stall and Loss of Control During Approach Embraer EMB-500, N100EQ Gaithersburg, Maryland December 8, 2014

NTSB/AAR-16/01 PB2016-103251

Aircraft Accident Report

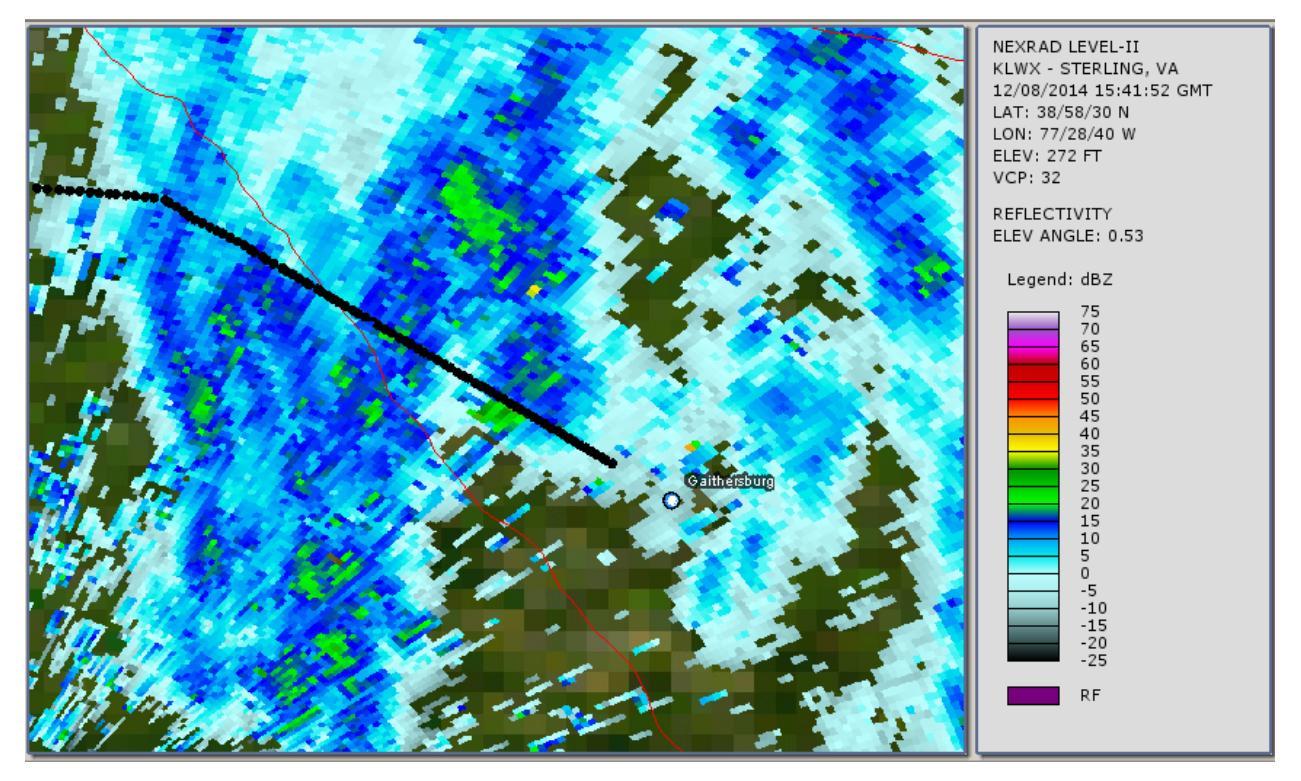
Figure 5. A Weather Surveillance Radar 88 Doppler base reflectivity scan with the accident airplane's flight track in black overlaid.

About 17 PIREPs were issued between 0845 and 1045 for conditions over the Washington, DC, area on the day of the accident.¹⁹ About one-third of these PIREPs indicated structural icing conditions between 2,500 and 5,300 ft. Most of these PIREPs reported light rime-type icing.²⁰ Multiple air carrier jet airplanes flying over the vicinity of the accident site reported icing conditions in the clouds, with cloud tops from 4,300 to 5,500 ft. A PIREP at 0845 near GAI indicated light clear-type icing at 4,000 ft and a temperature of -3° C. At 1045 (about 4 minutes after the accident), a pilot of an air carrier turboprop airplane immediately northwest

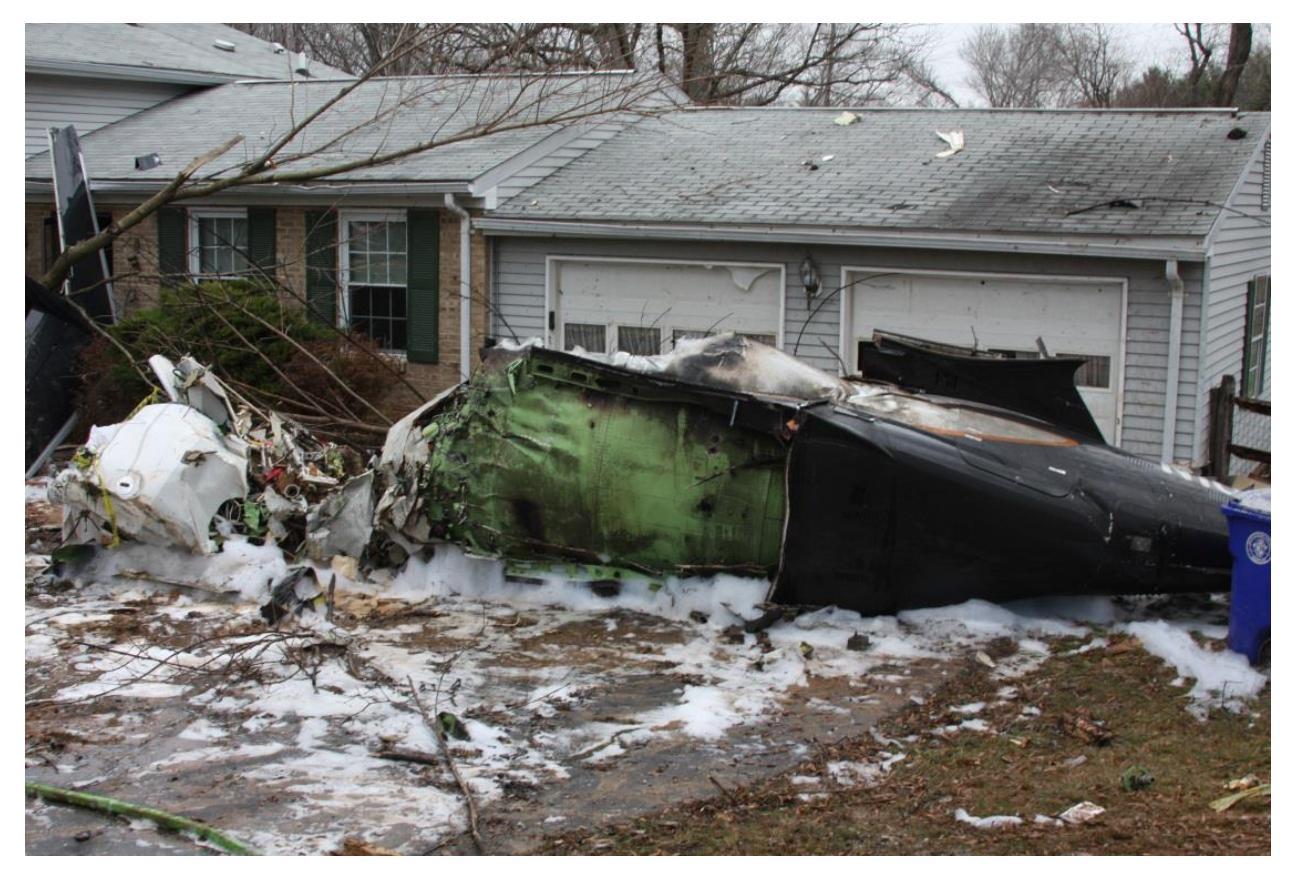
The fuselage was found on a 287° magnetic heading on the driveway of house B, facing the direction it came from. The portion with the cockpit came to rest in an inverted position, with heavy impact damage to the top half of the cockpit (see figure 6); the portion from the cabin door aft was found on its right side, and the cabin was consumed by fire. Damage to the ice protection/heating control panel was extensive, and it was not possible to visually determine the positions of the anti-ice or deice switches. The wing attach fittings on the center section of the fuselage were bent and broken, with both left fittings displaced aft and both right fittings displaced forward. The right wing leading edge was found in two segments on the driveway. Leading edge fragments from the left wing were found in the yard of house B. The tailcone and the left engine were located to the right of the house B driveway.

Figure 6. Photograph of the fuselage showing impact and fire damage to house B.
