DOT/FAA/AM-99/13

GPS User-Interface Design Problems

April 1999

Final Report

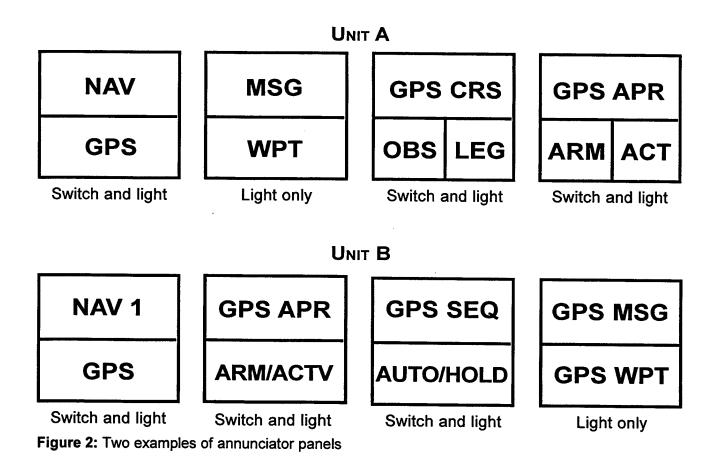
Also, annunciator panels can be made by a third party manufacturer, so that the panel for a particular unit can vary from airplane to airplane. The labeling of GPS modes varied across the units reviewed. Figure 2 shows two of the several different GPS annunciator panels reviewed.

In particular, notice the third box of each annunciator panel in Figure 2, labeled unit A and unit B respectively. TSO-C129a (FAA, 1996), Par (a)(3)(xi)(2), states that, "The equipment shall provide the capability for accomplishment of holding patterns and procedure turns. Activation of this function shall at least: a. Change automatic waypoint sequencing to manual. ... d. Permit the pilot to readily return to automatic waypoint sequencing at any time prior to the designated fix ("TO" waypoint) and continue with the existing flight plan."

For unit A, the annunciator button for manual interruption of autosequencing, for purposes of holding and procedure turns is called GPS SEQ, and includes two modes labeled AUTO and HOLD. Unit B labels their annunciator button GPS CRS, with the two modes labeled OBS and LEG. A third brand, not shown in the figure, does not have an external annunciator button and automatically enters the "hold" function when outbound on an approach and enters an "auto" sequence function when inbound. As will be discussed below, there can be confusion over the labeling and operation of a panel and receiver if a pilot is required to suspend and restart autosequencing.

Designing an "undo" function on all of these receivers would keep the pilot from becoming lost after making an entry error and reduce control inputs during critical phases of flight. Whether standards are imposed by the FAA, or volunteered by manufacturers, some standardization of button labels, annunciator panels, and displays is needed. At a minimum, a core set of GPS functions should be performed in essentially the same way for every unit on the market. John Steuernagle, of the Airplane Owners and Pilots Association Air Safety Foundation, has recommended that standardized procedures be designed for the following set of GPS functions (J. Steurenagle, personal communication, February 3, 1998):
